SOUTH ANDERSON WATER DISTRICT
142 SOUTH MAIN STREET
LAWRENCEBURG, KY 40342

CASE NO. 2008-00502

1. WHAT IS THE SPECIFIC DISTANCE BETWEEN THE METER BOX AND THE DAMAGE SITE ON THE DISTRICTS SIDE OF THE METER WHERE THE REPAIRS WERE MADE?

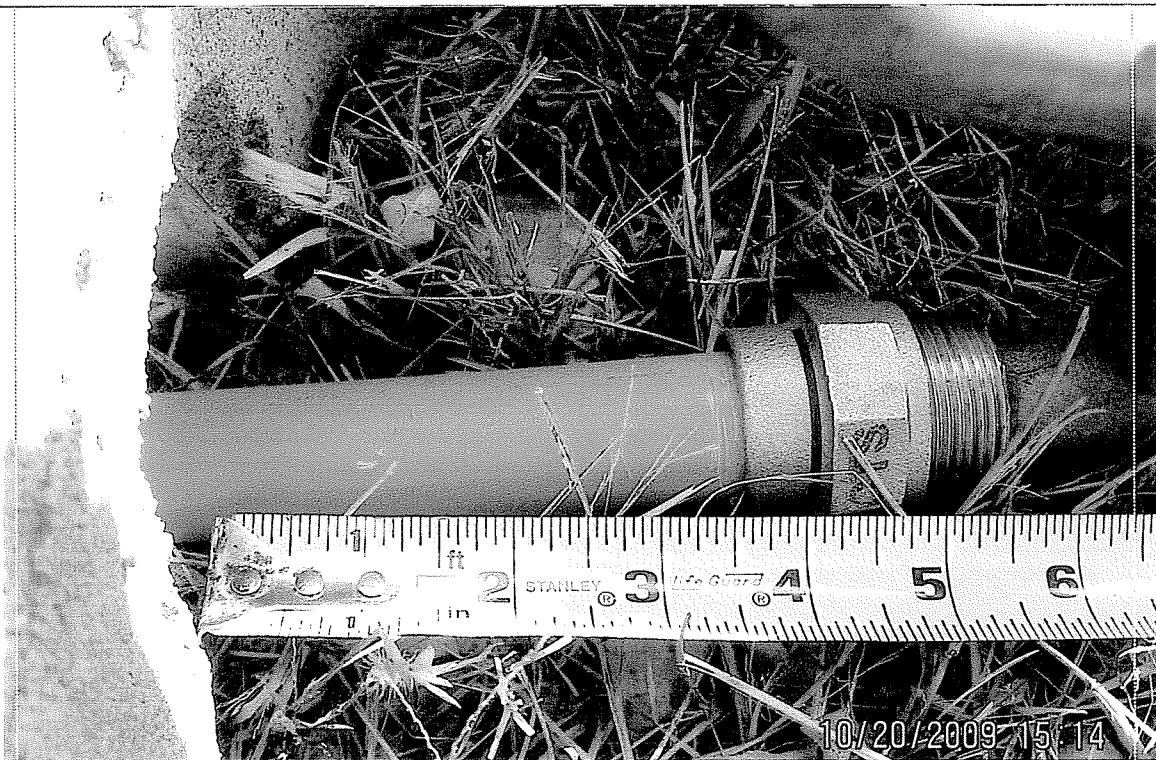
Photo shows approximate damage location of 3-4" from connection to meter setter. This is area of damage as found when excavated.

↑
Approximate damage location

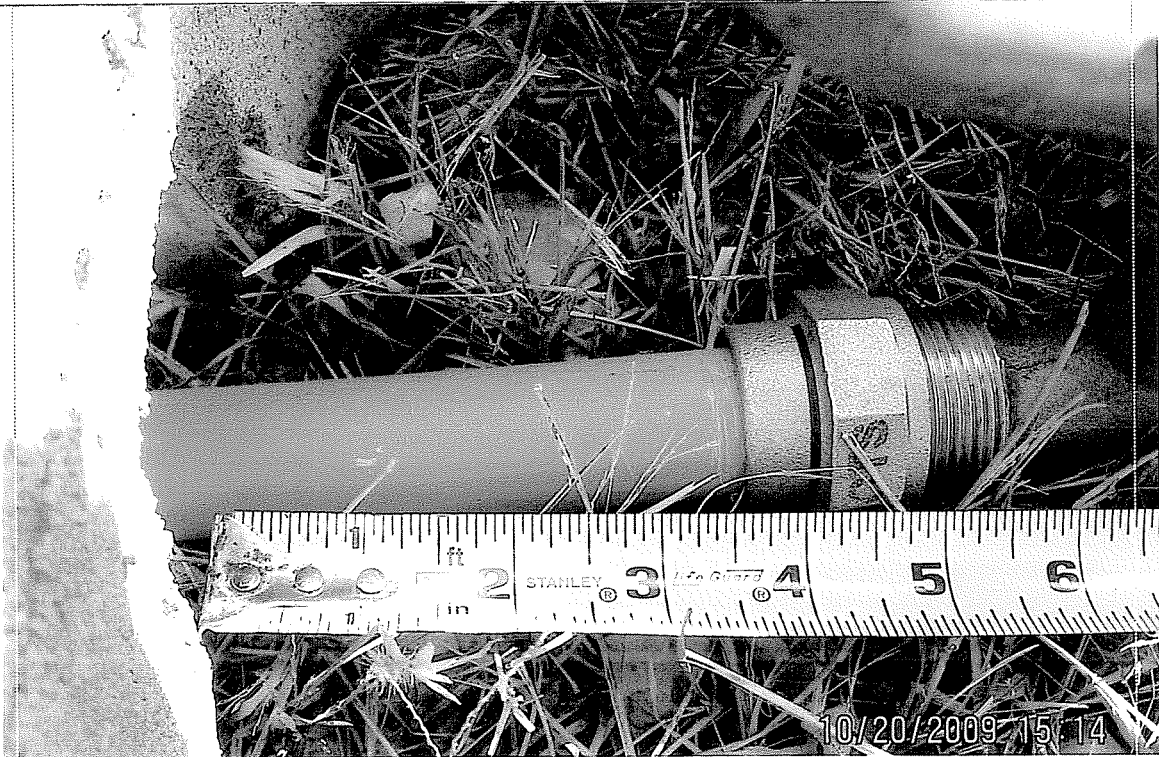
Photo shows approximate area of damage as discovered by district personnel when on site to repair. During the previous meter reading period no damage was noticed or reported by meter reader. This damage was reported by Ms. Johnstone after water would not stop after she attempted to cut off service.

End of Tape measure shows
Approximate spot of damage

Damage was reported late Friday afternoon of a three day holiday weekend by Ms. Johnstone. She reported that after she attempted to turn water off the water continued to run. I investigated the site and discovered that the line feeding the meter had been damaged. At the conclusion of the holiday weekend, I called our contractor about scheduling the repair to the area and had office staff contact BUD to locate any other utilities that may be in area. Returned to site after utilities had been located and scheduling/ weather allowed for repairs. Area was excavated with a backhoe and necessary repairs were made.

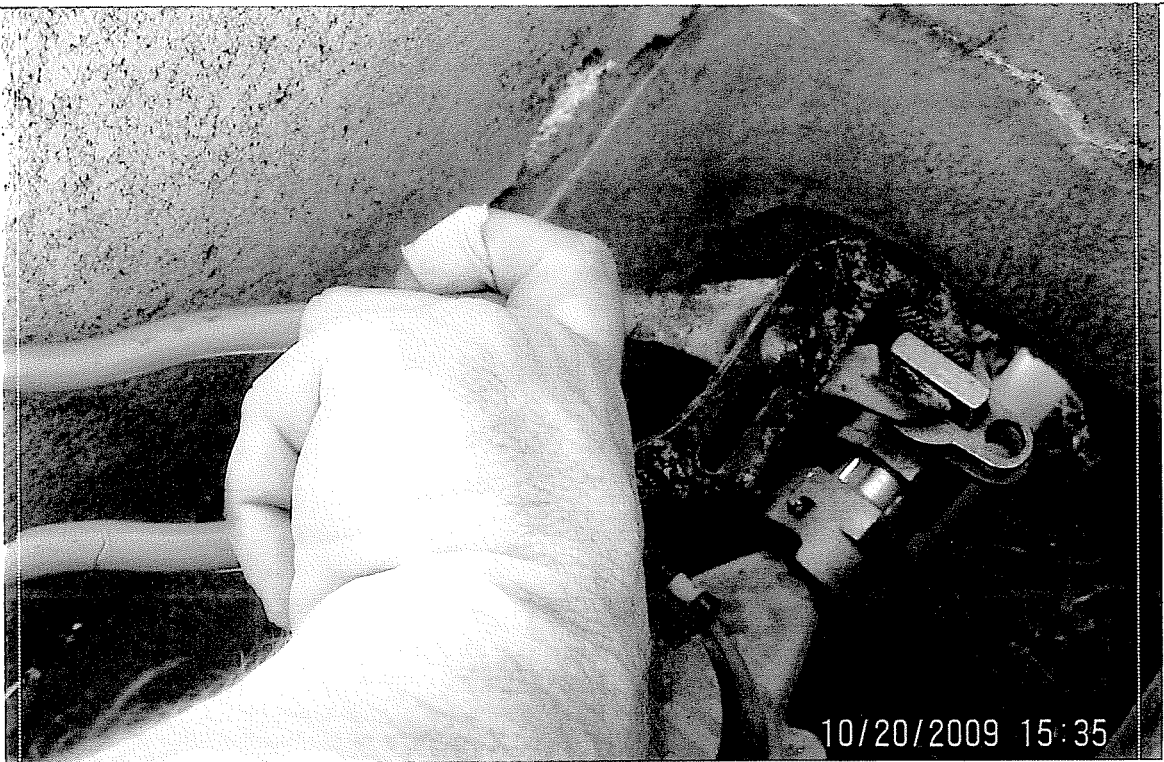
PHOTO#1

(A) Photo "A" shows vise grip pliers on the control valve of the meter setter. Pay special attention to the small work space and the end of the pliers against the concrete box. If this type tool is used it can cause excessive movement of the meter setter which can damage incoming and outgoing piping and fittings.

TOOL AGAINST METER BOX
