COMMONWEALTH OF KENTUCKY
BEFORE THE PUBLIC SERVICE COMMISSION

CASE NO.
2014-00141

**ANSWER TO KENTUCKY-AMERICAN WATER COMPANY'S FIRST REQUEST
FOR INFORMATION DATED MAY 30, 2014**

Address of Inspection: 3649 Winding Wood Lane

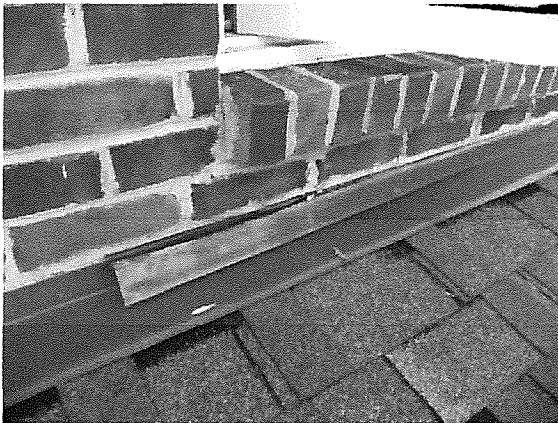
bricks could be a safety concern

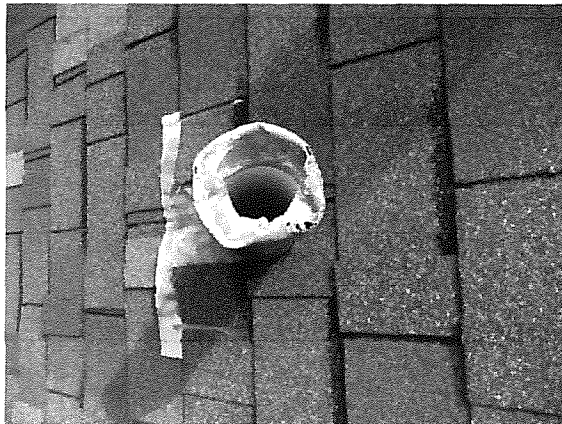
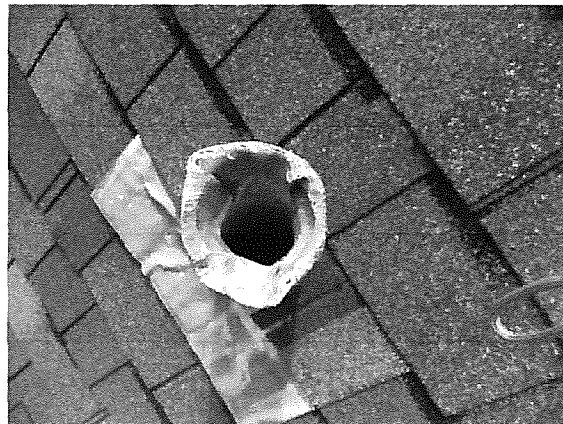
The lead boot around all of the plumbing vent pipes had openings in the top, which could allow water to drip down the pipe into the attic space. Repair or replacement should be made as necessary to help prevent water penetration into the attic space.

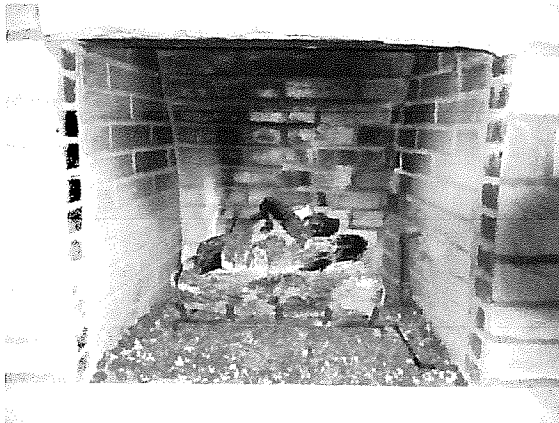
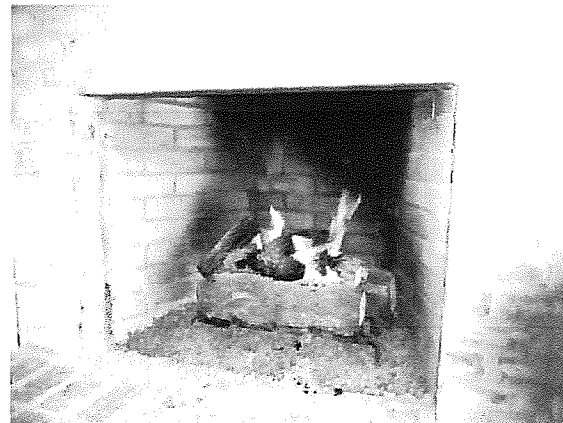
gas shut off valve for the basement fireplace gas log

The basement fireplace damper was not fully functional and should be repaired.

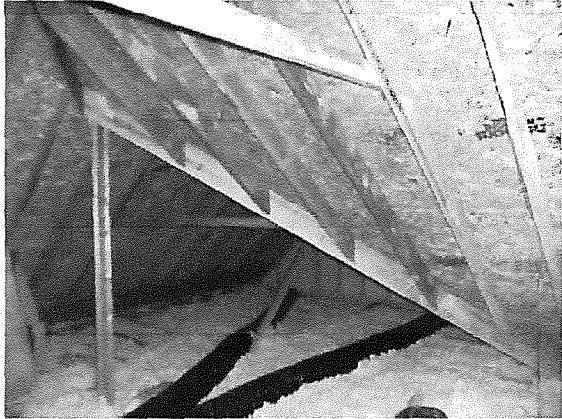
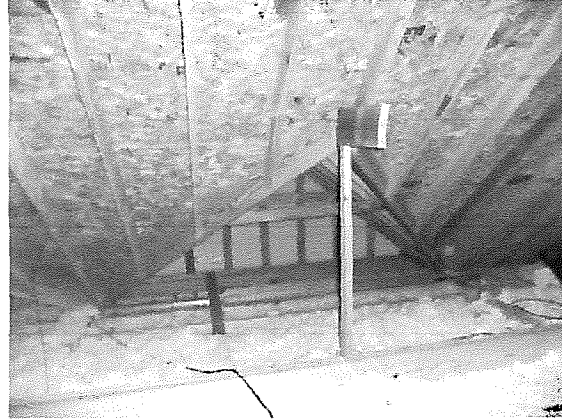
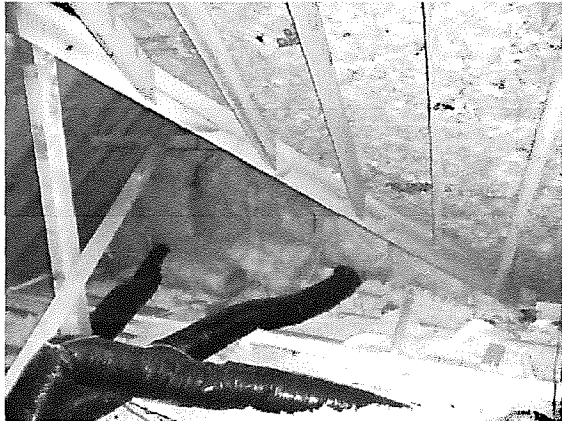
The roof structure valley rafters did not appear to be adequately supported with vertical bracing material. Adequate load-bearing bracing material should be installed to help maintain the structural integrity of the roof structure.
