Re: **BULLITT UTILITIES, INC.'S NOTICE OF SURRENDER
AND ABANDONMENT OF UTILITY PROPERTY**

**SUBJECT: Hunters Hollow Treatment Plant
Field Inspection for Steel Tank
Bullitt County, Kentucky**

**SUBJECT: Hunters Hollow Treatment Plant
Field Inspection & Analysis for Structural Slab/Foundation
Bullitt County, Kentucky**

**SUBJECT: Hunters Hollow Treatment Plant
Addendum for Field Inspection & Analysis for
Structural Slab/Foundation
Bullitt County, Kentucky**

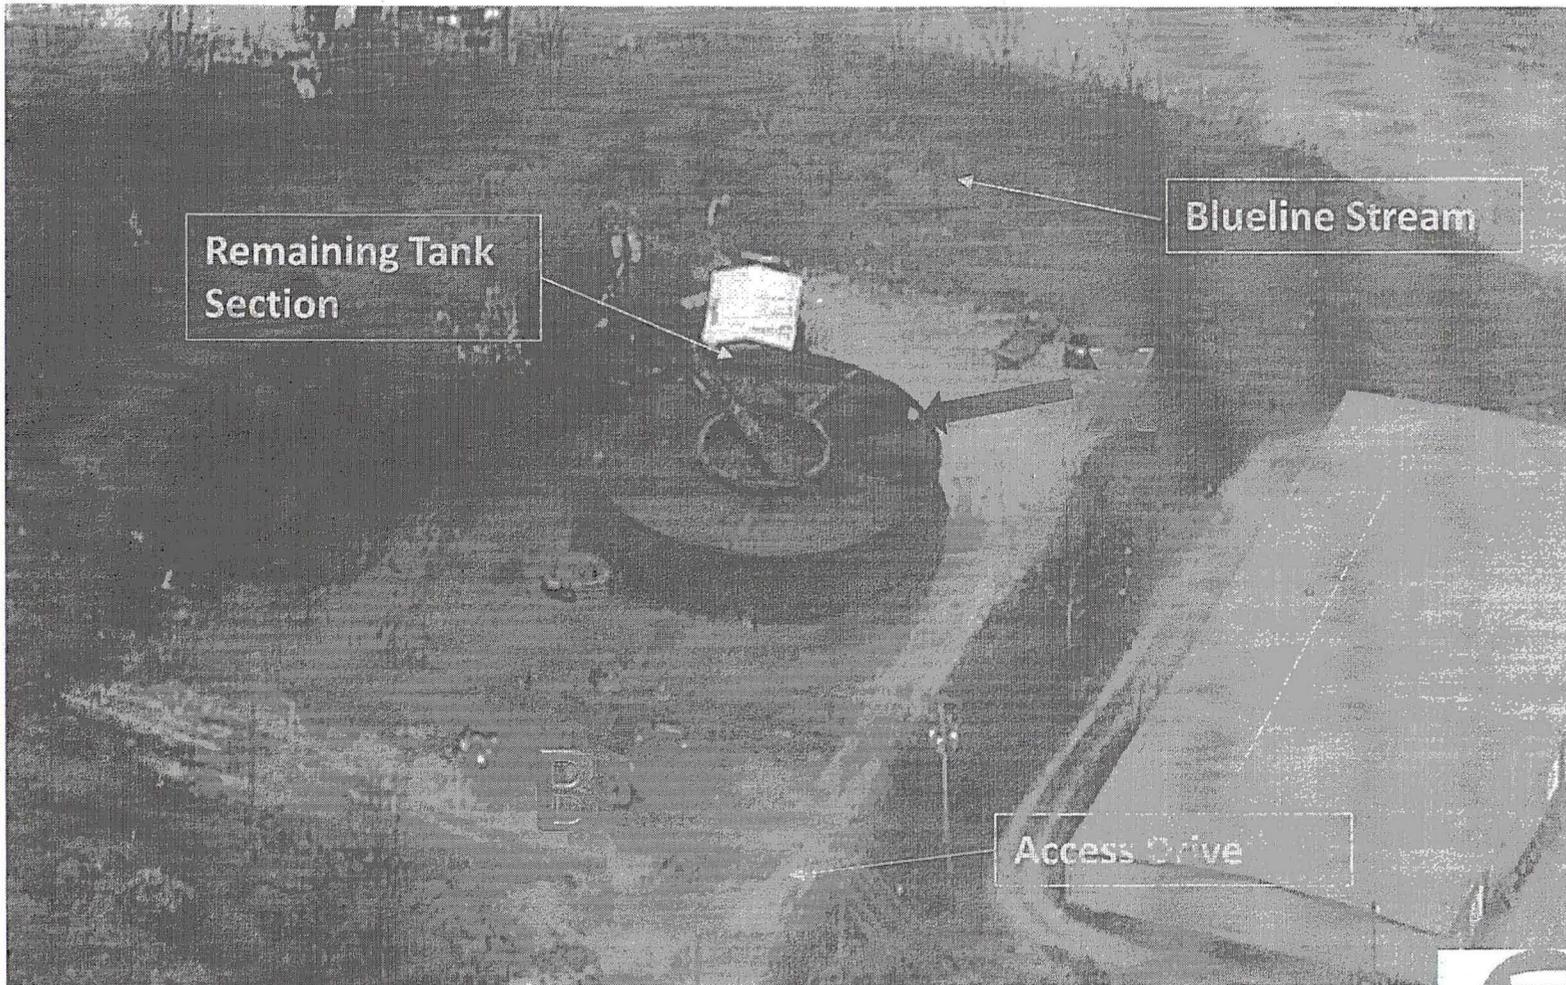
Exhibit "A" – Hunters Hollow WWTP
(looking East)

This letter serves as a summary of an additional structural field inspection to review the concrete foundation and slab for the subject treatment plant, after the sludge was vacuumed out to clean the area. The purpose of the inspection was to check the remaining concrete slab under the original tank, and to inspect the foundation area where the steel tank sides (and channel) were pulled away from the foundation during the failure. Reference Exhibit "A" to identify location of pictures taken during the review process (Exhibit "A" is an aerial view of the site prior to the failure looking east towards Blue Lick Road).
