COMMONWEALTH OF KENTUCKY  
BEFORE THE PUBLIC SERVICE COMMISSION

HENDERSON-UNION RURAL ELECTRIC COOPERATIVE CORPORATION, INC.	)	
_____	)	
ALLEGED FAILURE TO COMPLY WITH COMMISSION REGULATIONS	)	CASE NO. 90-260

ORDER TO SHOW CAUSE

ELECTRICAL UTILITY ACCIDENT INVESTIGATION

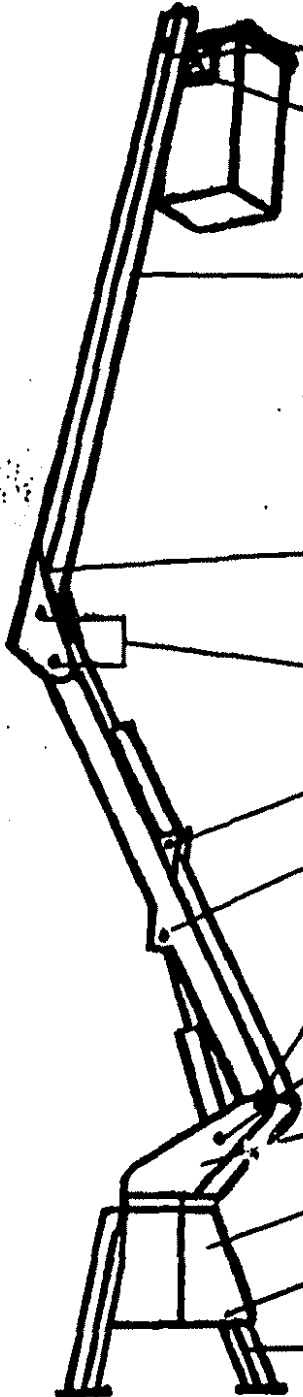
## BUCKET TEST REPORT

- PLATFORM PIN Could not be checked
- PLATFORM BRACKET OK
- UPPER CONTROLS OK
- BOOM EXTERIOR CONDITION OK
- ELECTRICAL HAZARD DECALS OK
- ELBOW WELDS OK - Lubricate chain
- ELBOW PINS OK
- CYLINDER BLOCK & PIN OK
- CYLINDER BLOCK & PIN OK
- LOWER CONTROLS OK
- MAIN BOOM PIN OK
- CYLINDER BLOCK & PIN OK
- TURRET WELDS OK
- LOWER PEDESTAL WELDS OK - Remove cover and grease rotation motor
- ANCHOR BOLTS OK
- OUTRIGGER WELDS OK
