COMMONWEALTH OF KENTUCKY  
BEFORE THE PUBLIC SERVICE COMMISSION

SOUTH KENTUCKY RURAL ELECTRIC	)	
COOPERATIVE CORPORATION	)	CASE NO.
_____	)	2009-00015
	)	
ALLEGED FAILURE TO COMPLY WITH	)	
KRS 278.042	)

**INCIDENT INVESTIGATION ~ Staff Report**

**Incident Date ~ August 5, 2008**

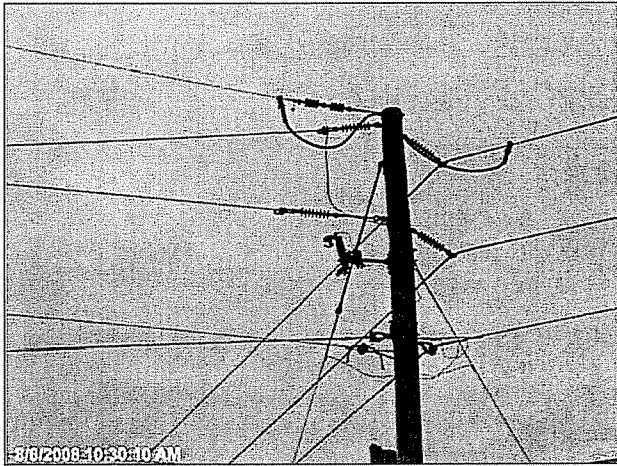
**#1**

# 1 looking up at take off pole # 128159. VB3 construction. Existing phase 6A CWC on top right hand side with Mechanical Jumper. Top left hand is short tap take off. Second take off is new conductor #2 ACSR that was pulled in to replace 6A.
