COMMONWEALTH OF KENTUCKY
BEFORE THE PUBLIC SERVICE COMMISSION

KENTUCKY POWER COMPANY)	
_____)	
ALLEGED FAILURE TO COMPLY)	CASE NO. 2016-00279
WITH KRS 278.042)

ORDER

Incident Investigation Staff Report

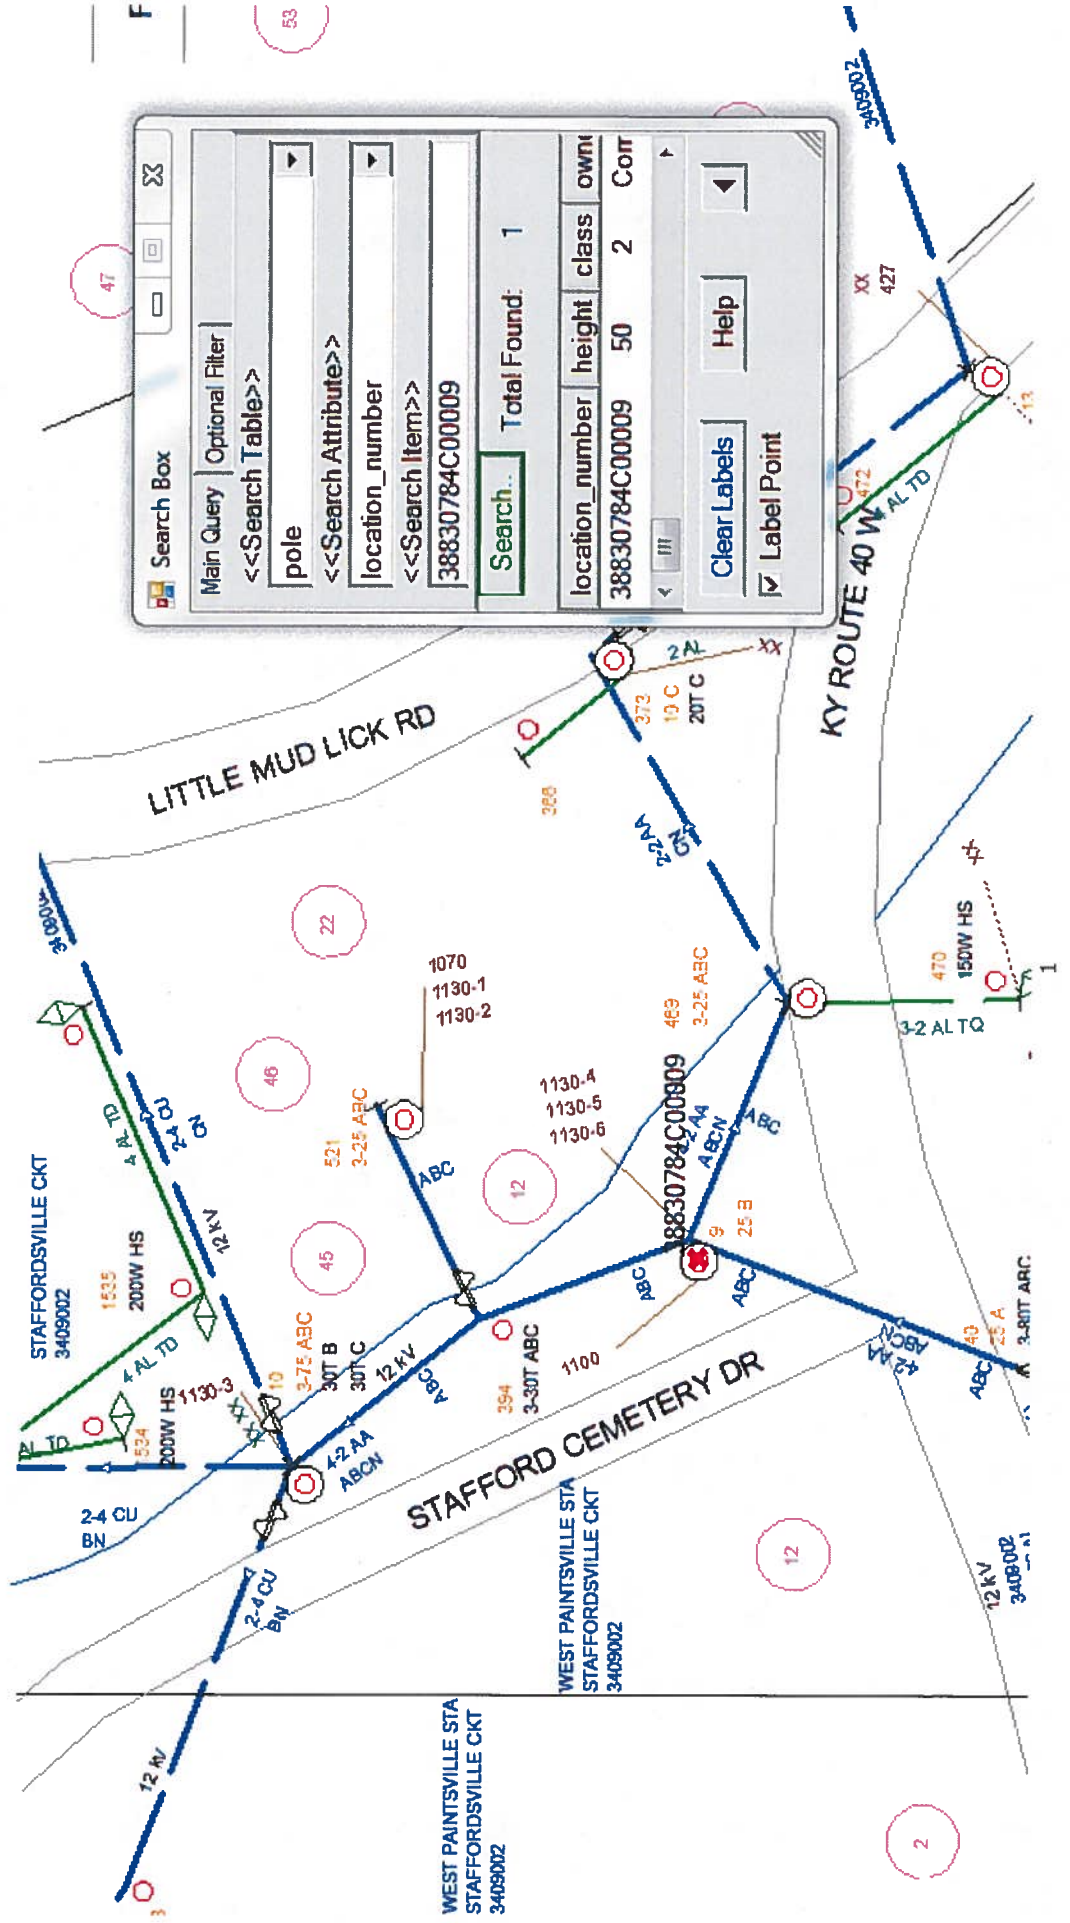
From: Dennis R Massey <drmassey@aep.com>
Sent: Sunday, July 13, 2014 9:21 AM
To: Dennis R Massey
Subject: Sent from Snipping Tool
