| CLOSURE OF INVESTIGATION OF |) | CASE NO |
| SEPTEMBER 9, 2019 INCIDENT – EAST |) | 2020-00075 |

ORDER

ACCIDENT INVESTIGATION STAFF REPORT

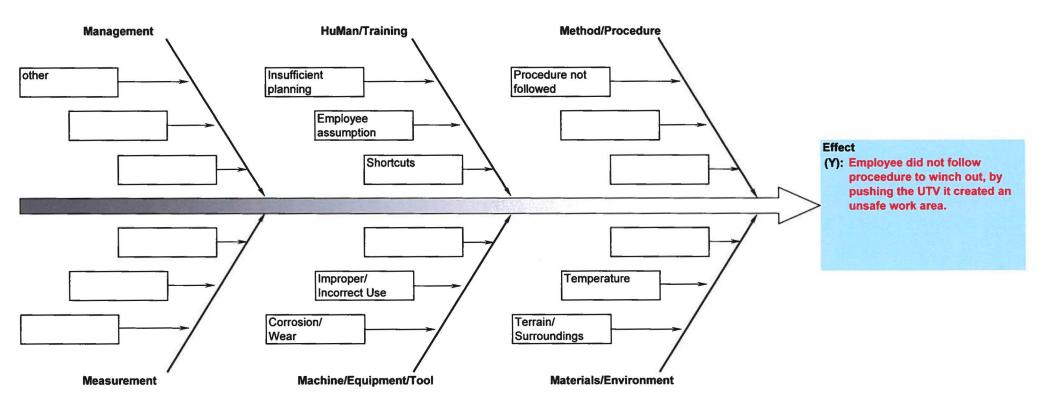
| | Incident State | ment | |
|---|---|---|--|
| WHY | Machine/Equip./Tool | Corrosion/ Wear | Tires were in poor condition |
