COMMONWEALTH OF KENTUCKY
BEFORE THE PUBLIC SERVICE COMMISSION

APPLICATION OF KENTUCKY UTILITIES)	CASE NO.
COMPANY FOR AN ADJUSTMENT OF)	2014-00371
ITS BASE RATES)

SUPPLEMENTAL RESPONSE OF
KENTUCKY UTILITIES COMPANY
TO
THE FIRST SET OF DATA REQUESTS OF
KENTUCKY INDUSTRIAL UTILITY CUSTOMERS, INC.
DATED JANUARY 8, 2015

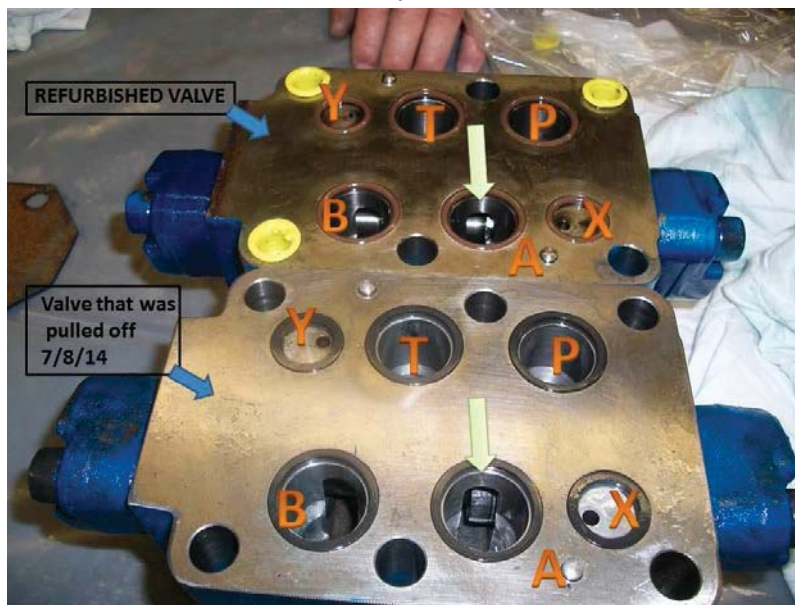
- Call with Rexroth regarding condition of trip manifold and pictures were sent (see attachment). There was water, varnish and oxidation in the ports and on spools. One of the pilot-operated valves did not shift at all and one only shifted partially. Commented that this unit was built in 2006 and didn't think that all the oxidation could have occurred in service. They were very concerned with the condition of the actuators based on what was seen in the trip manifold. According to Rexroth, actuators can only be rebuilt in Pennsylvania and would take weeks. Decision was made to flush through the actuators and trip them in addition to the hourly stroking as part of Hydra-lube's procedure.

- Meeting with Gary Williams from Hydra-Lube about EHC events and what actions can be taken to cleanse the system.
- Pilot Valves 305 and 301 pulled for inspection off the EHC trip manifold block around 6p.m. It was noticed that the spool positioning in those valves was different than that of the Refurbished Valves that had returned that day.

- Refurbished Valves placed on the EHC trip manifold that night

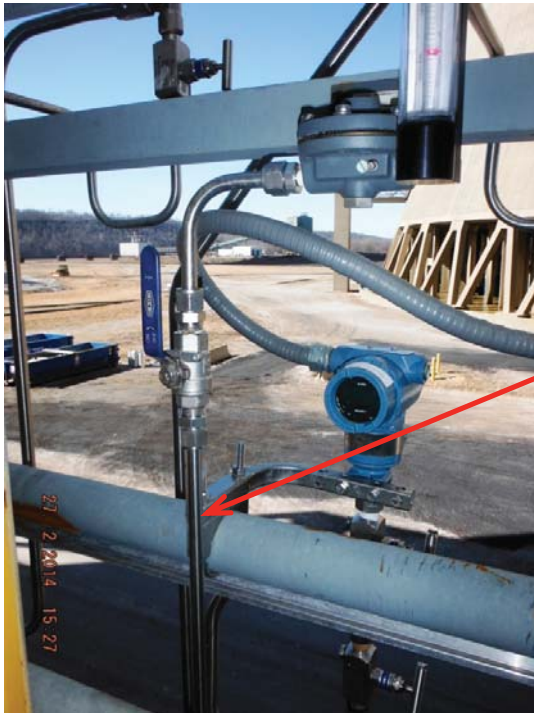
ID Fan Purge Units – Thermal Expansion – 28Feb14

The purge air inlet pipe to the flow control unit runs between a lower header and the metal body of the flow control unit and by inspection is sufficiently flexible

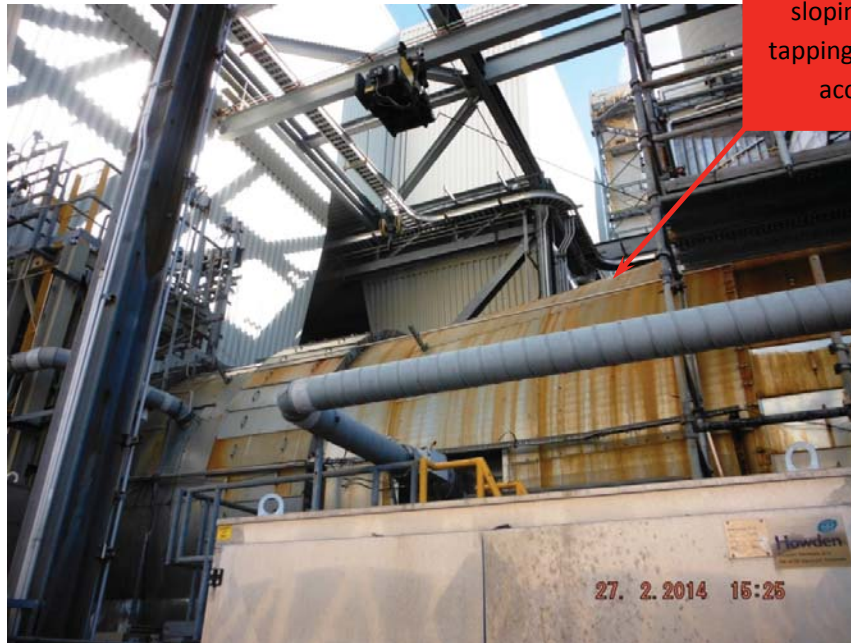
ID Fan A

Impulse pipe sloping towards tapping point and is acceptable

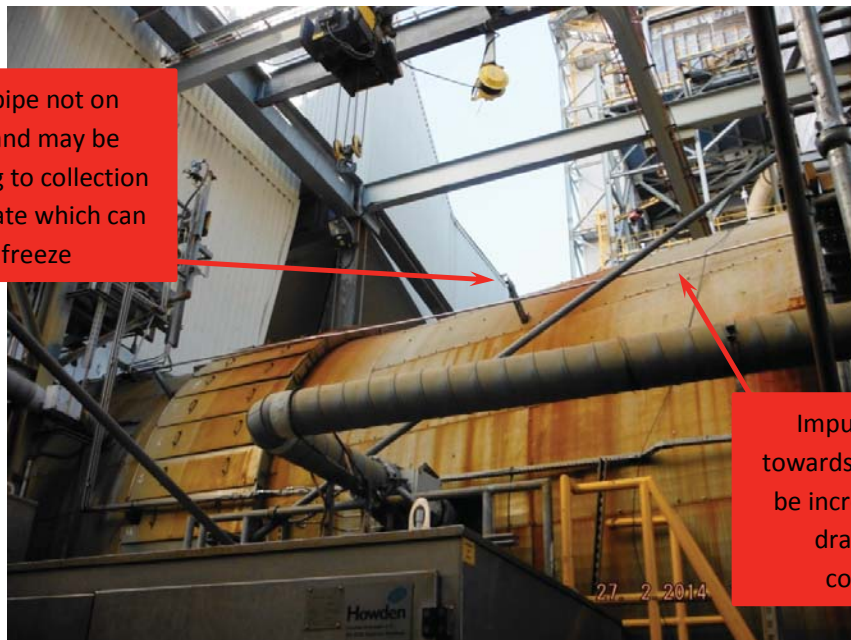
ID Fan B

Impulse pipe not on support and may be contributing to collection of condensate which can then freeze

Impulse pipe slope towards tapping point to be increased to ensure drainage of any condensation

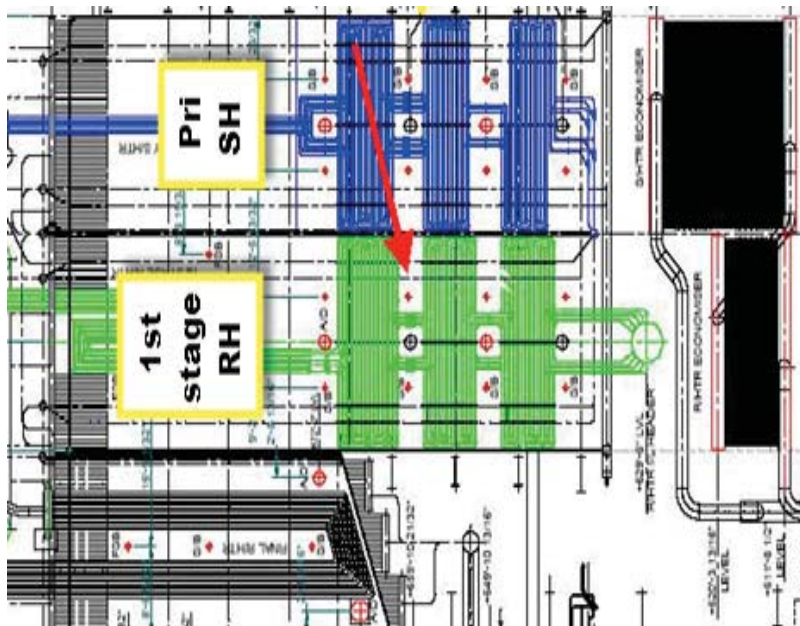
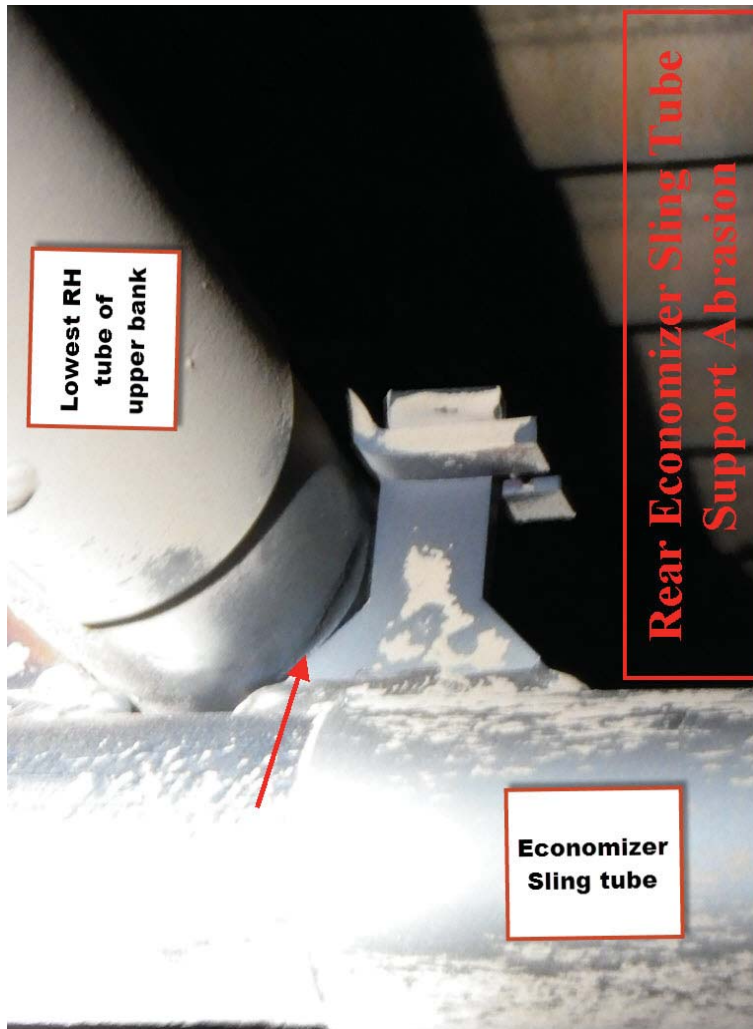
RH Backpass

141 out of 202 alignment straps were weld repaired

Between Top and Intermediate Bank

103 shields were installed IK 65/66 lane to protect the tubes from abrasion.

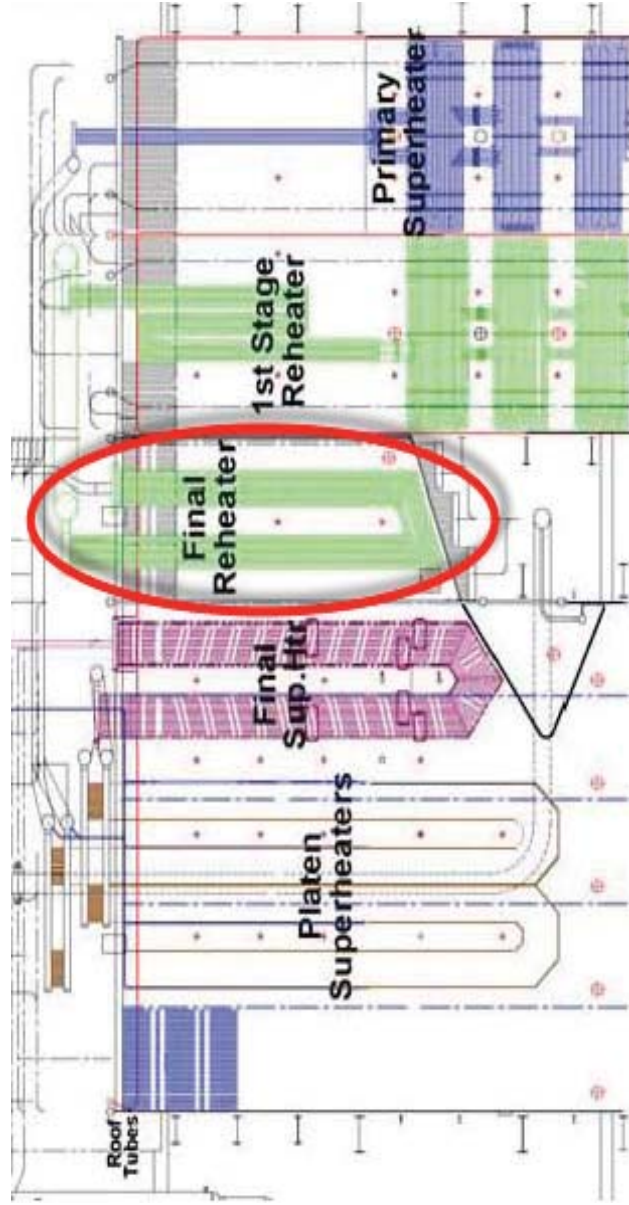
Final RH Pendant Assemblies

- Only minor erosion in IK-46/47 (lower) sootblower lane
- 14 of 68 RH assemblies are within 1 tube OD of each other at the rear; assemblies are to be on ~14" centers;
Effects: slag bridging, effects on gas flow, more risk for channeled sootblower erosion

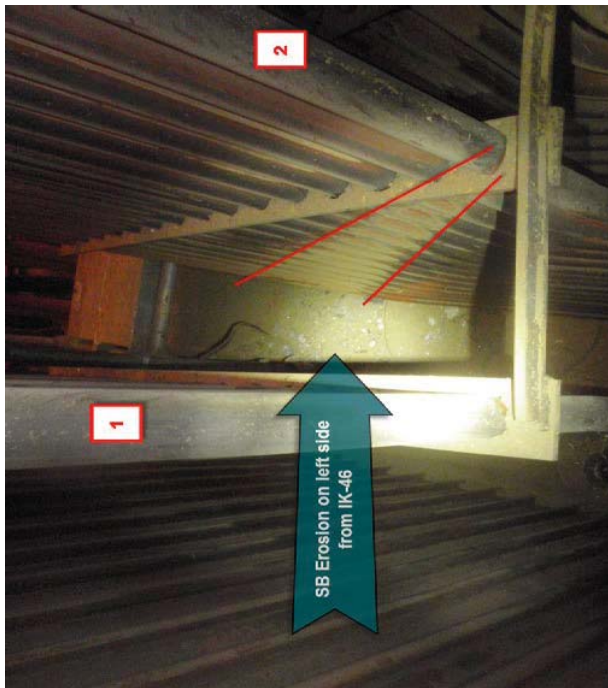
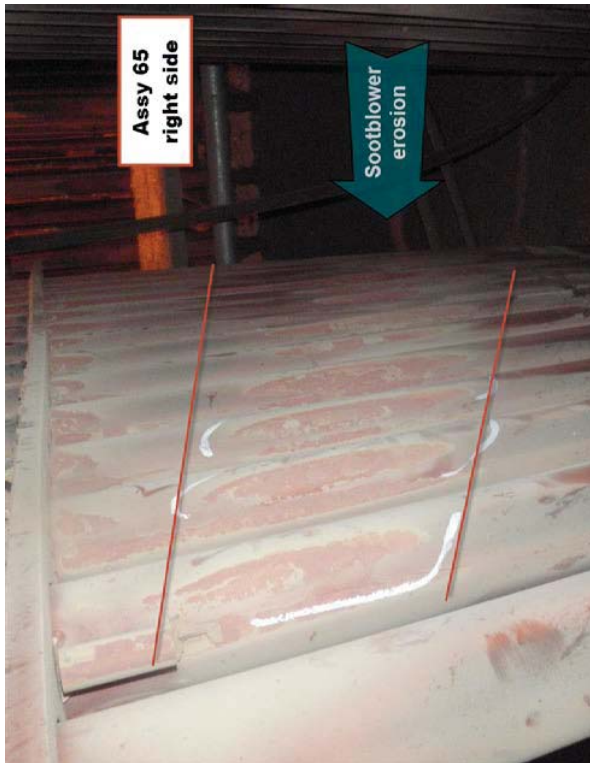
Final RH Pendant Assemblies

- Minor Erosion in IK-46/47 SB Lane

Consider installing SB indexing kits

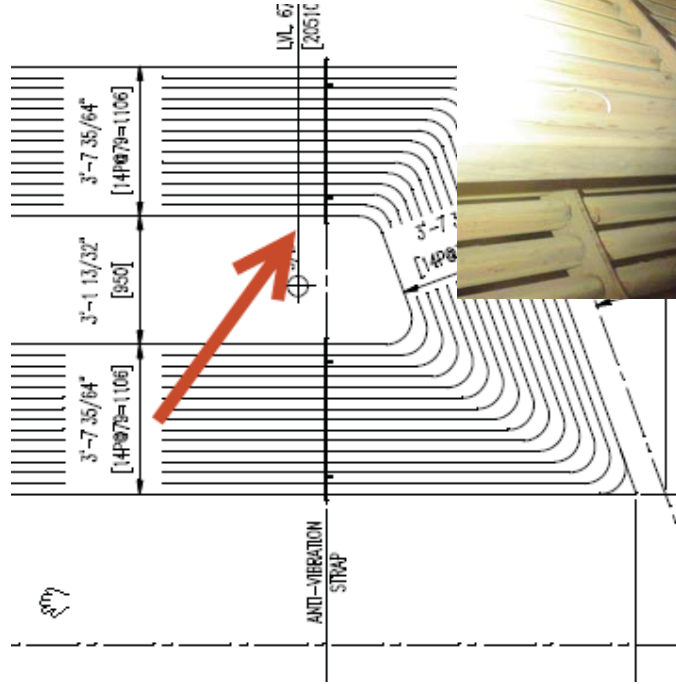
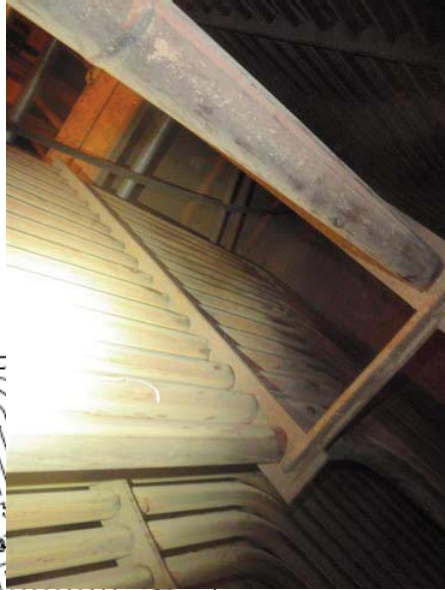
Final RH Pendants – Misalignment & Cupping

- Assembly to Assembly - 14 of 34 assemblies are within 1 tube diameter of each other at the rear
- Cupping - intra-assembly misalignment out of plain from the inside loop to the outside loop. Consider adding alignment system at rear side of assemblies.

Consider upgrading or installing additional alignment devices

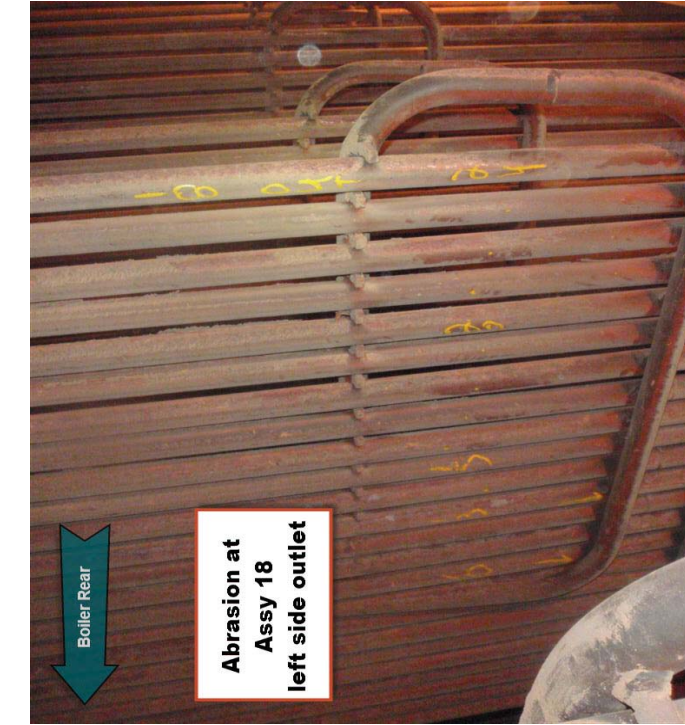
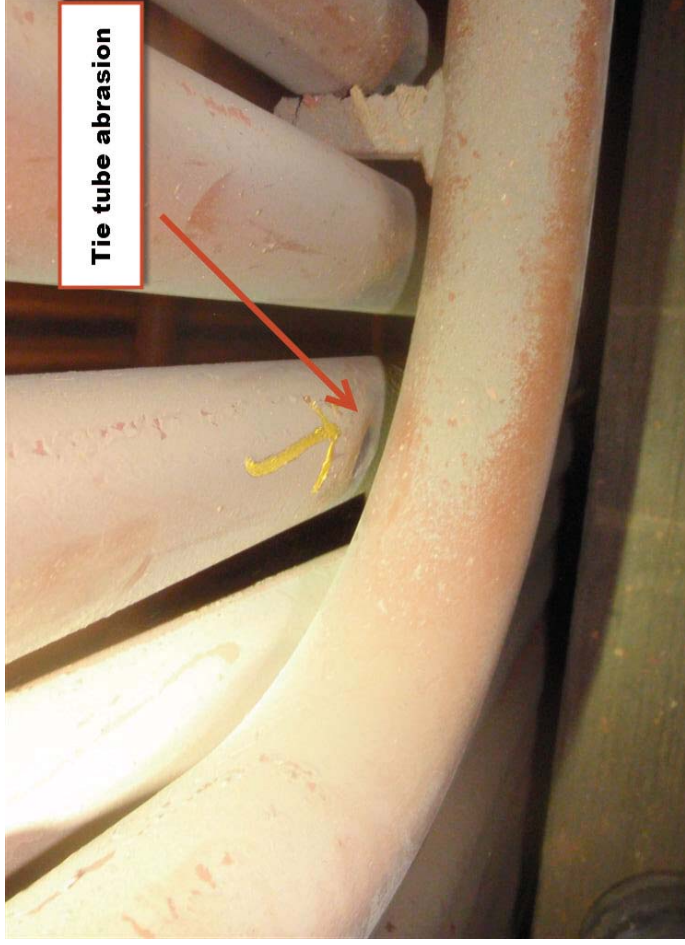
Final SH Pendant Assemblies - Minor Mechanical Abrasion

- Only inspected lower tie tube (paperclip) –limited access to front

Build scaffold to inspect front of assemblies and upper tie tube elevation

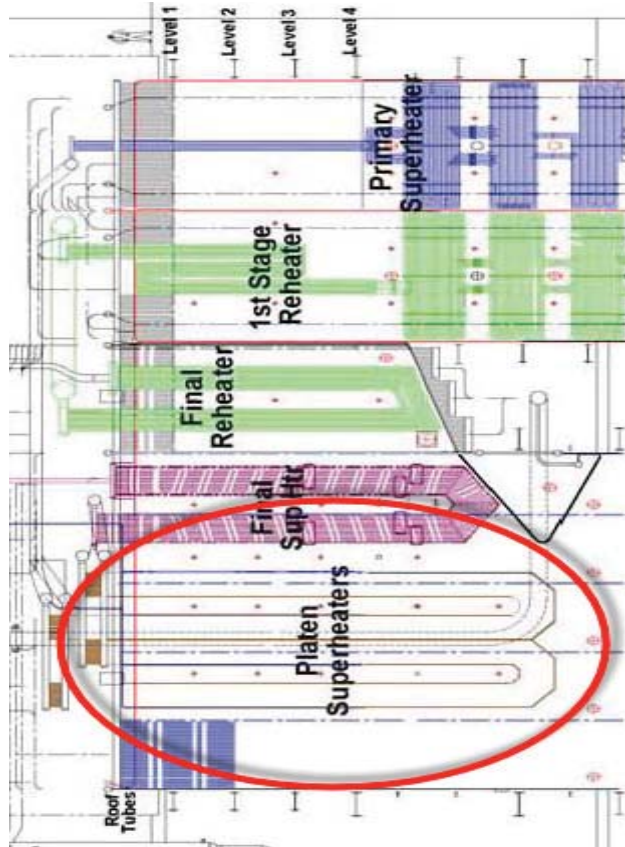
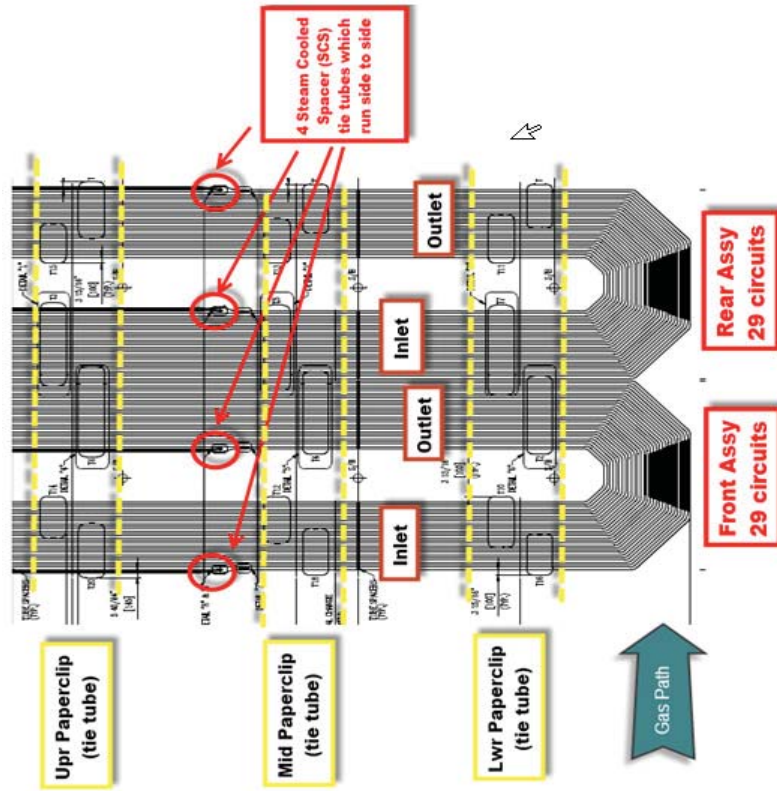
SH Platen Assemblies

18 Assemblies

Front and Rear

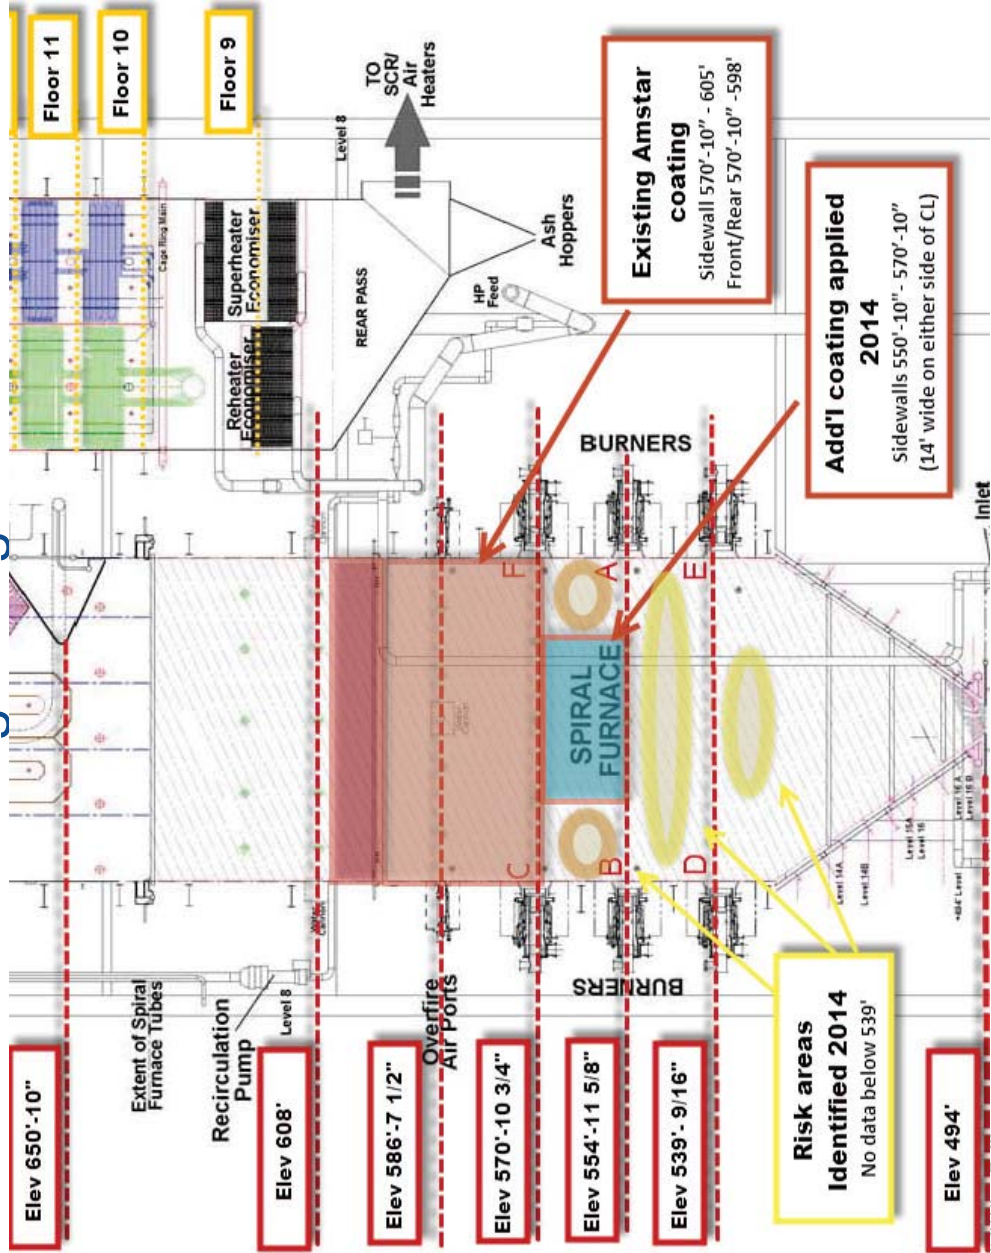
Wastage Mitigation

Waterwalls
