Re: Kenergy Corp.
Marion, Ky., office
Application for Certificate of Convenience
and Necessity

TESTIMONY OF TIM SKINNER

**INSPECTION
OF
EXISTING OFFICE / SERVICE FACILITY
KENERGY CORP
MARION, KENTUCKY
703 S. Main Street**

SKINNER EXHIBIT A

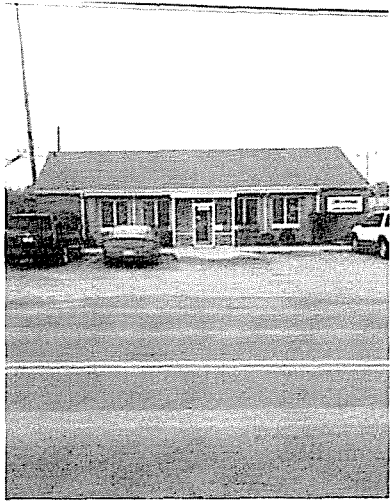
3.0 MAIN OFFICE BUILDING

This building was the original facility constructed in 1954. It is a wood framed facility with exterior brick veneer. The roof system is a gable with asphalt shingles. The windows are casement style aluminum. The current public entry fronts on Main Street. The actual finished floor of the office area is lower than the adjacent highway and the current parking lot slopes toward the building. This situation has caused site drainage problems to occur.

The facility has a serious problem with exterior water infiltration due to building construction problems and the building location. The lower level of the structure has had water in the building on numerous occasions. This water is caused by storm water that enters the building through various locations. Water is

entering thru cracks in the foundation wall system, roof system and under existing doorways. This is due to poor site grading. To correct these issues would require extensive site excavation and re-contouring of the existing grades. Exact repair requirements of the building could not be

determined until excavation takes place. This water infiltration has caused building deterioration and created some areas that contain active mold and mildew. Remediation of these areas would be required.

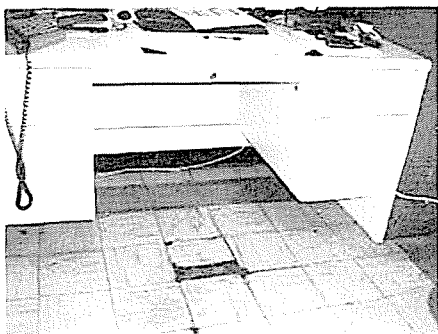
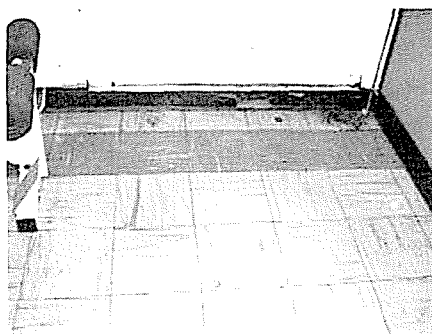
Several of the floor tile areas are asbestos. In some of these areas the tile has broken and has fragmented. These areas could potentially constitute a health hazard to both employees and members.
