City of Liberty

Re: Case No. 2016-00391
Investigation into Compliance of City of Liberty Gas
Company with KRS 278.495 and 49 CFR Part 192

DISTRIBUTION PLANT INSPECTION AND LEAKAGE REPAIR

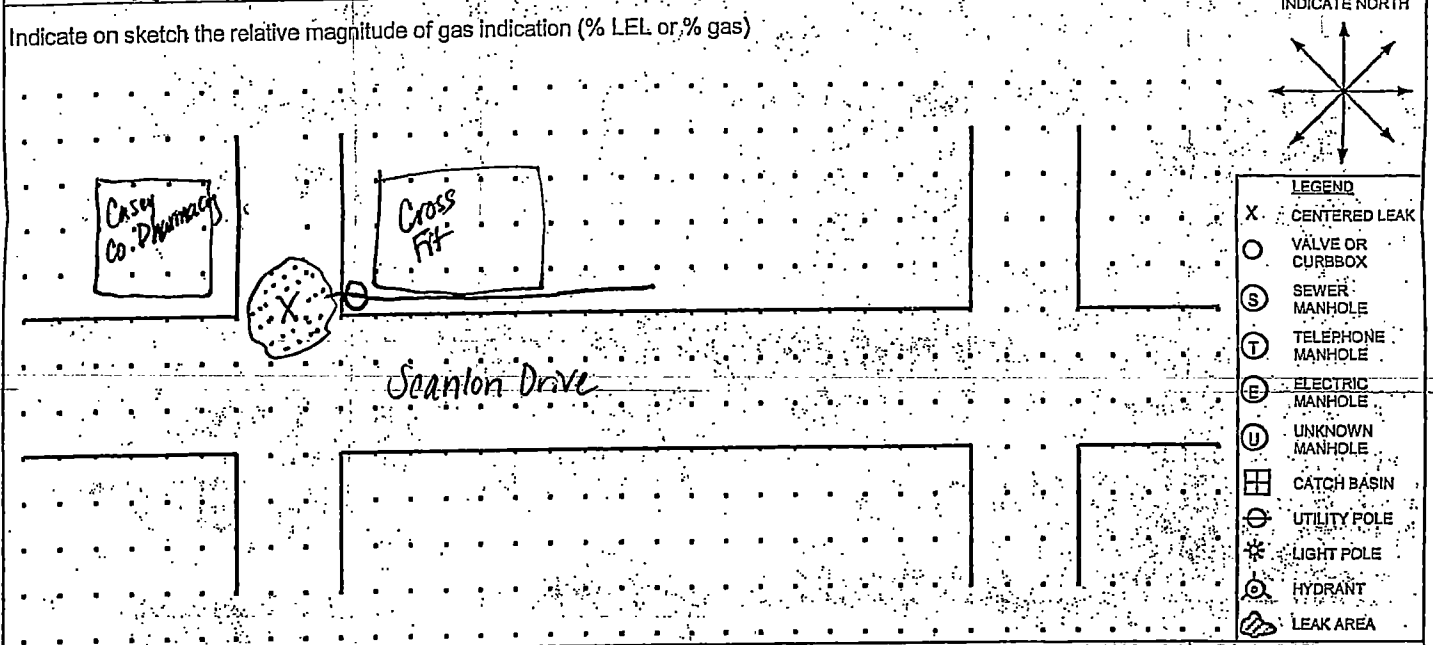
CO *	LOC. NO.	MAP NO.	SYSTEM NO.	DATE	ORIG. CODE *	REF. LEAK ORDER NO.	FOOTAGE INSP.	LEAK GRADE *	LEAK ORDER NO.
				<i>07/21/16</i>	<i>03</i>			<i>2</i>	
STREET NAME/RTE.-ADDRESS/LEAK LOCATION				MUNICIPALITY		COUNTY			R/R CODE *
<i>49, Scanlon Drive</i>				<i>Liberty</i>		<i>Casey</i>			
BETWEEN		AND		DETECTOR NUMBER		SERVICE OR WORK ORDER NUMBER		TIME FOUND	
<i>Casey Co. Pharmacy + Crossfit Building</i>									
GPS LONGITUDE (X) COORDINATE			GPS LATITUDE (Y) COORDINATE			GPS Z COORDINATE			
<i>37.319639</i>			<i>-84.927187</i>

Remarks: 50% gas detected in gravel lot 6 ft from EOP. Leak appears to be at tap tee.

LEAK CLEARANCE DATA	CLEARED BY CODE *	LEAK LOCATION CODE *	LEAK CAUSE CODE *	NO. CLAMPS INSTALLED	NO. ANODES INSTALLED	OPERATING PRESSURE CODE *	CLEARED DATE
	<i>25</i>	<i>52</i>	<i>G</i>	<i>0</i>	<i>0</i>	<i>MP</i>	<i>0.1/1.9/1.7</i>

REPAIRED BY	DATE	REINSPECTED BY	DATE	OTHER REFERENCE NUMBER (DAMAGE REPORT, FACILITY FAILURE REPORT, J.O., OTHER)
<i>Darren Atwood</i>	<i>1/19/17</i>			
CLEARED BY	DATE	REINSPECTED BY	DATE	
<i>Grey Rodgers</i>	<i>1/19/17</i>			
FOLLOWUP INSPECTION BY	DATE	REINSPECTED BY	DATE	PIPE TO SOIL POTENTIAL
FOLLOWUP INSPECTION RESULTS	NEW LEAK ORDER NUMBER (FOLLOWUP INSPECTION OR RECLASSIFICATION)			
<input type="checkbox"/> POSITIVE <input type="checkbox"/> NEGATIVE

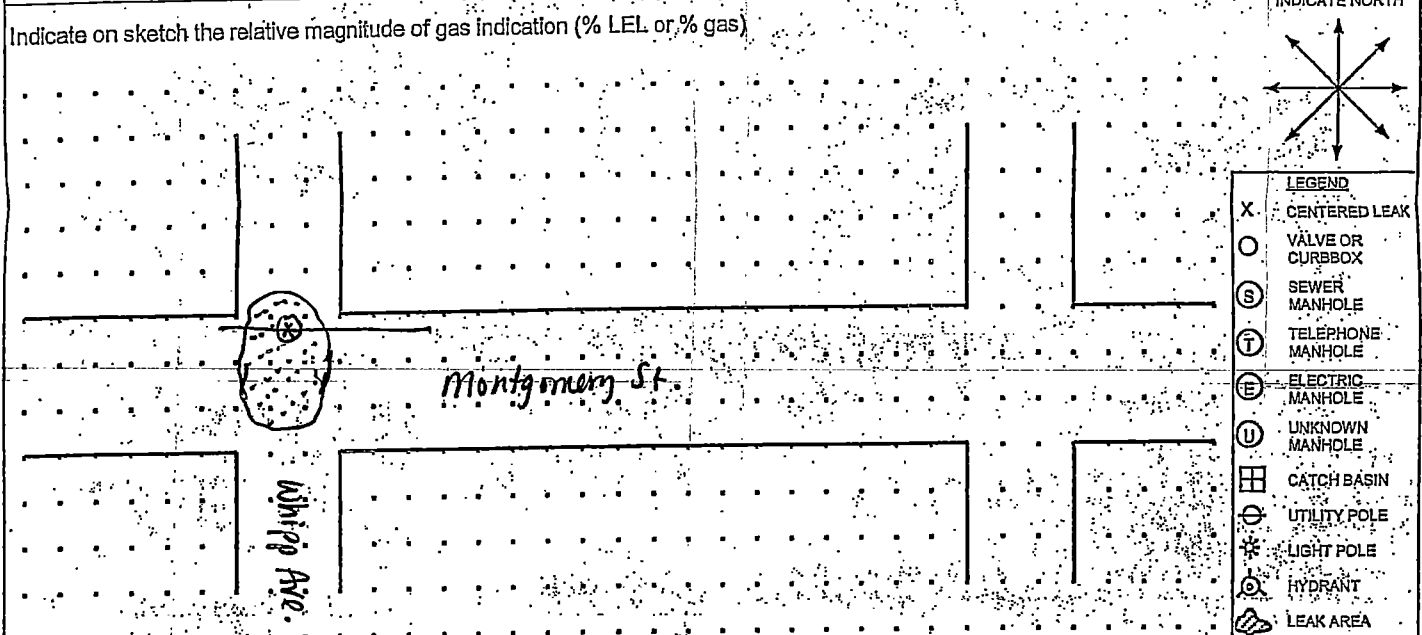
CO *	LOC. NO.	MAP NO.	SYSTEM NO.	DATE	ORIG. CODE #	REF. LEAK ORDER NO.	FOOTAGE INSP.	LEAK GRADE #	LEAK ORDER NO.
				07/21/16	03			2	
STREET NAME/RTE. ADDRESS/LEAK LOCATION				MUNICIPALITY		COUNTY		R/R CODE *	
MONTGOMERY ST + WHIPP AVE				LIBERTY		CASEY			
BETWEEN AND				DETECTOR NUMBER		SERVICE OR WORK ORDER NUMBER		TIME FOUND	
Intersection of Montgomery St. + Whipp Ave.									
GPS LONGITUDE (X) COORDINATE			GPS LATITUDE (Y) COORDINATE			GPS Z COORDINATE			
37.317821			-84.935168

LEAK CLEARANCE DATA	CLEARED BY CODE *	LEAK LOCATION CODE *	LEAK CAUSE CODE *	NO. CLAMPS INSTALLED	NO. ANODES INSTALLED	OPERATING PRESSURE CODE *	CLEARED DATE
	21	60	G	0	0	MP	0.1.19.17

REPAIRED BY	DATE	REINSPECTED BY	DATE	OTHER REFERENCE NUMBER (DAMAGE REPORT, FACILITY FAILURE REPORT, J.O., OTHER)
<u>Darren Howard</u>	1/19/17			
CLEARED BY	DATE	REINSPECTED BY	DATE	
<u>Greg Rodgers</u>	1/19/17			
FOLLOWUP INSPECTION BY	DATE	REINSPECTED BY	DATE	PIPE TO SOIL POTENTIAL
FOLLOWUP INSPECTION RESULTS	NEW LEAK ORDER NUMBER (FOLLOWUP INSPECTION OR RECLASSIFICATION)			VOLTS
<input type="checkbox"/> POSITIVE <input type="checkbox"/> NEGATIVE
