# City of Liberty

Re: Case No. 2017-00053

The leakage survey for the Liberty Gas System was completed by Heath Consultants in August 2017. During the survey, fourteen (14) grade 2 leaks were discovered in Liberty's gas system. Liberty Gas System has previously submitted a leakage repair report for eight (8) leaks found. Included in this letter, you will find four (4) more leakage repair reports and two (2) that have been monitored and are scheduled for repair from the Liberty Gas System as well as the Field Report from Heath Consultants.

**LEAKAGE CONTROL REPORT  
FIELD SURVEY**

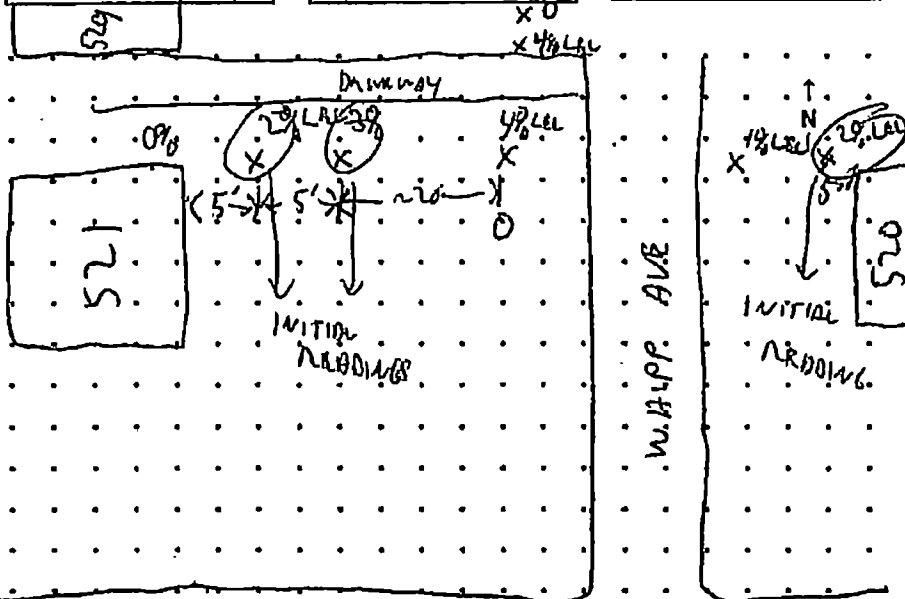
PRESSURE	
High	<input type="checkbox"/>
Intermediate	<input checked="" type="checkbox"/>
Low	<input type="checkbox"/>

CGI TEST	
Positive	<input checked="" type="checkbox"/>
Negative	<input type="checkbox"/>

LOCATION OF PIPE	
Street	<input type="checkbox"/>
Between St. & Sidewalk	<input type="checkbox"/>
Under Sidewalk	<input type="checkbox"/>
Lawn	<input checked="" type="checkbox"/>
Easement	<input type="checkbox"/>
R.O.W.	<input type="checkbox"/>
Other	<input type="checkbox"/>

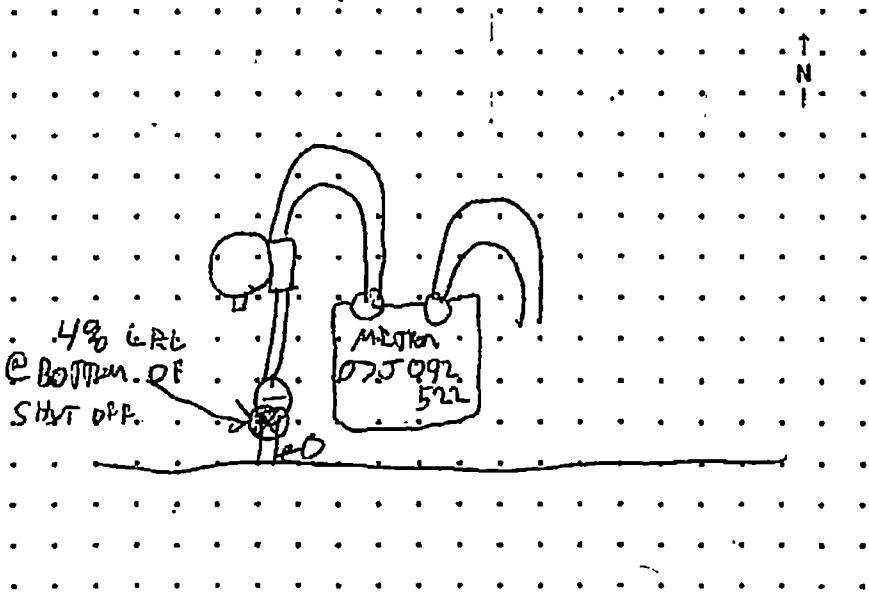
PRESSURE	
High	<input type="checkbox"/>
Intermediate	<input checked="" type="checkbox"/>
Low	<input type="checkbox"/>

CGI TEST	
Positive	<input checked="" type="checkbox"/>
Negative	<input type="checkbox"/>

LOCATION OF PIPE	
Street	<input type="checkbox"/>
Between St. & Sidewalk	<input type="checkbox"/>
Under Sidewalk	<input type="checkbox"/>
Lawn	<input checked="" type="checkbox"/>
Easement	<input type="checkbox"/>
R.O.W.	<input type="checkbox"/>
Other	<input type="checkbox"/>
