**Louisville Gas and Electric  
Company**  
State Regulation and Rates  
220 West Main Street  
PO Box 32010  
Louisville, Kentucky 40232  
www.lge-ku.com

**RE: *Louisville Gas and Electric Company Alleged Failure to Comply with  
KRS 278.495, 807 KAR 5:022, and 49 C.F.R. Part 192  
Case No. 2017-00119***

The following three couplings were removed from LG&E's transmission system:

## Bolt-Style Coupling (pressures > 3 psig)

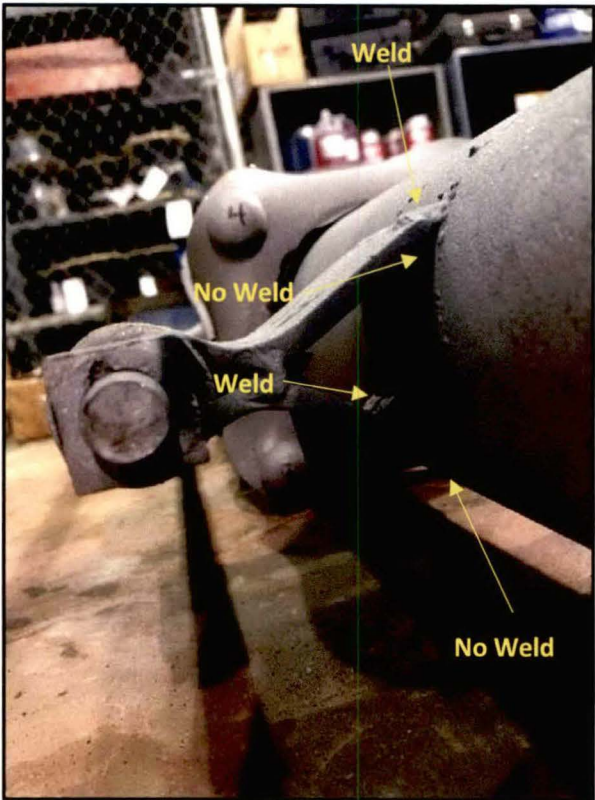
Figure 11- Lug A1 Welds

Lugs (Weld Quality)						
Pipe Side	Lug Number	Any part detached from pipe?	Welded on all sides of exterior? If no, describe	Are welds on exterior continuous? If no, describe	Welded on all sides of interior? If no, describe	Are welds on exterior continuous? If no, describe
A	1	Not completely.	No, no weld on outside of bottom leg. (Figure 11)	Yes on the top leg. No exterior weld on bottom leg.	No, no weld on inside of top leg. (Figure 11)	No, the interior weld on the bottom leg is not continuous. No interior weld on top leg.
A	2	Not completely.	No, no weld on outside of bottom leg. (Figure 12)	Yes on the top leg. No exterior weld on bottom leg.	No, no weld on inside of top leg. (Figure 12)	Yes on bottom leg. No interior weld on top leg.
B	1	Not completely.	No, no weld on outside of bottom leg. (Figure 13)	Yes on the top leg. No exterior weld on bottom leg.	No, no weld on inside of top leg. (Figure 13)	Yes on bottom leg. No interior weld on top leg.

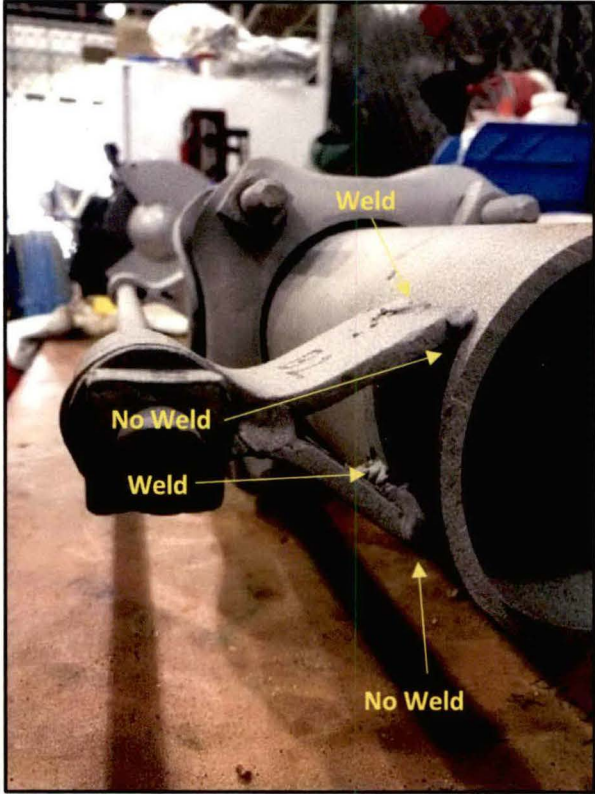
Figure 14- Lug B2 Welds

B	2	Not completely.	No, no weld on outside of bottom leg. (Figure 14)	Yes on the top leg. No exterior weld on bottom leg.	No, no weld on inside of top leg. (Figure 14)	Yes on bottom leg. No interior weld on top leg.

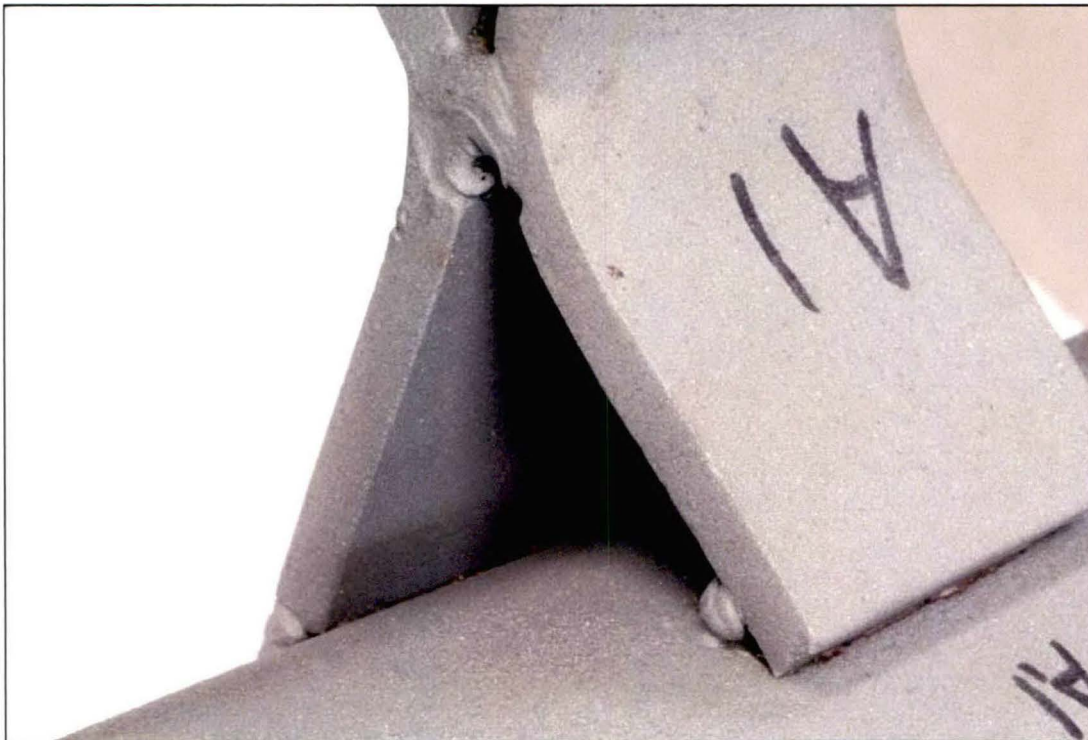
Figure 13. Image of the Lug A1 interior top weld (left) and the exterior bottom weld (right).

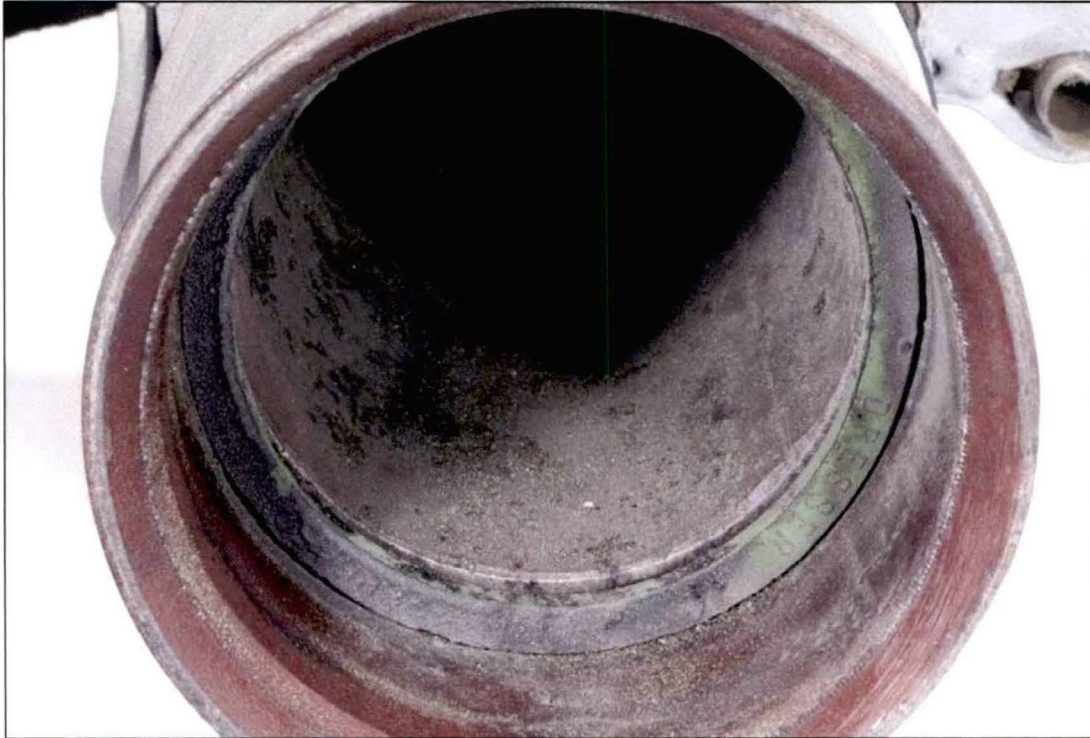
Figure 15. Photograph into the End A pipe section with the coupling attached. The green pipe separator ring was evident.

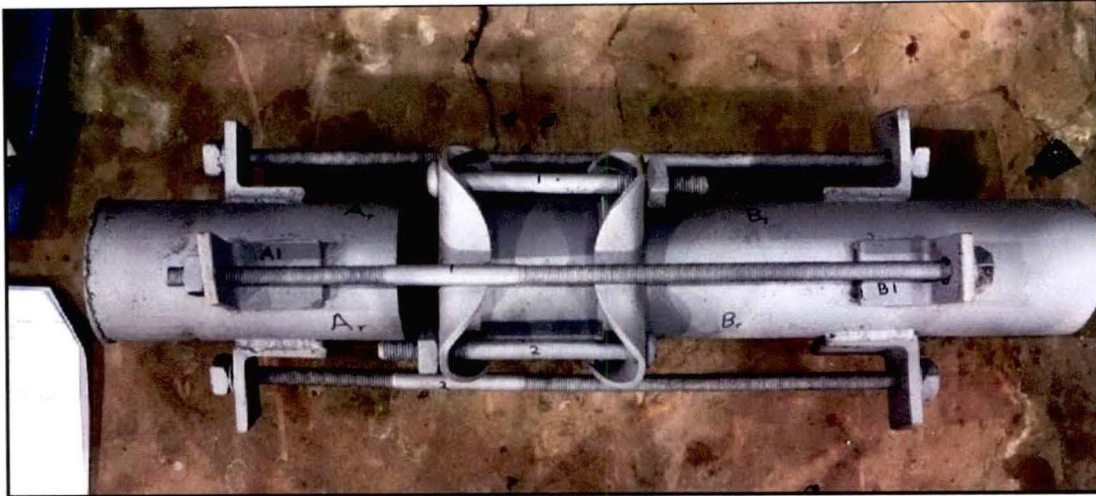
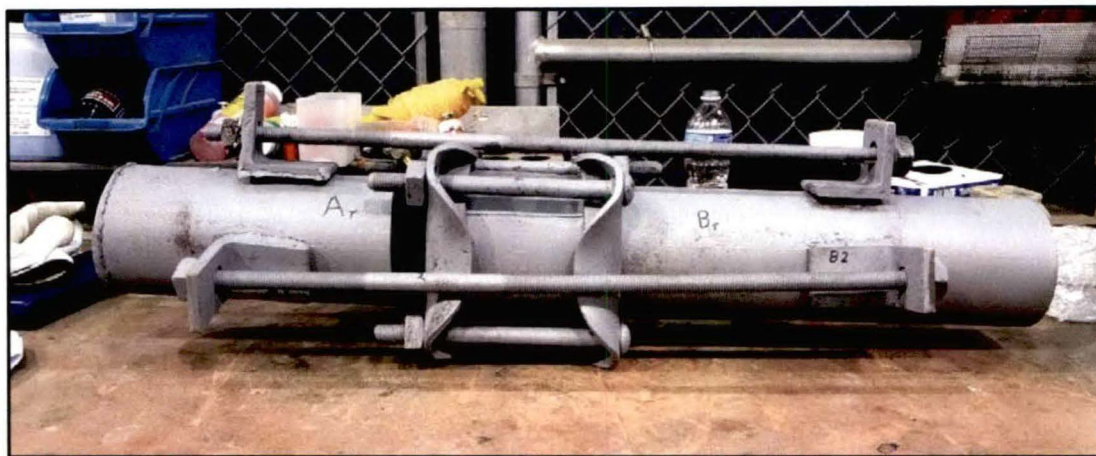
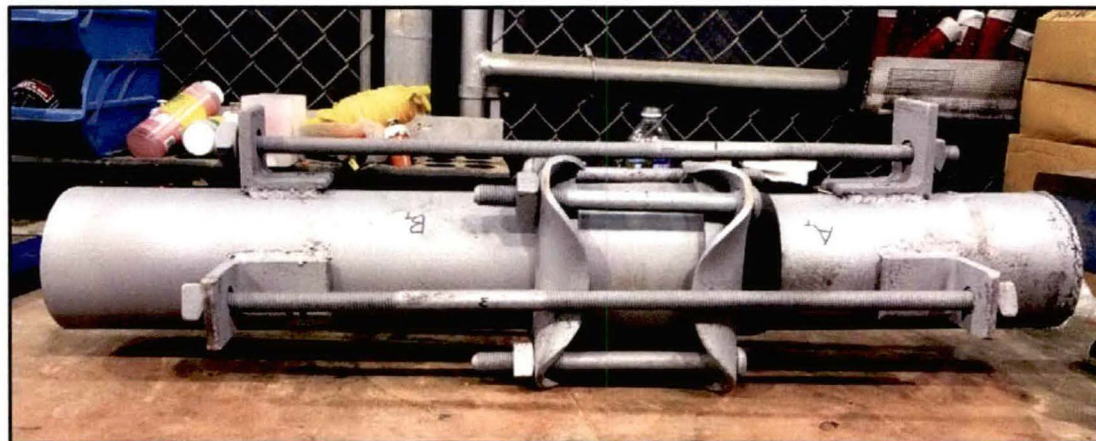
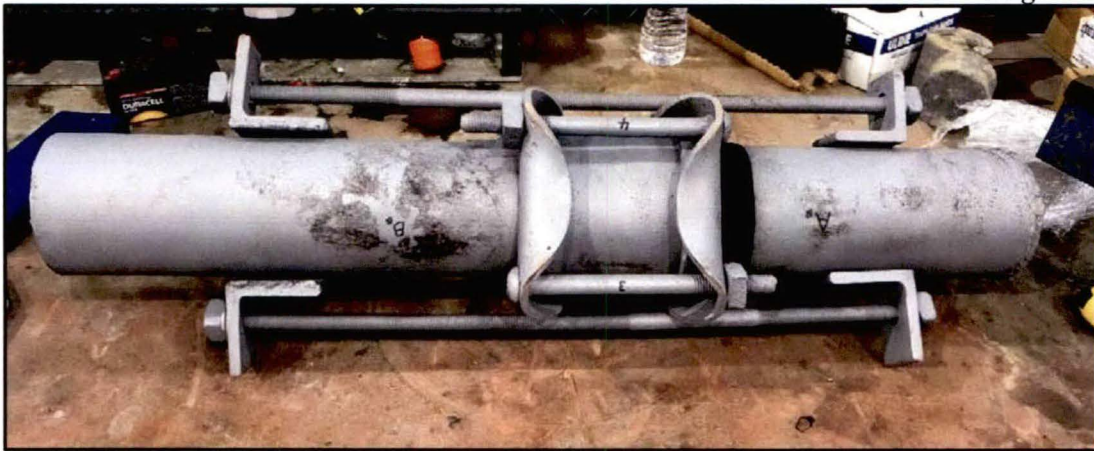
Lugs (Observations)				
Lug	Lug	Assembly sets aligned?	Deformed?	Deflected? (angle of)
A1	B1	Yes	Yes. The rods are bowed over the coupler body. See Figures 1, 2, 3, & 4.	0°
A2	B2	Yes	Yes. The rods are bowed over the coupler body. See Figures 1, 2, 3, & 4.	0°
A3	B3	Yes	Yes. The rods are bowed over the coupler body. See Figures 1, 2, 3, & 4.	0°

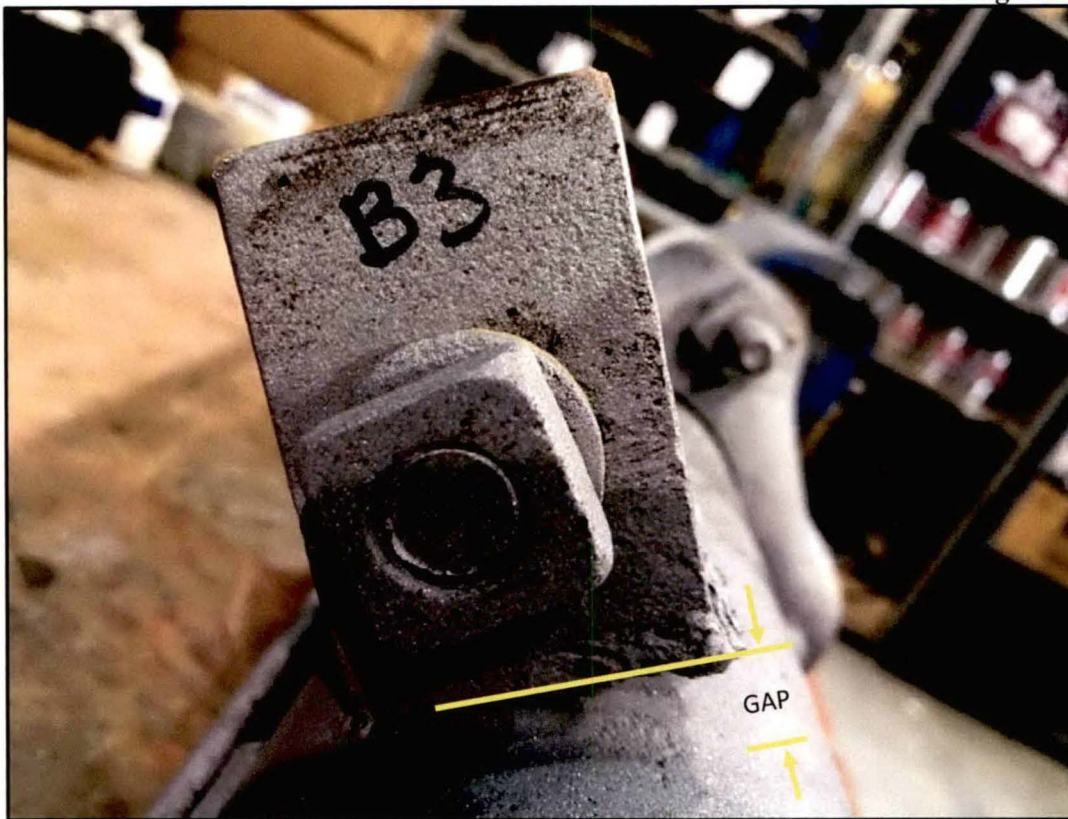
Figure 9- Side View of Lug

- <sup>1</sup> Possible corrosion on rod 1. The rod is in contact with the coupler brackets. It is unknown if the indications on the rod and bracket are corrosion or metal loss due to rod and bracket rubbing against each other. See Figure 7.
- <sup>2</sup> Severe corrosion on nut A1. It is greater than .03. The pit gage would not lay flat against the nut in order to get an accurate measurement. See Figure 8.
- <sup>3</sup> Does not have an insulating washer.
- <sup>4</sup> The lugs do not conform to the curvature of the pipe and cannot make complete contact. See Figures 9 & 10.
- <sup>5</sup> The lugs are solid flat surfaces with no interior. See Figure 11.

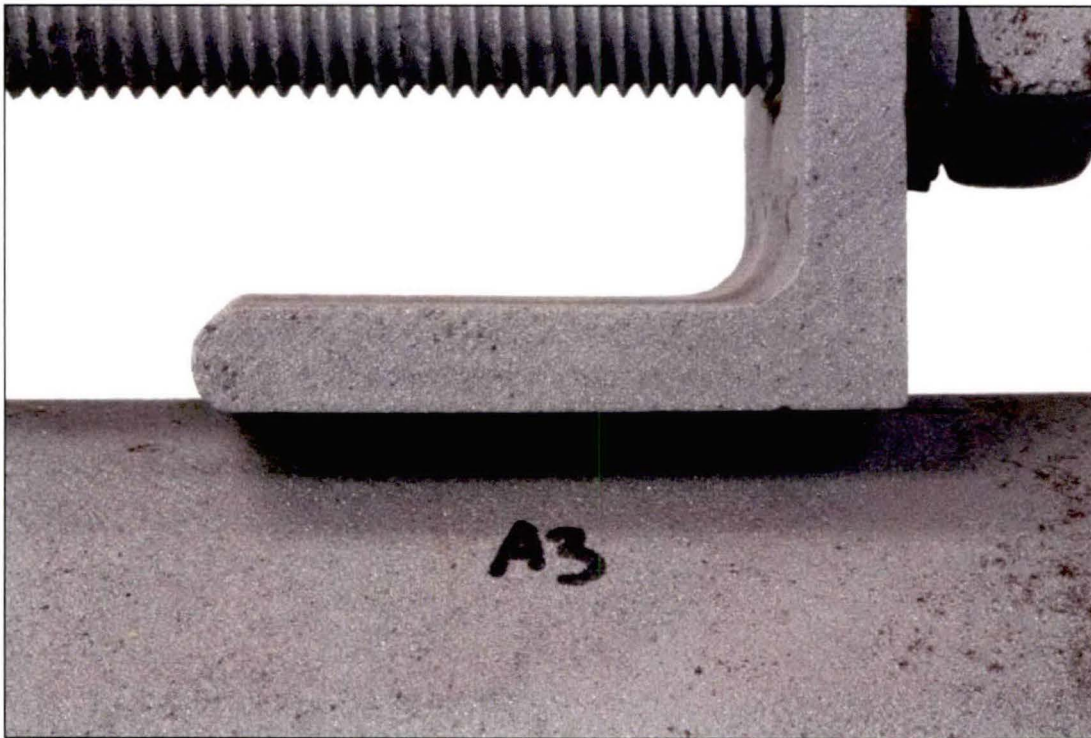
Figure 12. Image of the Lug A3 bottom weld.

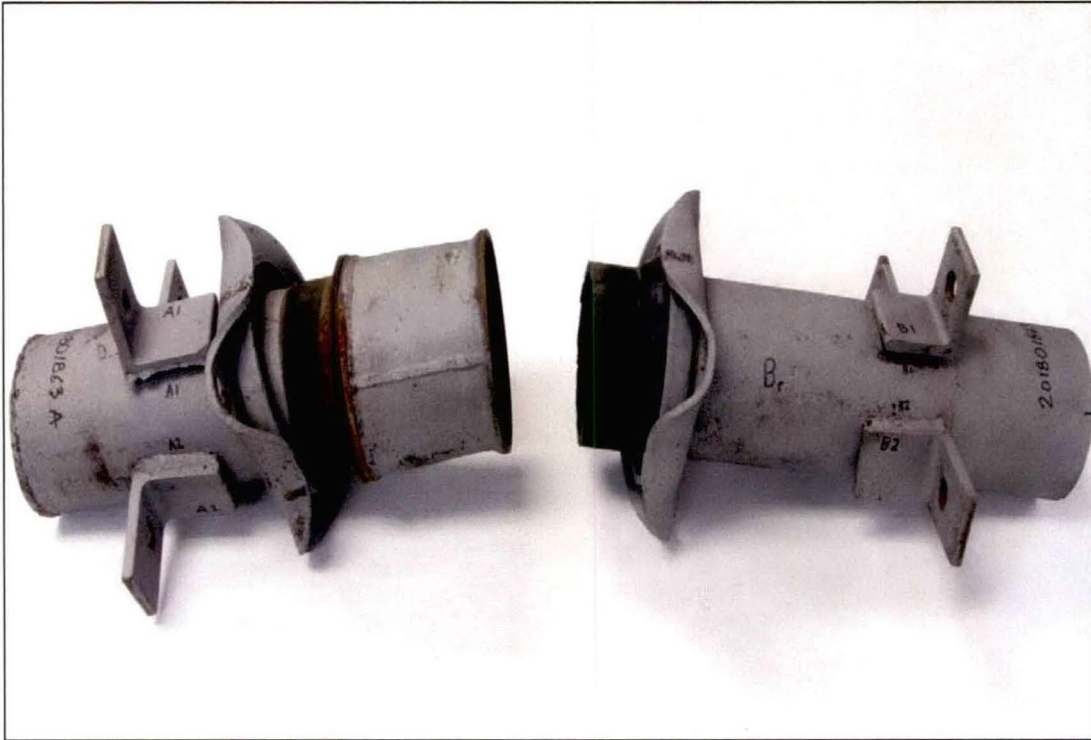
Figure 15. Photograph of the A (left) and B (right) sides of the coupled pipe after disassembly.

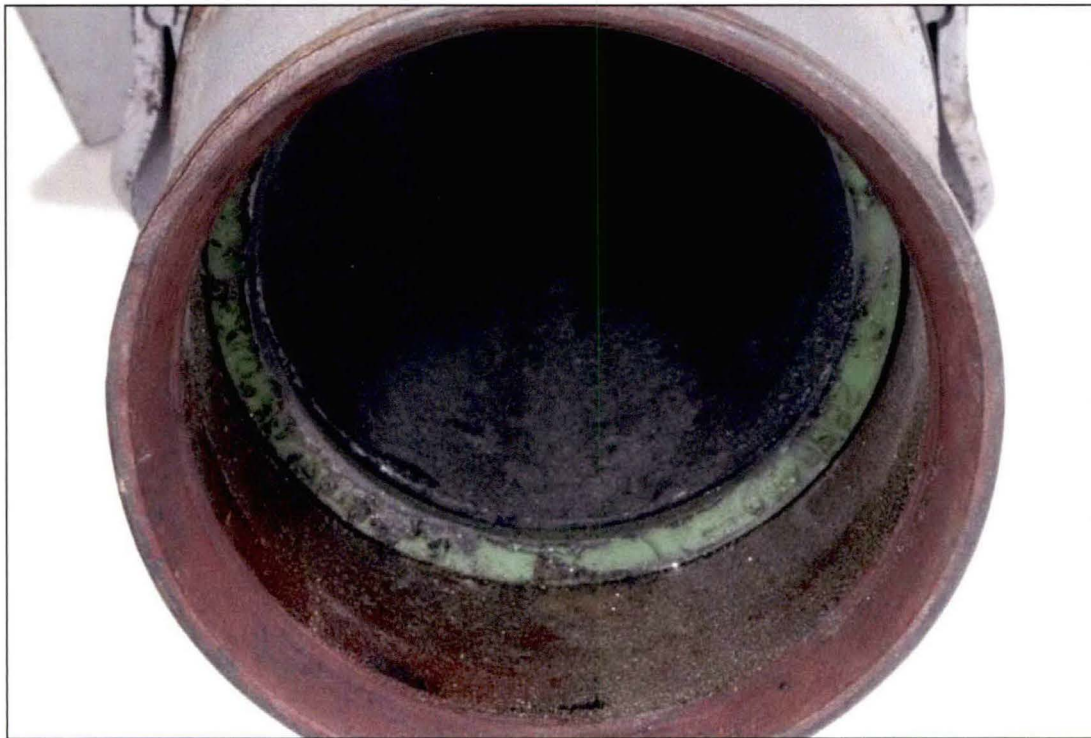
The harness rods and coupling bolts were also inspected for corrosion alteration. The observations are provided in Table 4. None of the fasteners, or the surrounding lugs, coupling components and pipe surfaces exhibited significant corrosion. The fasteners and the lugs were not necked down / stretched and no cracks were present. The coupling was disassembled during inspection and additional images of the observed features are included as Figures 14 through 18. The interior surfaces were not significantly degraded or corroded.

Figure 16. The interior of the coupling region contained a green colored pipe separator.

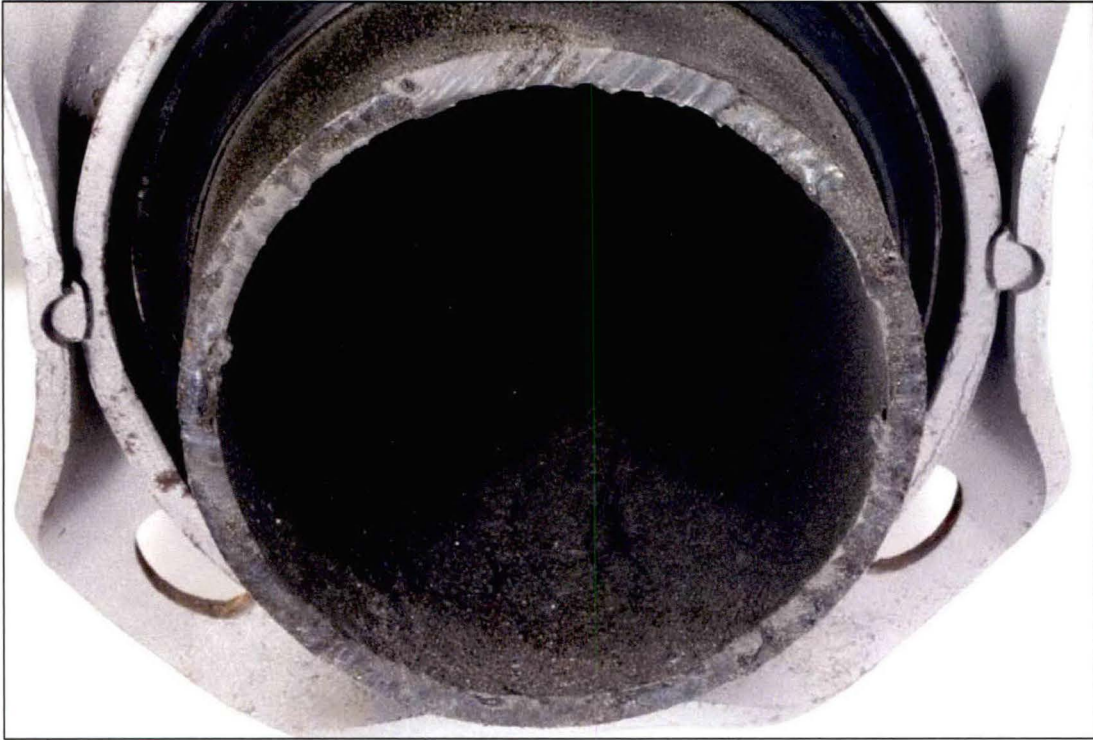
Figure 17. The bore of pipe end B is shown.

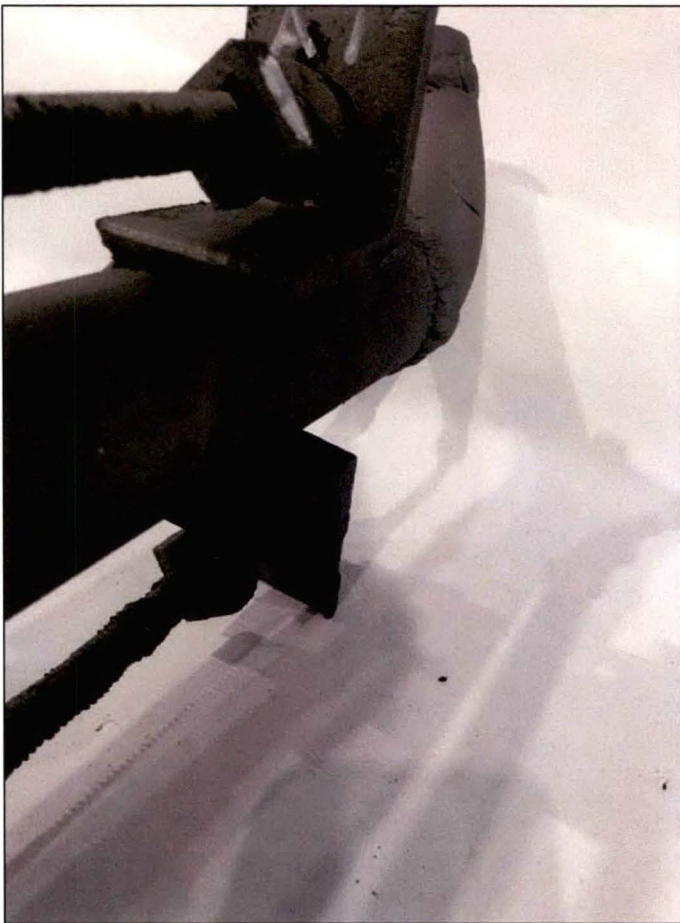
Figure 10- Lugs

<sup>6</sup> The lugs are not flush along the curvature of the pipe, so only one side of the lug was welded to the pipe. See Figures 10 & 11.

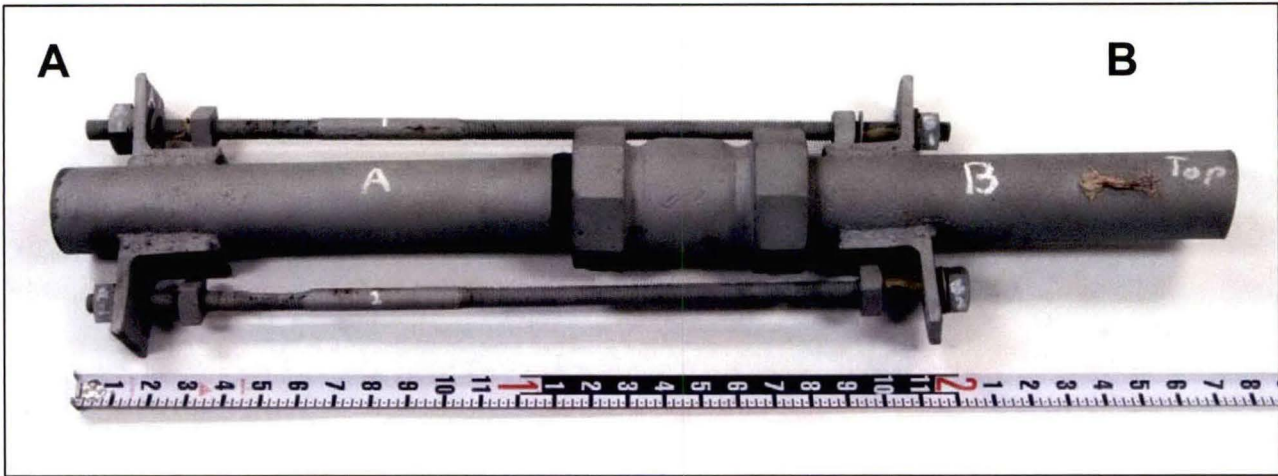
The submitted pipe section with the coupling is shown in Figures 1 and 2. Four lugs of the joint harnesses had been fillet welded to the pipe segments. Two rods and associated nuts had been affixed through the welded lugs to apply compression to the coupled joint. The coupling consisted of a steel coupling with an interior nonmetallic gasket / sleeve. Prior to receipt, the ends of the pipe segment were labelled as Ends A and B, as shown in Figures 1 and 2. The top and bottom of the coupling section were marked. Lugs A1 and A2 were welded to Pipe A, and Lugs B1 and B2 were welded to Pipe B. The rod between Lugs A1 and B1 was identified as Rod 1, whereas the opposite was Rod 2.

Figure 1. Photograph of the top of the submitted coupling sample.

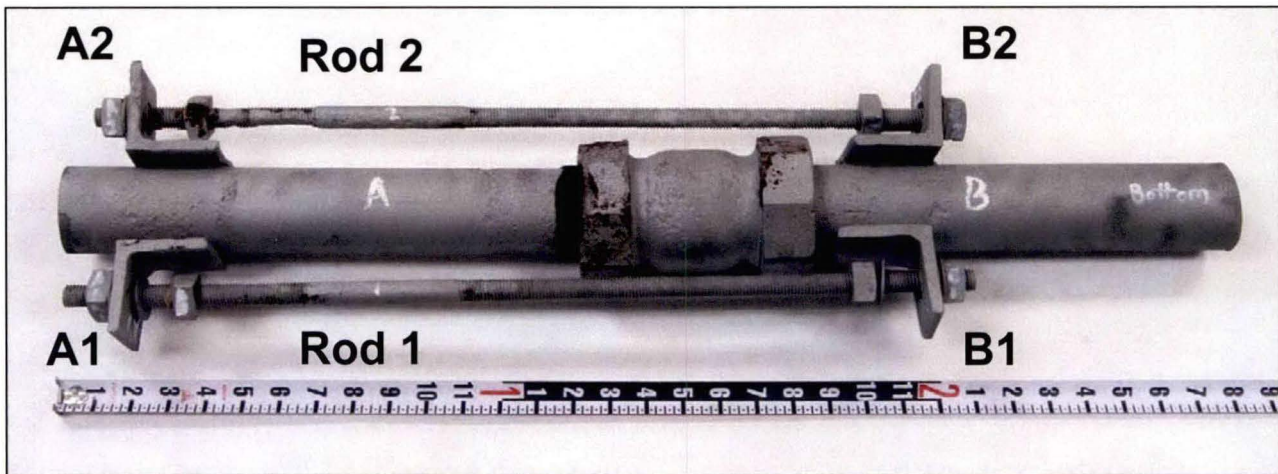
Figure 2. Photograph of the bottom of the submitted sample. Lug and rod identifications are shown.

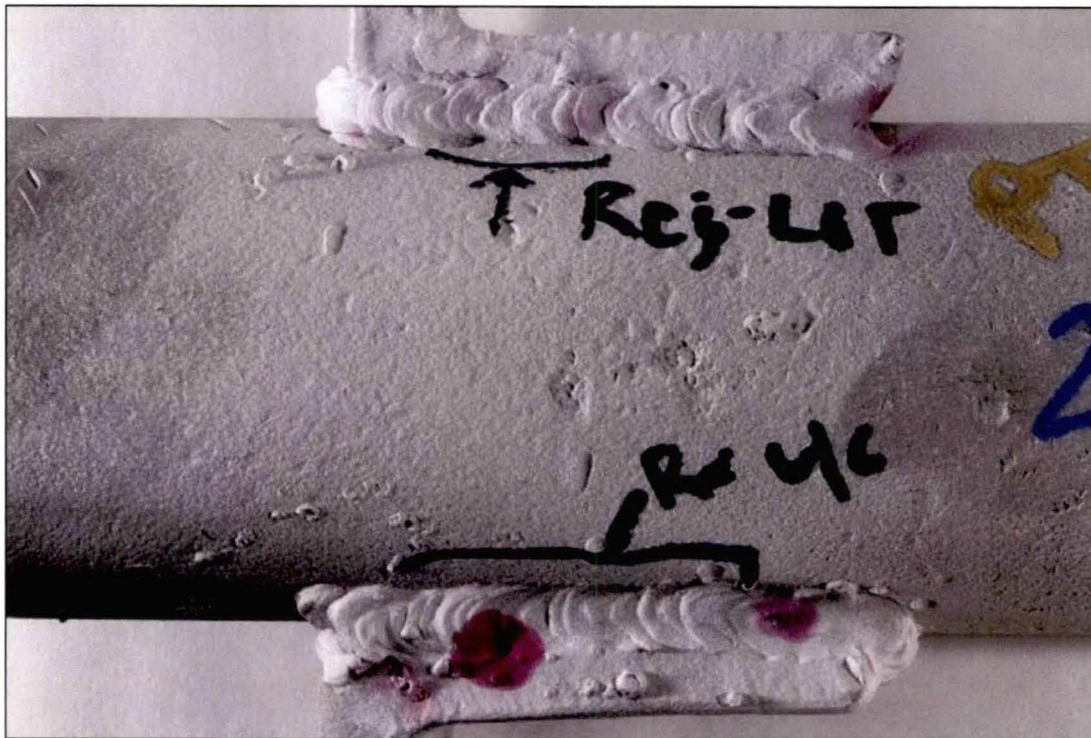
The two separated ends of the disassembled coupling were sent to a third party NDE laboratory for inspection. Visual and liquid dye penetrant inspection were performed on the lug attachment welds. Inspection was performed in accordance with the acceptance criteria of API 1104 “Welding of Pipelines and Related Facilities”. The inspection results are provided as Appendices A and B. Two representative welds are shown in Figures 13 and 14 with the dye penetrant test media remaining.

Figure 13. Image of the Lug A1 and A2 exterior top welds after dye penetrant media had been used during inspection.

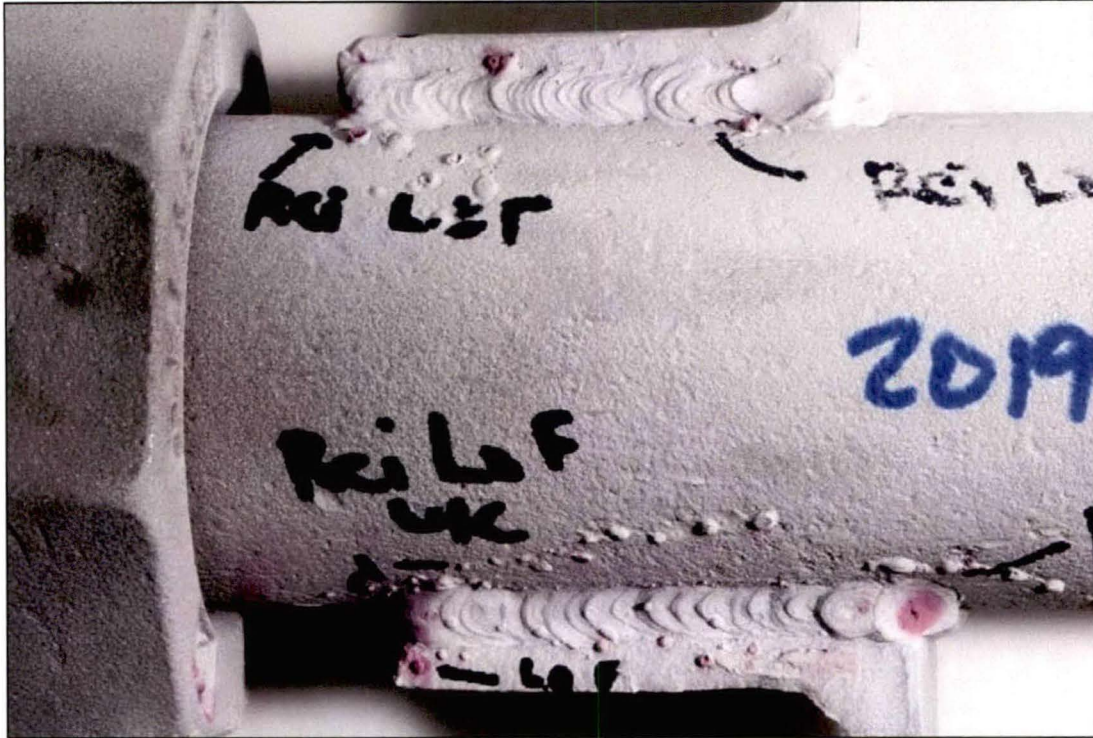
Figure 14. Image of the Lug B1 and B2 exterior top welds after dye penetrant media had been used during inspection.
