**RE: Louisville Gas and Electric Company Alleged Failure to Comply with
KRS 278.495, 807 KAR 5:022, and 49 C.F.R. Part 192
Case No. 2017-00119**

Louisville Gas and Electric Company
2020 Annual Report
Case No. 2017-00119

GTI Report Section 3, Part F: Continuous Process Improvement and Leading Indicators

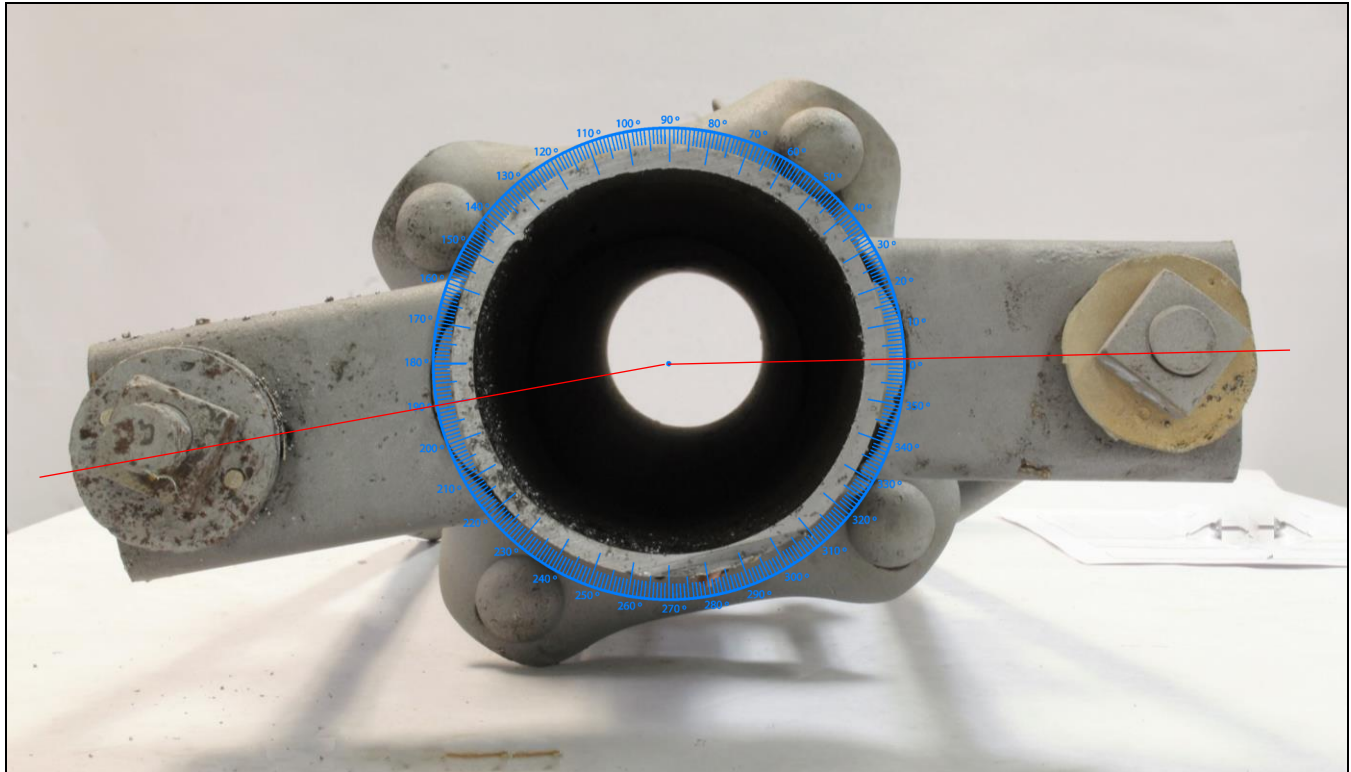
Component	Angle	Deviation from 180°	Image
Rod A1 / Rod A2	190°	10°	Figure 3
Rod B1 / Rod B2	185°	5°	Figure 4

Figure 3. End facing image of the sample at End A with a superimposed protractor.

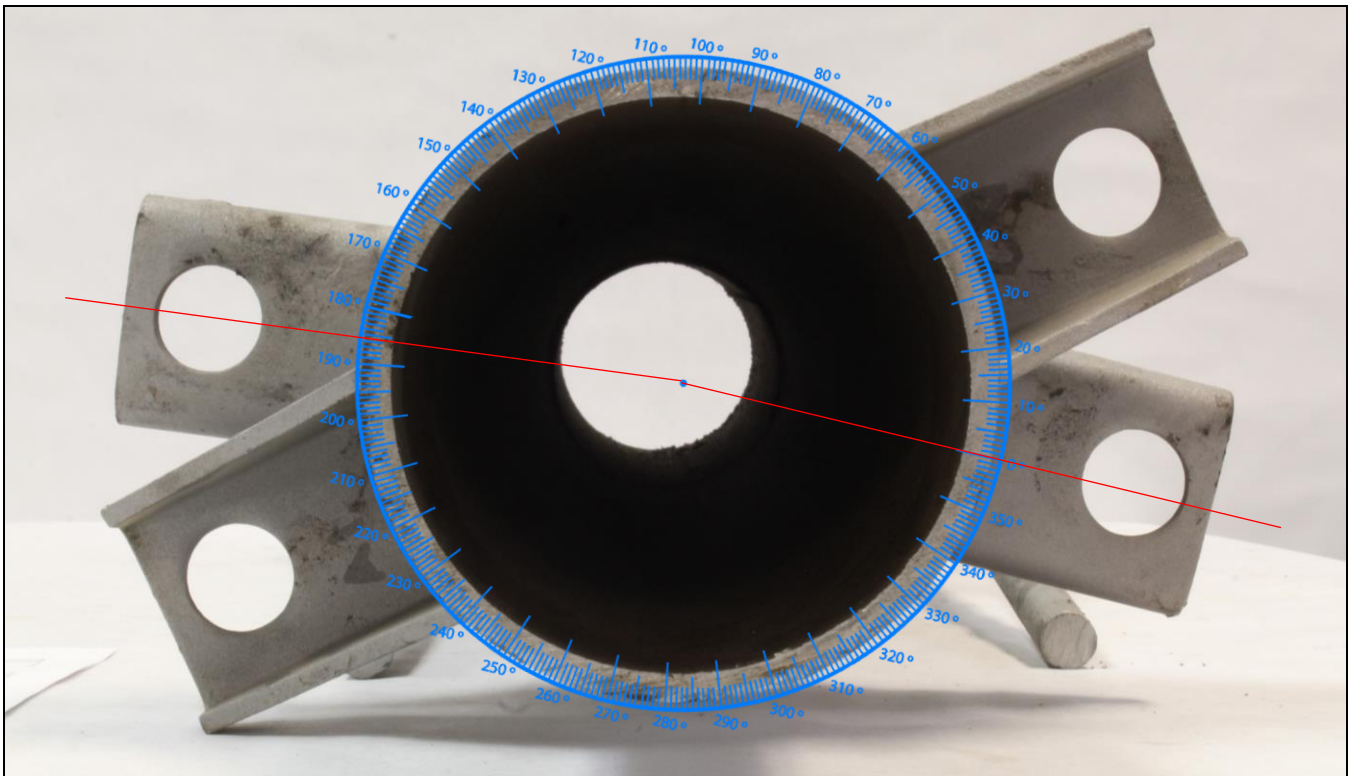
Figure 4. End facing image of the sample at End B with a superimposed protractor.

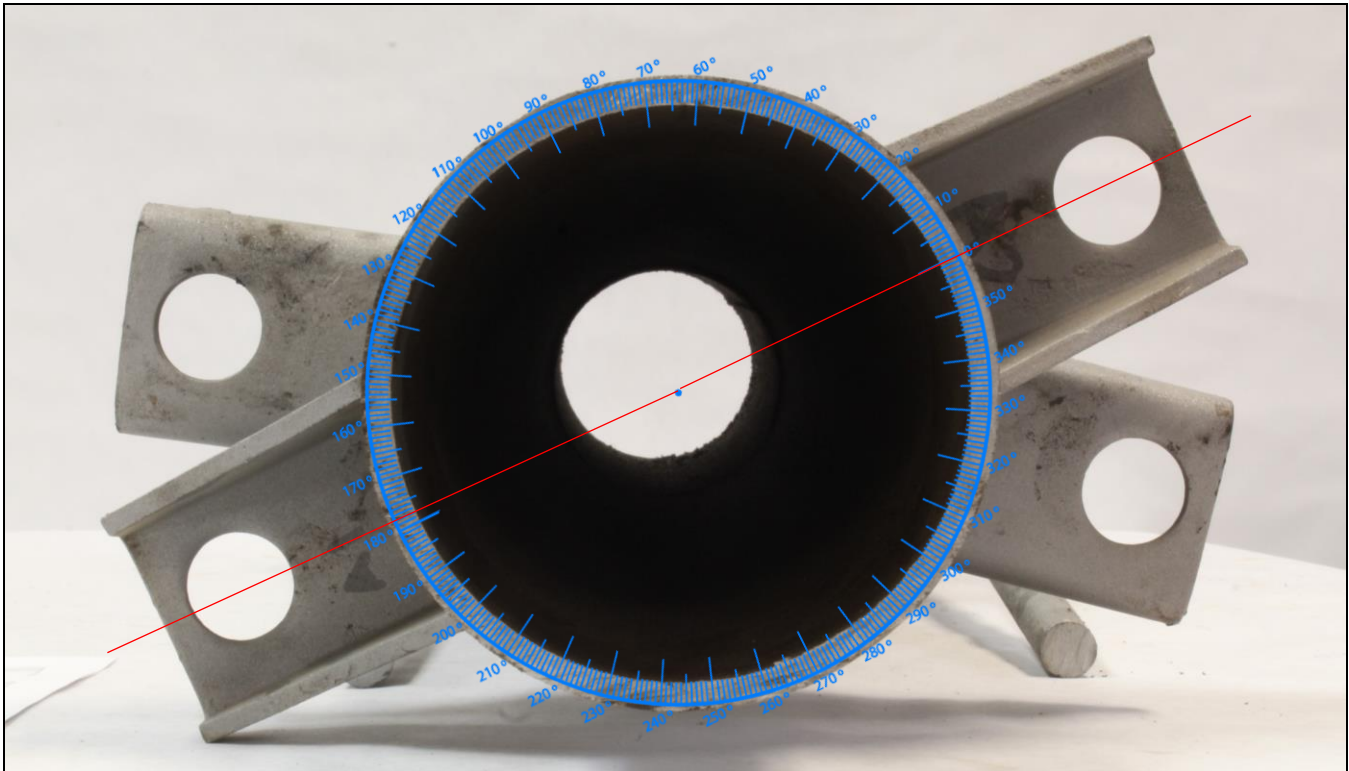
Component	Angle	Deviation from 180°	Image
Rod A1 / Rod A2	178°	2°	Figure 3

Figure 3. End facing image of the sample at End A with a superimposed protractor.

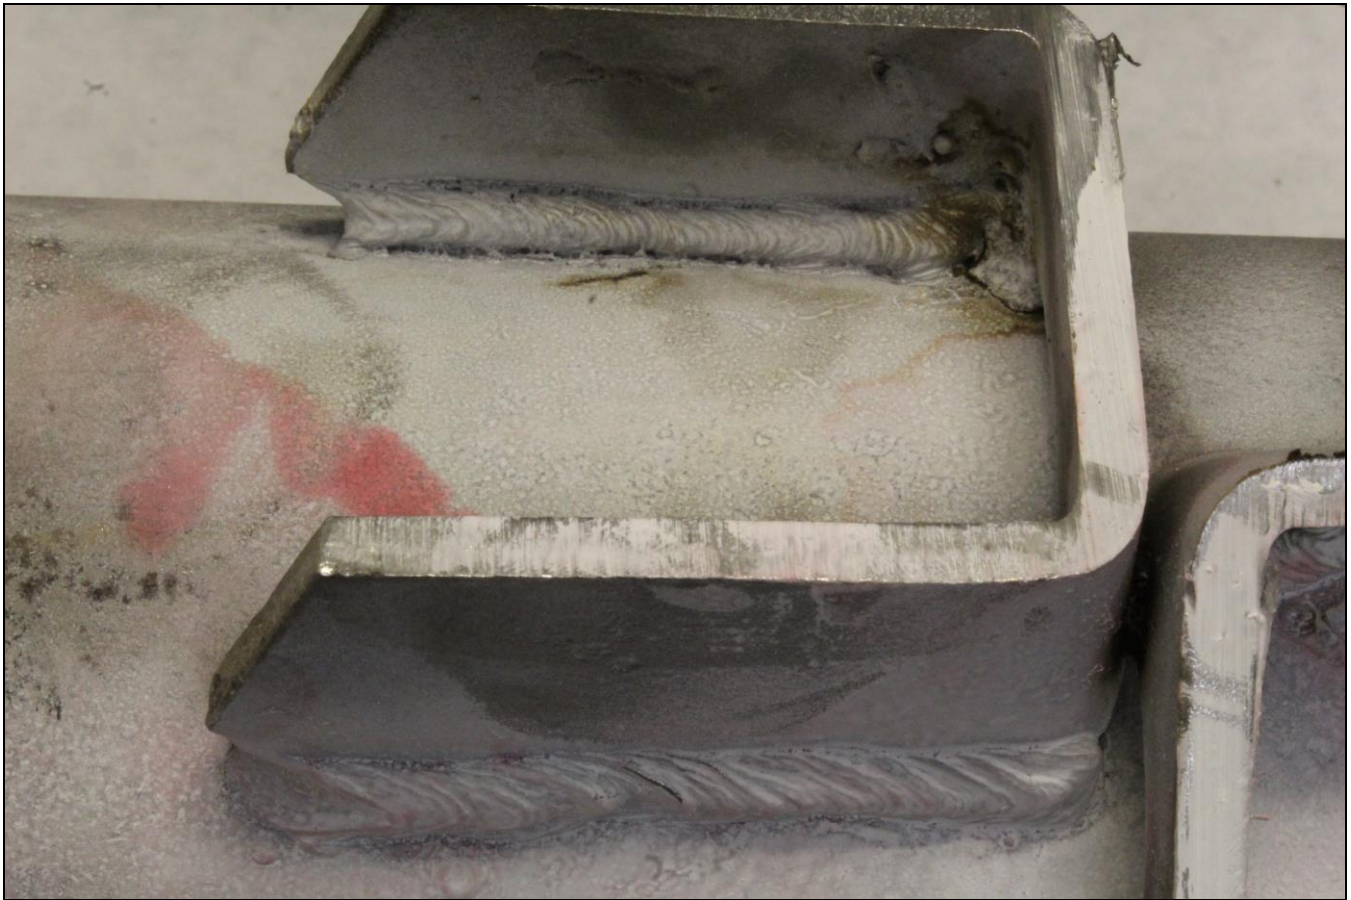
The end of the disassembled coupling was sent to a third party NDE laboratory for inspection. Visual and liquid dye penetrant inspection were performed on the lug attachment welds. Inspection was performed in accordance with the acceptance criteria of API 1104 “Welding of Pipelines and Related Facilities”. The inspection results are provided as Appendix A. Two representative welds are shown in Figures 8 and 9 with the dye penetrant test media remaining.

Figure 8. Image of the Lug A2 exterior top welds after dye penetrant media had been used during inspection.

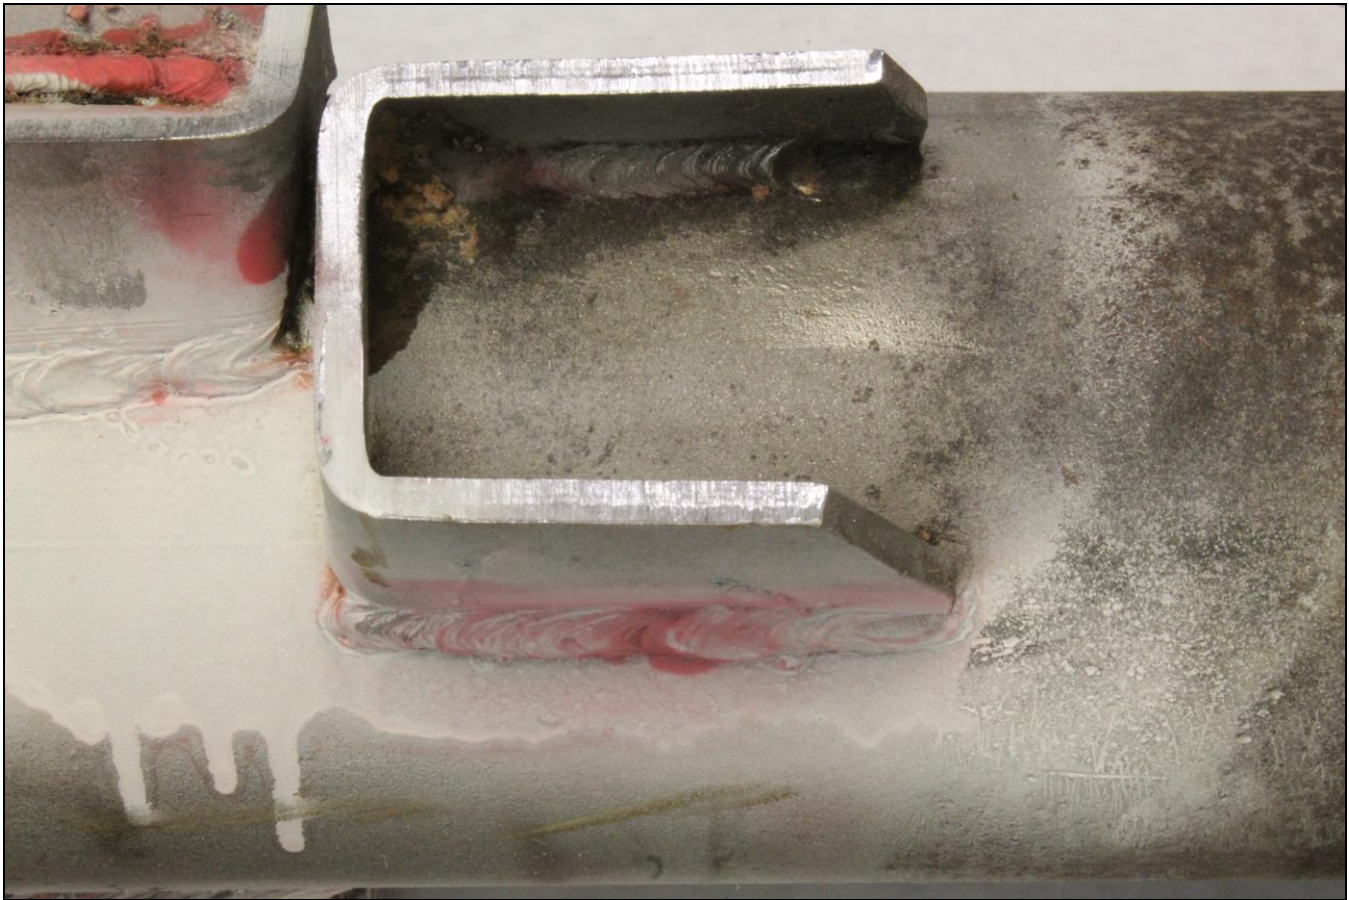
Figure 9. Image of the Lug B2 exterior top welds after dye penetrant media had been used during inspection.

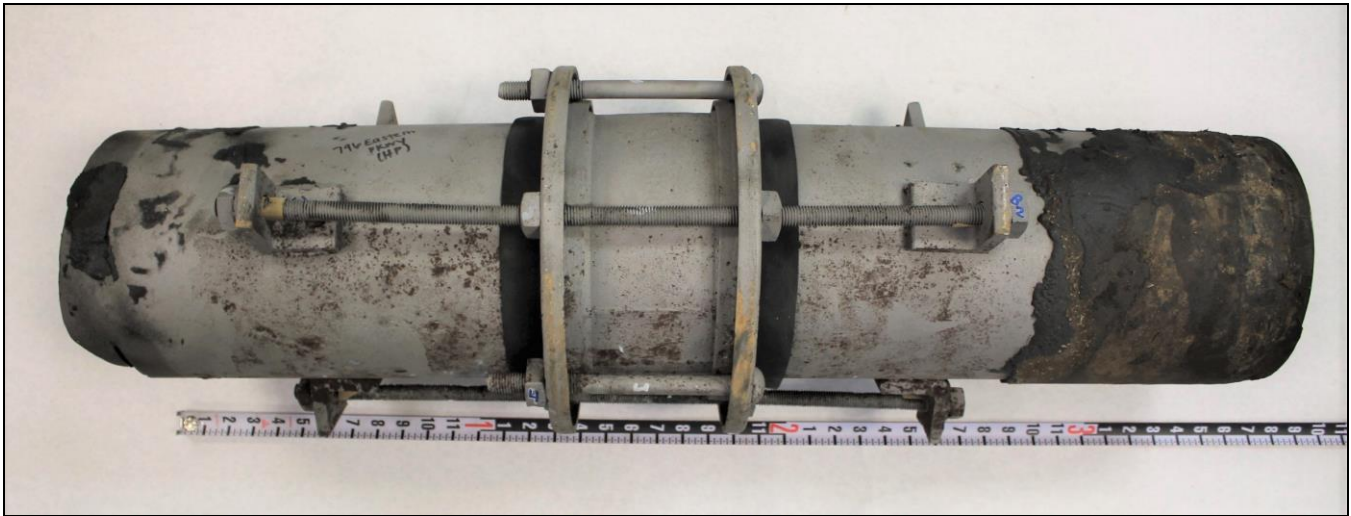
Figure 1. Photograph of the top of the submitted coupling sample.

Atypical for the couplings, three of the coupling holes accommodated the rods with standard bolts through the remaining three coupling holes.

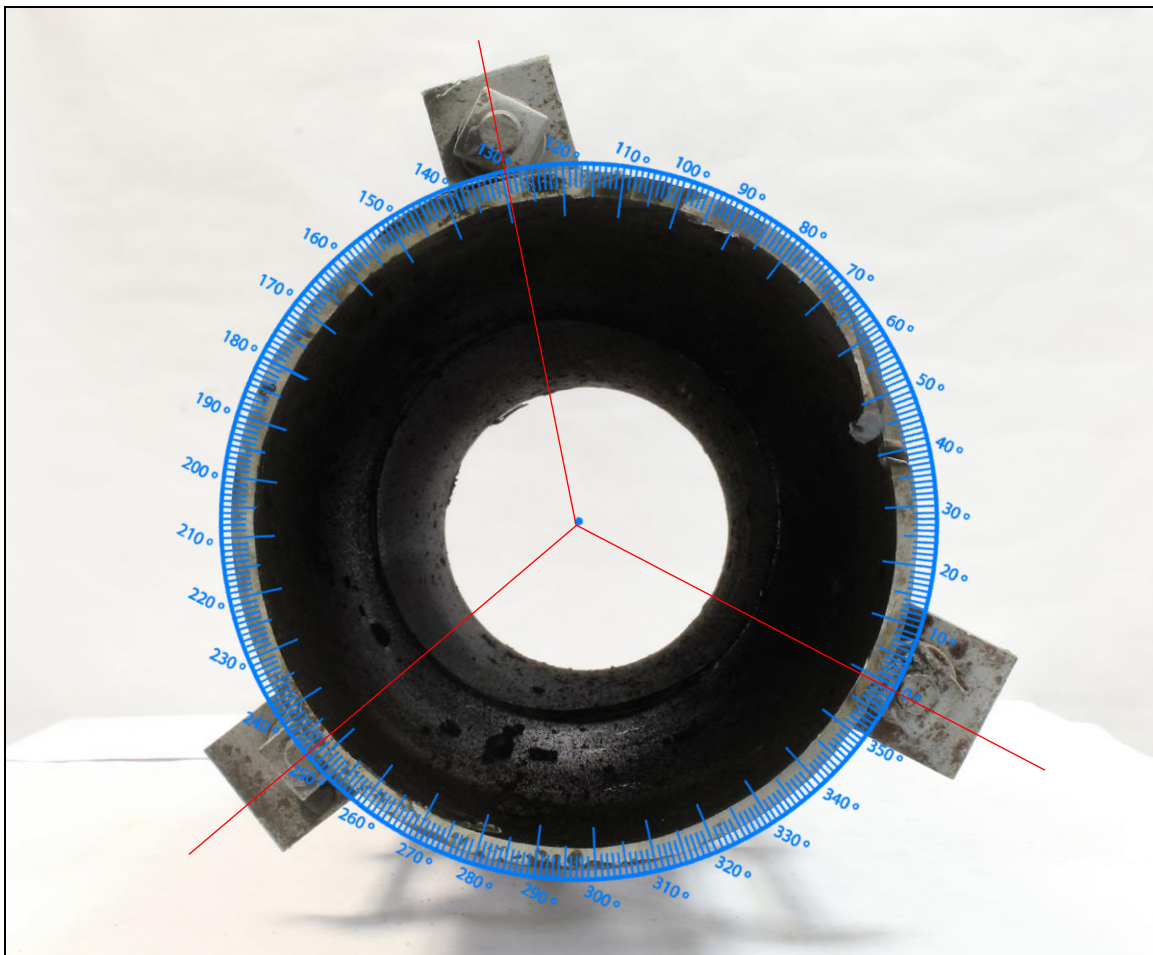
Component	Angle	Deviation from 120°	Image
Rod A1 / Rod A3	119°	0°	Figure 3
Rod A3 / Rod A5	129°	9°	Figure 3
Rod B1 / Rod B3	121°	1°	Figure 4
Rod B3 / Rod B5	117°	3°	Figure 4

Figure 3. End facing image of the sample at End A with a superimposed protractor.

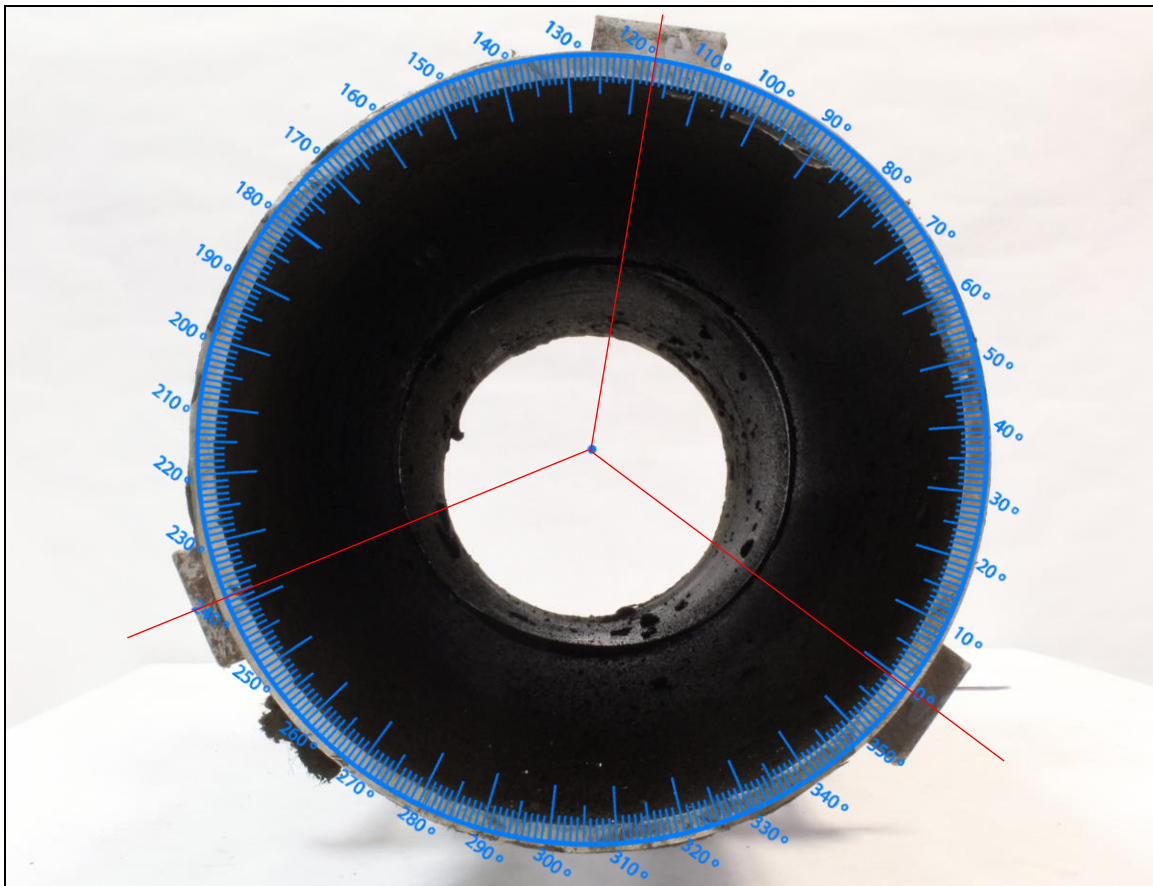
Figure 4. End facing image of the sample at End B with a superimposed protractor.

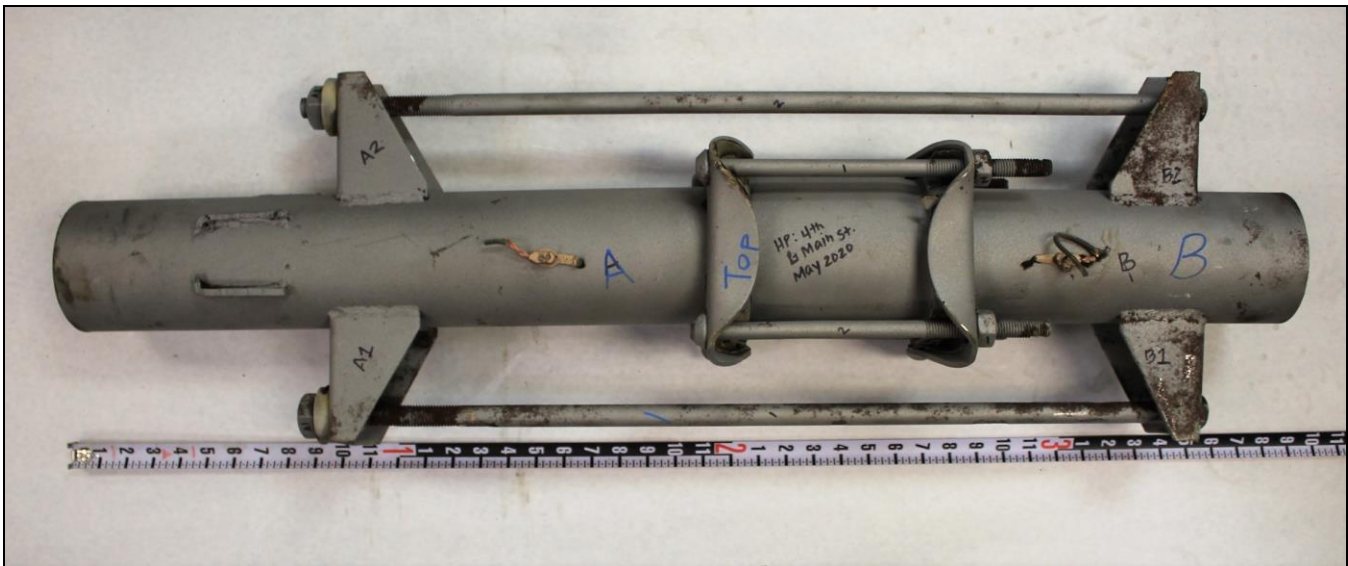
The submitted pipe section with the coupling is shown in Figures 1 through 4. Two lugs of the joint harnesses had been fillet welded to both pipe segments. Two rods and associated nuts had been affixed through the welded lugs to apply compression to the coupled joint. The coupling consisted of a steel coupling with an interior nonmetallic gasket / sleeve. Prior to receipt, the ends of the pipe segment were labelled as Ends A and B, as shown in Figures 1 through 4. The top and bottom of the coupling section were also marked. Lugs A1 and A2 were welded to Pipe A, and Lugs B1 and B2 were welded to Pipe B. The rod between Lugs A1 and B1 was identified as Rod 1. The remaining lugs were identified in a corresponding fashion. Several secondary welds without lugs were evident.

Figure 1. Photograph of the top of the submitted coupling sample.

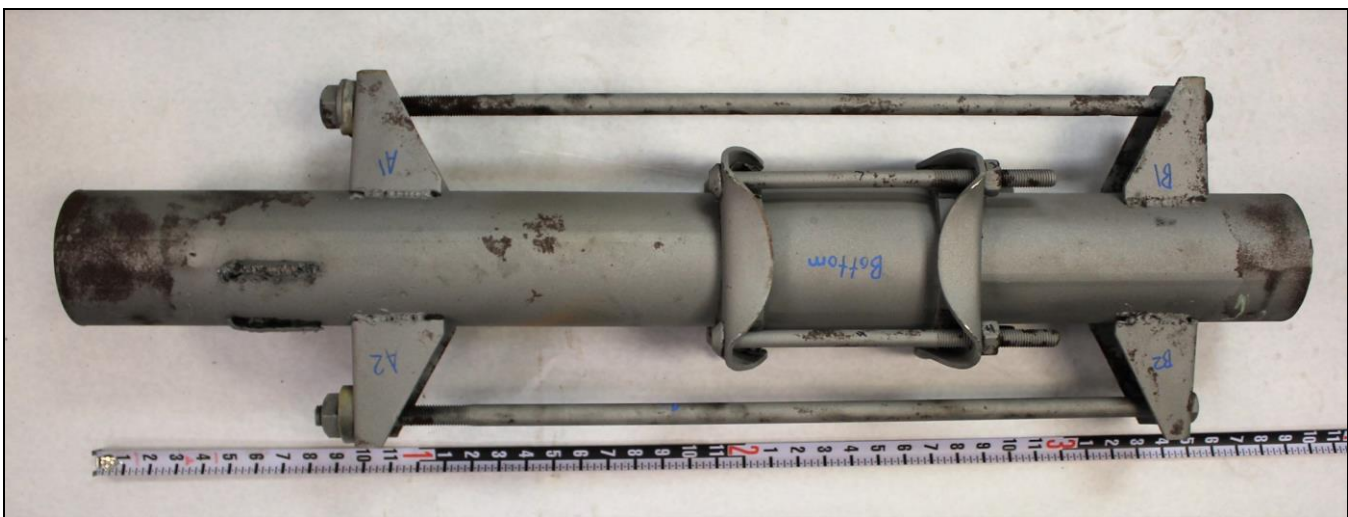
Figure 2. Photograph of the bottom of the submitted sample.

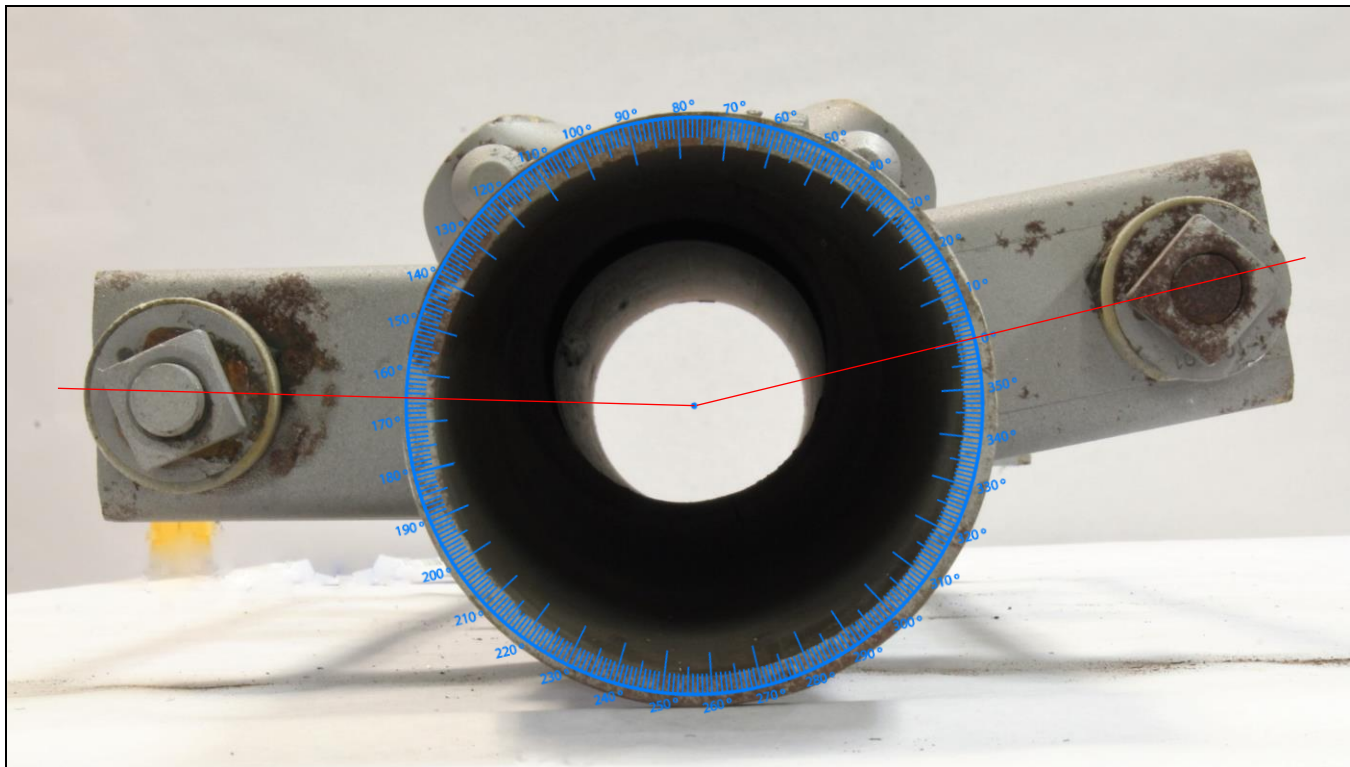
Component	Angle	Deviation from 180°	Image
Rod A1 / Rod A2	165°	15°	Figure 3
Rod B1 / Rod B2	173°	7°	Figure 4

Figure 3. End facing image of the sample at End A with a superimposed protractor.

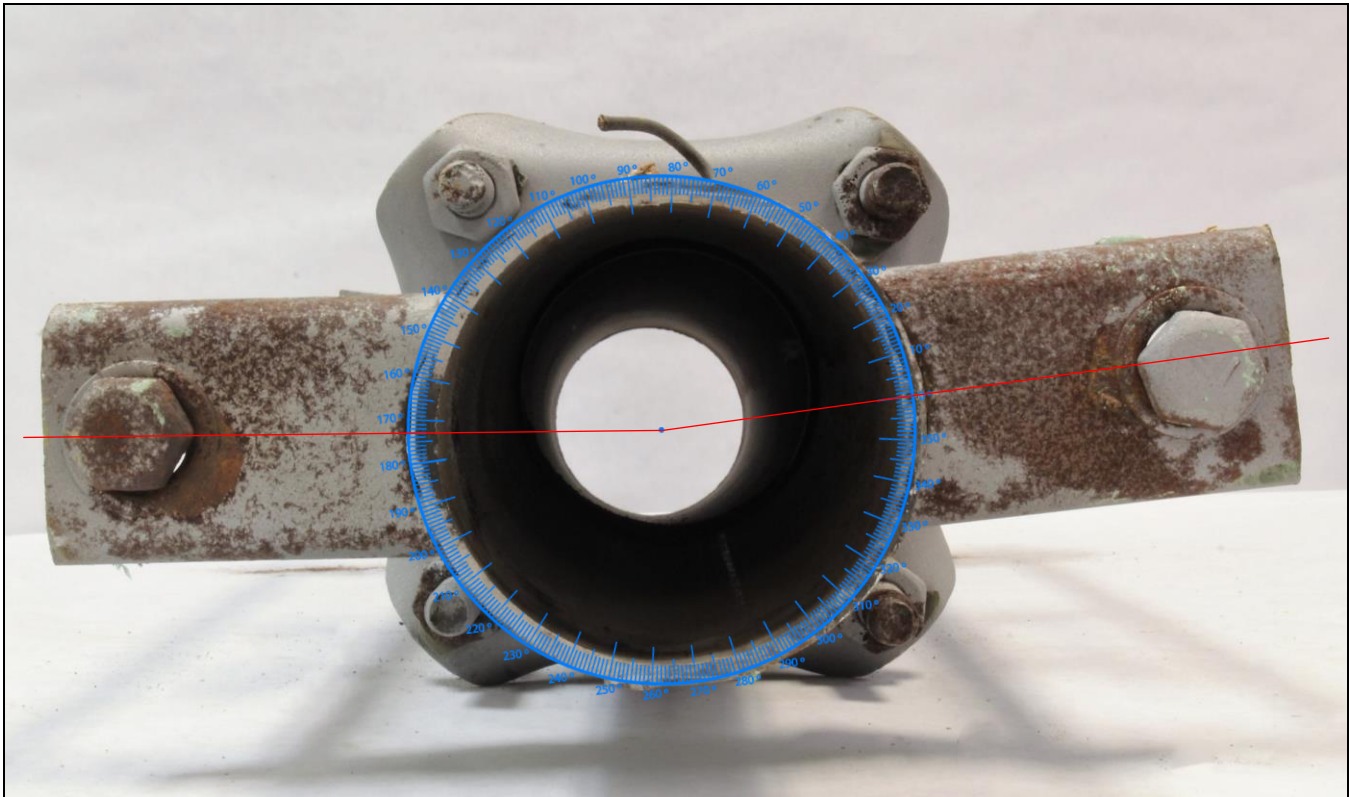
Figure 4. End facing image of the sample at End B with a superimposed protractor.

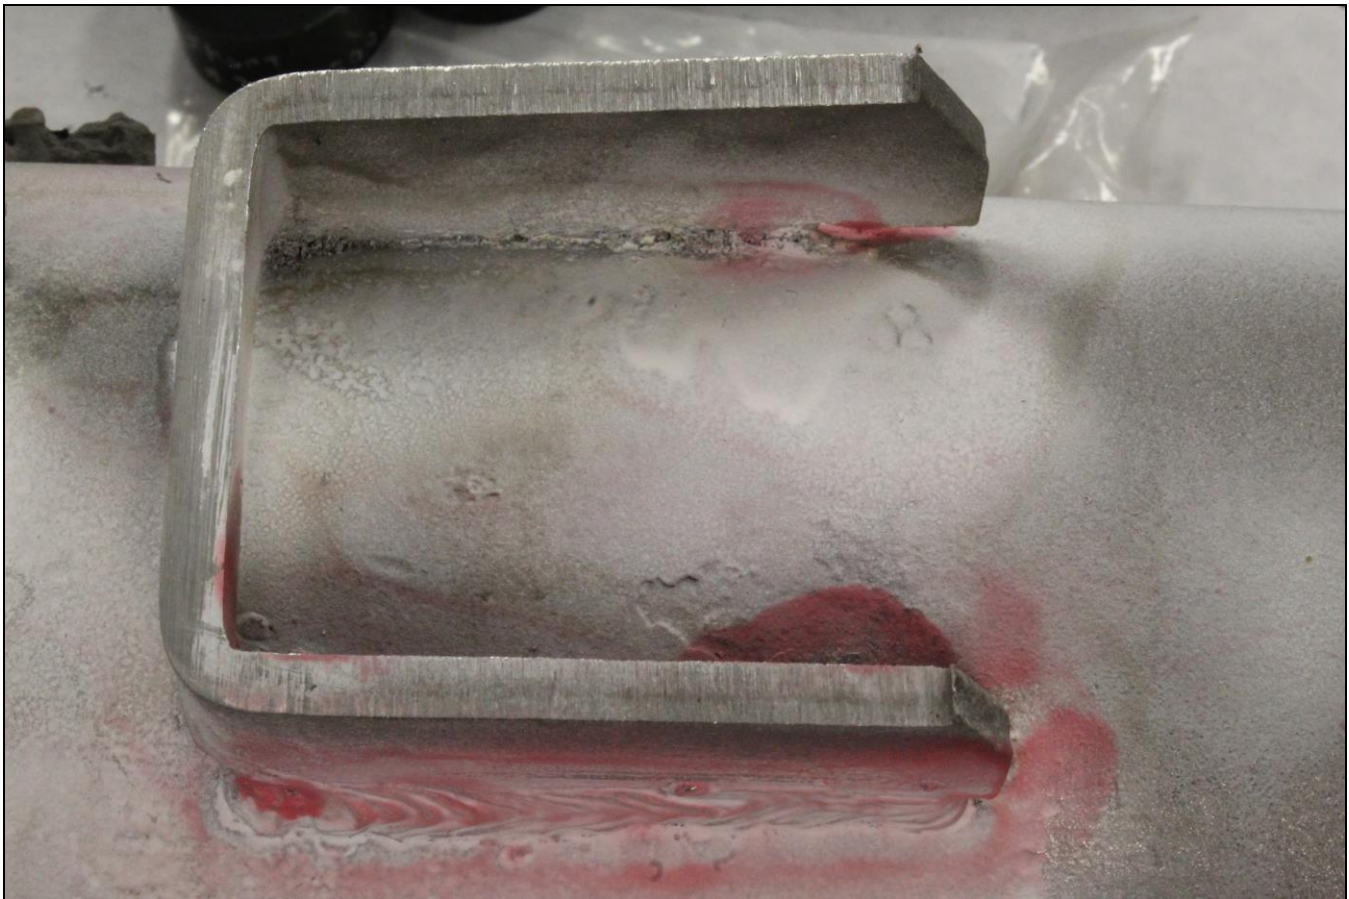
The two separated ends of the disassembled coupling were sent to a third party NDE laboratory for inspection. Visual, magnetic particle and liquid dye penetrant inspection were performed on the lug attachment welds. Inspection was performed in accordance with the acceptance criteria of API 1104 "Welding of Pipelines and Related Facilities". The inspection results are provided as Appendix A. Two representative welds are shown in Figures 11 and 12 with the dye penetrant test media remaining.

Figure 11. Image of the Lug A2 welds after dye penetrant media had been used during inspection.

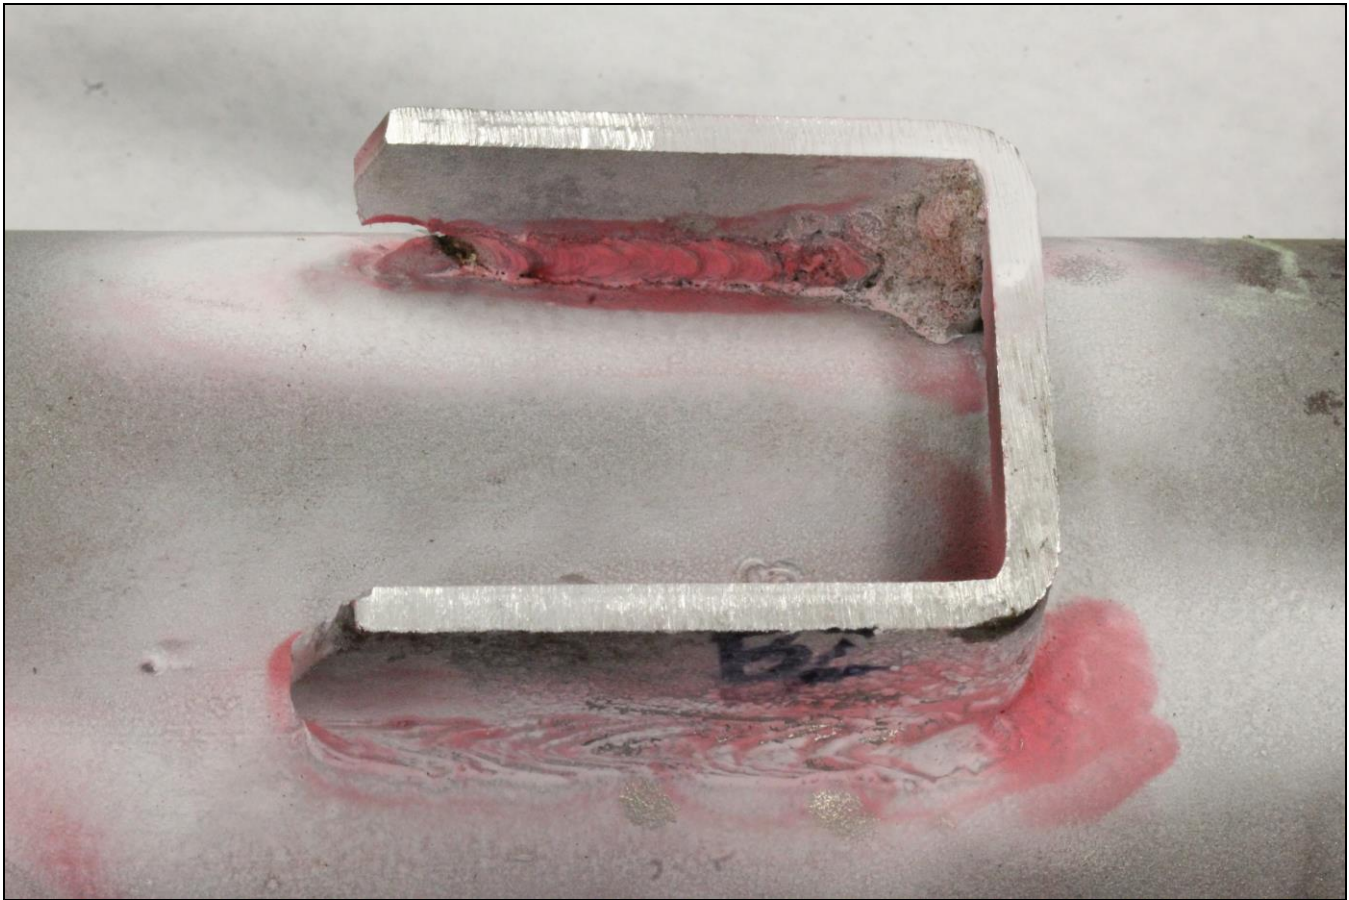
Figure 12. Image of the Lug B2 welds after dye penetrant media had been used during inspection.

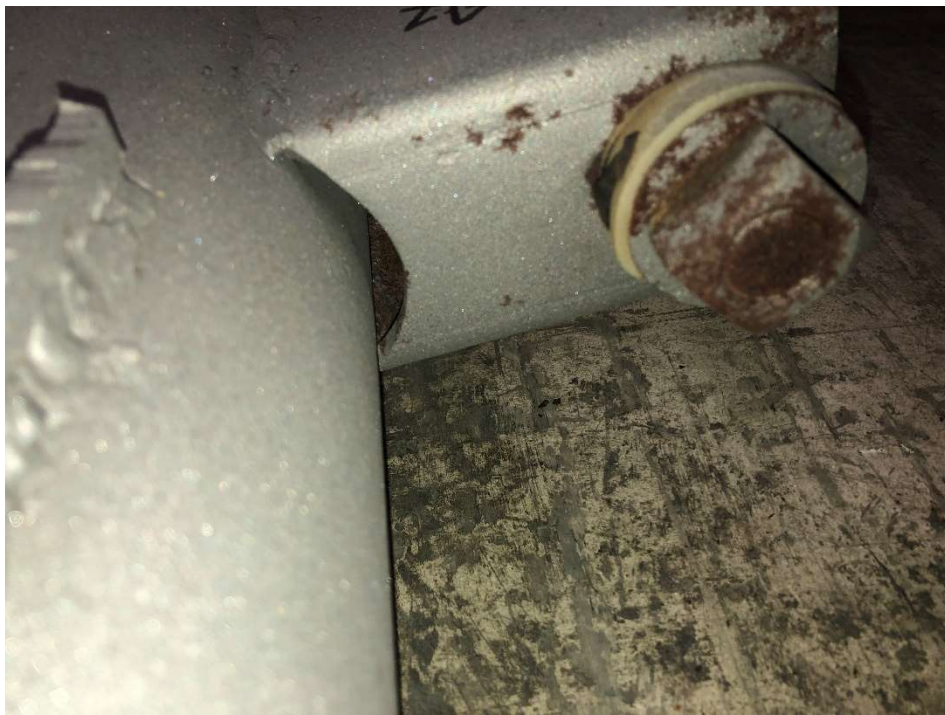
Figure 8 Close up of Lug Backend

NOTE: Back side of each lug detached from pipe
