Case No. 2005-00148

**COMMONWEALTH OF KENTUCKY
BEFORE THE PUBLIC SERVICE COMMISSION**

**NORTHERN KENTUCKY WATER DISTRICT'S RESPONSE TO THE
ATTORNEY GENERAL'S REQUEST FOR INFORMATION**

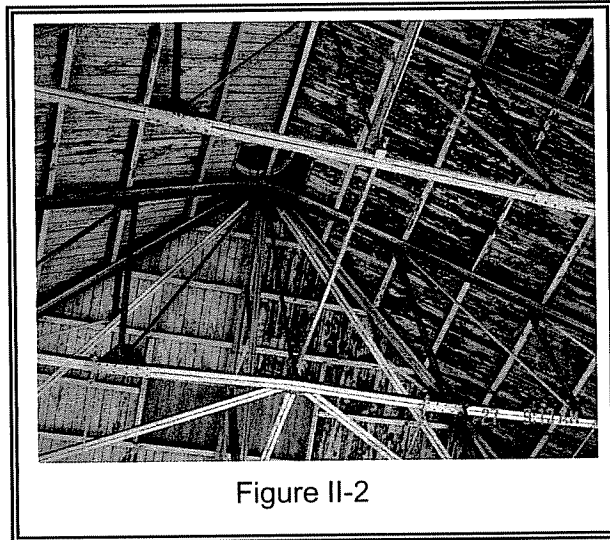
The roof of the building is constructed of wood framing members with wooden plank roofing and composite shingles. Figure II-2 shows the interior of the roof. There are a number of locations where daylight could be seen through the roof, indicating significant holes.

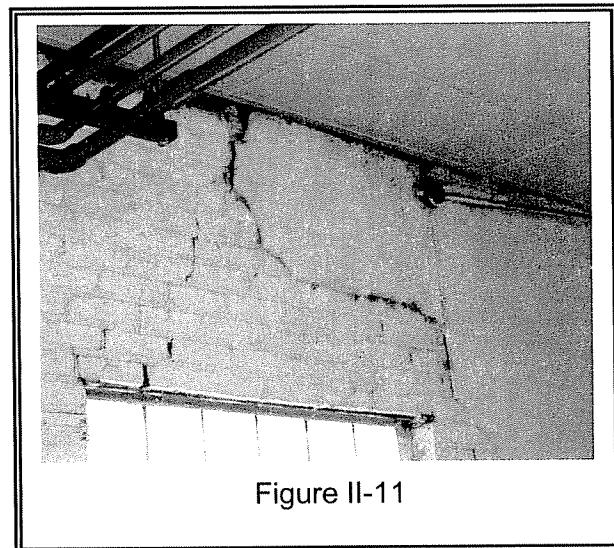
The interior of the building is in unsatisfactory shape. Walls are painted brick. It was noted during the site investigation that there is strong evidence that the building is experiencing differential settlement due to the cracking apparent in the brick walls. Figure II-11 shows cracking observed in the northeast corner of the building. The exterior of the building is brick which is in satisfactory condition; however where cracking was noted in the interior of the building, similar cracking and missing mortar was visible on the exterior. Glass block windows are located on three sides of the building with ventilation louvers and fans in the center of the window. The glass block was in good condition; however, ventilation in the building was unsatisfactory. At the time of the site investigation temperatures in

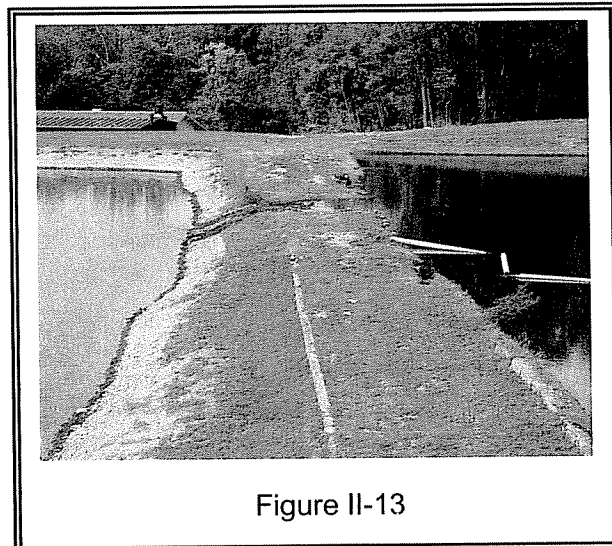
The South Reservoir is currently being used as the only presedimentation basin and is in good condition. The North Reservoir is currently being used as a sludge and backwash holding basin. Due to the inability of the Sludge Handling Facility at MPTP to function correctly, no mechanical dewatering of sludge is currently taking place. The condition of the North Reservoir is unsatisfactory due to the fact that no sludge is being removed from the reservoir, which is estimated to be at approximately 75 to 80% of capacity, based on comments from District staff. District staff indicated that the transfer piping between the two reservoirs is insufficient and should be replaced. Currently water flows from the North Reservoir to the South Reservoir over the dam between the two when the water level in the North Reservoir is high enough. There is a concern that this will erode the dam over time. Figure II-13 shows where water typically overflows the dam between the reservoirs.

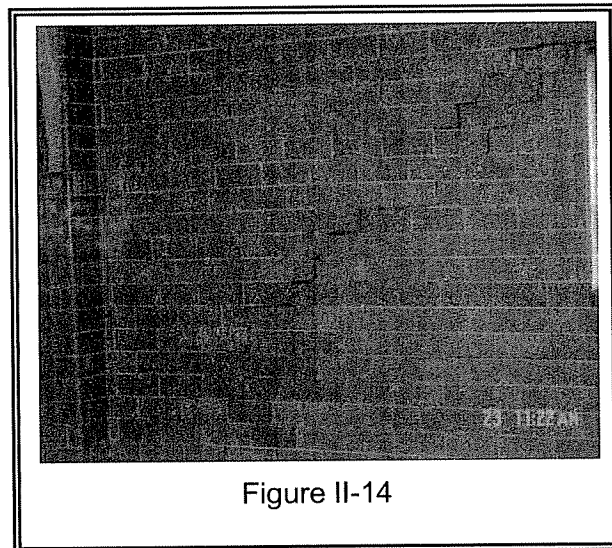
c. Filter Building. The Filter Building was constructed in 1961. The Filter Building is a block and brick, single story building with a basement. The interior of the building is in poor shape. Walls are glazed and painted CMU. There are numerous locations where cracking, chipping, or chalking was observed in portions of the walls and support columns. Figure II-14 shows an example of this cracking that was observed in the southwest corner of the building. It was noted during the site investigation that there is strong evidence that the building is experiencing differential settlement due to the cracking apparent in the CMU walls at different location of the building.

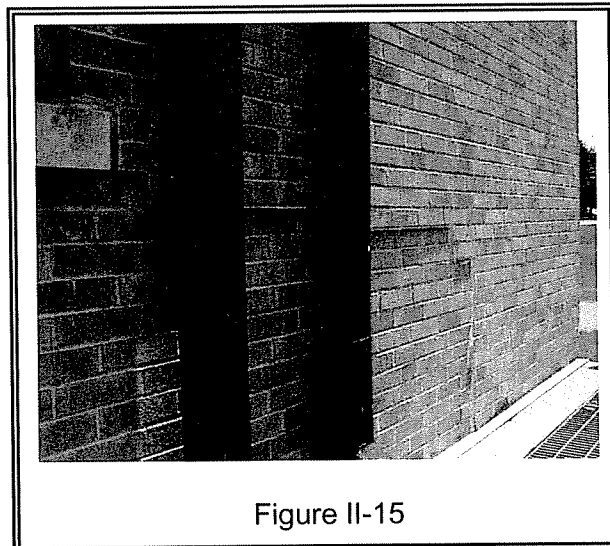
Figure II-15

The exterior of the building is brick, which is in unsatisfactory condition. In the areas where the CMU cracking was noted in the interior of the building, similar cracking and missing mortar was visible on the exterior of the building. At the southwest wall of the Filter Building, major cracking was observed. The interior block wall at this location is a load bearing member. The cracking and slipping of the brick was also noticed on the exterior brick facing of the Filter Building, as shown in Figure II-15. The brick wall is not load bearing; however, the cracking/slipping of the brick will only get worse over time, potentially leading to collapse of the brick wall in the future. The possible cause is continuous freeze/thaws that are pushing the brick facing away from the block wall.

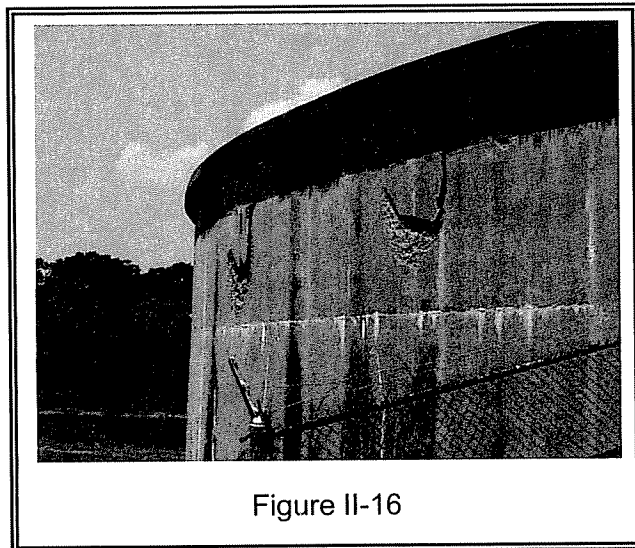
Figure II-16

During the site investigation, numerous locations were noted where concrete was severely cracking with places where the wall is chipping and falling off exposing reinforcement in the wall as shown in Figures II-16 and II-17. The top slab of the clearwell was noted to have similar structural deficiencies. Also of note is the clearwell does not have handrails on the access stairs and guardrails around the top

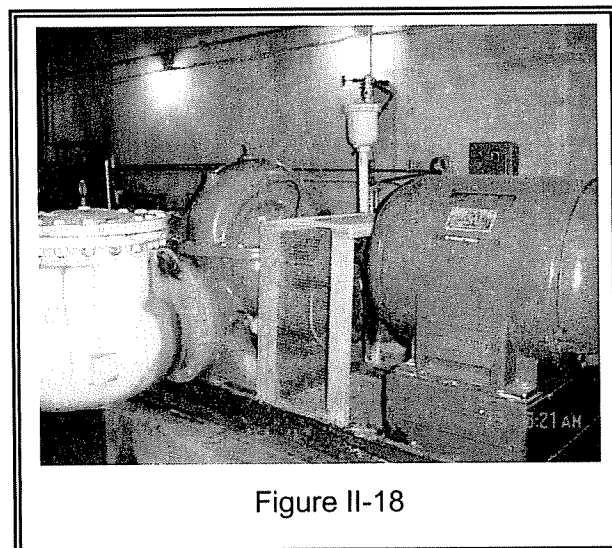
Figure II-18

Pump No. 2 is in unsatisfactory condition. Heavy to moderate corrosion was noted on the pump, pump base,

bearing housings, and piping and valves as shown in Figure II-18. The inlet valve for the pump is a 24 inch Keystone manual butterfly valve. The discharge valves are a 16 inch check valve and a 16 inch Pratt manual butterfly valve. Drive shaft guards were inadequate for personnel protection as they were made from thin gage wire and 2 inch by 4 inch boards causing a potential safety concern.

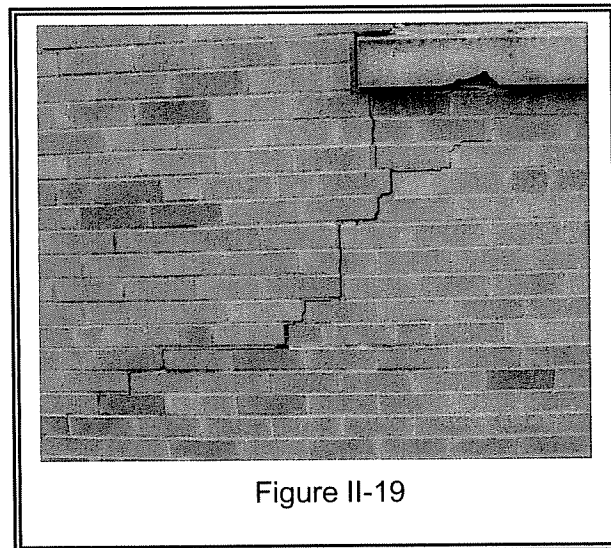
i. *Chemical Building*. The Chemical Building was constructed in 1961. The Chemical Building Chlorine Rooms are block and brick, single story rooms. The interior of the rooms are in satisfactory shape. Walls are painted CMU. The exterior of the building is brick which is in unsatisfactory condition. It was noted during the site investigation that there is strong evidence that the building is experiencing differential settlement due to the cracking apparent in the CMU walls and exterior brick walls at different location of the building. Figure II-19 shows an example of the cracking on the west side of the Chemical Building.

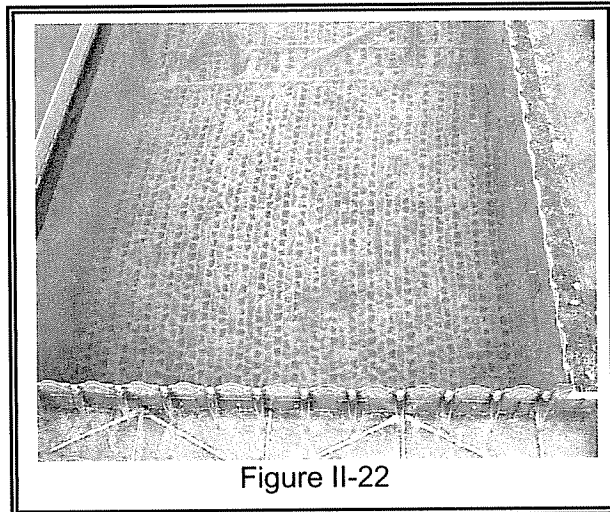
All the flocculators are in excellent condition, as they were replaced recently or were in the process of being replaced at the time of the site investigation. Minor corrosion was noted on the flocculator base plates in all cells. The clarifier rakes are in good condition. Light corrosion was noted on exposed metal surfaces and the bolts. Paint was peeling from the drive assemblies. The tube settlers are in good condition, although District staff indicated that pieces of the tubes are found when the basins are taken down for regularly scheduled maintenance. There are several places where the tubes are damaged from cleaning and maintenance. Figure II-22 shows the submerged tubes and examples of locations which are damaged.

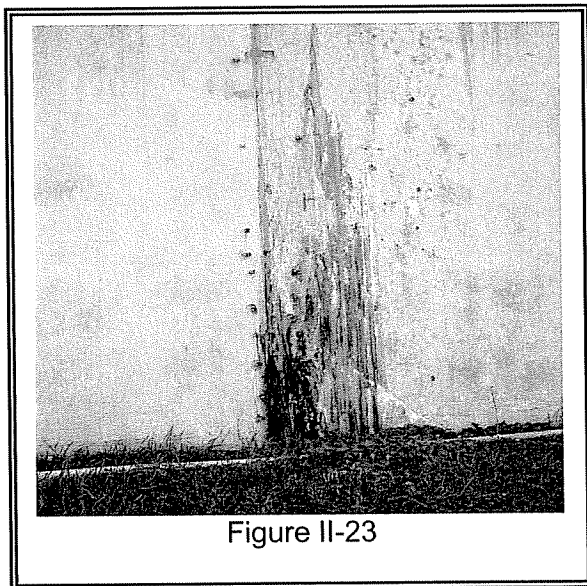
Figure II-23

Structurally, the basins are in unsatisfactory condition. Numerous locations were noted, as shown in Figure II-23, where water was leaking through the walls of the basins. District staff indicated that they are currently evaluating the structural integrity of the basins in a separate investigation.

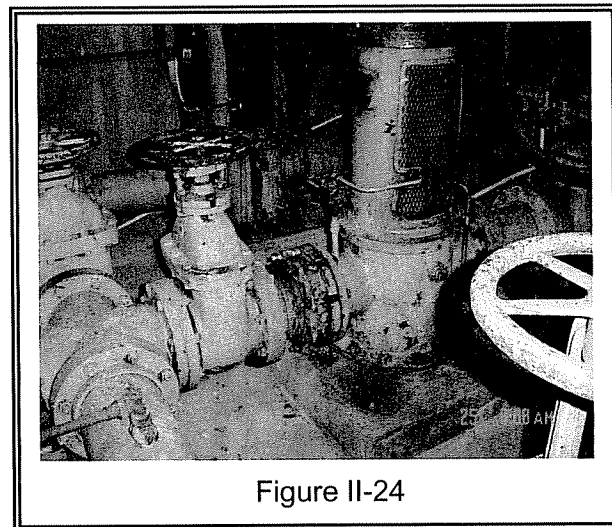
e. Pumping Equipment. The pumping equipment is located in the basement of the station, accessible by a ladder from the MCC room. The pumps were installed in 1968 (Pump No. 1) and 1986 (Pump Nos. 2 & 3), and are in unsatisfactory condition. Each pump and associated piping and valves has extensive corrosion present due to multiple seal leaks. Figure II-24 shows corrosion on Pump No. 2 and associated piping. Pipe supports are inadequate, and the level of actual support provided is questionable.

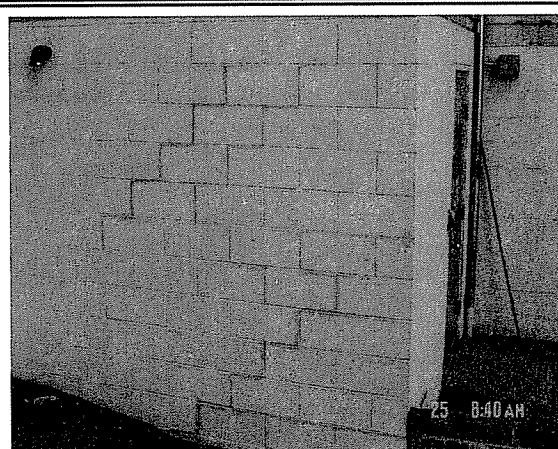
Figure II-25

The Sodium Hypochlorite room shows signs of differential settlement from the original pumping station. As shown in Figure II-25, this was evident by the cracking and movement of the CMU blockwork that comprises the walls of the building.

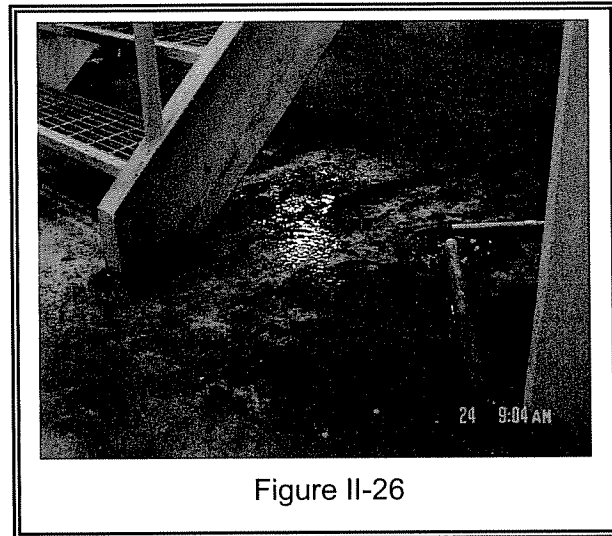
f. Water Quality Instrumentation. Water quality monitoring instrumentation is provided to monitor pH, turbidity, and chlorine residual. All instrumentation, and the connecting sample water piping, was noted to be in good condition. Drain piping from the equipment is routed to a floor drain in the middle of the pump room. The flow rate from the sampling equipment creates a large puddle adjacent to the floor drain which has resulted in heavy corrosion around the stair base and pipe supports as shown in Figure II-26.

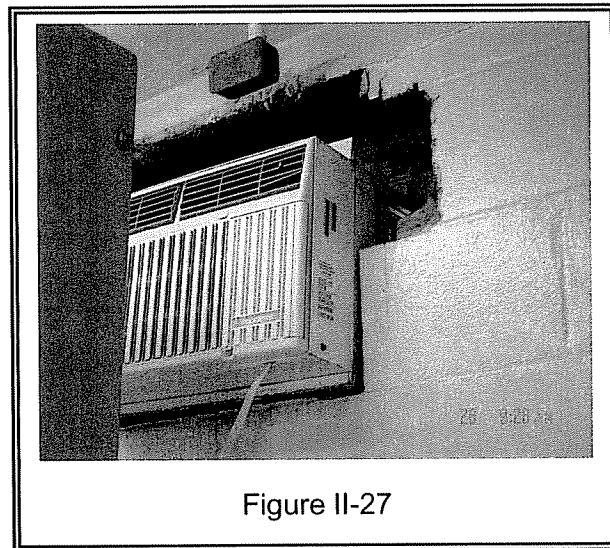
Figure II-27

g. Sodium Hypochlorite System. The sodium hypochlorite system is housed in two separate buildings on the site. The two 100 gallon day tanks and three metering pumps are located in the old chlorine feed building. The tanks, which are in good condition, and metering pumps, which are in satisfactory condition, are mounted on a pre-fabricated FRP secondary containment system. The secondary containment has adequate capacity, however the tanks and much of the piping hangs over the edges of the containment tank which could lead to accidental spills. The building is in satisfactory condition, although items of note include: a potentially leaking roof drain leader, CMU block wall damage due to the installation of a wall mounted AC unit, shown in Figure II-27, and old conduit and wiring from previous equipment that has since been removed. Structurally, the building is in good condition. There are no signs of differential settlement or other signs of structural damage. Lighting is incandescent and is in good condition. Ventilation is provided by a single wall mounted vent fan.

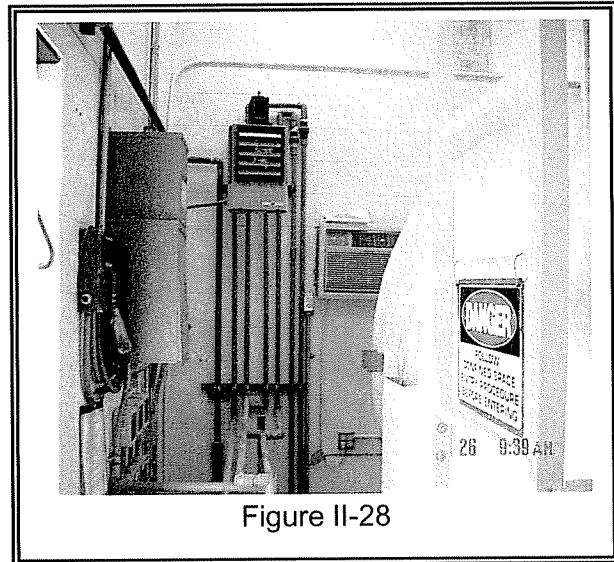
Figure II-28

The bulk storage tank and three transfer pumps are located in the old chlorine cylinder storage building. The 5,000 gallon double wall storage tank in good condition, although, the building itself is too small to properly house the tank. The size of the storage tank leaves approximately 1-1/2 feet on the sides and the ends of tank, making personnel movement within the building difficult, and unsafe in the event of an emergency. Figures II-28 and II-29 display the tight conditions inside the building.

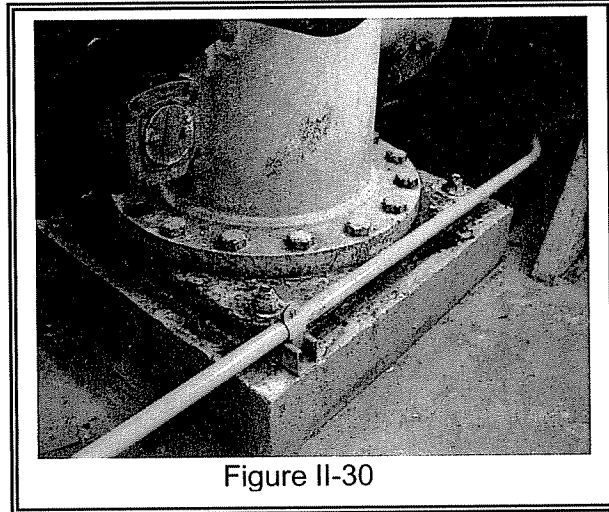
e. Pumping Equipment. The pumping equipment is generally in good condition. Vibration data for the period of November 2002 through April 2003, as measured by District staff, were within normal levels, with no indication that vibration of either pumping unit is increasing noticeably. Light corrosion was noted along the pump sub-bases. Figure II-30 shows corrosion around the sub-base of Pump No. 2 (HAND-PUMP2).

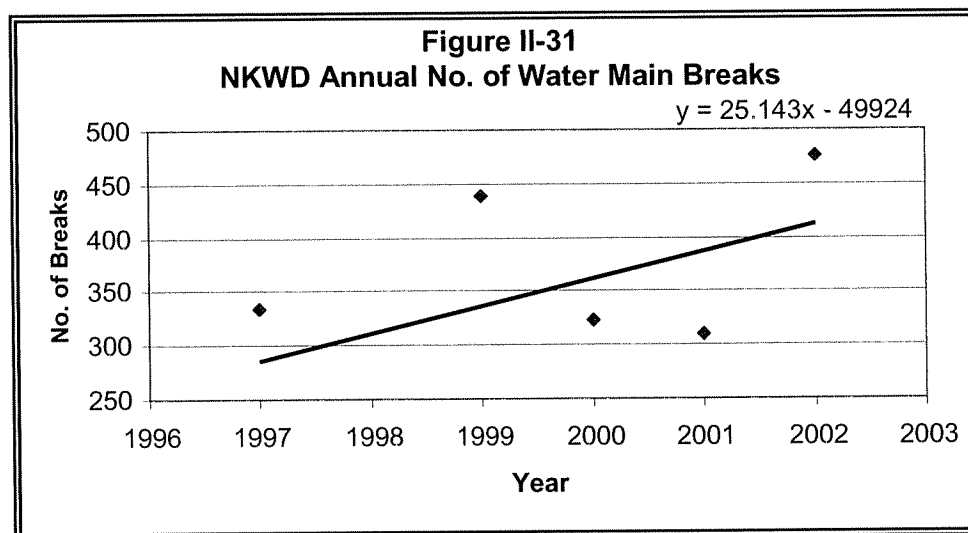
On average, the number of main breaks per year has increased over time, as indicated by Figure II-31. While there is some variance in the data, it appears the annual number of breaks is increasing at a rate of about 25 breaks per year. At this rate, the average number of breaks per year will double from the current 349 in approximately 14 years.

Based on the analysis of national water main break data, an AWWARF study ("Distribution System Performance Evaluation", 1995) recommended that utilities set a goal to keep the rate of their main breaks no more than 25 to 30 breaks per 100 miles per year. The District's current break rate of 34.9 per 100 miles per year exceeds these target values and is also expected to increase over time as discussed above. It therefore seems prudent for the District to take actions to reduce its break rate by at least 20%.

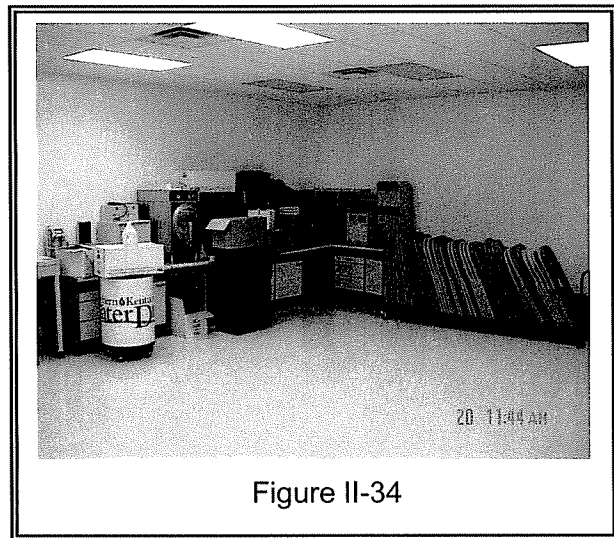
The Wet Chemistry Room is an important part of the laboratory because it houses the most basic and essential equipment needed to operate a compliance laboratory. As regulations become stricter and more testing is required, more bench space will be needed. One option to meet this need is to move the wet chemistry laboratory to the first floor of the building and install cabinets and bench casings. Figure II-34 shows a space on the first floor in the southeast corner that could be modified

to laboratory space. This would create space for another laboratory room, depending on District plans for future expansion.

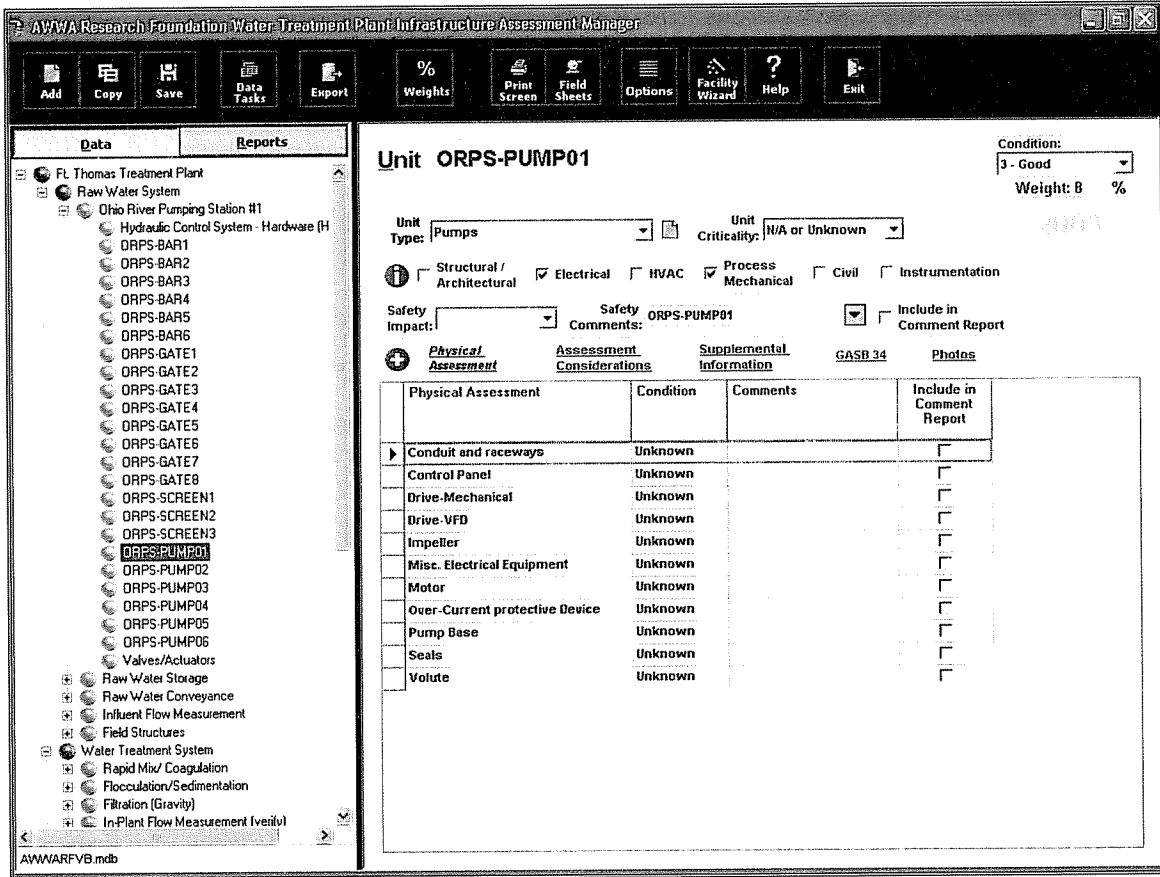
Figure V-3 is an example of a unit screen, the example shown here being for Pump No. 1 at ORPS1. The left side of the screen displays the facilities tree opened up under ORPS1 to display all of the units associated with this subsystem. The right side of the screen displays the characteristics of the unit that can be used while making evaluations for this unit. In the upper right corner of the screen are the condition and weight percentage of this unit. Here, the pump is in good condition with a weighting of 8 percent.

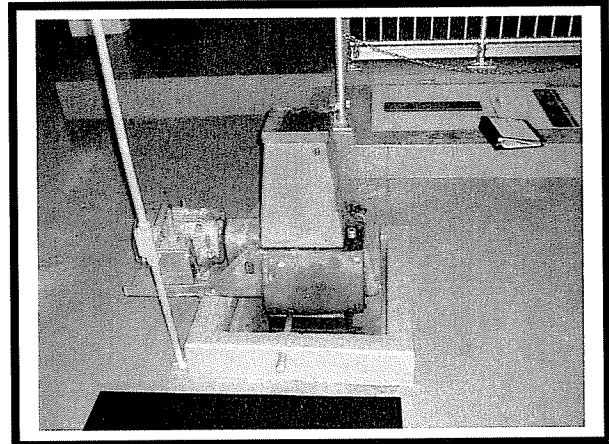
Equip Name: Rapid Mixer No. 1
 Tag ID: RAPID MIX FT1
 Service: Feeds Basins 2 & 3
 Make: Lightnin
 Model: 82 Q 7.5 LHR
 Ratio: 14.4:1
 No of Units: 1 (2 Total)
 Installation Date: 1936
 Replace Inst Date: 1990

Reliability:	<input type="checkbox"/> Excellent	<input checked="" type="checkbox"/> Satisfactory	<input type="checkbox"/> Fair	<input type="checkbox"/> Poor
Functionality:	<input checked="" type="checkbox"/> Excellent	<input type="checkbox"/> Satisfactory	<input type="checkbox"/> Fair	<input type="checkbox"/> Poor
Maint Access:	<input type="checkbox"/> Excellent	<input type="checkbox"/> Satisfactory	<input type="checkbox"/> Fair	<input type="checkbox"/> Poor
Corrosion:	<input type="checkbox"/> Extensive	<input type="checkbox"/> Moderate	<input checked="" type="checkbox"/> Light	<input type="checkbox"/> None
Vibration:	<input type="checkbox"/> Heavy	<input type="checkbox"/> Moderate	<input checked="" type="checkbox"/> Light	<input type="checkbox"/> Other
Noise:	<input type="checkbox"/> Loud	<input type="checkbox"/> Normal	<input checked="" type="checkbox"/> Light	
Operating Temp:	<input type="checkbox"/> High	<input type="checkbox"/> Normal	<input type="checkbox"/> Low	<input type="checkbox"/> Other

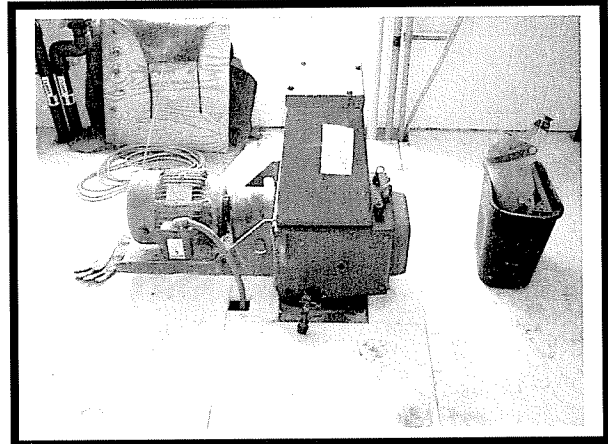
Equip Name: Rapid Mixer No. 2
 Tag ID: RAPID MIX FT2
 Service: Feeds Basins 1 & 4
 Make: Lightnin
 Model: 82 Q 7.5 LHR
 Ratio: 11.5:1
 No of Units: 1 (2 Total)
 Installation Date: 1987
 Replace Inst Date: 1990

Reliability:	<input type="checkbox"/> Excellent	<input checked="" type="checkbox"/> Satisfactory	<input type="checkbox"/> Fair	<input type="checkbox"/> Poor
Functionality:	<input checked="" type="checkbox"/> Excellent	<input type="checkbox"/> Satisfactory	<input type="checkbox"/> Fair	<input type="checkbox"/> Poor
Maint Access:	<input type="checkbox"/> Excellent	<input checked="" type="checkbox"/> Satisfactory	<input type="checkbox"/> Fair	<input type="checkbox"/> Poor
Corrosion:	<input type="checkbox"/> Extensive	<input type="checkbox"/> Moderate	<input checked="" type="checkbox"/> Light	<input type="checkbox"/> None
Vibration:	<input type="checkbox"/> Heavy	<input type="checkbox"/> Moderate	<input checked="" type="checkbox"/> Light	<input type="checkbox"/> Other
Noise:	<input type="checkbox"/> Loud	<input type="checkbox"/> Normal	<input checked="" type="checkbox"/> Light	
Operating Temp:	<input type="checkbox"/> High	<input type="checkbox"/> Normal	<input type="checkbox"/> Low	<input type="checkbox"/> Other

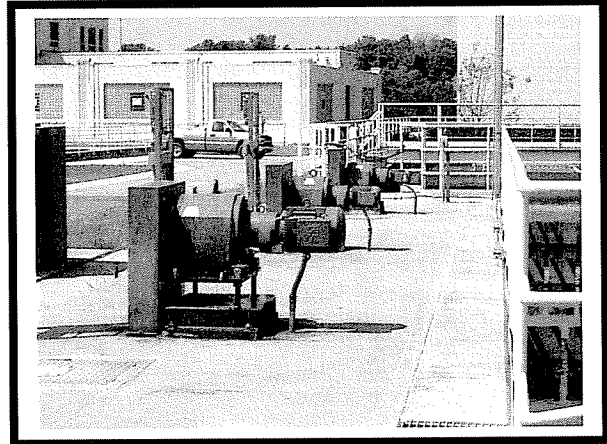
Installation Date: 1987

Reliability:	<input type="checkbox"/> Excellent	<input checked="" type="checkbox"/> Satisfactory	<input type="checkbox"/> Fair	<input type="checkbox"/> Poor
Functionality:	<input type="checkbox"/> Excellent	<input checked="" type="checkbox"/> Satisfactory	<input type="checkbox"/> Fair	<input type="checkbox"/> Poor
Maint Access:	<input type="checkbox"/> Excellent	<input checked="" type="checkbox"/> Satisfactory	<input type="checkbox"/> Fair	<input type="checkbox"/> Poor
Corrosion:	<input type="checkbox"/> Extensive	<input type="checkbox"/> Moderate	<input checked="" type="checkbox"/> Light	<input type="checkbox"/> None
Vibration:	<input type="checkbox"/> Heavy	<input type="checkbox"/> Moderate	<input type="checkbox"/> Light	<input type="checkbox"/> Other
Noise:	<input type="checkbox"/> Loud	<input type="checkbox"/> Normal	<input checked="" type="checkbox"/> Light	
Operating Temp:	<input type="checkbox"/> High	<input type="checkbox"/> Normal	<input type="checkbox"/> Low	<input type="checkbox"/> Other

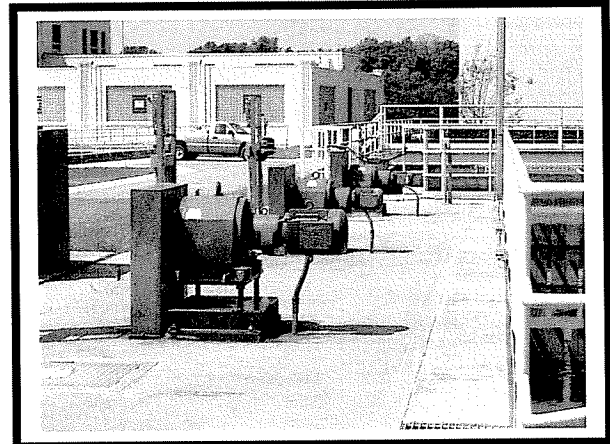
Equip Name: Basin # 1, Cells # 2 and # 3 Flocculators
 Tag ID: FTTP FLOC 1-2 (3)
 Service: Flocculators
 Make: Amwell
 Model: R10370DT100L4
 Ratio: 203
 No of Units: 2 (3 Total Flocculators)
 Installation Date: 1987
 Major Rehab Date: _____

Reliability:	<input type="checkbox"/> Excellent	<input checked="" type="checkbox"/> Satisfactory	<input type="checkbox"/> Fair	<input type="checkbox"/> Poor
Functionality:	<input type="checkbox"/> Excellent	<input checked="" type="checkbox"/> Satisfactory	<input type="checkbox"/> Fair	<input type="checkbox"/> Poor
Maint Access:	<input type="checkbox"/> Excellent	<input checked="" type="checkbox"/> Satisfactory	<input type="checkbox"/> Fair	<input type="checkbox"/> Poor
Corrosion:	<input type="checkbox"/> Extensive	<input type="checkbox"/> Moderate	<input checked="" type="checkbox"/> Light	<input type="checkbox"/> None
Vibration:	<input type="checkbox"/> Heavy	<input type="checkbox"/> Moderate	<input type="checkbox"/> Light	<input type="checkbox"/> Other
Noise:	<input type="checkbox"/> Loud	<input type="checkbox"/> Normal	<input checked="" type="checkbox"/> Light	
Operating Temp:	<input type="checkbox"/> High	<input type="checkbox"/> Normal	<input type="checkbox"/> Low	<input type="checkbox"/> Other

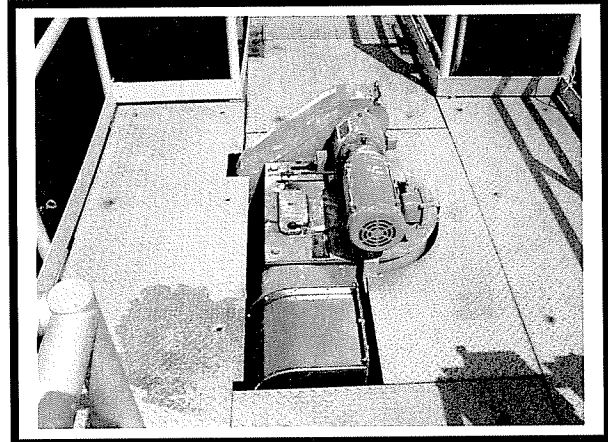
Equip Name: Clarifier No. 1
 Tag ID: FTTP-RAKE-1
 Service: Sedimentation Rake
 Make: Amwell Drive
 Model: R63DLR
 Ratio: 66.02:1
 No of Units: 1
 Installation Date: 1987
 Major Rehab Date: _____

Reliability:	<input type="checkbox"/> Excellent	<input checked="" type="checkbox"/> Satisfactory	<input type="checkbox"/> Fair	<input type="checkbox"/> Poor
Functionality:	<input checked="" type="checkbox"/> Excellent	<input type="checkbox"/> Satisfactory	<input type="checkbox"/> Fair	<input type="checkbox"/> Poor
Maint Access:	<input type="checkbox"/> Excellent	<input checked="" type="checkbox"/> Satisfactory	<input type="checkbox"/> Fair	<input type="checkbox"/> Poor
Corrosion:	<input type="checkbox"/> Extensive	<input type="checkbox"/> Moderate	<input checked="" type="checkbox"/> Light	<input type="checkbox"/> None
Vibration:	<input type="checkbox"/> Heavy	<input type="checkbox"/> Moderate	<input type="checkbox"/> Light	<input type="checkbox"/> Other
Noise:	<input type="checkbox"/> Loud	<input type="checkbox"/> Normal	<input type="checkbox"/> Light	
Operating Temp:	<input type="checkbox"/> High	<input type="checkbox"/> Normal	<input type="checkbox"/> Low	<input type="checkbox"/> Other

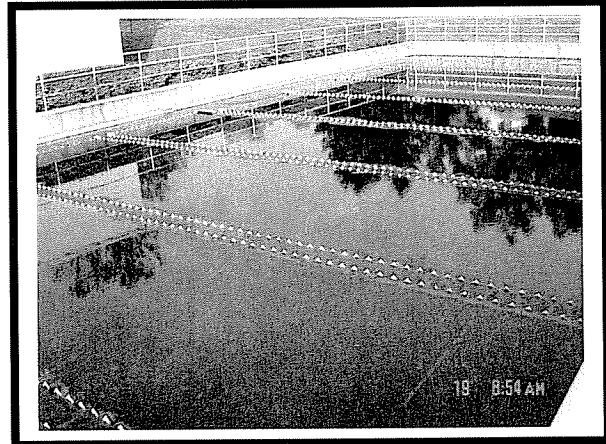
Equip Name: Basin # 1 Tube Settlers
 Tag ID: FTTP-Tubes 1
 Service: Tube Settlers
 Make: Unknown
 Material: _____
 Capacity: 2' depth
 No of Units: 1
 Installation Date: 1987
 Major Rehab Date: _____

Reliability:	<input type="checkbox"/> Excellent	<input type="checkbox"/> Satisfactory	<input checked="" type="checkbox"/> Fair	<input type="checkbox"/> Poor
Functionality:	<input type="checkbox"/> Excellent	<input checked="" type="checkbox"/> Satisfactory	<input type="checkbox"/> Fair	<input type="checkbox"/> Poor
Maint Access:	<input type="checkbox"/> Excellent	<input type="checkbox"/> Satisfactory	<input type="checkbox"/> Fair	<input type="checkbox"/> Poor
Corrosion:	<input type="checkbox"/> Extensive	<input checked="" type="checkbox"/> Moderate	<input type="checkbox"/> Light	<input type="checkbox"/> None
Vibration:	<input type="checkbox"/> Heavy	<input type="checkbox"/> Moderate	<input type="checkbox"/> Light	<input type="checkbox"/> Other
Noise:	<input type="checkbox"/> Loud	<input type="checkbox"/> Normal	<input type="checkbox"/> Light	
Operating Temp:	<input type="checkbox"/> High	<input type="checkbox"/> Normal	<input type="checkbox"/> Low	<input type="checkbox"/> Other

Tubes were submerged at time of inspection. However, past inspections as well as District's staff comments about condition factored into overall condition.

Showing signs of deterioration. Brittle when taken out of service for cleaning

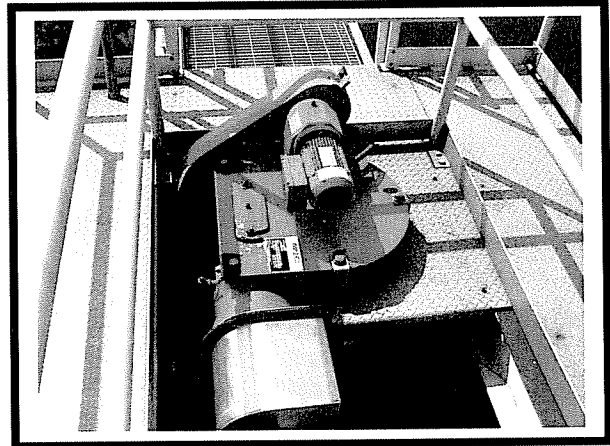
Equip Name: Clarifier No. 2 and No. 3
 Tag ID: FTTP-RAKE-2 (3)
 Service: Sedimentation Rakes
 Make: Amwell Drive
 Model: R63DT80N4
 Ratio: 48.65:1
 No of Units: 2
 Installation Date: 1936
 Replace Inst Date: 1991

Light corrosion on bolts, paint peeling.

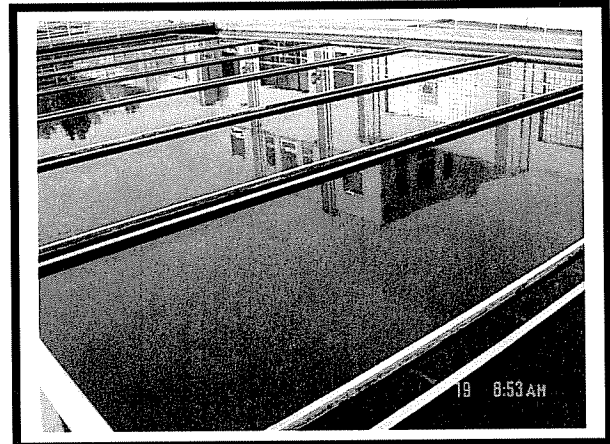
Equip Name: Basin # 2 Tube Settlers
 Tag ID: FTTP-Tubes 2
 Service: Tube Settlers
 Make: Envirofax
 Material: ABS
 Capacity: 2' depth
 No of Units: 1
 Installation Date: 1991
 Major Rehab Date: _____

| Reliability: | <input type="checkbox"/> Excellent | <input type="checkbox"/> Satisfactory | <input checked="" type="checkbox"/> Fair | <input type="checkbox"/> Poor |
| Corrosion: | <input type="checkbox"/> Extensive | <input checked="" type="checkbox"/> Moderate | <input type="checkbox"/> Light | <input type="checkbox"/> None |

Tubes were submerged at time of inspection. However, past inspections and reports as well as District's staff comments about condition factored into overall condition.

Showing signs of deterioration. Brittle when taken out of service for cleaning.

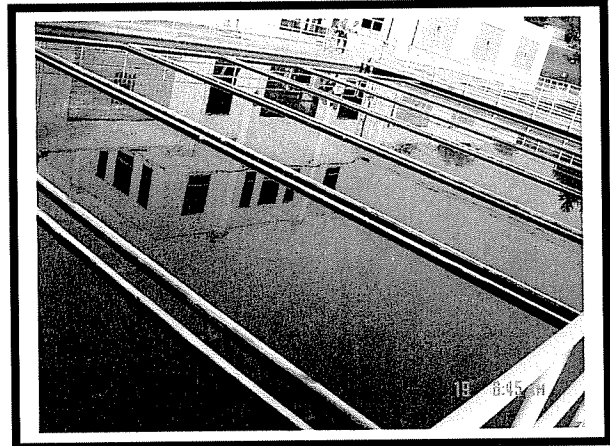
Equip Name: Basin # 3 Tube Settlers
 Tag ID: FTTP-Tubes 3
 Service: Tube Settlers
 Make: Envirofax
 Material: ABS
 Capacity: 2' depth
 No of Units: 1
 Installation Date: 1991
 Major Rehab Date: _____

| Reliability: | <input type="checkbox"/> Excellent | <input type="checkbox"/> Satisfactory | <input checked="" type="checkbox"/> Fair | <input type="checkbox"/> Poor |
| Corrosion: | <input type="checkbox"/> Extensive | <input checked="" type="checkbox"/> Moderate | <input type="checkbox"/> Light | <input type="checkbox"/> None |

Tubes were submerged at time of inspection. However, past inspections and reports as well as District's staff comments about condition factored into overall condition.

Showing signs of deterioration. Brittle when taken out of service for cleaning.

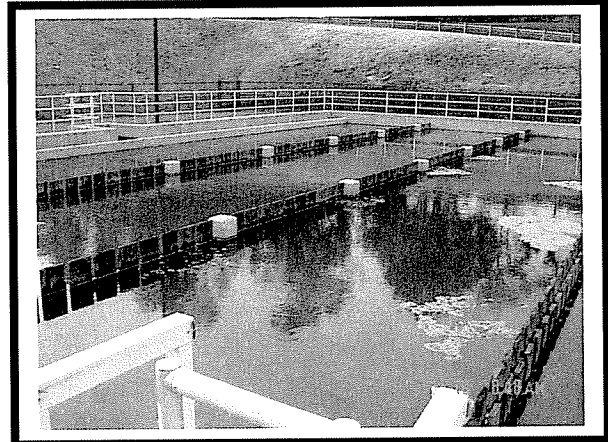
Confined space entry to inspect drives. Visual inspected from above on grating and based condition on District's staffs comments.

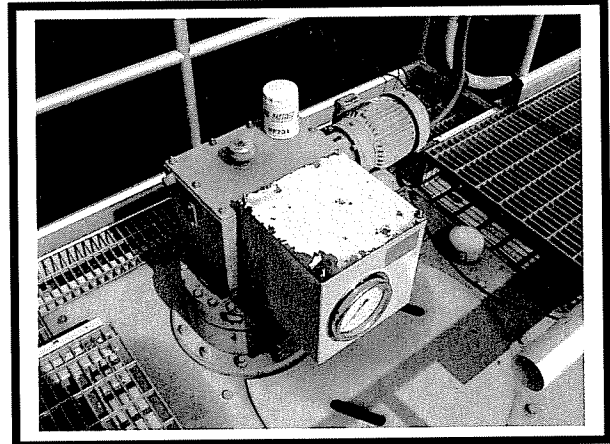
Equip Name: Clarifier No. 4
 Tag ID: FTTP-RAKE-4
 Service: Sedimentation Rake
 Make: DBS
 Model: DF-42-7
 Ratio: N/A
 No of Units: 1
 Installation Date: 1993
 Major Rehab Date: _____

Visual Observations (Note any visible corrosion, clogging, drive equipment problems, external damage or other items noted during site inspection):
 Light corrosion on bolts, paint peeling.

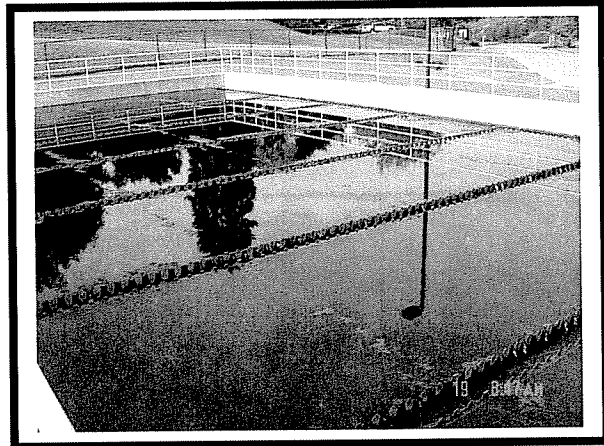
Equip Name: Basin # 4 Tube Settlers
 Tag ID: FTTP-Tubes 4
 Service: Tube Settlers
 Make: MRI (Meurer Research Inc.)
 Material: PVC
 Capacity: 2' depth
 No of Units: 1
 Installation Date: 1993
 Major Rehab Date: _____

Reliability:	<input type="checkbox"/> Excellent	<input type="checkbox"/> Satisfactory	<input type="checkbox"/> Fair	<input checked="" type="checkbox"/> Poor
Functionality:	<input type="checkbox"/> Excellent	<input checked="" type="checkbox"/> Satisfactory	<input type="checkbox"/> Fair	<input type="checkbox"/> Poor
Maint Access:	<input type="checkbox"/> Excellent	<input type="checkbox"/> Satisfactory	<input type="checkbox"/> Fair	<input type="checkbox"/> Poor
Corrosion:	<input checked="" type="checkbox"/> Extensive	<input type="checkbox"/> Moderate	<input type="checkbox"/> Light	<input type="checkbox"/> None
Vibration:	<input type="checkbox"/> Heavy	<input type="checkbox"/> Moderate	<input type="checkbox"/> Light	<input type="checkbox"/> Other
Noise:	<input type="checkbox"/> Loud	<input type="checkbox"/> Normal	<input type="checkbox"/> Light	
Operating Temp:	<input type="checkbox"/> High	<input type="checkbox"/> Normal	<input type="checkbox"/> Low	<input type="checkbox"/> Other

Tubes were submerged at time of inspection. However, past inspections and reports as well as District's staff comments about condition factored into overall condition.

Showing extensive signs of deterioration. Brittle when taken out of service for cleaning.
Pieces of tubes have been found in the basin drain when it is taken down for service.

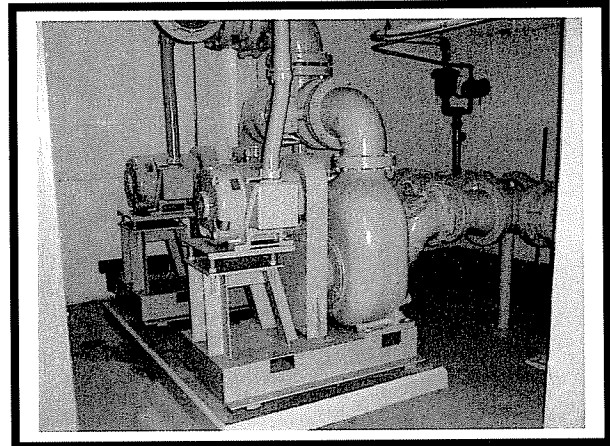
Equip Name: Backwash Pump
 Tag ID: FTTP-BCKW1 (2)
 Service: Filter Backwash Pumps
 Make: Gorman-Rupp Company
 Model: T10A61-B
 Capacity: 2500 gpm
 No of Units: 2
 Installation Date: 1987
 Major Rehab Date: _____

Reliability:	<input type="checkbox"/> Excellent	<input checked="" type="checkbox"/> Satisfactory	<input type="checkbox"/> Fair	<input type="checkbox"/> Poor
Functionality:	<input type="checkbox"/> Excellent	<input checked="" type="checkbox"/> Satisfactory	<input type="checkbox"/> Fair	<input type="checkbox"/> Poor
Maint Access:	<input type="checkbox"/> Excellent	<input checked="" type="checkbox"/> Satisfactory	<input type="checkbox"/> Fair	<input type="checkbox"/> Poor
Corrosion:	<input type="checkbox"/> Extensive	<input type="checkbox"/> Moderate	<input type="checkbox"/> Light	<input checked="" type="checkbox"/> None
Vibration:	<input type="checkbox"/> Heavy	<input type="checkbox"/> Moderate	<input type="checkbox"/> Light	<input type="checkbox"/> Other
Noise:	<input type="checkbox"/> Loud	<input type="checkbox"/> Normal	<input type="checkbox"/> Light	
Operating Temp:	<input type="checkbox"/> High	<input type="checkbox"/> Normal	<input type="checkbox"/> Low	<input type="checkbox"/> Other

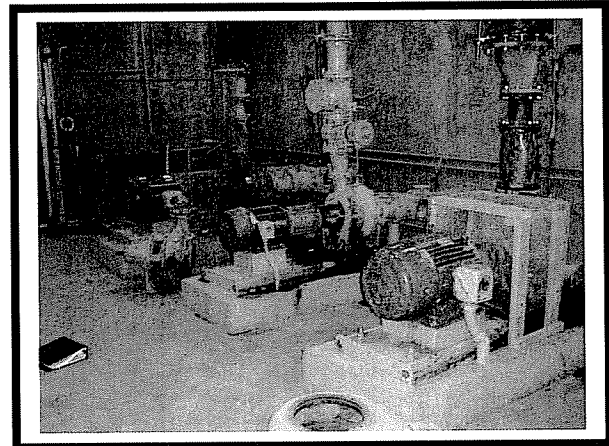
Equip Name: Backwash Return Pumps
 Tag ID: Backwash Return Pump 1 (2)
 Service: Return Backwash to Head of Plant
 Make: ITT Industries
 Model: Type NSW 5x5x12
 Capacity: 1200 gpm
 No of Units: 2
 Installation Date: _____
 Major Rehab Date: _____

Visible corrosion on pumps and bases.

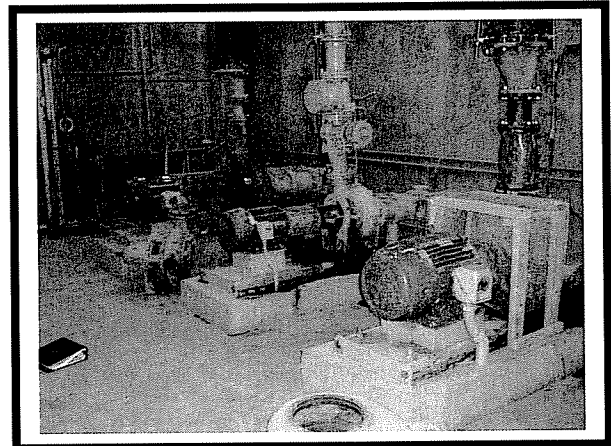
Equip Name: Backwash Transfer Pump
 Tag ID: Backwash Transfer Pump
 Service: Solids to Gravity Tckn
 Make: Allis - Chambers
 Model: Type NSW 6x4x12LC
 Capacity: 200 gpm @ 25 feet
 No of Units: 1
 Installation Date: 1987
 Major Rehab Date: _____

Visible corrosion on pump and base.

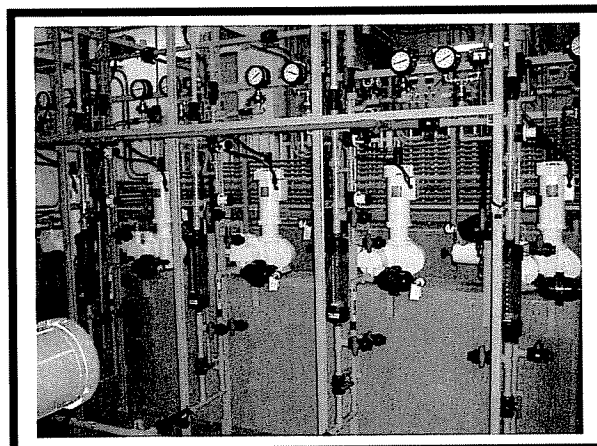
Equip Name: Coagulant Metering Pumps
 Tag ID: CP FT CLARION1 (2, 3, 4, 5)
 Service: Clarion Metering Pumps
 Make: Milton Roy
 Model: 231732-18
 Capacity: 35.9 gph @ 100 psig
 No of Units: 5
 Installation Date: 2001
 Major Rehab Date: _____

Reliability:	<input type="checkbox"/> Excellent	<input checked="" type="checkbox"/> Satisfactory	<input type="checkbox"/> Fair	<input type="checkbox"/> Poor
Functionality:	<input checked="" type="checkbox"/> Excellent	<input type="checkbox"/> Satisfactory	<input type="checkbox"/> Fair	<input type="checkbox"/> Poor
Maint Access:	<input type="checkbox"/> Excellent	<input type="checkbox"/> Satisfactory	<input checked="" type="checkbox"/> Fair	<input type="checkbox"/> Poor
Corrosion:	<input type="checkbox"/> Extensive	<input type="checkbox"/> Moderate	<input checked="" type="checkbox"/> Light	<input type="checkbox"/> None
Vibration:	<input type="checkbox"/> Heavy	<input type="checkbox"/> Moderate	<input type="checkbox"/> Light	<input type="checkbox"/> Other
Noise:	<input type="checkbox"/> Loud	<input type="checkbox"/> Normal	<input type="checkbox"/> Light	
Operating Temp:	<input type="checkbox"/> High	<input type="checkbox"/> Normal	<input type="checkbox"/> Low	<input type="checkbox"/> Other

Visible Light Corrosion were past spills have occurred.

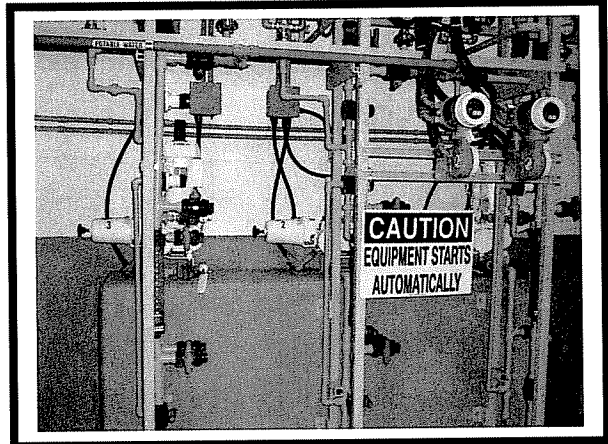
| Reliability: | <input type="checkbox"/> Excellent | <input checked="" type="checkbox"/> Satisfactory | <input type="checkbox"/> Fair | <input type="checkbox"/> Poor |
| Corrosion: | <input type="checkbox"/> Extensive | <input type="checkbox"/> Moderate | <input checked="" type="checkbox"/> Light | <input type="checkbox"/> None |

Light corrosion on pumps, piping from past spills / leaks.

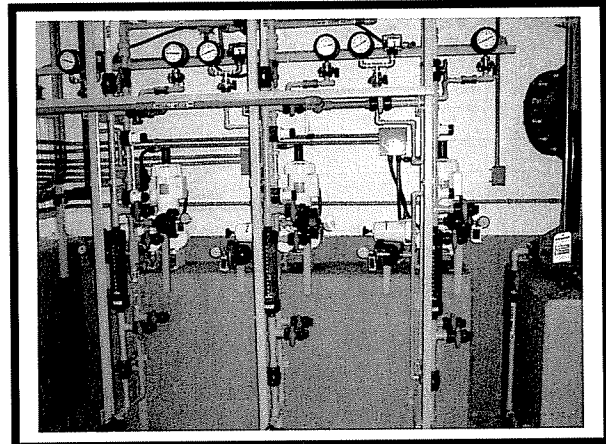
Equip Name: Ferric Sulfate Metering Pumps
 Tag ID: CP FT FERRIC1 (2, 3)
 Service: Metering Pumps
 Make: Milton Roy
 Model: _____
 Capacity: 11.0 gph
 No of Units: 3
 Installation Date: 2001
 Major Rehab Date: _____

Reliability:	<input type="checkbox"/> Excellent	<input checked="" type="checkbox"/> Satisfactory	<input type="checkbox"/> Fair	<input type="checkbox"/> Poor
Functionality:	<input type="checkbox"/> Excellent	<input checked="" type="checkbox"/> Satisfactory	<input type="checkbox"/> Fair	<input type="checkbox"/> Poor
Maint Access:	<input type="checkbox"/> Excellent	<input type="checkbox"/> Satisfactory	<input checked="" type="checkbox"/> Fair	<input type="checkbox"/> Poor
Corrosion:	<input type="checkbox"/> Extensive	<input type="checkbox"/> Moderate	<input checked="" type="checkbox"/> Light	<input type="checkbox"/> None
Vibration:	<input type="checkbox"/> Heavy	<input type="checkbox"/> Moderate	<input type="checkbox"/> Light	<input type="checkbox"/> Other
Noise:	<input type="checkbox"/> Loud	<input type="checkbox"/> Normal	<input type="checkbox"/> Light	
Operating Temp:	<input type="checkbox"/> High	<input type="checkbox"/> Normal	<input type="checkbox"/> Low	<input type="checkbox"/> Other

Minor Corrosion around valves pipe connections from leaks. Floor had a slight coating on it from leaks or spills.

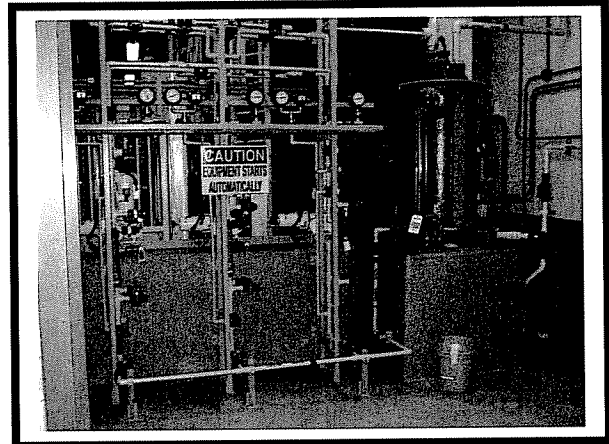
Equip Name: Corrosion Inhibitor Metering Pumps
 Tag ID: CP FT K-5 1 (2, 3)
 Service: Metering Pumps
 Make: Milton Roy
 Model: 231732-8
 Capacity: 1.6 gph, 100 psig
 No of Units: 3
 Installation Date: 2001
 Major Rehab Date: _____

Minor visible evidence of where spills or leaks have occurred.

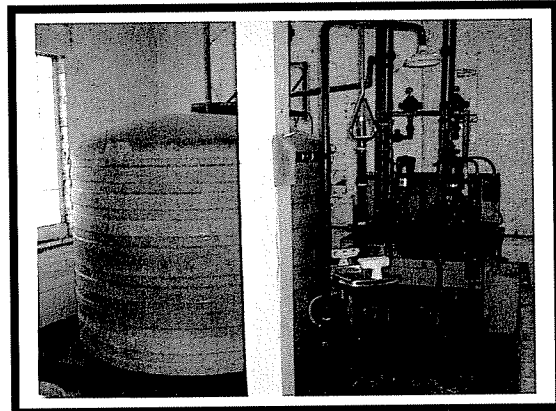
Equip Name: Potassium Permanganate Day Tank
 Tag ID: TANK FT-KMNO4
 Service: Day Tank
 Make: _____
 Model: _____
 Capacity: 1,750 gal
 No of Units: 1
 Installation Date: _____
 Major Rehab Date: _____

Very hot / humid inside the building causing the tank to excessively "sweat".

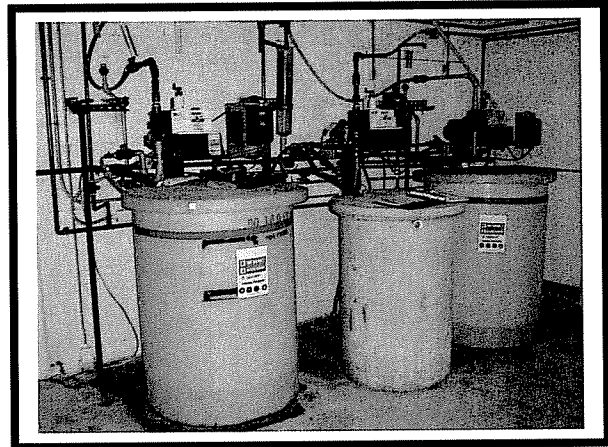
Light corrosion noted. No containment.

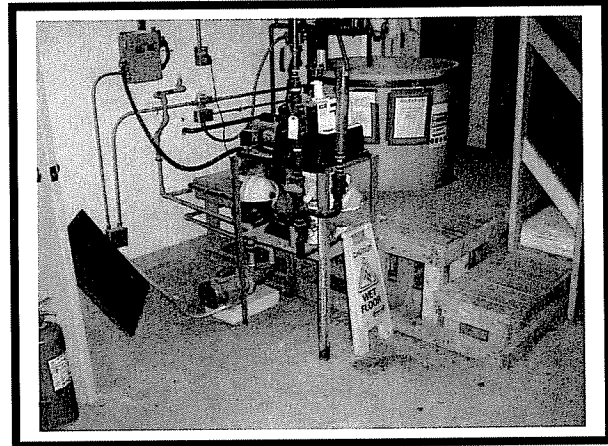
Light corrosion. No containment.

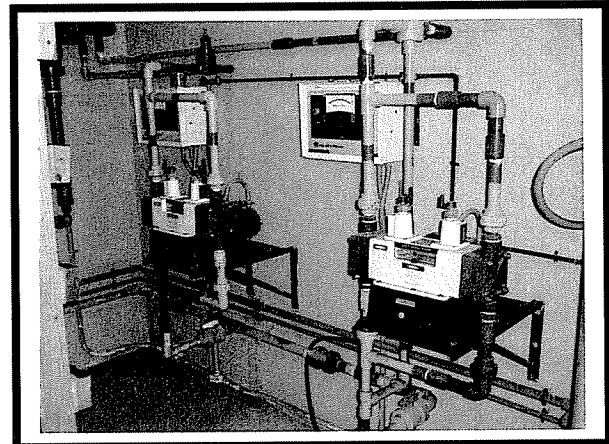
Equip Name: Sludge Polymer Pumps
 Tag ID: SLUDGE POLY FT1 (2)
 Service: Polymer Metering Pumps
 Make: Wallace & Tiernan
 Model: Series 44 125 M2P
 Capacity: 208 gph
 No of Units: 2
 Installation Date: 1991
 Major Rehab Date: _____

Evidence of spills and leaks

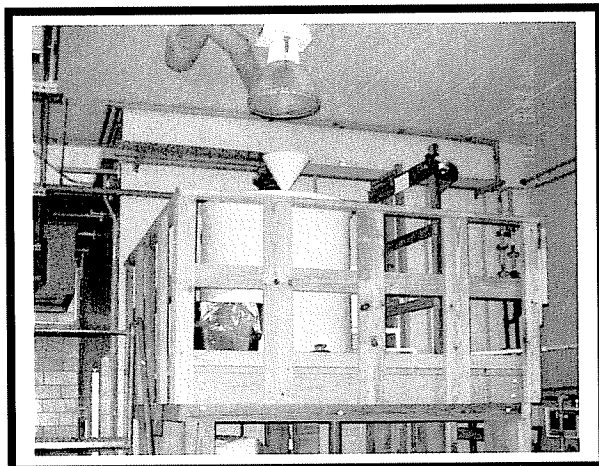
Equip Name: Sludge Polymer Tank
 Tag ID: TANK SLUDGE POLY 1
 Service: Polymer Storage Tank
 Make: _____
 Model: _____
 Capacity: 200 gal
 No of Units: 1
 Installation Date: 1999
 Major Rehab Date: _____

Evidence of spills and leaks

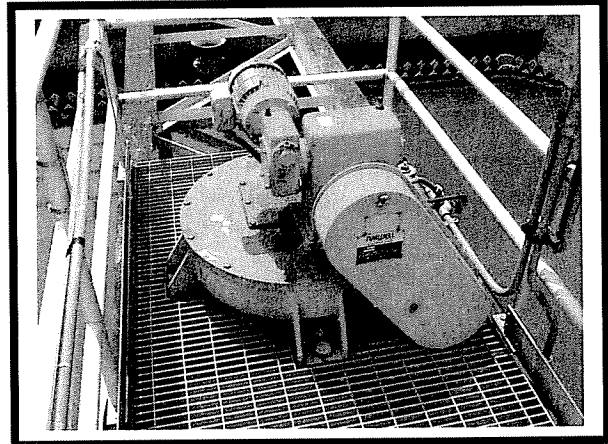
Equip Name: Gravity Thickener Drive
 Tag ID: SLUDGE RAKE FT
 Service: Gravity Thickener
 Make: Amwell
 Model: W28M
 Ratio: N/A
 No of Units: 1
 Installation Date: 1987
 Major Rehab Date: 1991

Minor corrosion / rust noted on the drive assembly

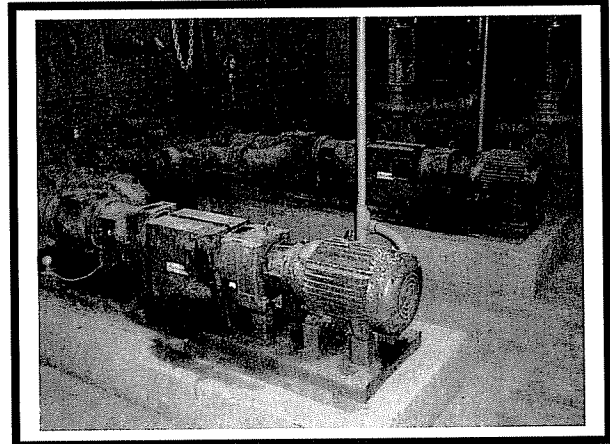
Equip Name: Sludge Pumps
 Tag ID: SLUDGE FT PUMP1 (2)
 Service: Sludge Progressing Cavity
 Make: Moyno
 Model: Type 1H115G1CDQ
 Capacity: N/A Variable Speed
 No of Units: 2
 Installation Date: 1987
 Major Rehab Date: _____

Moderate visible corrosion on pumps and bases.
