Case No. 2005-00148

**COMMONWEALTH OF KENTUCKY
BEFORE THE PUBLIC SERVICE COMMISSION**

**NORTHERN KENTUCKY WATER DISTRICT'S RESPONSE TO THE
ATTORNEY GENERAL'S REQUEST FOR INFORMATION**

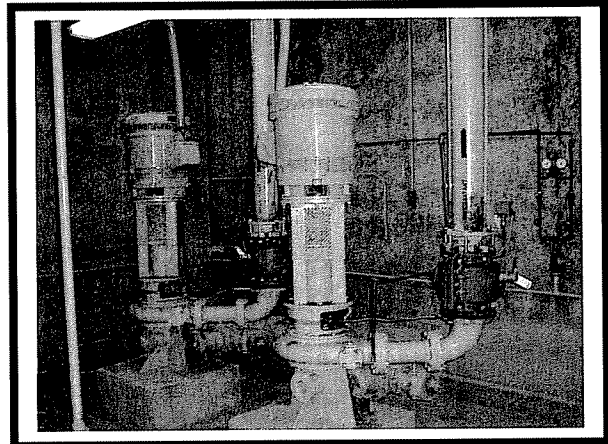
Equip Name: Sludge Supernatant Pumps
 Tag ID: SUPERNATANT FT PUMP1 (2)
 Service: Decant from Gravity Thck.
 Make: Fairbanks Morse
 Model: K3X1-071793
 Capacity: 750 gpm
 No of Units: 2
 Installation Date: 1991
 Major Rehab Date: _____

Light corrosion on pumps.

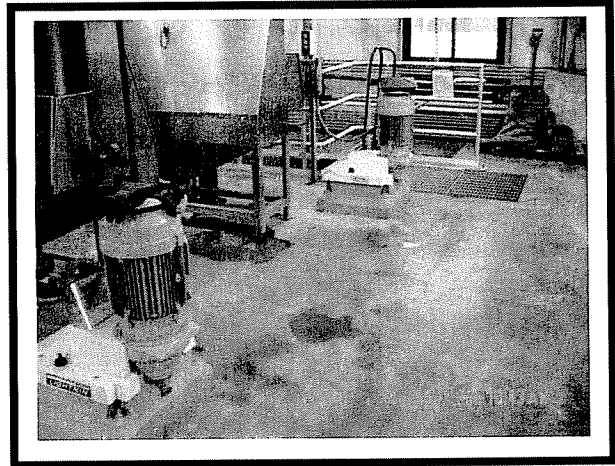
Equip Name: Injection Mixers
 Tag ID: MPTP INJECT-A (B)
 Service: Injection
 Make: Lightnin
 Model: Series 10
 Ratio: _____
 No of Units: 2
 Installation Date: 1999
 Major Rehab Date: 2003

Grating is loose in certain locations. District staff noted that that this is a safety concern.

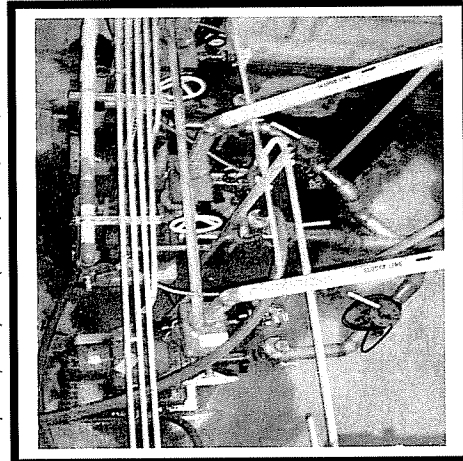
Equip Name: Sand Pumps
 Tag ID: MPTP SAND PUMP A1 (2, 3)
 Service: Sand Recycle Pumps
 Make: Ingersoll-Dresser, Flowserve
 Model: Type R 2 1/2 RO 90
 Capacity: 120 gpm
 No of Units: 3 (6 Total)
 Installation Date: 1999 (A1, A2) 2003 (A3)
 Major Rehab Date: 2001 (A1, A2)

Some corrosion, leaks on pumps.

Pump A3 was replaced in 2003 with a Flowserve Pump.

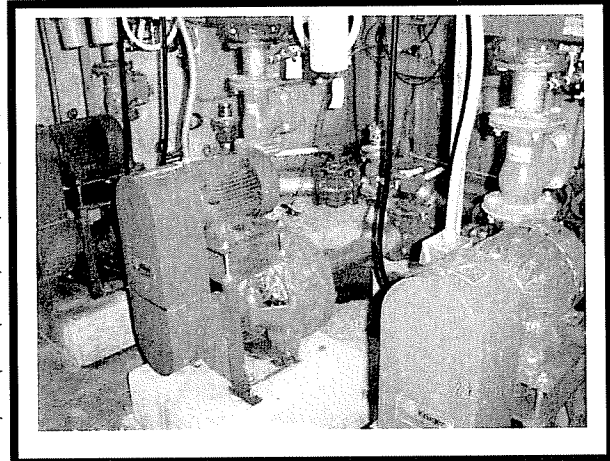
Equip Name: Sand Pumps
 Tag ID: MPTP SAND PUMP B1 (2, 3)
 Service: Sand Recycle Pumps
 Make: Ingersoll-Dresser
 Model: Type R 2 1/2 RO 90
 Capacity: 120 gpm
 No of Units: 3 (6 Total)
 Installation Date: 1999
 Major Rehab Date: 2001

Some corrosion, leaks on pumps.

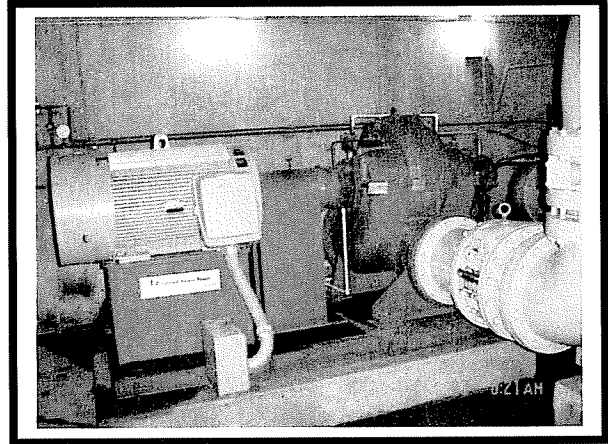
Equip Name: Backwash Pump
Tag ID: MPTP-BCKW1
Service: Filter Backwash Pump
Make: Ingersoll Dresser
Model: N/A
Capacity: 9000 gpm @ 45 ft
No of Units: 1 (2 Total)
Installation Date: 1998
Major Rehab Date: _____

Heavy to moderate corrosion on pumps, bases, connections, piping, valves.

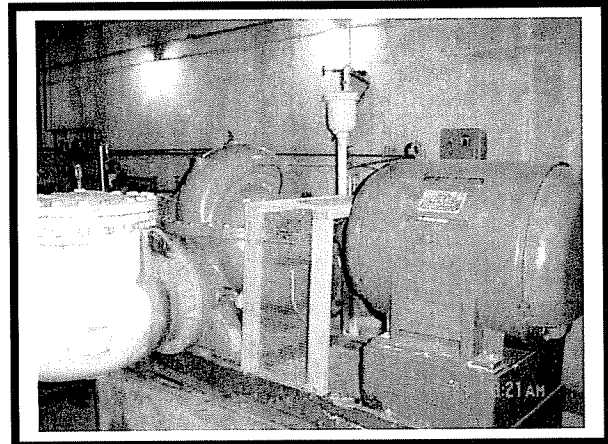
Equip Name: Backwash Pump
Tag ID: MPTP-BCKW2
Service: Filter Backwash Pump
Make: Worthington
Model: 16LA1
Capacity: 9000 gpm @ 45 ft
No of Units: 1 (2 Total)
Installation Date: 1961
Major Rehab Date: 2000

Heavy to moderate corrosion on pumps, bases, connections, piping, valves.

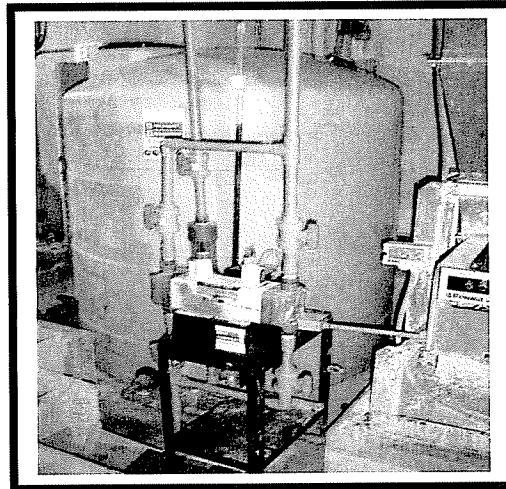
Equip Name: Ferric Sulfate Metering Pump
 Tag ID: CP MP FERRIC1
 Service: Metering Pump
 Make: Wallace & Tiernan
 Model: Series 44
 Capacity: ~2000 mL/ min
 No of Units: 1
 Installation Date: 2003
 Major Rehab Date: _____

Corrosion evident from past leaks or spills on pipe connections, pump, and floor.

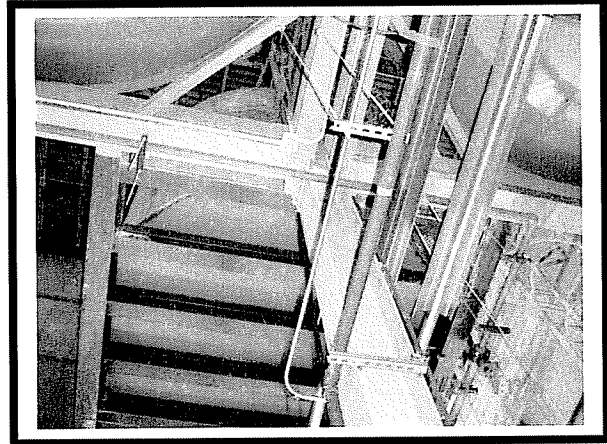
Equip Name: Ferric Sulfate Storage Tank
 Tag ID: TANK FERRIC MP1
 Service: Storage Tank
 Make: _____
 Model: _____
 Capacity: ~6,000 gal
 No of Units: 1
 Installation Date: 1961
 Major Rehab Date: _____

Elevated, no containment. Noted rusting at the bottom of the tank.

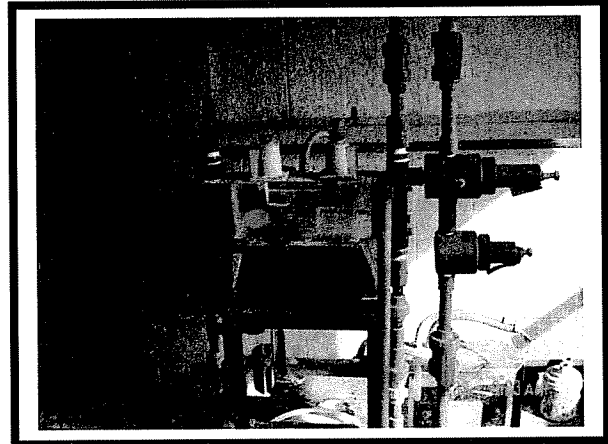
Equip Name: Coagulant Metering Pump
 Tag ID: CP MP COAG1
 Service: Polyaluminum Chloride
 Make: Wallace & Tiernan
 Model: Series 44 – 125 M9P
 Capacity: ~2000 mL/min
 No of Units: 1
 Installation Date: 2003
 Major Rehab Date: _____

Visible Corrosion where past spills or leaks have occurred.
Metering Pump appeared to be an old unit, rehabilitated and placed in service here.

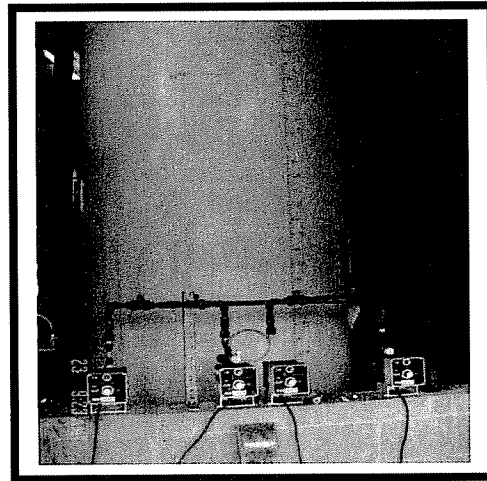
Equip Name: Coagulant Storage Tank
 Tag ID: TANK COAG MP1
 Service: Polyaluminum Chloride
 Make: _____
 Model: _____
 Capacity: 2,000 gal
 No of Units: 1
 Installation Date: 1994
 Major Rehab Date: _____

Visible Corrosion where past spills or leaks have occurred.
Inadequate Storage Capacity. Currently paying for full loads but can only handle about half to 2/3 of a load. Additional cost.

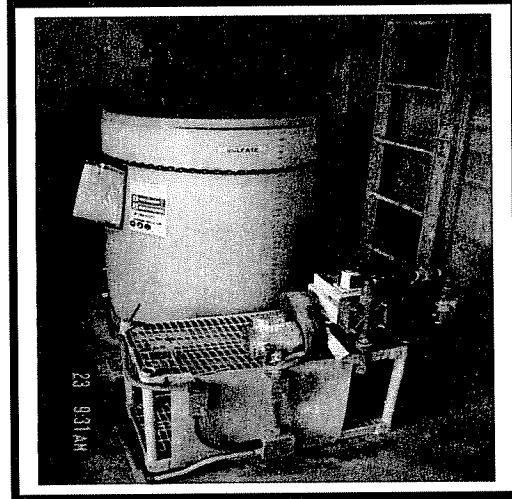
Equip Name: Copper Sulfate Metering Pump
 Tag ID: CP MP COPPER1
 Service: Metering Pump
 Make: Wallace & Tiernan
 Model: Series 44-118
 Capacity: ~500 mL/min
 No of Units: 1
 Installation Date: 1999
 Major Rehab Date: 2003

No containment, sitting on plastic shelves.
Moderate corrosion on piping, pump.
The metering pump appears to be an old unit, rehabilitated, and placed in service here.

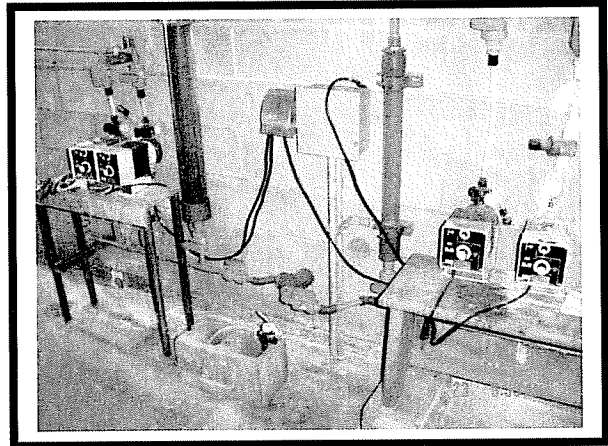
Noted connections on piping are leaking (minor)

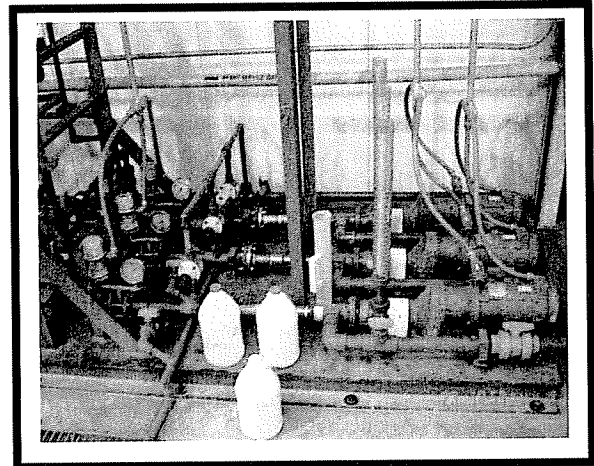
Equip Name: Polymer Metering Pumps
 Tag ID: CP MP POLY1 (2, 3)
 Service: Metering Pumps
 Make: SEW – Eurodrive - Moyno
 Model: RX 611 P56
 Capacity: 190 gph
 No of Units: 3
 Installation Date: 1999
 Major Rehab Date: _____

Minor corrosion on pipe connections.

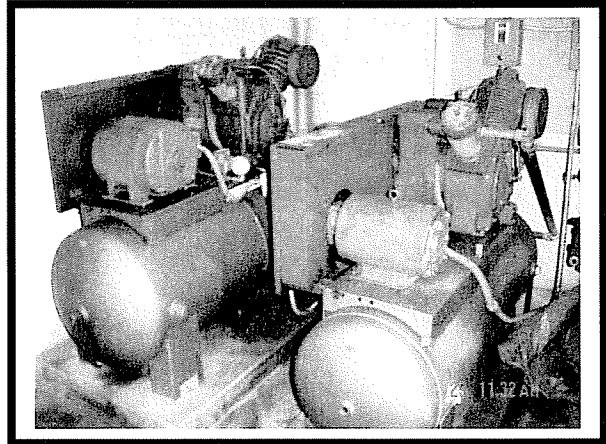
Equip Name: Compressors
 Tag ID: MPTP COMPRESS1 (2)
 Service: Air
 Make: Ingersoll-Rand
 Model: _____
 Load: _____
 No of Units: 2
 Installation Date: 1961
 Major Rehab Date: _____

One tank is cracked, not in use. Still use the compressor though.

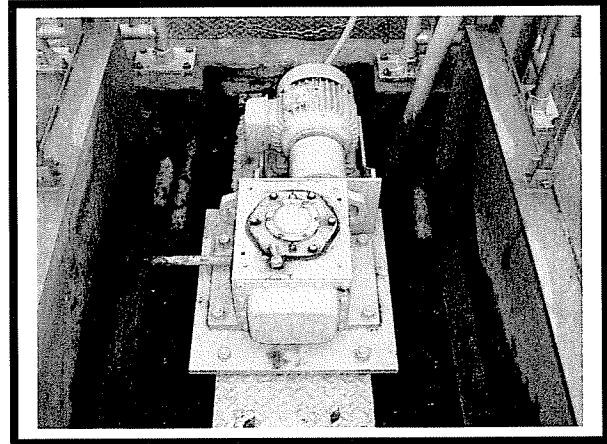
Equip Name: Rapid Mixer
 Tag ID: RAPID MIX TM
 Service: _____
 Make: Lightnin
 Model: N/A
 Ratio: N/A
 No of Units: 1
 Installation Date: 1953
 Replace Inst Date: 1989

Light corrosion on base plates, supports, and bolts.

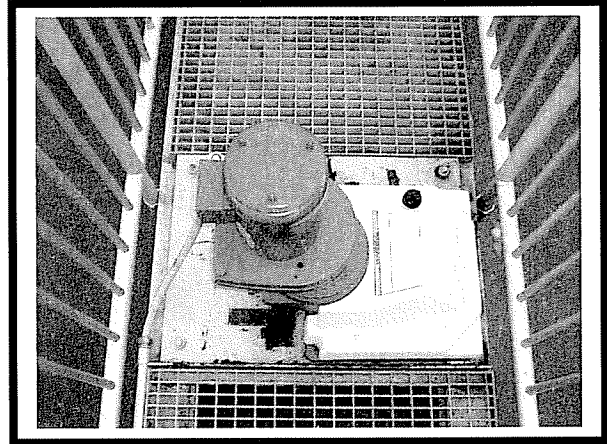
Equip Name: Flocculators
 Tag ID: TMTP-FLOC-N1 (2-4) (S1-S4)
 Service: Vertical Turbine Flocc.
 Make: Lightnin
 Model: Series 10, LFD4501CMX
 Ratio: 87.5:1
 No of Units: 8 (1 in each cell)
 Installation Date: 1953 (N) 1960 (S)
 Replace Inst Date: 2003

Visual Observations (Note any visible corrosion, clogging, drive equipment problems, external damage or other items noted during site inspection):
 Light corrosion on base plates.

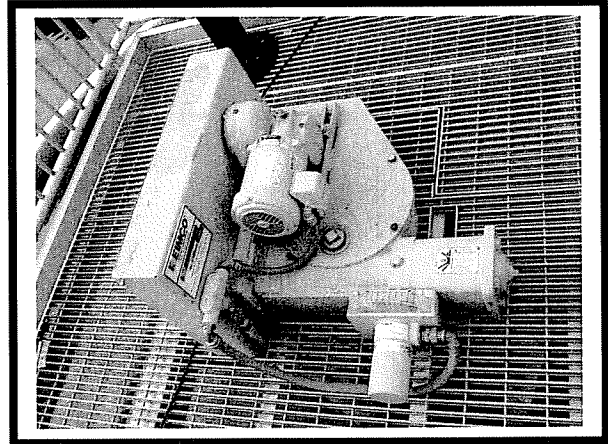
Equip Name: Clarifiers (North and South)
 Tag ID: TMTP-RAKE-N (S)
 Service: Rakes
 Make: Eimco
 Model: C30HT
 Ratio: 57.0:1
 No of Units: 2
 Installation Date: 1953 (N) 1960 (S)
 Replace Inst Date: 1997

Light corrosion on bolts, paint peeling.

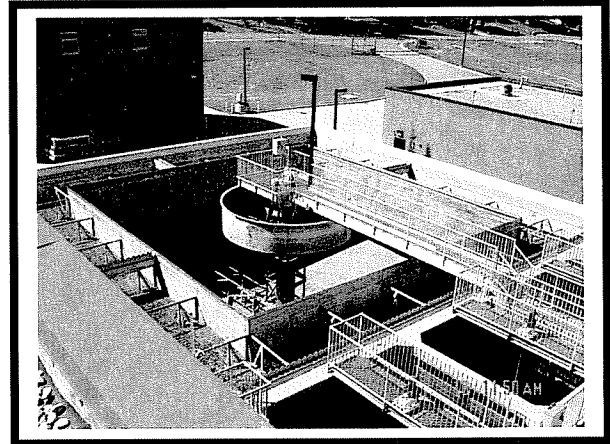
Equip Name: South Basin Tube Settlers
 Tag ID: TMTP Tubes S
 Service: Tube Settlers
 Make: N/A
 Material: N/A
 Capacity: 2' depth
 No of Units: 1
 Installation Date: 1997
 Major Rehab Date: _____

Showing signs of deterioration. Brittle when taken out of service for cleaning

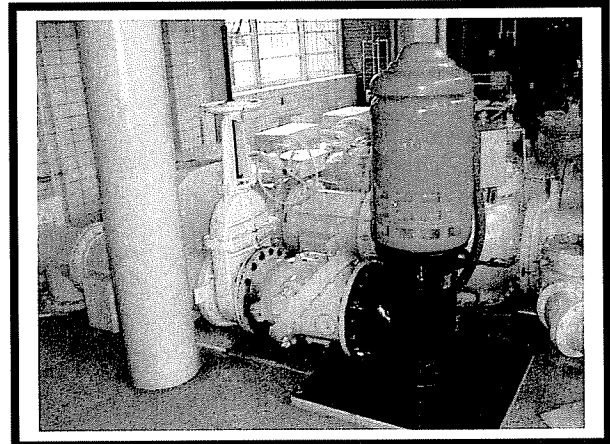
Equip Name: Backwash Pump
 Tag ID: TMTP-BWPUMP
 Service: Filter Backwash Pump
 Make: Cascade Pump
 Model: Size 12MFCA
 Capacity: 4,500 gpm
 No of Units: 1
 Installation Date: 2003
 Major Rehab Date: 2003

Light corrosion on check valve on discharge of pump.

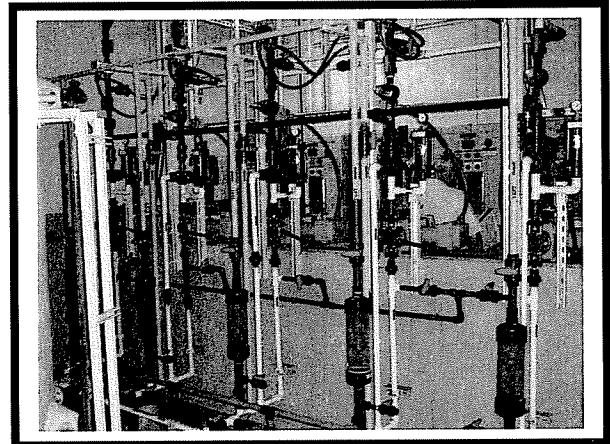
Corrosion is evident on pumps, piping, any exposed metal in area.

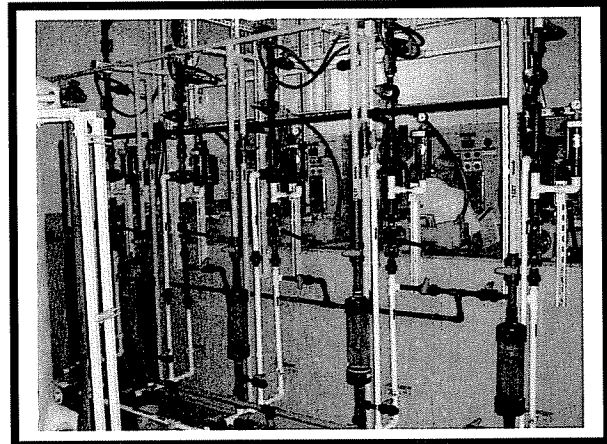
Corrosion is evident on pumps, piping, any exposed metal in area.

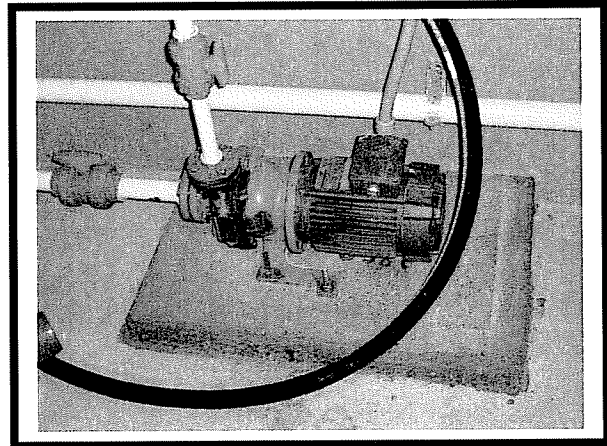
Visible corrosion on pipe connections and pump.

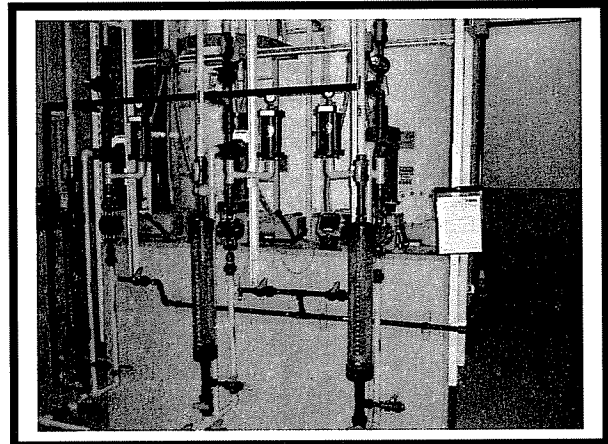
Equip Name: Coagulant Metering Pumps
 Tag ID: CP TM HYPER1 (2, 3)
 Service: Hyperion Metering Pumps
 Make: Wallace & Tiernan
 Model: Encore 700
 Capacity: 90 gph
 No of Units: 3
 Installation Date: 1998
 Major Rehab Date: _____

Visible Corrosion were past spills have occurred.

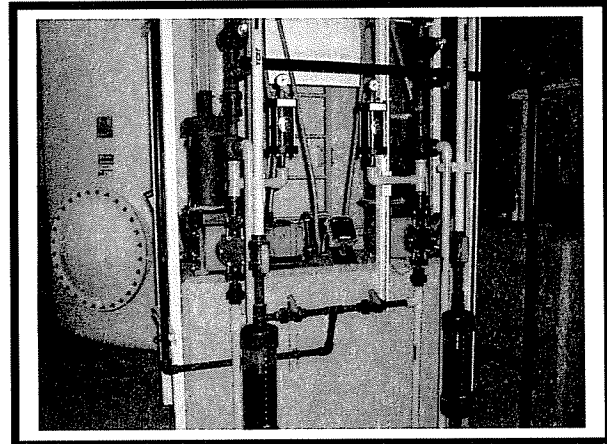
Past leaks visible on pumps and valves.

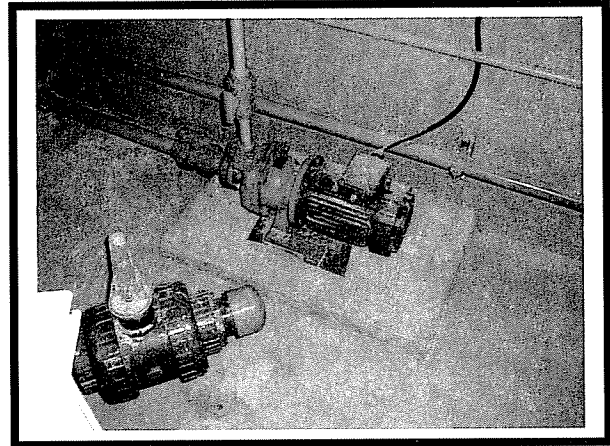
Equip Name: Ferric Sulfate Transfer Pump
 Tag ID: CP TM FER TRAN1
 Service: Transfer Pumps
 Make: Goulds Pump
 Model: Size 1x1.60-S
 Capacity: 45 gpm
 No of Units: 1 (currently)
 Installation Date: 1998
 Major Rehab Date: _____

Leaks visible on pumps and valves. Traces of spills are evident. Only one transfer pumps replaced two that were originally constructed on platform.

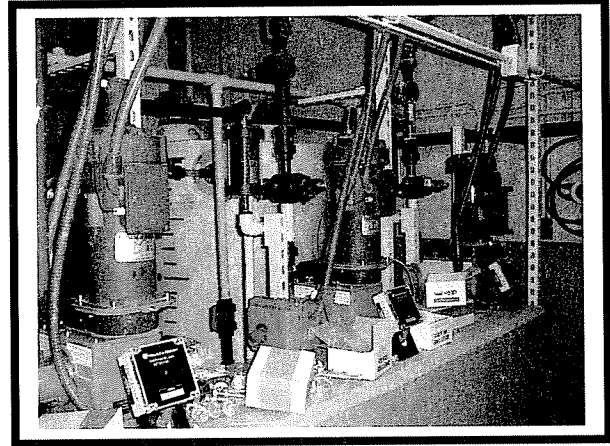
Equip Name: Caustic Soda Metering Pumps
 Tag ID: CP TM CAUSTIC1 (2, 3)
 Service: Metering Pumps
 Make: Wallace & Tiernan
 Model: Encore 700
 Capacity: 22.5 gph
 No of Units: 3
 Installation Date: 1998
 Major Rehab Date: _____

Corrosion from leak and spill around connections and on the floor.

Caustic Soda is currently being replaced with Sulfuric Acid.

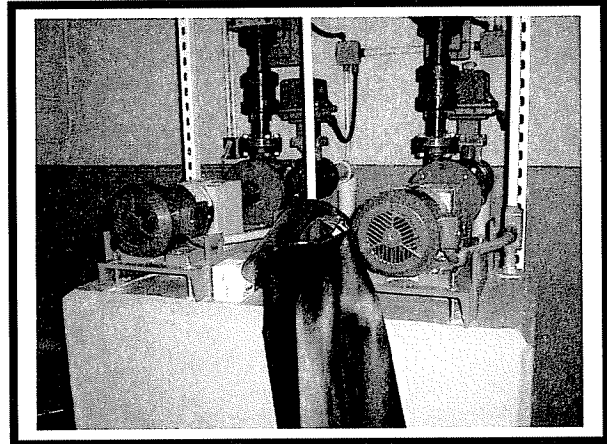
Equip Name: Caustic Soda Transfer Pumps
Tag ID: CP TM CAU TRAN1 (2)
Service: Transfer Pumps
Make: Goulds Pump
Model: 3200 Size 2-3-6
Capacity: 50 gpm
No of Units: 2
Installation Date: 1998
Major Rehab Date: _____

Corrosion from leak and spill around connections and on the floor.

Caustic Soda is currently being replaced with Sulfuric Acid.

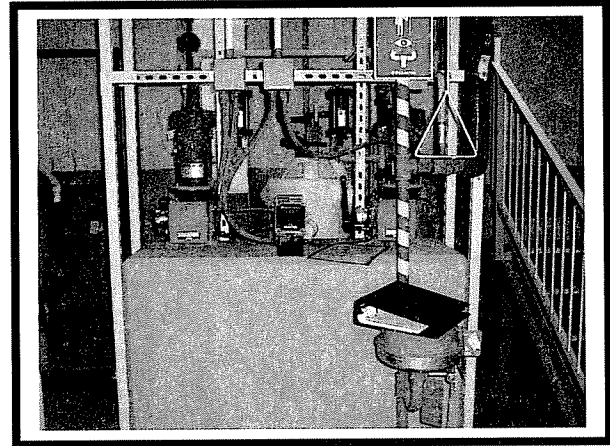
Equip Name: Hydrofluorosilicic Acid Metering Pumps
 Tag ID: CP TM HFS1 (2)
 Service: Metering Pumps
 Make: Wallace & Tiernan
 Model: Encore 700
 Capacity: 6 gph
 No of Units: 2
 Installation Date: 1998
 Major Rehab Date: _____

Minor Corrosion on pumps and piping.

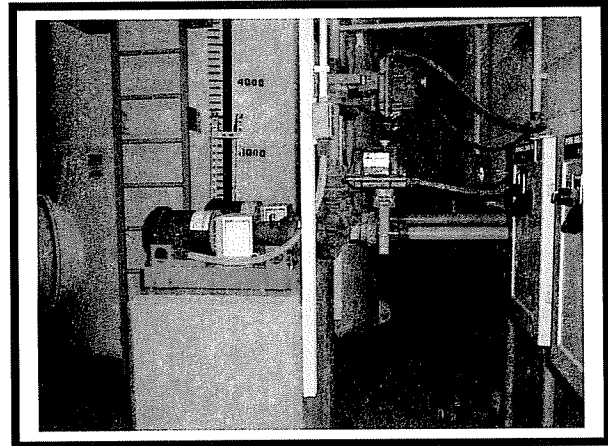
Minor Corrosion on pump base. Visible places where spills or leaks have occurred.

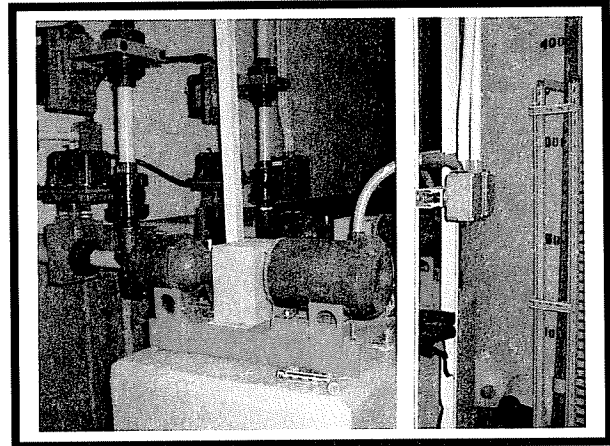
Equip Name: Corrosion Inhibitor Transfer Pumps
 Tag ID: CP TM K-5 TRAN1 (2)
 Service: Transfer Pumps
 Make: Goulds Pump
 Model: 3200
 Capacity: 6 gpm
 No of Units: 2
 Installation Date: 1998
 Major Rehab Date: _____

Visible evidence of where spills have occurred.
Leakage around pipe connections for Pump No. 1. (Closer to Storage Tank)

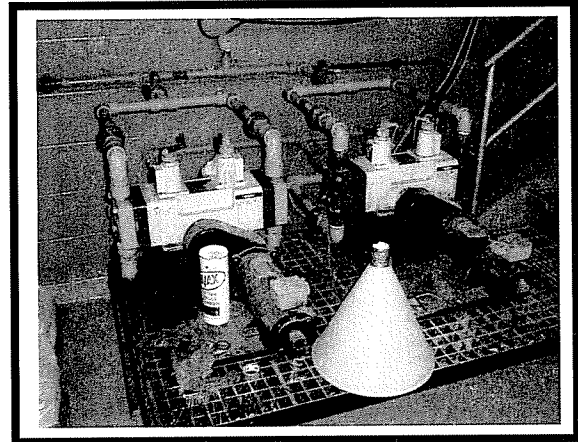
Equip Name: Sludge Polymer Pumps
 Tag ID: SLUDGE POLY TM1 (2)
 Service: Polymer Metering Pumps
 Make: Wallace & Tiernan
 Model: Series 44-125
 Capacity: 208 gpm
 No of Units: 2
 Installation Date: 1989
 Major Rehab Date: _____

A few minor places on pumps and connecting piping where spills or leaks have occurred.

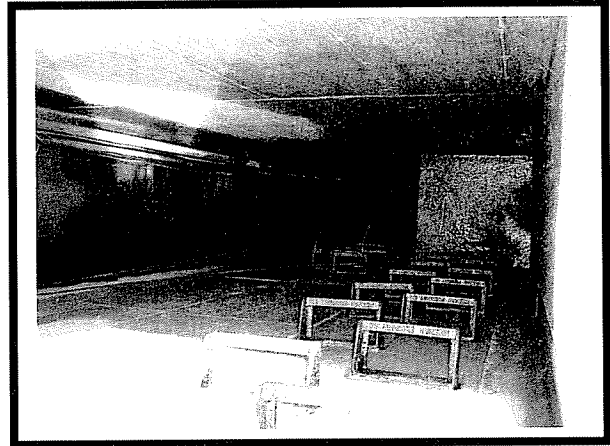
Equip Name: Sludge Clarifier Pumps
 Tag ID: SLUDGE CLARI 1 (2)
 Service: Submersible Pumps
 Make: ABS
 Model: _____
 Capacity: 400 gpm
 No of Units: 2
 Installation Date: 1989
 Major Rehab Date: _____

Unknown condition. Pumps not pulled out of pit.

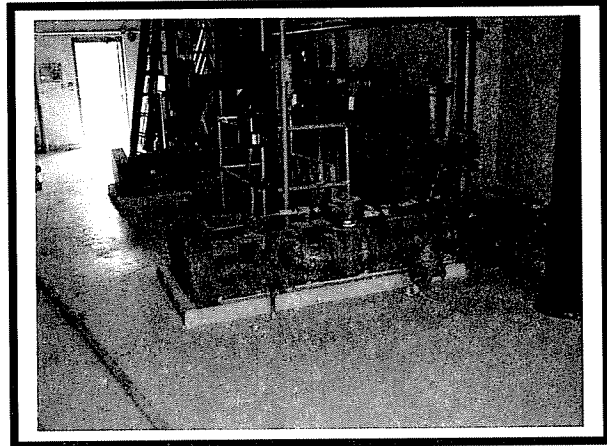
Equip Name: Sludge Pumps
 Tag ID: SLUDGE TM PUMP1 (2)
 Service: Sludge Progressing Cavity
 Make: Netzsch
 Model: Type NE 80A
 Capacity: N/A, Variable Speed
 No of Units: 2
 Installation Date: 1989
 Major Rehab Date: _____

Moderate corrosion around bases of pumps, pumps, valves, and piping.

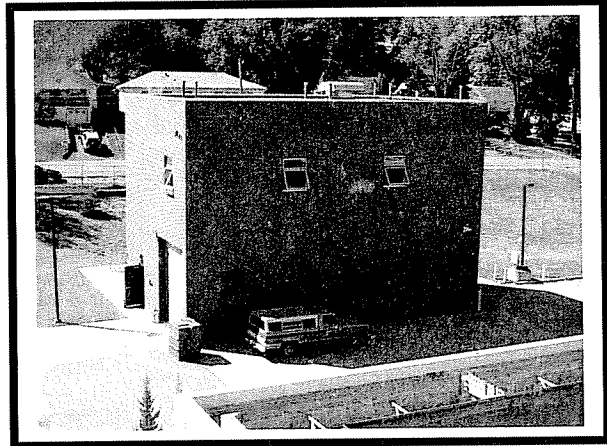
Submersible Pumps. No visual inspection. Condition based upon District's comments, and expected condition based upon age.

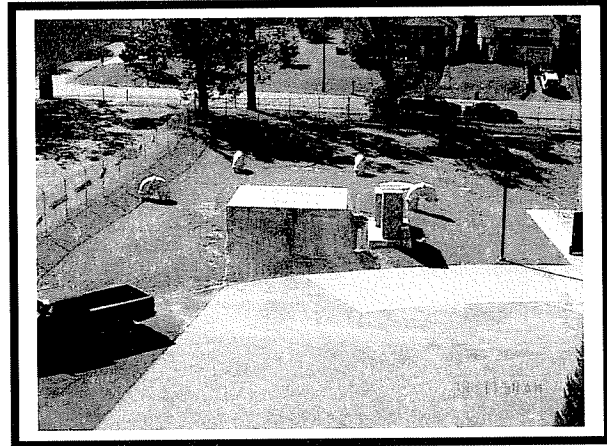
Equip Name: Filter to Waste Pumps
 Tag ID: TM FTW Pump 1 (2-4)
 Service: Submersible Pumps
 Make: Pumpex
 Model: K 103 F-CF3250
 Capacity: 375 gpm @ 64 ft
 No of Units: 4
 Installation Date: 2003
 Major Rehab Date: _____

Submersible Pumps. No visual inspection. Condition based upon District's comments and expected condition based upon age.

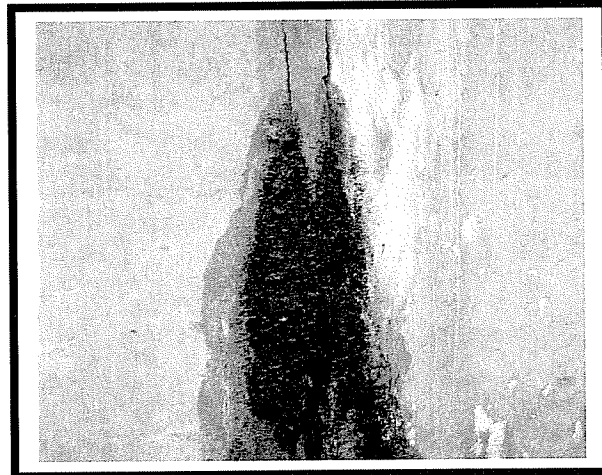
Major cracking at points in North Basin. Visible Leaks.

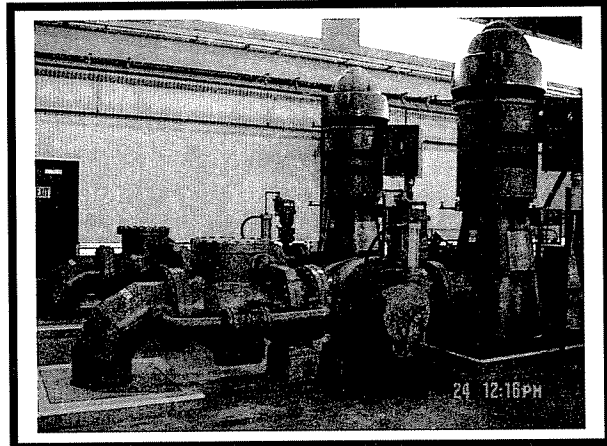
Equip Name: Pumps Nos. 1 - 6
Tag ID: ORPS-PUMP01 (2-6)
Service: Raw Water Booster
Make: Ingersoll Dresser (1-4, 6)
Model: 16QL21 (1-4, 6)
Capacity: 8400 gpm @ 430 ft
No of Units: 6
Installation Date: 1997 (1-4), 1999 (5), 1994 (6)
Major Rehab Date: N/A

The pumps are in excellent condition, minor leaking of hydraulic fluid was noted from several of the discharge valves. Valves for Pump No. 2 were noted to have more fluid leaks than the others.

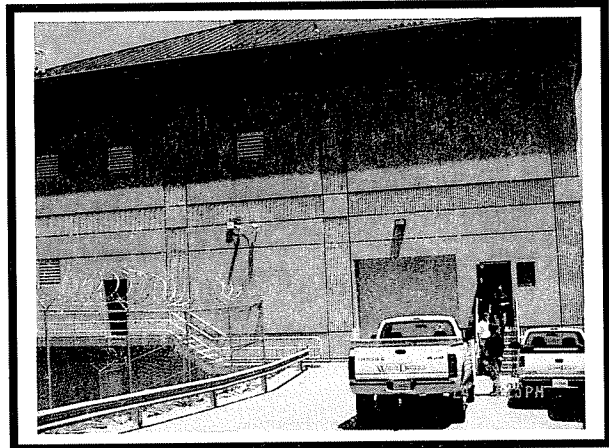
Equip Name: Building
 Tag ID: N/A
 Service: House Pumps and Equip
 Make: N/A
 Model: N/A
 Capacity: N/A
 No of Units: N/A
 Installation Date: 1997
 Major Rehab Date: N/A

1. There are three traveling screens (FMC) each feeding a separate wetwell section. All were observed to be in good working order. There was minor corrosion noted on the base of the head unit of two of the units.

4. A single hydraulic power unit is provided for powering a number of gates and the pump discharge cone valves. The unit is in excellent condition and only minor accumulation of hydraulic fluid was noted on the pump skid.

10. Lighting is a mixture of high bay metal halide and florescent. Lighting levels were noted to be good, and the fixtures were in excellent shape.
11. A potassium permanganate and sodium hypochlorite storage and feed area is located on a lower level adjacent to the pump room. The sodium hypochlorite storage and feed system has been transformed to a permanganate feed system and operations staff indicated that it works well. Heavy corrosion was noted around the metering pumps and the piping in the pump area, most likely due to minor leaks in the piping and pump connections.

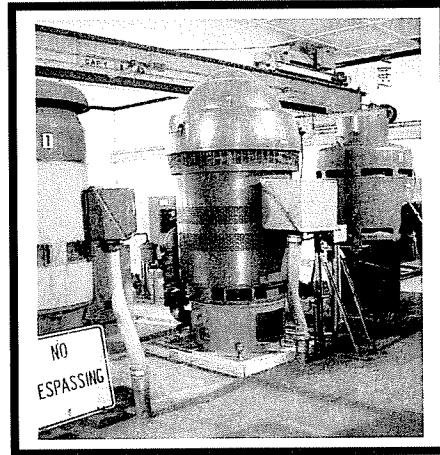
Equip Name: Pumps
 Tag ID: ORPS2-PUMP01 (2,3)
 Service: Raw water booster
 Make: Fairbanks Morse (3), N/A (1,2)
 Model: N/A
 Capacity: 6000 gpm (1, 2) 4000 gpm (3)
@ 430 ft
 No of Units: 3
 Installation Date: 2001 (1), 2001 (2), 1999 (3)
 Major Rehab Date: 2002 (3)

The pumps are in rough condition, pump No. 1's bearing are shot, and it is no longer used.

Access to the lower pump area for maintenance is dangerous do to limited lighting, safe egress, and excessive water leaking into the lower pump area.

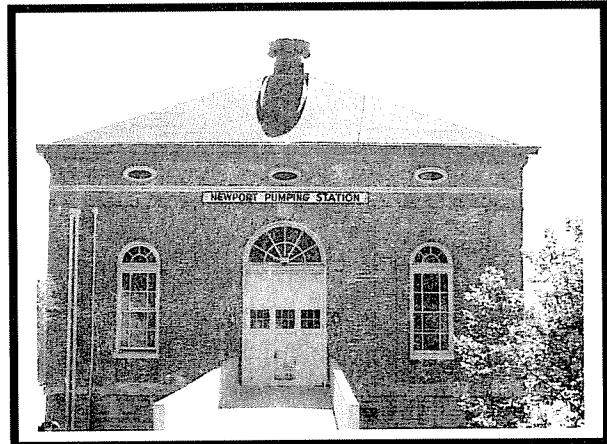
Equip Name: Building and Misc. Equip.
 Tag ID: ORPS2
 Service: House pumps and equip.
 Make: N/A
 Model: N/A
 Capacity: N/A
 No of Units: N/A
 Installation Date: 1872
 Major Rehab Date: Various

The pumping station building is a concrete and brick structure. The building is in very rough condition. Corrosion and deterioration of the concrete structure is extensive and may start to affect the ability to keep the pumping station in operation.

1. The pumping station is constructed of concrete and brick. The lower pump room is constructed of cast-in-place concrete and shows many signs of excessive corrosion and deterioration.

2. The upper portion of the pumping station is brick and there are a number of areas where differential settlement of the building is evident due to the cracking and separation of the brickwork is evident.

3. The lower pump pit is accessed by an elevator or by a spiral staircase. The elevator is old and operation is sporadic. The spiral stairs are structurally sound, however they provide inadequate egress by current standards.

5. A potassium permanganate system was added recently, and a secondary containment area is provided by a CMU wall around the pumps and storage tanks. The system is adequate, however storage of 55 gallon drums was noted outside the containment wall, leaving no secondary containment.

7. A rough screen (chain link fence) is provided, and access to the screen area is through a single floor hatch. Access to the area is confined and ventilation and lighting is inadequate.

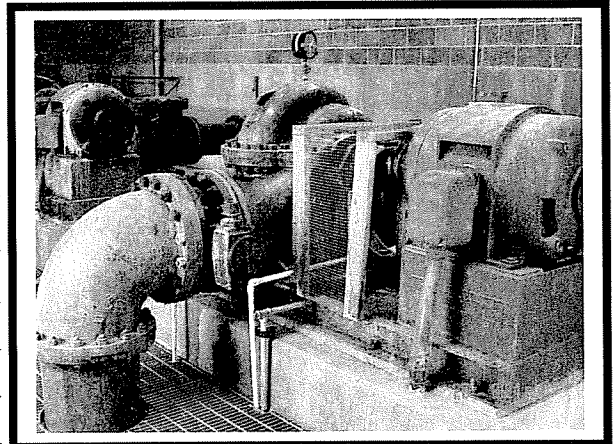
Equip Name: Pumps
 Tag ID: RES-PUMP01 (2,3)
 Service: Raw Water Booster
 Make: Worthington
 Model: 12 LN17
 Capacity: 5300 (1), 3675 gpm (2,3) @ 64 ft
 No of Units: 3
 Installation Date: 1961
 Major Rehab Date: Unk

Pumps and the associated piping and valves are operable, but in very rough condition. The pumps and the piping are heavily corroded. Pumps were noted to have excessive leakage at seals, etc. (See additional notes)

1. Corrosion of the pump bases, bearing races, and pump casings, etc. was excessive.
2. Piping and leakage at the check valves, and pump discharge valve shaft seals was noted to be excessive, and in several cases promoted corrosion on adjacent areas, including trench grating, pipe supports, etc.
3. Safety guards placed over the pump shafts are inadequate and space between the guard and the pump base/motor were large enough to allow for personal injury.

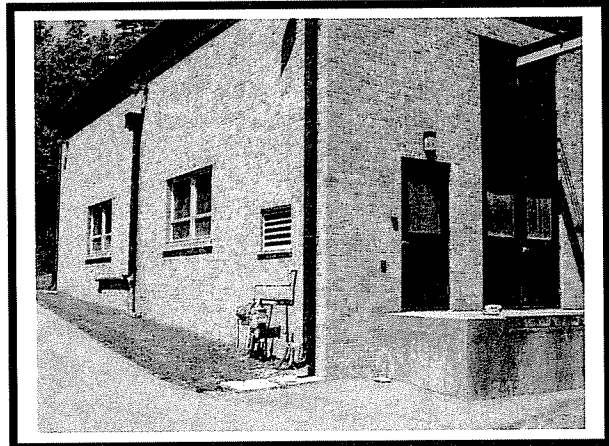
Equip Name: Building
Tag ID: RES-PS
Service: House Pumps & Equip
Make: CMU/Brick
Model: N/A
Capacity: N/A
No of Units: N/A
Installation Date: 1961
Major Rehab Date: Unk

1. Leakage from pump and valve seals is extensive, resulting in large areas of wet floor. In several areas the grating covering the pipe trench has corroded to a point where the structural integrity may soon be compromised.

2. Corrosion of the pump baseplates is extensive, and may be beyond what is repairable.
3. The building structure shows signs of differential settlement. Cracking in the CMU walls was evident on the north east and south west walls.

4. Pipe supports for the pump discharge lines are cracked and (as observed on Pump No. 2 discharge) is in some cases has cracked away to a point where there is no actual support.

5. The building is equipped with a single 3-ton Robbins/Meyers monorail, which appeared to be in good shape.
6. Ventilation is provided through side windows on the south wall, and two gravity dampers in the roof. The room was noted to be warm, and very little air was moving through the facility.

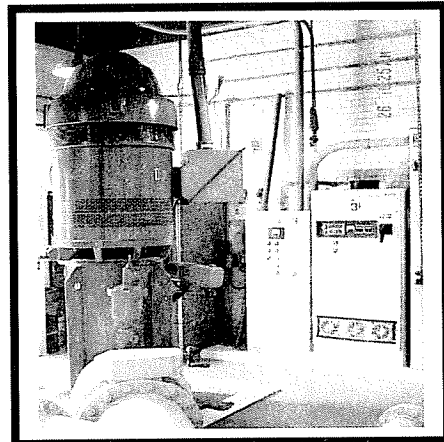
Equip Name: Pumps
Tag ID: LRPS-PUMP1 (2, 3)
Service: Raw Water Pumping
Make: See Below
Model: See Below
Capacity: See Below
No of Units: 3
Installation Date: 1-1990,2-1971,3-1993
Major Rehab Date: See Below

The pumps appeared to be in good working condition. Minor corrosion was noted on the piping, valves, and pump bases, but was not significant enough to cause concern.

1. Pump number 2 was completely overhauled in 1995 and received new bearings and wear rings.
2. Pump number 3 was complete overhauled in 1994 by the factory, approximately 1 year after its installation. Pump number 3 was overhauled again in 1998.

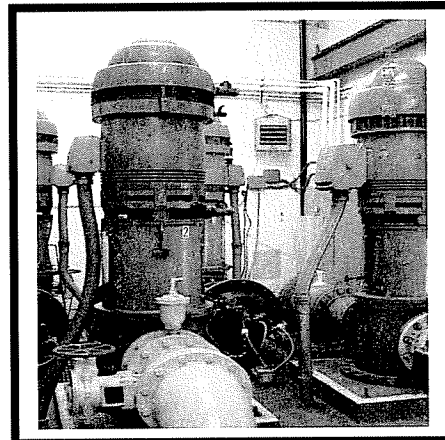
Equip Name: Pumps
Tag ID: DUD-PUMP1 (2, 3, 4)
Service: Treated Water Booster
Make: See "Notes" Below
Model: See "Notes" Below
Capacity: 2225 gpm @ 375 ft
No of Units: 4
Installation Date: (#1, 2, 3)-'65,(#4) -'79
Major Rehab Date: N/A

Pumps are in good condition, and only minor corrosion on the pumps and piping were noted. Heavy moss buildup was noted on the pump control valve of Pump No 1.

Operations staff indicated that the pumps have operated well since their installation. No major problems were noted.

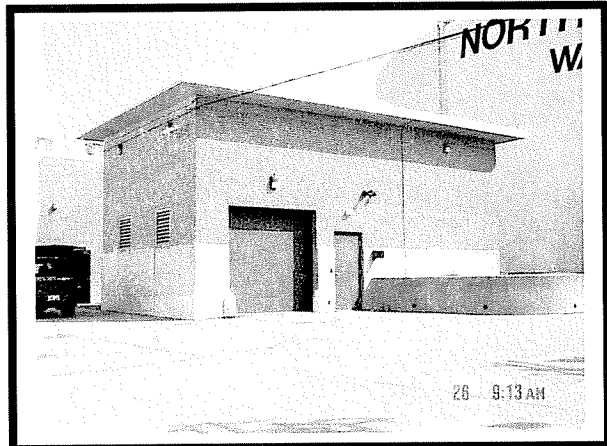
Equip Name: Building
 Tag ID: DUD-1040PS
 Service: House pumps & Equip
 Make: Concrete/Brick
 Model: N/A
 Capacity: N/A
 No of Units: N/A
 Installation Date: 1965
 Major Rehab Date: N/A

The building is constructed of concrete with brick exterior. The facility is in good shape
 With no visible cracking or differential settlement. (See additional notes)

1. The building structure is constructed of concrete with a brick exterior. No differential settlement or cracking was observed.
2. A single roll-up door is provided and appeared to be in good working order, the head box was observed to have a number of dents caused by piping and/or equipment as it was being loaded onto trucks.

8. Electrical switchgear is located on the same floor as the pumps, and appeared to be in good condition. Minor corrosion was noted at the base of the switchgear, and no accumulation of debris was noted.

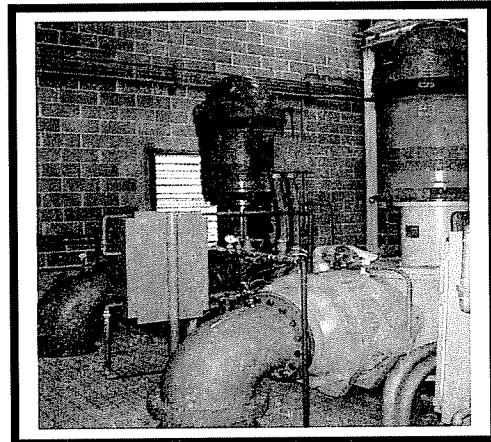
Equip Name: Dudley 1080 Pumps
Tag ID: DUD-Pump5 (6,7,8)
Service: Treated Water Booster
Make: Goulds
Model: VIC 18x20 EHC
Capacity: 6000 gpm @ 282 ft
No of Units: 4
Installation Date: 1990 (5,6,7) 1994 (8)
Major Rehab Date: See Notes Below

Pumps and the connecting piping are in excellent shape. Very minor corrosion was noted on the supply piping to the pumps. The pumps and motors were in excellent shape.

Operations staff indicated that the pump station has operated reliably since it began operation in 1990. No problems were noted.

Pump 5 – 1996 bearing and wear rings replaced, 1998 stuffing box busing and motor bearings replaced. Pump 6 – No repairs since new. Pump 7 – 1996 New bearings and wear rings. Pump 8 – See additional notes

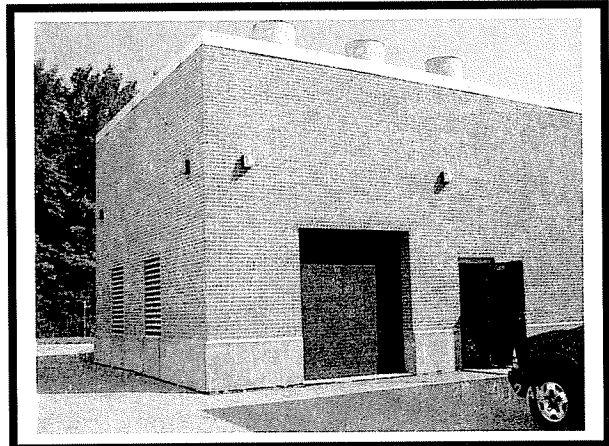
Equip Name: Building
Tag ID: DUD-1080PS
Service: House Pumps & Equip
Make: Brick
Model: N/A
Capacity: N/A
No of Units: N/A
Installation Date: 1990
Major Rehab Date: Unk

Building is in excellent condition. Very minor corrosion noted on the pump supply piping and within the piping trench, otherwise the building is very well maintained. (See additional notes)

1. The building is constructed of concrete and brick. There were no visible signs of differential settlement, or cracking that gave the impression of a problem.

2. Ventilation is provided by three roof mounted tubeaxial fans with discharge dampers. All the fans were noted to operate satisfactorily. Air movement within the pump room was significant, and the temperature within the pump room was good.

4. Wiring between the MCC cabinets and the pumps is via cable trays in the pipe trenches giving good access for maintenance purposes. All wiring and cable trays were in good condition.

5. The pump room is provided with a single roll-up door which was in excellent condition.
6. A single 3-ton top running bridge crane (Shepard Niles) is provided for maintenance of the pumps.

9. Water quality instrumentation for the 1040 and 1080 pressure zones is provided in the building, and appeared to be in good working order.
10. The electrical MCC panels are located in the building adjacent to the pumps on a 3" concrete housecleaning pad. No corrosion or accumulation of debris was noted within the panels.

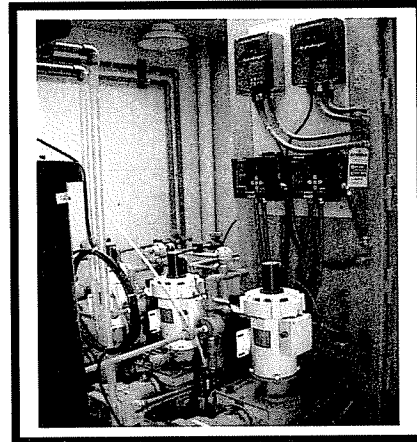
Equip Name: Hypo Metering Pumps
 Tag ID: DUD-HYPO1 (2, 3)
 Service: Hypo Feed
 Make: Various
 Model: Various
 Capacity: N/A
 No of Units: 3
 Installation Date: Unk
 Major Rehab Date: Unk

2 Day tanks – TANK HYPO DUD2 (3) – Good condition.

3. The building itself is in fair condition. A number of items require attention such as a potentially leaking roof drain leader, block wall damage due to the installation of a wall mounted AC unit, and removal of old conduit and wiring from removed equipment.

4. Structurally the building is in good shape, there were no signs of differential settlement or other signs of structural damage.
5. Lighting is incandescent and is in good condition.

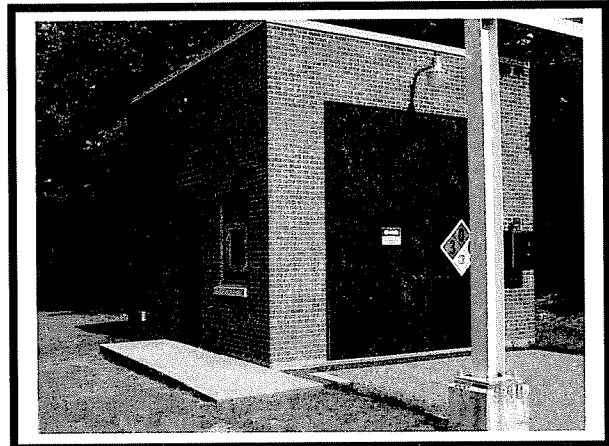
Equip Name: Bulk Chemical Storage
 Tag ID: TANK HYPO DUD1
 Service: Bulk Hypo Store & Trans
 Make: Brick
 Model: N/A
 Capacity: N/A
 No of Units: N/A
 Installation Date: N/A
 Major Rehab Date: N/A

Building is in good condition. Sodium Hypochlorite is stored in a single 5,000 gallon double wall storage tank. In addition there are three pumps for transferring chemical to the daytank in the feed room.

3 Transfer Pumps – DUD-HYPO TR1 (2, 3) are located in the building. They are in satisfactory condition.

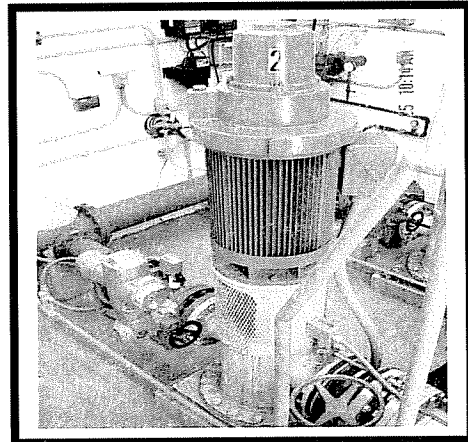
Equip Name: Pumps
 Tag ID: HAND – PUMP1 (2)
 Service: Treated Water Booster
 Make: Goulds
 Model: 6x10 GLC-14
 Capacity: 500 gpm at 426 ft
 No of Units: 2
 Installation Date: 1983
 Major Rehab Date: N/A

Pumps are in good operating condition, and appear to be in good mechanical condition.
Light corrosion was noted around the pump sub-bases.

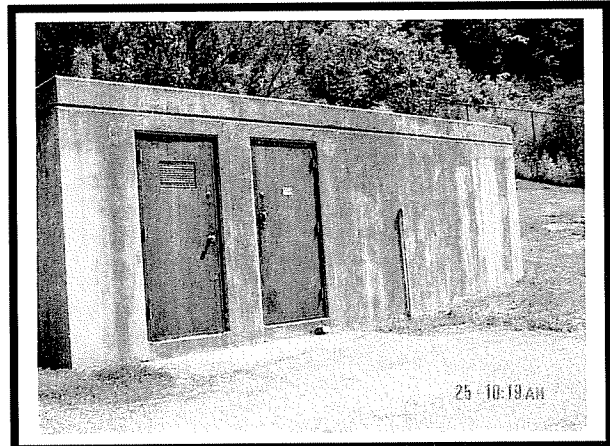
Equip Name: Building
 Tag ID: HAND - PS
 Service: Treated Water Booster
 Make: N/A
 Model: N/A
 Capacity: N/A
 No of Units: N/A
 Installation Date: 1983
 Major Rehab Date: N/A

Building is of concrete construction with a stucco finish. Portions of the building exterior are discolored; however, the overall condition of the pumping station is excellent. (See additional notes)

Operations staff indicate that the facility is in good operating condition, and note that it has a good operating history

1. Interior of the pumping station is in excellent shape, no visible cracks, corrosion, or roof leaks.
2. Building exterior is stucco finish, with some discoloring, but overall the condition of the pumping station is excellent.
3. Ventilation is provided by a single wall fan (Dayton) operated by a wall mounted thermostat.
4. Heating is provided by a single "Federal Pacific" electric unit heater.
5. Roof openings with removable access hatches are provided above each of the pumps to facilitate pump removal. Hatches and openings are in excellent condition.
6. Lighting is florescent, and is in good condition, lighting level is good.
7. Building includes a small room set up for hypochlorite storage and feed, however it has never been used.

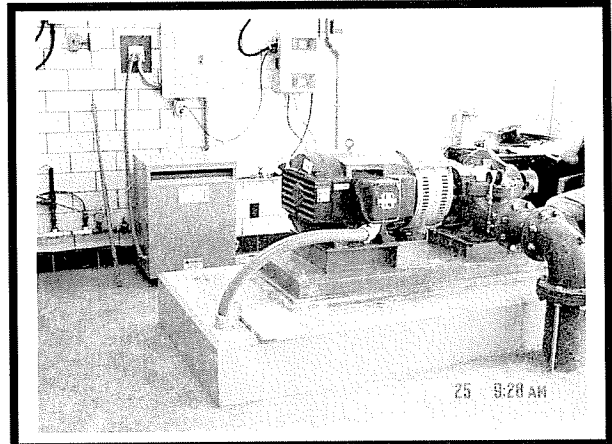
Equip Name: Pumps
 Tag ID: LAT-PUMP1 (2)
 Service: Treated Water Booster
 Make: Goulds
 Model: 4x6-10L Type 3408
 Capacity: 720 gpm @255 ft
 No of Units: 2
 Installation Date: 2003
 Major Rehab Date: N/A

Pumps and the associated suction and discharge piping are in excellent condition.

No corrosion of the piping or valves was noted.

Pumps were installed in early 2003, no problems have been noted since their installation.

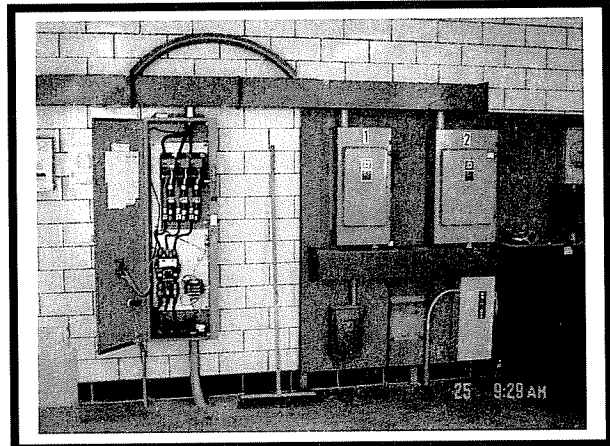
Equip Name: Pump Station Building
 Tag ID: LAT-PS
 Service: Treated Water Booster
 Make: CMU Block/Concrete
 Model: N/A
 Capacity: N/A
 No of Units: N/A
 Installation Date: N/A
 Major Rehab Date: N/A

Building is in excellent shape, no notable corrosion, cracking, differential settlement, or roof leakage was noted. (See additional comments)

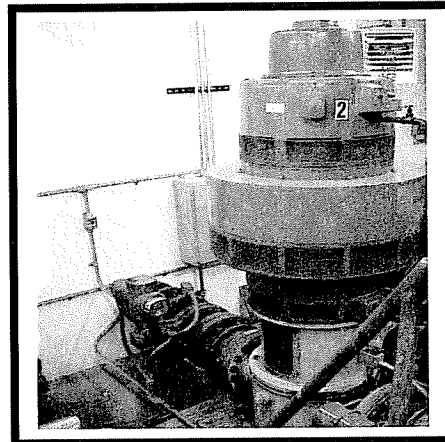
Equip Name: Pumps
Tag ID: RICH-PUMP1 (2,3)
Service: Treated Water Booster
Make: Goulds
Model: 10x16 BHC-4
Capacity: 2100 gpm @ 515 ft
No of Units: 3
Installation Date: #1-'81, #2-'01, #3-'98
Major Rehab Date: See Notes

Pumps were in good working order. No notable external damage or excessive corrosion was noted. Pumps operating during site investigation were operating within noise and vibration tolerance.

Operations staff indicated that the pumps have operated well. Pump No. 1 had motor bearings replaced in 1995, and bearings and wear rings were replaced in 1996. Pump No. 2 had wear rings replaced in 1994, and bearings replaced in 1995.

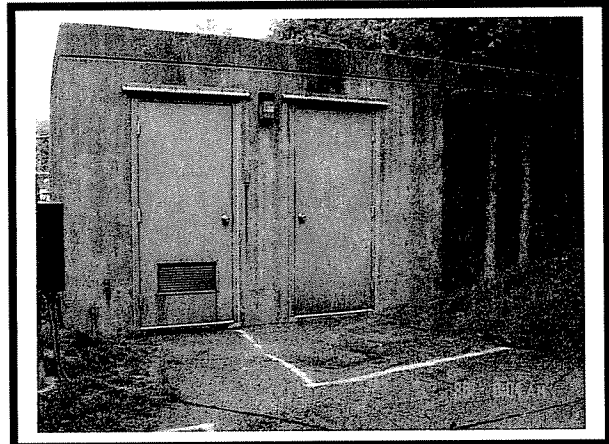
Equip Name: Building
 Tag ID: RICH-PS
 Service: House Pumps & Equip
 Make: Concrete
 Model: N/A
 Capacity: N/A
 No of Units: N/A
 Installation Date: 1981
 Major Rehab Date: N/A

The building is constructed of concrete with a concrete floor with depressed area for the pumps. The building is in excellent structural condition, some discoloring of the exterior was noted. The old chlorine storage room has some corrosion noted. (See additional notes)

Operations staff indicated that the pumping station has operated well since coming on line in 1981. The pumping station has had several potential dangerous accidents. (A chlorine leak and two flooding events.)

1. The building is constructed of concrete, with a concrete floor slab. No visible cracks or differential settlement was noted.
2. Ventilation is provided by two wall mounted fans (Coolair). Air is drawn through a single wall inlet air louver. The fans were in operation during the site investigation and were observed to be noisy, not due to wear or damage, but simply due to the amount of air being moved through the room. This was a major contributor to the amount of noise from the facility.

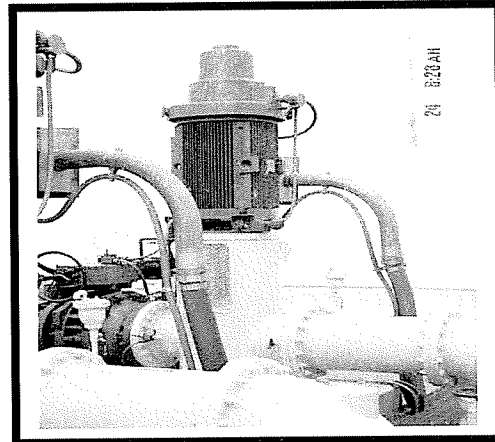
Pumps and associated piping and accessories were in excellent condition, no excessive corrosion or leakage was noted.

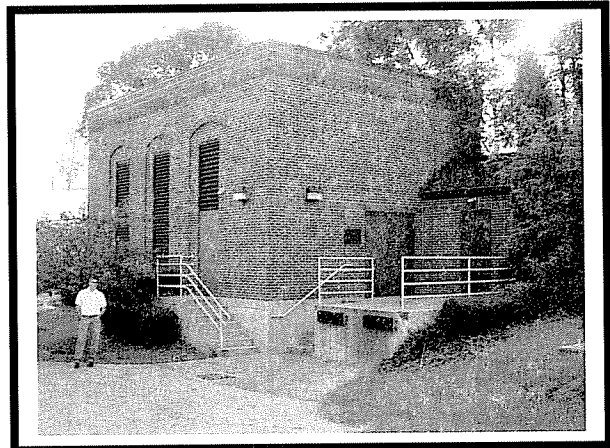
Operations staff noted that the facility has operated well since it's completion in 1992. No major problems were noted.

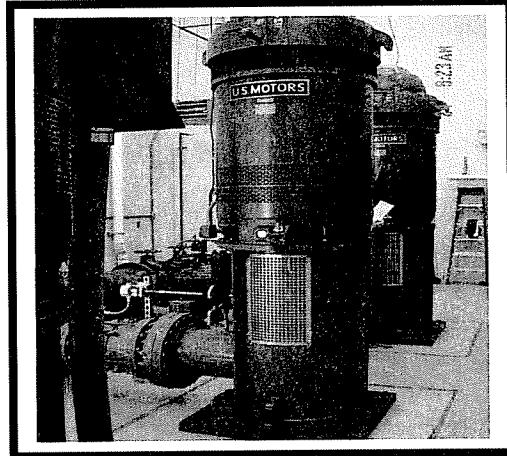
Pumps are in excellent shape. No corrosion, leaking or other malfunctioning noted.

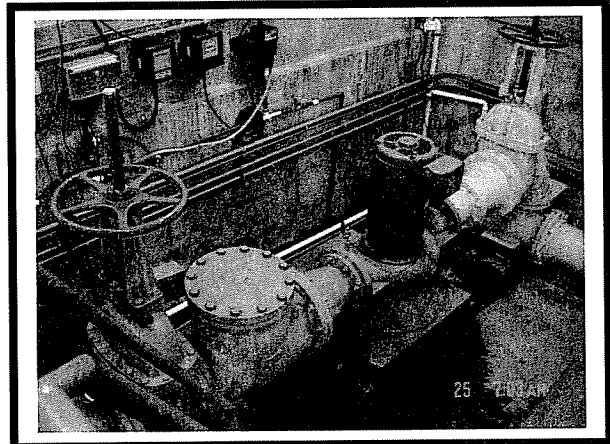
Pumps and piping appeared in good condition. Some light to moderate corrosion was noted on the piping and valves associated with the pumps. Also some leaking from pump and valve seals was noted (i.e. leaks from check valve seals on Pump 2 were noted).

1. Pump suction and discharge valves - 12" Kennedy manually operated gate valves. Visual corrosion noted on all valves (light to moderate).
2. Visual leakage noted from pump No. 2 shaft seal.
3. Visual leakage noted from pump No. 1 discharge check valve shaft seals.
4. Pump motors were noted to be Baldor 40 hp, 1760 RPM.
