Case No. 2005-00148

**COMMONWEALTH OF KENTUCKY
BEFORE THE PUBLIC SERVICE COMMISSION**

**NORTHERN KENTUCKY WATER DISTRICT'S RESPONSE TO THE
ATTORNEY GENERAL'S REQUEST FOR INFORMATION**

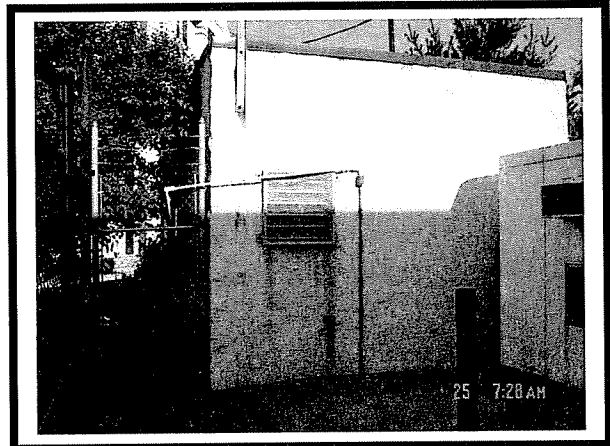
Overall the condition of the building was good. Exterior of the building showed signs of age (paint chipping, rust stains, etc.) Interior of the building was in good condition and no excessive Corrosion or damage was noted. (See additional notes for additional information)

1. Florescent lighting inside the facility in good condition, lighting levels are good.
2. Monorail with removable hoist in good condition, capacity un-available.
3. Water noted to be pooling on floor due to leakage from Pump No. 2 seals. This resulted in corrosion of conduit existing from the floor, and pipe supports in the area.
4. Ventilation provided by a single "Coolair" wall fan with gravity damper. Fan controller noted to be noisy, possibly due to dirty start/stop contacts.
5. Heating provided by a single "Carolina Production Enterprises", 10 Kw unit heater. Unit appeared to be in good working order.

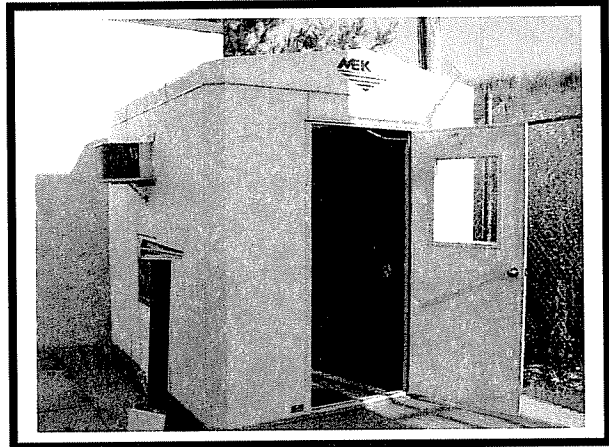
Building and the hypochlorite system were in excellent condition. Building is constructed of
Fiberglass and all storage and feed equipment is housed within the interior of the building.
(See additional notes).

1. Building is heated by a single Q-Mark electric unit heater.
2. Building is cooled by a single Whirlpool electric wall mounted air conditioning.
3. Building is constructed of fiberglass, with full secondary containment below the floor grating.
4. A single eye-wash station is provided in the building.
5. Minor corrosion noted at the base of the hypochlorite feed pumps. Most likely caused by spilled chemical during maintenance activities, no other leaks were noted.

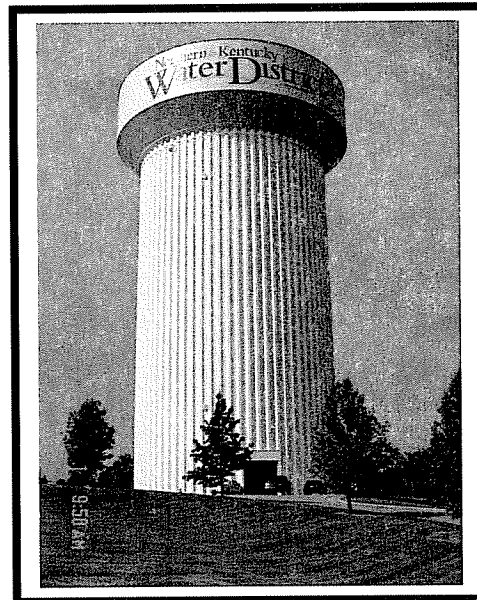
Coating systems are in new condition.

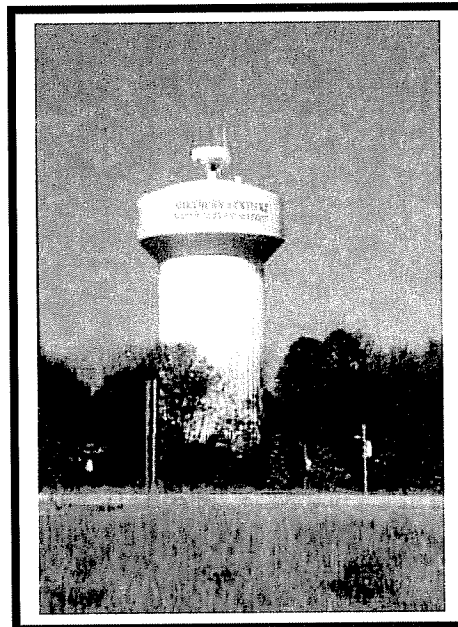
Coating system in good condition.

Fence around fuel tank in poor condition and gate does not have lock.

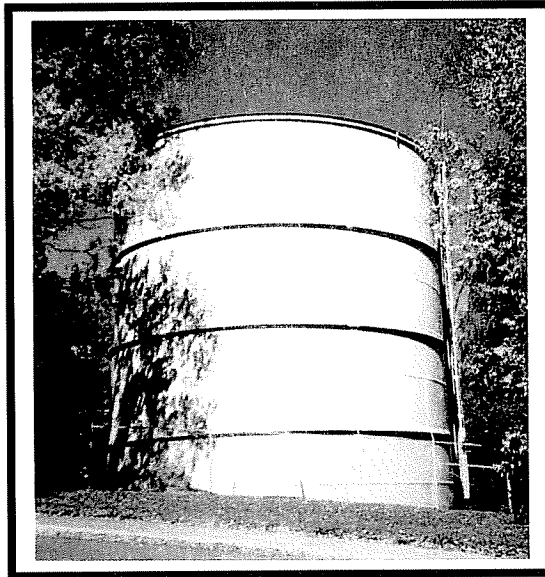
The coating system is in good condition.

The Bellevue Tank was renovated in 1999. The renovation included replacement of the interior coating system, overcoating of the exterior system, replacement of the roof support system and improvements to miscellaneous structural accessories.

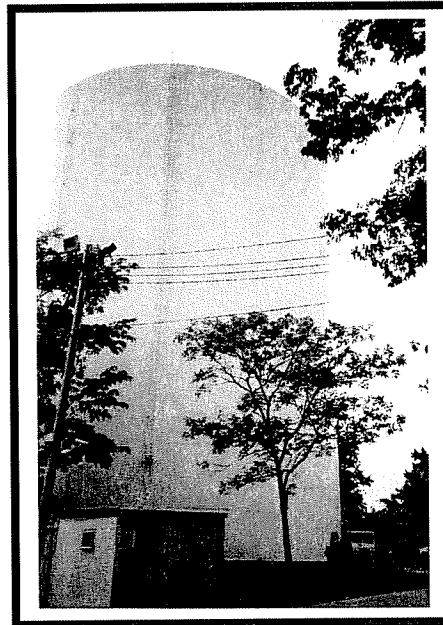
The coating system is in good condition.

Site Notes:
Card reader at facility access gate.
24 hour site lighting and cameras.
Fence in poor condition and overgrown on approximately 70% of perimeter
All valving buried beneath pavement. Four actuator's.

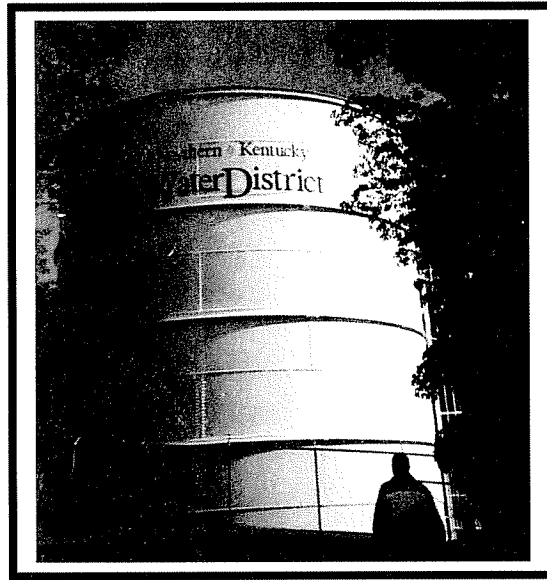
The coating system is in good condition.

The Dayton Tank was renovated in 2001. The renovation included replacement of the interior coating system, overcoating of the exterior system, replacement of the roof support system and improvements to miscellaneous structural accessories.

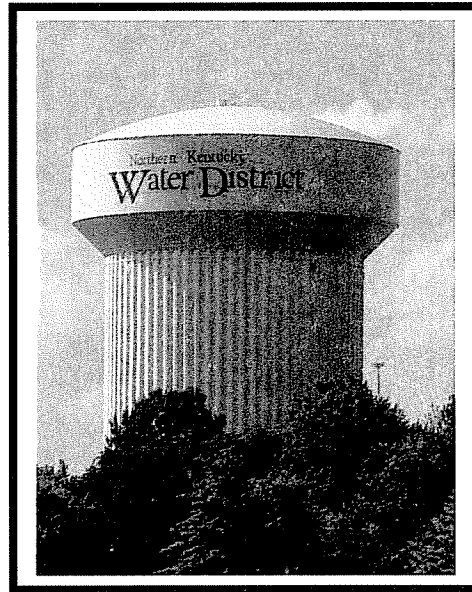
Coating system in new condition.

The Devon Tank was renovated in 2001. Coating systems and miscellaneous structural accessories were improved or replaced as part of the renovation.

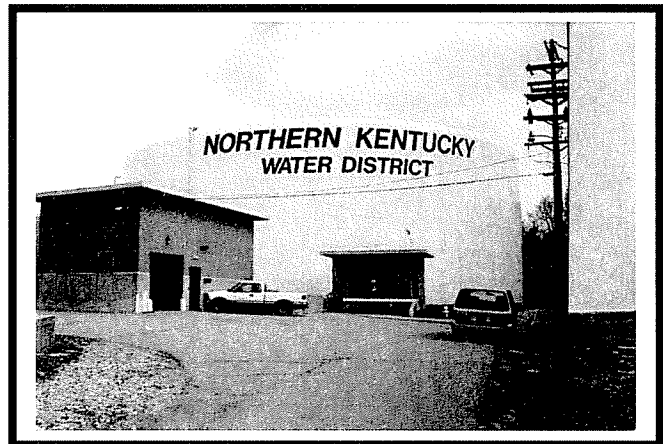
Coating system in good condition

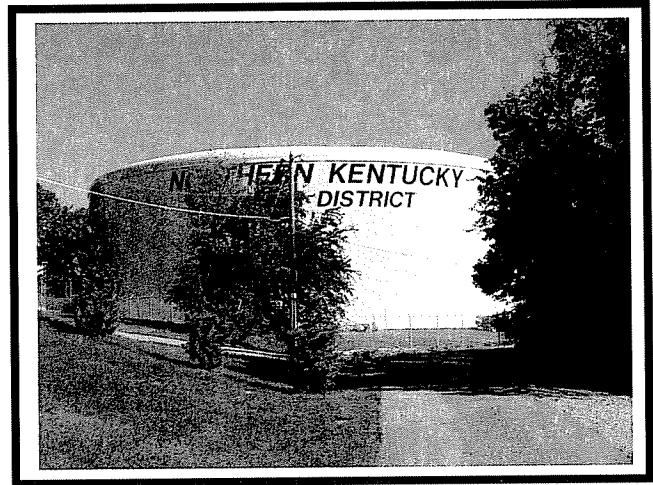
Coating system in good condition.

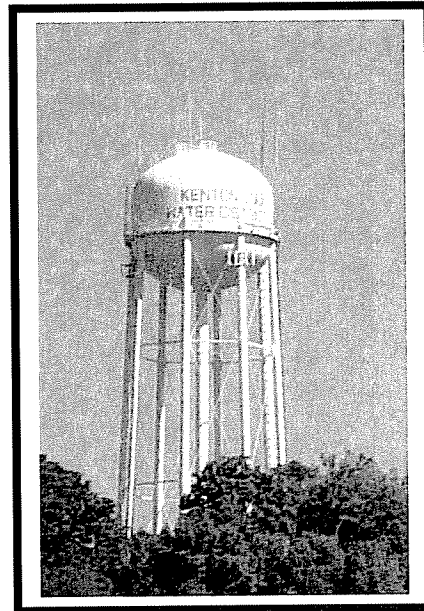
Coating systems are in good condition.

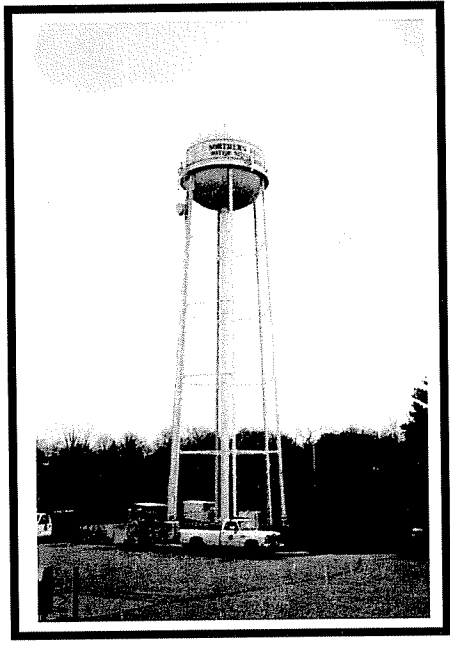
Equip Name: Lumley Tank
 Tag ID: LUM-TANK
 Capacity: 275,000 Gallons
 Type: Elevated Double Ellipsoidal Style
 Construction: Riveted
 Construction Date: 1934
 Major Rehab Date: 1999

Light corrosion on riser seams and anchor bolts.
Possible leaking at some riser seams.

Site Notes:
Padlock on gate and instrumentation building.
Intrusion alarm switch on ladder.
Two buried valves at base of riser.
Perimeter fence adjacent to antenna systems buildings in fair condition.

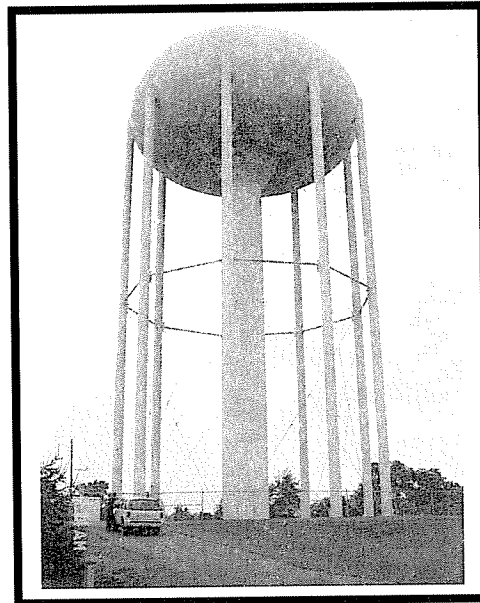
Equip Name: Old St Rt 4 Tank
 Tag ID: OLDST4-TANK
 Capacity: 1.0 Million gallon
 Type: Elevated Torosphere
 Construction: Welded
 Construction Date: 1976
 Major Rehab Date: None

Coatings are chalking and faded. Numerous localized corrosion cells on exterior.

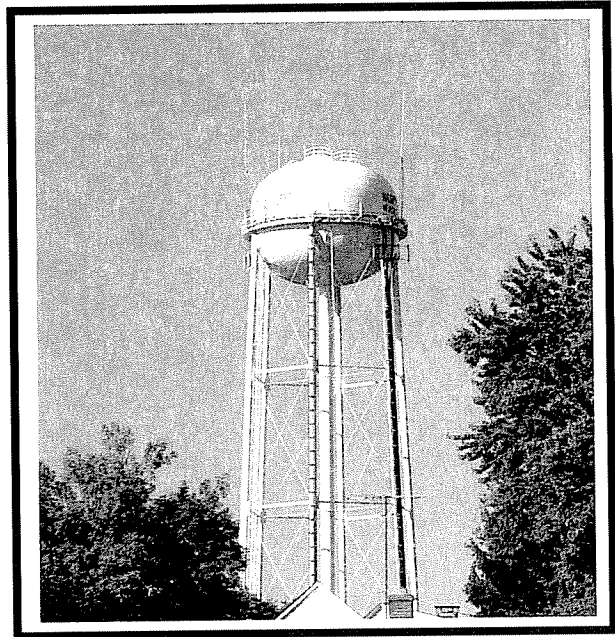
Equip Name: Rossford Tank
 Tag ID: ROSS-TANK
 Capacity: 300,000 Gallons
 Type: Elevated Double Ellipsoidal Style
 Construction: Welded
 Construction Date: 1958
 Major Rehab Date: 1997

Coating systems are in good condition.

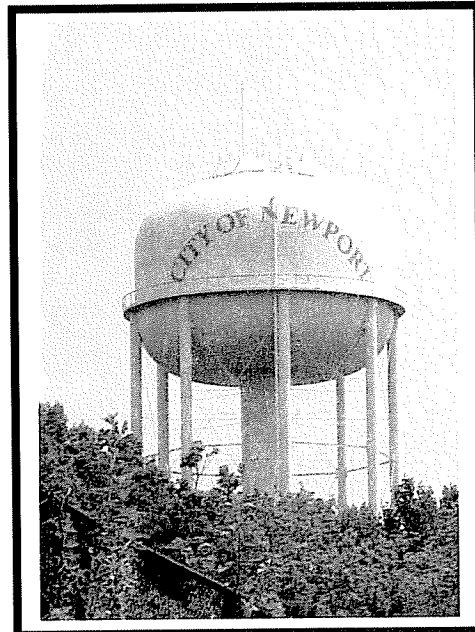
Equip Name: South Newport Tank
 Tag ID: S.NEWPORT-TANK
 Capacity: 1.0 Million Gallons
 Type: Elevated Double Ellipsoidal Style
 Construction: Welded
 Construction Date: 1972
 Major Rehab Date: _____

Equipment:	Comments:
1) Cathodic Protection	Not activated. Condition unknown. Manufacturer: Harco
2) Antenna	Multiple antenna mounted on tank roof.
3)	
4)	
5)

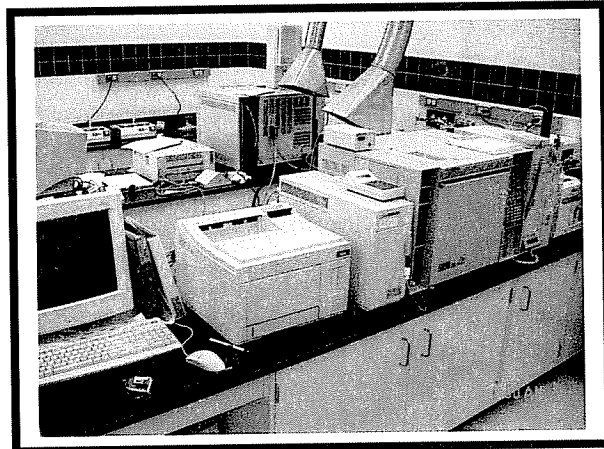
Equip Name: Mass Spectrometer
 Tag ID: _____
 Service: Organics Lab
 Make: Hewlett Packard
 Model: 5972
 Capacity: _____
 No of Units: 1
 Installation Date: ~1994
 Major Rehab Date: _____

Possible leak in the Helium line inside the instrument.

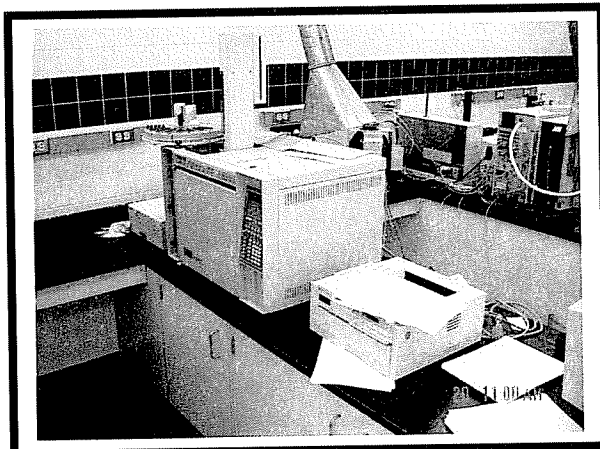
Equip Name: Gas Chromatograph
 Tag ID: _____
 Service: Organics Lab
 Make: Hewlett Packard
 Model: 5890 Series II
 Capacity: _____
 No of Units: 1
 Installation Date: 1988
 Major Rehab Date: _____

Age causes problems. Older software. Is using a rebuilt computer.

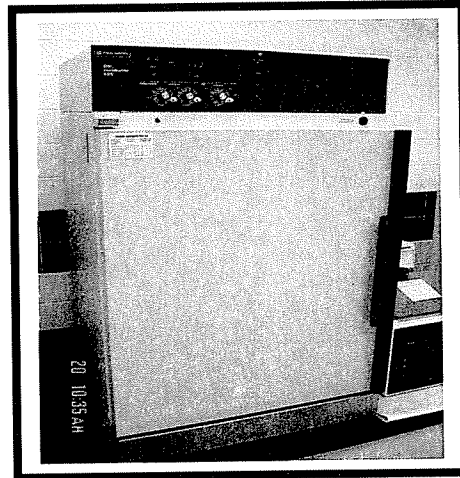
Equip Name: CO2 Incubator
 Tag ID: _____
 Service: Microbiology Lab
 Make: Fisher Scientific
 Model: 605
 Capacity: _____
 No of Units: 1
 Installation Date: 1988
 Major Rehab Date: _____

No humidity control available.

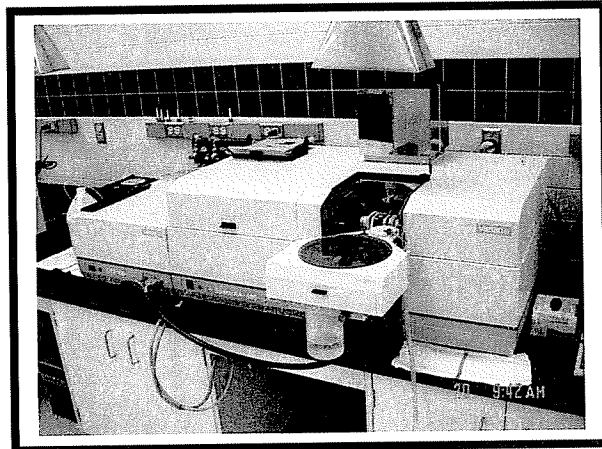
Switching from the furnace to the flame is not done often because of spare flame in other equipment. Also cause excess wear and tear and too much time.

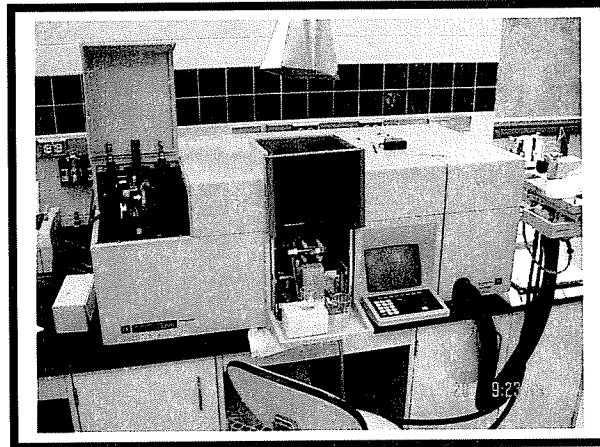
The furnace does not work and no replacement parts are available. The flame works now, however, no replacement parts are available. The Auto Sampler leaks.

Looking at an ICP Mass Spectrometer for replacement.

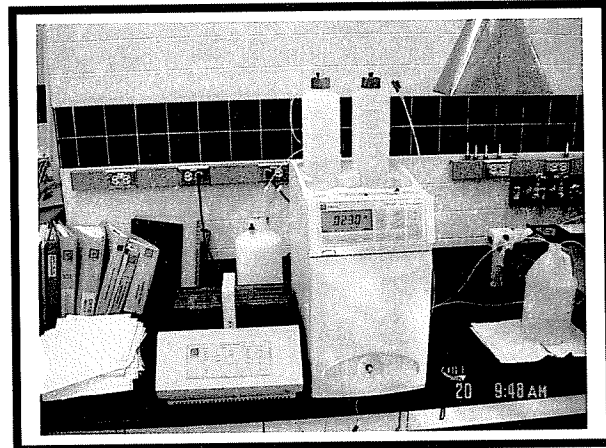
Equip Name: Ion Chromatograph
 Tag ID: _____
 Service: Inorganics Lab
 Make: Dionex
 Model: DX-120
 Capacity: _____
 No of Units: 1
 Installation Date: 1998
 Major Rehab Date: _____

Also at this workstation was the following: Dionex AS40 Automated Sampler - In good condition and Dionex is still producing replacement parts.
