# SHIELD Environmental Associates, Inc.

**SHIELD Environmental Associates, Inc.**  
**Manhole Inspection Checklist**  
**Cedarbrook Subdivision**

**CEDARBROOK SUBDIVISION  
Sanitary Sewer System Maximum Design Capacities**

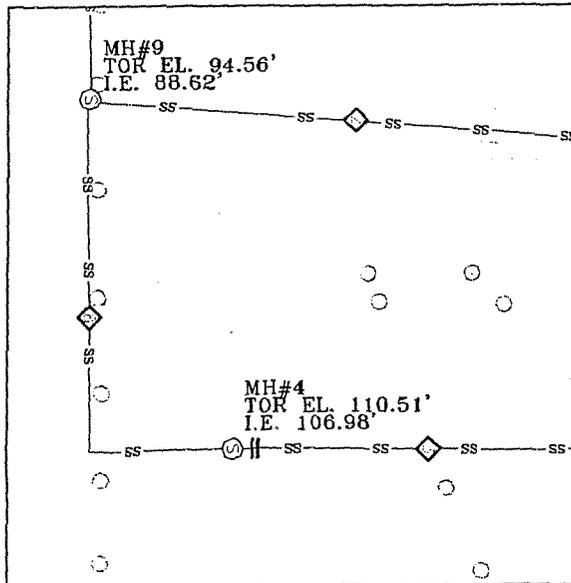
Smoke issuance from ground on southeast side of manhole 4; smoke issuance from ground approx. 150 feet from manhole 4 near telephone pole. See photos page C-3

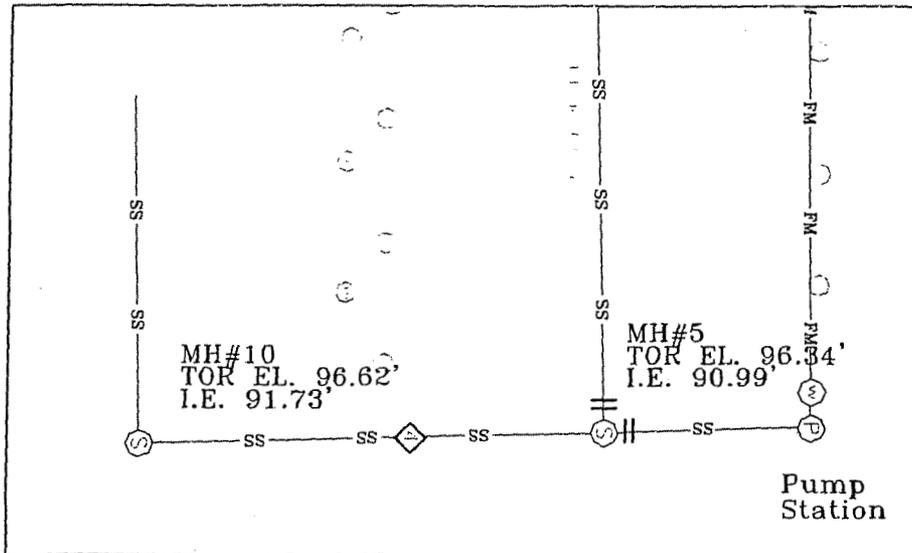
Smoke issuance from ground on east side of manhole 5

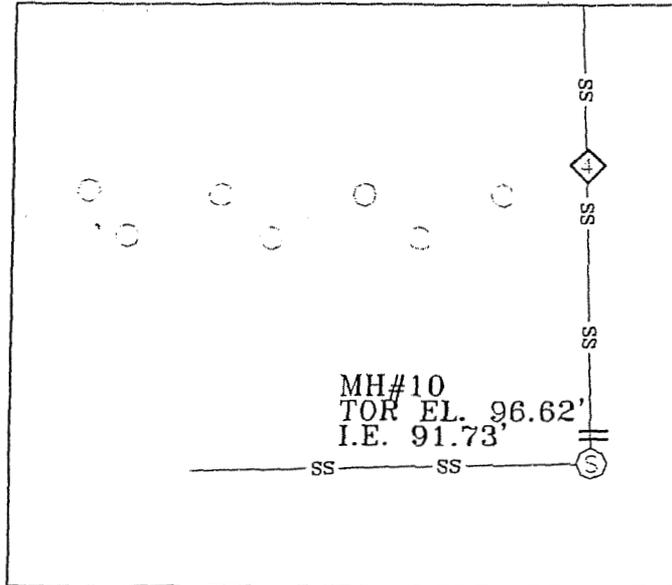
Smoke issuance from ground surrounding manhole 10

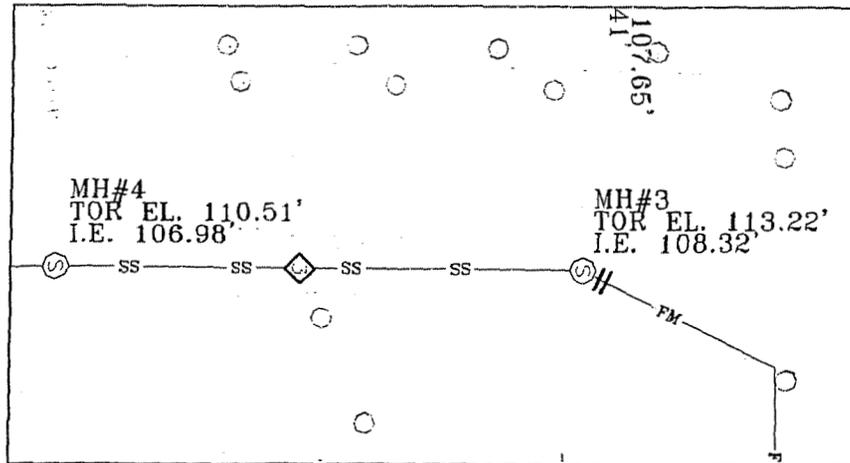
Subsystem: Line 3 Date Tested: 11/16/00  
Time of Day: 1310  
Inspected by: KM Regan/KG Mills  
Present Weather Conditions: Windy and cold/Mid-20s/Dry  
Previous Weather Conditions: Windy and cold/Mid-20s/Dry  
Access to Manhole: Good X Poor \_\_\_\_\_  
Access for Cleaning/TV: Good X Poor \_\_\_\_\_  
Number of Manhole Reaches Tested: 1  
Total Footage Inspected: 299'  
Location of Smoke Blower: MH Manhole #3  
Special Problems/Comments:  
No faults noted.

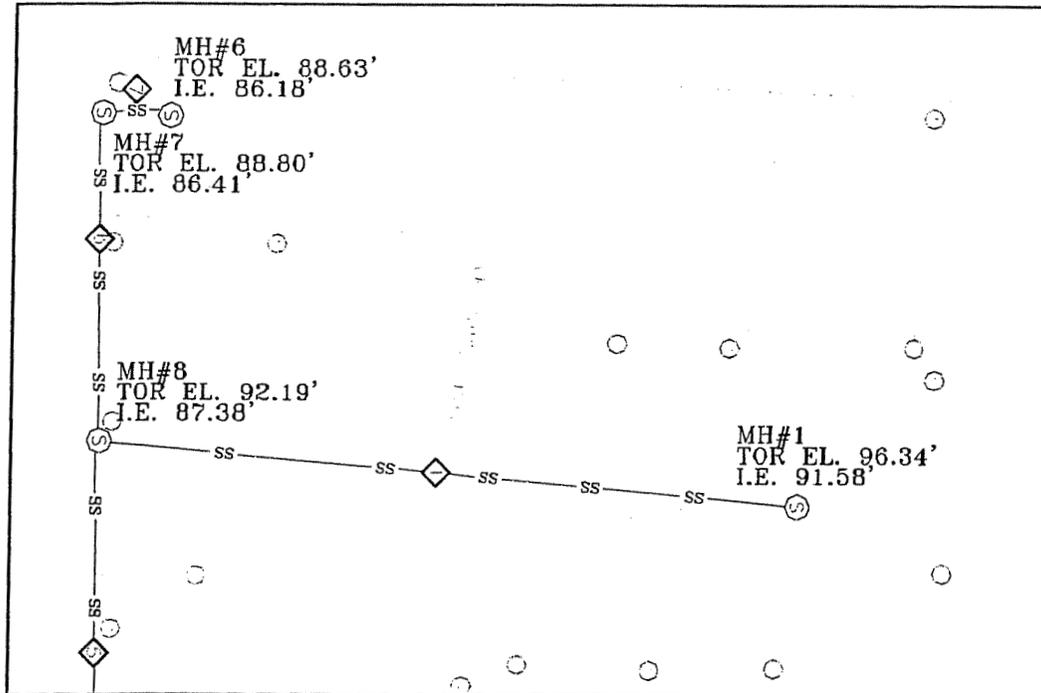
No smoke noted from two storm sewer grates; very heavy smoke from manhole #8; poorly seated lid; manhole located in naturally occurring low spot

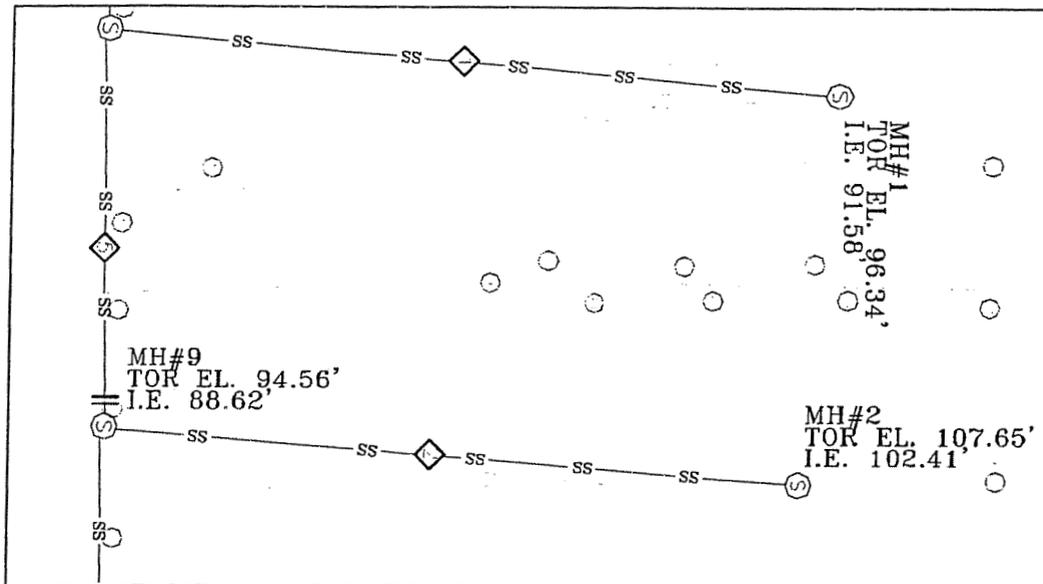
Subsystem: Line 2 Date Tested: 11/2200  
Time of Day: 1135  
Inspected by: KM Regan/KG Mills  
Present Weather Conditions: Windy and cold/Mid-20s/Dry  
Previous Weather Conditions: Windy and cold/Mid-20s/Dry  
Access to Manhole: Good X Poor \_\_\_\_\_  
Access for Cleaning/TV: Good \_\_\_\_\_ Poor X  
Number of Manhole Reaches Tested: 1  
Total Footage Inspected: 401'  
Location of Smoke Blower: MH Manhole #9  
Special Problems/Comments:  
Manhole 9 located in backyard with dog; prior coordination required for access; manhole 9 located in naturally occurring low spot

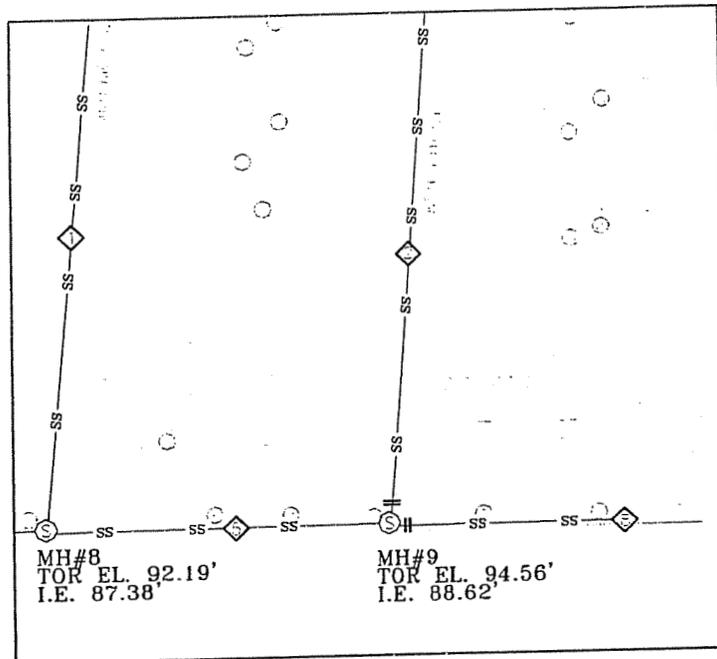
Subsystem: Line 5 Date Tested: 11/2200  
Time of Day: 1200  
Inspected by: KM Regan/KG Mills  
Present Weather Conditions: Windy and cold/Mid-20s/Dry  
Previous Weather Conditions: Windy and cold/Mid-20s/Dry  
Access to Manhole: Good X Poor \_\_\_\_\_  
Access for Cleaning/TV: Good \_\_\_\_\_ Poor X  
Number of Manhole Reaches Tested: 1  
Total Footage Inspected: 234'  
Location of Smoke Blower: MH Manhole #9  
Special Problems/Comments:  
Manhole 9 located in backyard with dog; prior coordination required for access; manhole 9  
located in naturally occurring low spot; smoke in back of lot 8 near telephone pole
