Mitchell Unit 1

Turbine – Generator Outage

Fall 2001

Report Prepared by
John Lackner
RSO Turbine Coordinator

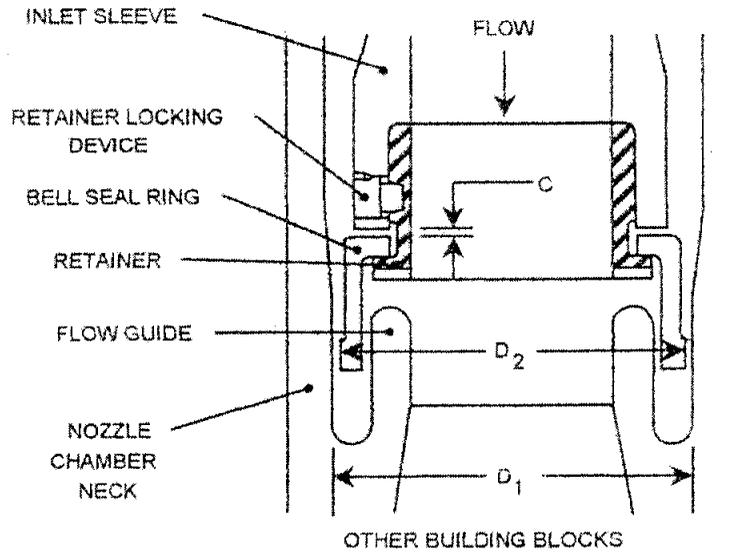
CROSS SECTION THROUGH INLET SEAL

After the lower inner shell had been removed, it was noted that the retaining nut for the bell seal on the right hand side (#B-1) was rotating freely. The threads in the steam inlet pipe for this seal had been completely eroded/stripped free. The threads on the retaining nut were also badly damaged.

CMS personnel weld repaired the eroded threads and tapped new threads into the inlet pipe. The retaining nuts were installed without the bell seals and the axial gaps were checked. The spare bell seals were machined to the correct OD and were trimmed to provide for the correct axial clearance.

Recommend to replace all bell seals

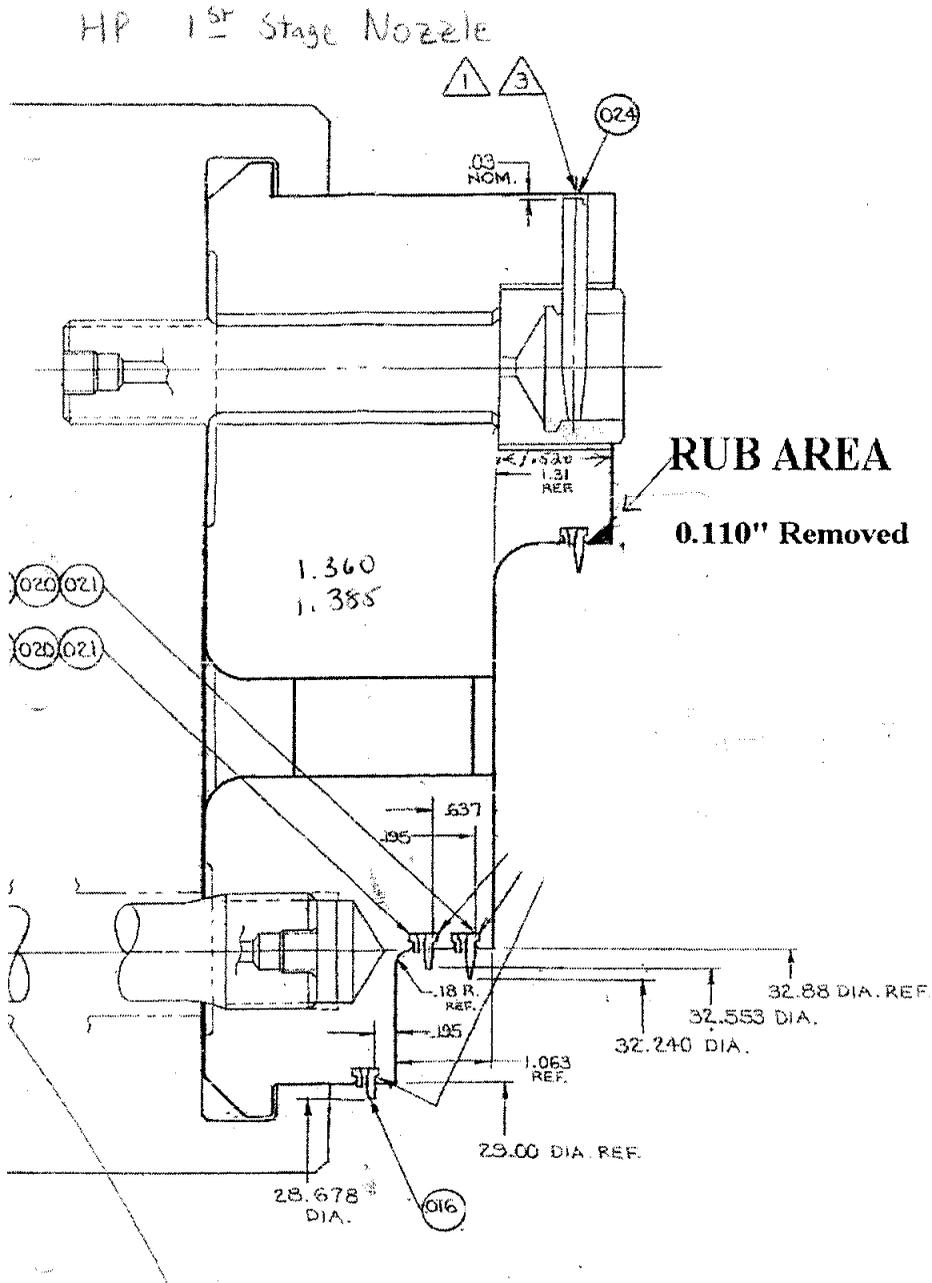
After installing the rotor, it was noted that the tennons of the Curtis wheel had too tight of a clearance with a lip on the nozzle. The rotor was removed and the nozzle was hand ground to chamfer the nozzle at the point of the tightest clearance. A drawing is attached to this section detailing the corner that had to be removed.

Comments
<p>The HP nozzle had rubbed against the rotor during reassembly. The area denoted by "RUB AREA" should have been machined off of the new nozzle. This area was ground by hand to remove 0.110" of material as shown.</p>

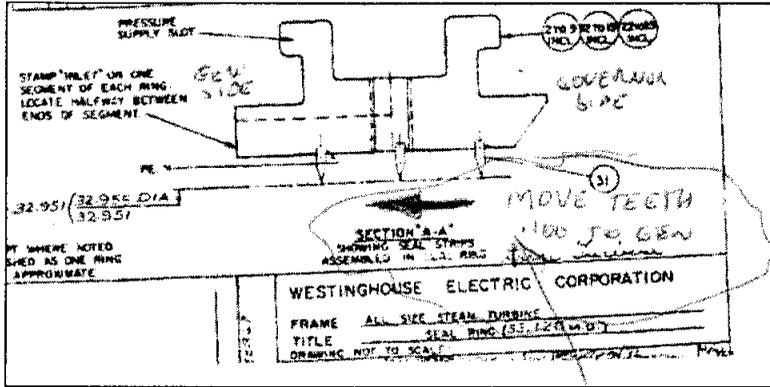
Stage 7 Spring Back Seals

Comments
The teeth of the stage 7 spring back seals were moved 0.100" towards the generator from design position. Work was done by STAR per above drawing.

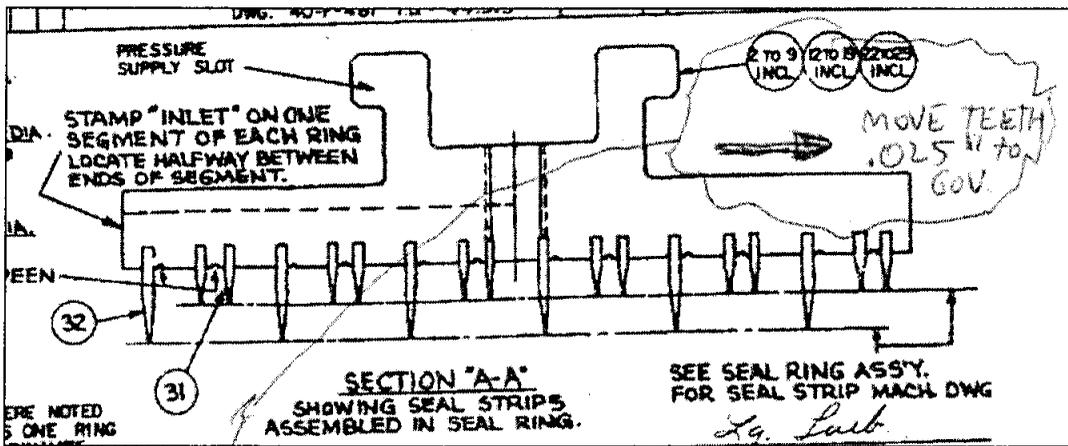
HP Dummy Ring Spring Back Seals

Comments
The teeth of the spring back seals for the HP dummy ring were moved 0.025" towards the governor from design position. Work was done by STAR per above drawing.

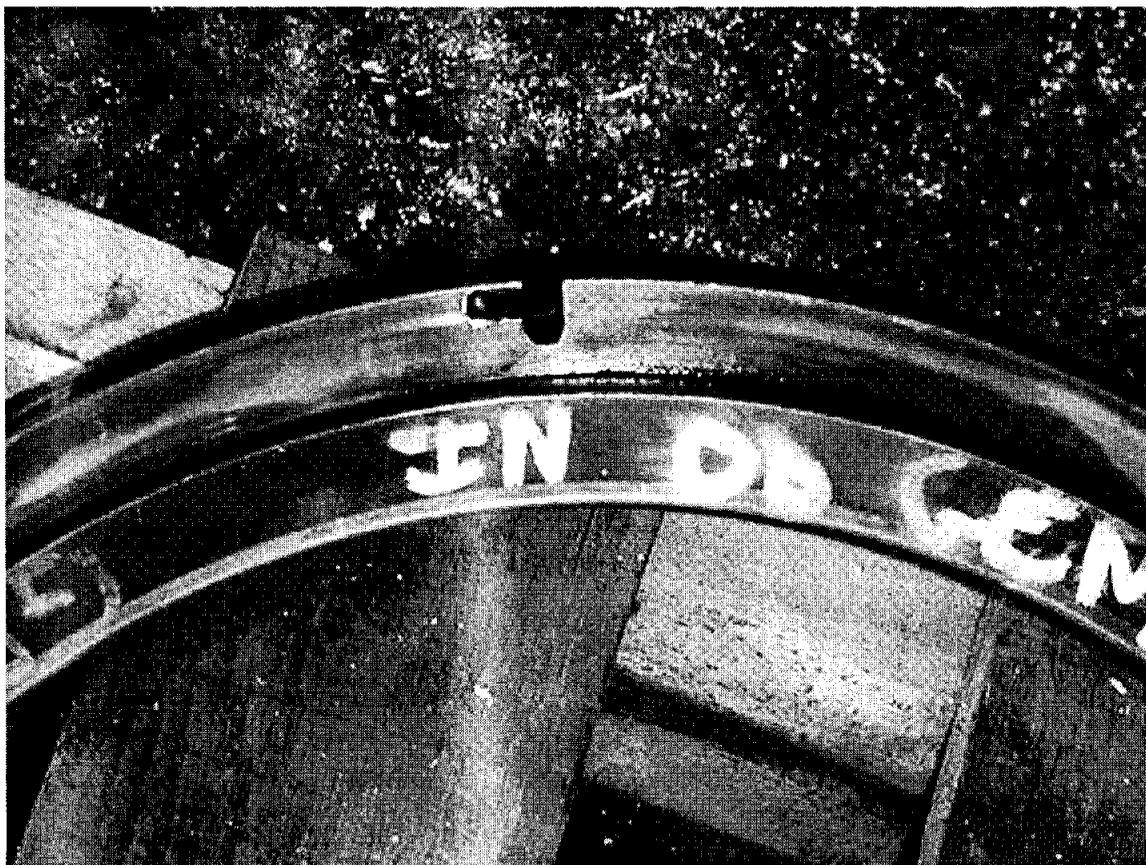
T-1 bearing was sent to RPM for repairs prior to inspection due to journal size differences between the running and spare rotors. One item noted by RPM was the damage to the anti-rotation pin slot for T-1 bearing's GE oil seal ring as shown above. This was repaired by RPM. The axial clearance of the seal ring was excessive and was repaired by thermal spraying.

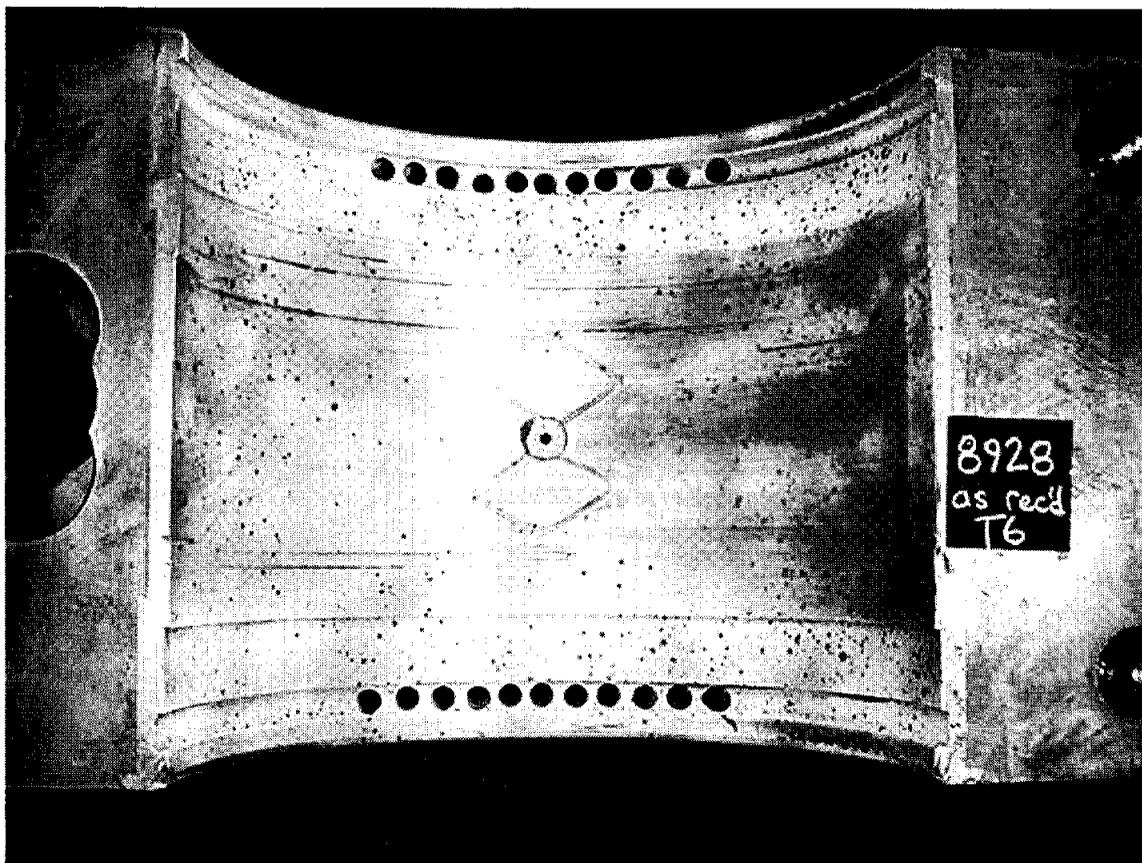
T-6 bearing was found to be wiped. It was sent to RPM, cleaned up, and NDE inspected. This photo shows T-6 bearing as received at RPM. The bearing was spin cast for repairs. Note that T-5 bearing was found in a similar poor condition and was also spin cast repaired.

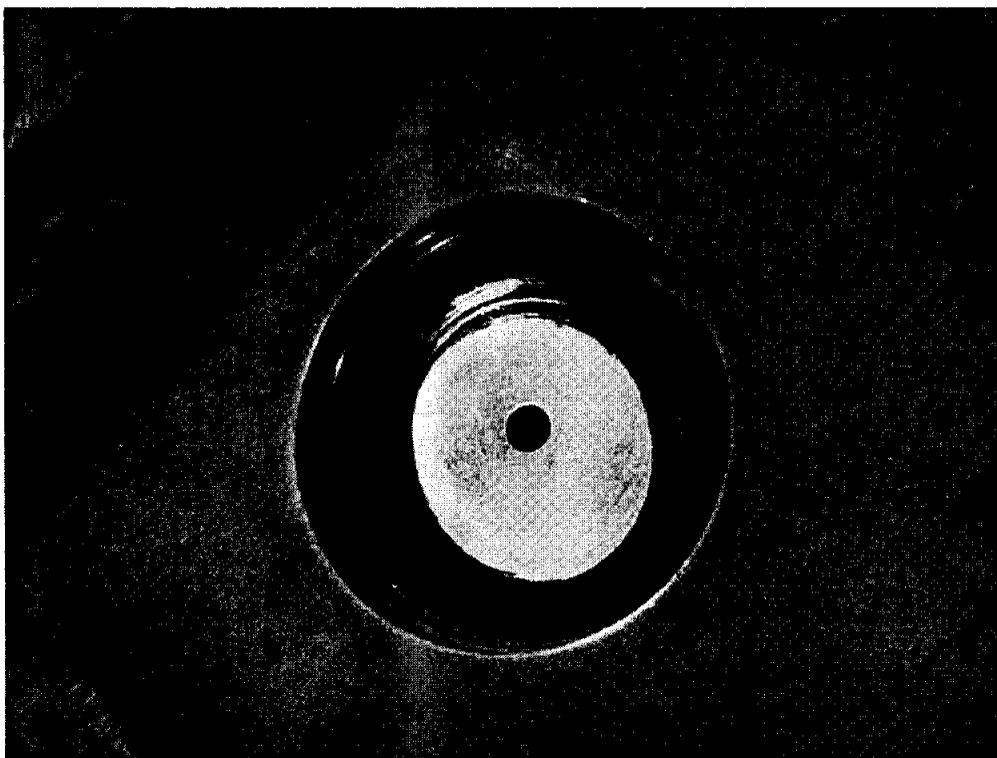
T-2 bearing was sent to RPM for repairs prior to inspection due to journal size differences between the running and spare rotors. One item noted by RPM was the lack of contact between the conical puck and bearing housing as shown above. This was repaired by RPM.

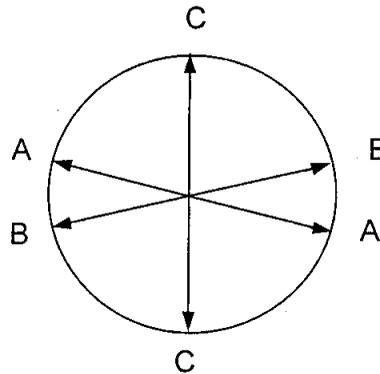
Number	Location	Oil Deflector			Journal Dia	Average	Clearance		Condition Comment
		A-Dia	B-Dia	C-Dia			Min.	Max.	
T-1	HP - TE	13.510	13.503	13.518	13.453	0.057	0.050	0.065	Used as found
T-2	HP - GE	15.481	15.481	15.481	15.441	0.040	0.040	0.040	After Repairs
T-3	IP - TE	NT	NT	NT		0.029			By feeler gauge
T-4	IP - GE	17.494	17.496	17.503	17.457	0.041	0.037	0.046	Used as found
T-5	LP A - TE	17.493	17.491	17.496	17.457	0.036	0.034	0.039	Used as found
T-6 TE	LP A - GE	19.475	19.475	19.474	19.434	0.041	0.040	0.041	After Repairs
T-6 GE	JS - TE	17.487	17.485	17.498	17.438	0.052	0.047	0.060	Used as found
T-7 TE	JS - GE	17.492	17.490	17.491	17.430	0.061	0.060	0.062	Used as found
T-7 GE	LP B - TE	17.492	17.491	17.510	17.456	0.042	0.035	0.054	Used as found

All repairs done by RPM.

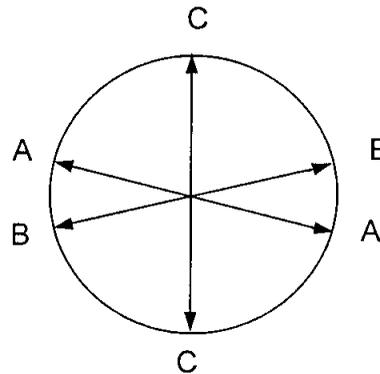
Number	Location	Oil Deflector			Journal Dia	Clearance			Condition Comment
		A-Dia	B-Dia	C-Dia		Average	Min.	Max.	
T-1	HP - TE	13.510	13.503	13.518	13.453	0.057	0.050	0.065	OK for reuse
T-2	HP - GE	15.514	15.530	15.545	15.441	0.089	0.073	0.104	Sent out for repairs
T-3	IP - TE	NT	NT	NT		0.029			By feeler gauge
T-4	IP - GE	17.494	17.496	17.503	17.457	0.041	0.037	0.046	OK for reuse
T-5	LP A - TE	17.493	17.491	17.496	17.457	0.036	0.034	0.039	OK for reuse
T-6 TE	LP A - GE	19.506	19.512	19.524	19.434	0.080	0.072	0.090	Sent out for repairs
T-6 GE	JS - TE	17.487	17.485	17.498	17.438	0.052	0.047	0.060	OK for reuse
T-7 TE	JS - GE	17.492	17.490	17.491	17.430	0.061	0.060	0.062	OK for reuse
T-7 GE	LP B - TE	17.492	17.491	17.510	17.456	0.042	0.035	0.054	OK for reuse

T-2 & T-6 TE oil deflectors were sent to RPM for repairs.
 Design Clearances: T-1, T-2, T-3, T-4, T-5, T-6 TE, T-7 GE = 0.040" / T-6 GE, T-7 TE = 0.060"

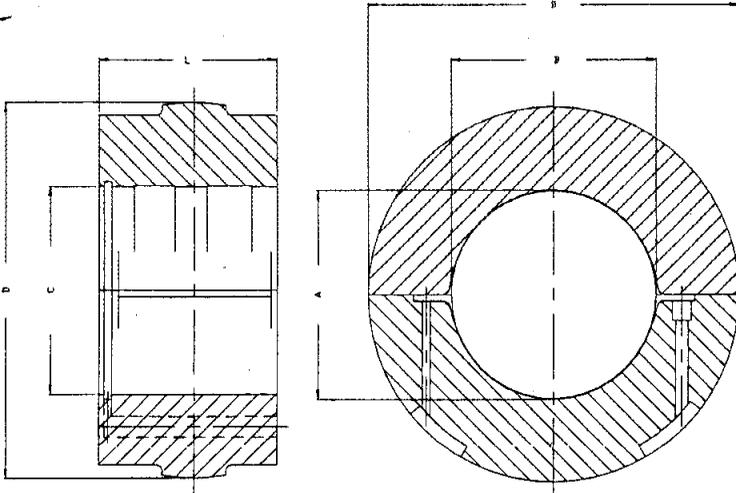
RPM Job # 8927

Both T-5 and T-6 bearings were found wiped. The bearings were repaired by RPM.
 Data above is final - after repairs data.
 Westinghouse bearings have 2 mils per inch design clearance.

Customer: American Electric Power		Plant/Unit: Mitchell Plant #1					
OEM/Design: Cylindrical		Comments:					
Work Scope: Centrifugal Cast Repair							
P/N T5 Design Cylindrical		As Received Date: 9/14/01			As Shipped Date: 9/25/01		
		Vert	Horz	Horz	Vert	Horz	Horz
Inside Diameter	Inboard	15.975	15.968	15.973	15.9557	15.9558	15.9557
	Midboard						
	Outboard	15.975	15.968	15.973	15.9557	15.9557	15.9558
Seal Diameter	Inboard	15.978	15.969	15.976	15.956	15.9562	15.9561
	Outboard	15.980	15.969	15.972	15.956	15.9561	15.9562
Outside Diameter	Inboard	22.960	22.958	22.962	22.935	22.935	22.935
	Midboard						
	Outboard	22.970	22.950	22.966	22.940	22.940	22.940
Length		Babbitt 15.955			Babbitt 15.935		
Joints		In .005 / Out .002			In .000 / Out .001 Contact 75%		
Dowels		(2) Condition Fair			(2) 1" Mfg New		
Babbitt Bond		Not Recorded			UT/PT>95% Adhesion

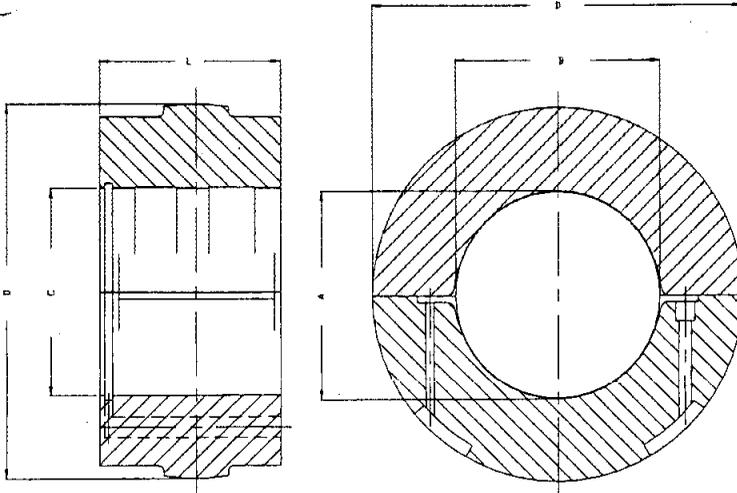
RPM Job # 8928

Customer: American Electric Power		Plant/Unit: Mitchell Plant #1					
OEM/Design: Cylindrical		Comments:					
Work Scope: Centrifugal Cast Repair							
P/N T6 Design Cylindrical		As Received Date: 9/14/01			As Shipped Date: 9/25/01		
		Vert	Horz	Horz	Vert	Horz	Horz
Inside Diameter	Inboard	16.855	16.845	16.843	16.9828	16.9828	16.9827
	Midboard						
	Outboard	16.857	16.846	16.845	16.9829	16.9827	16.9828
Seal Diameter	Inboard	16.858	16.848	16.846	16.9832	16.9832	16.9833
	Outboard	16.860	16.846	16.847	16.9833	16.9832	16.9833
Outside Diameter	Inboard	28.464	28.460	28.462	28.440	28.440	28.440
	Midboard						
	Outboard	28.472	28.460	28.464	28.445	28.445	28.445
Length		OAL 16.986			Babbitt 16.940		
Joints		In .007 / Out .003 Contact 35%			In .000 / Out .001 Contact 60%		
Dowels		(2) 1" Condition Good			(2) 1" As Is		
Babbitt Bond		Not Recorded			UT/PT>95% Adhesion

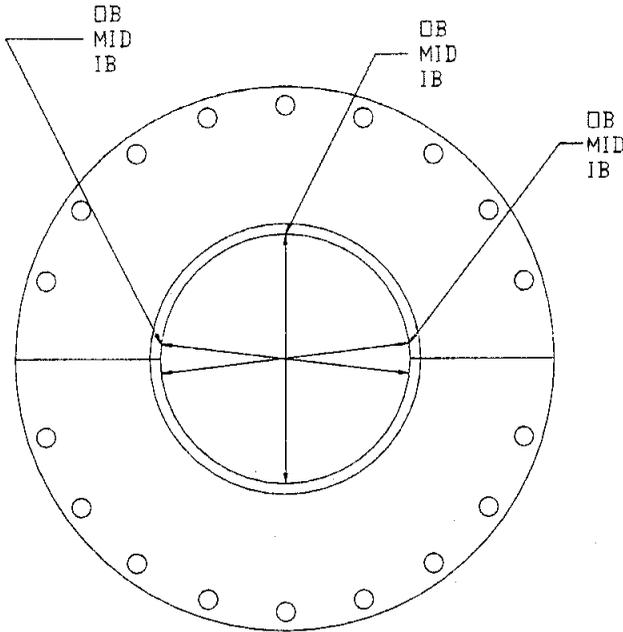
**Inspection Report
 Oil Deflector
 RPM Job # 8961**

Customer: American Electric Power				Plant/Unit: Mitchell #1			
Work Scope: Provide/Install New Teeth				No. Teeth/style: 4 Teeth, Insert, Aluminum			
Comments: Provide and install new teeth							
P/N T2		As Received Date: 9/19/01			As Shipped Date: 9/25/01		
OEM Cylindrical		Vert	Horz	Horz	Vert	Horz	Horz
Inside Diameter	Inboard	15.5			15.481	15.481	15.481
	Midboard						
	Outboard				15.481	15.481	15.481
Warpage		.004			No Change		
Joints		In .012 / Out .009			In .000 / Out .001		
Dowels		½" Condition Good			No Change

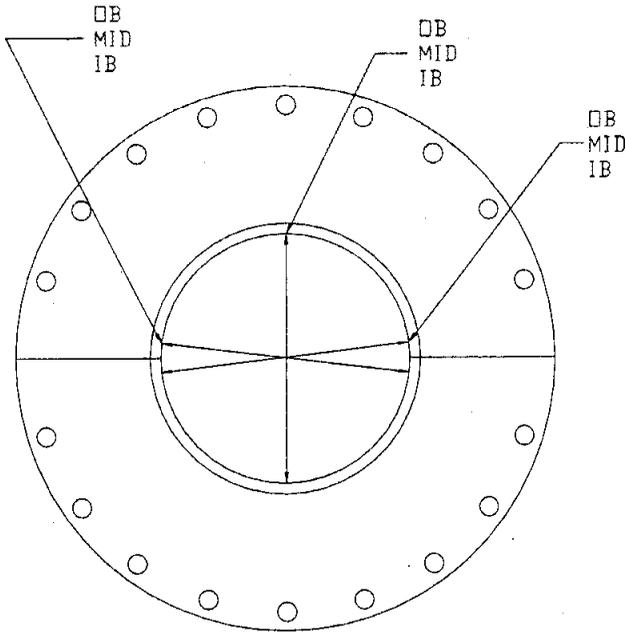
Inspection Report Oil Deflector RPM Job # 8961

Customer: American Electric Power				Plant/Unit: Mitchell #1			
Work Scope: Provide/Install New Teeth				No. Teeth/style: 4 Teeth, Insert, Aluminum			
Comments: Provide and install new teeth							
P/N T6		As Received Date: 9/19/01			As Shipped Date: 9/25/01		
OEM Cylindrical		Vert	Horz	Horz	Vert	Horz	Horz
Inside Diameter	Inboard	19.5			19.474	19.474	19.474
	Midboard						
	Outboard				19.474	19.474	19.474
Warpage		.028			.005		
Joints		In .004 / Out .002			In .001 / Out .000		
Dowels		1/2" Condition Good			No Change

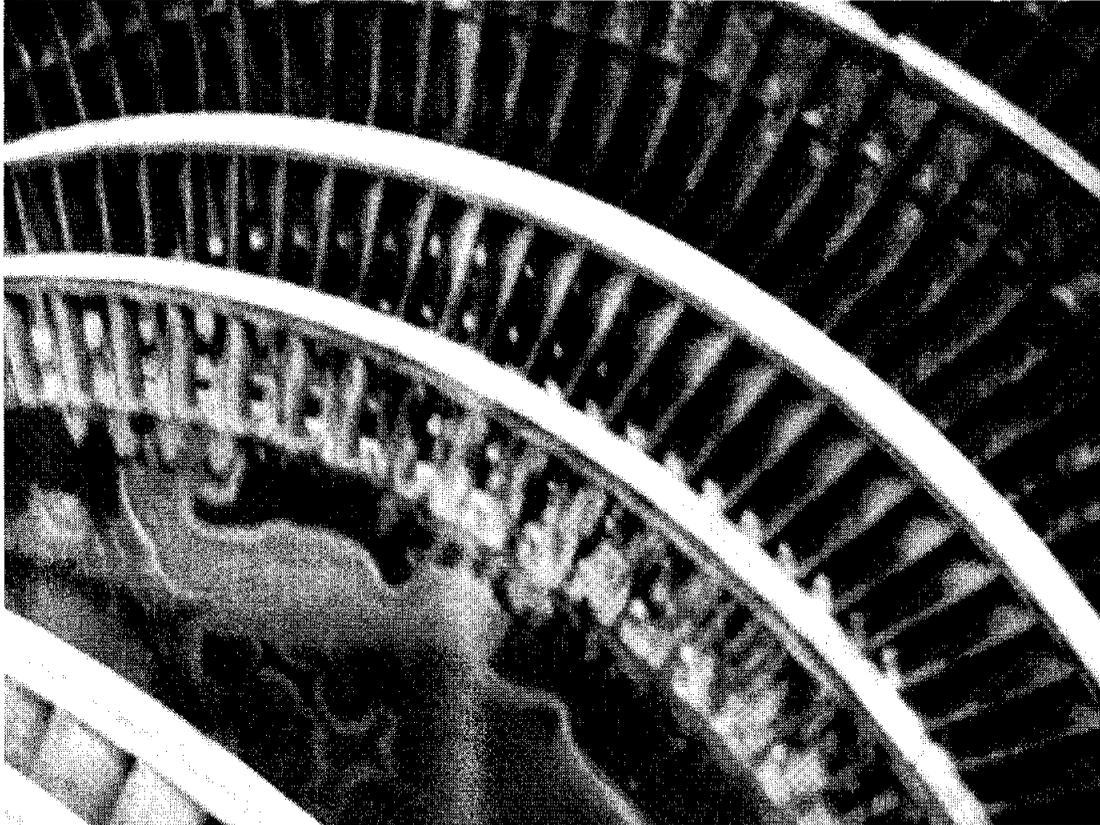
Mitchell Unit 1 – LP “A” Rotor

This photo shows the blading for the LP “A” rotor. Note the white deposits on the blading. The rotor was replaced with a spare rotor.

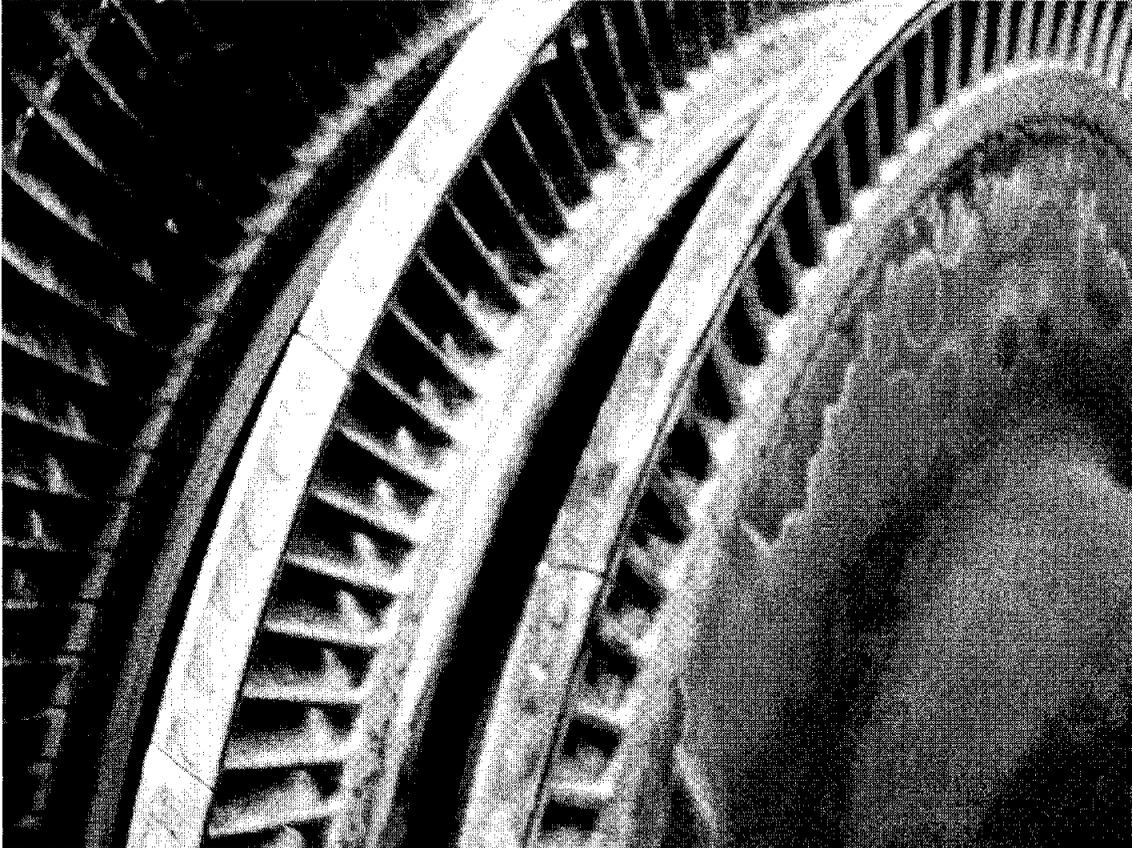
Mitchell Unit 1 – LP “A” Turbine

Another photo of the deposits on the blading of the LP “A” rotor. The rotor was replaced with a spare rotor.

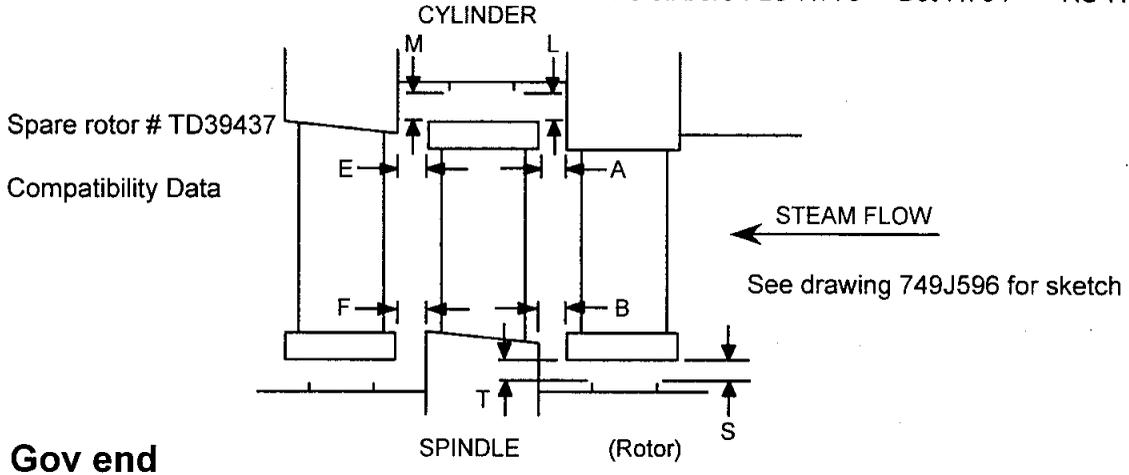
Seal with n/a - damaged

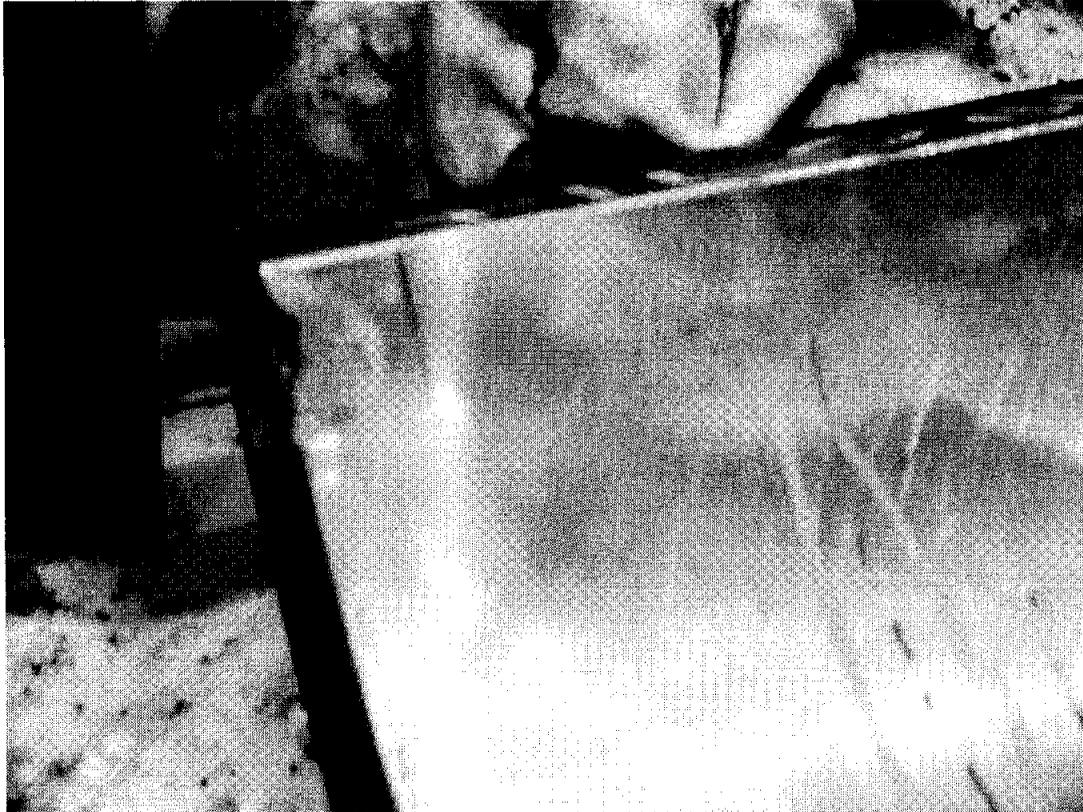
Both bearings were in fairly good condition when disassembled, except that one of the upper bearing pads on T-9 bearing had some babbitt chipped out at the corners. Due to journal size differences with the spare rotor, both T-9 and T-10 bearings had to be repaired.

This photo shows an upper pad from T-9 bearing. This bearing was repaired at RPM due to journal size differences associated with the generator rotor change-out.

Both T-9 and T-10 bearings were sent to RPM for repairs. New mandrels were made by RPM for repairing the bearings. The lower pads were in good shape and were shimmed to close up the clearance. The upper pads were spin cast and machined to the proper contour.

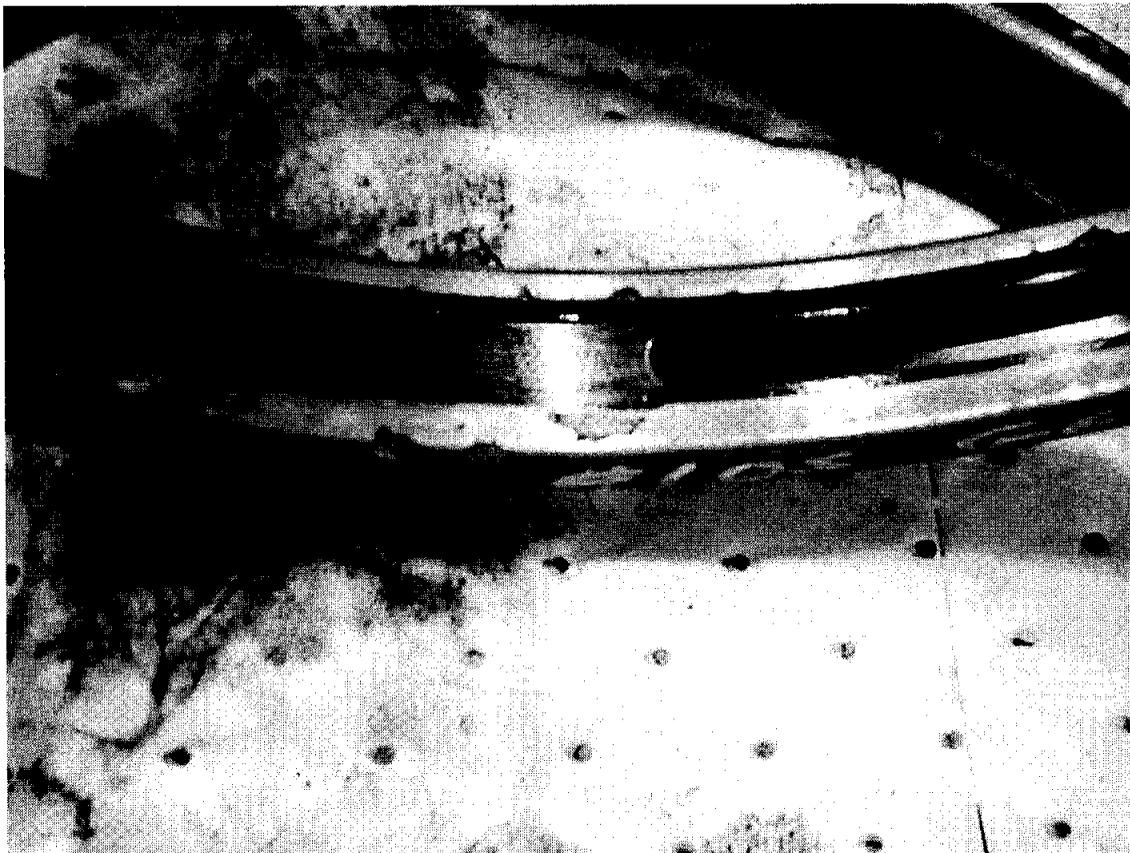
This photo shows the GE seal ring for T-10 bearing. T-10 bearing and both seal rings were repaired at RPM due to journal size differences associated with the generator rotor change-out.

The bearing seal rings for T-9 and T-10 all had acceptable bonding of the babbitt. All four seal rings were Tig weld repaired and machined to design clearances.

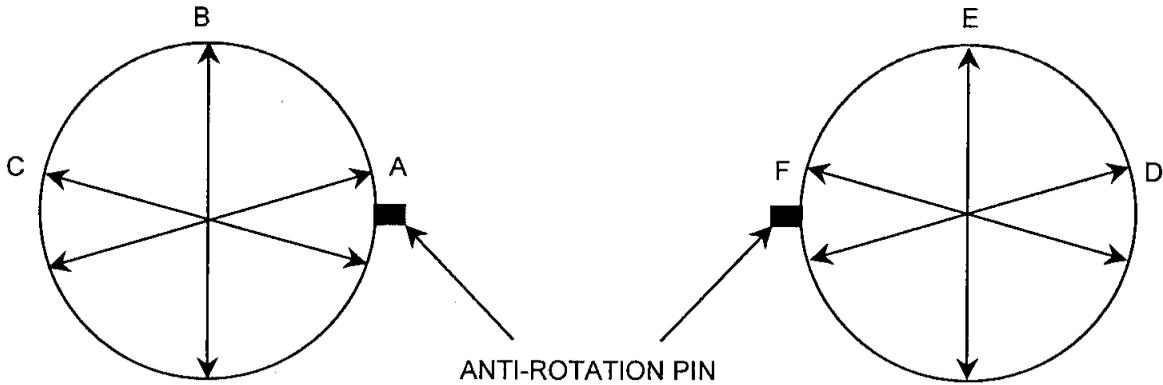
BEARING NUMBER 9					
TURBINE SIDE		EXCITER END		CALCULATIONS	
POSITION	DIM.	POSITION	DIM.	AVG SHAFT O.D.	CLEARANCE
A	20.832	D		20.819	0.013
B	20.829	E		20.819	0.01
C	20.833	F		20.819	0.014

BABBITTED SEAL RINGS: TIG weld repair and bored to 20.833"

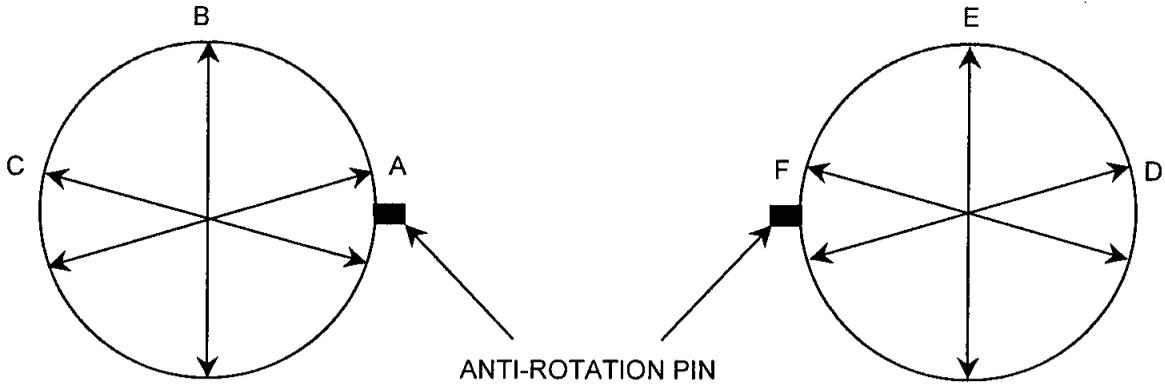
BEARING NUMBER 10					
TURBINE SIDE		EXCITER END		CALCULATIONS	
POSITION	DIM.	POSITION	DIM.	AVG SHAFT O.D.	CLEARANCE
A	20.884	D		20.868	0.016
B	20.8815	E		20.868	0.0135
C	20.8865	F		20.868	0.0185

BABBITTED SEAL RINGS: TIG weld repair and bored to 20.884"

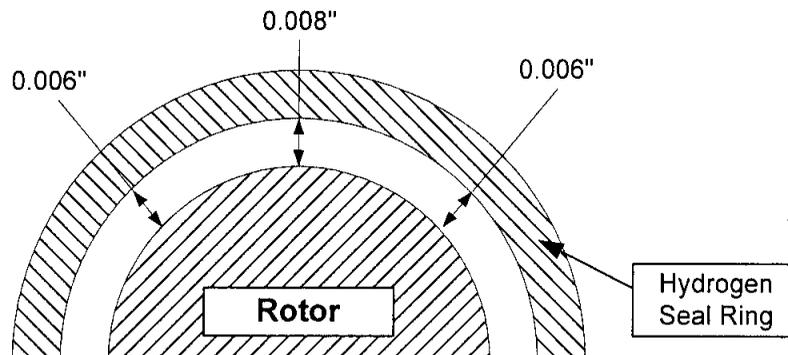
The T-10 upper oil seal was removed, the T-10 bearing and bearing seals were removed. The plug to the CE hydrogen seals was removed and the movement of the seals was confirmed. Feeler gages were inserted between the CE hydrogen seal ring and the shaft as shown below.

The hydrogen seal ring moved freely with the feeler gages still between the seal and the shaft, so the clearance was confirmed.

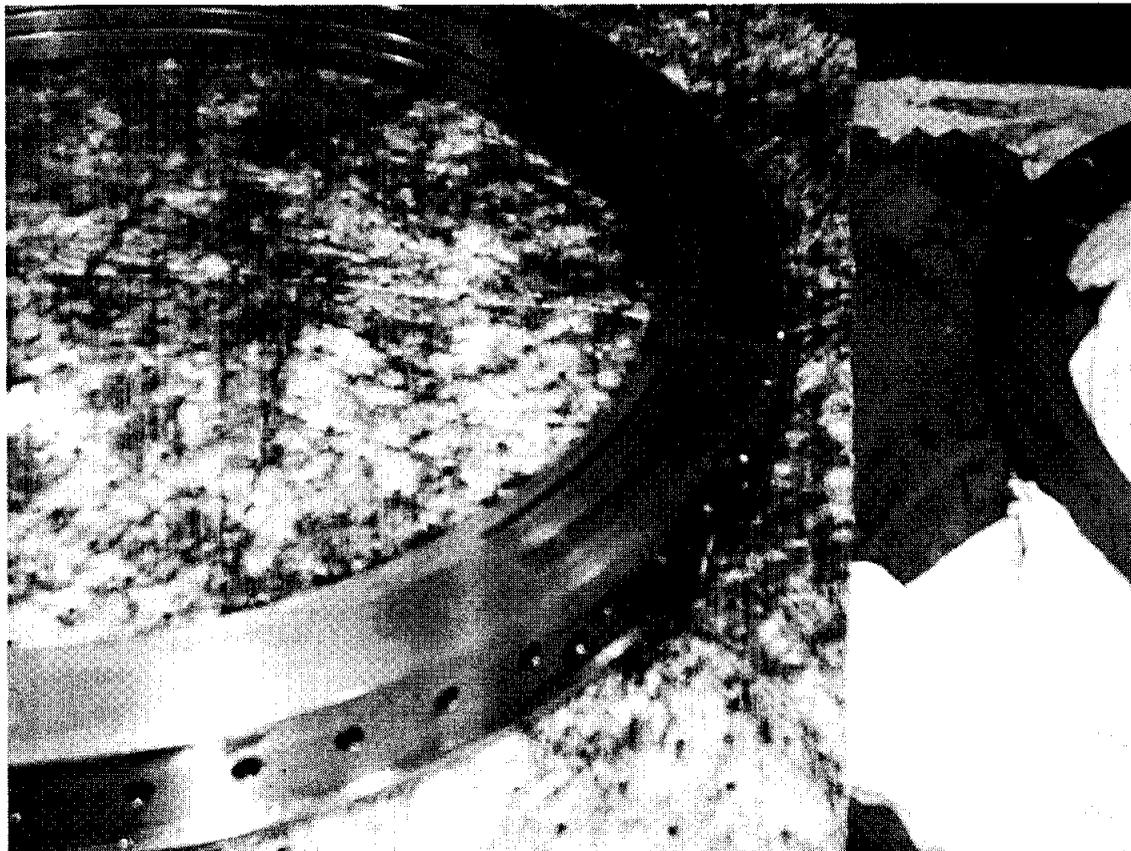
This photo shows the CE hydrogen seal ring as inspected after the unit was shut down to correct the hydrogen seal rub. The seal ring showed scoring on the face as shown and also had a slight rub which can not be seen in this photo.

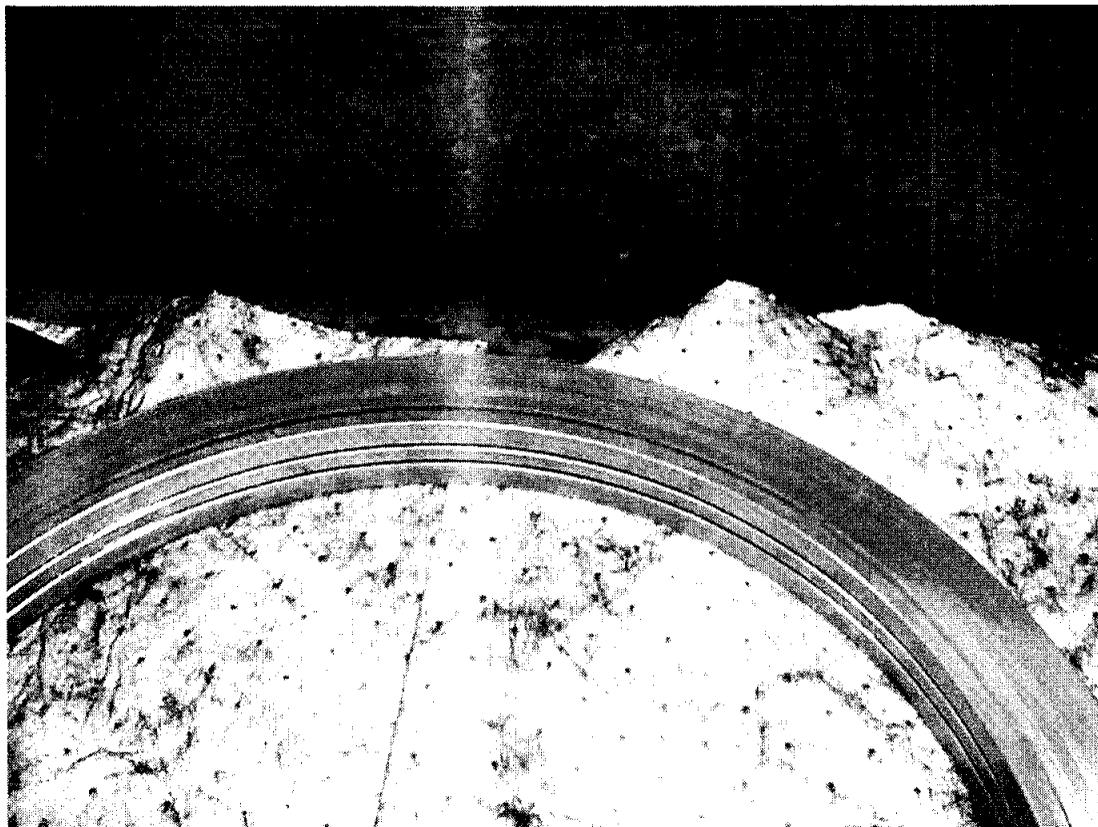
This photo shows the CE hydrogen seal ring as inspected after the unit was shut down to correct the hydrogen seal rub. The seal ring showed scoring on the face as shown and also had a slight rub which can not be seen in this photo.

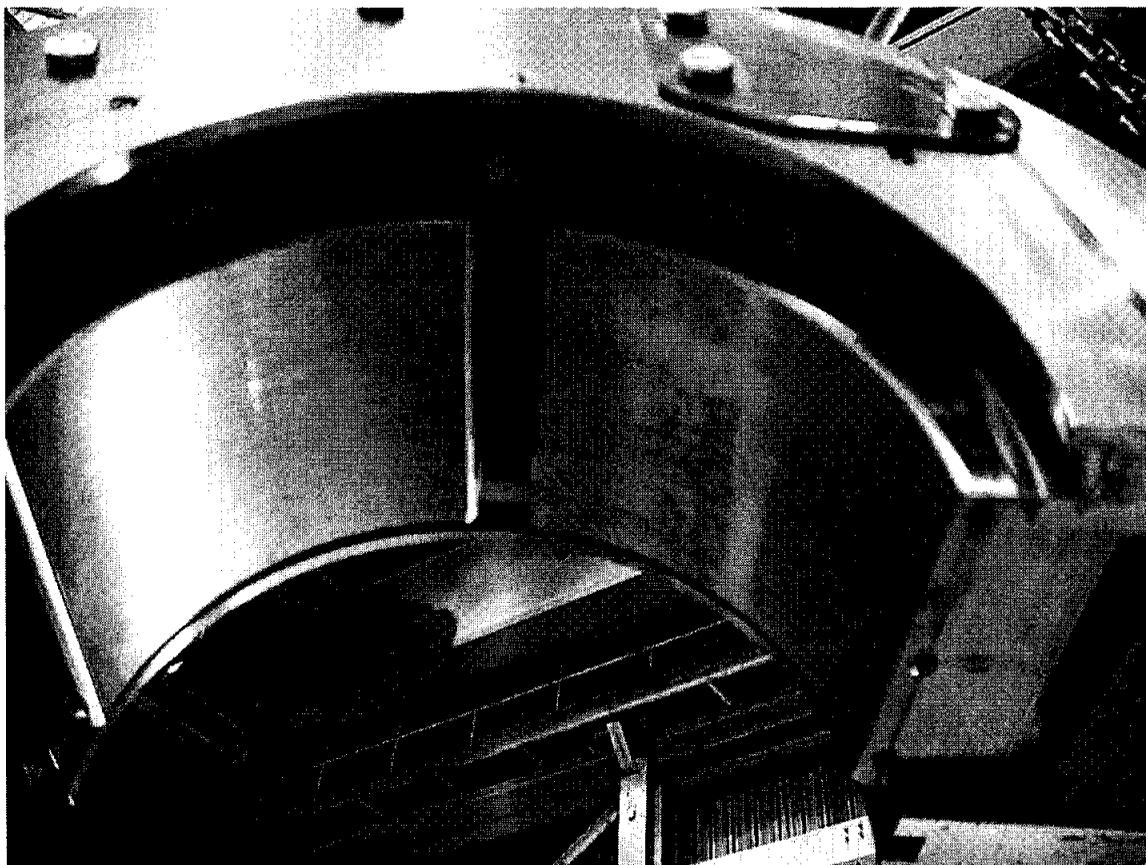
This photo shows the T-11 bearing. It was inspected after the heavy vibration was noted during start-up, and the unit was shut down to correct a hydrogen seal rub. No damage was noted during the inspection.

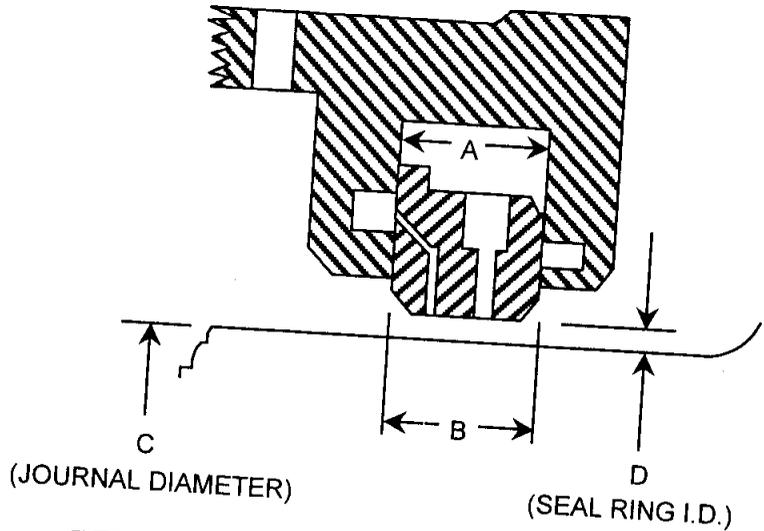
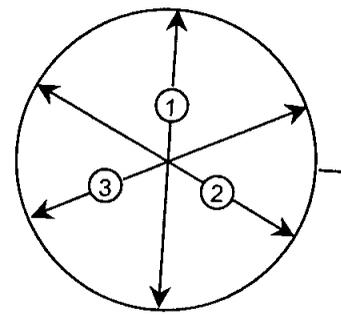
Spare rotor # S/N 79P030
 H2 seal ring EE

AXIAL CLEARANCES			
LOCATION	DIM A = GROOVE WIDTH	DIM B = RING THICKNESS	CLEARANCE
TOP	1.912	1.901	0.011
BOTTOM	1.911	1.901	0.01
RIGHT SIDE	1.911	1.901	0.01
LEFT SIDE	1.911	1.901	0.01

Design clearance: .0071/2 - .009

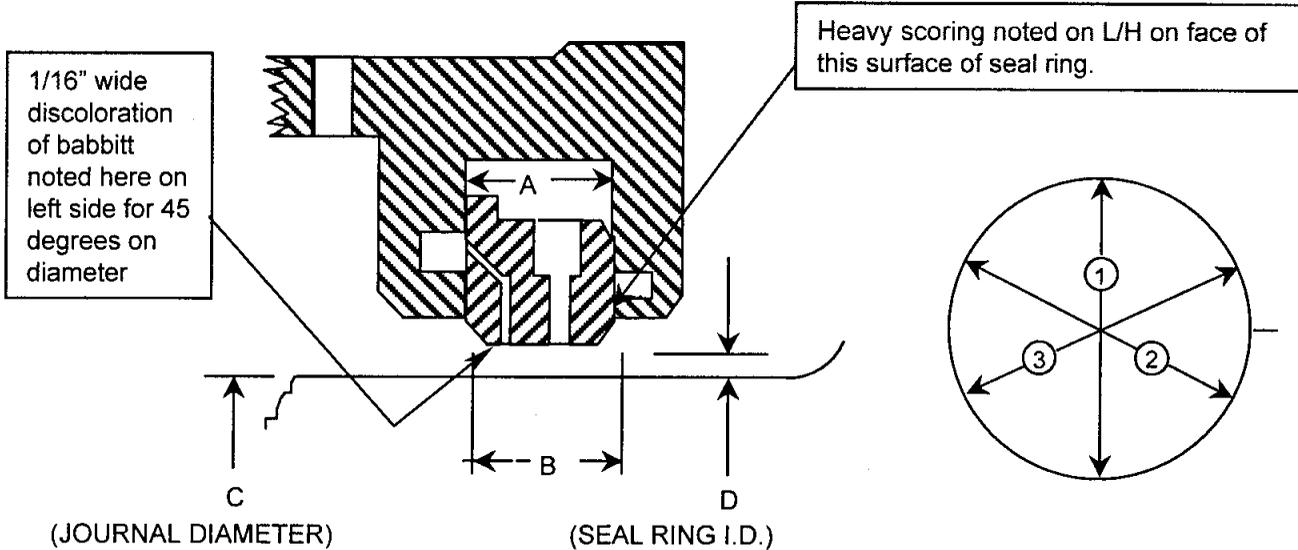
Spare rotor # S/N 79P030
 H2 seal ring EE

AXIAL CLEARANCES			
LOCATION	DIM A = GROOVE WIDTH	DIM B = RING THICKNESS	CLEARANCE
TOP	1.911	1.903	0.008
BOTTOM	1.911	1.903	0.008
RIGHT SIDE	1.911	1.903	0.008
LEFT SIDE	1.911	1.903	0.008

Design clearance: .0071/2 - .009

Comments
* One of the dowel pin holes is cracked. When the dowel is installed, the area near the pin has a thickness of 1.907"
* A minor rub was noted by J. Cable as seen by a 1/16" wide discoloration on the left side TE of the seal ring.

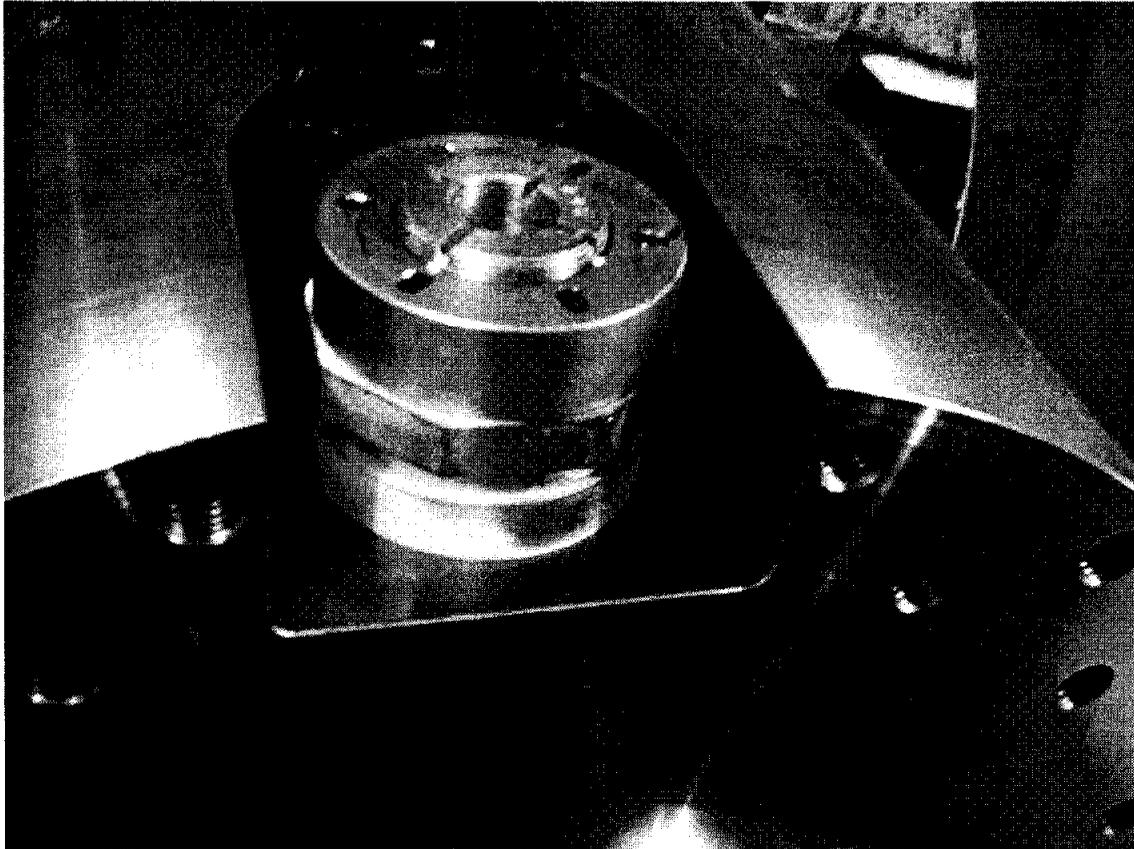
This photo shows the radial lead for the generator / collector assembly as assembled new. This is the collector side of the coupling.

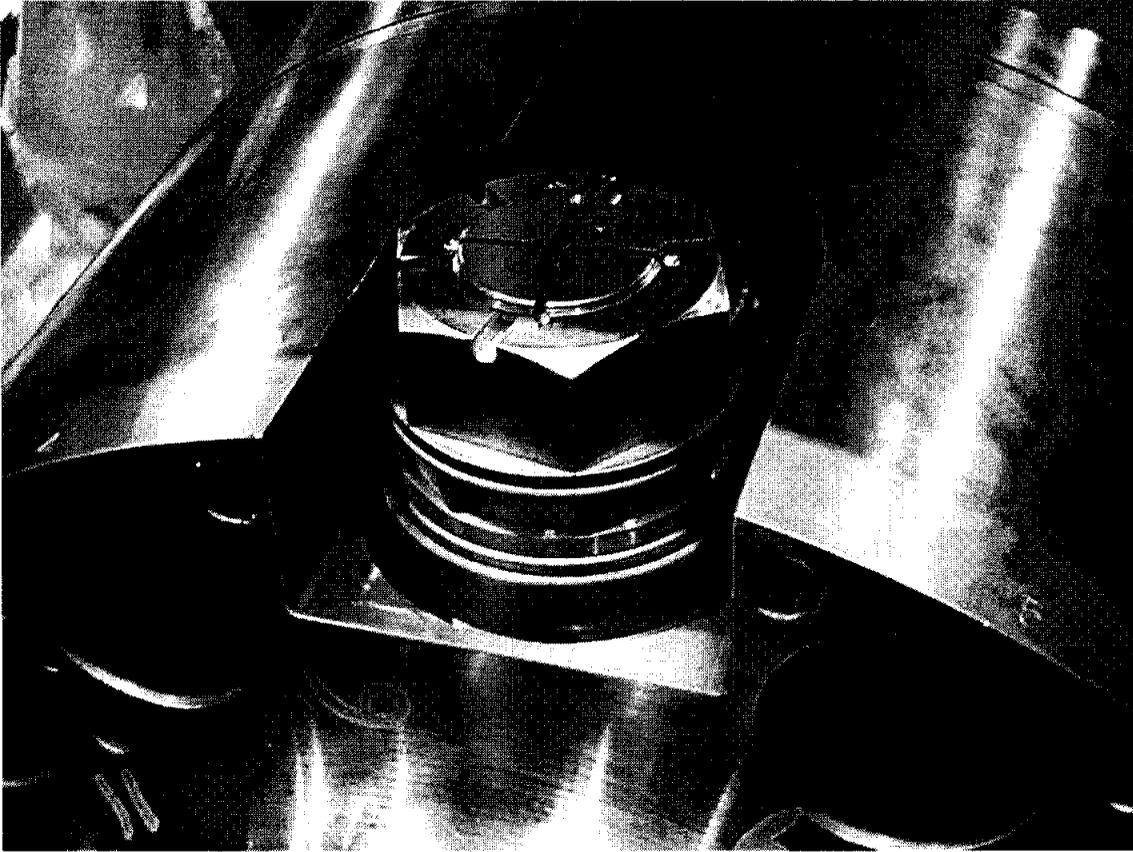
This photo shows the radial lead for the generator / collector assembly as assembled new.

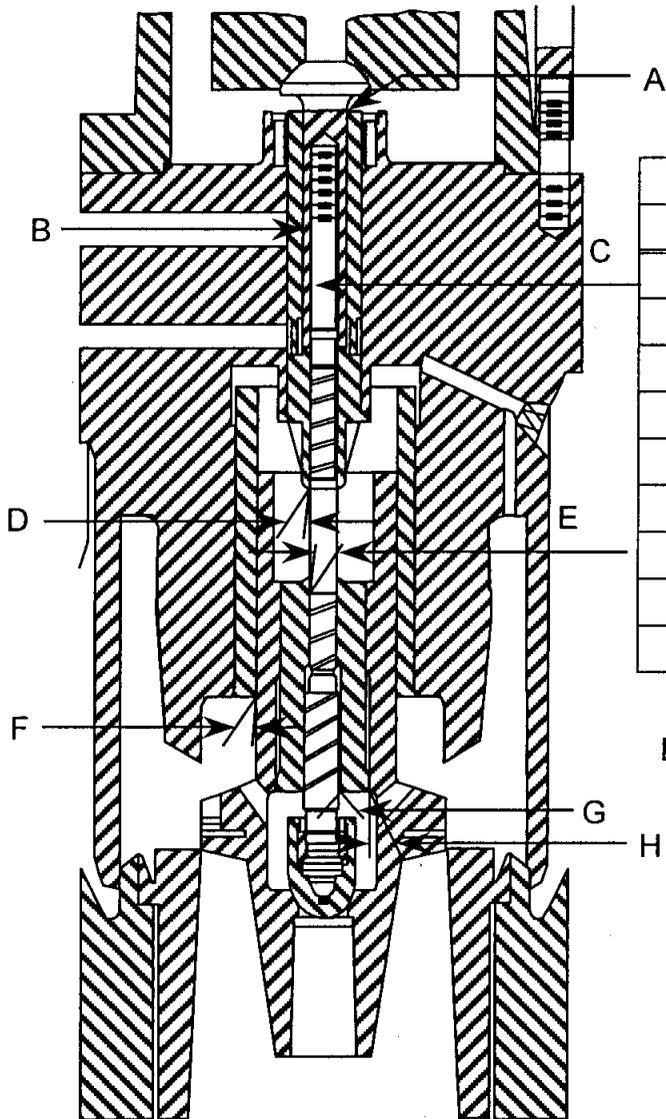
LOCATION _____ #1 Gen end LS _____

DIA	O.D.	I.D.	ACTUAL	DESIGN
A	2.112	2.124	0.012	.010/.013
B	2.112	2.125	0.013	.010/.013
C	1.381	1.393	0.012	.005/.007
D	1.486	1.500	0.014	.010/.013
E	1.486	1.498	0.012	.010/.013
F	5.486	5.490/5.495	.004/.009	.011/.017
G	1.929	1.935	0.006	.010/.013
H	3.806	3.809/3.812	.003/.006	.002/.005
I = RUNOUT = TIR .012				0/.003

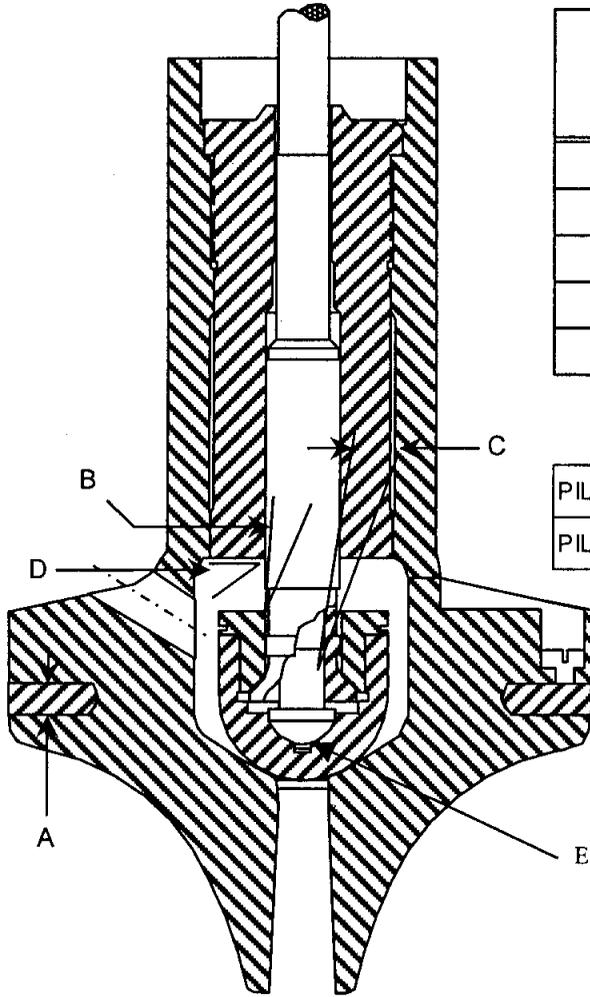
Valve #1 Gen End LS

DIM	O.D.	I.D.	ACTUAL CLR	DESIGN CLR
A				.004/.006
B	1.862/1.877	1.835/1.845	.017/.042	.057/.069
C	1.185	1.187/1.194	.002/.009	.010/.012
D	1.929	1.936	0.007	.010/.013
E	**0.51	0.52		.012/.018

** Mushroom, bad reading

Parts Replaced on Valve #1
 Stem, Stem End, Spring, Spring Seat,
 Pilot Valve, Pilot Valve Retaining Nut,
 Main Valve Disk, 4 Screws to flex plate
