Mitchell Unit 1

Turbine – Generator Outage

Fall 2001

Report Prepared by
John Lackner
RSO Turbine Coordinator

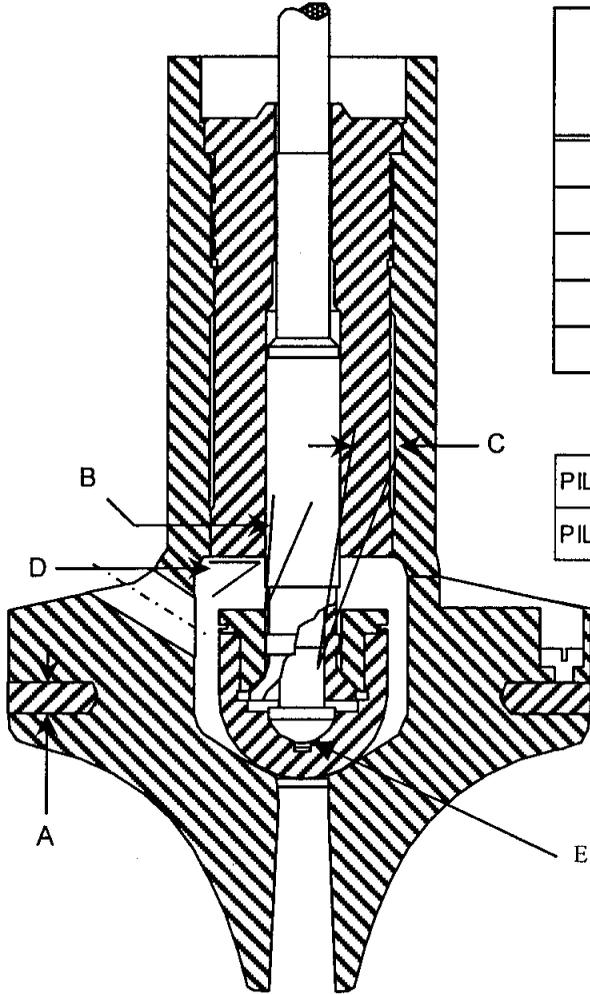
Valve #3 Gov End LS

DIM	O.D.	I.D.	ACTUAL CLR	DESIGN CLR
A	0.368	.370/.388	.002/.020	.004/.006
B	1.866/1.877	1.947	.081/.070	.057/.069
C	1.170/1.180	1.18	.010/.000	.010/.012
D	1.927	1.935	0.008	.010/.013
E	0.48	0.516	0.036	.012/.018

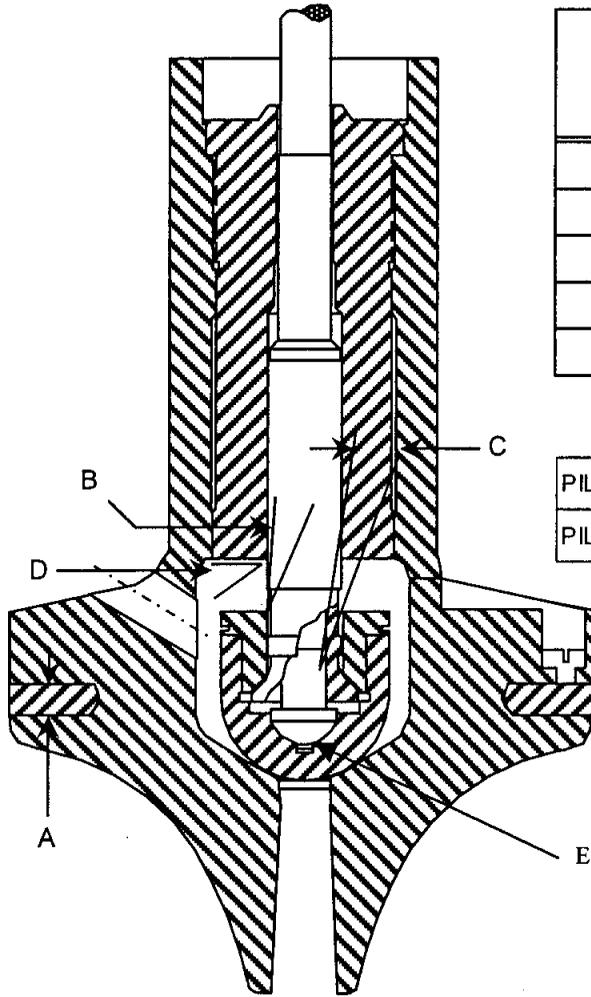
Valve #4 Gov End RS

DIM	O.D.	I.D.	ACTUAL CLR	DESIGN CLR
A	0.372	.372/.392	.000/.020	.004/.006
B	1.863/1.880	1.940	.077/.060	.057/.069
C	1.178	1.187	0.016	.010/.012
D	1.93	1.935	0.005	.010/.013
E	0.494	0.535	0.041	.012/.018

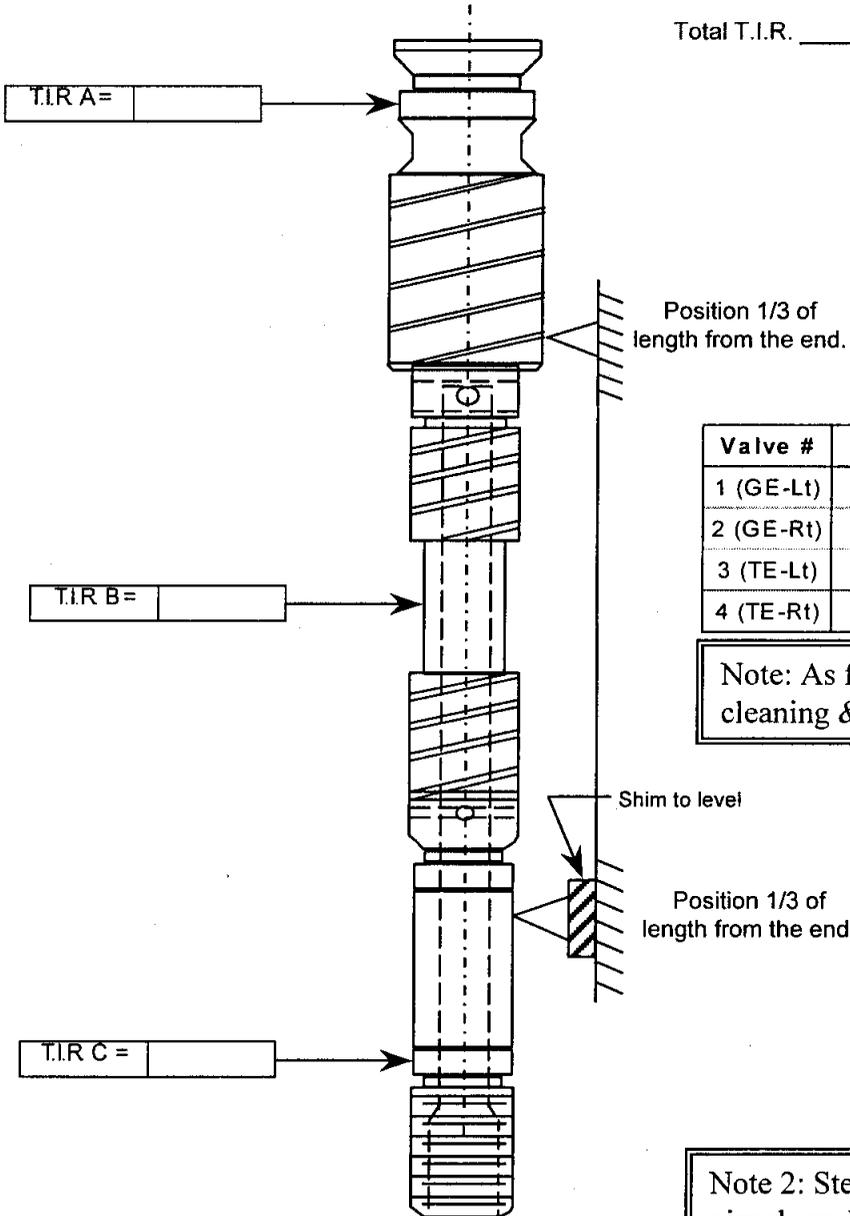
Valve #	A	B	C
1 (GE-Lt)	-0.003	-0.006	0.002
2 (GE-Rt)	-0.003	-0.008	0.008
3 (TE-Lt)	-0.003	-0.003	-0.002
4 (TE-Rt)	-0.002	-0.010	0.003

Note: As found data after cleaning & polishing the stems.

Note 2: Stem for valve #2 has a visual crack in it.

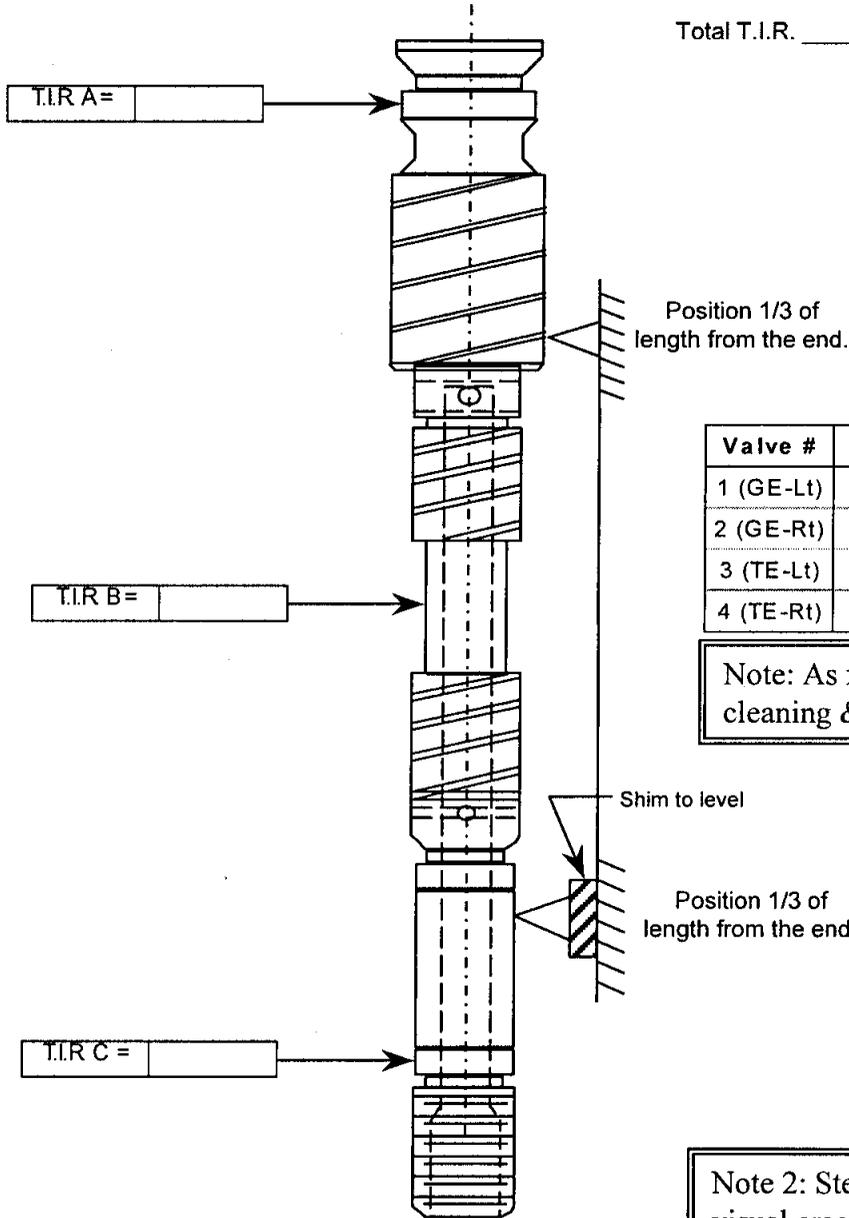
Valve #	A	B	C
1 (GE-Lt)	0.012	0.002	0.002
2 (GE-Rt)	0.011	0.007	0.002
3 (TE-Lt)	0.008	0.002	0.003
4 (TE-Rt)	0.021	0.012	0.003

Note: As found data prior to cleaning & polishing the stems.

Note 2: Stem for valve #2 has a visual crack in it.

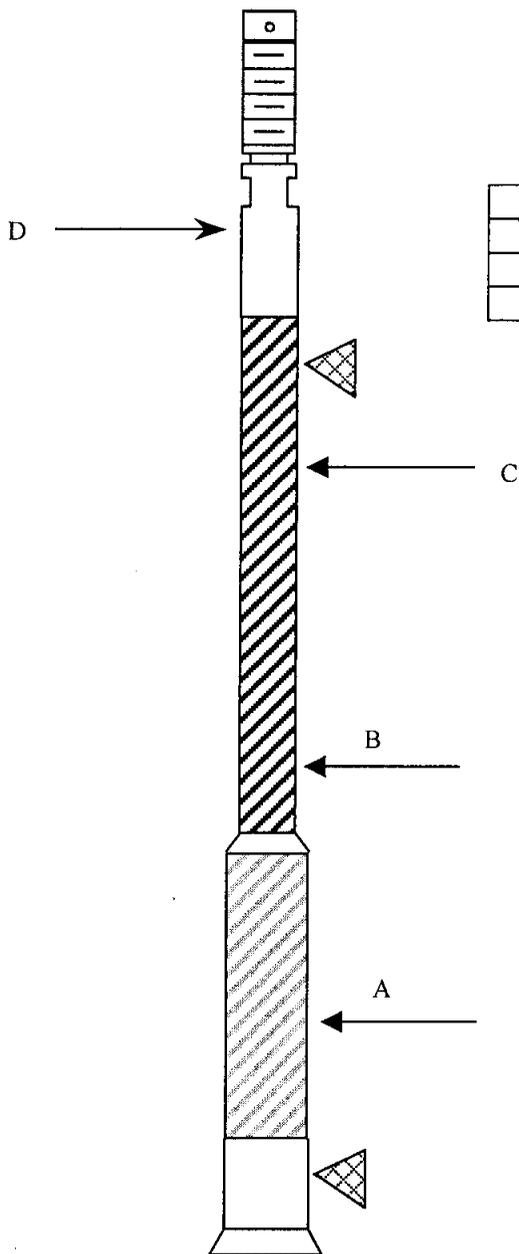
Runout - Total Indicator Runout (T.I.R.)				
Valve	A	B	C	D
Right	0.001	0	0	0
Left	0.001	0.001	0.001	0.001

NEW STEMS FOR BOTH VALVES

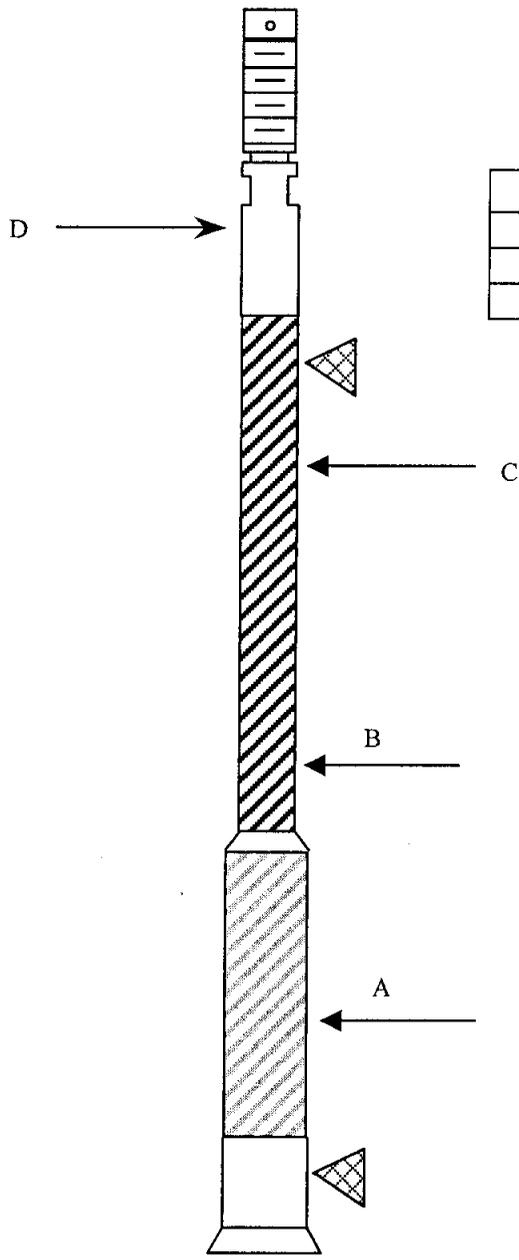
HP 1st Reheat Intercept Valves

Runout - Total Indicator Runout (T.I.R.)				
Valve	A	B	C	D
Right	0.013	NT	NT	0.037
Left	0.002	0.005	0.004	0.010

BOTH STEMS WERE REPLACED

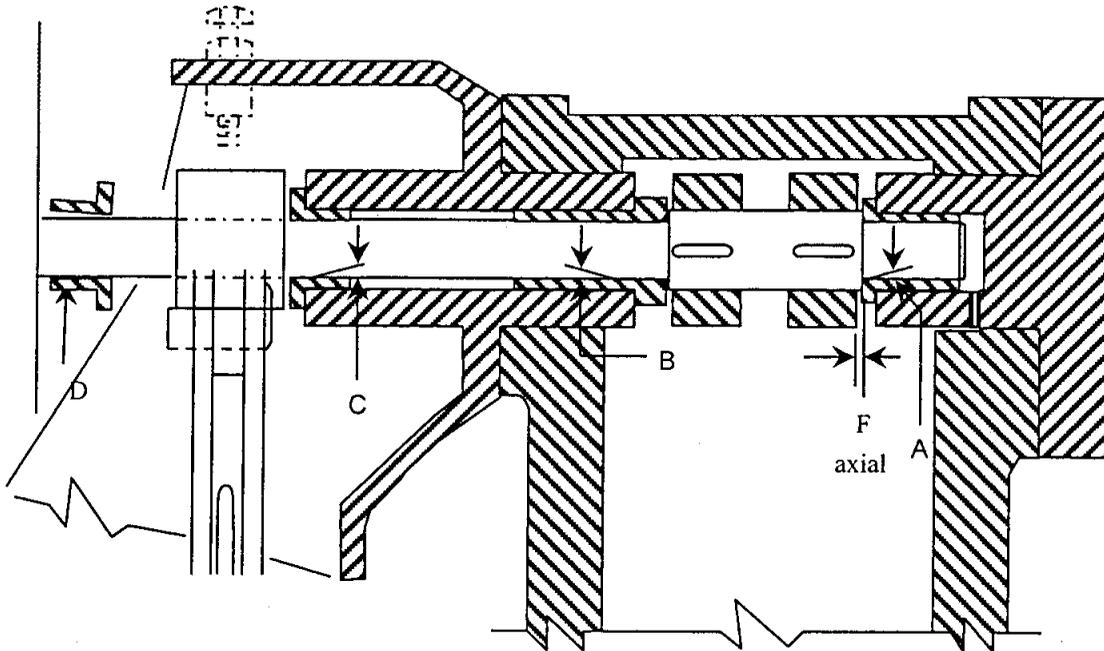
LEFT VALVE CLEARANCE DATA - HP First Reheat						
DIA	AS FOUND			AS LEFT		
	I.D.	O.D.	CLR	I.D.	O.D.	CLR
A	4.873	NT		4.873	4.866	0.007
B	4.620	NT		4.620	4.608	0.012
C	4.625	NT		4.625	4.608	0.017
D	4.505	NT		4.505	4.483	0.022
F (Axial)

RIGHT VALVE CLEARANCE DATA -HP First Reheat						
DIA	AS FOUND			AS LEFT		
	I.D.	O.D.	CLR	I.D.	O.D.	CLR
A	4.863	4.871	-0.008	4.880	4.866	0.014
B	4.616	4.612	0.004	4.624	4.609	0.015
C	4.605	4.609	-0.004	4.628	4.610	0.018
D	4.506	4.484	0.022	4.503	4.484	0.019
F (Axial)						0.115

The bushings were honed to provide proper clearance to the RSV shafts. While fitting the shaft keys to the flapper arms, it was noted that the key slots were worn. The key slots for the right side RSV were cleaned up so that the keys fit, but the flapper arm for the left side had to be replaced. The shaft keys were fit to the slots of the new arm.

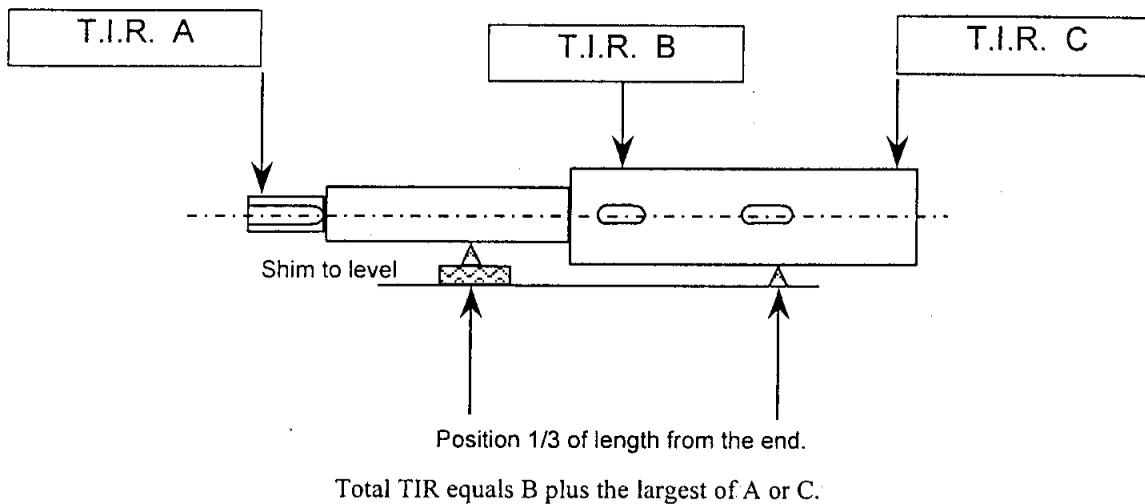
Reheat Valve Shaft Runout			
Valve #	TIR A	TIR B	TIR C
1st Reheat - Left	0.008	0.003	0.015
1st Reheat - Right	0.010	0.002	0.019
2nd Reheat - TE/L	0.009	0.002	0.009
2nd Reheat - TE/R	0.001	0.001	0.003
2nd Reheat - GE/L	0.014	0.004	0.015
2nd Reheat - GE/R	0.012	0.003	0.013

All data taken is included with this report. During the next outage, three spare shafts for the 2nd reheat stop valves should be in stock to allow replacement of the three with excessive runout; (TE-left, GE-left, GE-right). New keys will also be needed for these valves.

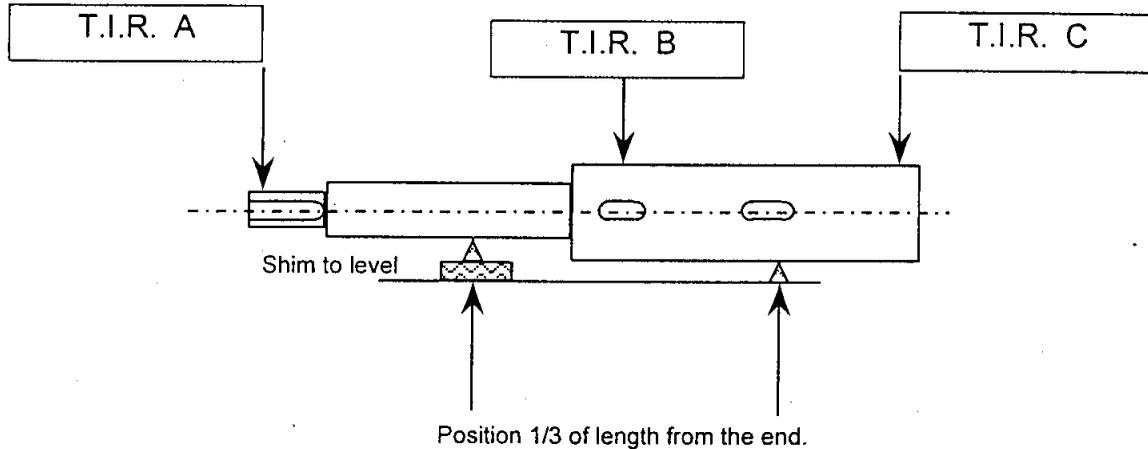
Reheat Valve Shaft Runout			
Valve #	TIR A	TIR B	TIR C
1st Reheat - Left	0.000	0.000	0.000
1st Reheat - Right	0.000	0.000	0.000
2nd Reheat - TE/L	0.010	0.005	0.010
2nd Reheat - TE/R	0.008	0.003	0.006
2nd Reheat - GE/L	0.005	0.007	0.011
2nd Reheat - GE/R	0.011	0.002	0.007

Note: New shafts were installed in both 1st Reheat Stop Valves.

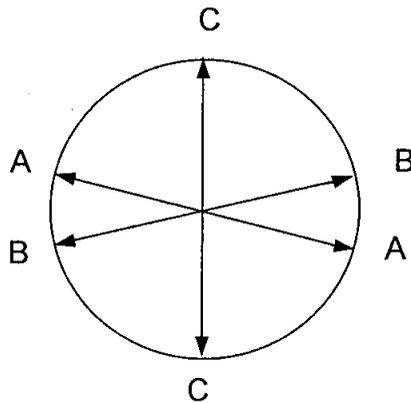
The oil deflectors for the BFP turbine rotor were disassembled and inspected as part of the turbine outage. All three oil deflectors were cleaned up, assembled, and miced up. All three oil deflectors were out of specs and were replaced with spare components.

Location Number	Oil Deflector			Journal Dia	Clearance			Condition Comment
	A-Dia	B-Dia	C-Dia		Average	Min.	Max.	
#1	9.526	9.523	9.532	9.481	0.046	0.042	0.051	Spare shaft dia.
#2	9.530	9.558	9.570	9.479	0.074	0.051	0.091	Spare shaft dia.
#3	6.055	6.040	6.067	7.479	-1.425	-1.439	-1.412	Spare shaft dia.

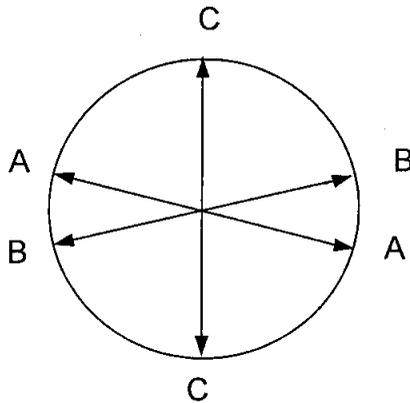
Location Number	Oil Deflector			Journal Dia	Clearance			Condition Comment
	A-Dia	B-Dia	C-Dia		Average	Min.	Max.	
#1	9.502	9.504	9.505	9.481	0.023	0.021	0.024	New oil deflector
#2	9.499	9.499	9.496	9.479	0.019	0.017	0.020	New oil deflector
#3	7.497	7.497	7.497	7.479	0.018	0.018	0.018	New oil deflector

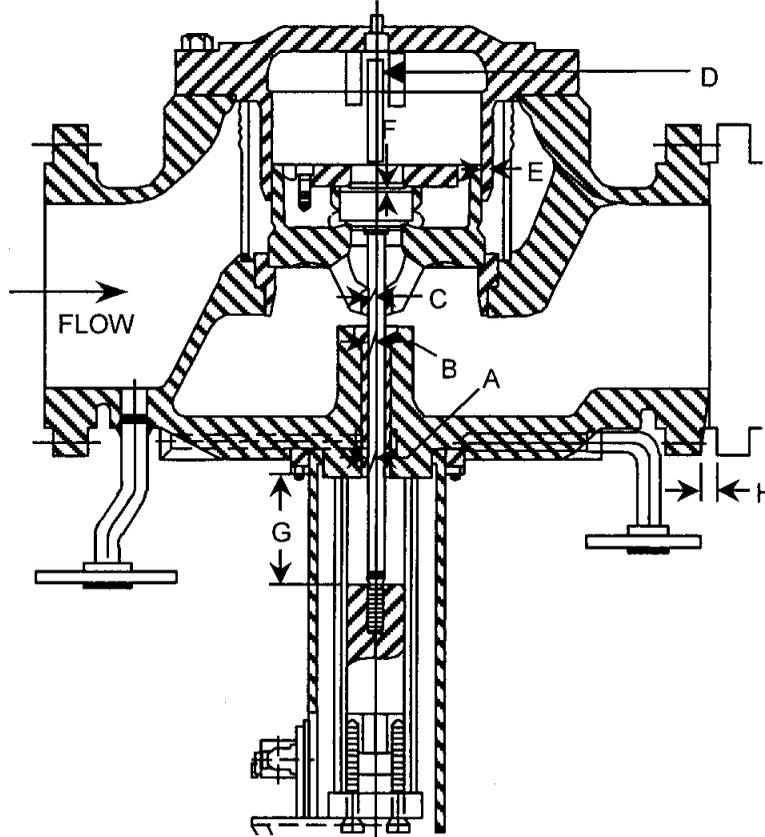
Right Side

BFPT STOP VALVE CLEARANCES - RIGHT SIDE							
LOCATION	INSIDE DIAMETER	OUTSIDE DIAMETER	CLEARANCE	LOCATION	INSIDE DIAMETER	OUTSIDE DIAMETER	CLEARANCE
A	1.504	1.497	0.007	E	17.995 / 18.005	17.955	.040 / .050
B	1.506	1.497	0.009	F	PILOT VALVE AT DISASSEMBLY = TRAVEL AT REASSEMBLY =		
C	1.512	1.500	0.012	G	MAIN VALVE AT DISASSEMBLY = TRAVEL AT REASSEMBLY =		
D	1.502/1.504	1.500	.002/.004	H

Note: installed new stem

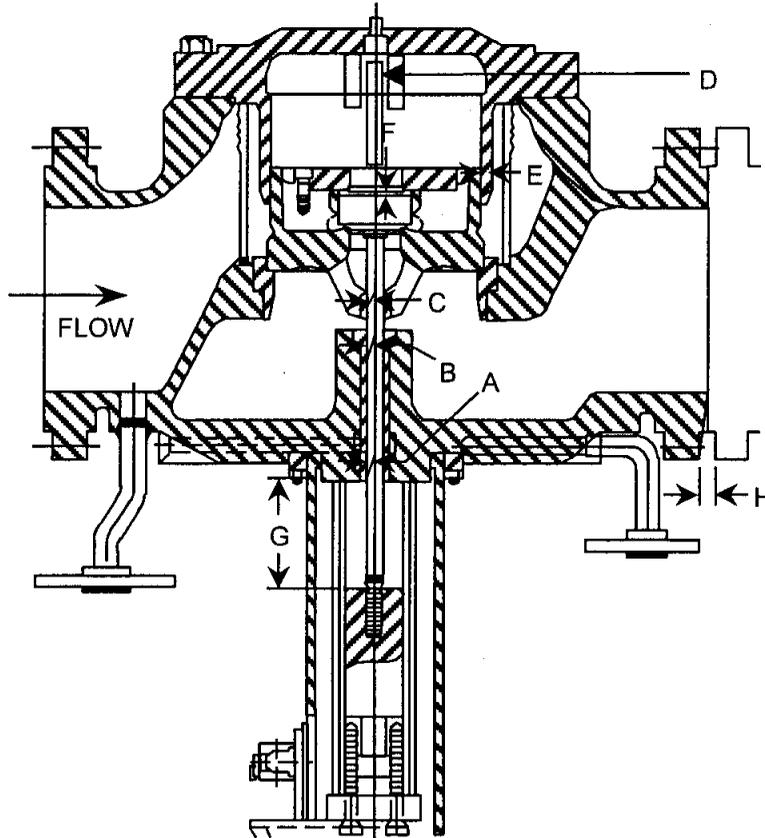
Right Side

BFPT STOP VALVE CLEARANCES - RIGHT SIDE							
LOCATION	INSIDE DIAMETER	OUTSIDE DIAMETER	CLEARANCE	LOCATION	INSIDE DIAMETER	OUTSIDE DIAMETER	CLEARANCE
A	1.504	1.497	0.007	E	17.995 / 18.005	17.955	.040 / .050
B	1.506	1.497	0.009	F	PILOT VALVE AT DISASSEMBLY = TRAVEL AT REASSEMBLY =		
C	1.512	1.499	0.013	G	MAIN VALVE AT DISASSEMBLY = TRAVEL AT REASSEMBLY =		
D	1.502/1.504	1.495/1.496 **	.006/.009	H

** Stem badly scarred

All stem and bushing sizes were checked and compared for clearance. The stems were checked for runout. The stem for the right side SV was badly scarred and was replaced with a new stem. The stem for the left side SV had heavy scale on it, and was polished. All of the valve bushings were honed as necessary to provide for proper clearance.

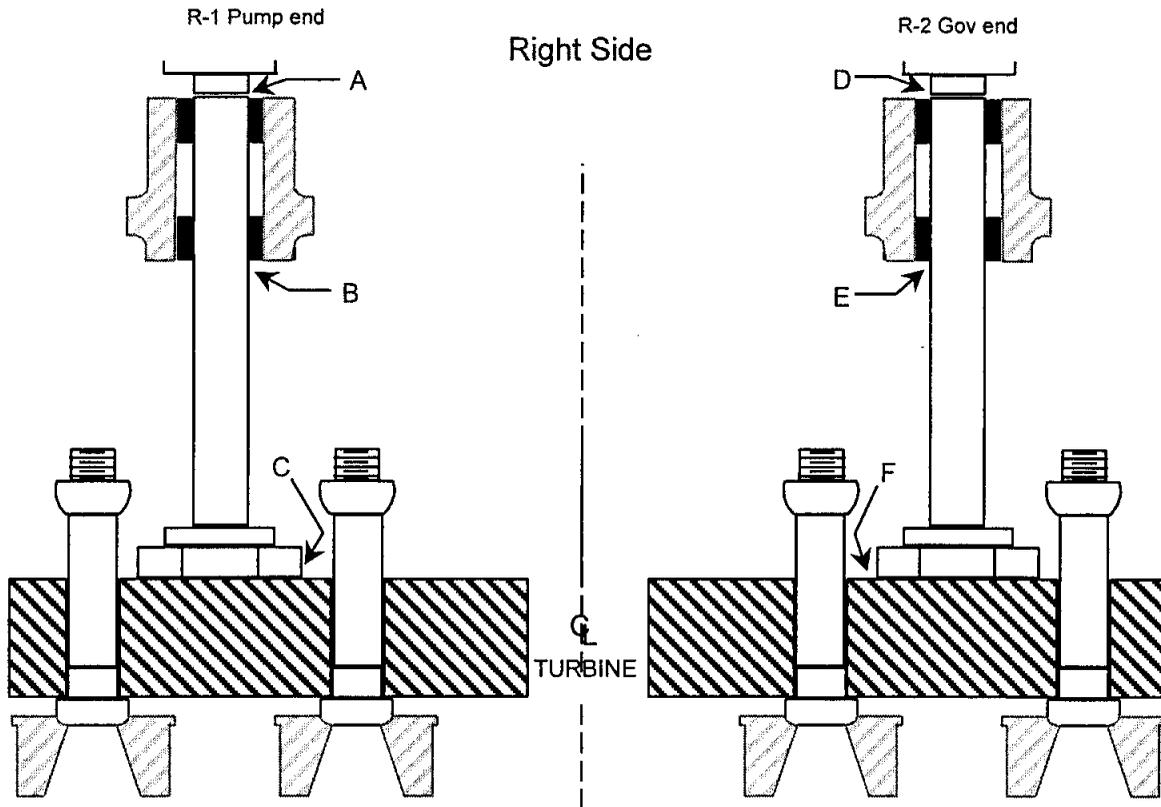
DIM.	LIFT ROD O.D.	BUSHING I.D.	CLEARANCE	COMMENT	
R-1	A	1.248	1.257 / 1.253	.005 / .009		Design .005 / .007
	B	1.249	1.253	0.004		.005 / .007
	C	 	 			CLR UNDER NUT
R-2	D	1.248	1.255 / 1.256	.007 / .008		.005 / .007
	E	1.248	1.253	0.005		.005 / .007
	F	 	 			CLR UNDER NUT

Note: new stem installed on R-2, new bushing on "B" & "E"

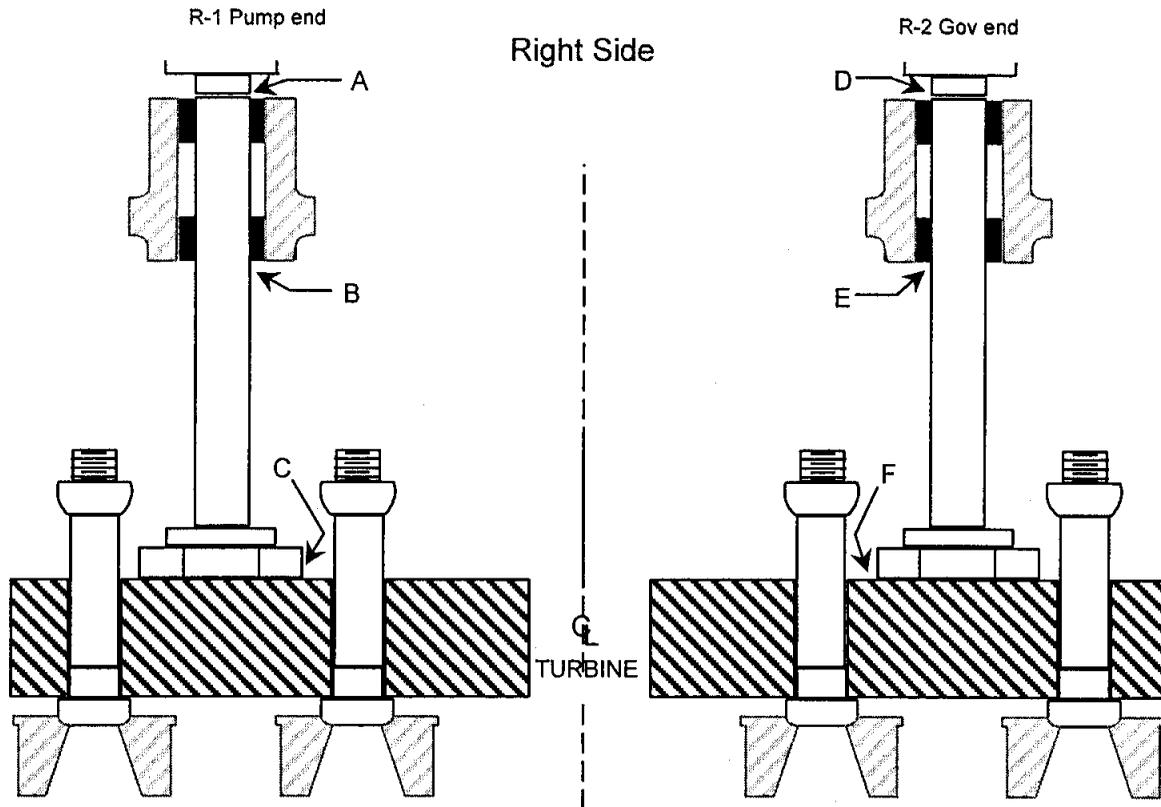
DIM.	LIFT ROD O.D.	BUSHING I.D.	CLEARANCE	COMMENT	
R-1	A	1.248	1.257 / 1.253	.005 / .009		Design .005 / .007
	B	1.249	1.283 / 1.269	.020 / .034	Bushing oval	.005 / .007
	C	 	 		CLR UNDER NUT	
R-2	D	1.247	1.255 / 1.256	.008 / .009		.005 / .007
	E	1.246	1.271	0.025		.005 / .007
	F	 	 		CLR UNDER NUT

The lifting rods were removed and cleaned up. The stems and bushings were inspected for clearance. The runout of the lift rods was also checked. Three of the lift rods were bent and were replaced with new lift rods. Two of the bushings were oversized and were replaced with new bushings.

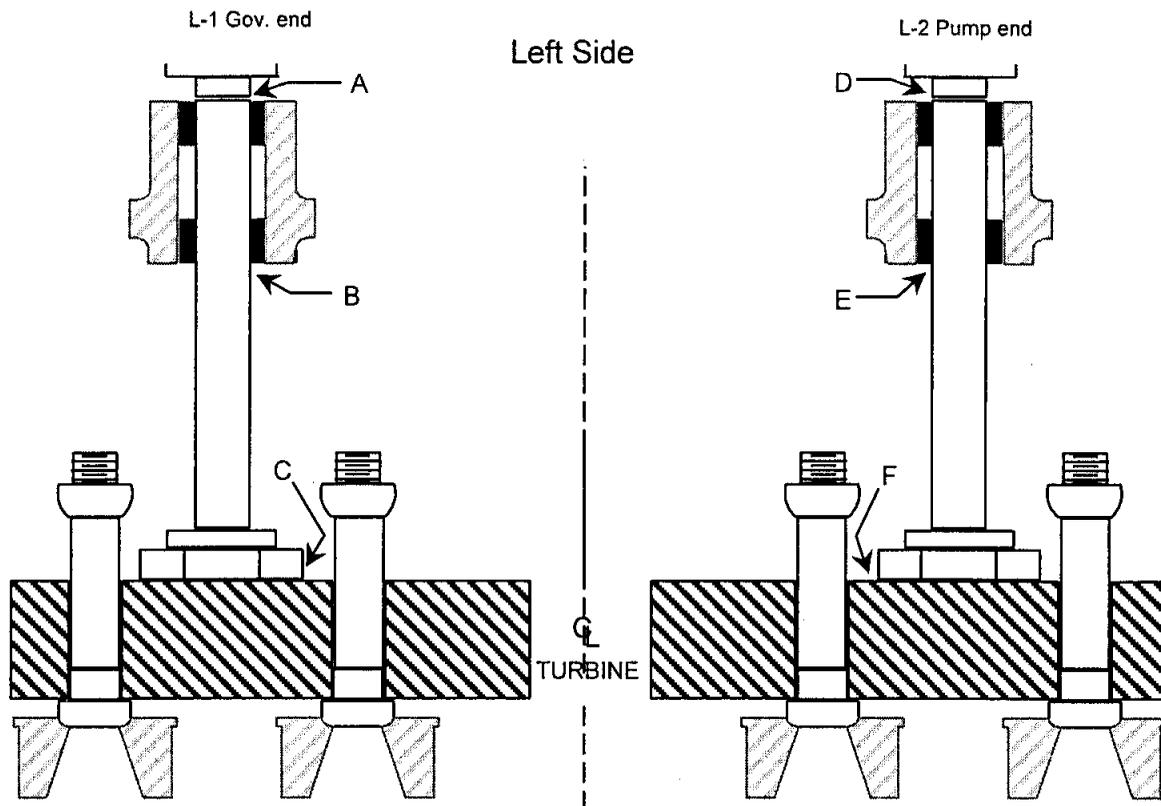
DIM.	LIFT ROD O.D.	BUSHING I.D.	CLEARANCE	COMMENT	
L-1	A	1.248	1.252	0.004		Design
	B	1.245	1.253 / 1.264	.008 / .019	Bushing oval	.005 / .007
	C	 	 		CLR UNDER NUT	
L-2	D	1.248	1.264 / 1.251	.003 / .006		.005 / .007
	E	1.242 / 1.247	1.253 / 1.262	.011/.020, .006/.015	Bushing oval	.005 / .007
	F	 	 		CLR UNDER NUT

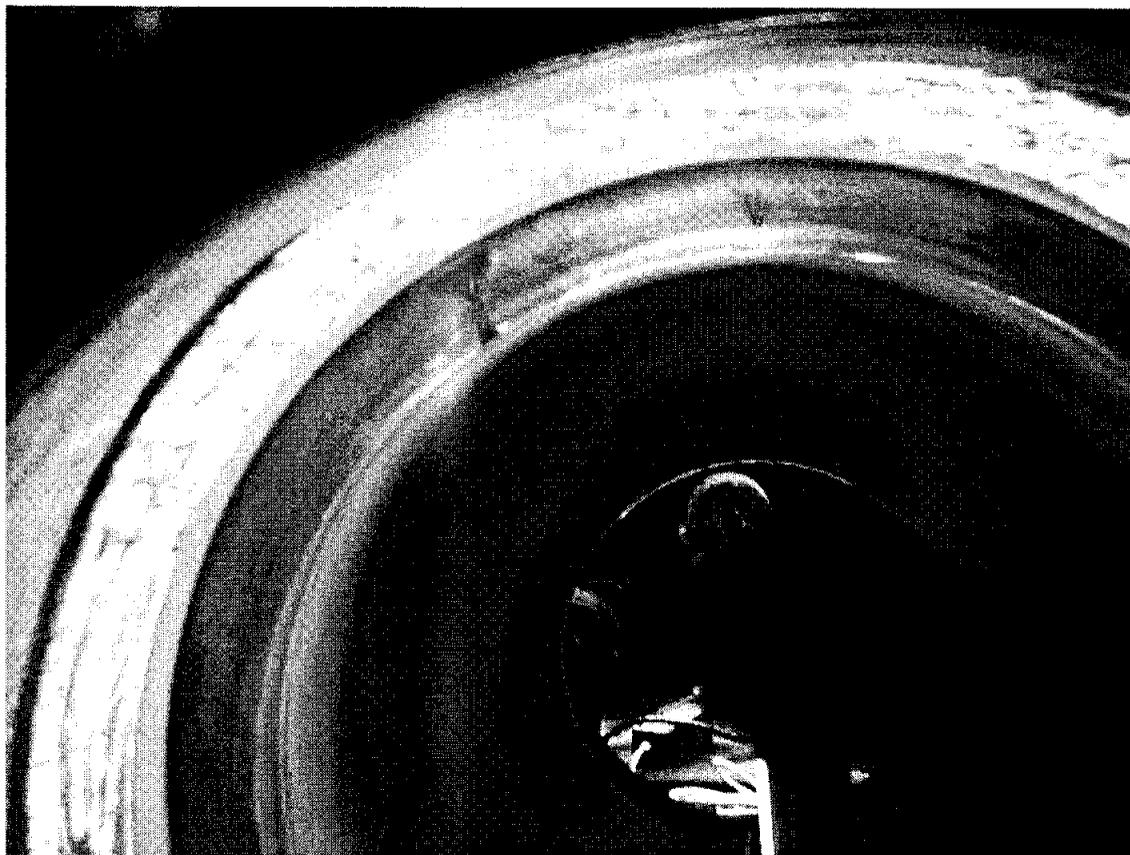
This photo shows the water cutting across the gasket fit in the boiler feed pump. This area was cut back, weld repaired and machined true by CMS personnel.
