# STEAM TURBINE INSPECTION REPORT

## ADSP Installation

AMERICAN ELECTRIC POWER COMPANY INC  
MITCHELL, Unit 2

Report Printed: January 30, 2006

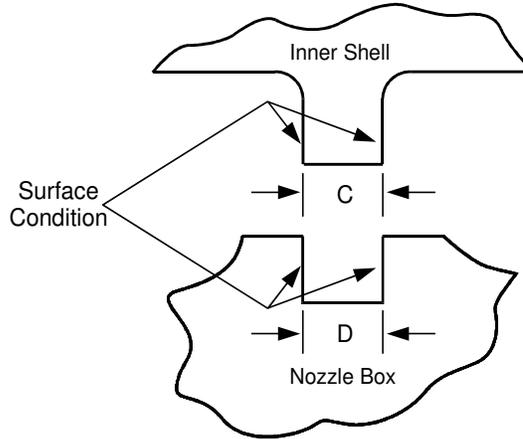
## Axial Rabbet Fit Clearance Data – Form B

UPPER HALF				Axial Float Check
Fit	Left	Right	Top	
D	1.956	1.956	1.956	
C	1.947	1.947	1.947	
Clearance D-C	0.009	0.009	0.009	0.007
SURFACE CONDITION				
Acceptable	X	X	X	
Needs Repair				
LOWER HALF				Axial Float Check
Fit	Left	Right	Top	
D	1.956	1.957	1.957	
C	1.948	1.947	1.947	
Clearance D-C	0.008	0.010	0.010	0.007
SURFACE CONDITION				
Acceptable	X	X	X	
Needs Repair

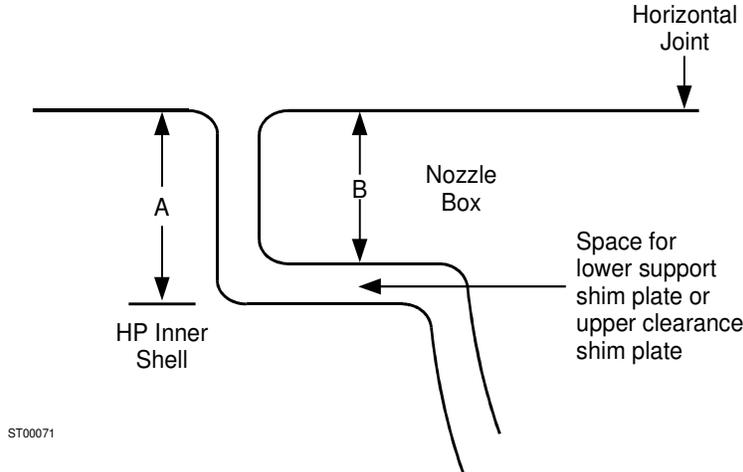
## Vertical Positioning Shim Data – Form E

DIMENSION	UPPER BOX (CLEARANCE SHIM)			
	TURBINE END		GENERATOR END	
	Left	Right	Left	Right
A	5.049	5.055	5.055	5.054
B	4.325	4.327	4.325	4.326
Temporary Shim (A-B)	0.724	0.728	0.730	0.728
Permanent Shim	0.701	0.703	0.703	0.700

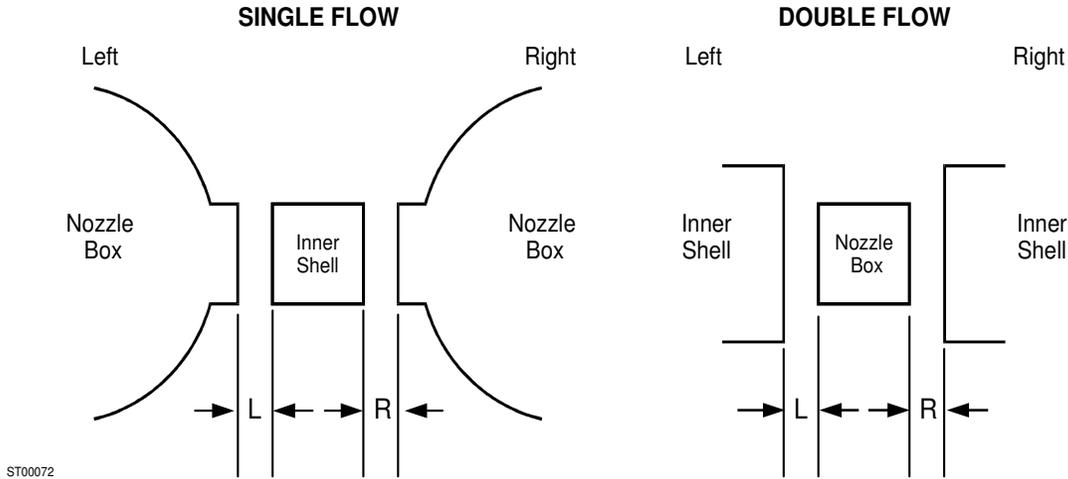
## Vertical Centerline Gib Key Data – Form F

UPPER HALF		
KEY		UPPER HALF	LOWER HALF	KEY	TURBINE END	GENERATOR END
L	Temporary			L	Temporary	
	Permanent	0.896	0.869		Permanent	
R	Temporary			R	Temporary	
	Permanent	1.041	1.067		Permanent

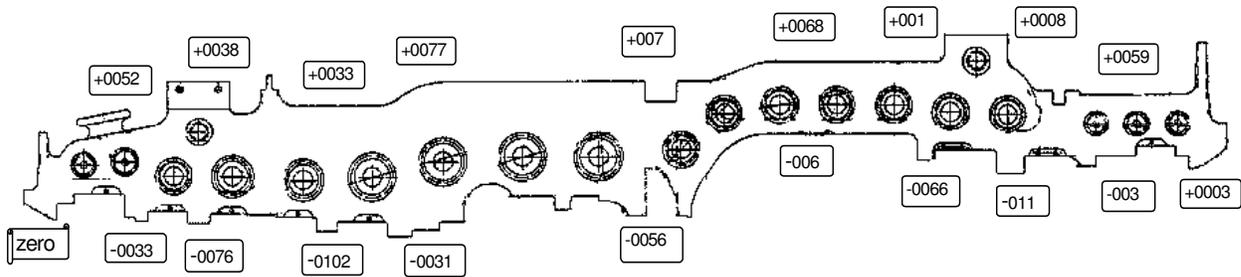
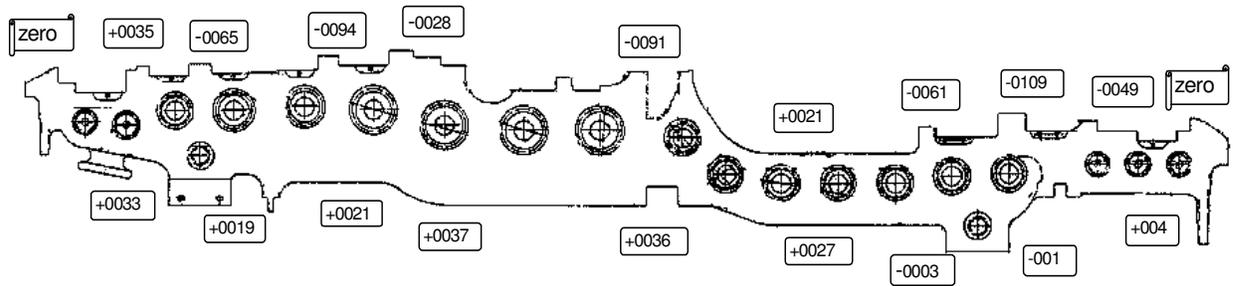
## H P Inner Shell Mitchell Unit # 2 Laser Horizontal Joint Flatness Check

The upper and lower inner shells were removed and sent to CMS for seal ring removal, blast cleaning and NDT. A previously repaired large crack along the bolting flange in the upper shell was repair welded at CMS. I&RS completed laser mapping on the horizontal joints of both halves to determine flatness. The lower half was in plane and had minimal distortion from outer to inner. The upper half also had minimal outer to inner distortion, but one corner was out of plane by 28 mils. Since the joint closed when bolted, no horizontal joint machining was done. However, this joint distortion affects lateral tops-on, tops-off alignment changes.

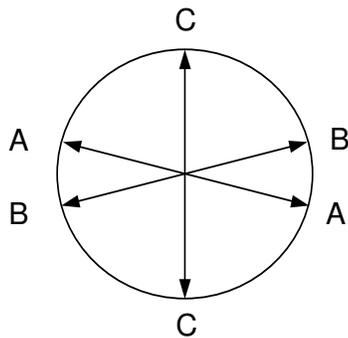
Packing Casing	Upper Outer Shell Off			Upper Outer Shell Bolted			Comments
	A-Dia	B-Dia	C-Dia	A-Dia	B-Dia	C-Dia	
N1 G1 OB	21.522	21.502	21.497	21.511	21.506	21.490	
N1 G1 IB	21.521	21.501	21.495				
N1 G2 IB	21.520	21.500	21.492	21.513	21.508	21.489	
N1 G2 OB	21.523	21.502	21.493				
N3 G4 OB	22.542	22.541	22.486	22.540	22.537	22.487	
N3 G4 IB	22.537	33.537	22.488				
N3 G5 IB	22.525	22.526	22.484				
N3 G5 OB	22.518	22.523	22.482	22.523	22.520	22.479

Note: For the N1 "Outer Shell Off readings", the left side dowel was not in. There was a step at the joint from the UH being warped outward. Use "B" readings for horizontal comparison. A new dowel was made for the "Shell Bolted" readings.

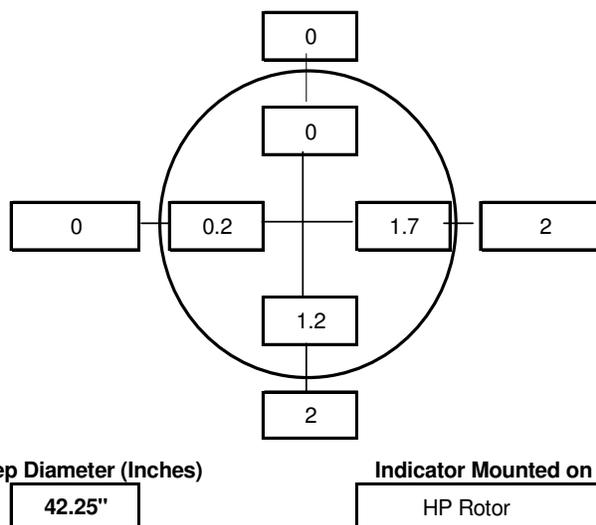
Final A Coupling Check(a)

Position	Top	Left	Bottom	Right
Rim	0	0	2	2
Face 0°	609	610	610	610
Face 90°	608	609	611	611
Face 180°	608	608	610	611
Face 270°	608	607	607	608
Average	608.3	608.5	609.5	610.0
Relative	0	0.2	1.2	1.7
<b>Check</b>		<b>Face</b>	<b>Rim</b>	
Top + Bottom =		1.2	2.0	
Right + Left =		1.9	2.0	
Difference =		-0.7	0.0

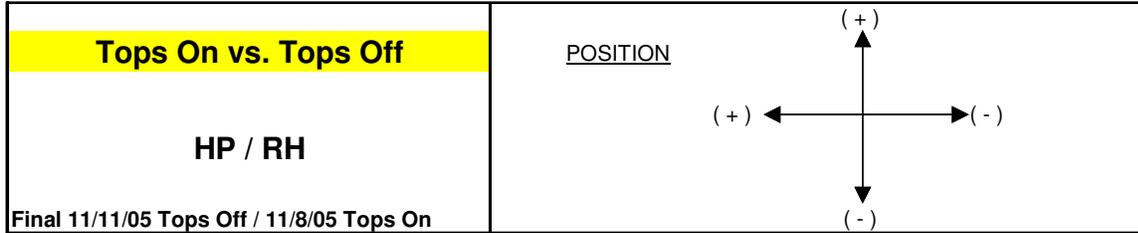
# Mitchell Unit 2 Laser Alignment

COMPONENT NAME	AXIAL DISTANCE	11/11/2005		11/8/2005		DIFFERENCE	
		TOPS OFF		TOPS ON		HORZ	VERT
		HORZ	VERT	HORZ	VERT		
<b>T2 Oil Deflector</b>	309.875"	-3.6	-25.3	-0.8	-11.0	2.8	14.3
<b>N3 G5</b>	303.625"	<b>0.0</b>	<b>0.0</b>	<b>0.0</b>	<b>0.0</b>	0.0	0.0
<b>Outer Shell Bore GE</b>	297.750"	8.3	-27.5	4.7	-14.5	-3.6	13.0
<b>N3 G2</b>	288.500"	8.6	-26.3	8.4	-29.0	-0.2	-2.7
<b>10th Stage</b>	274.875"	8.9	-3.6	-7.7	15.8	-16.6	19.4
<b>GE Inn Shell Bore</b>	268.875"	5.6	-64.3	-8.7	-16.9	-14.3	47.4
<b>9th Stage</b>							
<b>8th Stage</b>	253.500"	24.0	-12.7	6.9	14.0	-17.1	26.7
<b>7th Stage</b>	240.500"	17.4	-16.3	4.6	3.7	-12.8	20.0
<b>N2 G7</b>	236.125"	-9.1	-26.8	-25.8	-1.3	-16.7	25.5
<b>N2 G1</b>	209.250"	-13.6	-9.1	-25.2	10.9	-11.6	20.0
<b>Nozzle Left</b>	155.625"	93.6	-62.4	97.7	-54.1	4.1	8.3
<b>Nozzle Right</b>	155.875"	70.4	-62.4	74.9	-54.2	4.5	8.2
<b>2rd Stage</b>	145.000"	-10.3	-1.0	-7.2	12.3	3.1	13.3

<b>3th Stage</b>	135.875"	-4.7	0.8	1.0	15.2	5.7	14.4
<b>4th Stage</b>	127.750"	8.4	41.3	13.2	49.9	4.8	8.6
<b>5th Stage</b>							
<b>TE Inn Shell Bore</b>	116.250"	-3.6	-46.1	10.5	-20.0	14.1	26.1
<b>6th Stage</b>	111.750"	3.4	17.6	11.0	24.1	7.6	6.5
<b>N1 G7</b>	101.250"	0.1	1.6	1.2	-1.4	1.1	-3.0
<b>N1 G5</b>	92.500"	-2.4	-3.9	1.7	-6.8	4.1	-2.9
<b>N1 G3</b>	79.125"	-2.0	-10.0	-2.0	-10.9	0.0	-0.9
<b>Outer Shell Bore TE</b>	77.625"	-1.8	8.6	-0.2	9.9	1.6	1.3
<b>N1 G1</b>	69.000"	<b>0.0</b>	<b>0.0</b>	<b>0.0</b>	<b>0.0</b>	0.0	0.0
<b>T1 Oil Deflector</b>	62"	4.1	30.6	-3.3	26.1	-7.4	-4.5

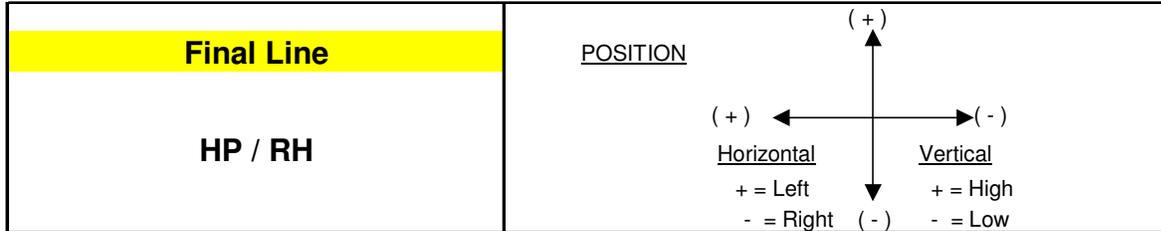
# Mitchell Unit 2 Laser Alignment

COMPONENT NAME	AXIAL DISTANCE	FINAL LINE		IDEAL LINE		Joint Checks	
		HORZ	VERT	HORZ	VERT	Left	Right
<b>N3 G5</b>	303.625"	<b>0.0</b>	<b>18.0</b>	<b>0.0</b>	<b>18.0</b>		
<b>N3 G2</b>	288.500"	0.6	-2.8	<b>0.0</b>	<b>0.0</b>		
<b>GE Inner Shell Bore</b>	268.875"	-6.4	-62.7	-----	-----		
<b>10th Stage</b>	274.875"	17.0	-24.2	<b>15.0</b>	<b>-23.0</b>		
<b>9th Stage</b>		13.7	-27.7	<b>15.0</b>	<b>-27.0</b>		
<b>8th Stage</b>	253.500"	15.7	-30.5	<b>15.0</b>	<b>-30.0</b>		
<b>7th Stage</b>	240.500"	13.9	-33.3	<b>15.0</b>	<b>-34.0</b>		
<b>N2 G7</b>	236.125"	14.7	-35.6	<b>15.0</b>	<b>-34.0</b>		
<b>N2 G1</b>	209.250"	13.7	-35.7	<b>15.0</b>	<b>-34.0</b>		
<b>Nozzle Left</b>	155.625"	1.6	-20.2	<b>4.0</b>	<b>-16.0</b>		
<b>Nozzle Right</b>	155.875"	-14.7	-18.5	<b>-12.0</b>	<b>-16.0</b>		
<b>2rd Stage</b>	145.000"	-3.3	-23.1	<b>-5.0</b>	<b>-20.0</b>		
<b>3th Stage</b>	135.875"	-4.9	-21.7	<b>-5.0</b>	<b>-21.0</b>

<b>4th Stage</b>	127.750"	-2.5	-16.9	<b>-5.0</b>	<b>-16.0</b>		
<b>5th Stage</b>		-3.8	-13.6	<b>-5.0</b>	<b>-14.0</b>		
<b>6th Stage</b>	111.750"	-5.1	-12.4	<b>-5.0</b>	<b>-12.0</b>		
<b>TE Inner Shell Bore</b>	116.250"	-6.2	-49.9	-----	-----		
<b>N1 G7</b>	101.250"	-2.6	-2.6	<b>-4.0</b>	<b>-1.0</b>		
<b>N1 G5</b>	92.500"	-0.5	-2.8	<b>-4.0</b>	<b>-1.0</b>		
<b>N1 G3</b>	79.125"	-2.0	-6.4	<b>-4.0</b>	<b>-1.0</b>		
<b>N1 G1</b>	69.000"	<b>0.0</b>	<b>6.0</b>	<b>0.0</b>	<b>6.0</b>

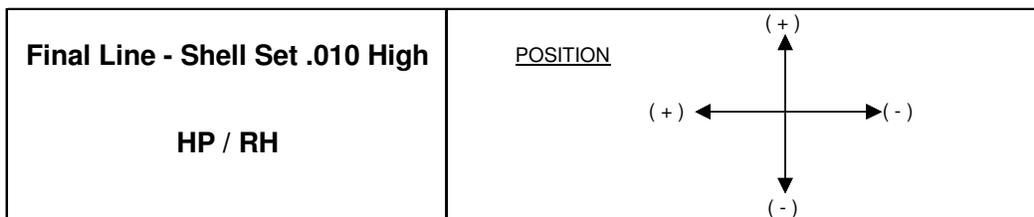
## Mitchell Unit 2 Laser Alignment (Adjusted for setting shell high in tops off condition)

COMPONENT NAME	AXIAL DISTANCE	FINAL LINE		IDEAL LINE		DIFFERENCE	
		HORZ	VERT	HORZ	VERT	HORZ	VERT
<b>N3 G5</b>	303.625"	<b>0.0</b>	<b>28.0</b>	<b>0.0</b>	<b>28.0</b>	<b>0.0</b>	<b>0.0</b>
<b>N3 G2</b>	288.500"	0.6	7.2	0.0	10.0	-0.6	2.8
<b>GE Inn Shell Bore</b>	268.875"	-6.4	-52.7	---	---		
<b>10th Stage</b>	274.875"	17.0	-14.2	15.0	-13.0	-2.0	1.2
<b>9th Stage</b>	264.375"	13.7	-17.7	15.0	-17.0	1.3	0.7
<b>8th Stage</b>	253.500"	15.7	-20.5	15.0	-20.0	-0.7	0.5
<b>7th Stage</b>	240.500"	13.9	-23.3	15.0	-24.0	1.1	-0.7
<b>N2 G7</b>	236.125"	14.7	-25.6	15.0	-24.0	0.3	1.6
<b>N2 G1</b>	209.250"	13.7	-25.7	15.0	-24.0	1.3	1.7
<b>Nozzle Left</b>	155.625"	1.6	-10.2	4.0	-6.0	2.4	4.2
<b>Nozzle Right</b>	155.875"	-14.7	-8.5	-12.0	-6.0	2.7	2.5
<b>2rd Stage</b>	145.000"	-3.3	-13.1	-5.0	-10.0	-1.7	3.1
<b>3th Stage</b>	135.875"	-4.9	-11.7	-5.0	-11.0	-0.1	0.7
<b>4th Stage</b>	127.750"	-2.5	-6.9	-5.0	-6.0	-2.5	0.9
<b>5th Stage</b>	119.875"	-3.8	-3.6	-5.0	-4.0	-1.2	-0.4

<b>6th Stage</b>	111.750"	-5.1	-2.4	-5.0	-2.0	0.1	0.4
<b>TE Inn Shell Bore</b>	116.250"	-6.2	-39.9	---	---		
<b>N1 G7</b>	101.250"	-1.6	12.6	-4.0	9.0	-2.4	-3.6
<b>N1 G5</b>	92.500"	-0.5	7.2	-4.0	9.0	-3.5	1.8
<b>N1 G3</b>	79.125"	-2.0	1.6	-4.0	9.0	-2.0	7.4
<b>N1 G1</b>	69.000"	<b>0.0</b>	<b>16.0</b>	<b>0.0</b>	<b>16.0</b>	<b>0.0</b>	<b>0.0</b>

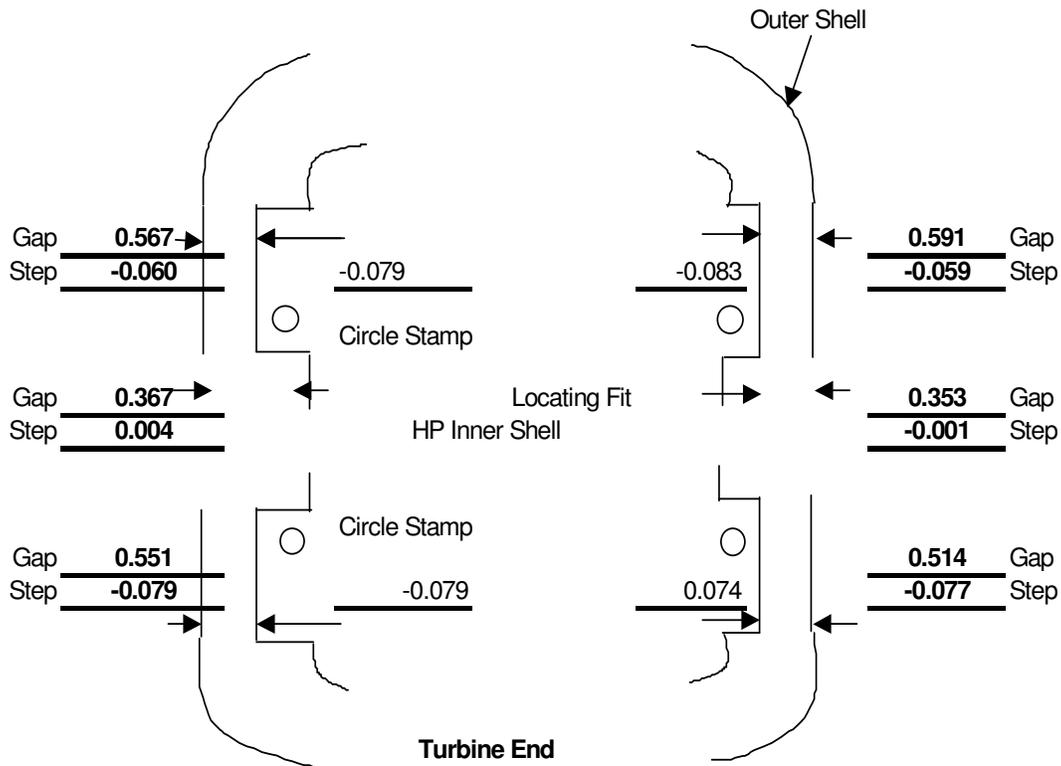
Generator End

Comments
Float = Left Side .008 Right Side .011

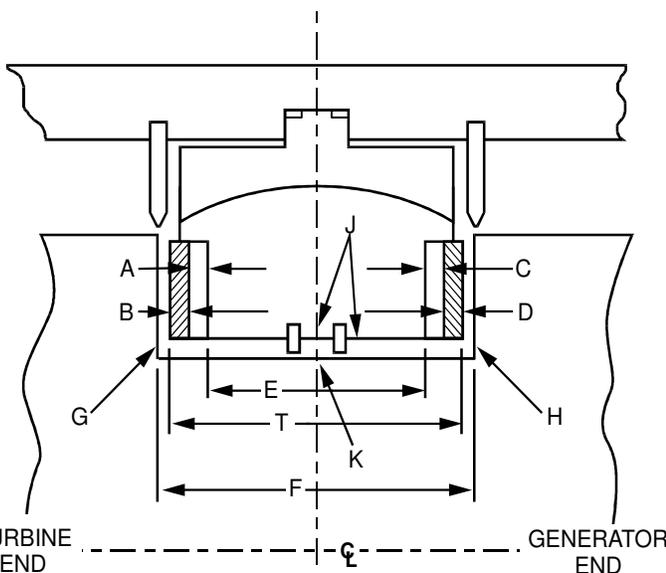
### THRUST BEARING DATA

"A" Shim	.563"
"B" Plate	1.249"
"C" Shim	.415"
"D" Plate	1.262"
"E" Gasing	11.496"
"T" Total	14.985"
"F" Rotor	15.007"

Clearance (F minus T)	.022"
Clearance (By float)	.022"
Difference	.000"
Stack Check	✓

2 mil shim was added at assembly for 1 mil loose pinch.

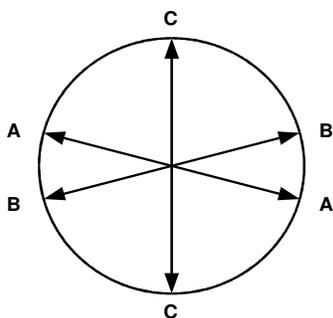
The T1 and T2 oil deflectors were found rubbed and packed with coal dust. Both were retooled by AEP and aligned at assembly.

Location Number	Oil Deflector			Journal Dia	Clearance			Condition Comment
	A-Dia	B-Dia	C-Dia		Average	Min.	Max.	
T-1 OB	18.527"	18.527"	18.527"	18.497"	.030"	.030"	.030"	
T-1 IB	18.528"	18.530"	18.529"	18.497"	.032"	.031"	.033"	
T-2 OB	18.024"	18.020"	18.025"	17.991"	.032"	.029"	.034"	
T-2 IB	18.024"	18.020"	18.024"	17.991"	.032"	.029"	.033"

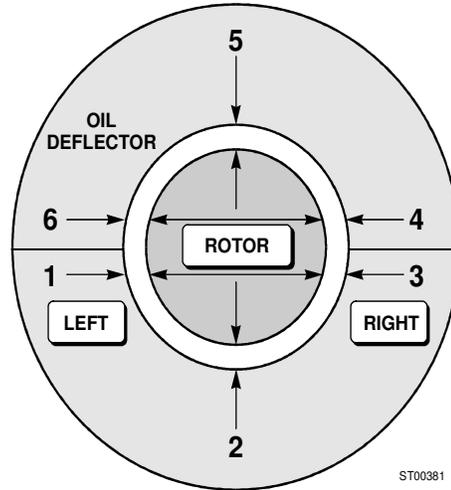
# Oil Deflector Alignment

Deflector Location	POSITION (Mils)						CLEARANCE			IDEAL POSITION		
	1	2	3	4	5	6	Median	Min.	Max	Top	Bottom	Sides
T1	14	8	14	14	20	14	14	8	20	19	9	14
T2	13	6	13	13	20	13	13	6	20	17	9	13

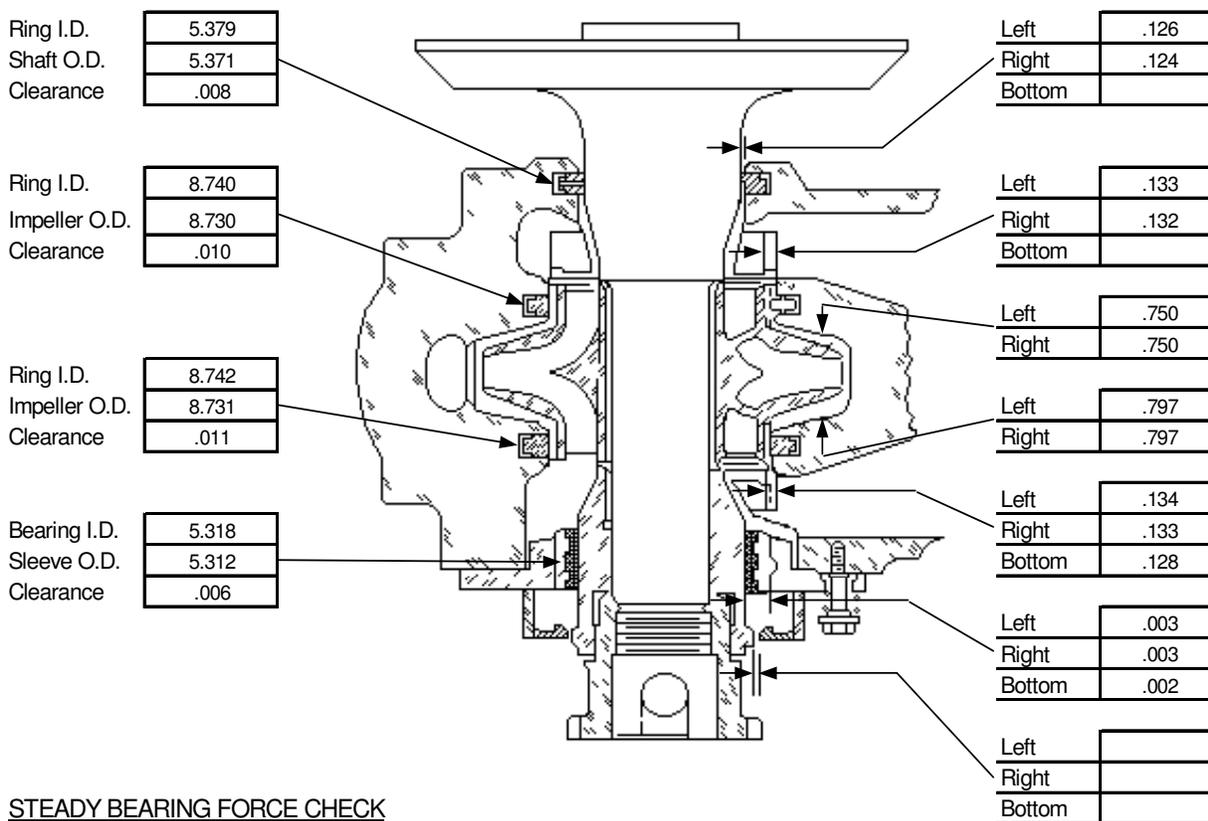
**STEADY BEARING FORCE CHECK**

FORCE(lbs)	MOVEMENT (inches)
500	_____
1000	_____
1500	_____
2500	_____
3000	_____
SLIPS	<u>2700#</u>
