# Mitchell Station Unit #1

## American Electric Power Company

## Westinghouse T-G Set

VHP-HP Turbine	Serial Number	13A3160-1
IP Turbine	Serial Number	13A3161-1
LP Turbine #1	Serial Number	13A3162-1
LP Turbine #2	Serial Number	13A3163-1
Turbine Instruction Book		1250-C679
Generator	Serial Number	1-S-87P0755
Brush Collector	Serial Number	1-S-94P0063
Generator Instruction Book		90P0944
Brush Collector Instruction Book		1560-0093
Boiler Feed Pump Drive Turbine		15-A-2961-1
BFP/DT Instruction Manual		1150-C129
Spring Outage		4-1-2006 to 6-18-2006

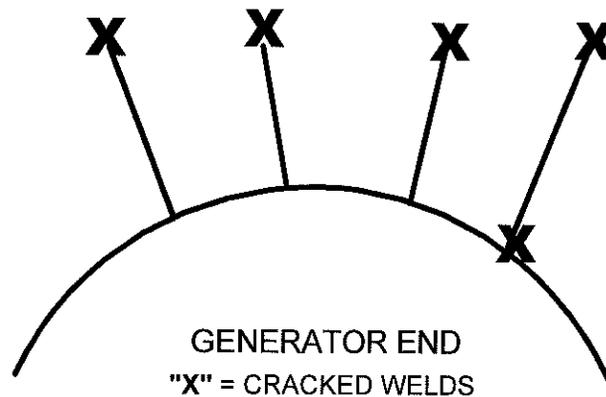
2ND REHEAT TURBINE SHELL LOWER HALF SUPPORT BRACES (STRUTS)

The outer cylinder was grit blasted and NDE inspected. The component halves were found in good condition. The lower cylinder exhaust bowl struts and their seal welds were found cracked. These were repair welded using 7018-A1 electrodes after removing the fractured inconel seal.

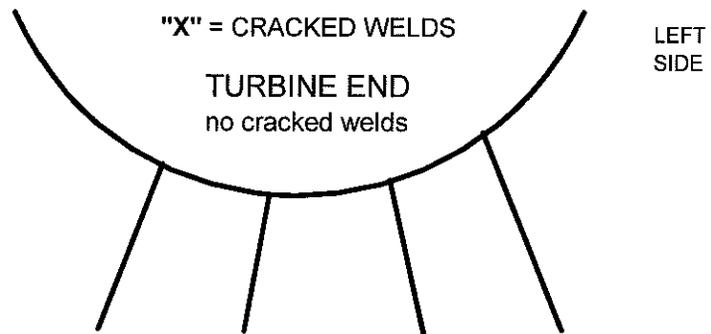
The following is a sketch showing the location of three (3) cracked welds of 16 welds on the eight (8) stiffener braces:

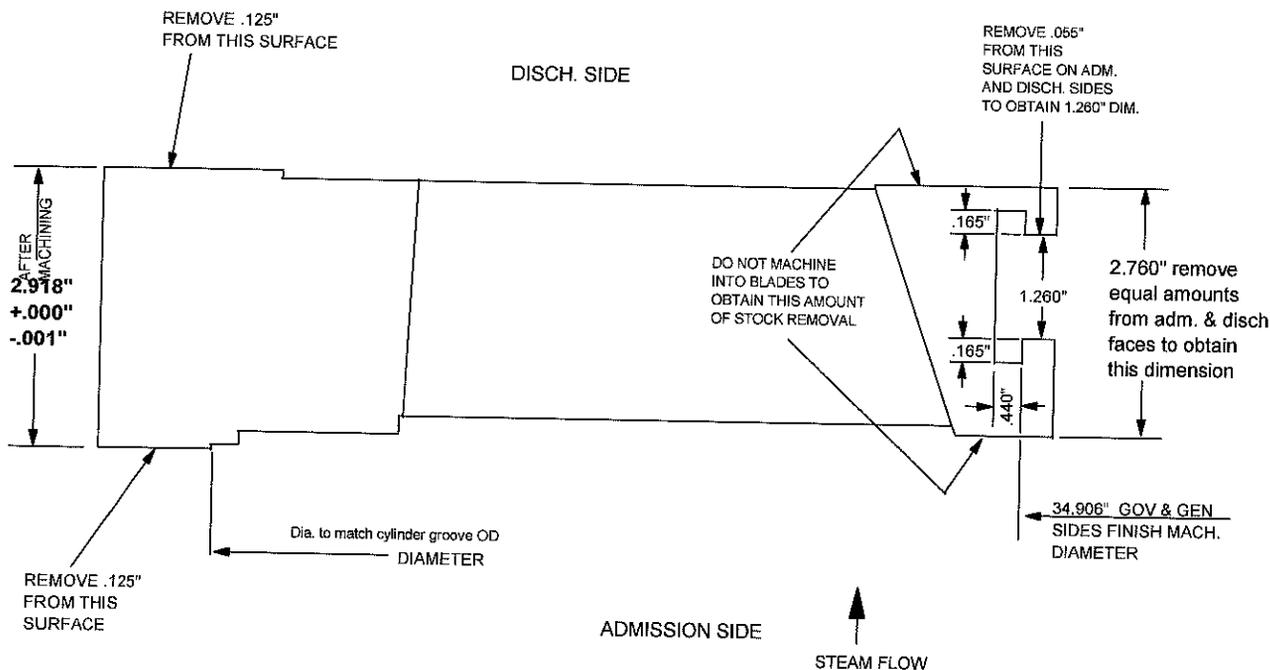
FINISH MACHINING DRAWING FOR GOV. & GEN ENDS  
 OF MITCHELL PLANT UNIT 1 2ND REHEAT TURBINE  
 STATIONARY 1ST ROW BLADES APRIL 29, 2006

The #2 blade rings (GVN & GNN) were grit cleaned and NDE inspected. Several rows of required repair welding of hard particle erosion (see CMS Shop Report).

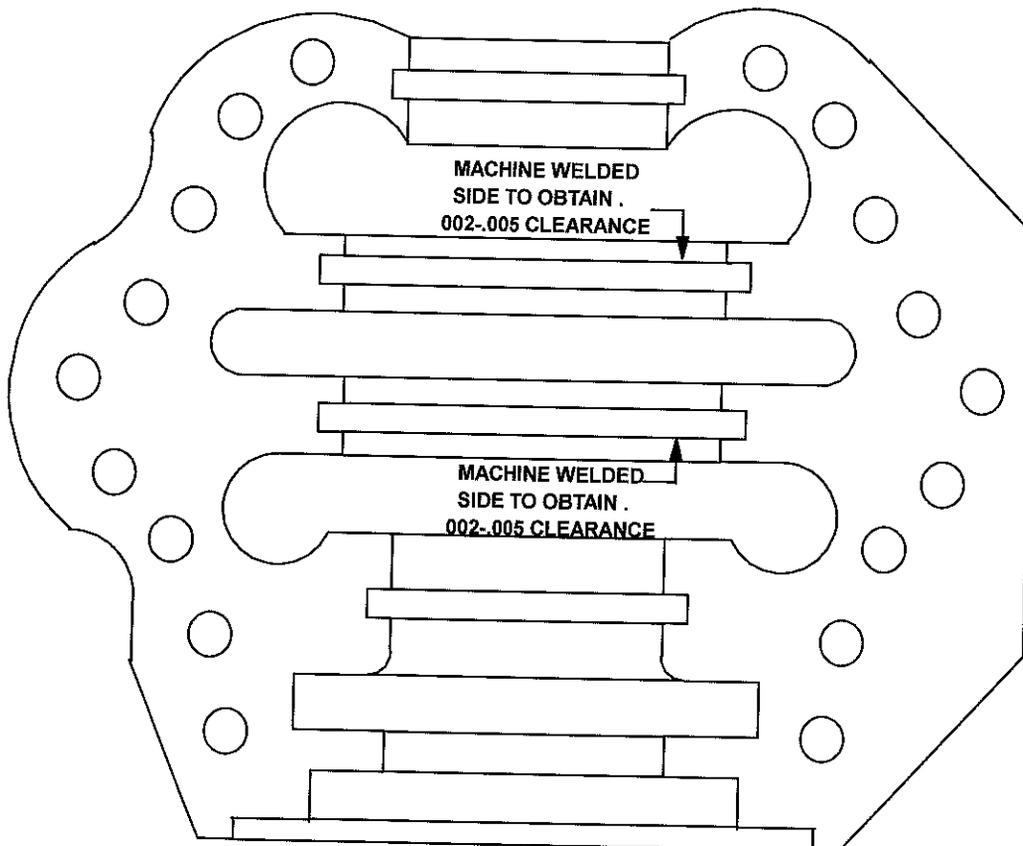
### MITCHELL UNIT 1 MAIN OIL PUMP HOUSING

THERE ARE TWO GROOVES TO MACHINE IN THE  
LOWER HALF AND ONE GROOVE IN THE UPPER HALF

The main oil pump housing was transported to CMS where it was weld repaired and machined. See attached sketch for area that was welded and machined.

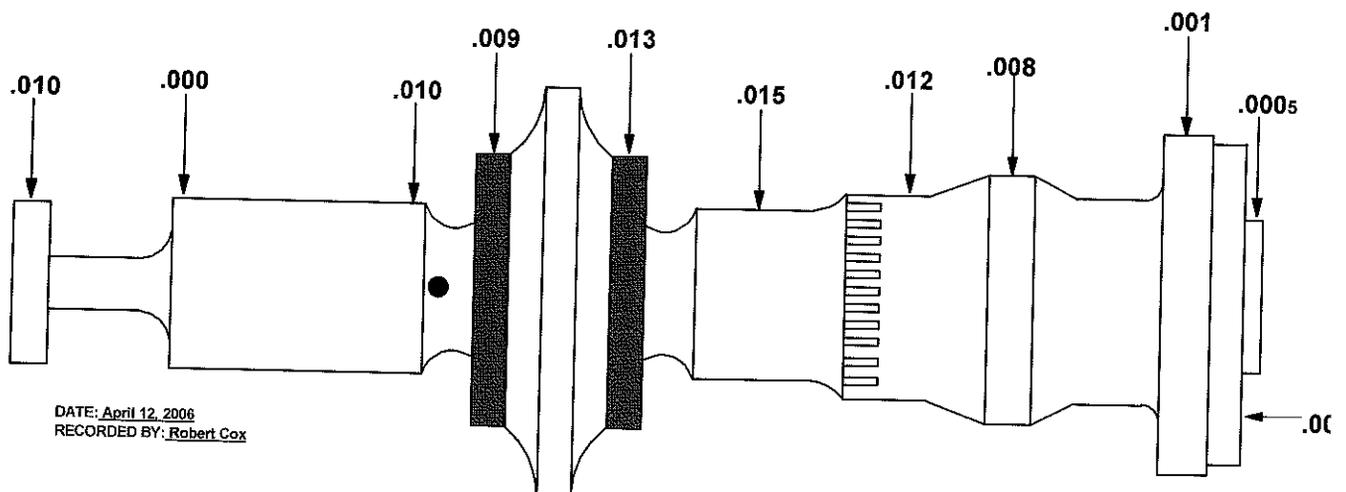
#### INITIAL RUNOUTS

The control rotor for the second reheat turbine rotor was transported to CMS for repair of rough areas on the fits. The following tasks were performed on the control rotor:

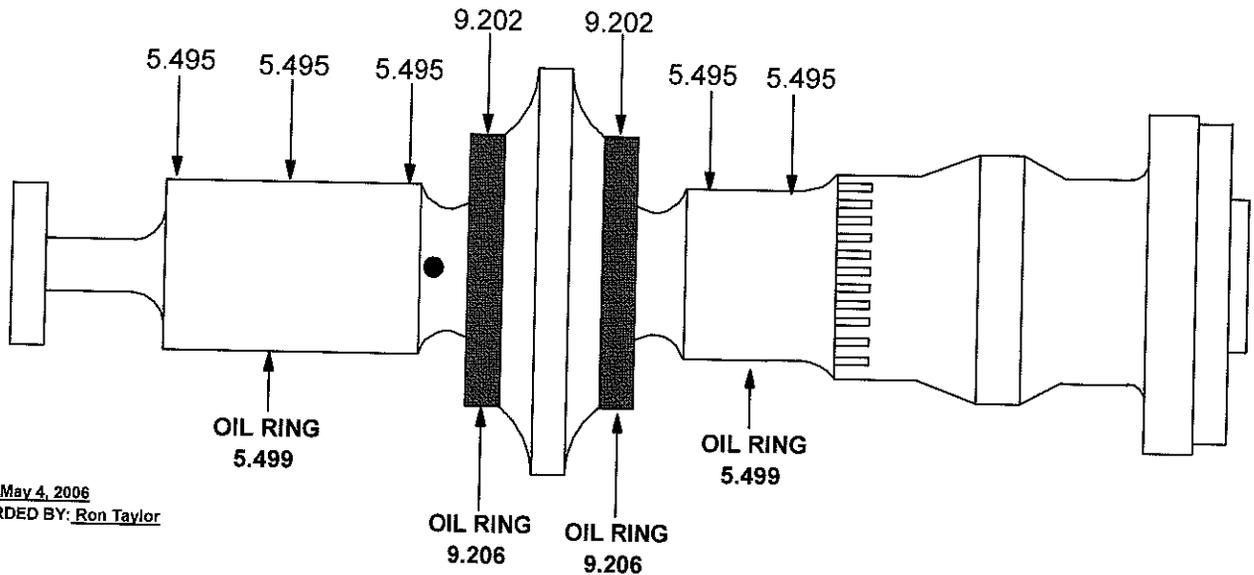
MITCHELL UNIT 1 SECOND REHEAT TURBINE ROTOR CONTROL ROTOR JULY 2006

FINAL DIAMETERS  
AFTER FITS WERE  
GROUND

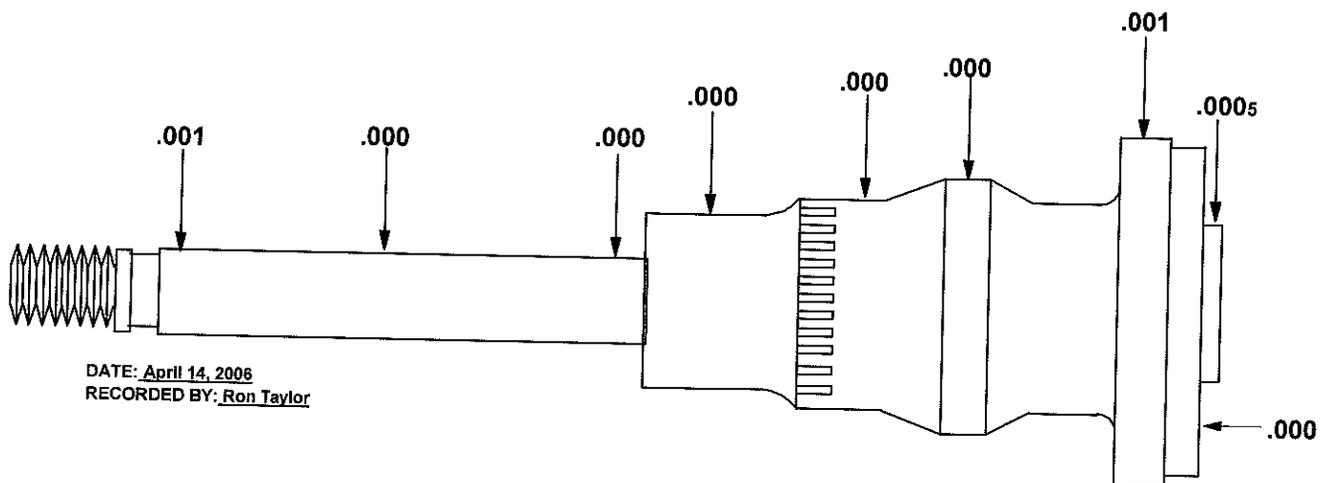
MITCHELL UNIT 1 2ND REHEAT TURBINE ROTOR CONTROL ROTOR JULY 2006

FINAL RUNOUTS  
WITHOUT STUB  
SHAFT BOLTED ON

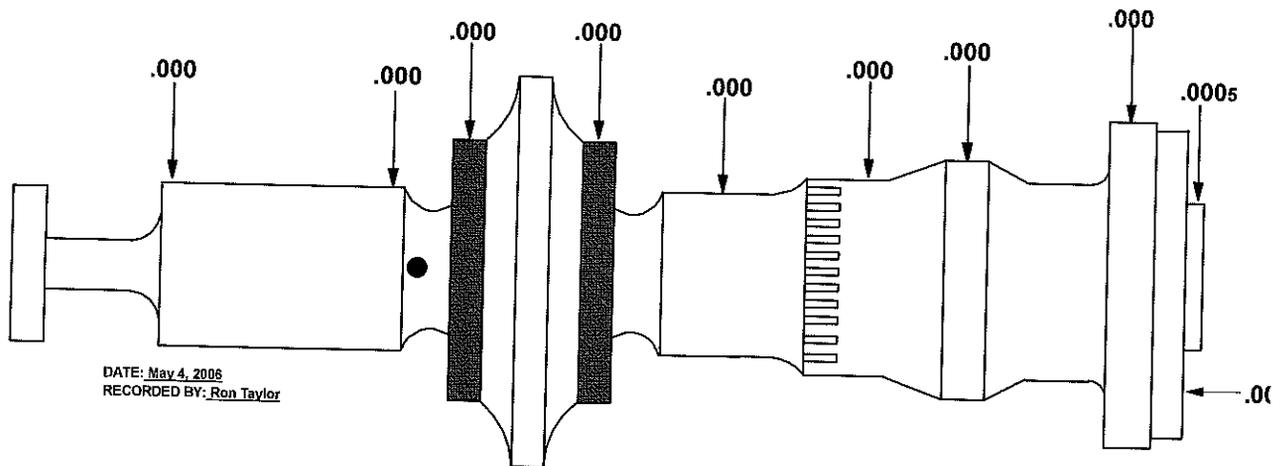
MITCHELL UNIT 1 SECOND REHEAT TURBINE ROTOR CONTROL ROTOR JULY 2006

FINAL RUNOUTS AFTER STUB SHAFT  
WAS REATTACHED AND FITS WERE  
GROUND

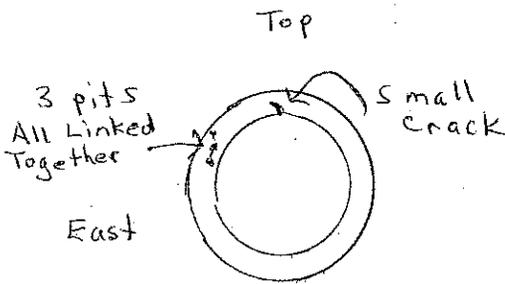
Value #4

A visible dye inspection was performed to the stellite seats of the 4 throttle valves.

Value #1 - Seat OK  
Value #3 - Seat OK  
Value #2 - Seat OK

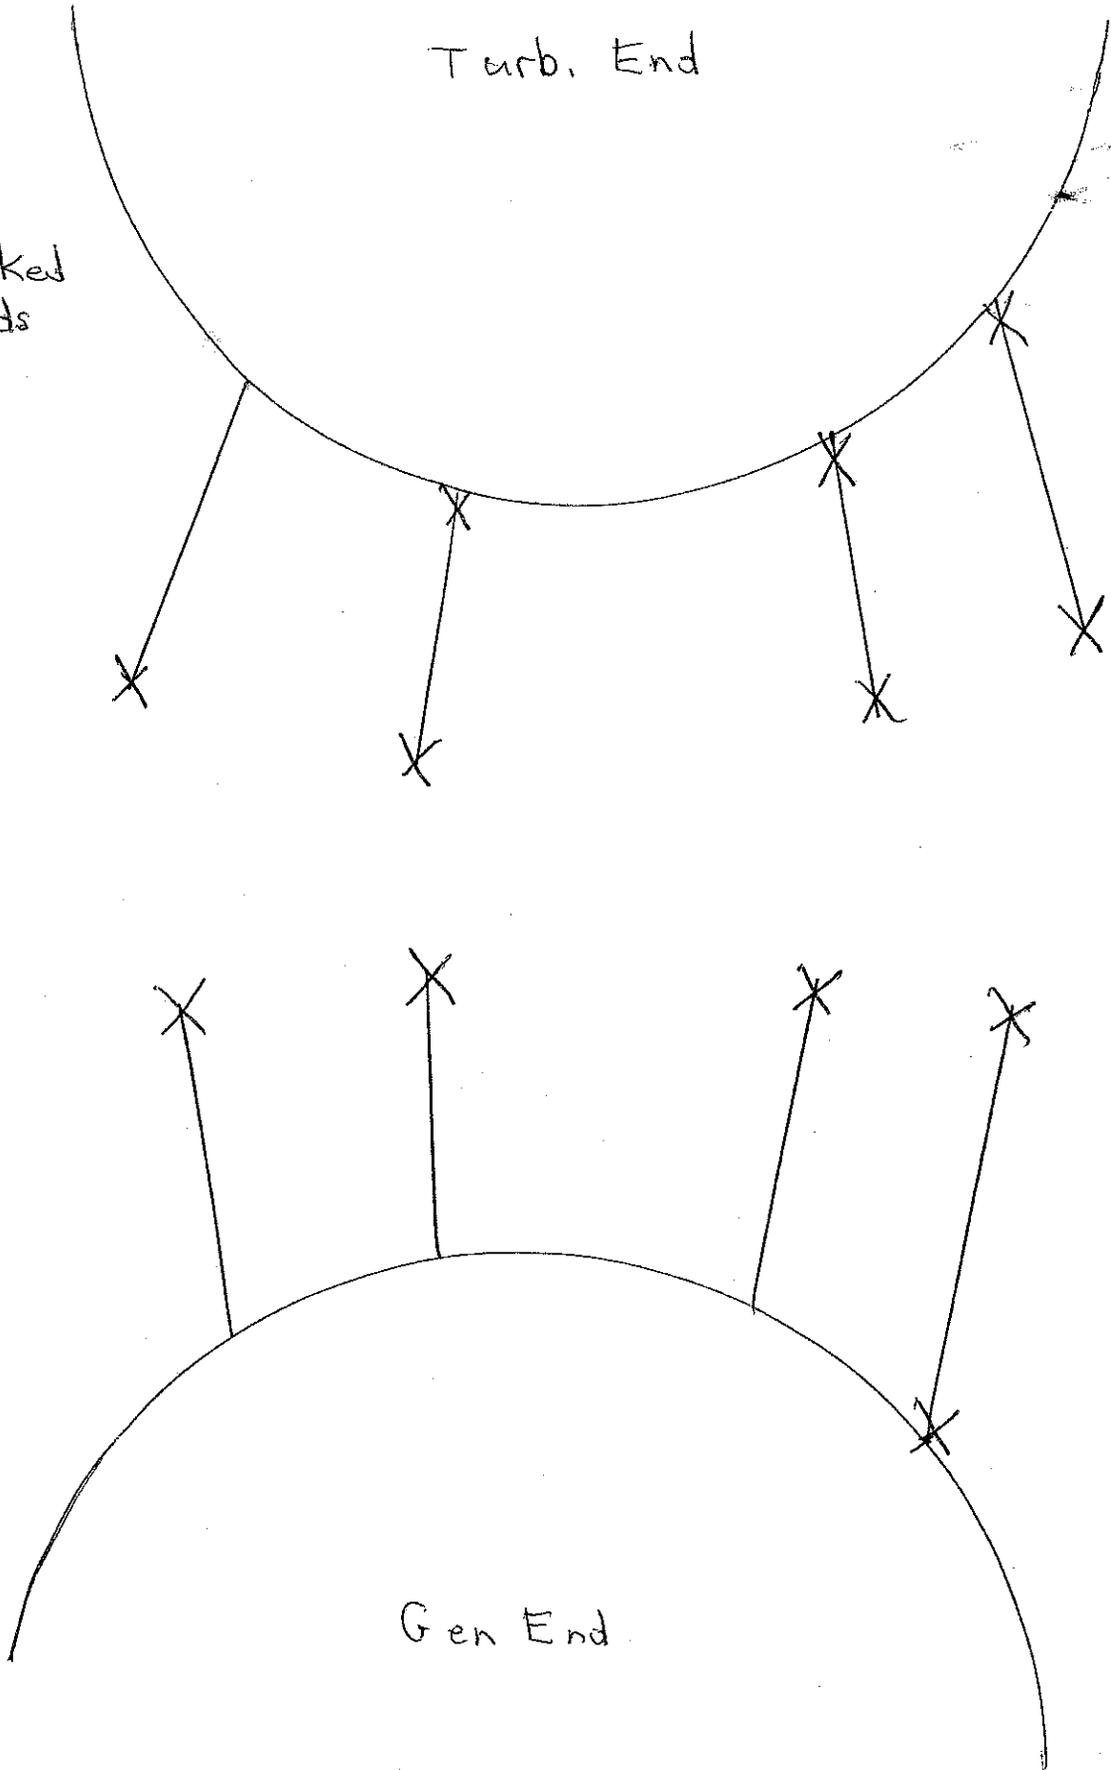
Left  
Side

X = Cracked  
welds

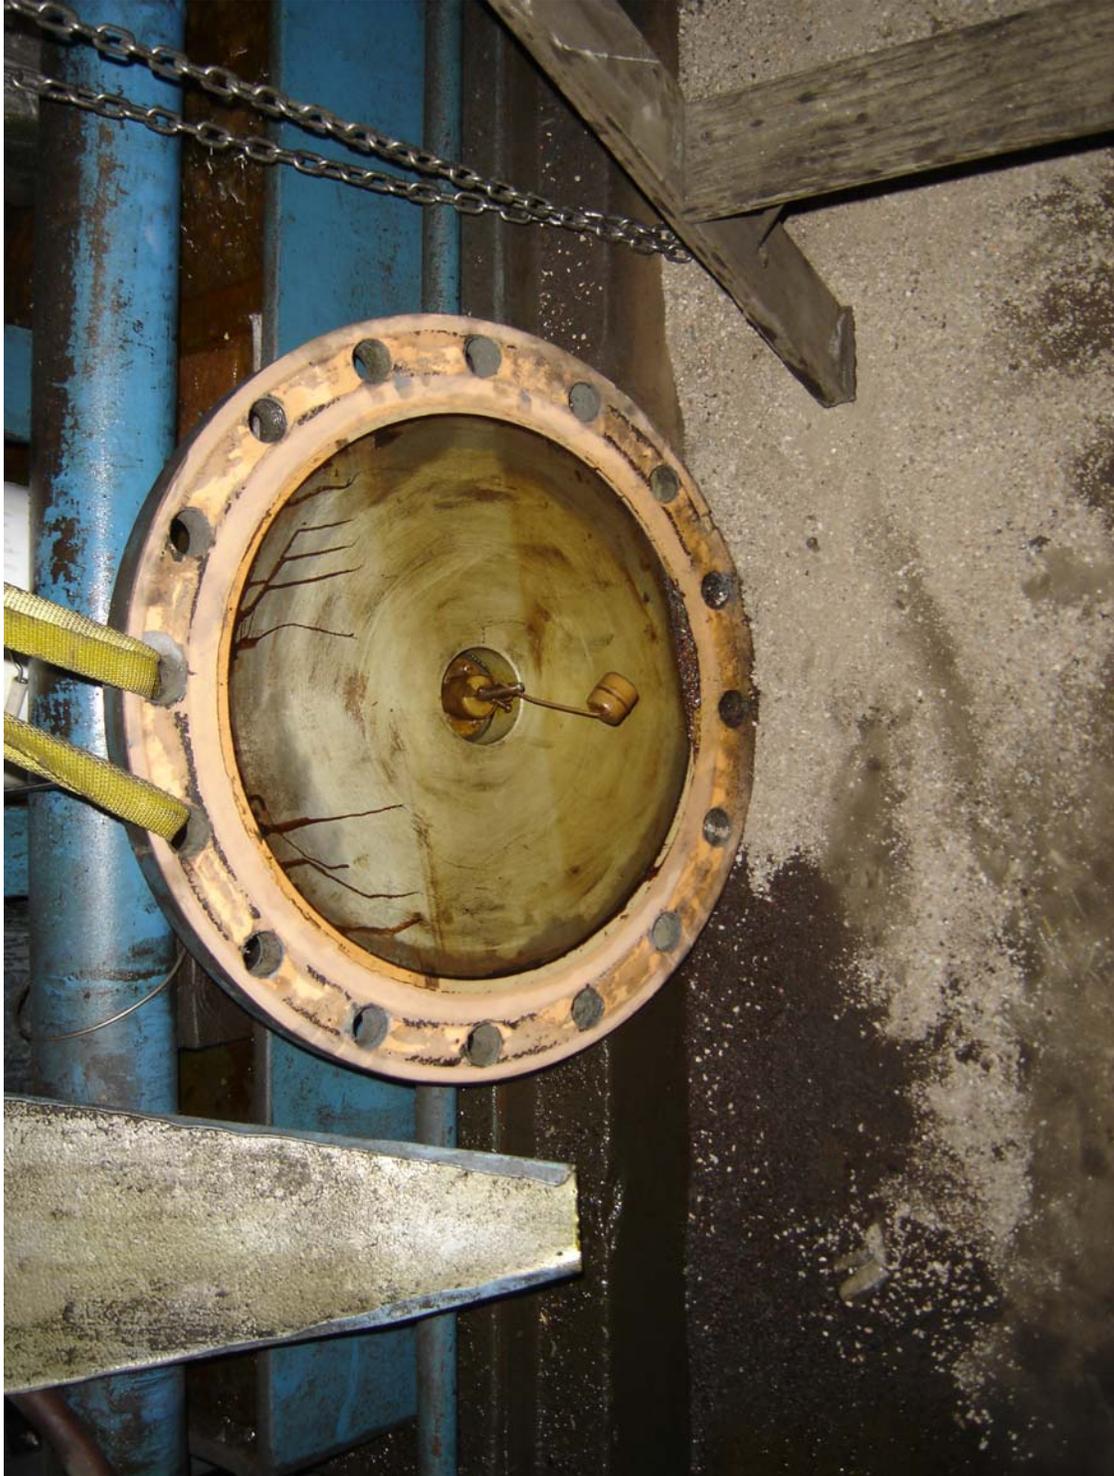
The mechanical magnetic level indicator was inspected to determine cause to failure to properly show level. The action of level indicator during inspection was good. The cause of poor indication service appeared to be the swing arc of the inlet valve float arm could strike the indicator. This was reviewed and the concern for impeded operation of the two devices was corrected by establishing a 3/16" clearance between the devices. Westinghouse Tech Manual diagram intends this removed regulating tank cover to be at the west end.

Attachment 3 - SOS Regulating Tank Level Indication Float

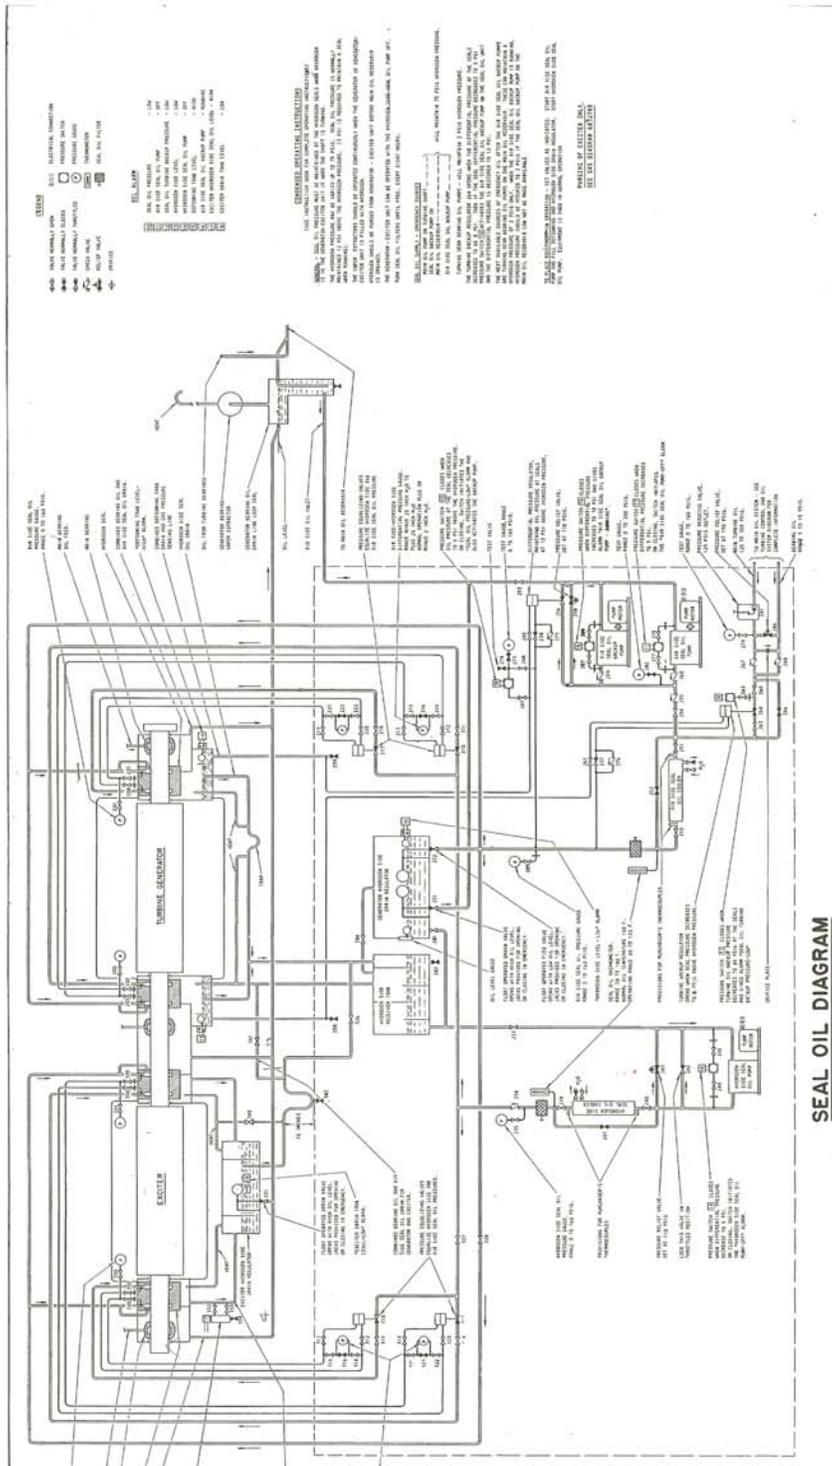
Attachment 4 - Old Tech Manual Seal Oil Diagram

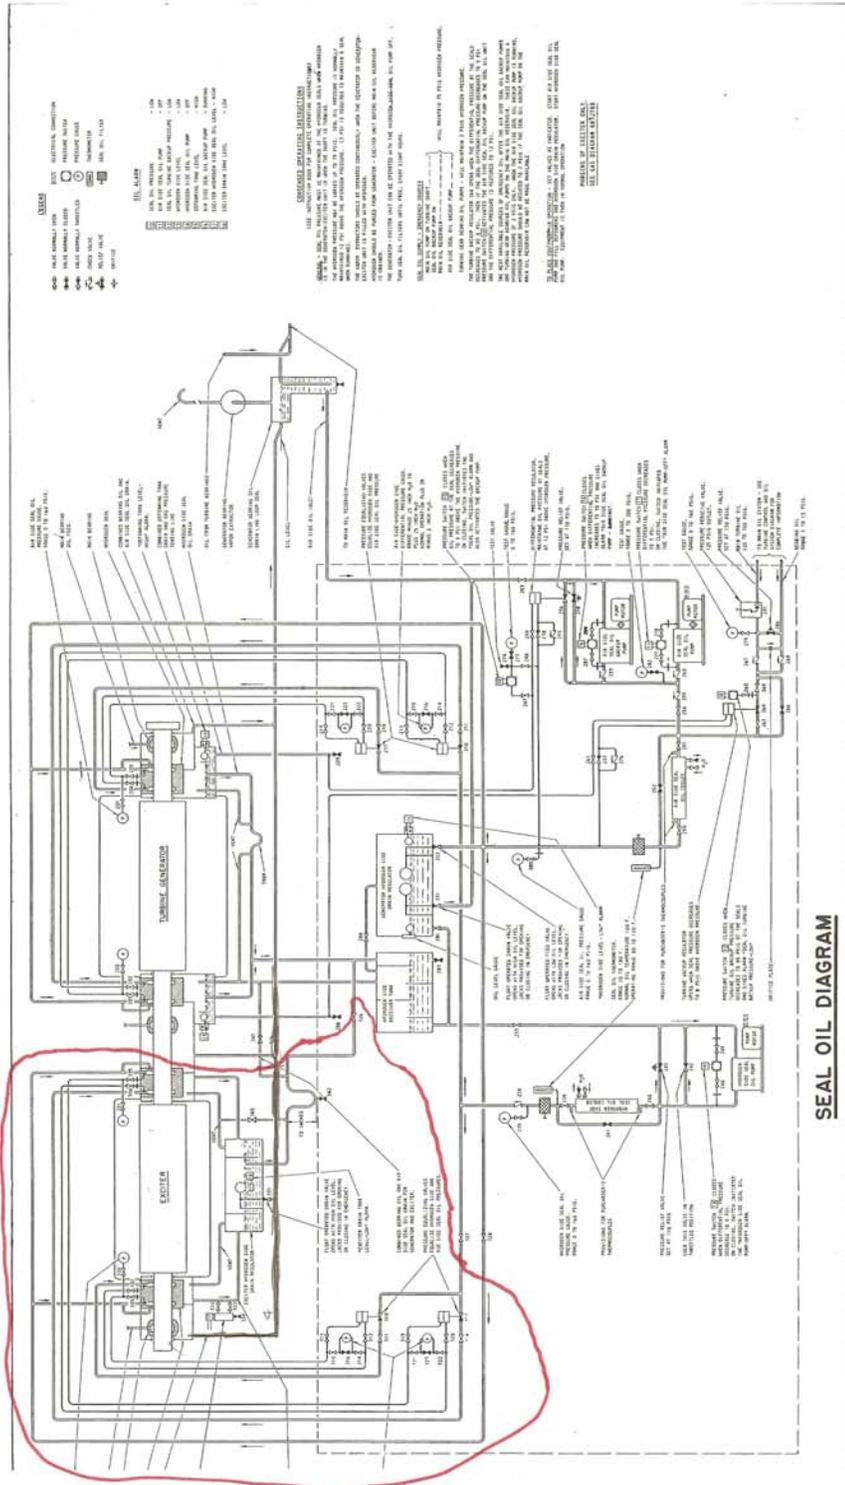
Attachment 5 - Seal Oil Diagram Red Line

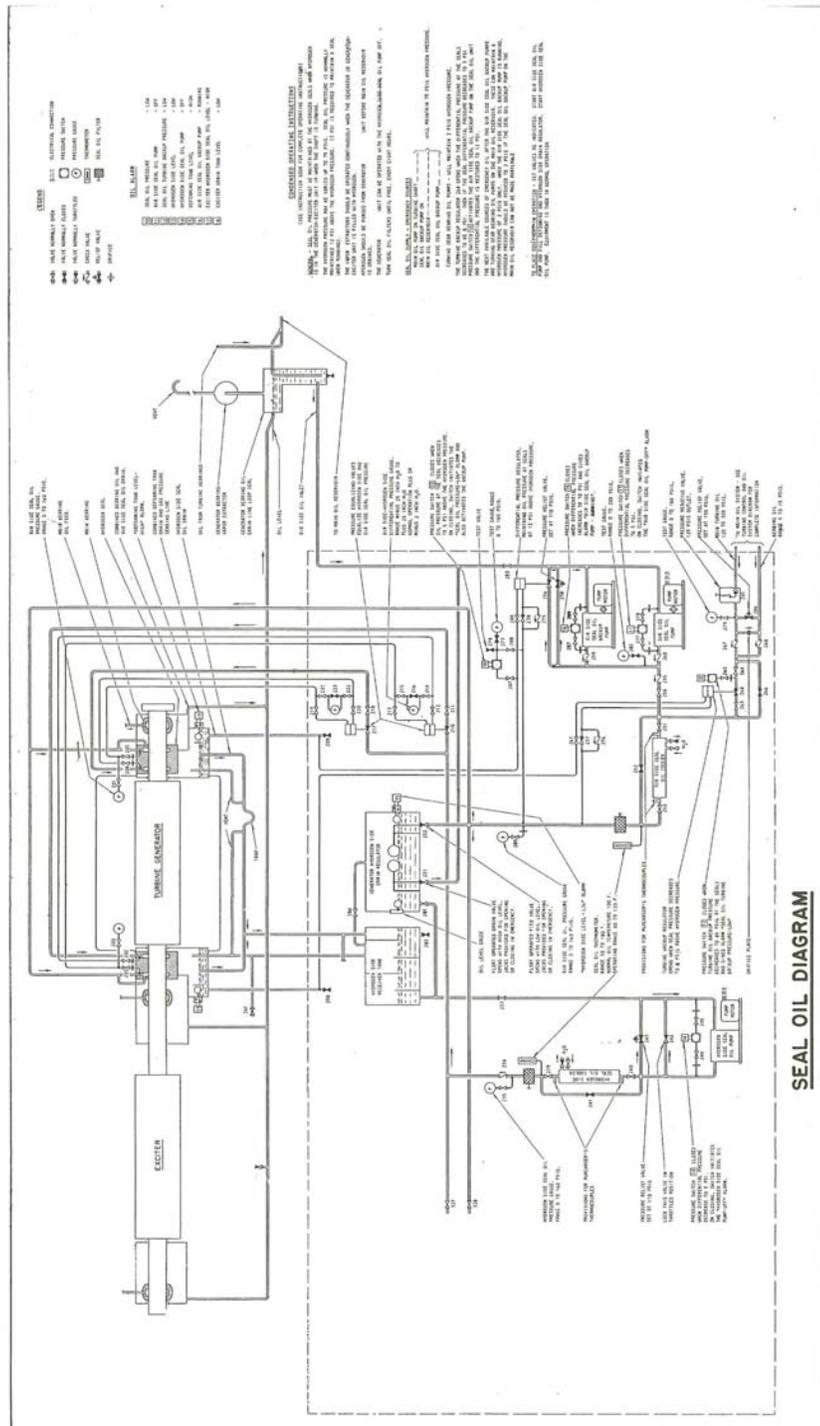
Attachment 6 - Seal Oil Diagram Cleaned Up As Built

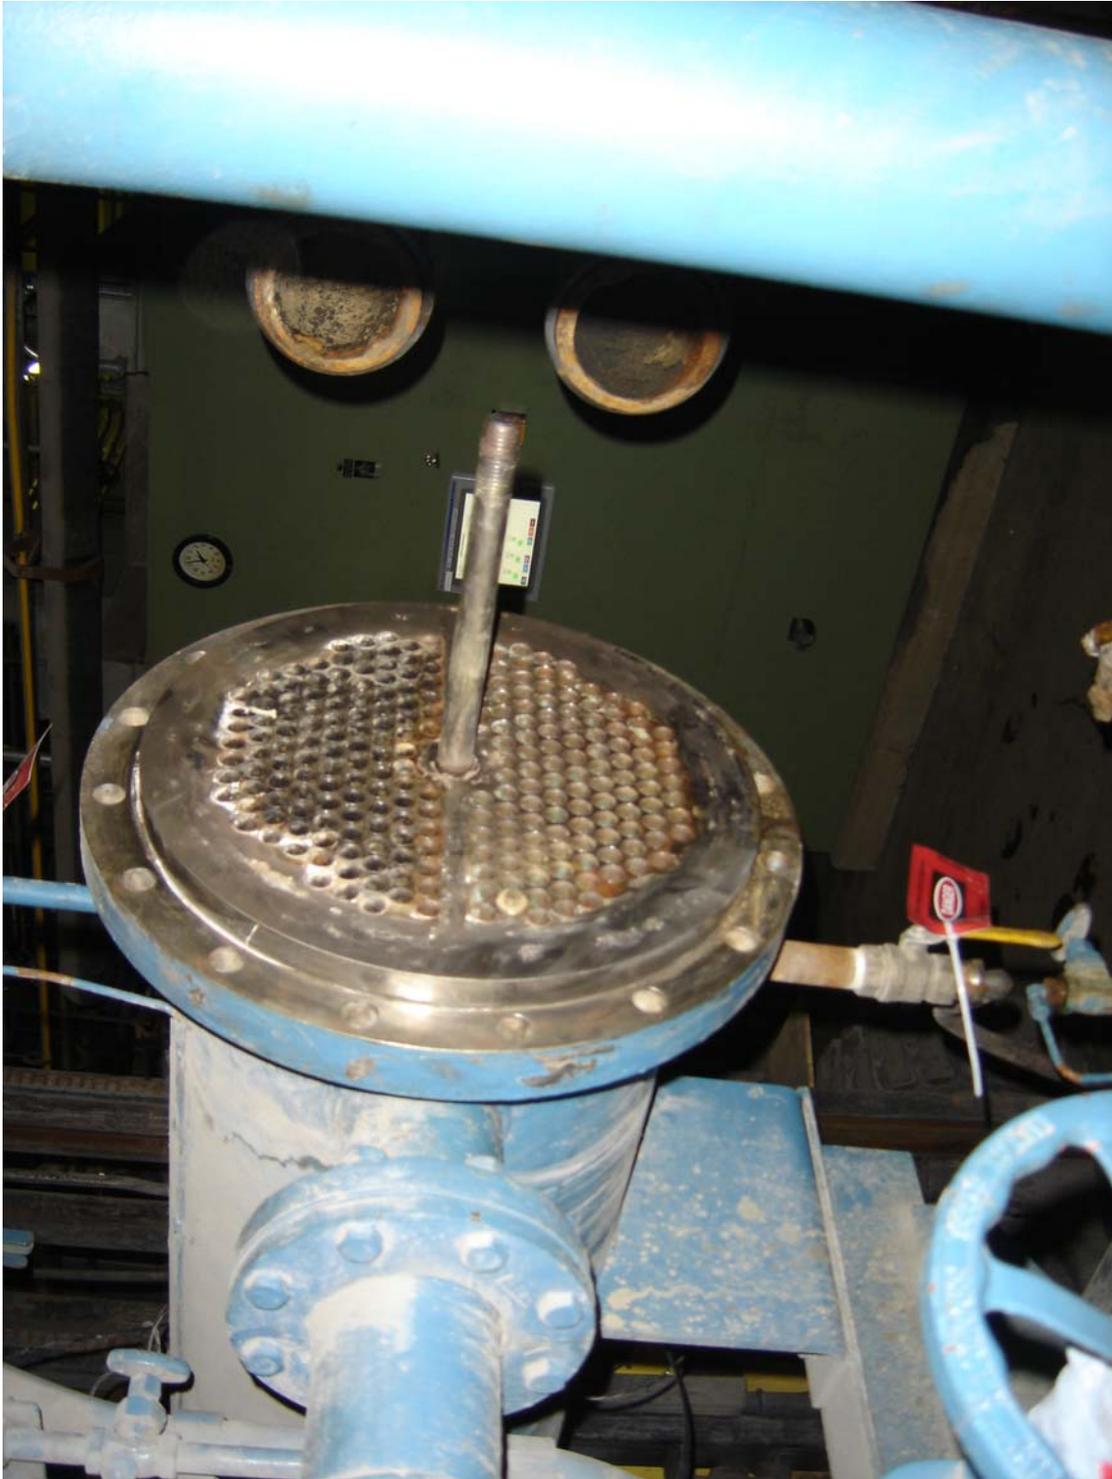
The plant reported the Stator Water Coolant Skid to be using approximately 30 to 40 gallons of demineralized water a shift for makeup. It was felt that there was a tube leak to the circulating water side. The skid coolers were isolated from the stator and pressure tested using circulating water. The through wall tube leak was found to be in the top cooler. The circulating water isolation valves at the cooler were found to leak through and thus the isolation was moved to the cooling tower line. The inlet-outlet and reversing heads were removed and the tube sheets soaped to determine damaged tube while the cooler shell side was pressurized with 5-PSI air. A single tube was found to be the source of leakage and brass tube plugs seated. The cooler heads were reassembled using new gaskets. An existing linear indication was found on the reversing head. The indication is water tight and has been coated with an epoxy sometime in the past. The cooler head assembly interfaces were pressurized with circulating water to review for leakage to human environment. None were observed. The reversing head was installed as is as the indication had been epoxy coated in the past and was water tight. See Photos.

Attachment 9 - Stator Water Inlet-Outlet End Tube Plug

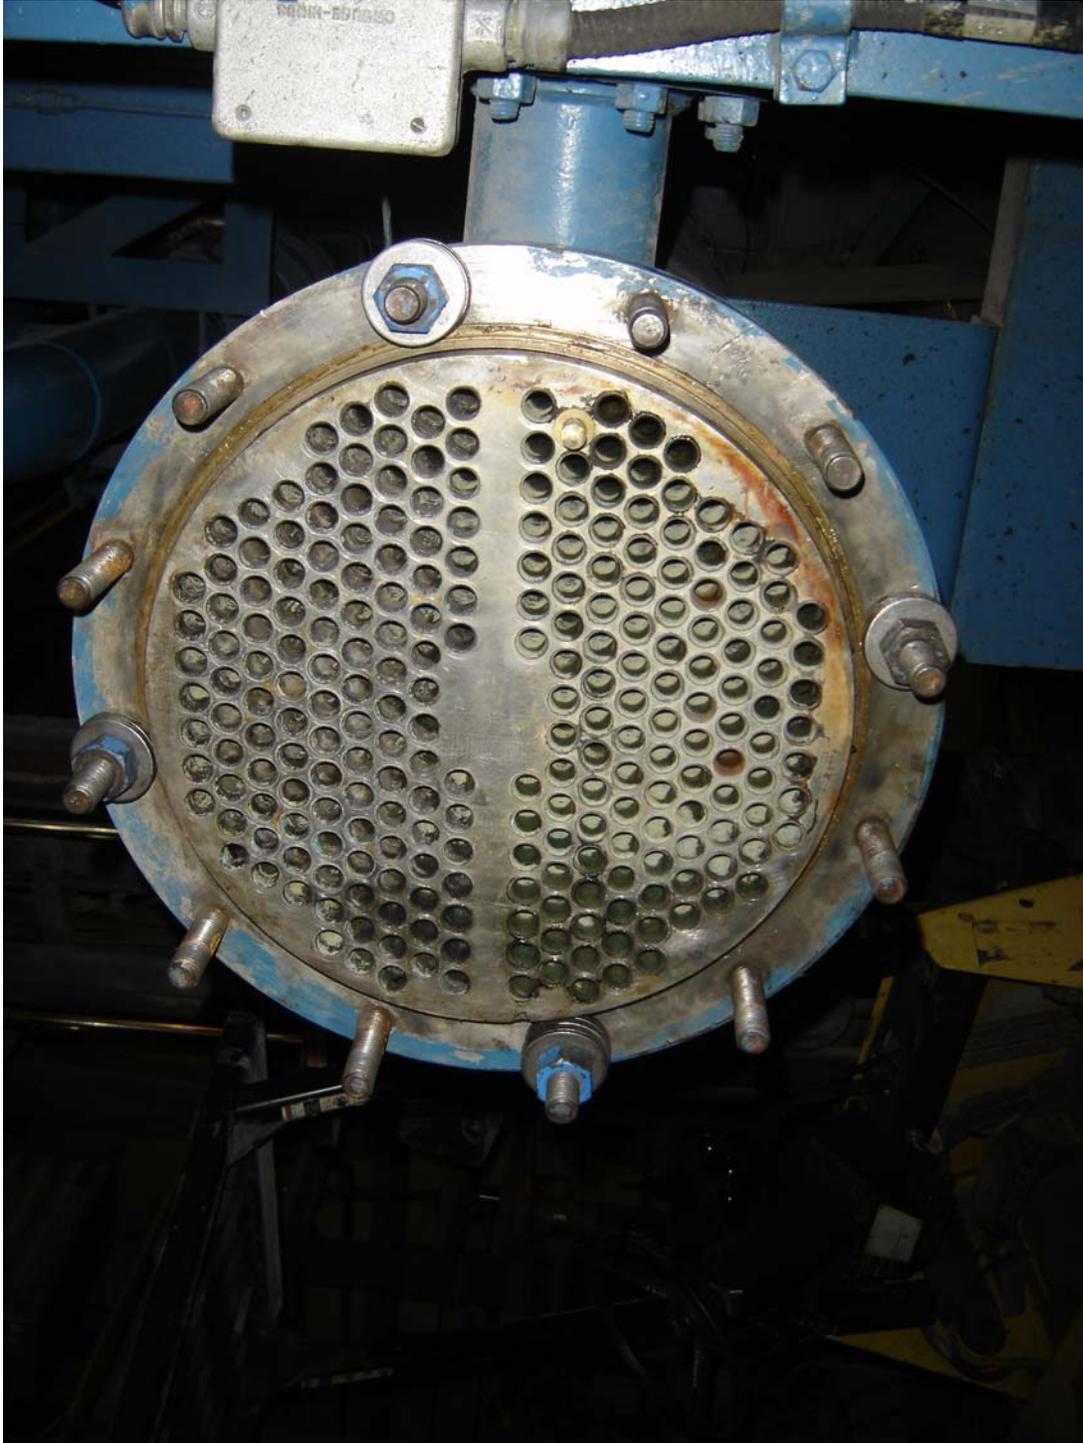
Attachment 10 - Stator Water Reversing End Tube Plug

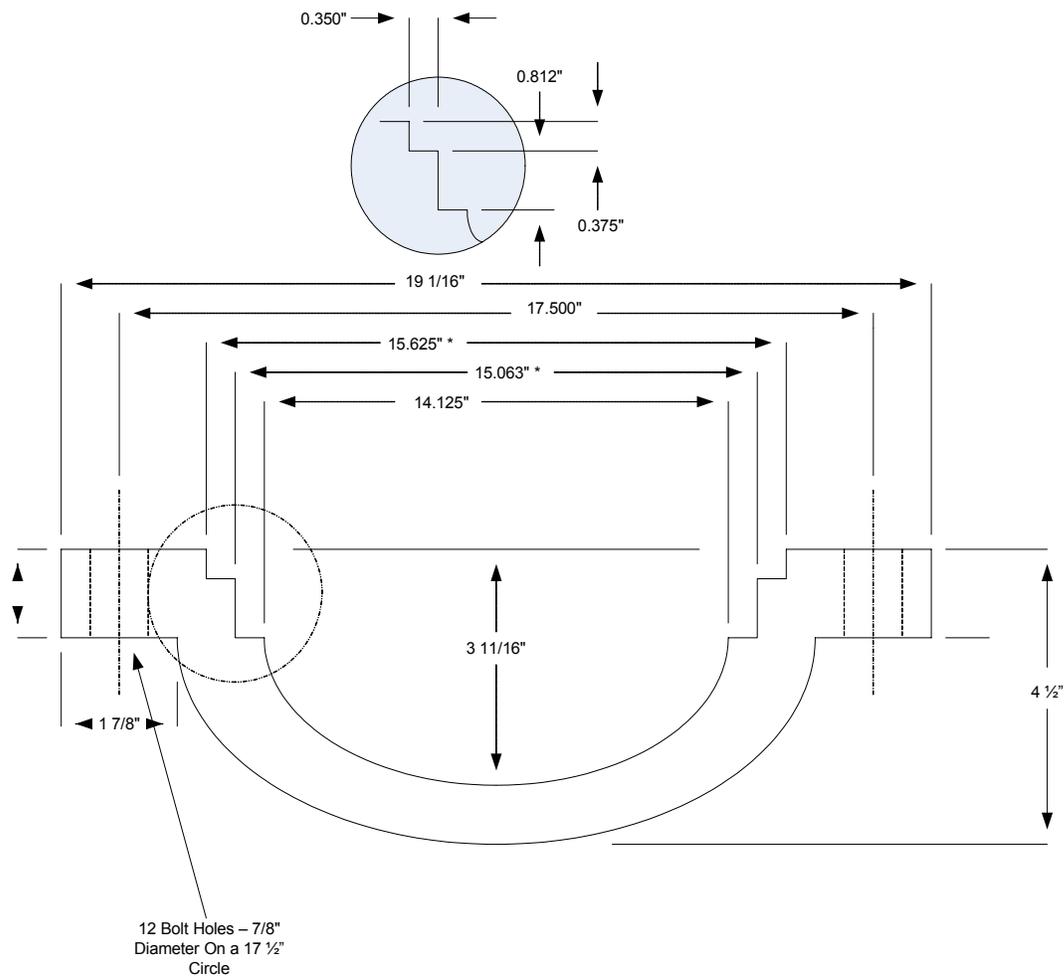
### Attachment 13 - Stator Water Reversing Cover Dimensions

#### Mitchell Unit #1 Stator Cooling Water Upper Cooler Reversing Cover Dimensions

1. Install new circulating water isolation valves for the stator water coolant skid.
2. Replace the upper cooler reversing head of the stator water coolant skid.
3. Replace root valves for main turbine steam chest sensing lines.
4. Had Auto – Cad correct OEM Tech Manual Seal Oil Diagram to reflect the abandonment of the hydrogen cooled exciter. All in-use Tech Manuals should be updated accordingly.

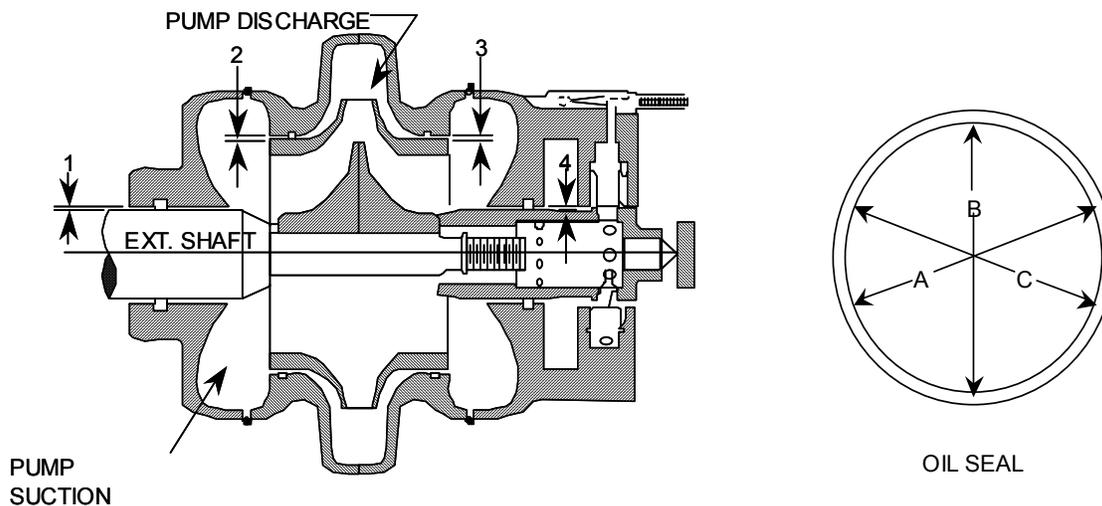
CUSTOMER: American Electric Power	
LOCATION/UNIT #: Mitchell #1 / MLU106	
<b>MAIN OIL PUMP OIL SEAL RING CLRS</b>	
BB/FRAME:	JOB NO.:
COMPONENT/S.O.:	DWG.:

SEAL NO.	Groove Width	Ring thickness	Axial Clrs	Diametrical Clearance			SHAFT DIA.	MAX. CLR
				A	B	C		
1	0.630	0.623	0.007	5.498	5.498	5.498	5.495	0.003
2	0.630	0.623	0.007	9.208	9.205	9.208	9.202	0.005
3	0.629	0.623	0.006	9.210	9.206	9.210	9.202	0.006
4	0.634	0.623	0.011	5.500	5.499	5.500	5.495	0.005

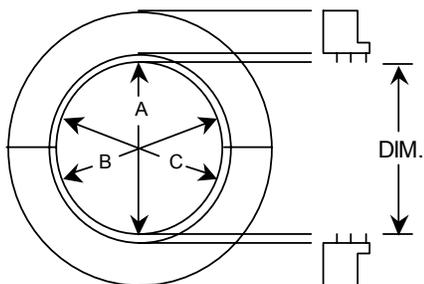
CUSTOMER: <i>American Electric Power / Ohio Power Company</i>	
LOCATION/UNIT #: <i>Mitchell Unit #1 MLU106</i>	
<b>OIL SEAL RING AND SHAFT DIMENSIONS</b>	
BB/FRAME:	JOB NO.:
COMPONENT/S.O.:	DWG.:

SEAL NO.	LOCATION	A	B	C	AVG SEAL I.D.	ROTOR O.D.	AVE Clearance	Min / Max	Design Clearance
<i>T-1</i>		<i>15.518</i>	<i>15.496</i>	<i>15.501</i>	<i>15.505</i>	<i>15.455</i>	<i>0.050</i>	<i>54/59</i>	<i>0.031</i>
<i>T-3</i>		<i>15.468</i>	<i>15.463</i>	<i>15.468</i>	<i>15.466</i>	<i>15.448</i>	<i>0.018</i>	<i>15/20</i>	<i>0.031</i>
<i>T-4</i>		<i>17.463</i>	<i>17.461</i>	<i>17.466</i>	<i>17.463</i>	<i>17.445</i>	<i>0.018</i>	<i>16/21</i>	<i>0.035</i>
<i>T-11 GVN</i>		<i>9.976</i>	<i>9.976</i>	<i>9.976</i>	<i>9.976</i>	<i>9.958</i>	<i>0.018</i>	<i>18/18</i>	<i>0.020</i>
<i>T-11 GNN</i>		<i>9.976</i>	<i>9.976</i>	<i>9.975</i>	<i>9.976</i>	<i>9.958</i>	<i>0.018</i>	<i>17/18</i>	<i>0.020</i>

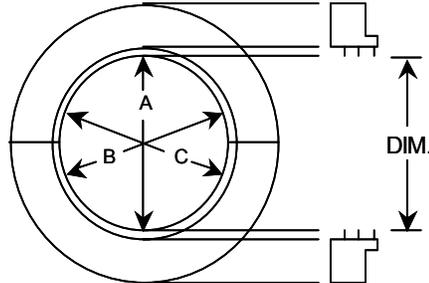
CUSTOMER: <i>American Electric Power / Ohio Power Company</i>	
LOCATION/UNIT #: <i>Mitchell Unit #1 MLU106</i>	
Tilting Pad Bearing Flood Ring Dimensions	
BB/FRAME:	JOB NO.:
COMPONENT/S. O.:	DWG.:

SEAL NO.	LOCATION	A	B	C	AVG SEAL I.D.	ROTOR O.D.	AVE Clearance	Min / Max	Design Clearance
<i>T-3</i>									
<i>GVN</i>		<i>13.987</i>	<i>13.992</i>	<i>13.992</i>	<i>13.990</i>	<i>13.959</i>	<i>0.031</i>	<i>28/33</i>	<i>0.028</i>
<i>GNN</i>		<i>13.987</i>	<i>13.991</i>	<i>13.991</i>	<i>13.990</i>	<i>13.959</i>	<i>0.031</i>	<i>28/32</i>	<i>0.028</i>
<i>T-4</i>									
<i>GVN</i>		<i>15.991</i>	<i>15.991</i>	<i>15.991</i>	<i>15.991</i>	<i>15.958</i>	<i>0.033</i>	<i>33/33</i>	<i>0.032</i>
<i>GNN</i>		<i>15.992</i>	<i>15.991</i>	<i>15.991</i>	<i>15.991</i>	<i>15.958</i>	<i>0.033</i>	<i>32/33</i>	<i>0.032</i>
<i>T-11</i>									
<i>GVN</i>		<i>9.014</i>	<i>9.012</i>	<i>9.012</i>	<i>9.012</i>	<i>9.000</i>	<i>0.012</i>	<i>12/14</i>	<i>0.018</i>
<i>GNN</i>		<i>9.013</i>	<i>9.011</i>	<i>9.013</i>	<i>9.012</i>	<i>9.000</i>	<i>0.012</i>	<i>11/13</i>	<i>0.018</i>

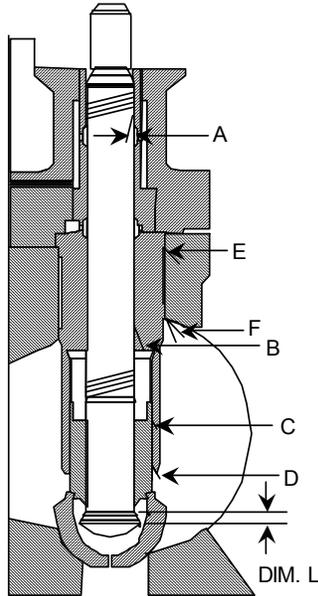
Valve #   1

NO. <u>  1  </u> VALVE DATA (AS FOUND)				Design Clear.	Service allowed	NO. <u>  1  </u> VALVE DATA (AS LEFT)			
DIM.	O.D.	I.D.	CLR			DIM.	O.D.	I.D.	CLR
A	1.736	1.752	0.016	.010/.012	.009/.018	A	1.736	1.752	0.016
B	1.736	1.751	0.015			B	1.736	1.751	0.015
C	4.174	4.183	0.009	.010/.012	.009/.018	C	4.174	4.183	0.009
D	4.168	4.186	0.018			D	4.175	4.185	0.010
E	5.580	5.583	0.003	.001/.003	.001/.015	E	5.577	5.583	0.006
F	5.579	5.593	0.014			F	5.572	5.593	0.021
STEM RUNOUT =			0.001	.001/.003	.004	STEM RUNOUT =			0.001
DIMENSION L =			0.176			DIMENSION L =			0.134

New Disc & Nut

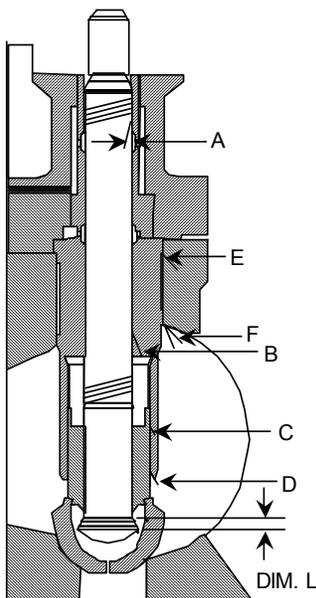
Valve #   2

NO. <u>  2  </u> VALVE DATA (AS FOUND)				Design Clear.	Service allowed	NO. <u>  2  </u> VALVE DATA (AS LEFT)			
DIM.	O.D.	I.D.	CLR			DIM.	O.D.	I.D.	CLR
A	1.738	1.755	0.017	.010/.012	.009/.018	A	1.738	1.755	0.017
B	1.739	1.749	0.01	.010/.012	.009/.018	B	1.739	1.750	0.011
C	4.177	4.185	0.008	.010/.012	.009/.018	C	4.177	4.185	0.008
D	4.177	4.186	0.009	.010/.012	.009/.018	D	4.177	4.186	0.009
E	5.790			.001/.003	.001/.015	E	5.576	5.589	0.013
F	5.578			.001/.003	.001/.015	F	5.574	5.597	0.023
STEM RUNOUT =			0.002	.001/.003	.004	STEM RUNOUT =			0.002
DIMENSION L =			0.183	.115/.135	.115/.135	DIMENSION L =			0.183

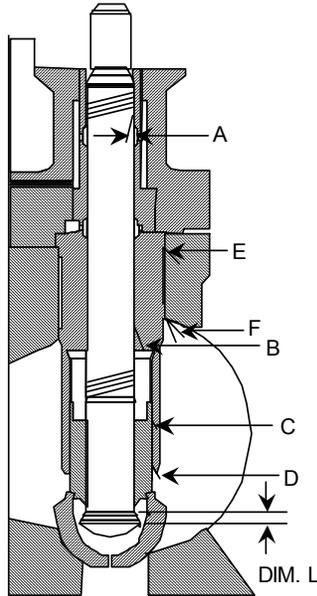
Valve #   3

NO. <u>  3  </u> VALVE DATA (AS FOUND)				Design Clear.	Service allowed	NO. <u>  3  </u> VALVE DATA (AS LEFT)			
DIM.	O.D.	I.D.	CLR			DIM.	O.D.	I.D.	CLR
A	1.738	1.751	0.013	.010/.012	.009/.018	A	1.737	1.751	0.014
B	1.734	1.750	0.016	.010/.012	.009/.018	B	1.737	1.750	0.013
C	4.173	4.184	0.011	.010/.012	.009/.018	C	4.174	4.184	0.010
D	4.169	4.187	0.018	.010/.012	.009/.018	D	4.174	4.188	0.014
E	5.583	5.586	0.003	.001/.003	.001/.015	E	5.576	5.586	0.010
F	5.583	5.586	0.003	.001/.003	.001/.015	F	5.577	5.595	0.018
STEM RUNOUT =			0.002	.001/.003	.004	STEM RUNOUT =			0.001
DIMENSION L =			0.218	.115/.135	.115/.135	DIMENSION L =			0.172

New Stem, Plug & Nut

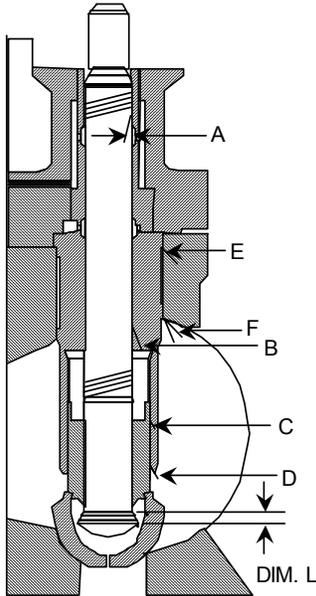
Valve #   4

NO. <u>  4  </u> VALVE DATA (AS FOUND)				Design Clear.	Service allowed	NO. <u>  4  </u> VALVE DATA (AS LEFT)			
DIM.	O.D.	I.D.	CLR			DIM.	O.D.	I.D.	CLR
A	1.735	1.768	0.033	.010/.012	.009/.018	A	1.735	1.768	0.033
B	1.736	1.710	-0.026	.010/.012	.009/.018	B	1.736	1.752	0.016
C	4.173	4.185	0.012	.010/.012	.009/.018	C	4.173	4.190	0.017
D	4.170	4.187	0.017	.010/.012	.009/.018	D	4.170	4.191	0.021
E	5.566			.001/.003	.001/.015	E	5.573	5.577	0.004
F	5.545			.001/.003	.001/.015	F	5.570	5.593	0.023
STEM RUNOUT =		0.000		.001/.003	.004	STEM RUNOUT =		0.000	
DIMENSION L =		0.180		.115/.135	.115/.135	DIMENSION L =		0.172

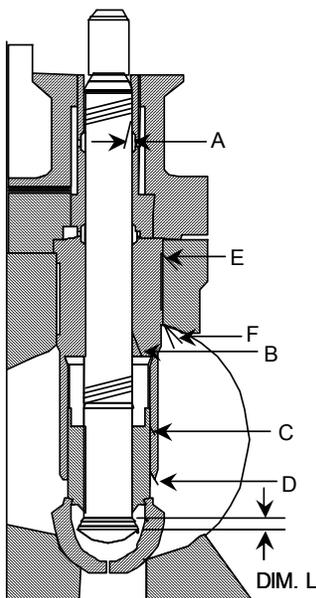
Valve #   5

NO. <u>  5  </u> VALVE DATA (AS FOUND)				Design Clear.	Service allowed	NO. <u>  5  </u> VALVE DATA (AS LEFT)			
DIM.	O.D.	I.D.	CLR			DIM.	O.D.	I.D.	CLR
A	1.737	1.752	0.015	.010/.012	.009/.018	A	1.737	1.752	0.015
B	1.737	1.751	0.014	.010/.012	.009/.018	B	1.737	1.751	0.014
C	4.175	4.183	0.008	.010/.012	.009/.018	C	4.175	4.183	0.008
D	4.171	4.185	0.014	.010/.012	.009/.018	D	4.171	4.185	0.014
E	5.582	5.589	0.007	.001/.003	.001/.015	E	5.580	5.589	0.009
F	5.582	5.603	0.021	.001/.003	.001/.015	F	5.577	5.603	0.026
STEM RUNOUT =			0.000	.001/.003	.004	STEM RUNOUT =			0.000
DIMENSION L =			0.162	.115/.135	.115/.135	DIMENSION L =			0.162

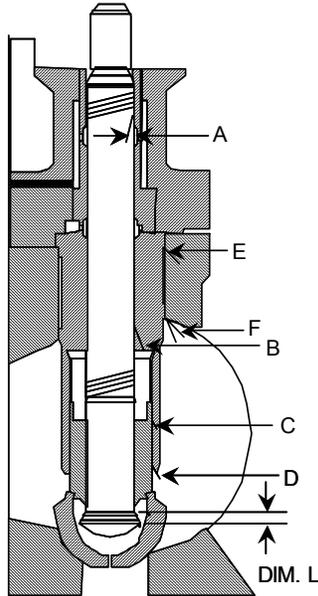
Valve # 6

NO. <u>6</u> VALVE DATA (AS FOUND)				Design Clear.	Service allowed	NO. <u>6</u> VALVE DATA (AS LEFT)			
DIM.	O.D.	I.D.	CLR			DIM.	O.D.	I.D.	CLR
A				.010/.012	.009/.018	A	1.737	1.752	0.015
B				.010/.012	.009/.018	B	1.737	1.753	0.016
C				.010/.012	.009/.018	C	4.175	4.184	0.009
D				.010/.012	.009/.018	D	4.175	4.187	0.012
E				.001/.003	.001/.015	E	5.578	5.585	0.007
F				.001/.003	.001/.015	F	5.579	5.596	0.017
STEM RUNOUT =				.001/.003	.004	STEM RUNOUT =			0.002
DIMENSION L =				.115/.135	.115/.135	DIMENSION L =			0.143

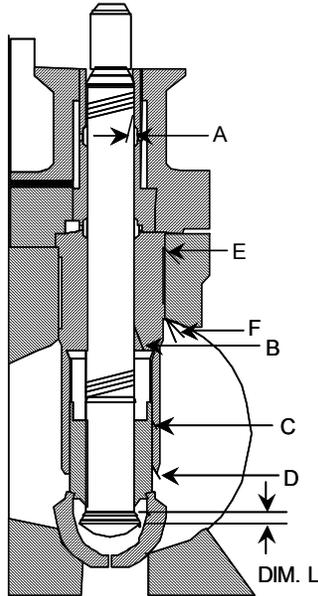
Valve #   7

NO. <u>  7  </u> VALVE DATA (AS FOUND)				Design Clear.	Service allowed	NO. <u>  7  </u> VALVE DATA (AS LEFT)			
DIM.	O.D.	I.D.	CLR			DIM.	O.D.	I.D.	CLR
A		1.755		.010/.012	.009/.018	A	1.738	1.755	0.017
B		1.752		.010/.012	.009/.018	B	1.738	1.752	0.014
C		4.186		.010/.012	.009/.018	C	4.172	4.186	0.014
D		4.187		.010/.012	.009/.018	D	4.172	4.187	0.015
E	5.585	5.588	0.003	.001/.003	.001/.015	E	5.580	5.588	0.008
F	5.583	5.607	0.024	.001/.003	.001/.015	F	5.580	5.607	0.027
STEM RUNOUT =				.001/.003	.004	STEM RUNOUT =			0.002
DIMENSION L =				.115/.135	.115/.135	DIMENSION L =			0.142

New Stem, Plug & Nut

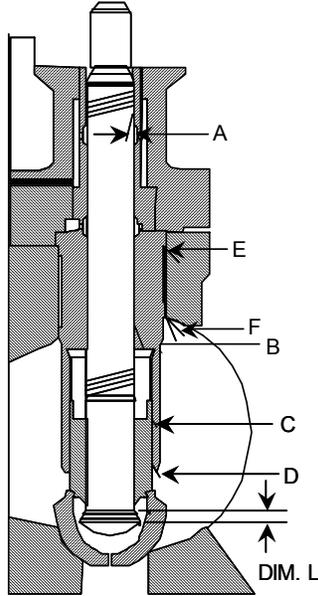
Valve #   8

NO. <u>  8  </u> VALVE DATA (AS FOUND)			
DIM.	O.D.	I.D.	CLR
A	1.737	1.750	0.013
B	1.737	1.753	0.016
C	4.174	4.185	0.011
D	4.172	4.183	0.011
E	5.583		
F	5.584		
STEM RUNOUT =		0.001	
DIMENSION L =		0.171

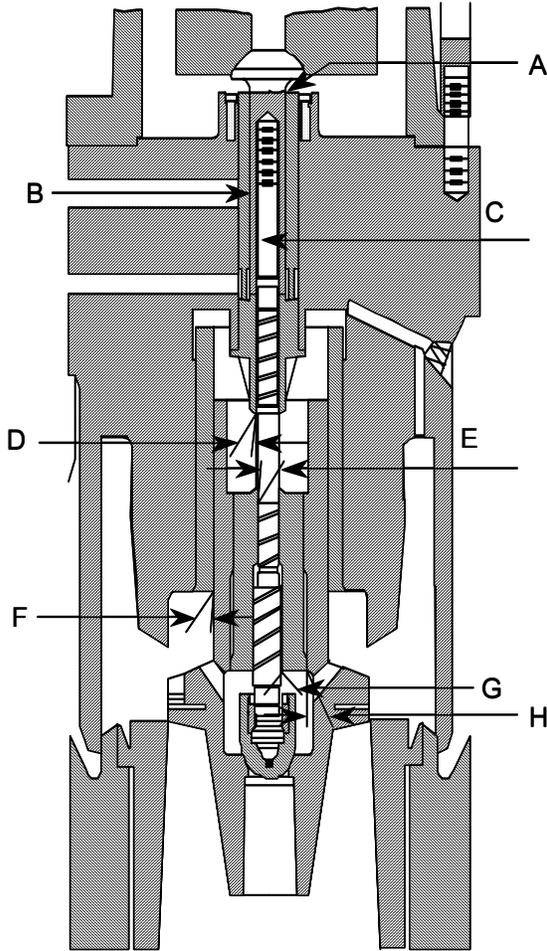
LOCATION : \_\_\_\_\_ #1 \_\_\_\_\_

As Found Throttle Valve Clearances				
DIA	O.D.	I.D.	ACTUAL	DESIGN
A	2.111	2.124	0.013	.010/.013
B	2.111	2.125	0.014	.010/.013
C	1.381	1.393	0.012	.005/.007
D	1.487	1.499	0.012	.010/.013
E	1.487	1.498	0.011	.010/.013
F	5.491	5.494	0.003	.011/.017
G	1.930	1.935	0.005	.010/.013
H	3.806	3.808	0.002	.002/.005
I = RUNOUT				0/.003

As Assembled Throttle Valve Clearances				
DIA	O.D.	I.D.	ACTUAL	DESIGN
A	2.110	2.125	0.015	.010/.013
B	2.110	2.125	0.015	.010/.013
C	1.381	1.392	0.011	.005/.007
D	1.487	1.501	0.014	.010/.013
E	1.487	1.497	0.010	.010/.013
F	5.487	5.497	0.010	.011/.017
G	1.924	1.935	0.011	.010/.013
H	3.805	3.808	0.003	.002/.005
I = RUNOUT				0/.003
