# Mitchell Station Unit #1

## American Electric Power Company

## Westinghouse T-G Set

VHP-HP Turbine	Serial Number	13A3160-1
IP Turbine	Serial Number	13A3161-1
LP Turbine #1	Serial Number	13A3162-1
LP Turbine #2	Serial Number	13A3163-1
Turbine Instruction Book		1250-C679
Generator	Serial Number	1-S-87P0755
Brush Collector	Serial Number	1-S-94P0063
Generator Instruction Book		90P0944
Brush Collector Instruction Book		1560-0093
Boiler Feed Pump Drive Turbine		15-A-2961-1
BFP/DT Instruction Manual		1150-C129
Spring Outage		4-1-2006 to 6-18-2006

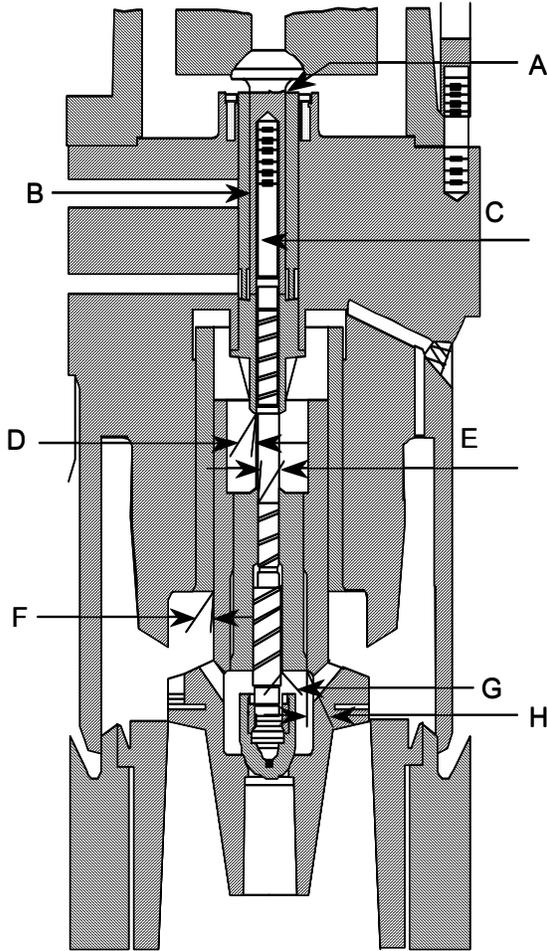
LOCATION : \_\_\_\_\_ #2 \_\_\_\_\_

As Found Throttle Valve Clearances				
DIA	O.D.	I.D.	ACTUAL	DESIGN
A	2.109	2.124	0.015	.010/.013
B	2.110	2.124	0.014	.010/.013
C	1.382	1.391	0.009	.005/.007
D	1.481	1.501	0.020	.010/.013
E	1.482	1.497	0.015	.010/.013
F	5.471	5.486	0.015	.011/.017
G	1.926	1.935	0.009	.010/.013
H	3.803	3.808	0.005	.002/.005
I = RUNOUT				0/.003

As Assembled Throttle Valve Clearances				
DIA	O.D.	I.D.	ACTUAL	DESIGN
A	2.110	2.124	0.014	.010/.013
B	2.110	2.124	0.014	.010/.013
C	1.381	1.391	0.010	.005/.007
D	1.488	1.501	0.013	.010/.013
E	1.488	1.498	0.010	.010/.013
F	5.482	5.494	0.012	.011/.017
G	1.924	1.934	0.010	.010/.013
H	3.806	3.808	0.002	.002/.005
I = RUNOUT				0/.003

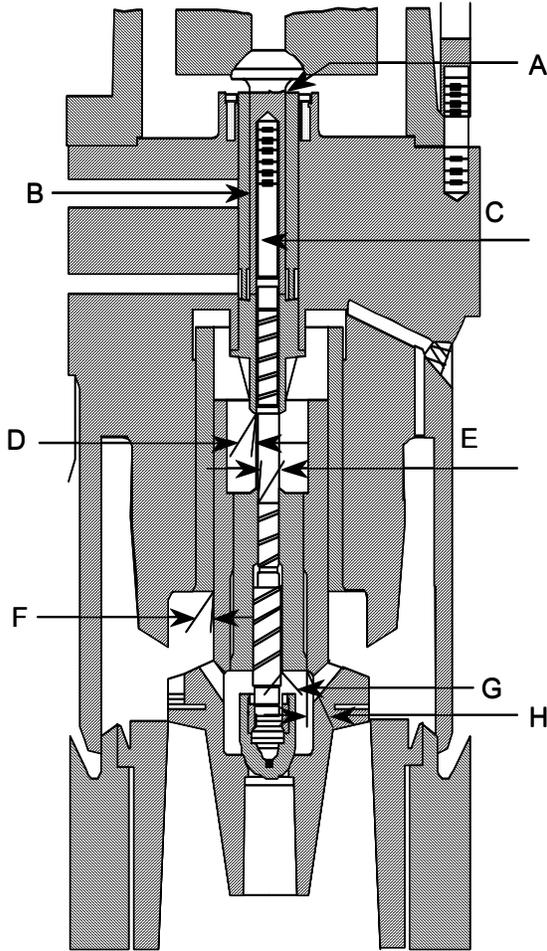
LOCATION : \_\_\_\_\_ #3 \_\_\_\_\_

As Found Throttle Valve Clearances				
DIA	O.D.	I.D.	ACTUAL	DESIGN
A	2.114	2.125	0.011	.010/.013
B	2.115	2.124	0.009	.010/.013
C	1.380	1.387	0.007	.005/.007
D	1.485	1.496	0.011	.010/.013
E	1.486	1.497	0.011	.010/.013
F	5.476	5.490	0.014	.011/.017
G	1.926	1.936	0.010	.010/.013
H	3.806	3.809	0.003	.002/.005
I = RUNOUT				0/.003

As Assembled Throttle Valve Clearances				
DIA	O.D.	I.D.	ACTUAL	DESIGN
A	2.113	2.125	0.012	.010/.013
B	2.114	2.124	0.010	.010/.013
C	1.380	1.388	0.008	.005/.007
D	1.487	1.496	0.009	.010/.013
E	1.487	1.497	0.010	.010/.013
F	5.470	5.490	0.020	.011/.017
G	1.926	1.936	0.010	.010/.013
H	3.805	3.809	0.004	.002/.005
I = RUNOUT				0/.003

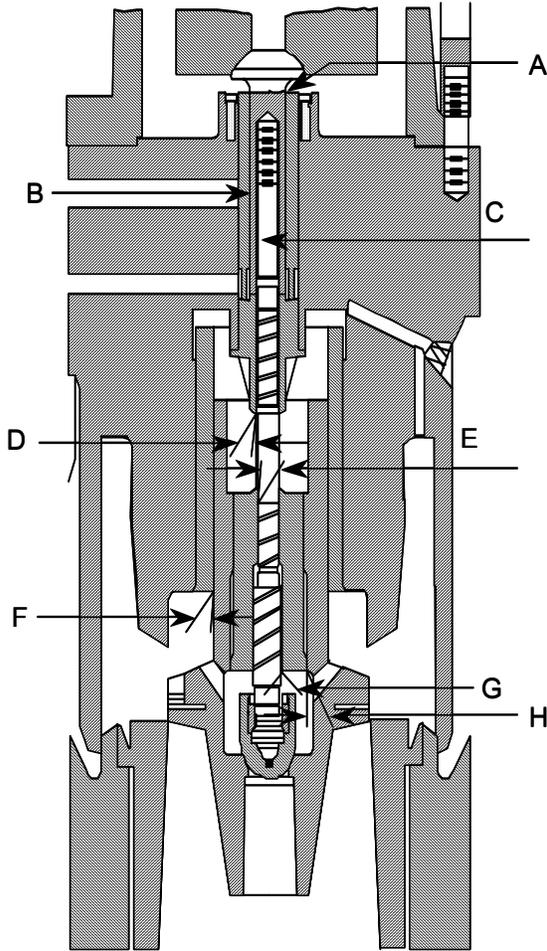
LOCATION : \_\_\_\_\_ #4 \_\_\_\_\_

As Found Throttle Valve Clearances				
DIA	O.D.	I.D.	ACTUAL	DESIGN
A	2.111	2.125	0.014	.010/.013
B	2.111	2.124	0.013	.010/.013
C	1.381	1.393	0.012	.005/.007
D	1.487	1.498	0.011	.010/.013
E	1.488	1.498	0.01	.010/.013
F	5.482	5.489	0.007	.011/.017
G	1.929	1.935	0.006	.010/.013
H	3.802	3.806	0.004	.002/.005
I = RUNOUT				0/.003

As Assembled Throttle Valve Clearances				
DIA	O.D.	I.D.	ACTUAL	DESIGN
A	2.110	2.125	0.015	.010/.013
B	2.110	2.124	0.014	.010/.013
C	1.382	1.387	0.005	.005/.007
D	1.487	1.498	0.011	.010/.013
E	1.488	1.498	0.010	.010/.013
F	5.486	5.497	0.011	.011/.017
G	1.924	1.935	0.011	.010/.013
H	3.808	3.809	0.001	.002/.005
I = RUNOUT				0/.003

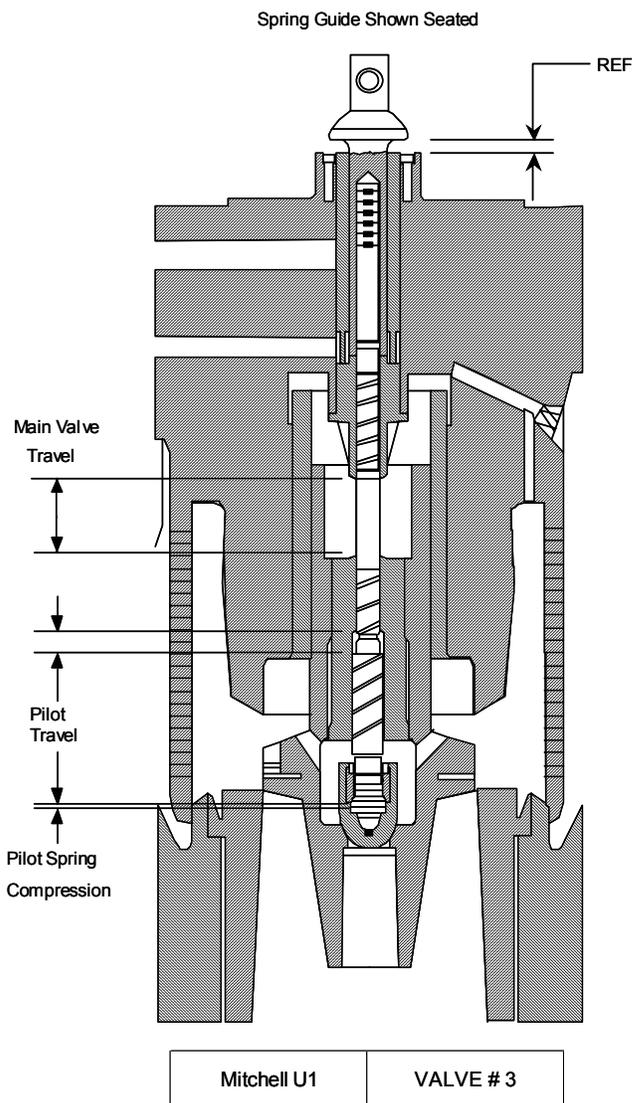
CUSTOMER:	AEP
LOCATION/UNIT #:	
<b>THROTTLE VALVE</b>	
BB/FRAME:	JOB NO.:
COMPONENT/S.O.:	DWG.:

AXIAL TRAVEL			
NUMBER	DESCRIPTION		DISTANCE
1	A2 SPRING GUIDE SEATED		0.686
2	A1 SPRING GUIDE NOT SEATED		0.849
3	STEM BACKSEATED		1.361
4	MAIN VALVE BACKSEATED		5.436
CALCULATED VALUES			
	DESCRIPTION	DISTANCE CALCULATION	VALUE
	PILOT SPRING COMPRESSION	#2 MINUS #1	0.163
	PILOT TRAVEL	#3 MINUS #2	0.512
	MAIN VALVE TRAVEL	#4 MINUS #3	4.075
	TOTAL TRAVEL	#4 MINUS #2	4.587

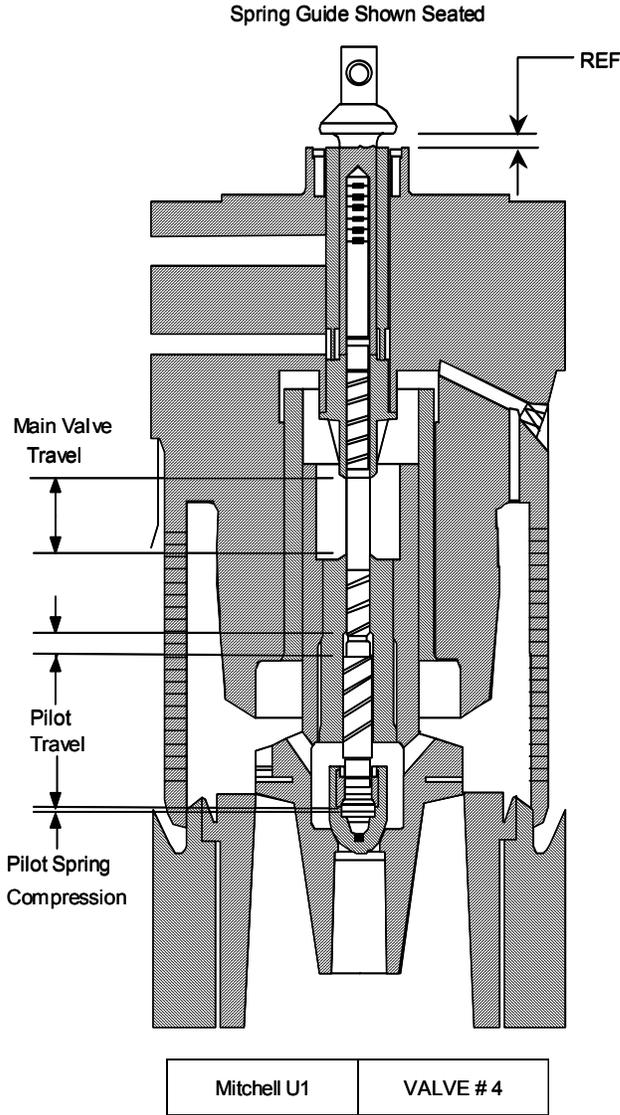
CUSTOMER:	AEP
LOCATION/UNIT #:	
<b>THROTTLE VALVE</b>	
BB/FRAME:	JOB NO.:
COMPONENT/S.O.:	DWG.:

AXIAL TRAVEL			
NUMBER	DESCRIPTION		DISTANCE
1	A2 SPRING GUIDE SEATED		0.505
2	A1 SPRING GUIDE NOT SEATED		0.640
3	STEM BACKSEATED		1.150
4	MAIN VALVE BACKSEATED		5.405
CALCULATED VALUES			
	DESCRIPTION	DISTANCE CALCULATION	VALUE
	PILOT SPRING COMPRESSION	#2 MINUS #1	0.135
	PILOT TRAVEL	#3 MINUS #2	0.510
	MAIN VALVE TRAVEL	#4 MINUS #3	4.255
	TOTAL TRAVEL	#4 MINUS #2	4.765

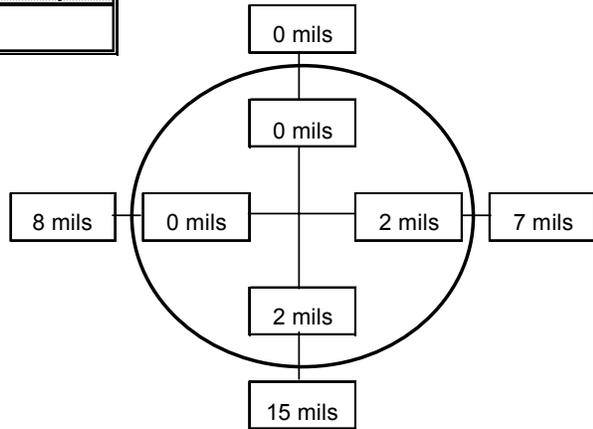
### Alignment Readings

Position	Top	Left	Bottom	Right	Top
Rim (Mils)	0 mils	8 mils	15 mils	7 mils	
Face 0°	0.945"	0.945"	0.947"	0.949"	
Face 90°	0.947"	0.945"	0.947"	0.948"	
Face 180°	0.931"	0.932"	0.932"	0.932"	
Face 270°	0.930"	0.931"	0.933"	0.931"	
Average	0.938"	0.938"	0.940"	0.940"	
Relative	0 mils	0 mils	2 mils	2 mils

Check	Face	Rim
Top + Bottom =	2 mils	15 mils
Right + Left =	2 mils	15 mils
Difference =	0 mils	0 mils
