Inspection Report

Station: Mitchell Unit: 1 Report Name: 1-WATER WALL FRONT

AREA: Water Wall Front

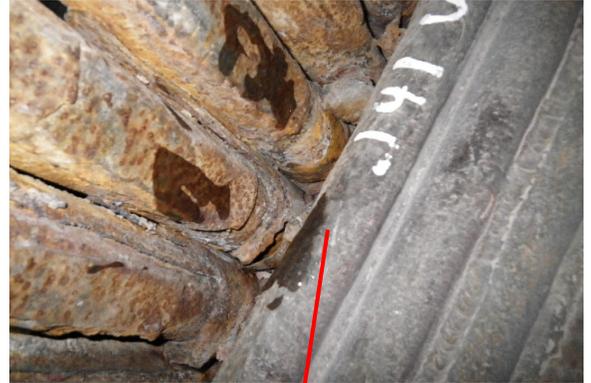
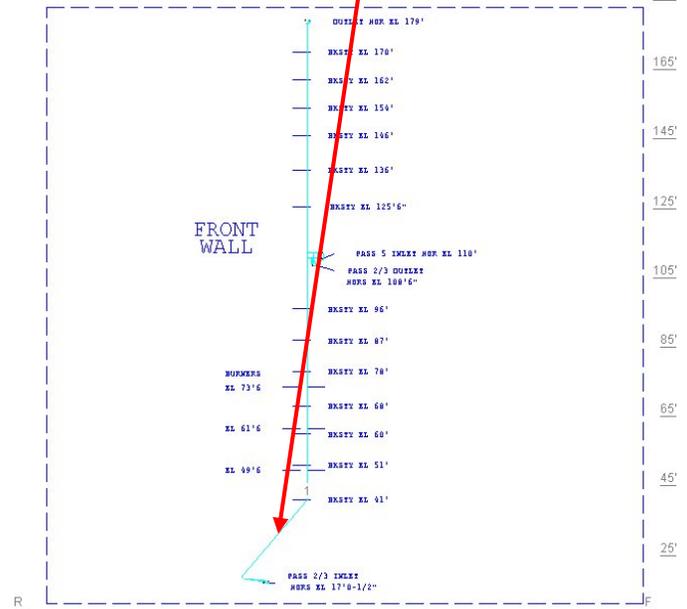
Cause: Erosion (Fly Ash)

The UT Data is 0.141

Install 6' Dutchman on **Tube 279** due to fly ash erosion and a RWT of 0.141. The tube is located on the left side of the Division Wall and the cut lines are marked with white paint stick.

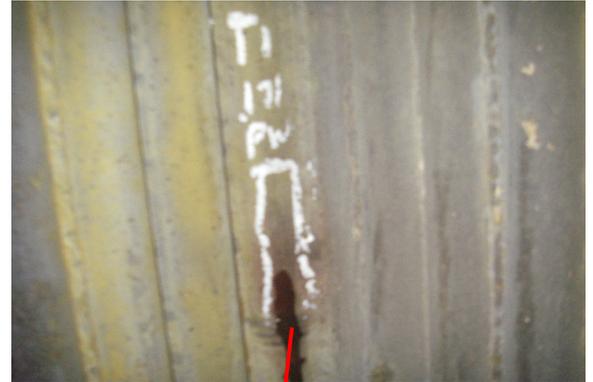
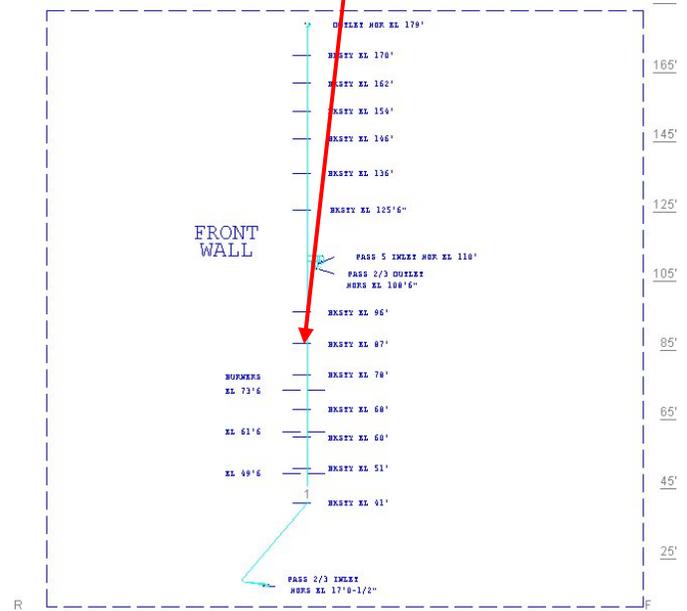
Cause: Erosion (Soot Blower)

The eroded area on the tube is just above a previously installed 1' dutchman.

Apply one 1"x4" pad weld to **Tube 1** due to previous soot blower erosion from the left side wall IR#1.

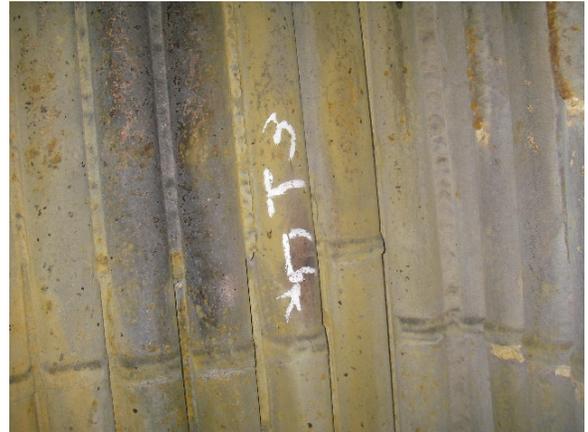
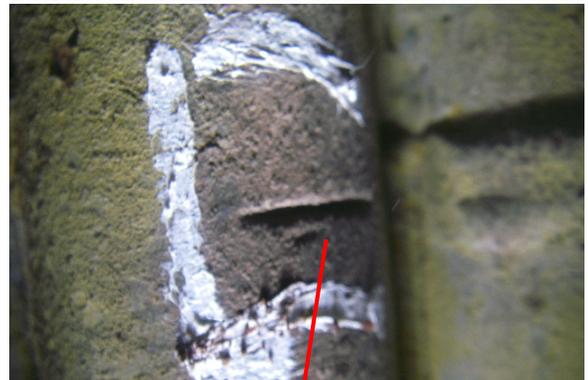
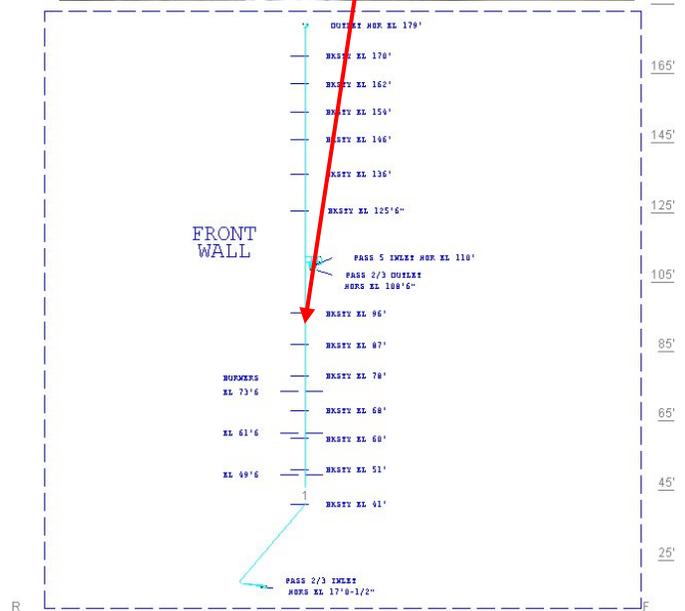
Cause: Maintenance Damage

The UT Data is N/A

Grind out and weld restore T3 at the front wall due to a wafer wheel cut of a depth estimated >1/16".

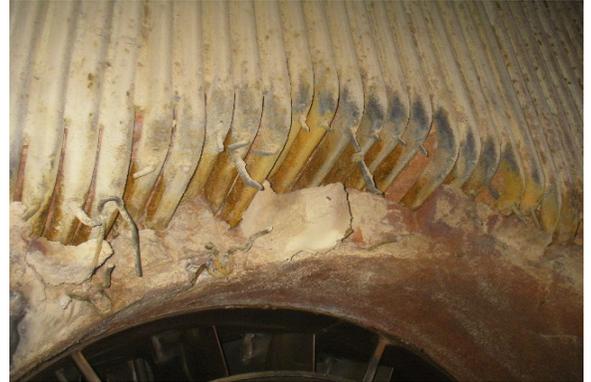
Cause: Fatigue (Thermal/ Vibration)

Appearance: Missing

The outer edge of refractory is missing and broken back on the majority of front wall burners throat tubes.

Repair/Replace the missing Refractory.

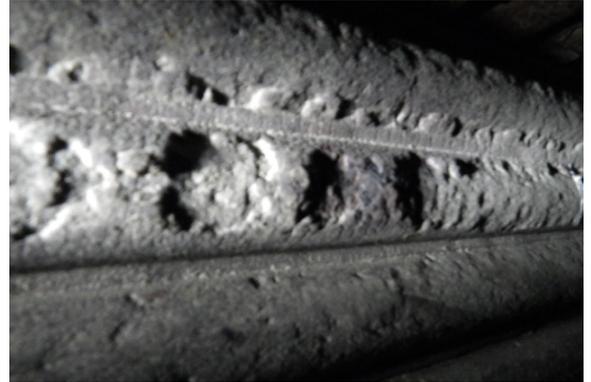
Cause: Fatigue (Thermal)

Verify that the missing material and fatigue cracking is in the overlay and not the tube.

Further research is recommended at **Tube 282** on the right side of the Division Wall.

Replace tube if defects are in the actual tube material. Length will be approximately 6'.

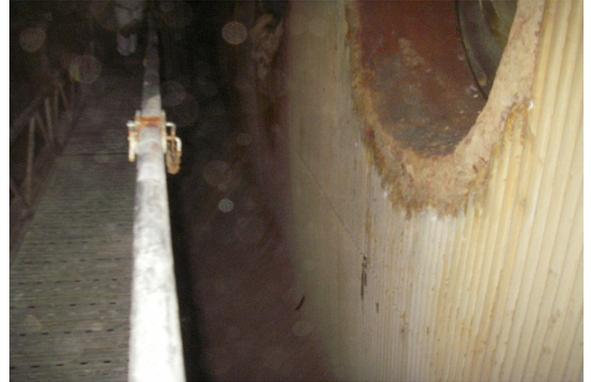
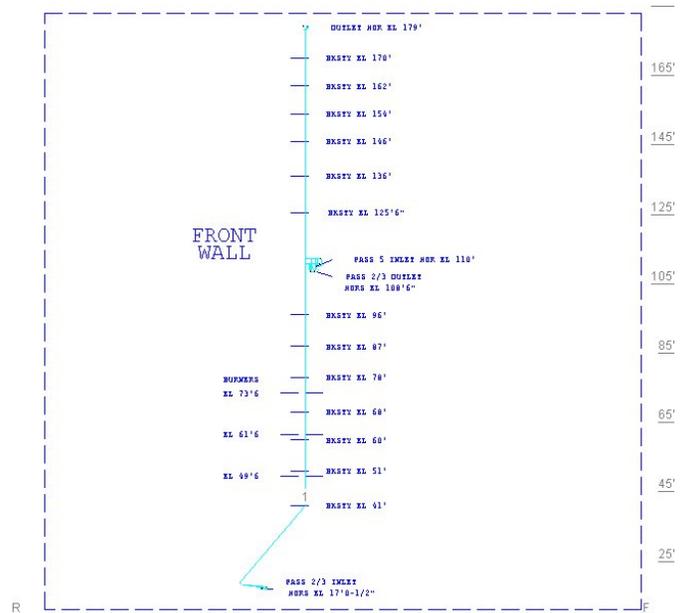
Inspections of the front wall (left and right sides of the division wall) were limited due to the position of the sky climber as it was consistently 2'-3' from the wall.

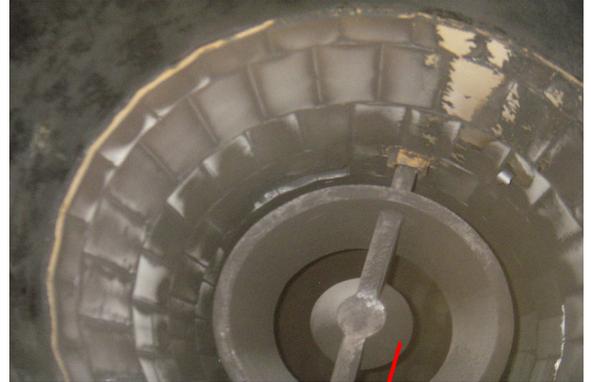
General location is Water Wall Front, Burner Coal Nozzle, 12F.

Appearance: Missing

Replace the missing ceramic liner tiles at **Burner #12F** in the 11:00-12:00 o'clock positions.

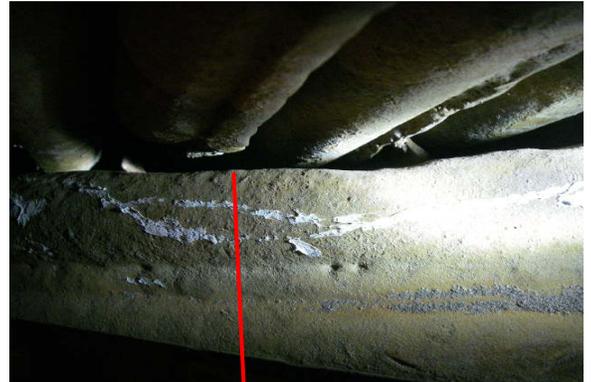
Cause: Erosion (Fly Ash)

Appearance: Erosion Flat

Install approximately 2' dutchman to the eroded area on tube 1. The eroded area is located 12" above the throat of the coutant slope. The gap needs to be filled from the rear wall to the left wall the help seal up the boiler and to stop the fly ash being channeled through this area. There was no UT reading obtained due to the location of the eroded area.

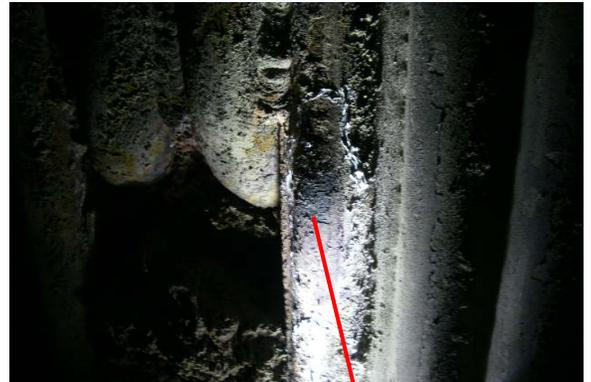
General location is Water Wall Rear, Rear Wall, At Burners.

The UT Data is .183

Install 2' dutchman on tube 520 due to bulge and UT readings of 0.183". This tube is located at the top row of burners adjacent to old IR port. Bottom cutline should be approximately 10" down from IR and up 24" to remove bulge and existing pad weld.

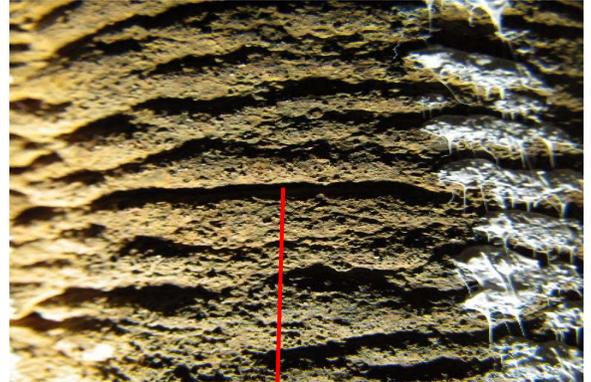
Appearance: Quench Cracked Tube

This tube appears to have been quenched from the IR that has been taken out of commission. This tube is located approximately 5' above the top row of burners.

Grind surface indications to termination and then verify that the indications are limited to the overlay material only and not the actual tube surfaces. Should indications continue beyond the overlay, determine the RWT of the underlying tube material and repair as needed.

Grind until visible defect reaches termination and call for re-inspection.

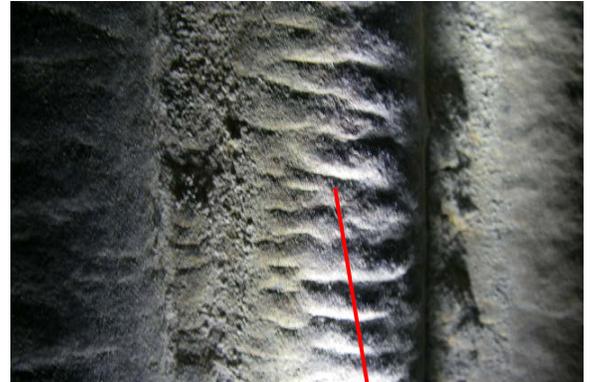
Appearance: Stress Fatigue Cracks

Further research required for tubes 557-559. These tubes appear to have stress fatigue cracks located at the rear wall right below where the rear wall transitions to the lower slope.

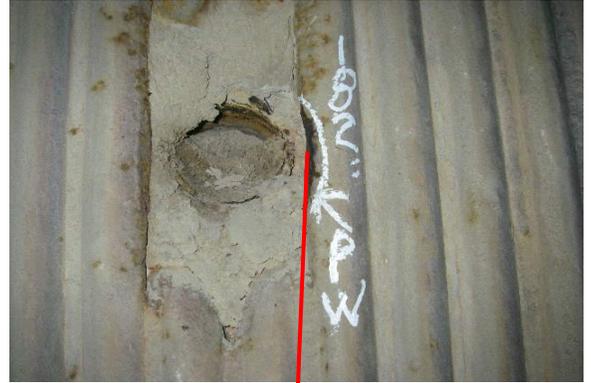
Cause: Erosion (Soot Blower)

The UT Data is .182

Apply 1" x 2" pad weld to the eroded area on tube 41 on the left side of the tube. This area appears to be at an old IR that has been taken out of commission. This eroded area is located level with the second row of burners.

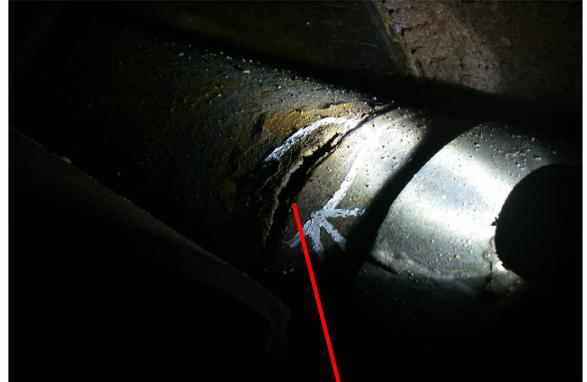
Cause: Fatigue (Thermal)

Appearance: Deteriorated

Weld repair igniter approximately 6" back from the tip at 14F.

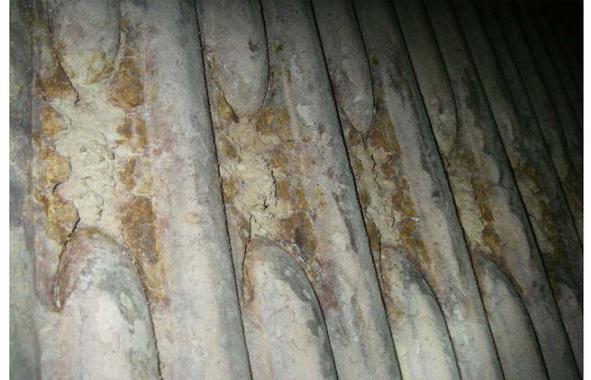
Cause: Fatigue (Thermal/ Vibration)

Appearance: Missing

Install refractory at the mixing header on the rear wall from the left to the right side of the boiler.

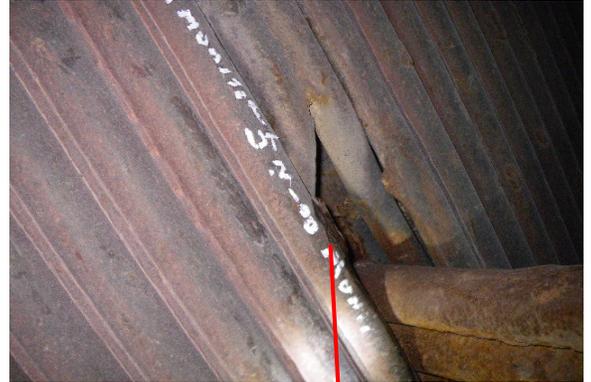
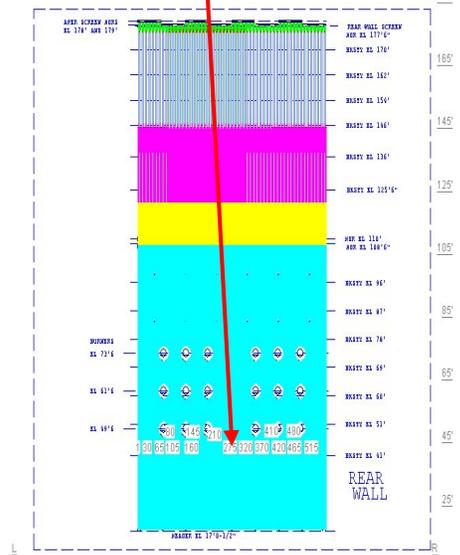
Cause: Erosion (Fly Ash)

The UT Data is .218

Monitor tube 279 during future outages. The RWT is 0.218".

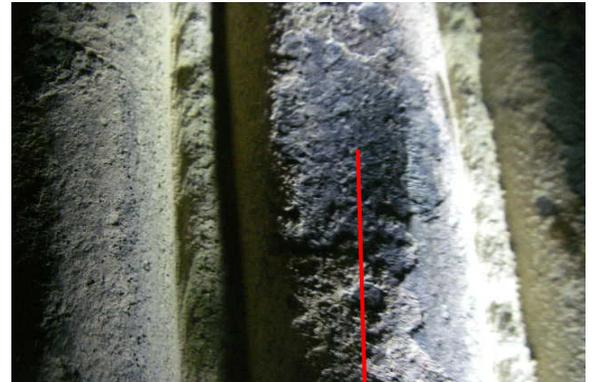
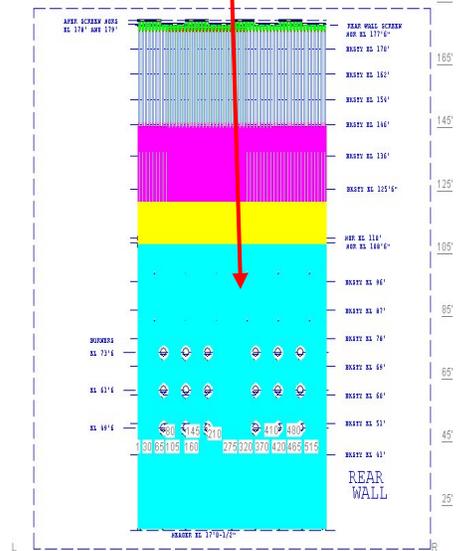
The UT Data is .200

The other UT readings obtained were on tube 150 UT of 0.213" and 153 UT of 0.220". These eroded areas are located adjacent to the water cannon at the 2 o'clock position.

Monitor tubes 147-160 during future outages. These tubes appear to have been eroded from an old IR at the water cannon elevation. The lowest UT reading came from tube 152 and had a RWT of 0.200".

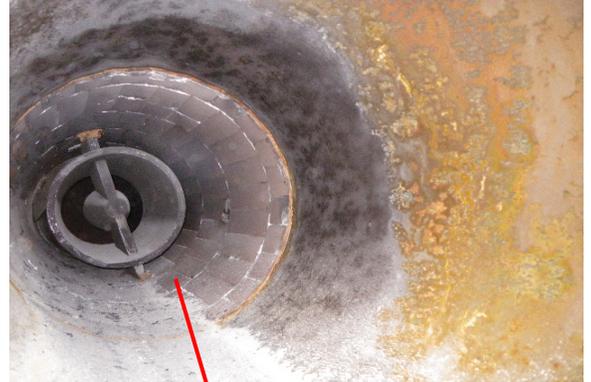
The ceramic tiles are missing or damaged at rear wall burner 16C. The tiles to be repaired or replaced are located at the following positions:

- 11 o'clock 2' back
- 3 o'clock 2' back and 1" back
- 12 o'clock 6" back

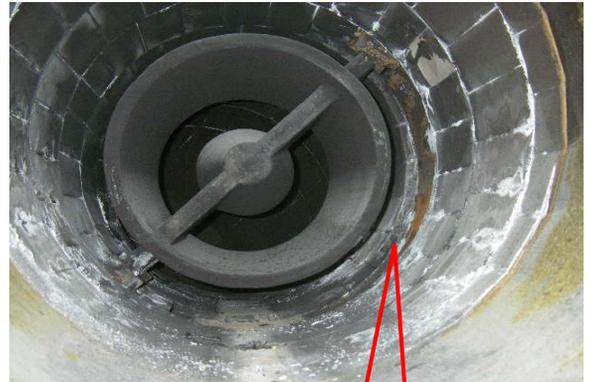
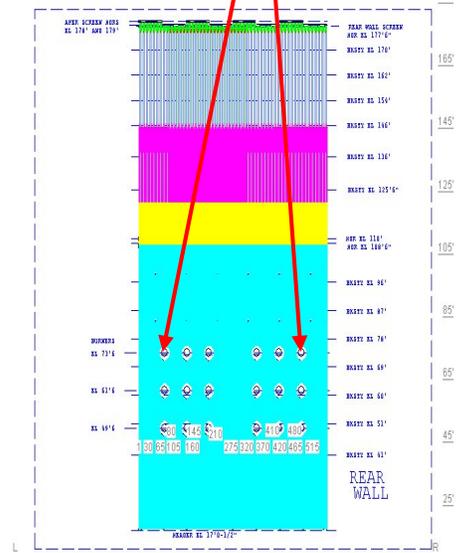
Cause: Fatigue (Thermal/ Vibration)

Appearance: Missing

Replace missing tiles located at the following burners/ location of missing tiles:

14 A located approximately 2.5' back at the 7 o'clock position

14 F/ located 3' back at the 10 to 12 o'clock position

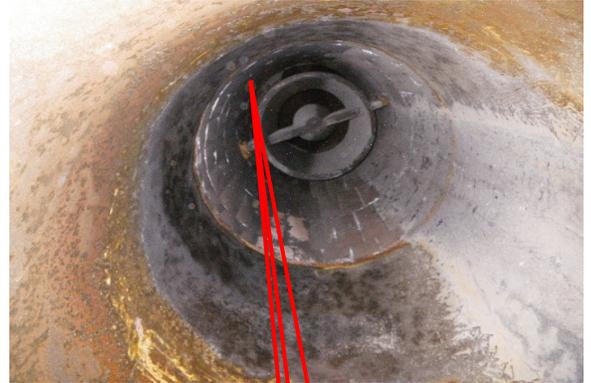
Appearance: Missing

Replace missing tiles located at burners 15B, 15C, and 15D. The tiles missing from 15B are located at the 11 o'clock position 3' back, tiles missing from 15C are located at the 12 o'clock position 2" back, and 15D at the 12 o'clock position 2.5' back.

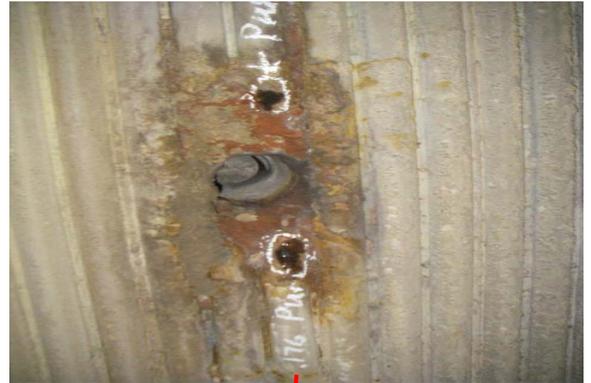
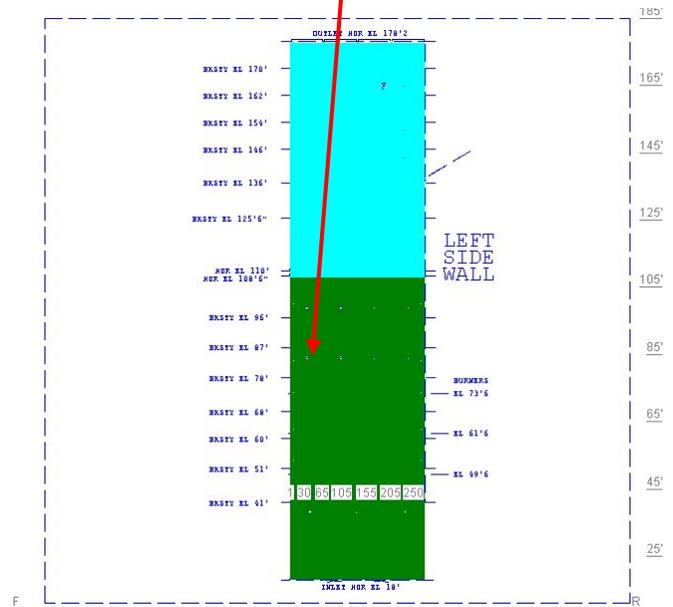
Cause: Erosion (Soot Blower)

Appearance: Eroded

Apply two (2) 1"x1" pad welds to offset Tube #35 above and below the IR#1 due to old blower erosion and a RWT of .176".

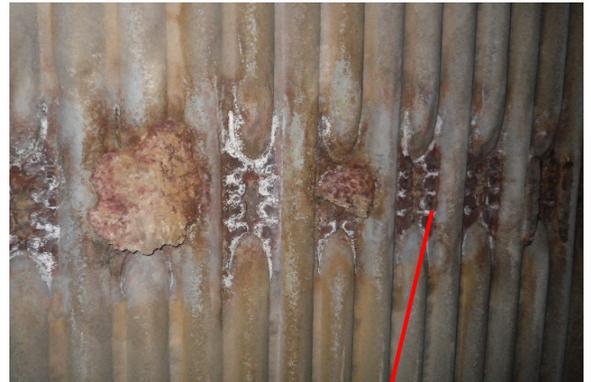
Cause: Fatigue (Thermal/ Vibration)

Appearance: Missing

Re-Install missing/broken Refractory along the tube penetrations on the Mixing Header.

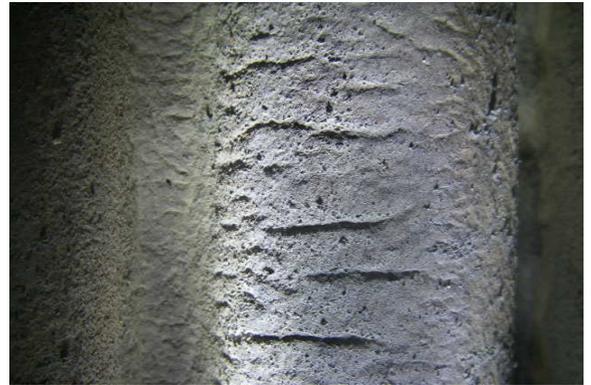
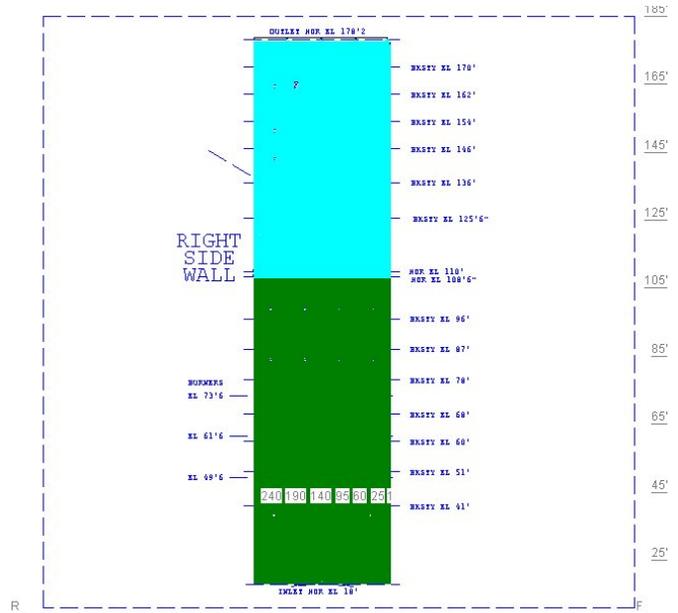
Appearance: Quench Cracked Tube

These tubes appear to have been quenched from the IR that has been taken out of commission and are located approximately 15' down from the mixing header.

Should indications continue beyond the overlay, determine the RWT of the underlying tube material and repair as needed at the following tubes:

- 27-32
- 519-533

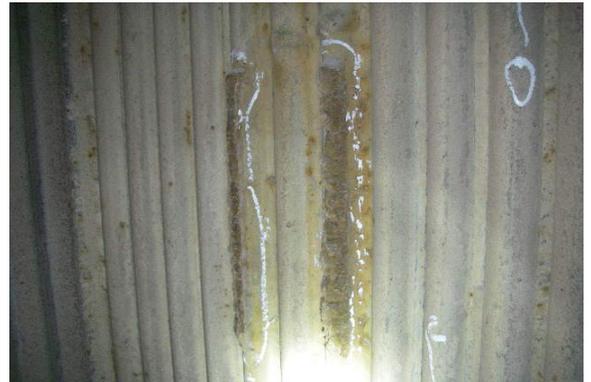
Appearance: Excessive Weld Attachment

These tubes are located approximately 5' above the top row of burners.

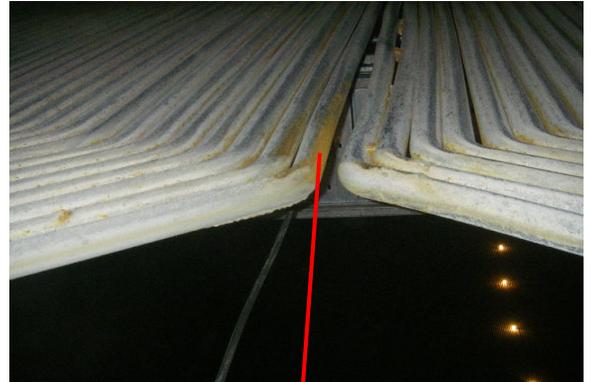
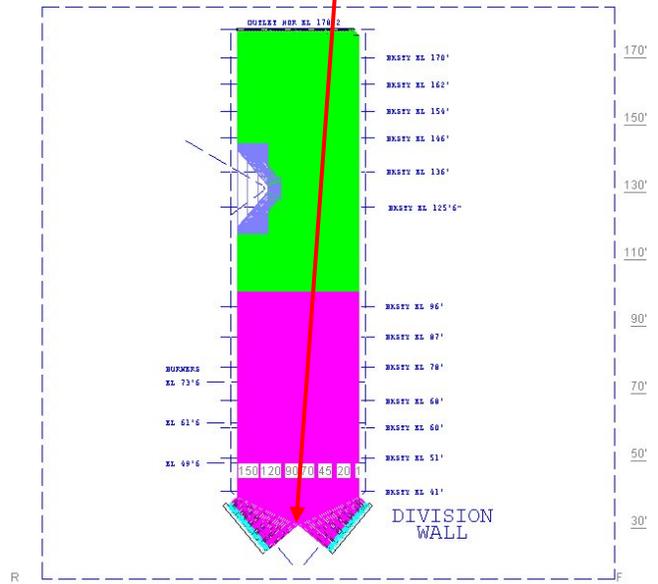
Cause: Fretting or Rubbing (Abrasion)
Appearance: Abraded

Provide access to the bottom side of the
division wall in the middle at **tubes 84
and 85**. The two tubes appear to be
abrading on each other during operation.

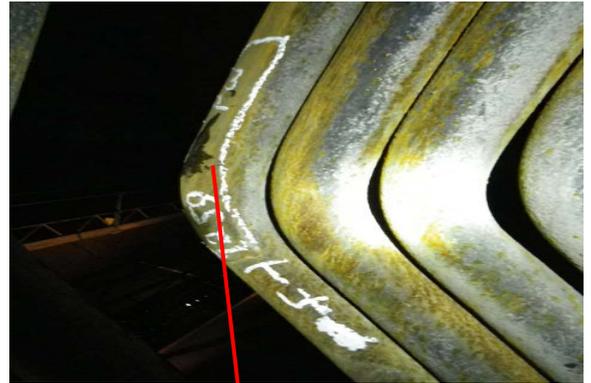
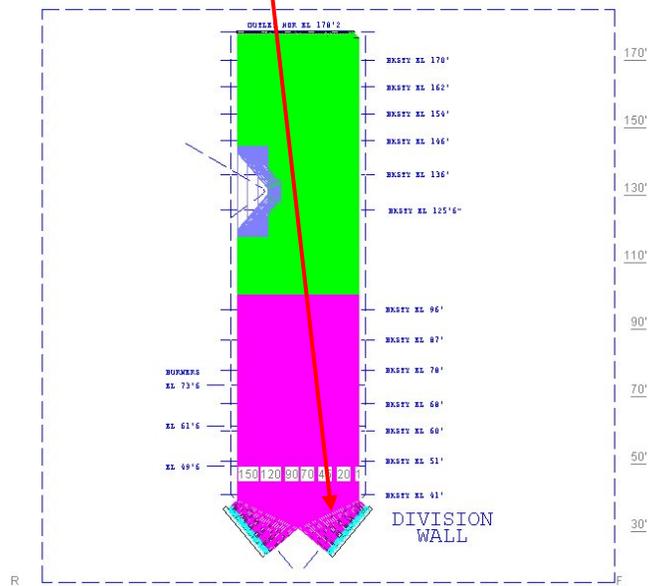
Cause: Fretting or Rubbing (Abrasion)
 Appearance: Eroded

Location is on the left/right front
 Division Wall.

Pad-Weld approximately 12"x3" on the left
 and approximately an 8"x3" on the right of
 the 45 deg. elbow bend on **Tube 41** due to a
 RWT of 0.259. When in service it appears
 that Tube 40 and 41 are rubbing/fretting
 against each other.

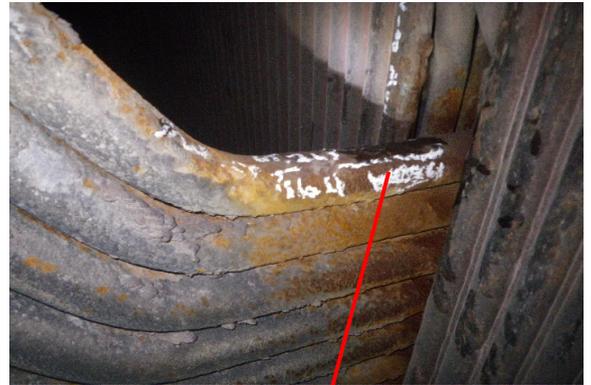
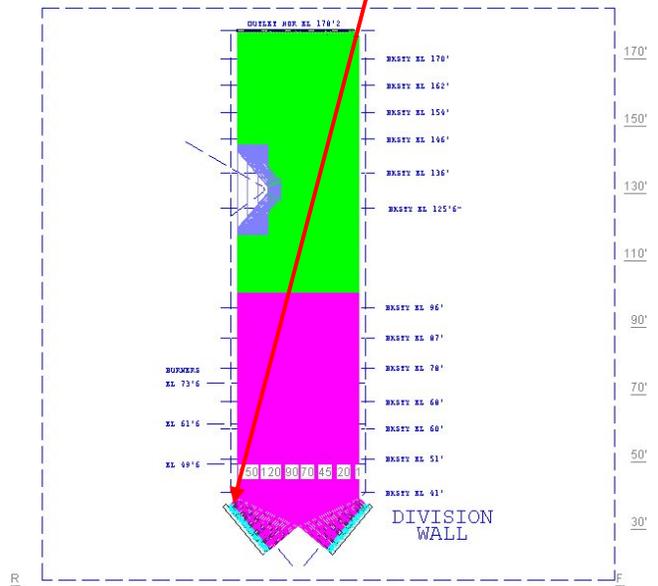
Cause: Erosion (Fly Ash)

The UT Data is .265

Pad-Weld approximately 12"x3" on the top center of the tube, approximately 5" below the 45 deg. elbow bend on **Tube 164** of the division wall due to a RWT of 0.265.

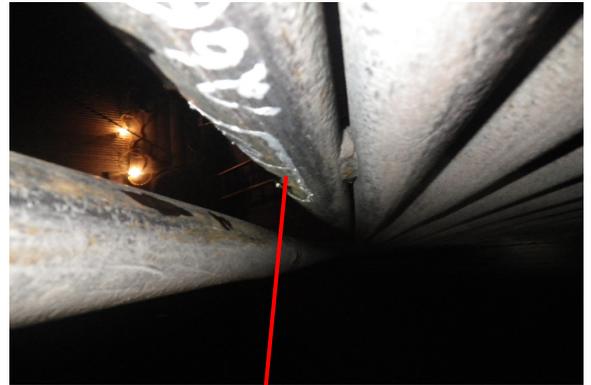
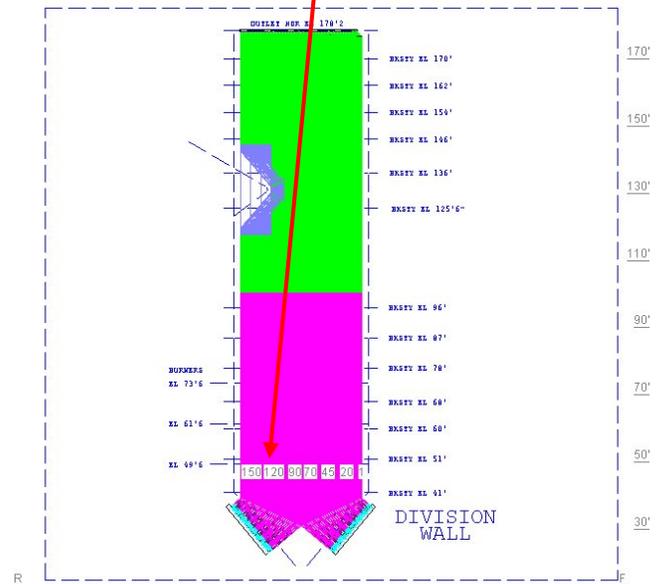
Cause: Fretting or Rubbing (Abrasion)

The UT Data is 0.266

Apply a 12"x3" Pad-Weld to **Tube 124** due to the tube to tube welds being broke causing the tubes to be abrading one another.

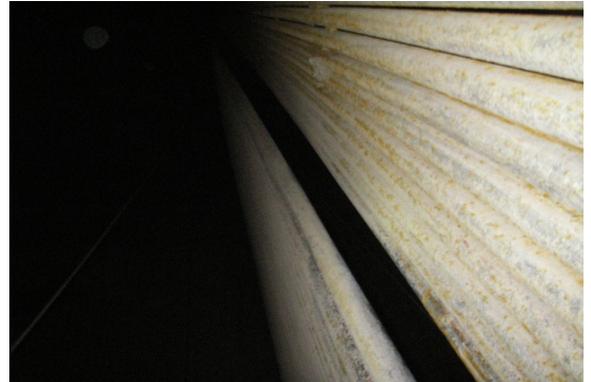
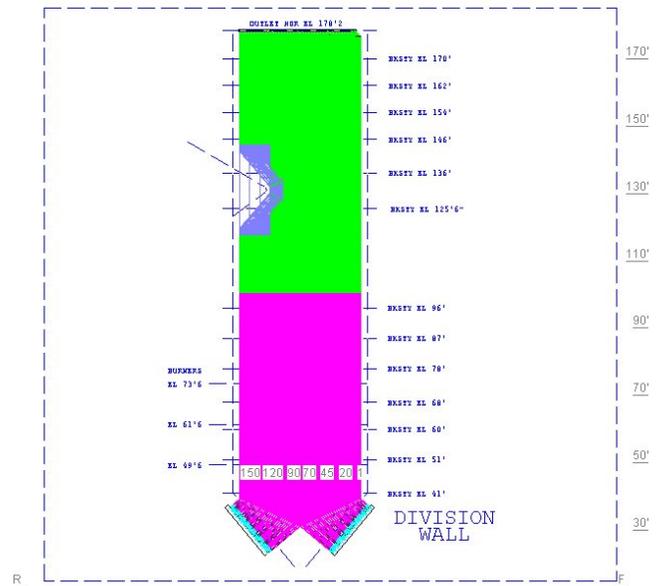
Cause: Fatigue (Thermal/ Vibration)

At present, the wall sections where
separated, allow for abrasion in the lower
sections.

Realign and panels and install tube to
tube tangent welds along the walls height
to restore wall sections to their intended
positions.

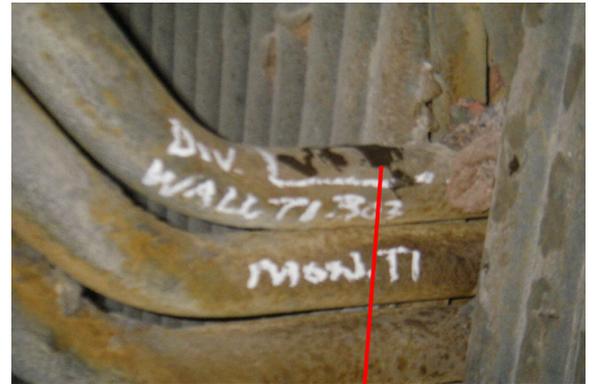
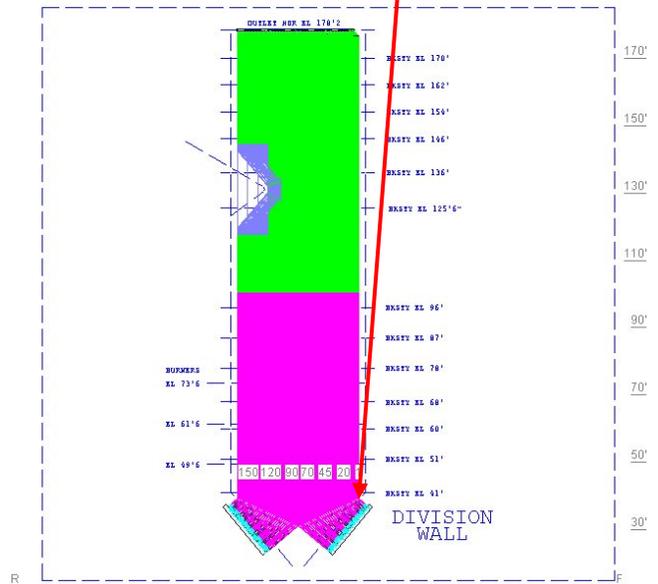
Cause: Erosion (Falling Slag)

Appearance: Eroded

The UT Data is .303

Monitor tube 1 of the division wall just
above the front lower slope penetration
where fallen ash erosion is impacting the
tube. The RWT was measured is .303".

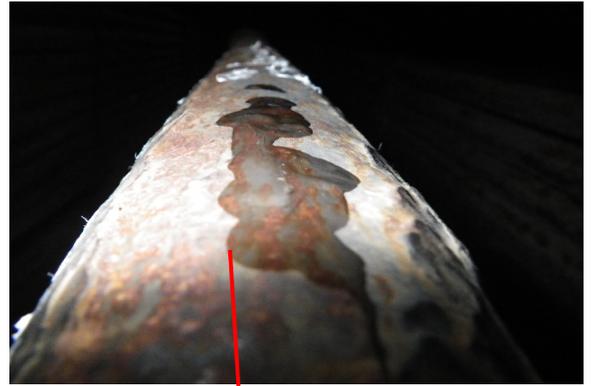
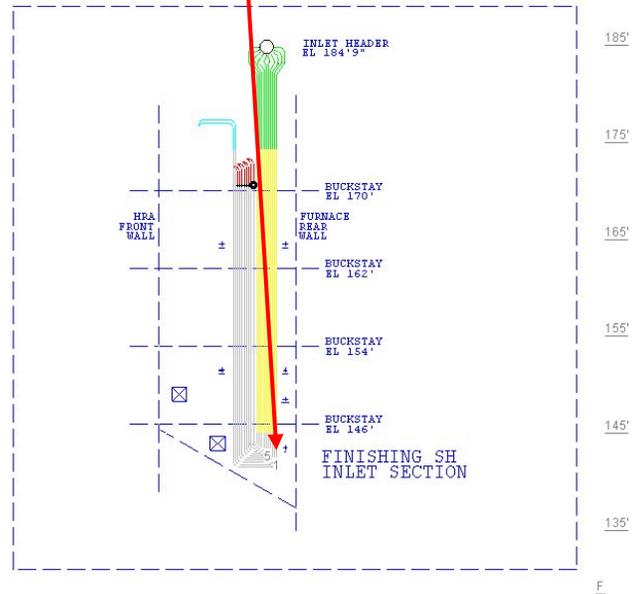
Cause: Erosion (Soot Blower)

31/2/.348"

33/2/.356"

Replace tube sections due to soot Blower erosion. The replacements should start at the vertical field weld approximately 3' above the 90 degree bend and extend 1' pass the horizontal bend on the following:

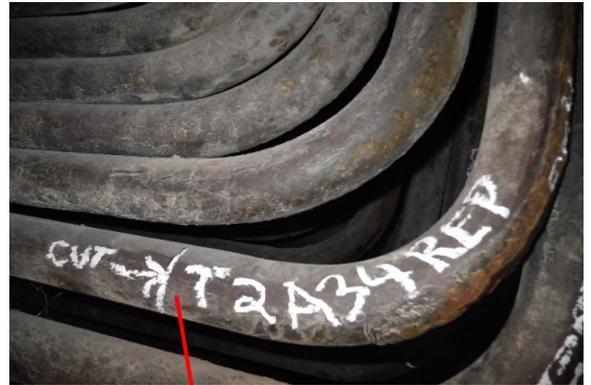
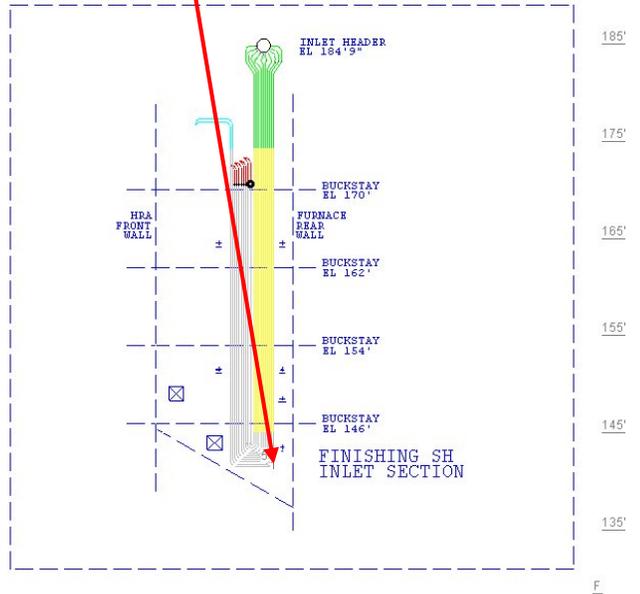
Cause: Erosion (Soot Blower)
Appearance: Eroded

- 25/1/.394"
- 26/1/.344"
- 27/2/.303"
- 31/1/.232"
- 31/2/.348"
- 33/2/.356"

The eroded areas are located at the front lower loops.

Replace 6' section of the following tubes due to Soot Blower erosion. The replacements should start 1' off the 90 degree bend on the horizontal section and extend to the field weld on the vertical section on the following:

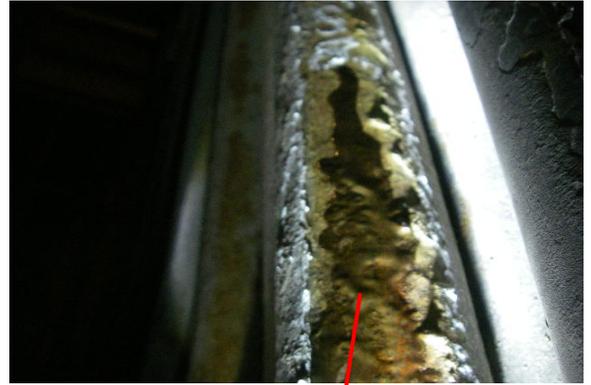
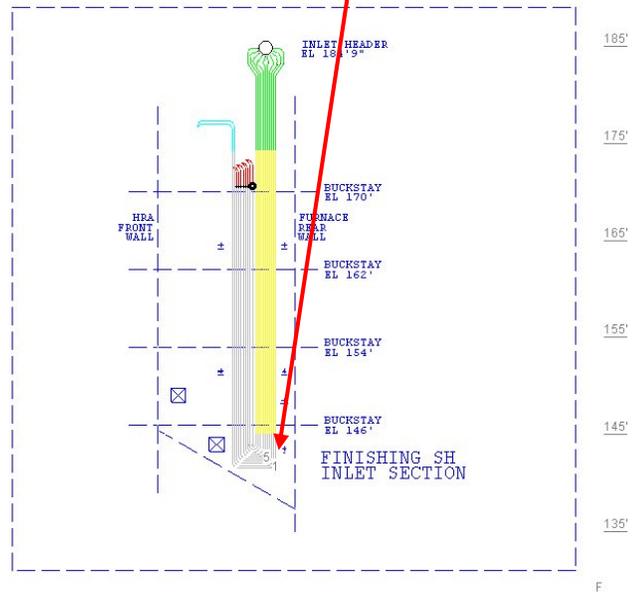
Cause: Erosion (Soot Blower)

33/1/0.417"/18"x3"

These eroded areas are located at or right above the front 90 degree bend at the front lower loops.

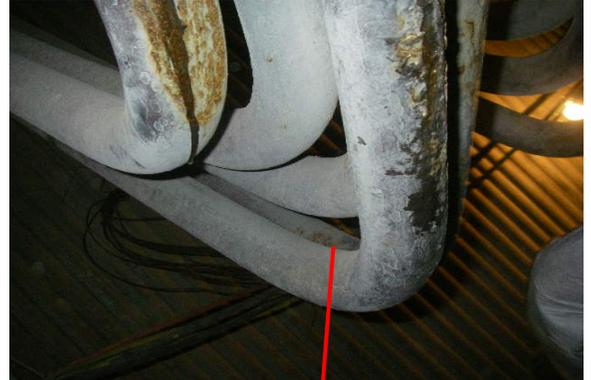
The hand cuffs are missing/broken on assembly 8, causing the tubes to be out of alignment.

Attach hand cuffs to tubes 1-20 for realignment and replace broken hand cuff on assembly 39.

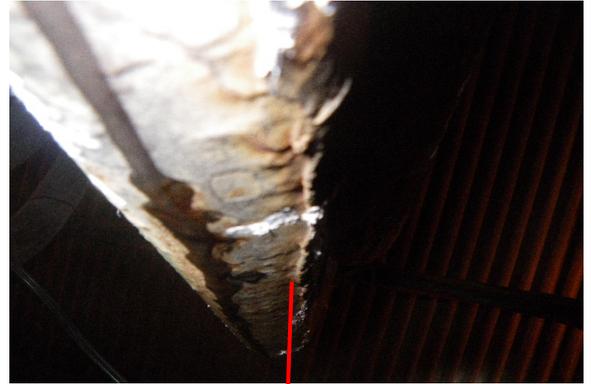
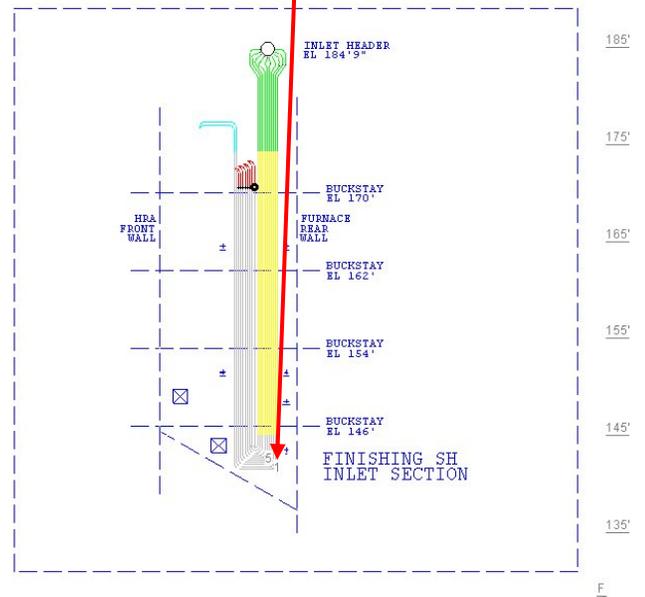
Cause: Erosion (Soot Blower)

- 25/20/NA
- 26/6/.500"
- 30/1/.498"
- 30/2/.506"

The eroded areas are located at the bottom of the inlet at the lower loops

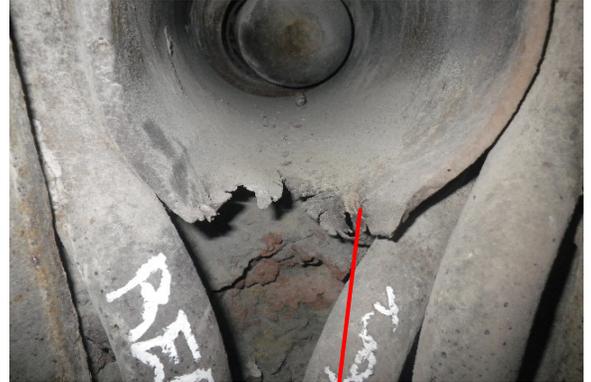
Cause: Fatigue (Thermal)

Appearance: Deteriorated

Replace Soot Blower lance sleeve due to thermal fatigue.

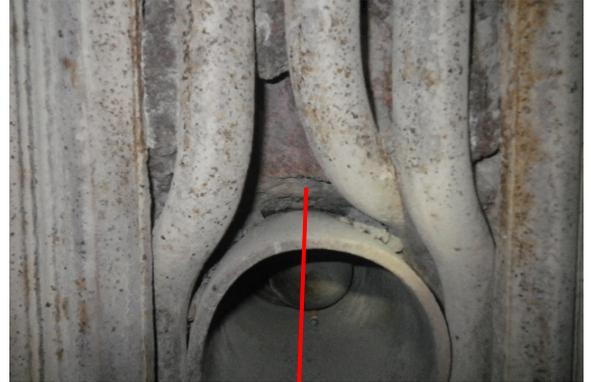
Cause: Fatigue (Thermal)

Appearance: Missing

Replace missing Refractory around IK-7/8 due to thermal fatigue.

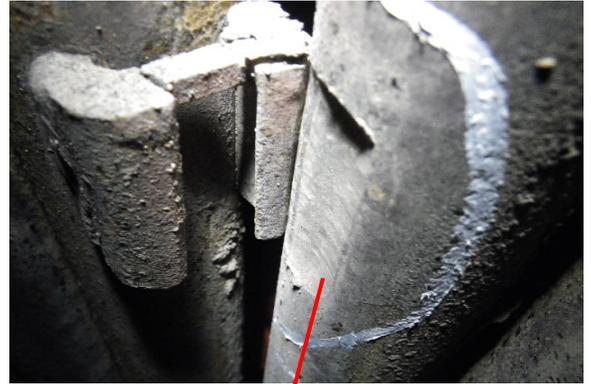
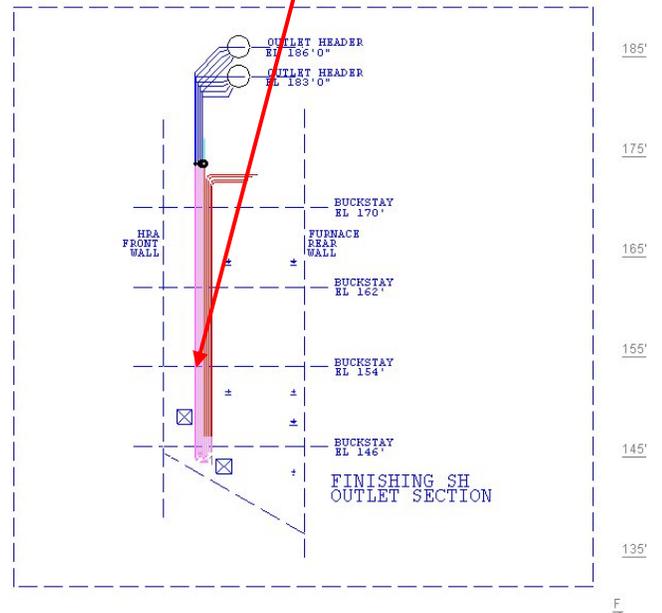
Cause: Fretting or Rubbing (Abrasion)
Appearance: Abraded

84/6

100/7

Apply 2"x3" pad-weld to the abrasions caused by the slip spacers, and re-attach the broken/missing slip spacers on the following:

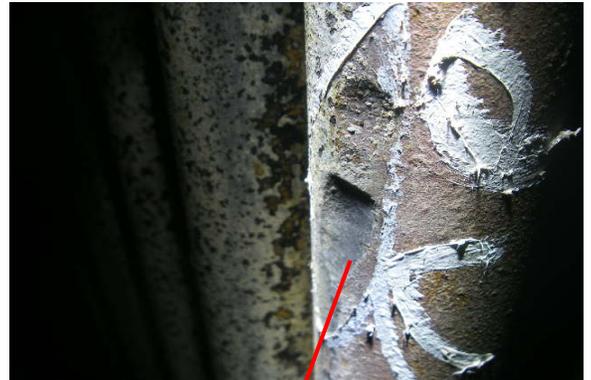
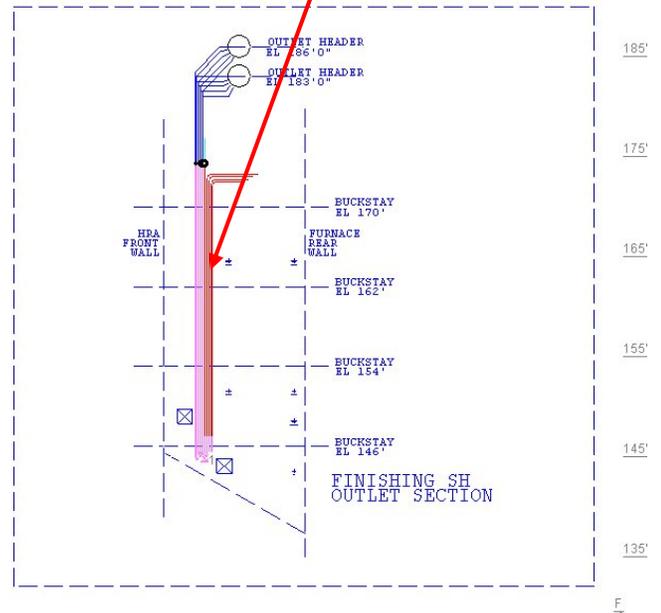
Cause: Fretting or Rubbing (Abrasion)

The abraded area is located approximately 2' down from the upper IK path at the front of the Finishing Superheat Outlet.

Apply 2" x 2" pad weld to the abraded area due to the adjacent handcuff.

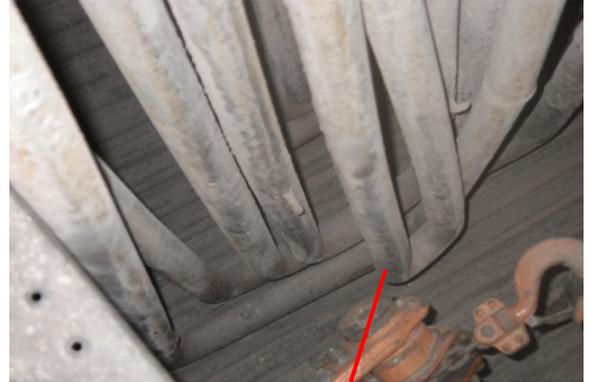
Cause: Fatigue (Thermal)
Appearance: Bowed Tubing

The same condition still exists and should be addressed in order to prevent the possibility of future boiler tube failures. The severity of the misalignment is causing the pendants to abrade one another; this abrasion appears to have caused failures in the past.

Refer to the February 2007 UDC Boiler Inspection Report. Report #3 Secondary Superheat Outlet, pages 6 through 8.

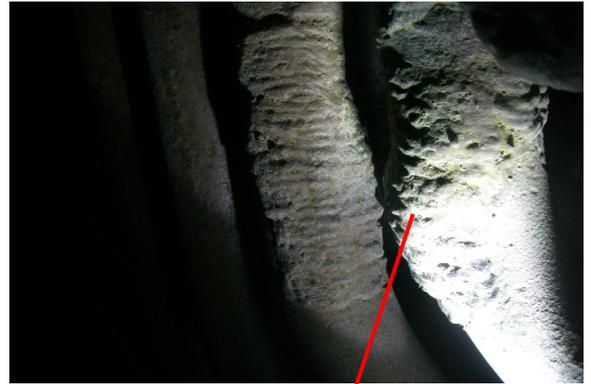
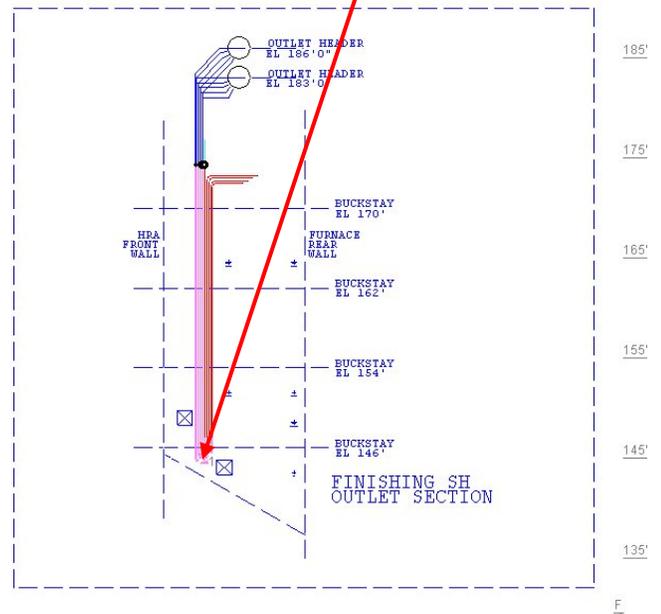
These pad welds are located at the lower loops of pendant 94.

Install approximately 2' dutchman due to excessive horizontal weaved pad welds.

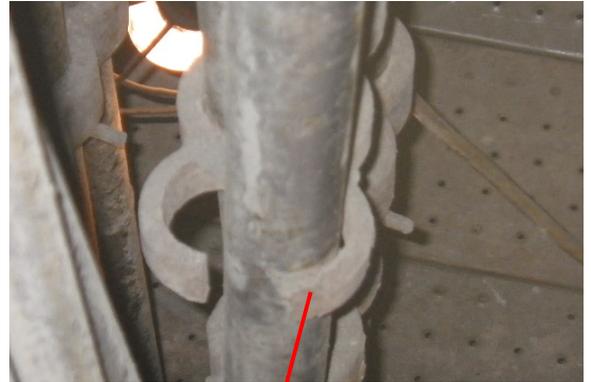
Cause: Fatigue (Thermal/ Vibration)
Appearance: Broken

Replace missing/broken Ring Castings (handcuffs). Approximately 20% of the Handcuffs are missing/broken in this area and need to be replaced to prevent from any further alignment issues in this area.

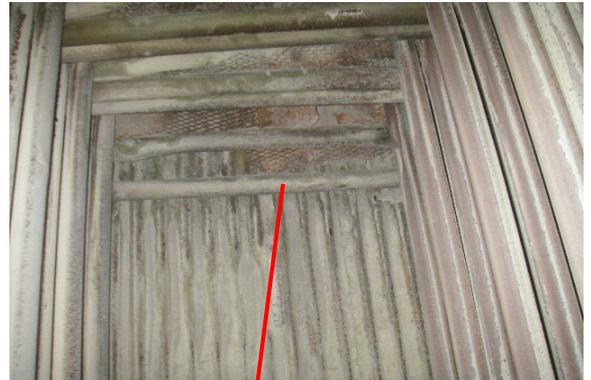
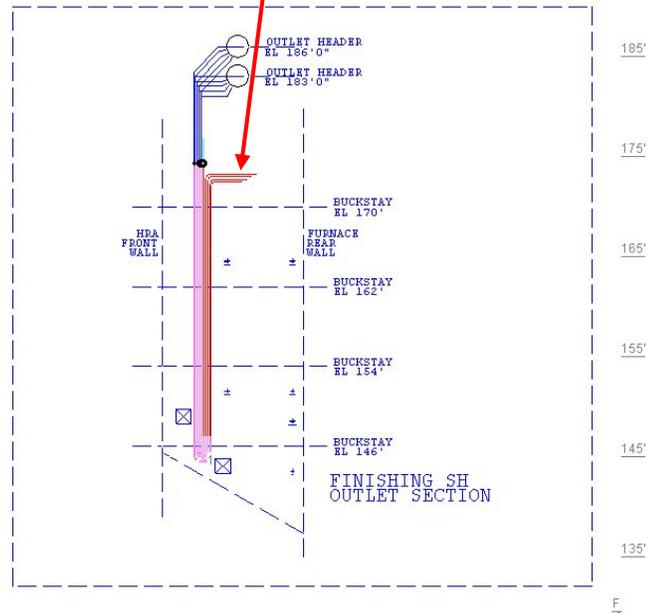
Cause: Fatigue (Thermal/ Vibration)

Tubes are dropped about 10" in this area.

Raise and reattach roof **tubes 447-448** where detached between the FSH Inlet/Outlet pendants.

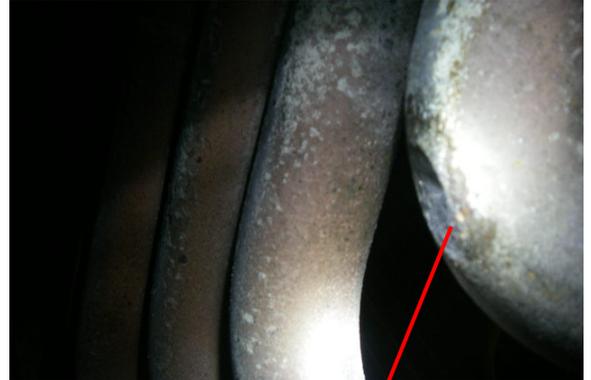
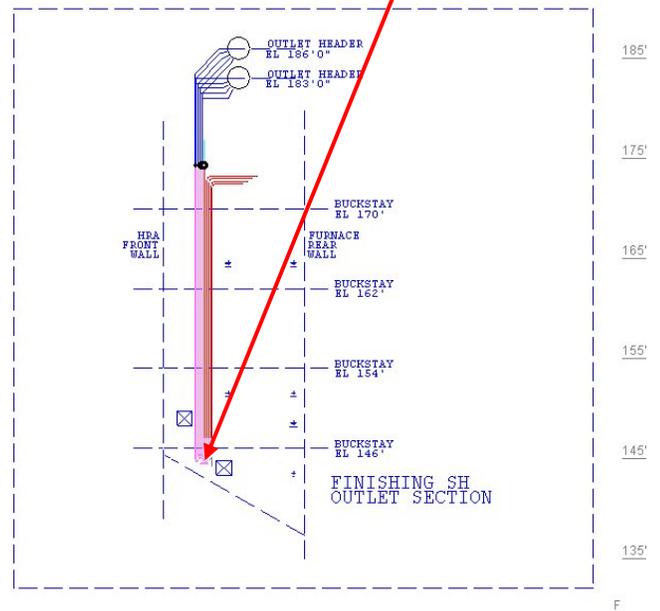
Specific location: Tube #:6 Element #:93
Elevation: 145'

Cause: Fretting or Rubbing (Abrasion)
Appearance: Abraded

These pendants appear to be swinging while the unit is online and are abrading the sides of the lower hair pin loops.

This abrasion is occurring randomly throughout the component. Monitor all during future outages.

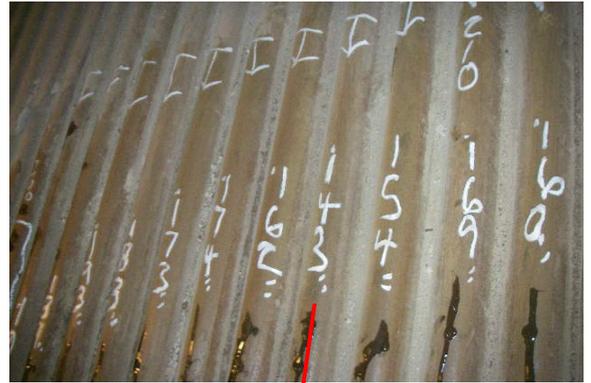
Elevation: 140'

Cause: Erosion (Soot Blower)
Appearance: Eroded

Material: 1.50" OD x .320" MWT x SA-213T22

If the tube is load bearing (hanger tube), temporarily support the tube before replacement is made. Verify replacement material before removing old tube section.

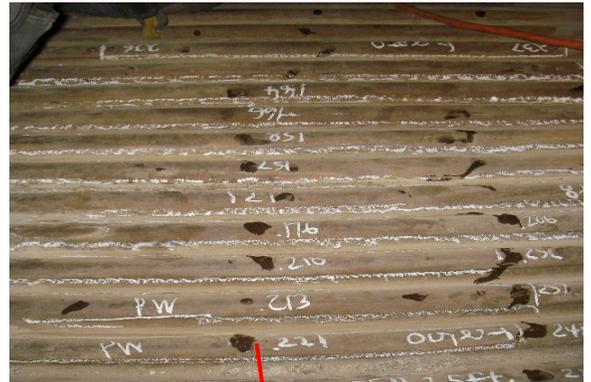
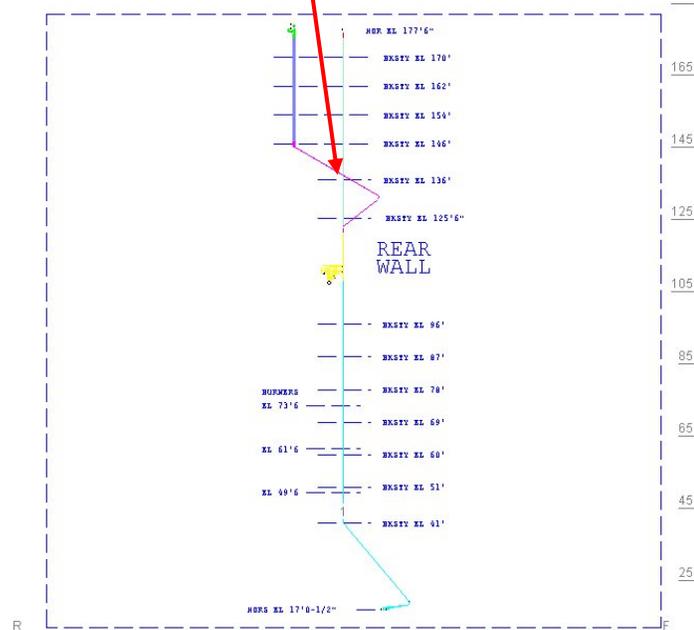
Cause: Erosion (Soot Blower)

255(.228)

All areas for repair are boxed in with a
white paint stick.
