Inspection Report

Station: Mitchell Unit: 1 Report Name: 1-WATER WALL FRONT

AREA: Water Wall Front

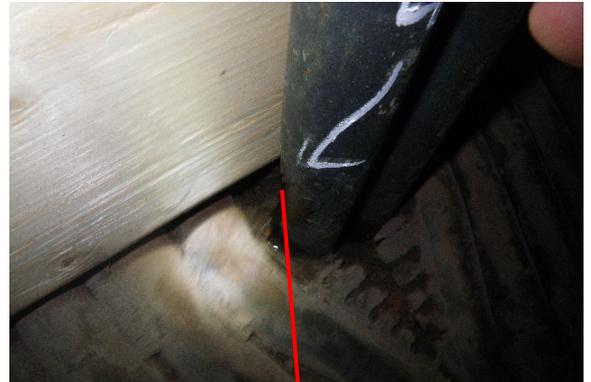
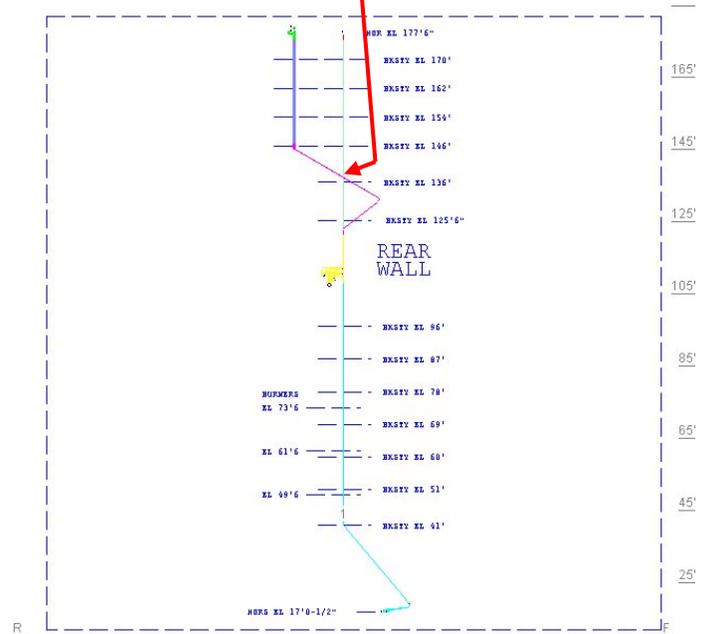
Cause: Erosion (Soot Blower and/or Falling Ash)

The lowest recorded UT reading was .334".

Install refractory at the base of all support tubes above the arch penetration to provide erosion and fallen ash resistance.

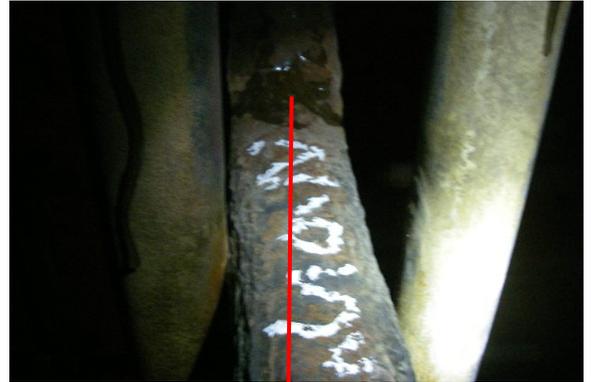
Specific location: Tube #:17 Element #:12
Elevation: 137'

Cause: Erosion (Soot Blower)

Appearance: Eroded

Install approximately 10' dutchman to the eroded area. The eroded area is at the front inner radius bend on **17F**. It is recommended to replace the entire lower loop of **tube 17** approximately 4' up on either side.

If the tube is load bearing (hanger tube), temporarily support the tube before replacement is made. Verify replacement material before removing old tube section.

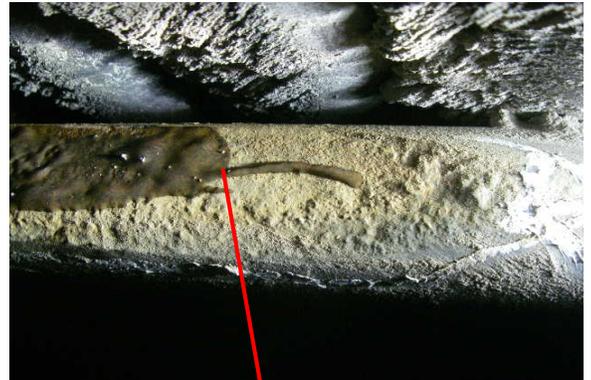
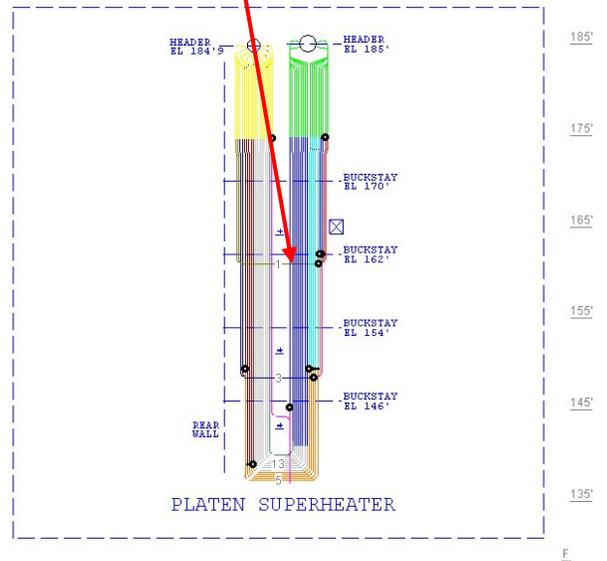
Cause: Erosion (Soot Blower)

This is at the top elevation of wrappers.

Install approximately 8' dutchman to the eroded area on **platen 23 tube 2F**. The eroded area is located on the top side of the wrapper. The front cutline will be just inside of the front 90 degree bend and the rear cutline will be just to the front of the rear 90 degree bend.

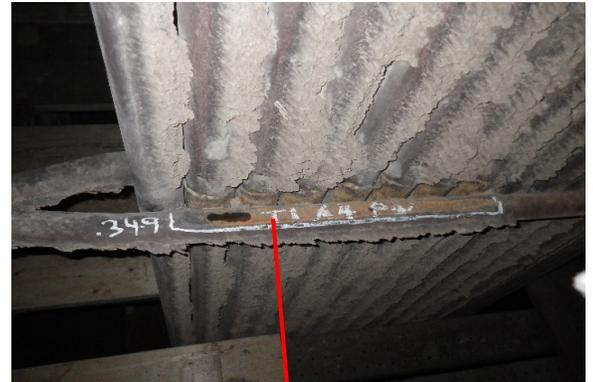
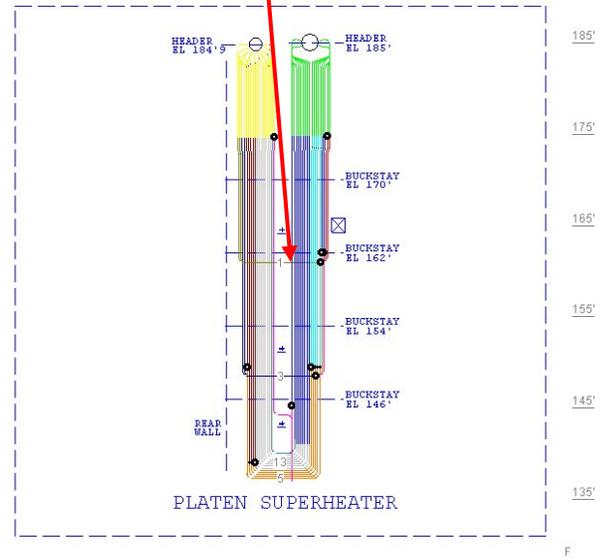
Cause: Erosion (Soot Blower)

NOTE: Monitor all the wrapper tubes in this area.

Use vertical stringers and feather (taper) by grinding all four of the edges at top, bottom, right and left orientations. Do not horizontal weave pad weld. Down hand is suggested to keep the temperature as cool as practical. Do not weld if copper deposition is present on the internal surface of the tubing. Use TIG if the tube remaining wall is less than .125".

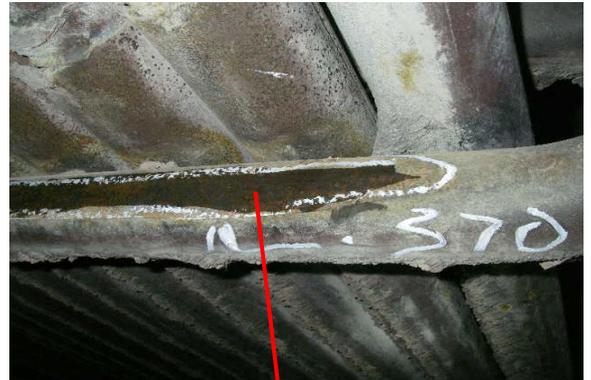
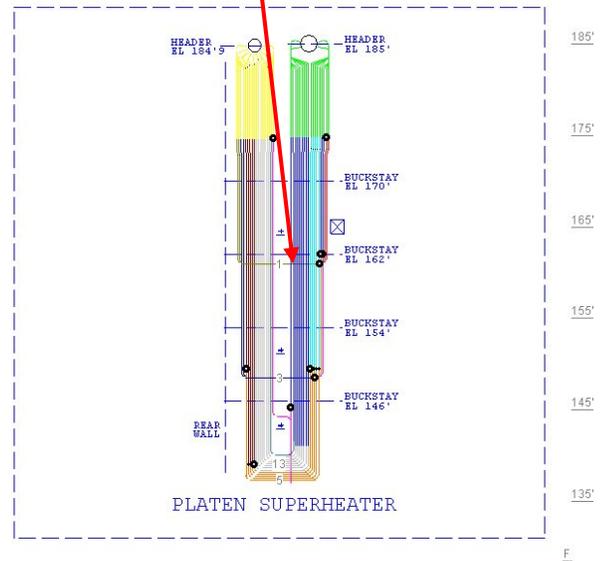
Cause: Erosion (Soot Blower)

The UT Data is .370

Apply 24" x 2" pad weld to the eroded area on **platen 25F tube 2F**. The eroded area is located to the top side of the 1st set of wrappers counting from the top down. The pad weld will start approximately 3' to the rear of the front 90 degree bend.

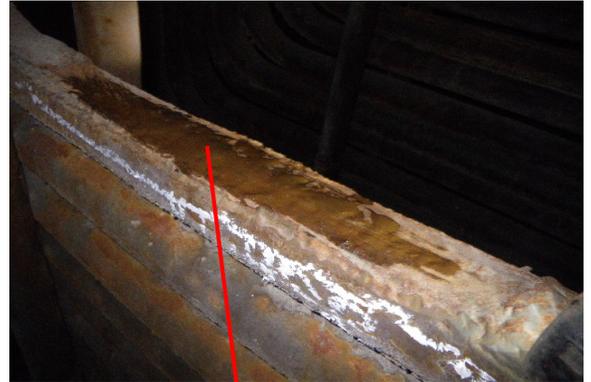
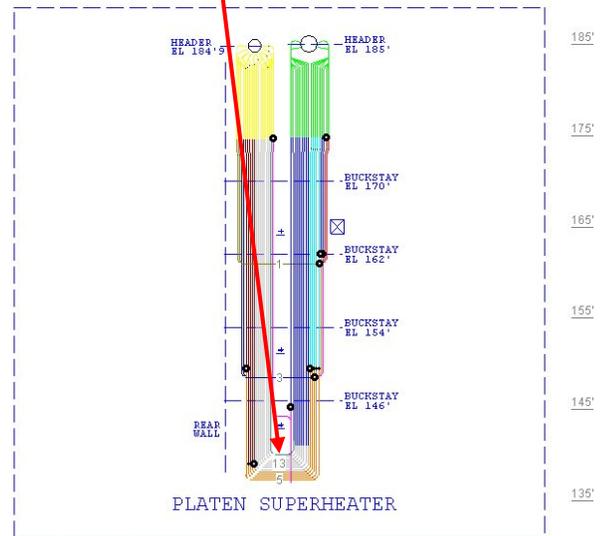
Cause: Erosion (Soot Blower)

The UT Data is .408

Apply one 36"x3" pad weld to restore **tube 17 lower loop assembly 15** due to soot blower erosion. The RWT was measured at 408".

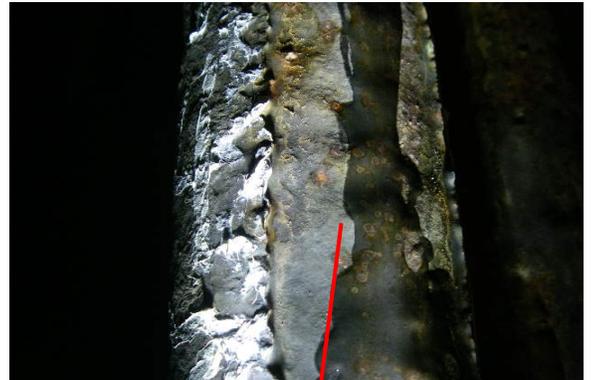
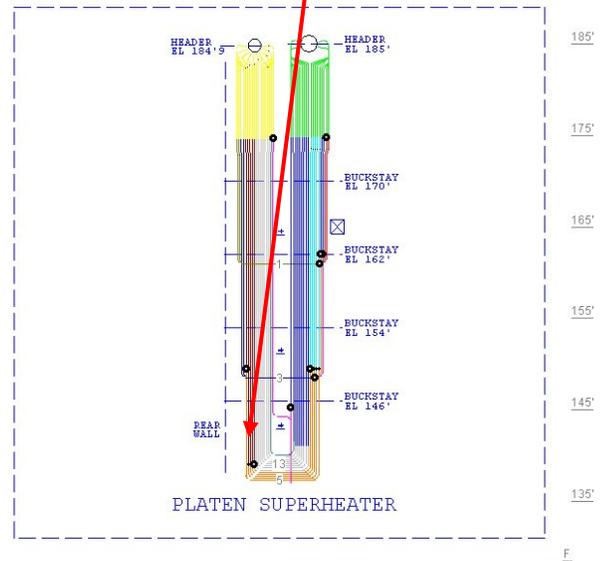
Cause: Erosion (Soot Blower)

The UT Data is .423

Apply approximately 24" x 2" pad weld to
the eroded area on **platen 12 tube 6R** on
the trail edge of the tube. This eroded
area is 5' up from the bottom of the
platen.

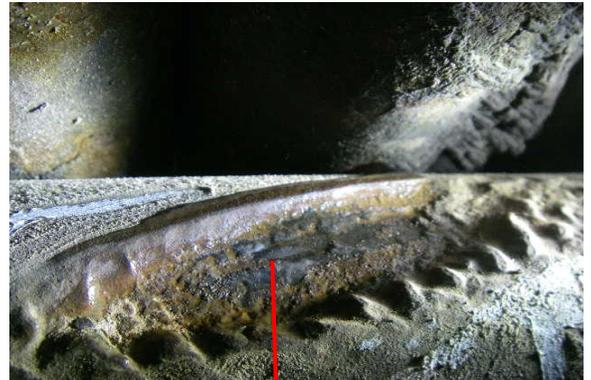
Cause: Erosion (Soot Blower)

26/ 4R/ 0.453"

The locations of the eroded areas are on the top side of the wrapper tube adjacent to **tube 17R**. Note: These tubes don't fall into pad weld criteria, but due to the sharp edge erosion UDC recommends pad welding.

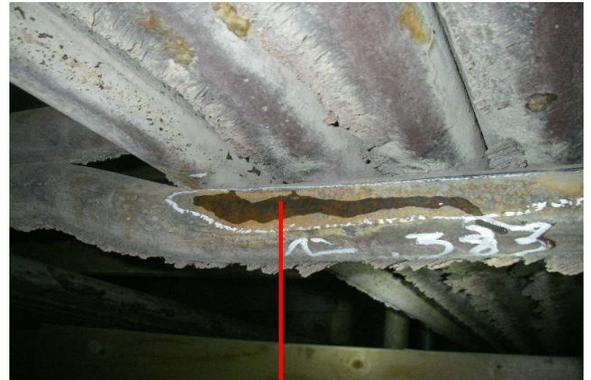
Cause: Erosion (Soot Blower)

Note: This tube doesn't fall into pad weld criteria, but due to the sharp edge erosion UDC recommends pad welding.

Apply approximately 12" x 2" pad welds to the eroded area on **platen 25 tube 2R**. The location of the eroded area is on the top side of the wrapper tube adjacent to tube 17R.

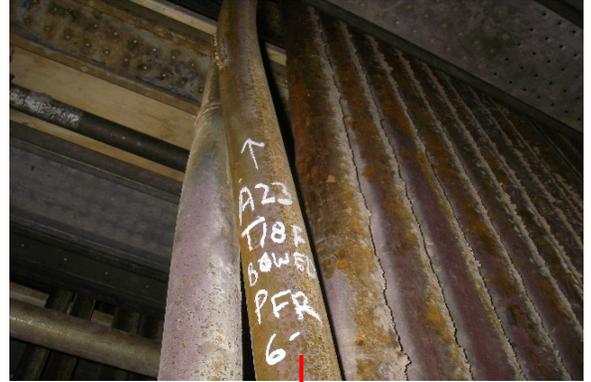
Material: 2.5" OD x .593" MWT x SA-213-
TP321H

Due to excessive bowing, plan for future
replacement Tube 18R at Assembly 23.

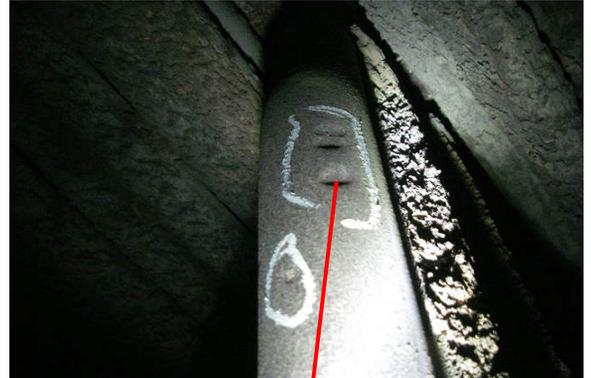
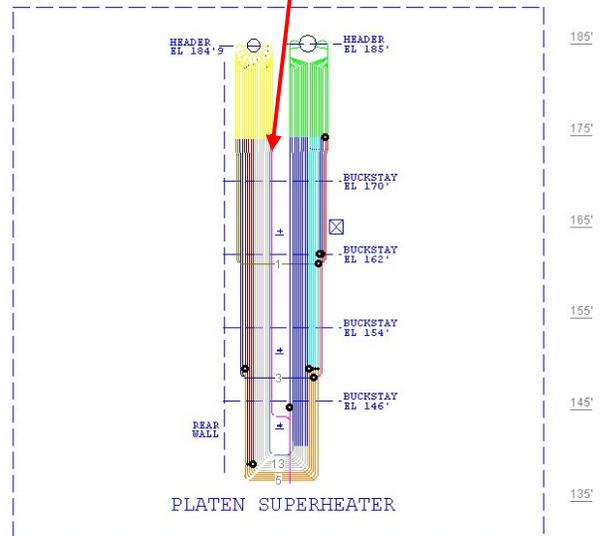
Cause: Impact Damage (shot gun)

Appearance: Shot Gum Damage

Material: 2.0" OD x .296" MWT x SA-
213TP321H

Install 24" dutchman when time permits due
to shot gun dents approximately 12" down
from the roofline. The dents are located at
the leading edge of **platen 24 tube 18R**.

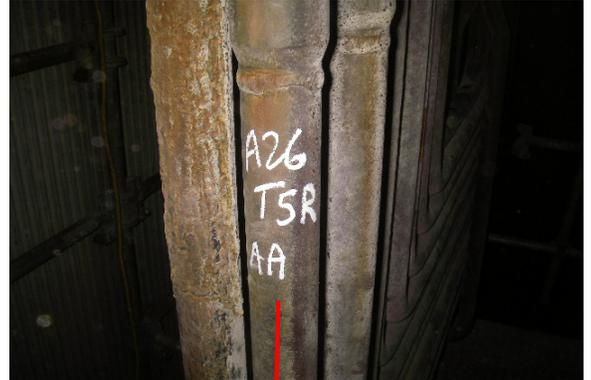
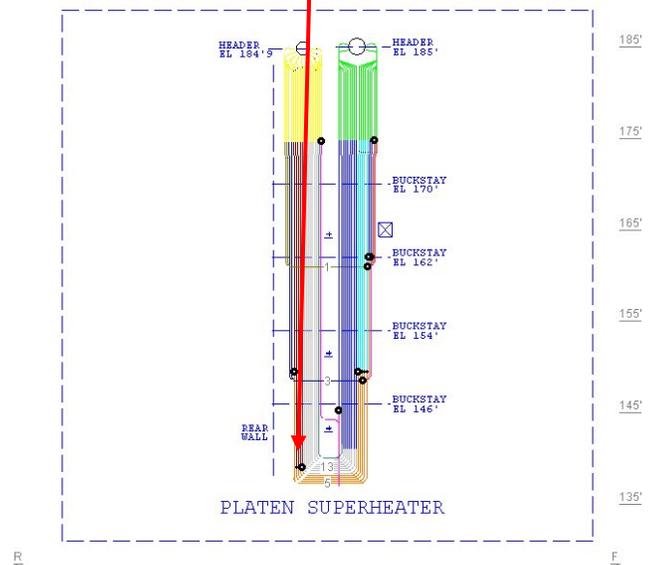
Cause: Fatigue (Thermal/ Vibration)

Material: 2.5" OD x .593" MWT x SA-250T22

Align and attach (AA) **tubes 5-7** at the lower side at most of the 26 total assemblies to prevent reduce channeled soot blower erosion at the rear of the pendants.

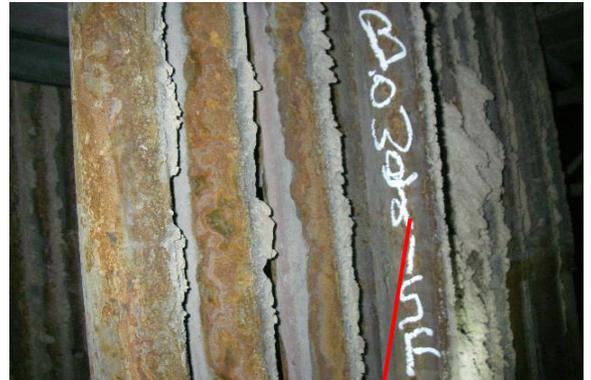
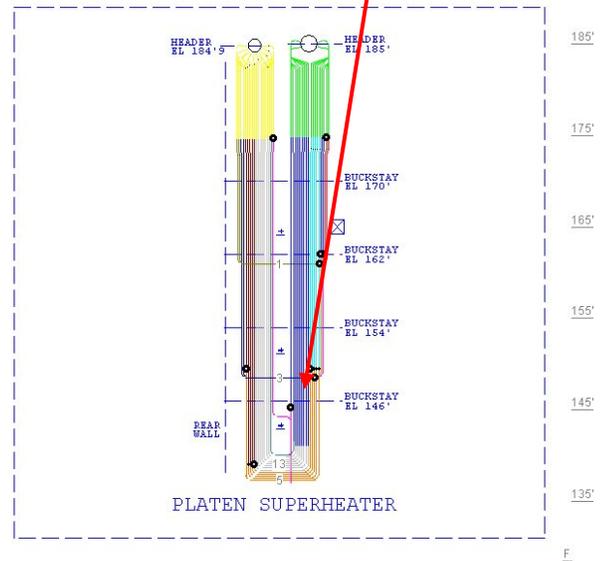
Cause: Fatigue (Vibration)

15/ 15F

These tubes are bowed out approximately 1 tube diameter at the 2nd wrapper elevation counting from the top down.

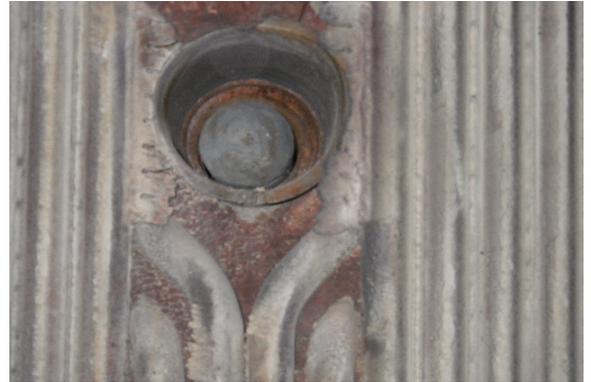
Cause: Fatigue (Thermal)

Appearance: Missing

The IK/IR is 1/2 3/4 5/6

Replace Refractory on *IK's 1-6* due to missing/broken Refractory.
