Inspection Report

Station: Mitchell Unit: 2 Report Name: 1-Reheater High Pressure

AREA: Reheater High Pressure

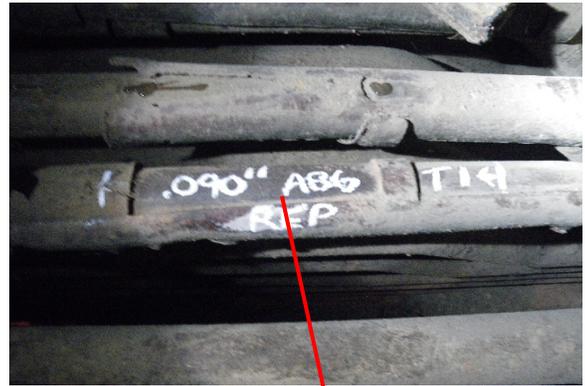
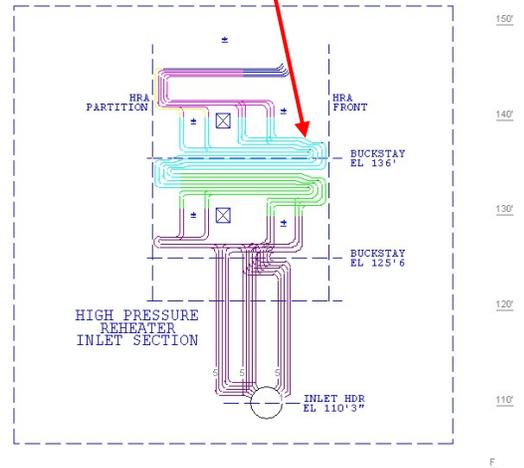
General location is Reheater High Pressure,
Bank 2 Top, Front.

Cause: Erosion (Soot Blower)
Appearance: Eroded

The UT Data is .090

**Replace tube 1 of assembly 86 for a length of
2' due to a RWT of 0.090".**

Note: Prior to completing repair, remove
shield remnants to determine any further
damage and lengthen repair if necessary.

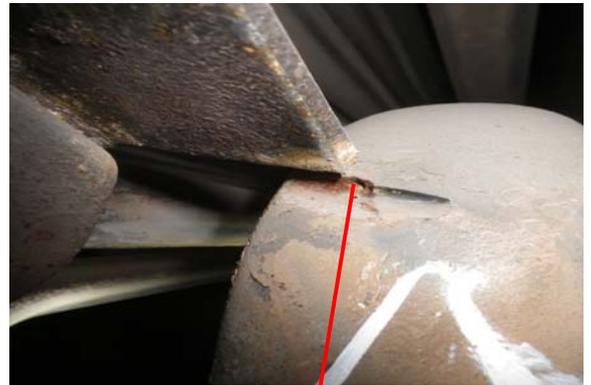
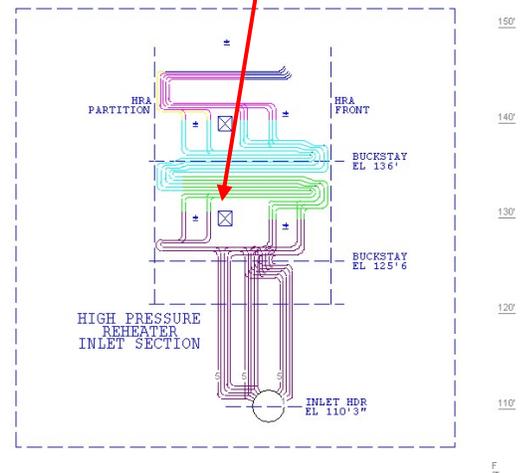
Cause: Fretting or Rubbing (Abrasion)

Spacer cane has abraded a hole in the tube
causing failure.

**Replace a 2' section of tube 1 assembly 199
encompassing the 90 degree bend.**

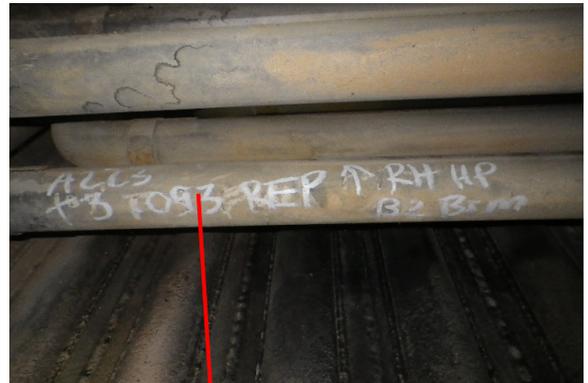
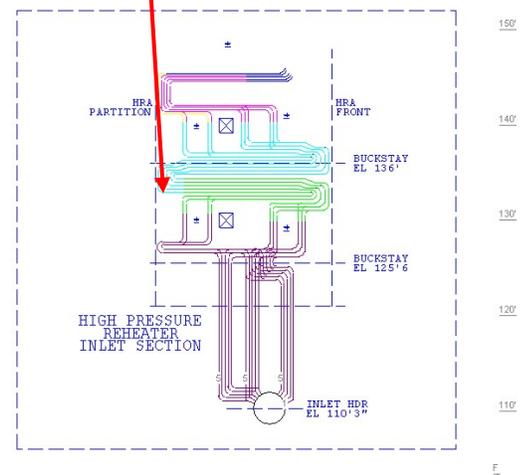
Cause: Erosion (Fly Ash)

NOTE: Erosion flats could also be felt on tube 4 near the inside radius at an eroded through shield. Tubes were counted up from the bottom.

Replace the loop section of Tube 3 at Assembly 223 due to erosion occurring adjacent to the side wall. Front cut-line should extend to the front approximately 1' and extend up through the loop into the vertical section for about 6".

Verify replacement material before removing old tube section.

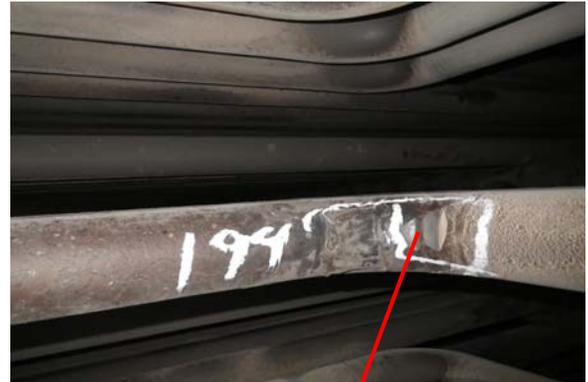
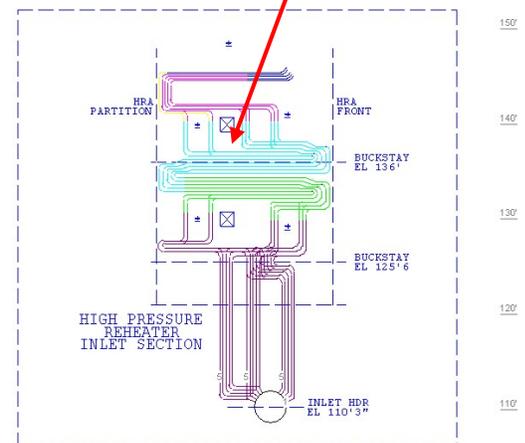
A194/T1

Cause: Fretting or Rubbing (Abrasion)

Both tubes are gouged, however the mechanism
is no longer present.

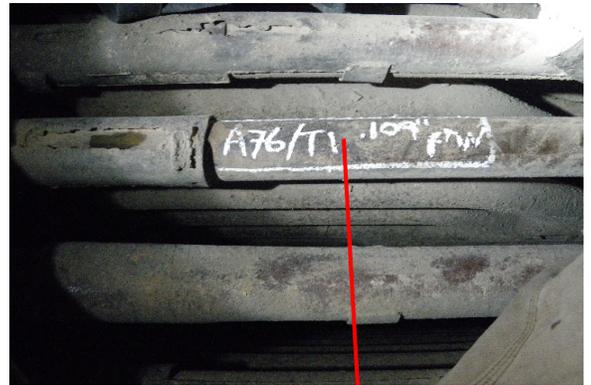
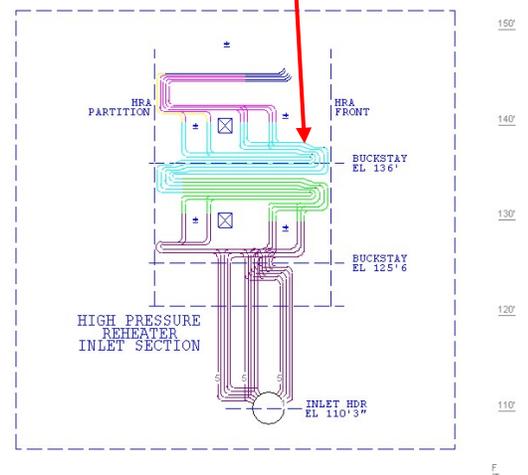
Cause: Erosion (Soot Blower)

Due to a remaining wall thickness between 66%
to 75% of MWT, the following are recommended
for pad weld repair:

The pad weld will encompass the area of wall loss which has been denoted on
tubing by a white box.

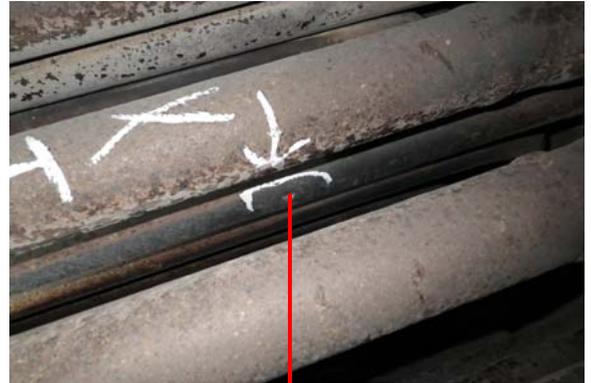
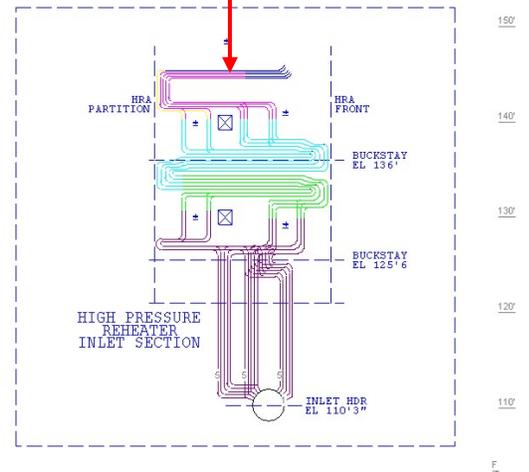
Cause: Work Quality (Maintenance Damage)

**Restore tube 2 of assembly 19 to MWT by
applying a 1" x 1" pad weld due to estimated
RWT of 0.237".**

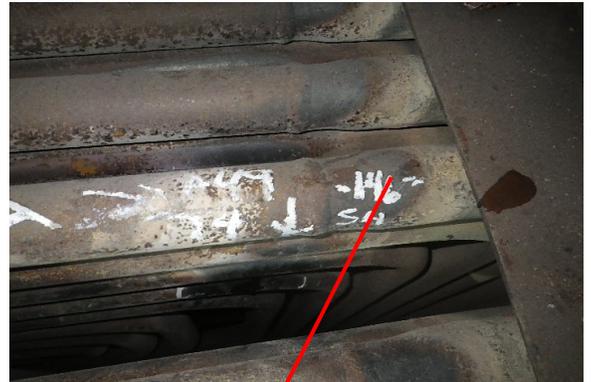
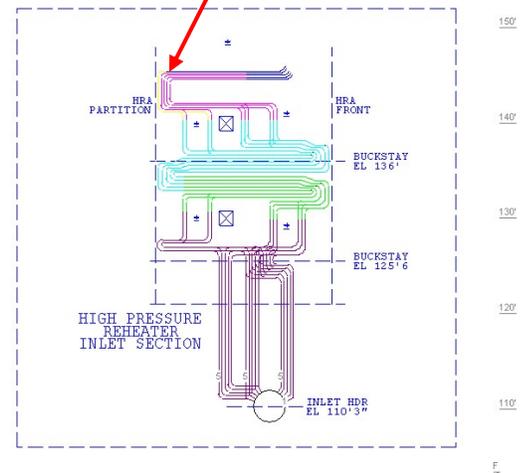
Cause: Erosion (Fly Ash)

NOTE: Photo depicts (SH) for shield, however,
the tube is actually just into pad weld
criteria.

Apply one pad weld to Tube 4 of Assembly 49
near the partition wall. Repair area is
marked on the right upper side of the tube
and is about 6" in length.

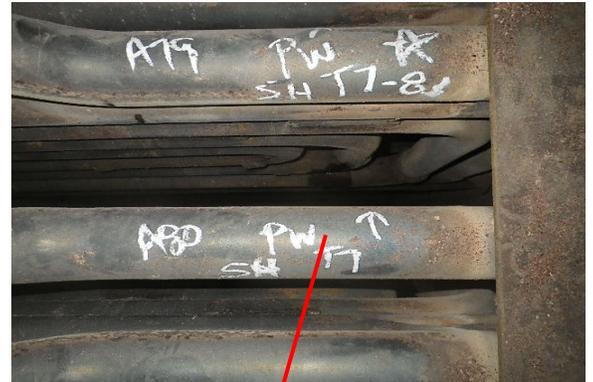
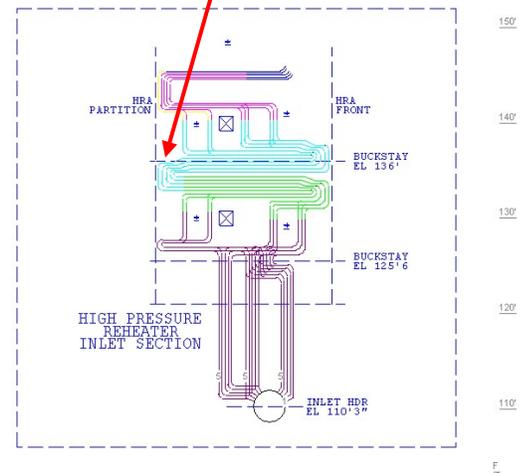
Cause: Erosion (Fly Ash)

Repair area is where shields have eroded through and appear visually to be in weld repair criteria.

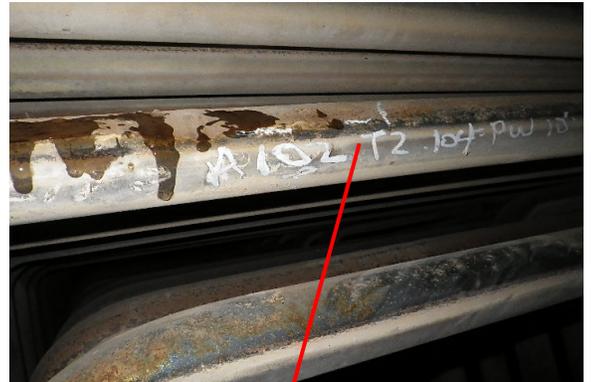
Cause: Erosion (Fly Ash)

Apply one approximate 12" pad weld to Tube 2 at Assembly 102 due to fly ash erosion on a previous weld repair. Repair is on the top side of the tube in the rear blower path.

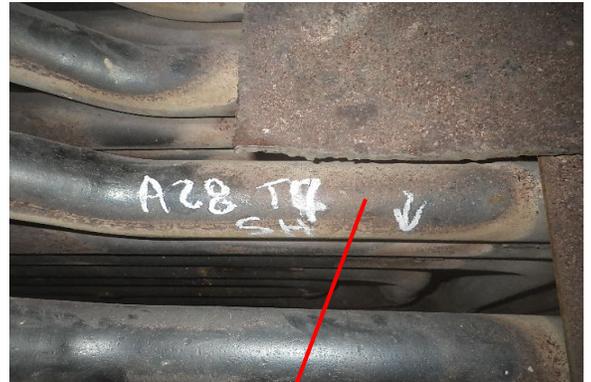
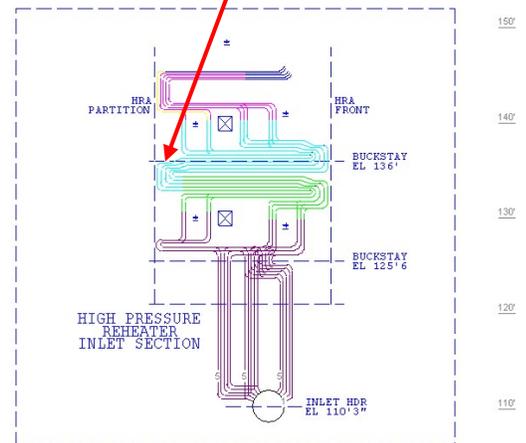
Cause: Erosion (Fly Ash)

Possibly as much as 50% of the shields located on the inside radius of Tube 7, near the partition wall, has been eroded through with varying degrees of tube erosion present. Replace shields and evaluate the RWT at the following Assemblies:

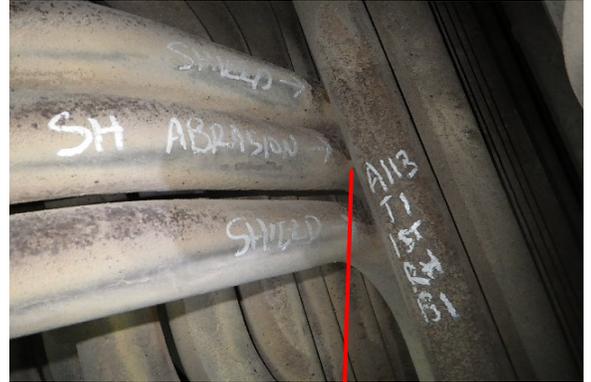
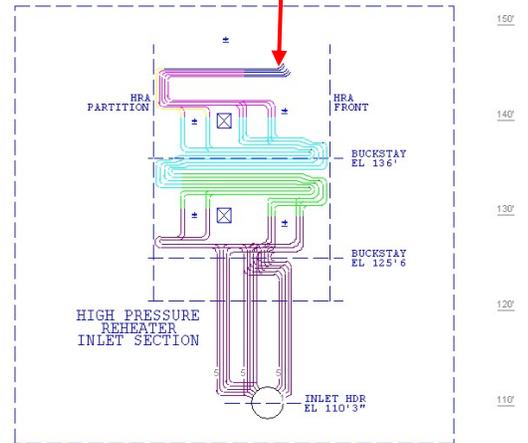
Cause: Fretting or Rubbing (Abrasion)

It is recommended that three wear shields be installed on the vertical tubes adjacent to Assembly 113, Tube 1 to halt the abrasion that is occurring there. Shield length should be about 6" in length and may require a radius bend on the lower ends.

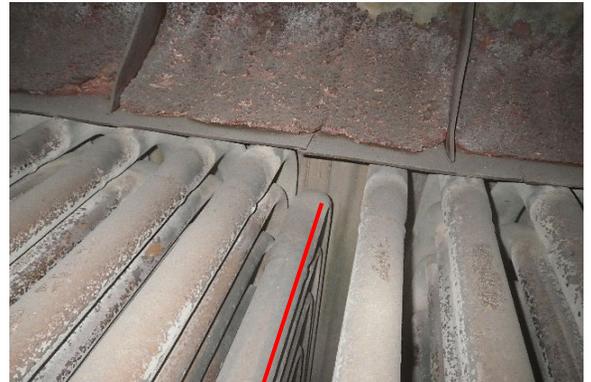
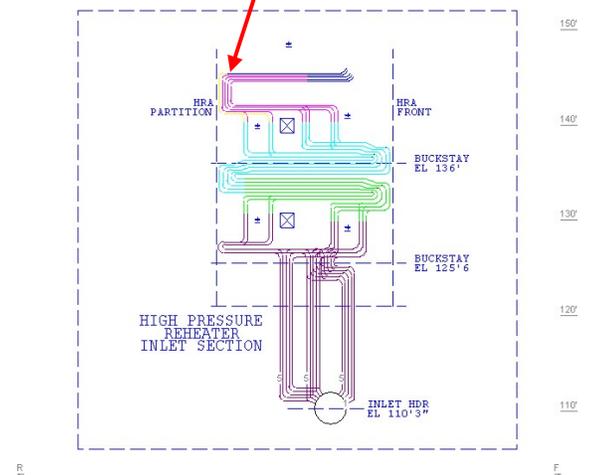
Cause: Fatigue (Thermal/ Vibration)
Appearance: Detached

Raise these assemblies and reposition them back onto their respective rear wall
support brackets.

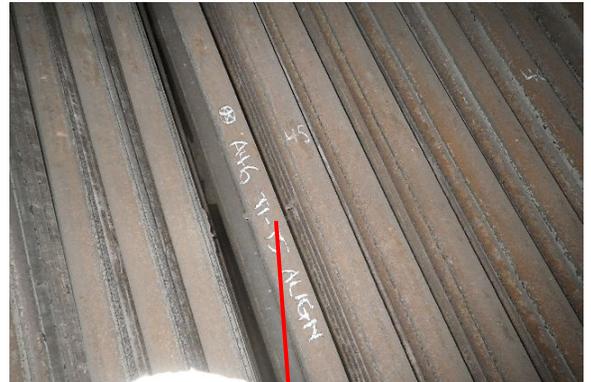
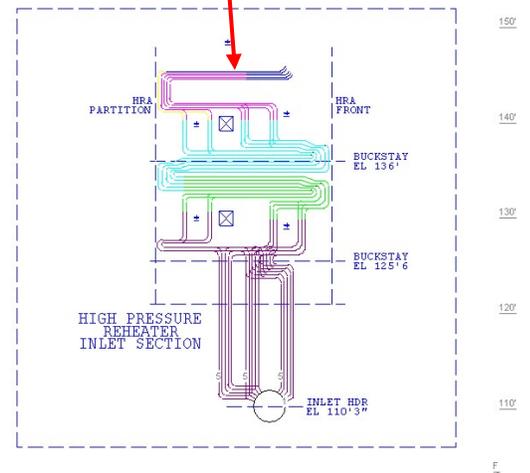
Cause: Fatigue (Thermal/ Vibration)
Appearance: Misaligned

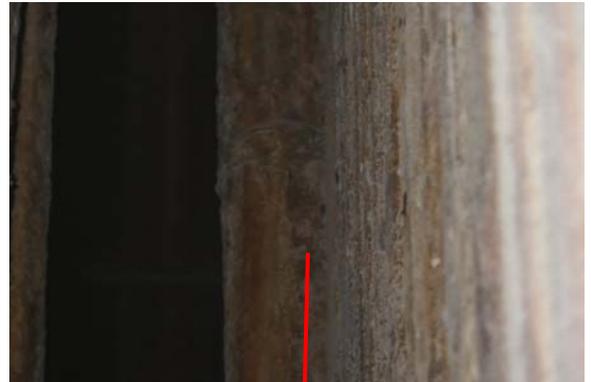
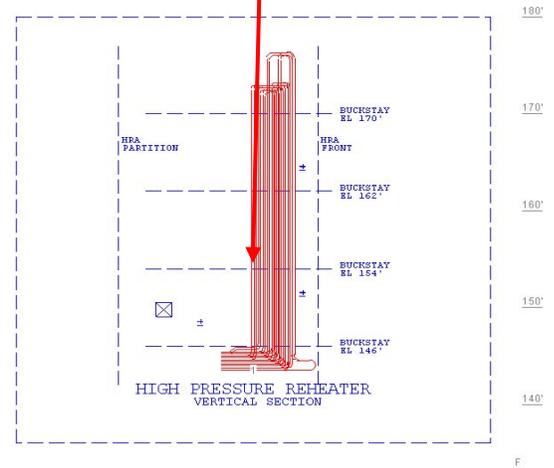
Cause: Thermal Fatigue

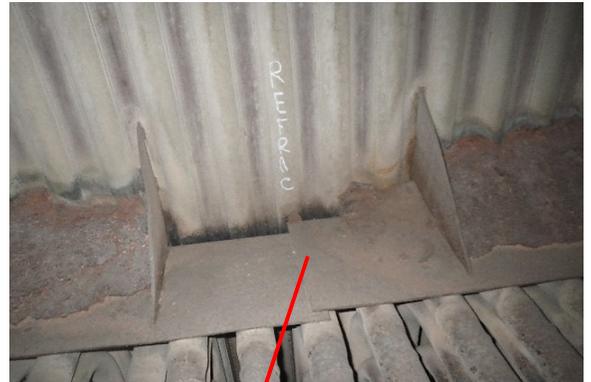
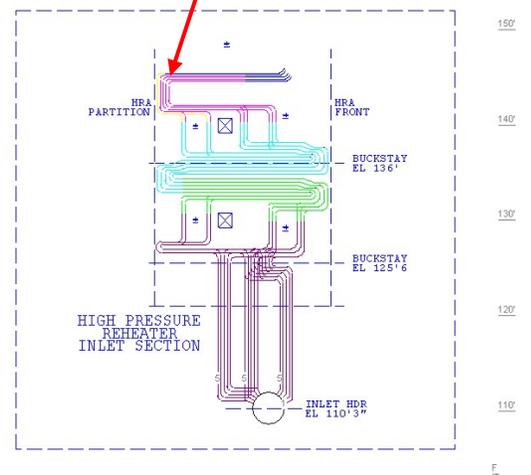
Cause: Erosion (Falling Slag)

Appearance: Missing

Replace missing refractory along rear wall
at the following horizontal assemblies:

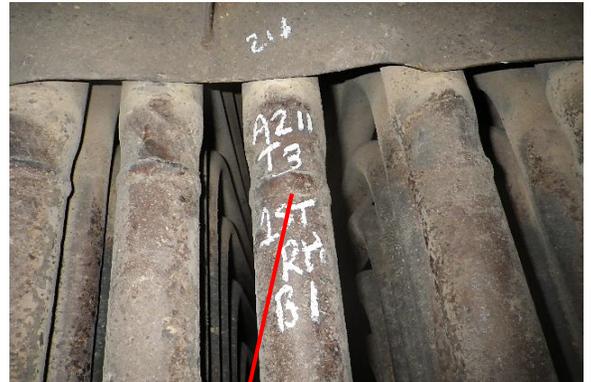
Cause: Erosion (Fly Ash)

Install one 6" shield to Tube 3 at Assembly 211 due to fly ash erosion. Repair is at the upper left side of the tube where gouging erosion is occurring. No UT was possible due to tube surface condition.

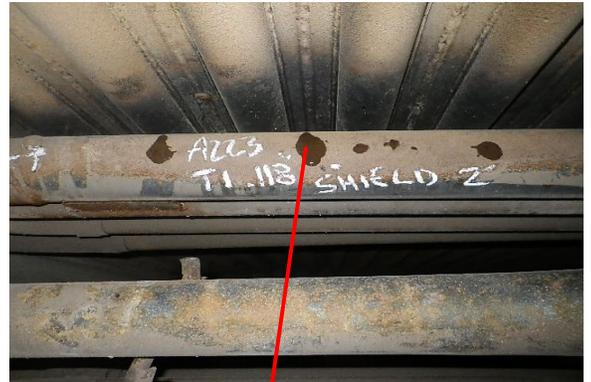
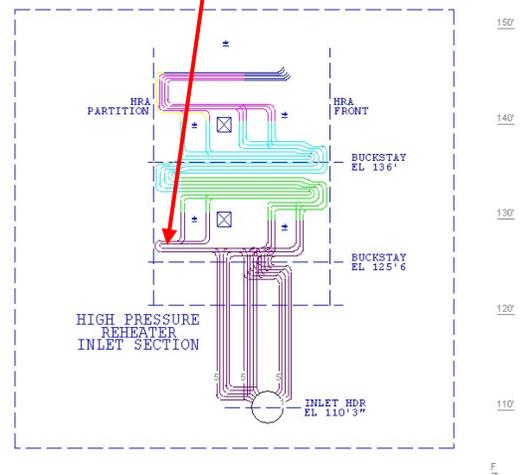
Cause: Erosion (Fly Ash)

The UT Data is .118

Install one 2' shield at Assembly 223 Tube 1
beginning at the partition wall solid baffle
plate and extend towards the front for the
given length.

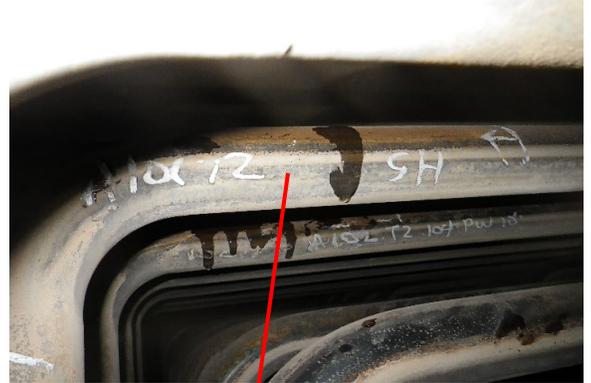
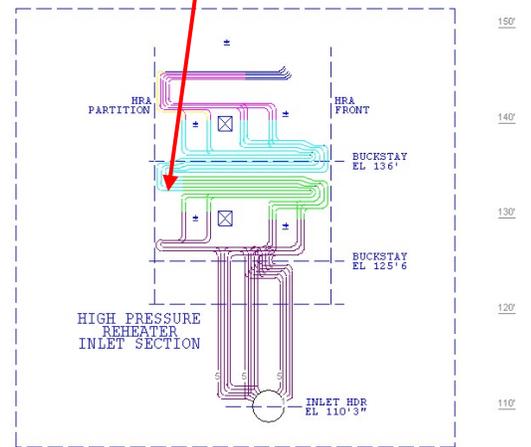
Cause: Erosion (Fly Ash)

Install one 12" shield to Tube 2 at Assembly 101 due to fly ash erosion on the top side of the tube. UT readings could not be obtained due to surface profile but visually, appears to be at or near shield criteria.

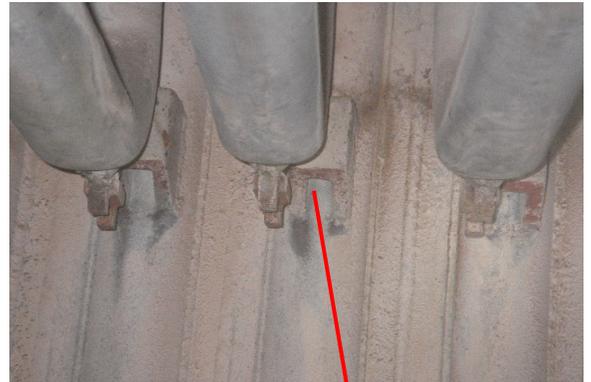
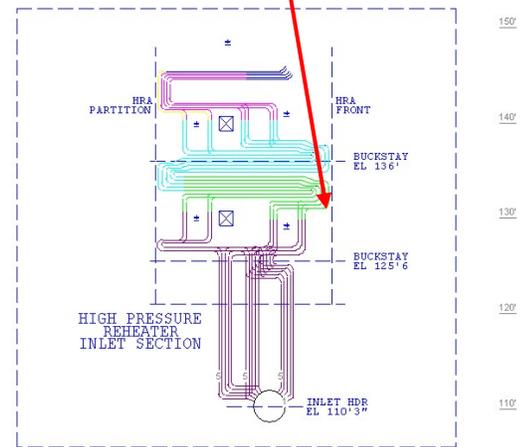
Cause: Fatigue (Vibration)

Raise, align and attach the support saddles
to their associated support bracket on the
front HRA wall. Approximately 25% of the
assemblies have dislodged from the associated
supports.

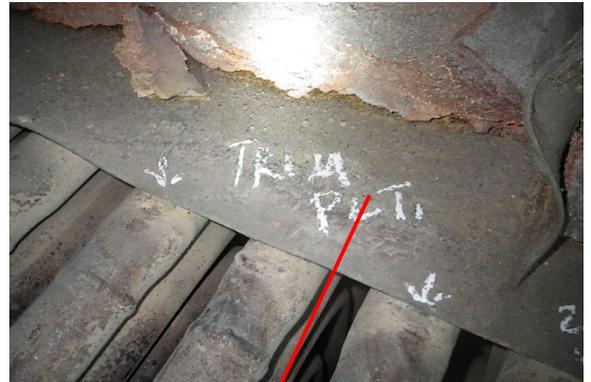
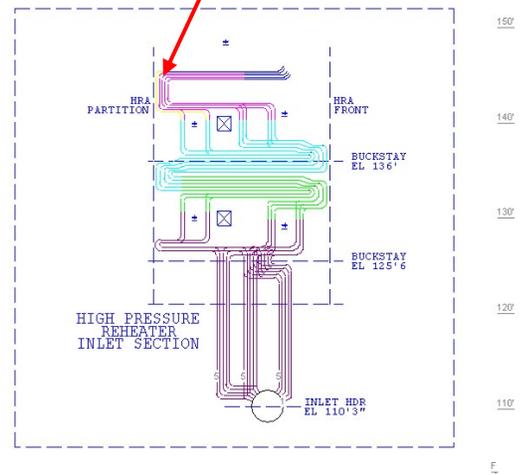
Cause: Fretting or Rubbing (Abrasion)
Appearance: Abraded

Trim back or replace the solid deflection
plate where marked to prevent the abrasion
that is occurring from the plate to tube
surfaces.

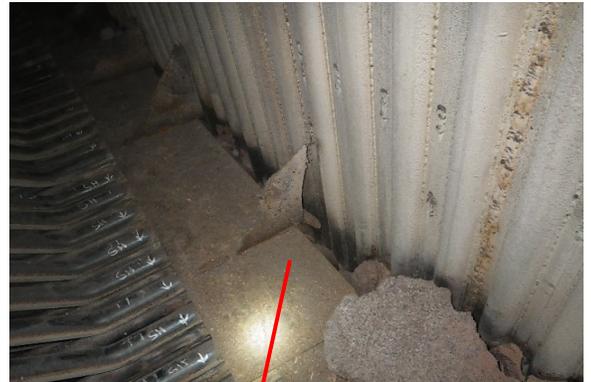
Cause: Fatigue (Thermal/ Vibration)

Reattach or replace two (2) sections of solid
baffle plate and gussets at the partition
wall roughly between assemblies 90-110.

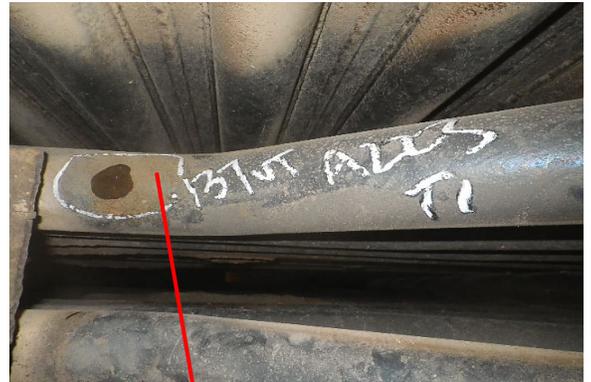
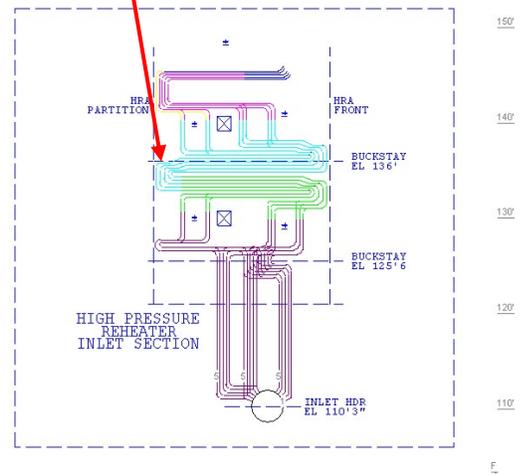
The Final Risk Index Number is 3

Monitor the area adjacent to the partition
wall baffle plate at Assembly 223, Tube 1. UT
reading was 0.137 near the plate.

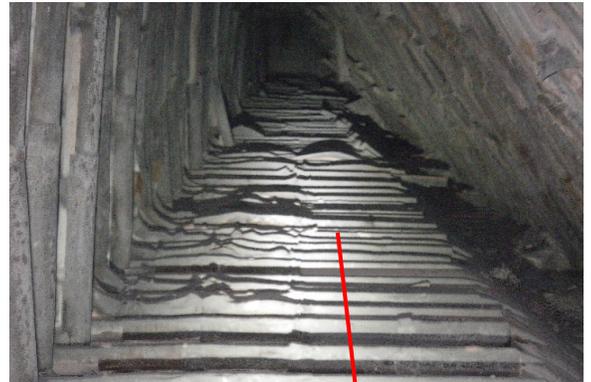
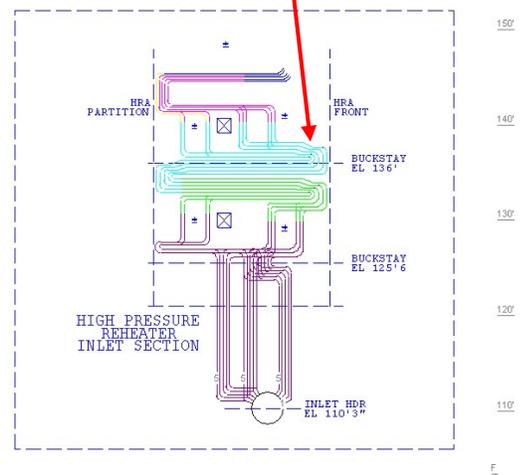
Cause: Erosion (Soot Blower)
Appearance: Deteriorated

Shields are deteriorated from previous soot blower operation. They need to be repaired/replaced if soot blowers are brought back into service.

If soot blowers are not going to be utilized, it is recommended all shields here be removed as they are trapping ash and after wash down contributing to excessive corrosion and pitting.

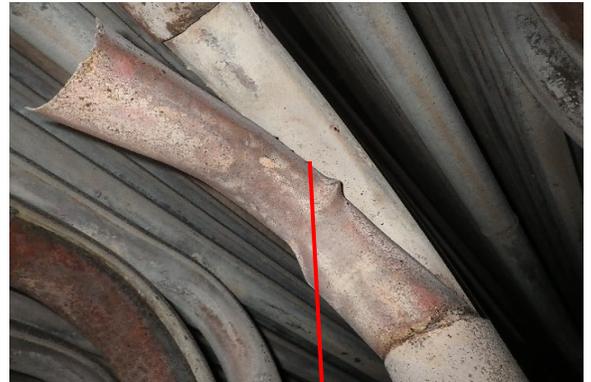
Cause: Thermal Fatigue

Appearance: Deteriorated

Numerous shields are deteriorated, damaged,
detached, or missing throughout the entire
bank. Replace or reattach shields as
needed.

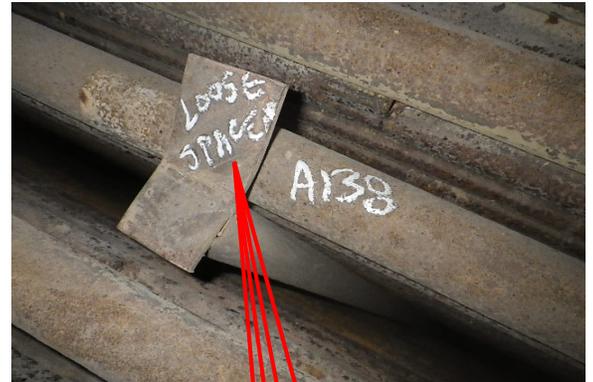
The Final Risk Index Number is 4

Throughout the HP Banks, the spacer canes where installed, are detached and/or loose causing abrasion potentials to occur to the adjacent tubes. It is recommended that those that are loose either be secured or removed as some do not appear to be offering any benefit to assembly spacing.

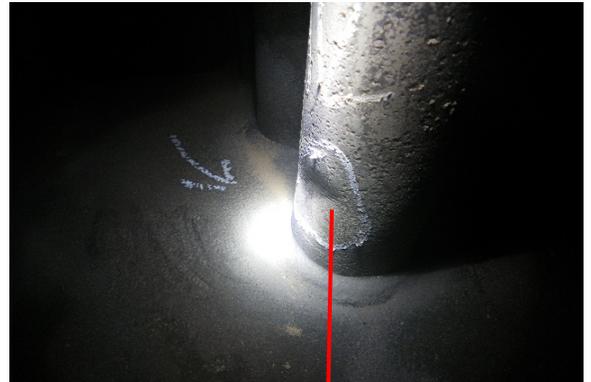
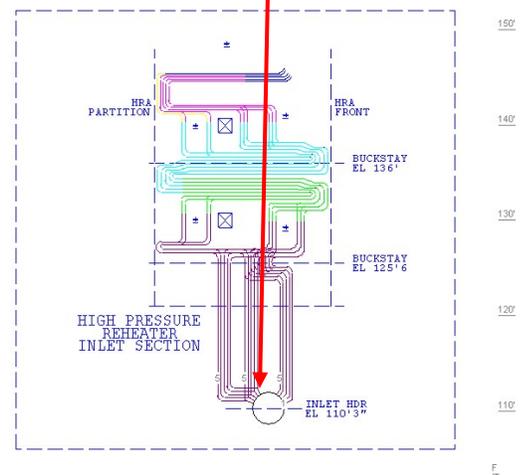
Located on the rear side of the High Pressure Reheat Inlet Header, tube 1 of assembly 90 is dented approximately 2 inches above the header. UT readings are at or above MWT.

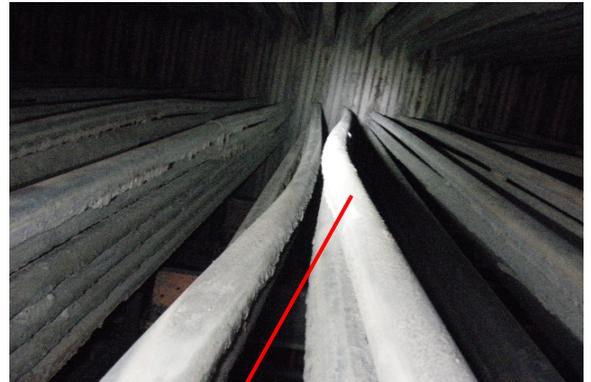
Cause: Fatigue (Thermal)

Plan for Future Replacement the following tubes of the HRA Front Wall Hangers due to bowing approximately 1 tube diameter:

The replacements would begin 12' above the refractory extending upward approximately 15' into the penthouse.

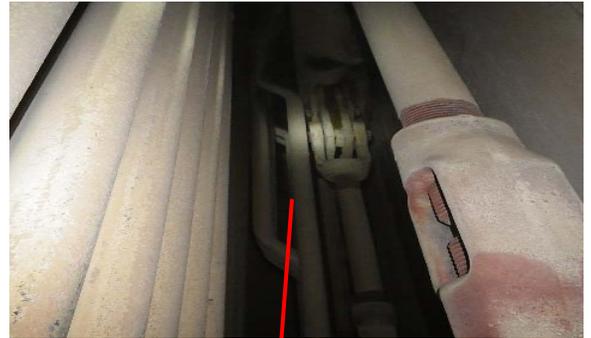
Cause: Erosion (Fly Ash)
Appearance: Eroded

It is recommended that access be provided to the inlet header at the right side wall to inspect for erosion at the offset tubes. The partition baffle wall does not allow for access to this area.

Tubes are polished however no repairs are present at this time. Monitor during future outages and repair as necessary.

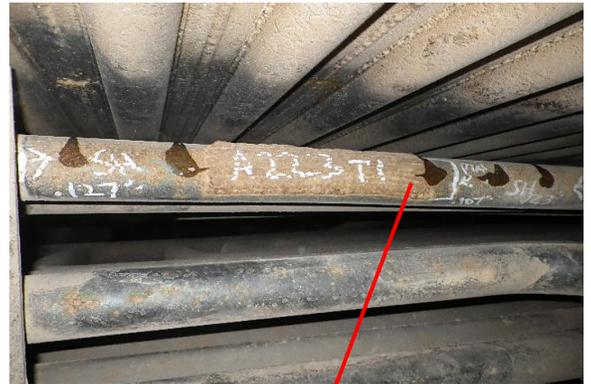
Cause: Erosion (Fly Ash)

In addition, install an approximate 2'
shield after weld repair as UT readings
of 0.123" and 0.127" were on both sides
of the existing pad weld.

The shield should begin at the
deflection plate and extend to the front
for the given length.

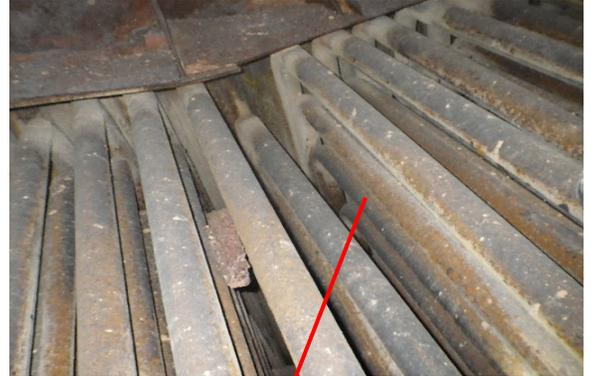
Cause: Fatigue (Thermal/ Vibration) or
Detached
Appearance: Misaligned

Numerous dropped assemblies are present
at the top rear side of the unit
indicating detachment or broken support
clips.

Per OEM dwg's, there are upper and lower
support clips for bank 2. Those involved
here are the uppers supports as no
alignment issues were observed on the
bottom side of the bank.

Further research will be required to
determine the extent of repair.

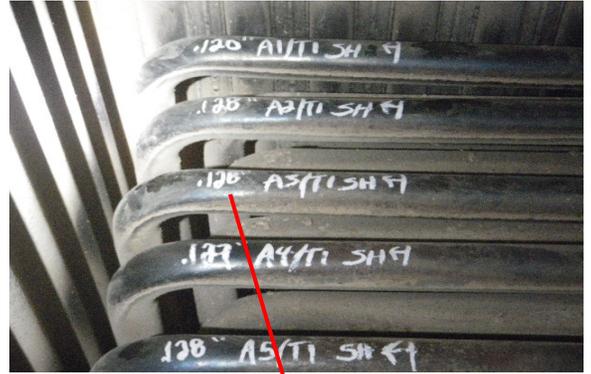
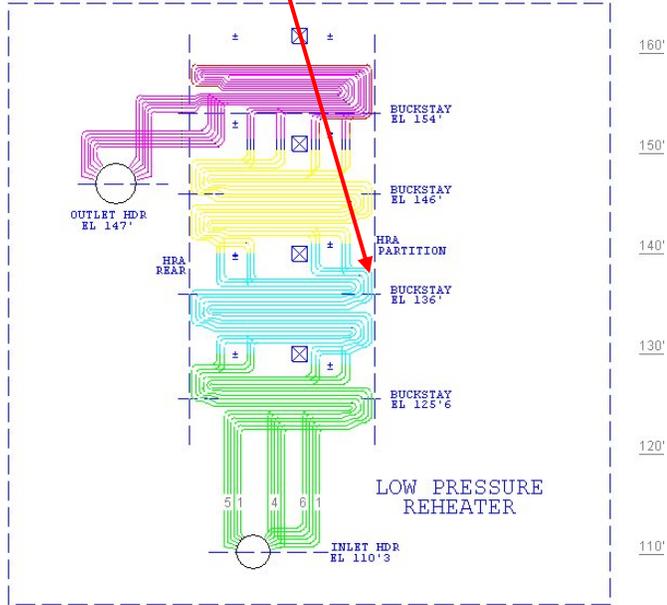
Cause: Erosion (Fly Ash)

Due to a remaining wall thickness between 76% to 85% of MWT, the following are recommended for shield repair for a length of 18":

- A1/T1(0.120"), A2/T1(0.128"),
- A3/T1(0.128"), A4/T1(0.127"),
- A5/T1(0.128"), A5/T1(0.128"),
- A8/T1(0.127"), A221/T1(0.126"),
- A223/T1(0.115")

The shields will begin 12" to the rear of the partition wall extending toward the front of the boiler encompassing the bends.

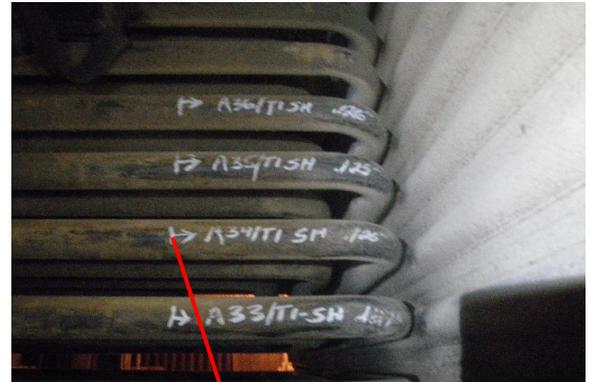
Cause: Erosion (Fly Ash)

Due to a remaining wall thickness
between 76% to 85% of MWT, the following
are recommended for shield repair for a
length of 18":

- A33/T1(0.127"), A34/T1(0.126"),
- A35/T1(0.125"), A36/T1(0.126"),
- A37/T1(0.128"), A38/T1(0.125"),
- A39/T1(0.126"), A43/T1(0.128"),
- A44/T1(0.125"), A53/T1(0.125"),
- A54/T1(0.127"), A55/T1(0.128"),
- A121/T1(0.127"), A122/T1(0.126")
- A123/T1(0.124")

The shields will begin 12" to the rear of the partition wall extending toward the front of the boiler encompassing the bends. Tube 1 of the remaining assemblies, not covered by the baffles, are at or just above shield criteria. Due to the quantity of shields needed, extending the plate baffle across the top of bank 4 at the partition wall would be an acceptable repair.

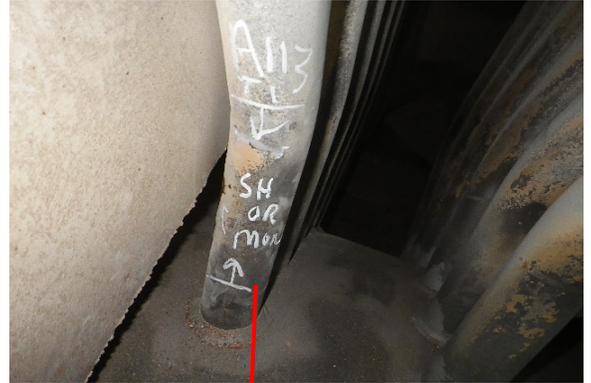
Cause: Erosion (Fly Ash)

One is just above the header proper and the second is about at chest level.

NOTE: The tubes may not be in shield criteria at this time, however, due to the obscure location, shielding is recommended.

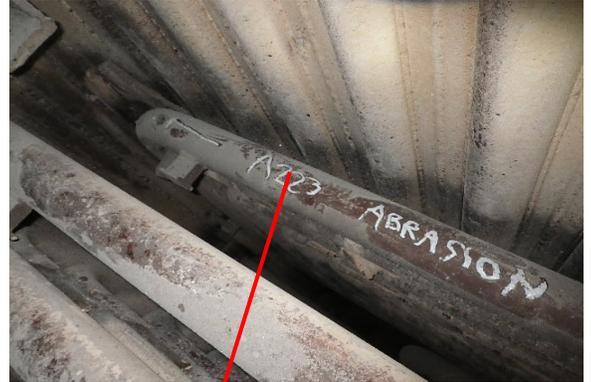
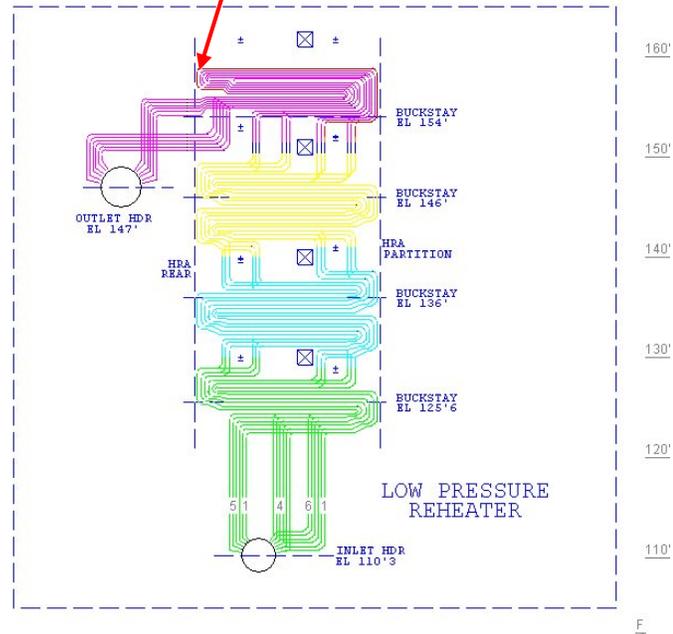
Cause: Fatigue (Thermal/ Vibration)

Detached and dropped horizontal **Assembly 223** is rubbing against the corner wall at the rear and right walls, creating a concern for abrasion in its current position.

Raise and realign onto its rear wall bracket to prevent abrasion erosion.

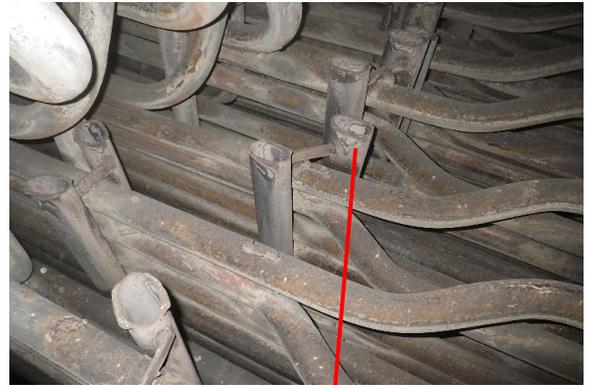
Cause: Fatigue (Vibration)

Several spacer canes in the front
sootblower path have detached and slid
away from their respective attachment
brackets, causing potential for abrasion
on assembly tubes.

Move the loose canes and properly
reattach them back into their attachment
brackets.

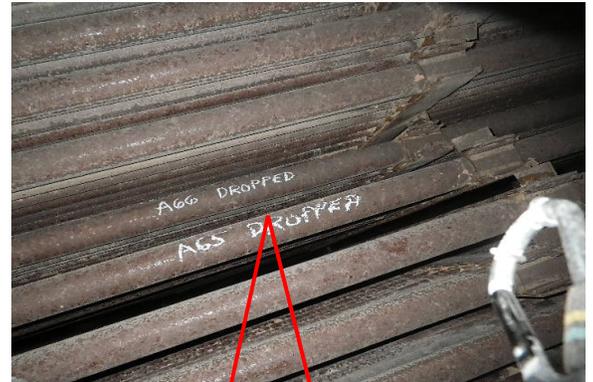
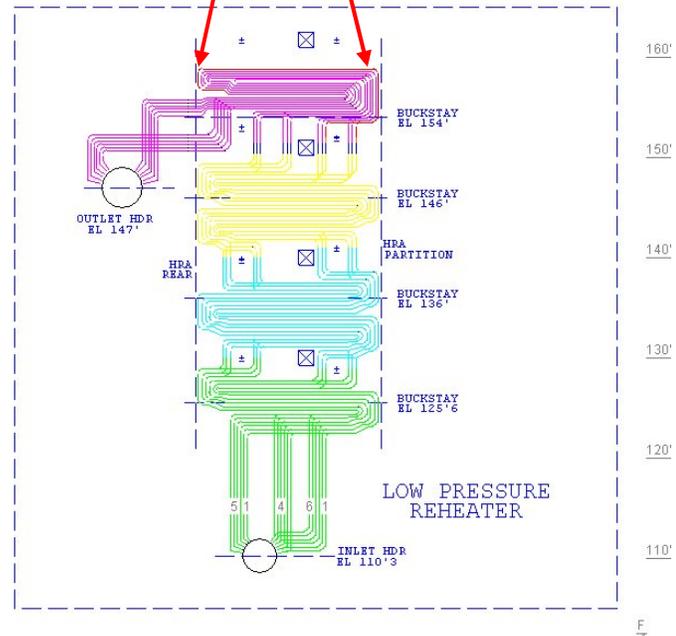
Cause: Fatigue (Thermal/ Vibration)
 Appearance: Detached

Raise and reattach these assemblies onto their respective rear wall brackets and/or front brackets.

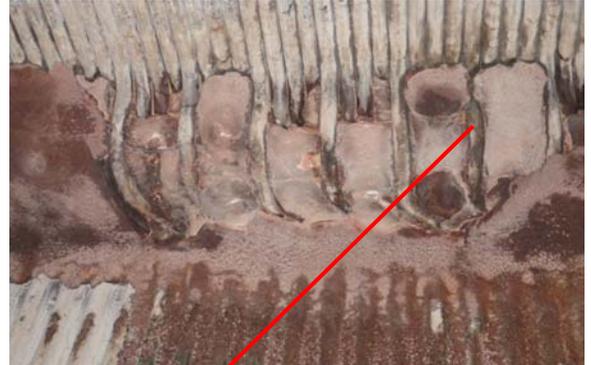
Cause: Fatigue (Thermal/ Vibration)

Appearance: Missing

Replace missing refractory where the HRA rear wall tubes meet the roof tubes.

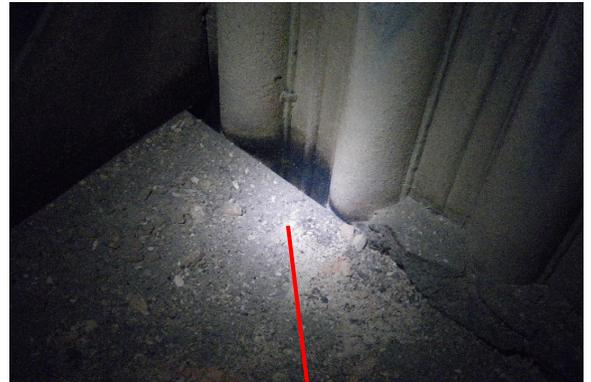
Cause: Erosion (Fly Ash)

Note: Minor erosion is apparent however
no partition wall tubes require repair
at this time.

Replace missing refractory along the
front partition wall baffle.

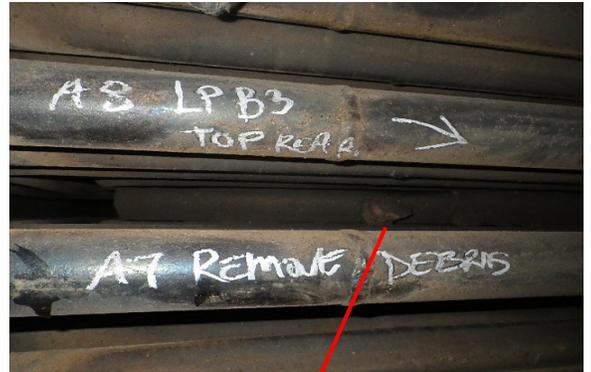
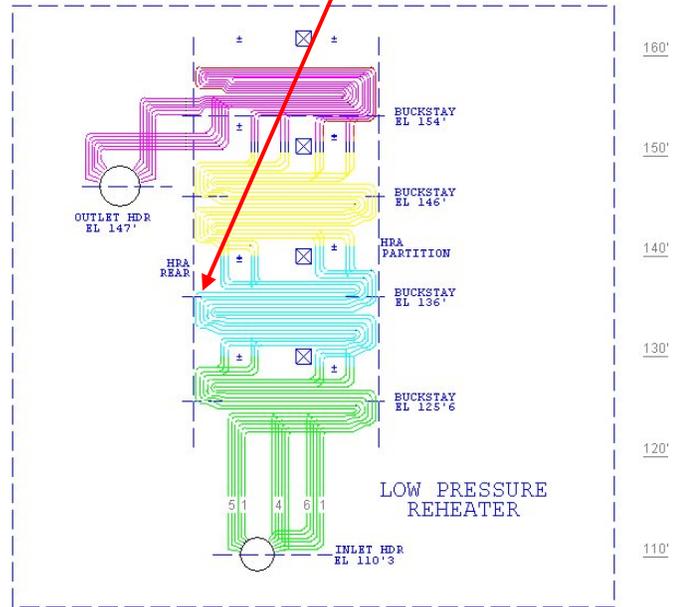
The Final Risk Index Number is 3

Remove the debris lodged between **assemblies 7-8** (long spacer cane remnant) and **assembly 194-195** (refractory) to restore gas flow and eliminate channeled erosion issues.

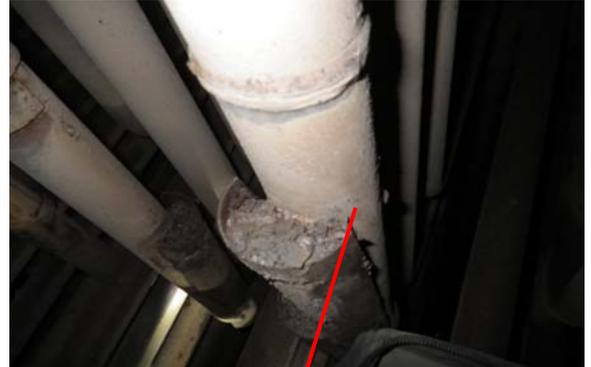
Cause: Fatigue (Thermal/ Vibration)

The shields in this area are disengaged
and trapping ash. During wash down, the
moisture and ash create conditions that
are conducive to tube corrosion.

It is recommended that any loose or
damaged shields in this area be removed.

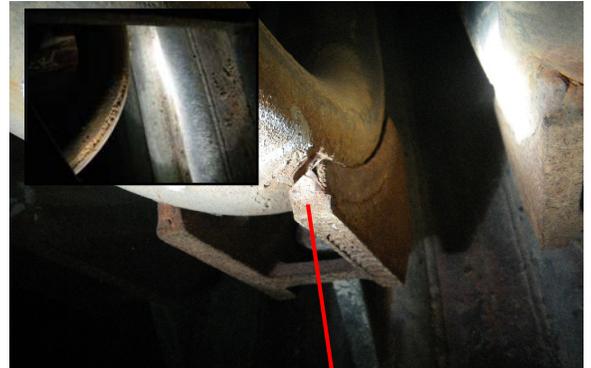
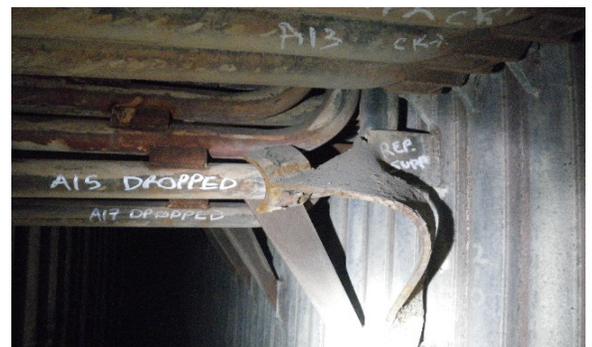
Cause: Fatigue (Stress)

Appearance: Cracked Weld

Add 3210,3208 - As noted during previous inspections, the support lugs at the bottom of the Low Pressure Reheat are beginning to fail. Some loss of tube material is present where welds are completely detached.

In addition, the supplemental "knee" supports are also failing. Continue to monitor and raise, realign and reattach supports as necessary.

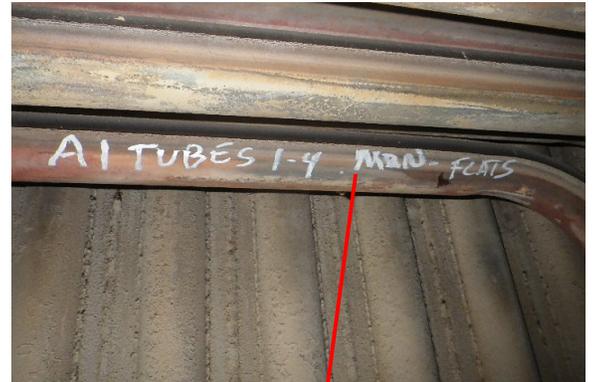
Cause: Erosion (Fly Ash)

Erosion flats could be felt on **Tubes 1-4**
(counted up) at **Assembly 1** from the
approximate unit center and near the
rear of the unit.

UT measurements at this time do not
indicate the need for repair as readings
are below the nominal thickness but
still above MWT. Monitor at each outage.

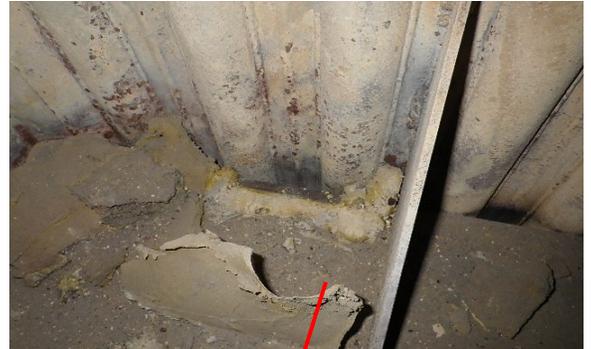
Cause: Fatigue (Thermal/ Vibration)
 Appearance: Broken and Missing

The refractory seal on the deflection plate at the rear wall is cracked, broken and missing throughout the bank. A gap is present where the plate contacts the crown of the tube.

NOTE: No erosion was observed from channeling. Monitor for erosion at each outage and replace refractory if erosion becomes evident in the future.

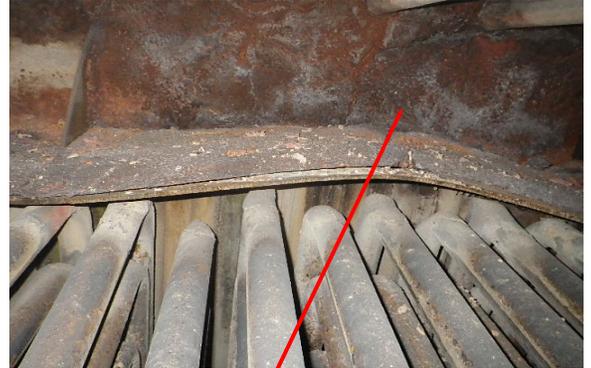
Cause: Fatigue (Thermal/ Vibration)

The plate is deflected in sections along
 its entire length, however still
 functional at this time.

Plan for the replacement of the solid
 deflection plate located on top of bank
 2 at the rear wall.

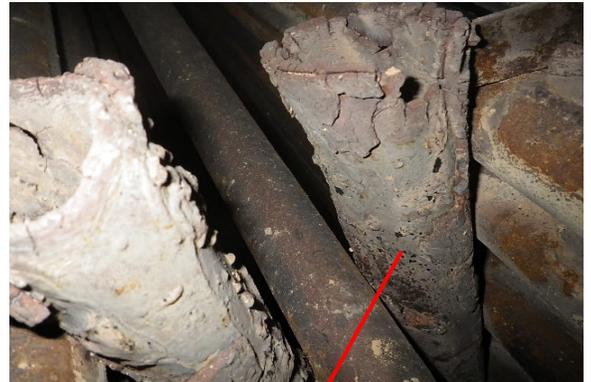
Cause: Fatigue (Thermal/ Vibration)

Appearance: Deteriorated

Remove or replace all spacer canes on
the top side of bank 2. All have become
fatigued, and deteriorated.

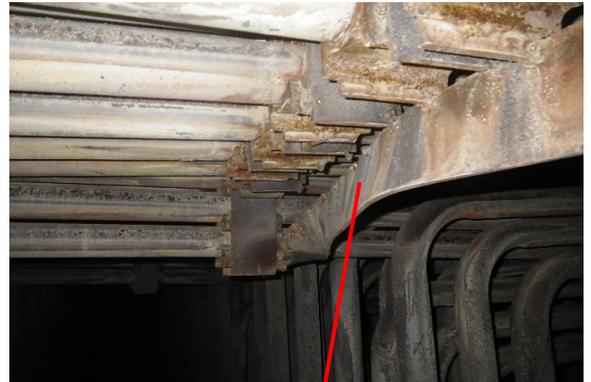
Cause: Fatigue (Thermal/ Vibration)

Appearance: Deteriorated

After the dropped assemblies have been returned to their intended positions, replace the lower deteriorated edge of the components center ladder bracket throughout the bank.

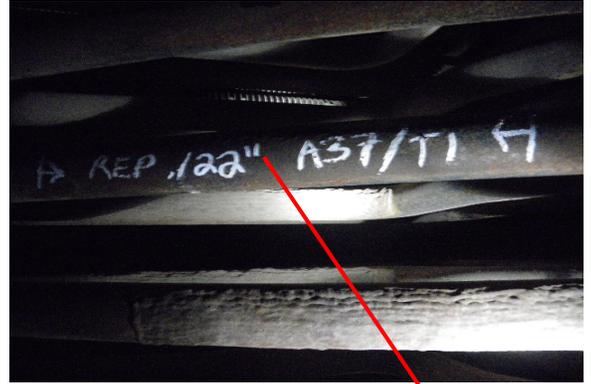
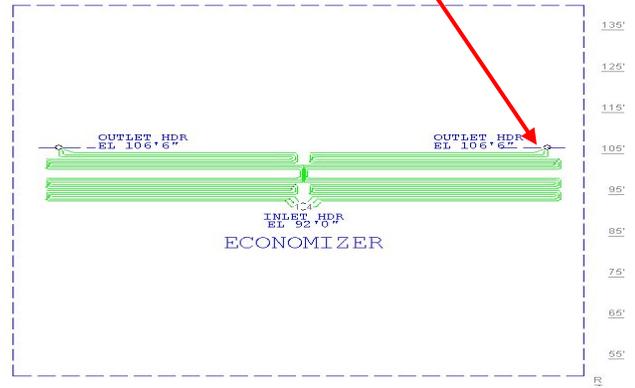
Cause: Erosion (Fly Ash)

The Final Risk Index Number is 20

Replace tube 1 of assembly 37 for a length of 2' due to a RWT of 0.122". The replacement is on the header leg and cut lines are marked with white grease stick.

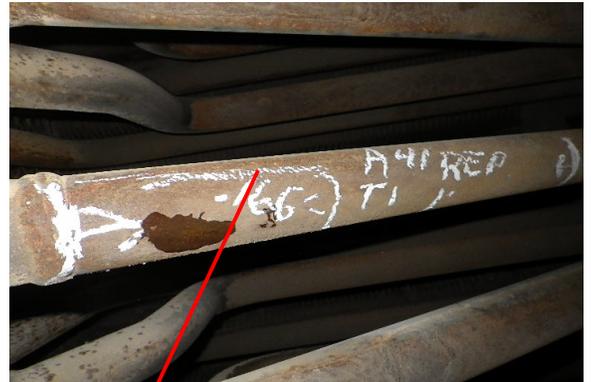
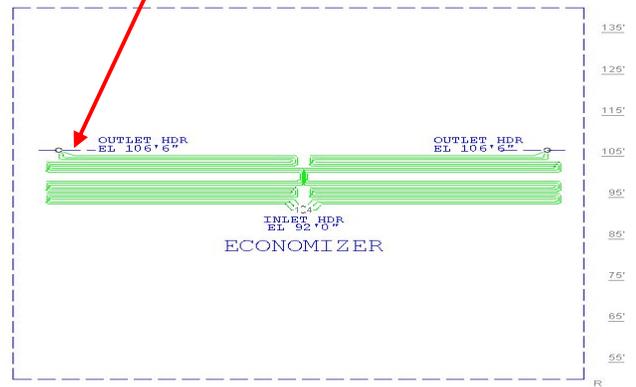
Cause: Erosion (Fly Ash)

The Final Risk Index Number is 20

Replace a 1' section of tubing at Assembly 41, Tube 1 located on the right side of the left outlet header. Cut lines should begin at the tube stub and proceed down the given length. The area of least RWT is marked on tube should pad welding be used.

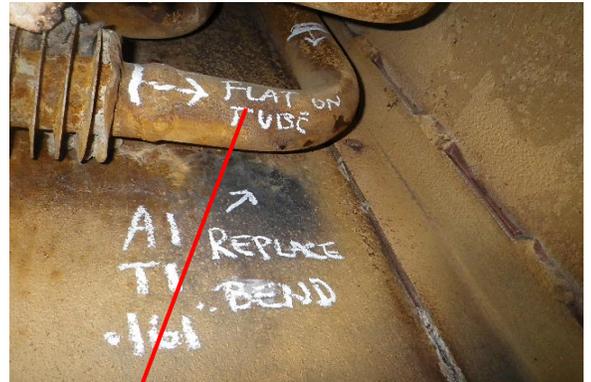
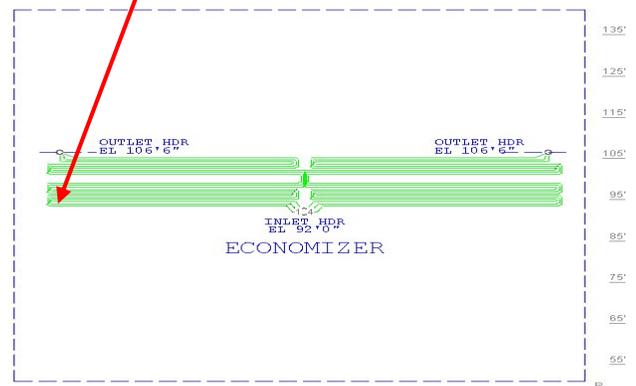
Record: #61
Action: **TUBE REPLACEMENT-P1**
Priority #: 1

Cause: Erosion (Fly Ash)
Appearance: Erosion Flat

The Final Risk Index Number is 25

Due to erosion flat and a **RWT of 0.161"**, **replace a 1.5' section of Tube 1, Assembly 1** located in the bottom front corner above the proportioning dampers. Replacement will involve the 90 degree bend with cut-lines equally spaced from the center line of the bend.

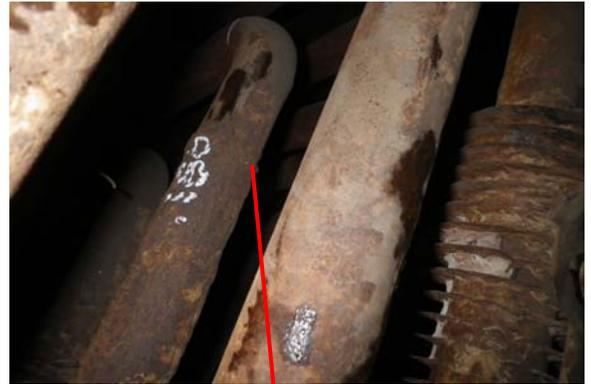
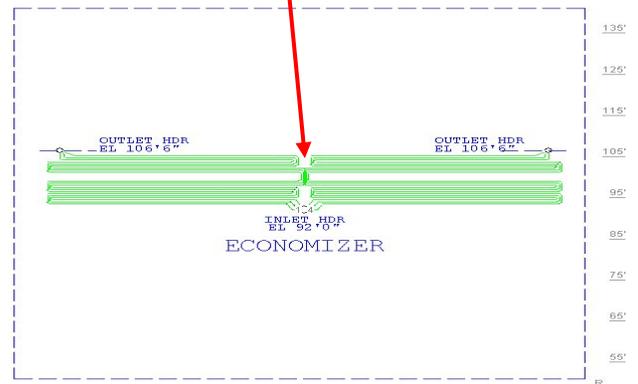
Cause: Erosion (Fly Ash)
 Appearance: Erosion Flat

Due to a remaining wall thickness between 66% to 75% of MWT, the following are recommended for pad weld repair:
 Assembly/Tube(RWT)Length:

The pad weld will encompass the area of wall loss which has been denoted on tubing by a white box.
