Inspection Report

Station: Mitchell Unit: 2 Report Name: 1-Reheater High Pressure

AREA: Reheater High Pressure

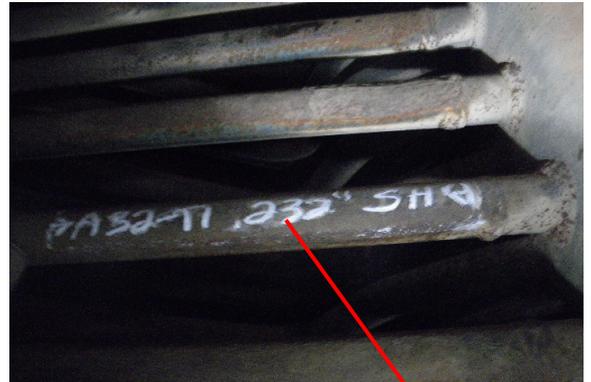
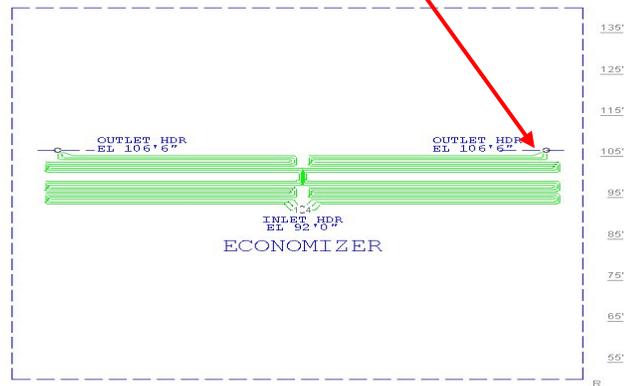
Cause: Erosion (Fly Ash)

Due to a remaining wall thickness between 76% to 85% of MWT, the following are within shield criteria for a repair length of 18": Assembly/Tube(RWT):

Due to location of repair and consultation with plant personnel, pad weld is the recommended repair.

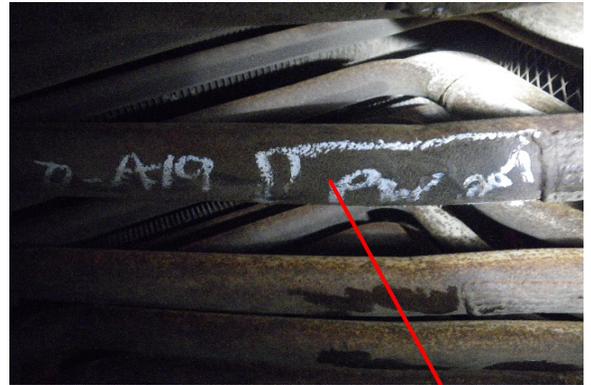
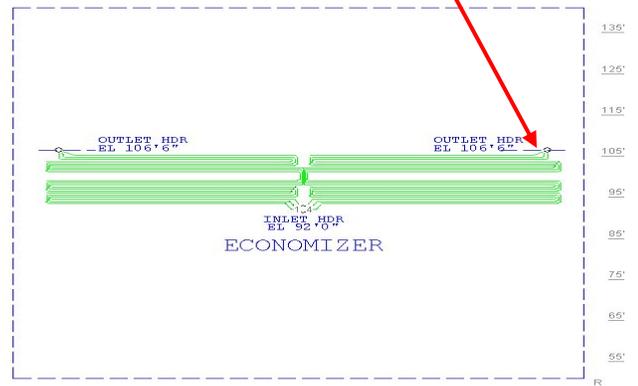
Cause: Erosion (Fly Ash)

Extend existing pad weld 8" x 2" on tube 1 of assembly 19 due to a RWT of 0.207".

Pad weld has been denoted by white box.

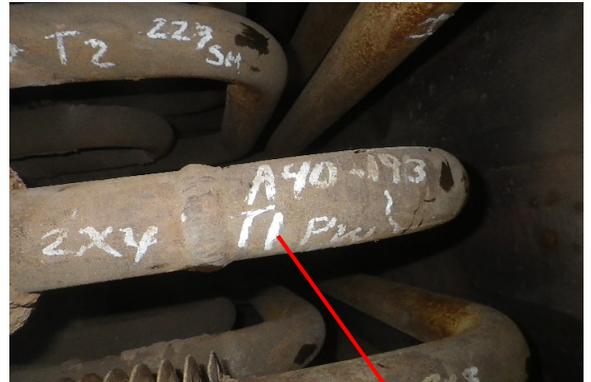
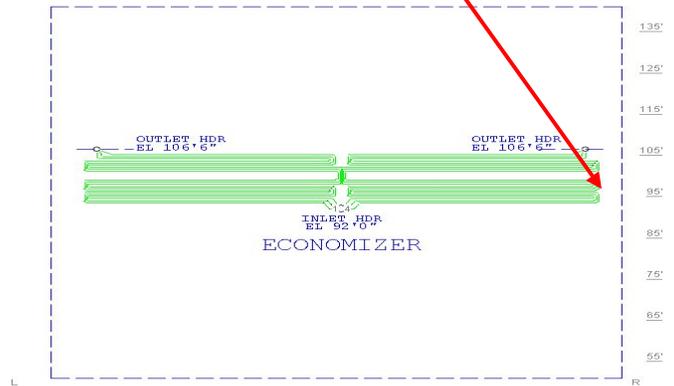
Cause: Erosion (Fly Ash)
Appearance: Eroded

Apply one 2"x4" pad weld at Tube 1 of Assembly 40 adjacent to the right side wall. Repair area is marked on the bend of the tube.

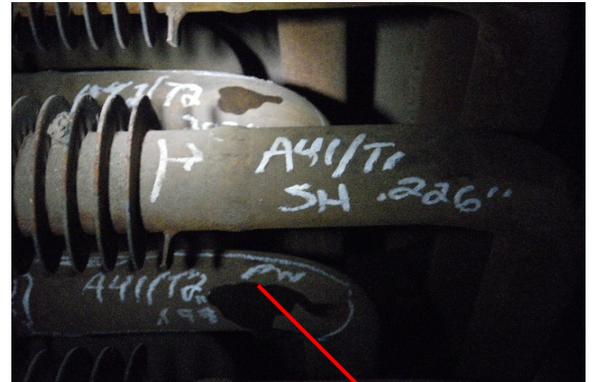
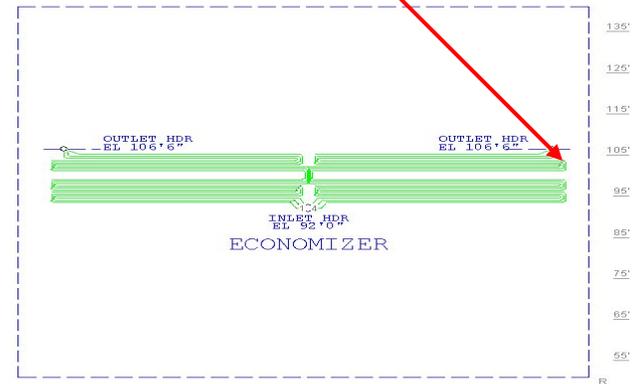
Cause: Erosion (Fly Ash)

Due to a remaining wall thickness between 66% to 75% of MWT, the following are recommended for pad weld repair:

The pad weld will encompass the area of wall loss which has been denoted on tubing by a white box.

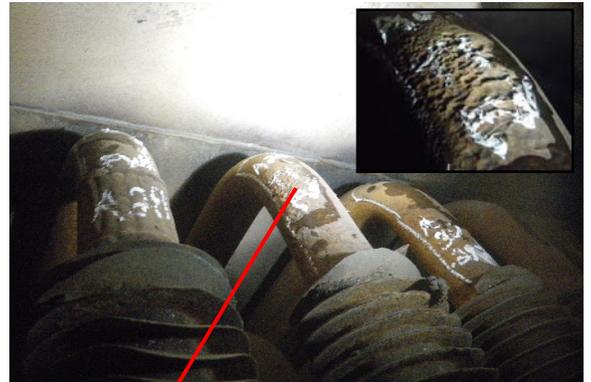
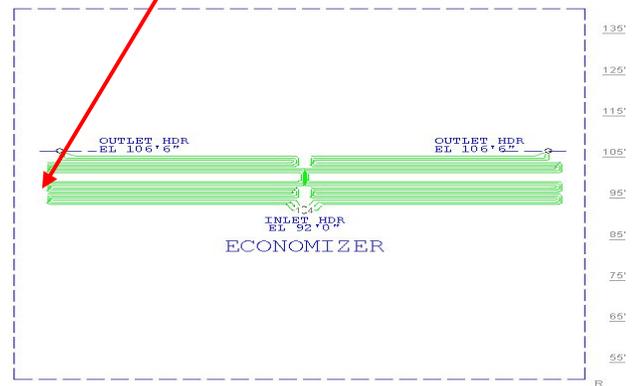
Cause: Erosion (Fly Ash)

Due to a remaining wall thickness between 66% to 75% of MWT, the following are recommended for pad weld repair:

A30/T1(0.217")8"

A32/T1(0.219")8"

Note: Due to surface condition of the tubes in shield criteria, pad weld is the recommended repair.

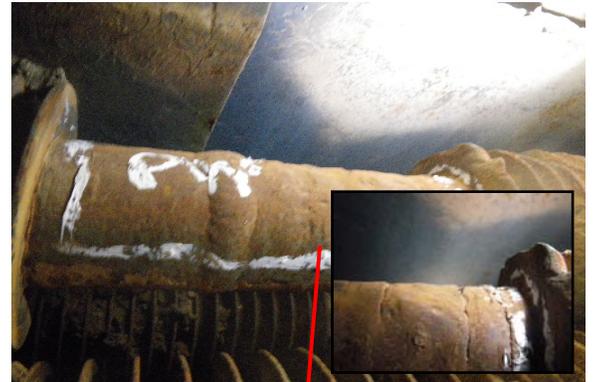
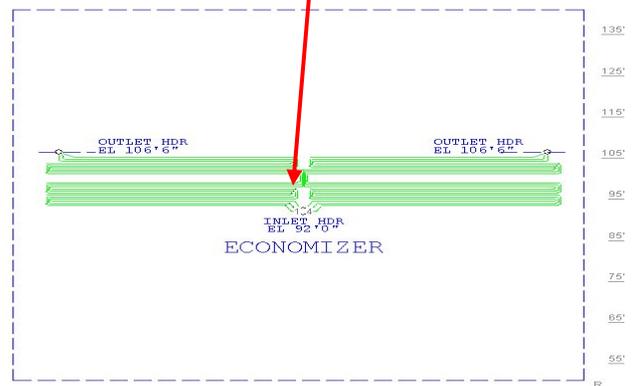
Cause: Erosion (Fly Ash)
Appearance: Eroded

The Final Risk Index Number is 13

Restore tube 1 of assembly 43 to MWT by applying an 8" x 2" pad weld. The repair is located 18" to the left of the doglegs at the partition wall. No UT information was obtainable given the surface condition of the tube.

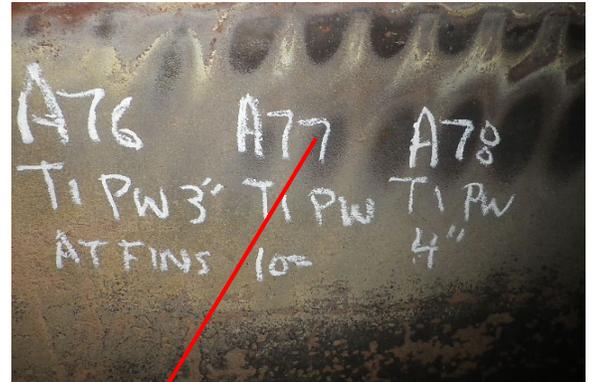
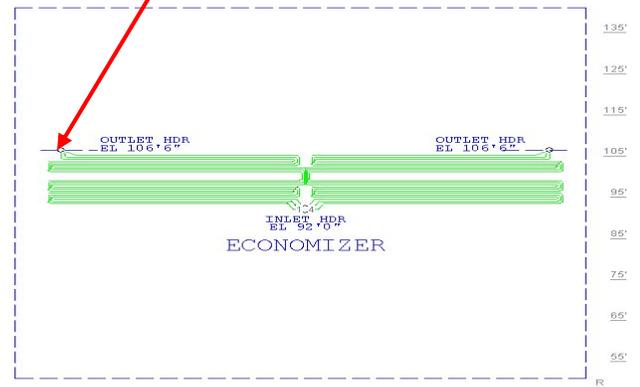
Cause: Erosion (Fly Ash)

Apply pad welds between the spiral fins at the following Assemblies/Length of repair located between the left outlet header and side wall:

Repair areas are marked on the spiral fins.

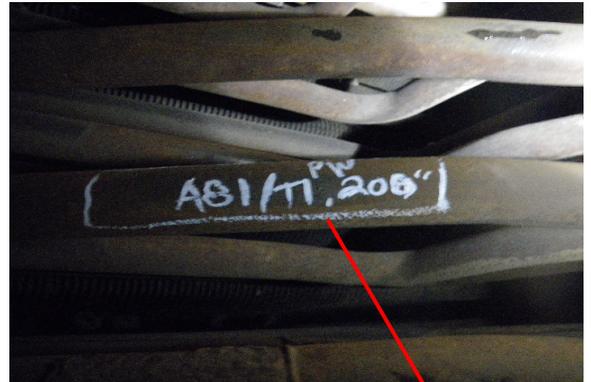
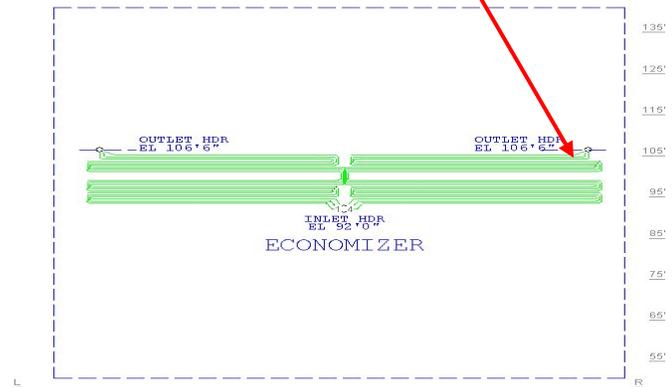
Cause: Erosion (Fly Ash)
Appearance: Eroded

Due to a remaining wall thickness between 66% to 75% of MWT, the following are recommended for pad weld repair:
Assembly/Tube(RWT)PW Length:

- A79/T1(0.210")5"
- A81/T1(0.200")10"
- A83/T1(0.209")12"

The pad weld will encompass the area of wall loss which has been denoted on tubing by a white box.

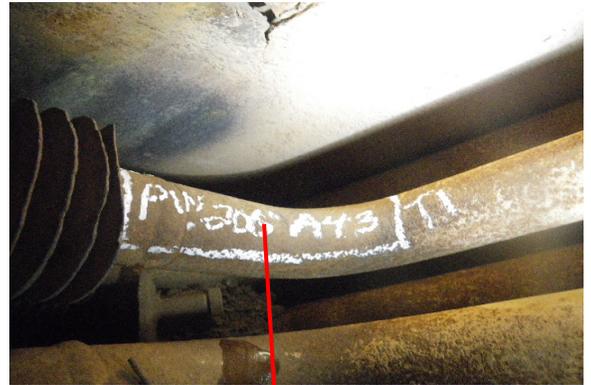
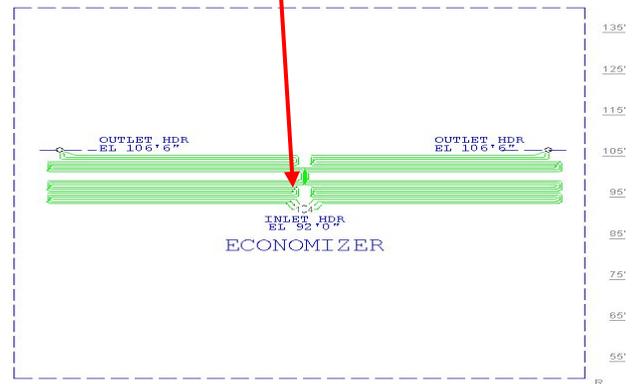
Cause: Erosion (Fly Ash)
Appearance: Eroded

The Final Risk Index Number is 13

Restore tube 1 of assembly 43 of the left doglegs to MWT by applying a 8" x 2" pad weld due to a RWT of 0.206". The pad weld will encompass the area of wall loss which has been denoted on tubing by a white box.

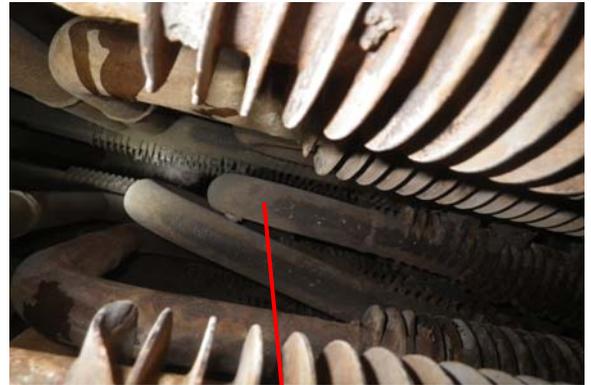
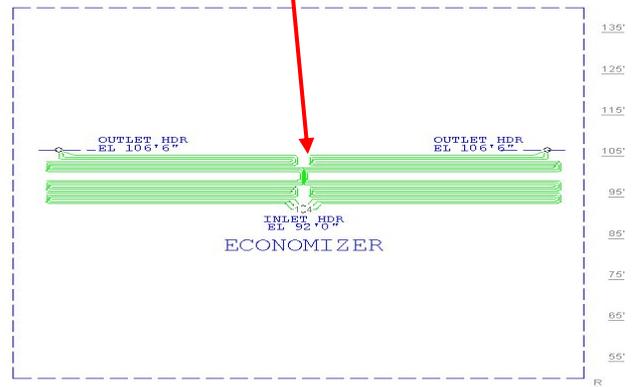
The Final Risk Index Number is 4

On the top of the economizer assemblies 19 and 20, the center loops are distorted over to assembly 21. Recommend re-aligning these loops to prevent abrading and fly ash erosion.

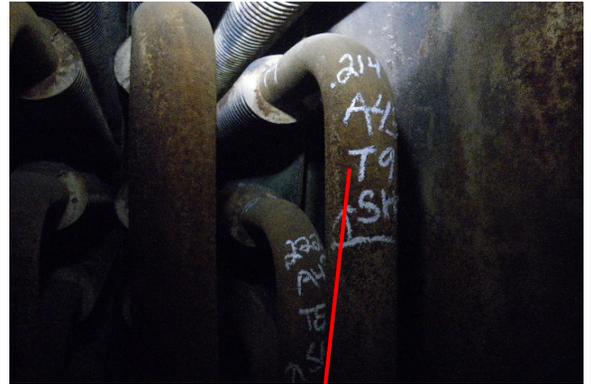
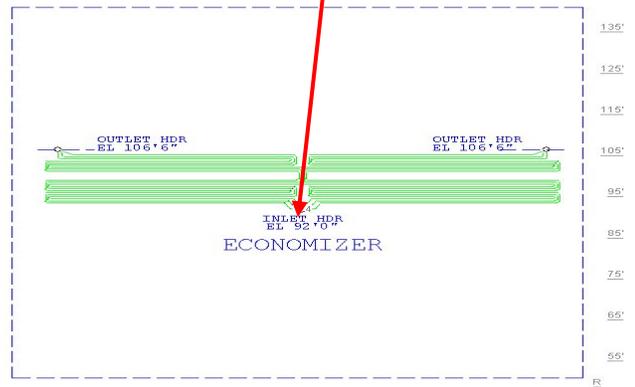
Cause: Erosion (Fly Ash)
 Appearance: Erosion Flat

Due to a remaining wall thickness between
 76% to 85% of MWT, the following are
 recommended for shield repair for a length
 of 18":

- A43/T8(0.222")Ext
- A43/T9(0.214")Ext

The shields will abut to the fin and encompass the 90 degree bends. Note: Tubes counted from bottom to top.

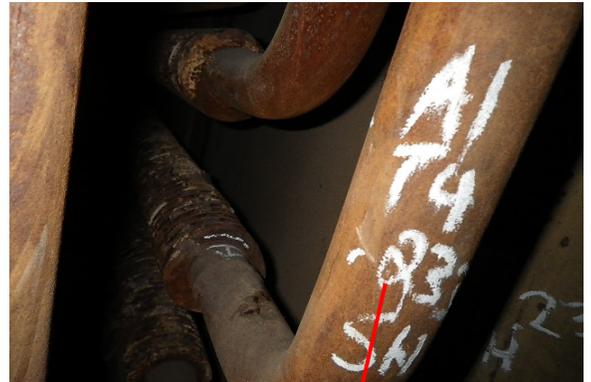
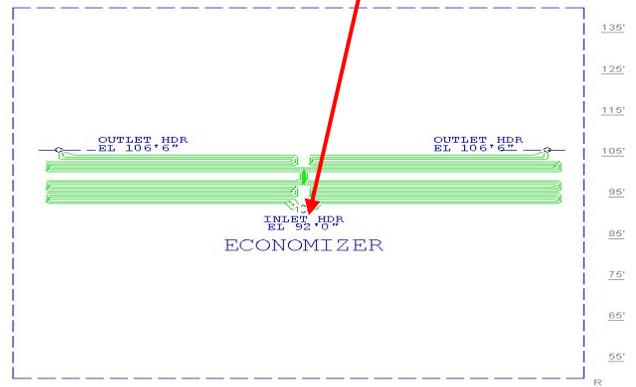
Cause: Erosion (Fly Ash)
Appearance: Erosion Flat

Due to a remaining wall thickness between
76% to 85% of MWT, the following are
recommended for shield repair for a length
of 18":

The shields will abut to the fin and encompass the 90 degree bend. Note: Tubes
counted from bottom to top.

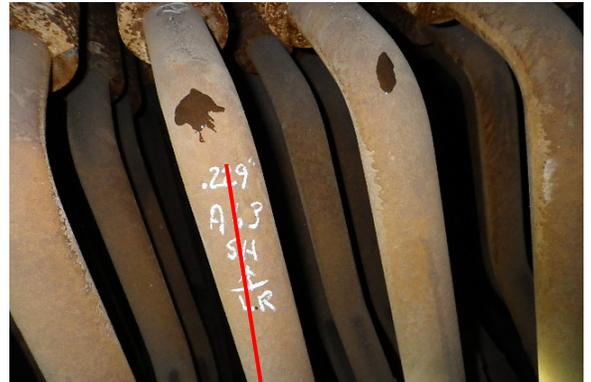
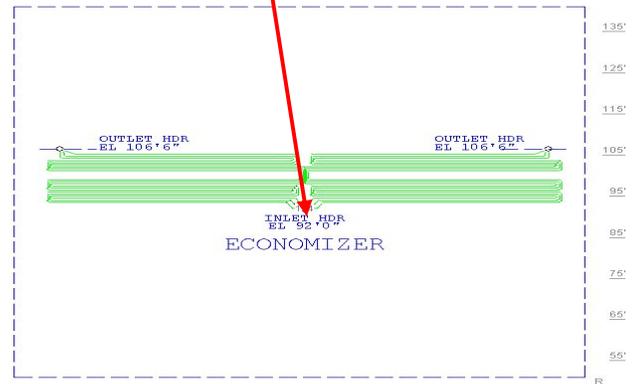
Cause: Erosion (Fly Ash)
Appearance: Erosion Flat

Shields should butt up to the spiral fins to avoid gaps.

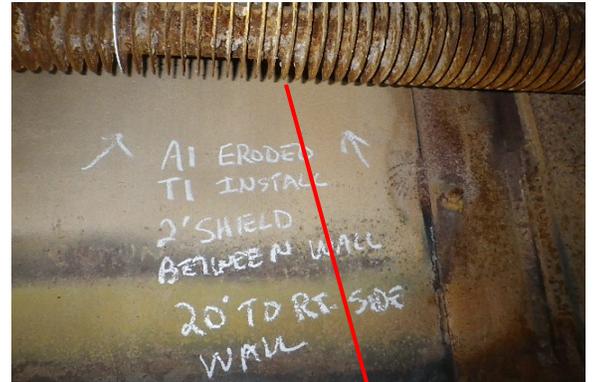
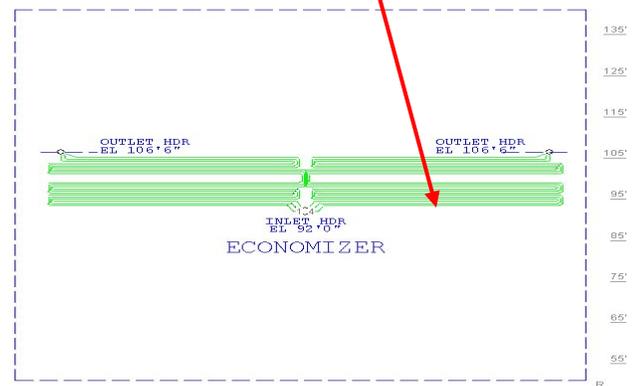
Cause: Erosion (Fly Ash)
Appearance: Erosion Flat

The Final Risk Index Number is 6

Install an approximate 2' shield to Tube 1 of Assembly 1 located approximately 20' from the right side wall above the proportioning dampers. The spiral fins are completely eroded away along with some tube material.

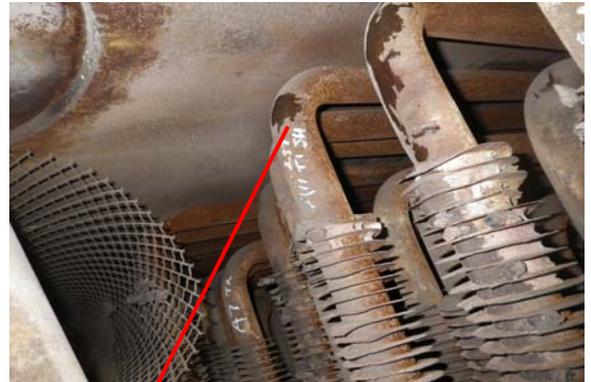
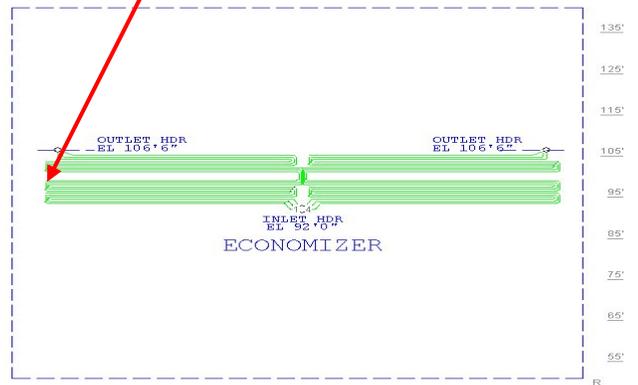
Cause: Erosion (Fly Ash)
Appearance: Eroded

Due to a remaining wall thickness between 76% to 85% of MWT, the following are recommended for shield repair for a length of 18" - Assembly/Tube(RWT):

The shields will begin at the fin on the horizontal run and extend encompassing the 90 degree bend.

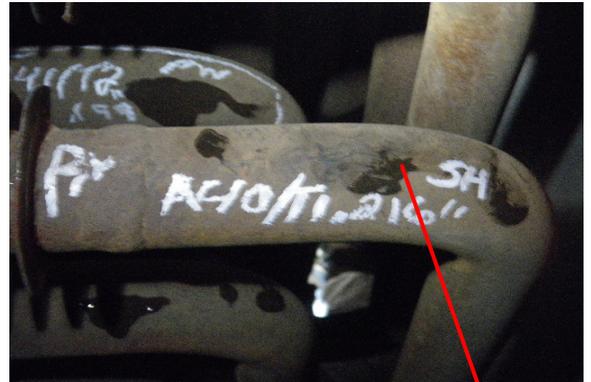
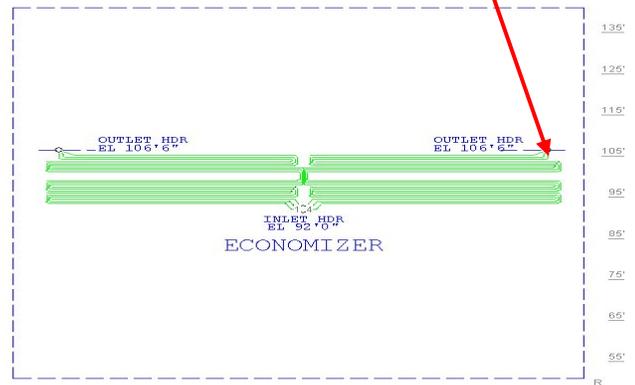
Cause: Erosion (Fly Ash)
Appearance: Eroded

Due to a remaining wall thickness between 76% to 85% of MWT, the following are recommended for shield repair for a length of 18" - Assembly/Tube(RWT):

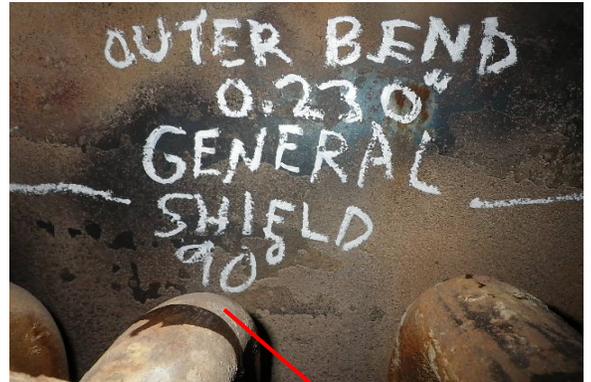
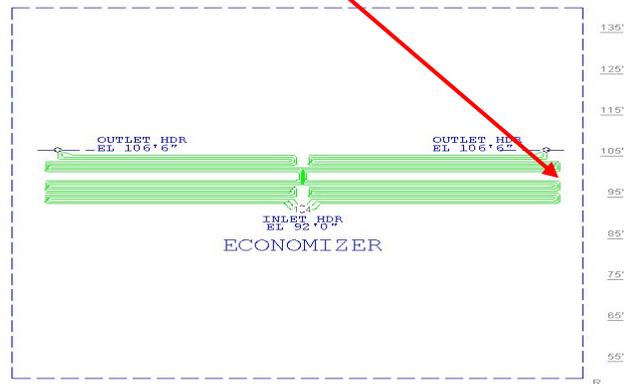
Cause: Erosion (Fly Ash)
Appearance: Eroded

The shields will begin at the fin on the horizontal run and extend encompassing the 90 degree bend.

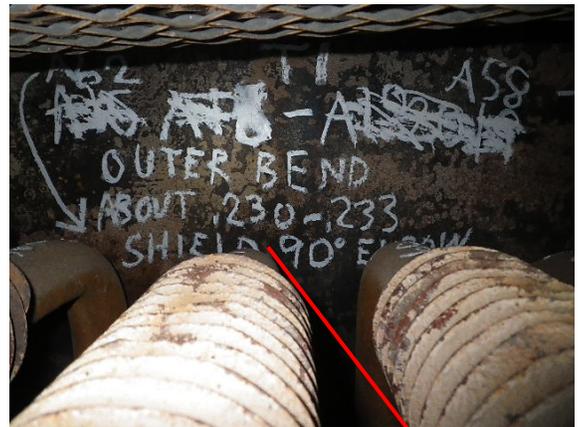
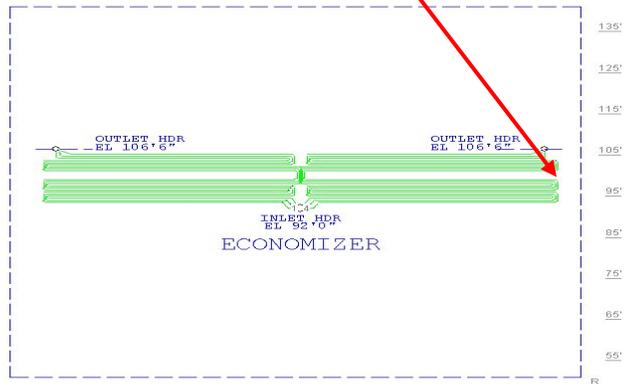
Cause: Erosion (Fly Ash)
Appearance: Eroded

Due to a remaining wall thickness between 76% to 85% of MWT, the following are recommended for shield repair for a length of 18":

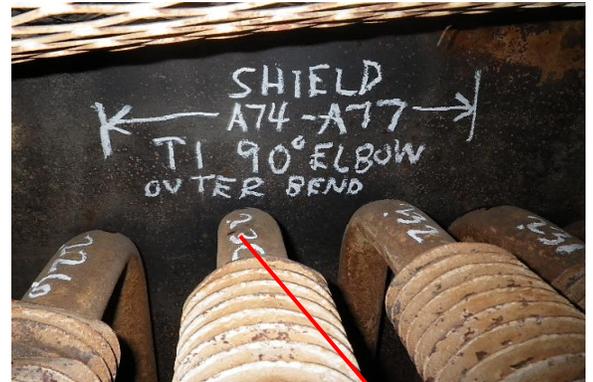
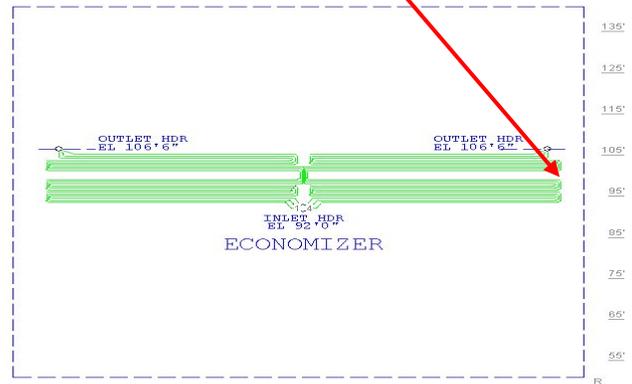
Cause: Erosion (Fly Ash)
Appearance: Eroded

Due to a remaining wall thickness between 76% to 85% of MWT, the following are recommended for shield repair for a length of 18" - Assembly/Tube(RWT):

The shields will begin at the fin on the horizontal run and extend encompassing the 90 degree bend.

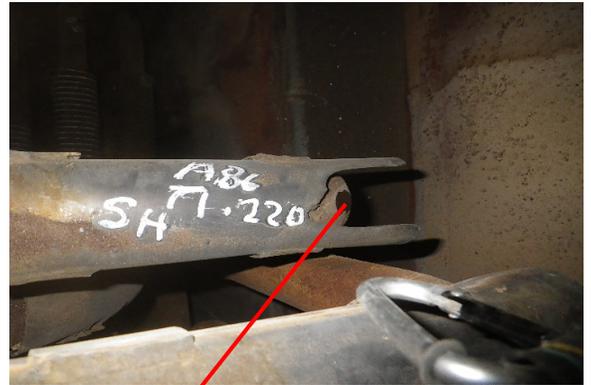
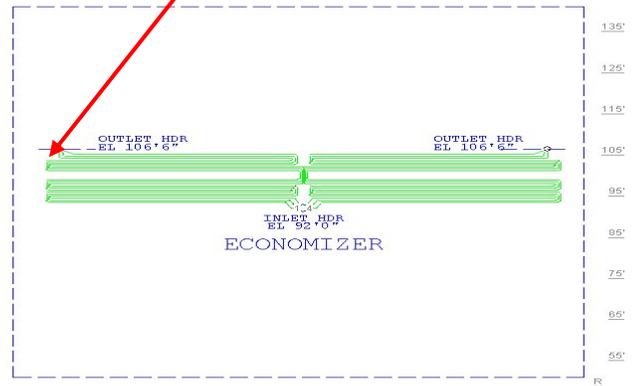
Cause: Erosion (Fly Ash)

Replace the eroded through shield located at Tube 1 of Assembly 86 at the tubes connection at the rear end of the outlet header.

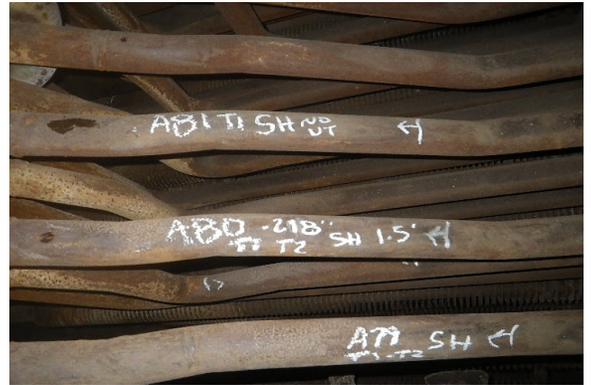
Cause: Erosion (Fly Ash)
Appearance: Eroded

- A79/1-2(N/A)
- A80/1-2(0.218")
- A81/1(N/A).

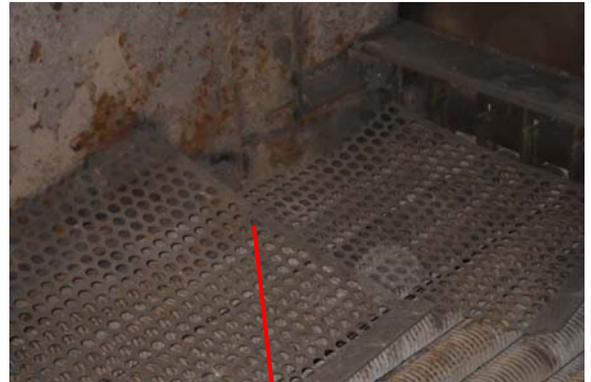
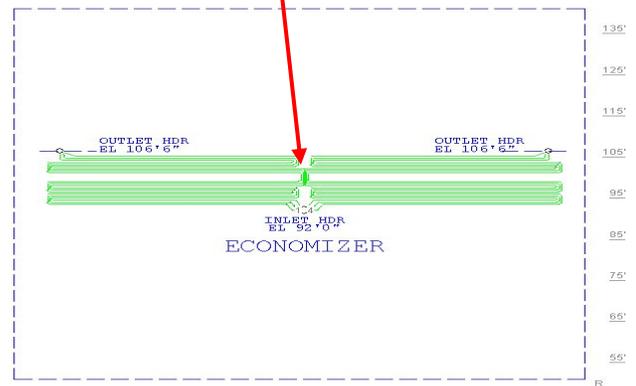
Cause: Fatigue (Thermal/ Vibration)

Appearance: Broken

Reattach the perforated plate baffles at the partition wall.

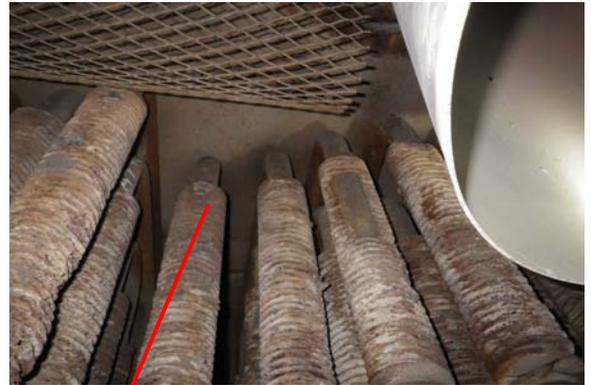
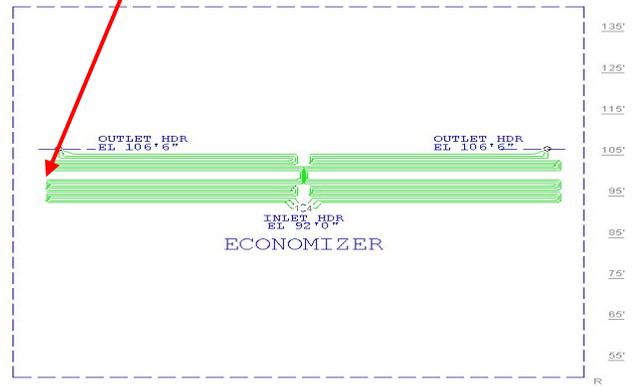
Cause: Fatigue (Stress)
Appearance: Detached

In the economizer between banks 1 and 2 assemblies 8, 9, and 10 have broken loose from their hangers and dropped down. They need to be pulled up and re-attached to hanger.

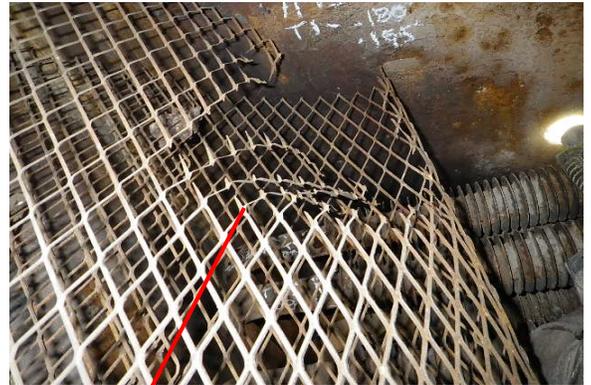
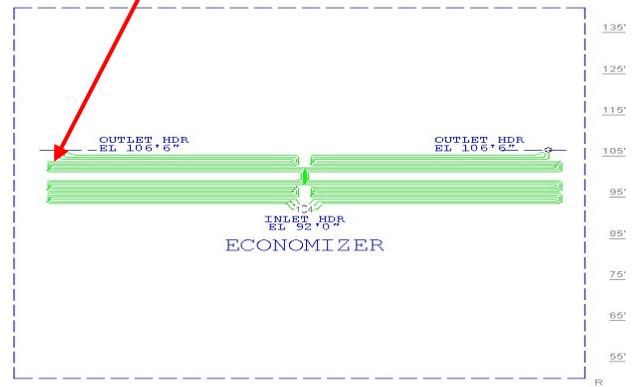
Cause: Erosion (Fly Ash)
Appearance: Eroded

Replace the rear most section of expanded metal baffle at the junction of the left side and partition wall between the outlet header. This area is experiencing aggressive erosion.

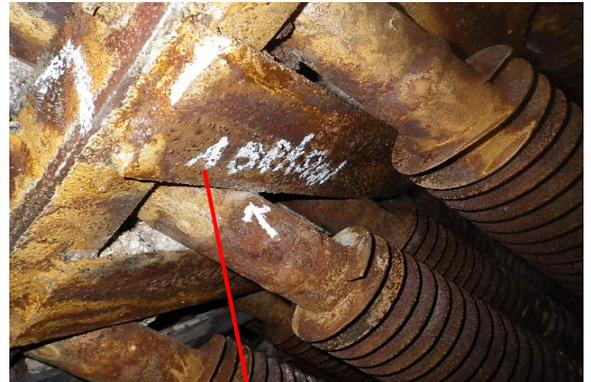
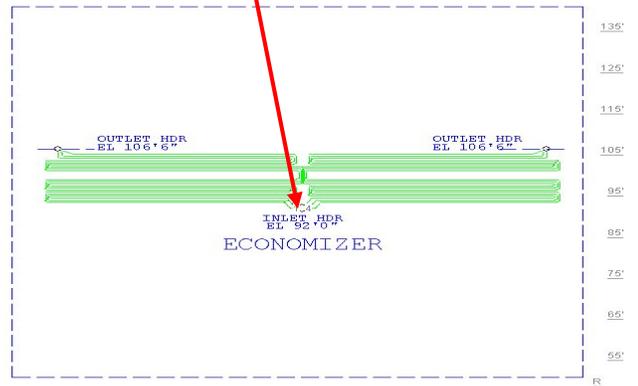
Cause: Fretting or Rubbing (Abrasion)
Appearance: Abraded

Monitor closely abrasion observed on un-finned portions of finned economizer tubes before reaching the tube elbows. Alignment/support plate abrading tubes.

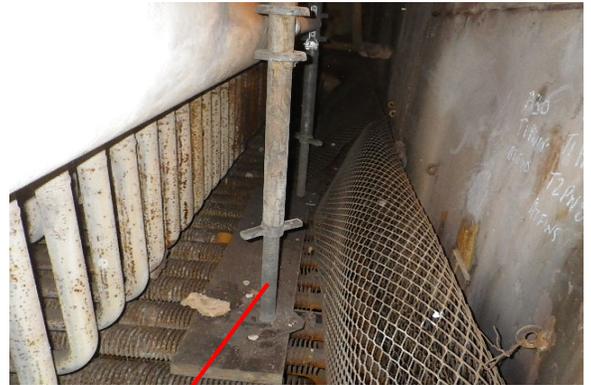
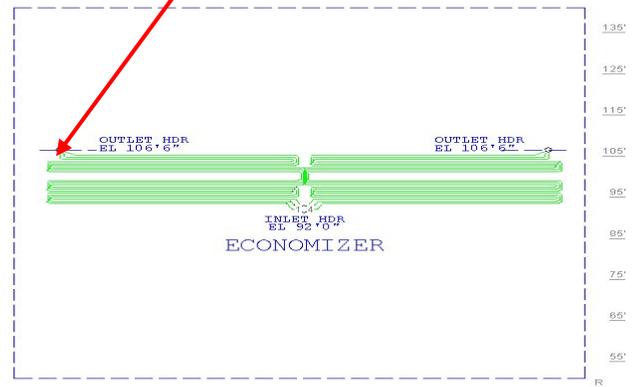
Cause: Erosion (Fly Ash)
Appearance: Eroded

Inspections at the left side wall were restricted by the RH Inlet header scaffolding. It is recommended that this area be inspected after the scaffolding is removed and before the unit is returned to service.

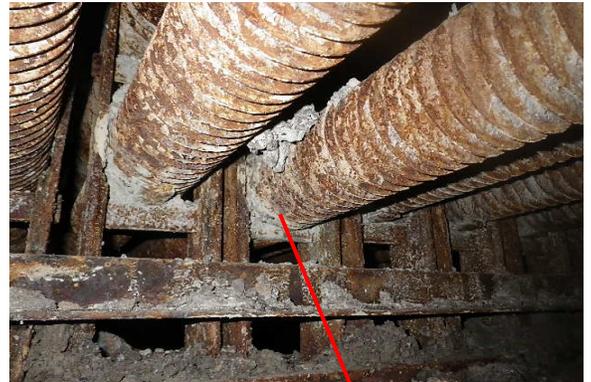
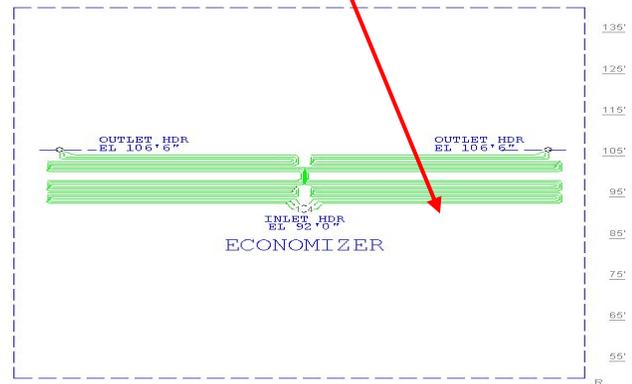
Cause: Thermal Fatigue
Appearance: Out of Alignment

Above the proportioning dampers, approx. 20' from right wall, at 2nd to last support structure from the right end, finned tubes are improperly bearing onto the support structure in a manner that may be causing abrasion between tube fins. The flat bearing plate is missing or broken at assemblies A10, A12, & A22 causing these assemblies to be dropped down with tubes bearing directly onto the edge of the supporting plate. Further research required to determine the actual condition of these tubes.

After all tubes in question are either determined to be satisfactory or are properly repaired, raise them up into their proper positions and reinstall the proper flat plate under the fins for proper bearing support.

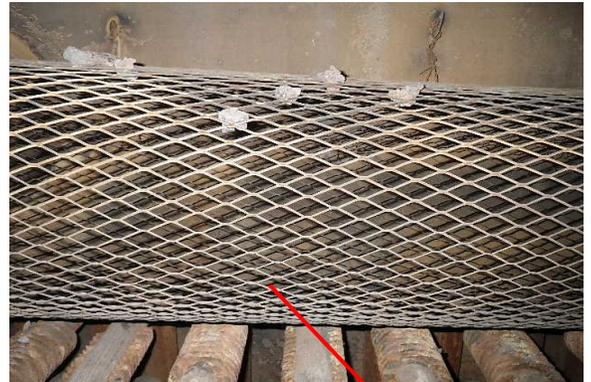
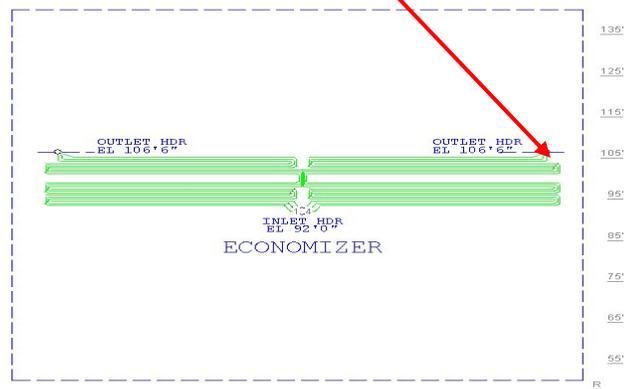
Inspection limited on tube 1 of assemblies 1-10 due to expanded metal baffle. It is recommended that baffle be removed to provide access for inspection.

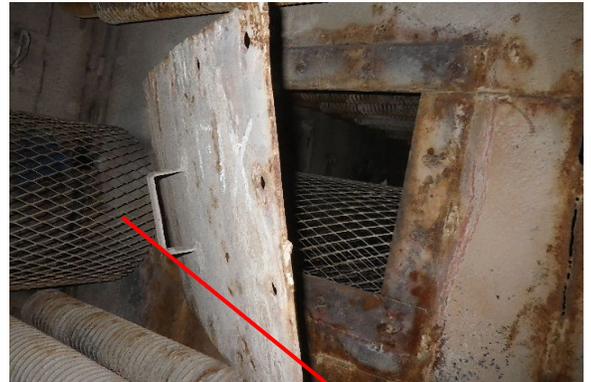
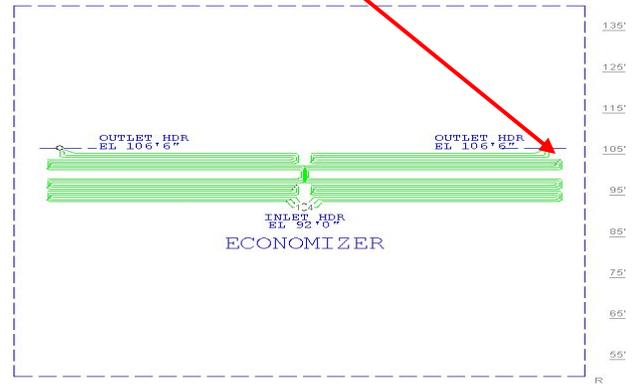
Unable to inspect Tube 1 of Assemblies A44 through A49 unable due to expanded metal baffles at the wall corner. Further inspection needed once baffle is removed to check RWT on outer elbows at T1.

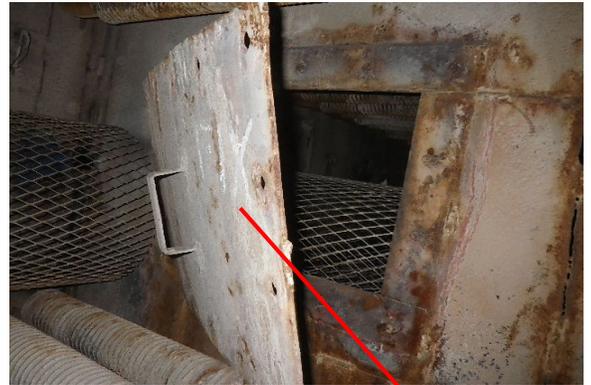
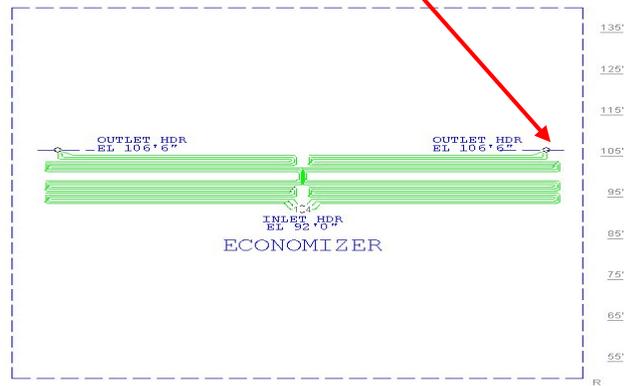
Cause: Undetermined
Appearance: Out of Alignment

Reposition and secure the access door
securely on the partition wall.

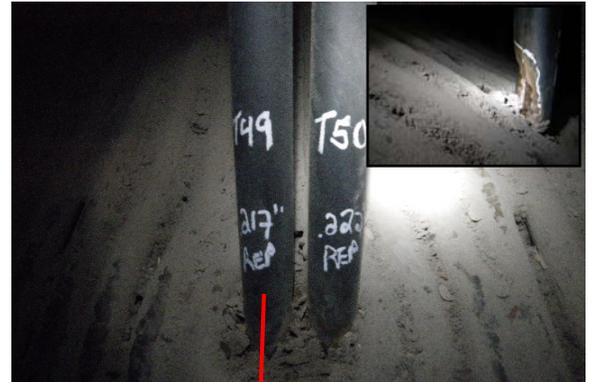
Cause: Erosion (Fly Ash)

The RWWH tubes are eroded at the slope penetration. Obtainable UTs were taken on tubes 49 and 50 of 0.217" and 0.222" respectively, putting them in replacement criteria.

It is recommended that all hanger tubes have refractory removed, be assessed and repair as needed. Note: If replacement is not an option, pad weld would be the recommended repair.

If the tube is load bearing (hanger tube), temporarily support the tube before replacement is made. Verify replacement material before removing old tube section.

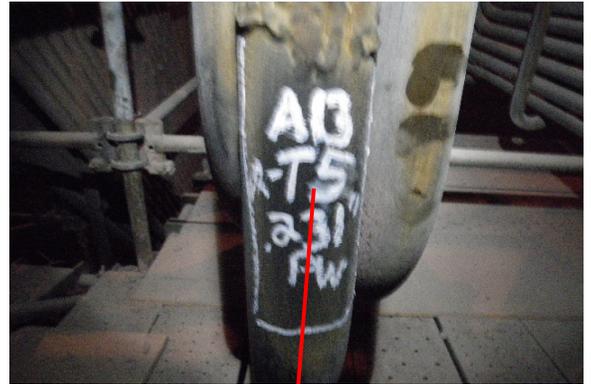
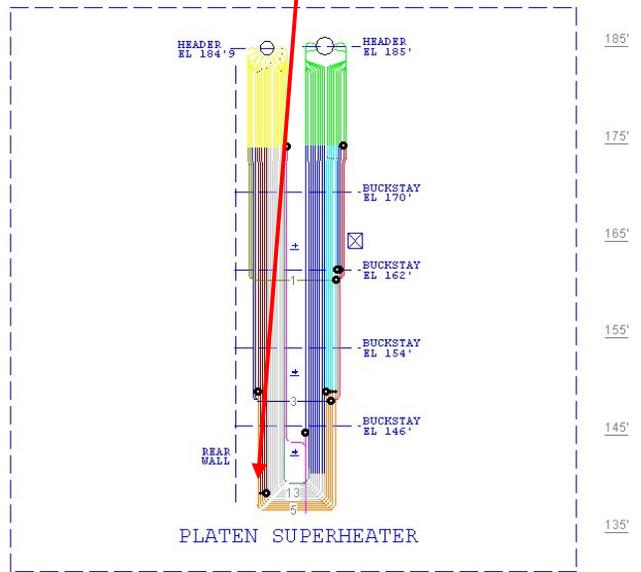
Cause: Erosion (Soot Blower)
 Appearance: Erosion Flat

A13/R-T5(0.231) 6"

Due to a remaining wall thickness between
 66% to 75% of MWT, the following are
 recommended for pad weld repair:

The pad weld will encompass the area of
 wall loss which has been denoted on
 tubing by a white box.

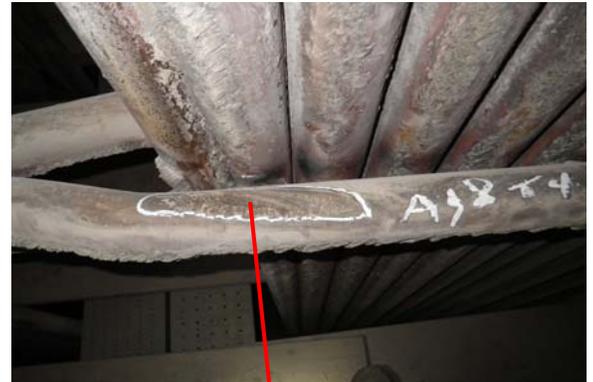
Cause: Erosion (Soot Blower)

This area is too rough for accurate UT but depth is estimated over 0.125" up to 0.187" deep. With other pad welds in this area it is recommended to restore these areas to MWT.

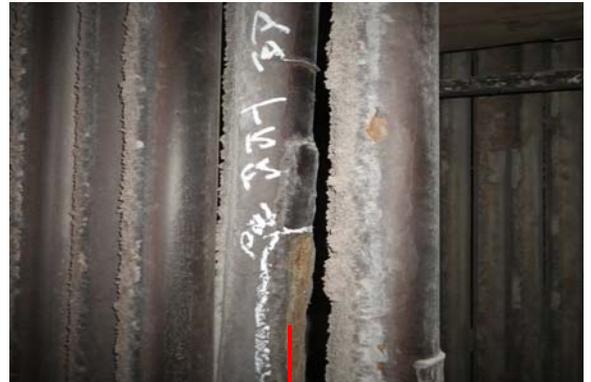
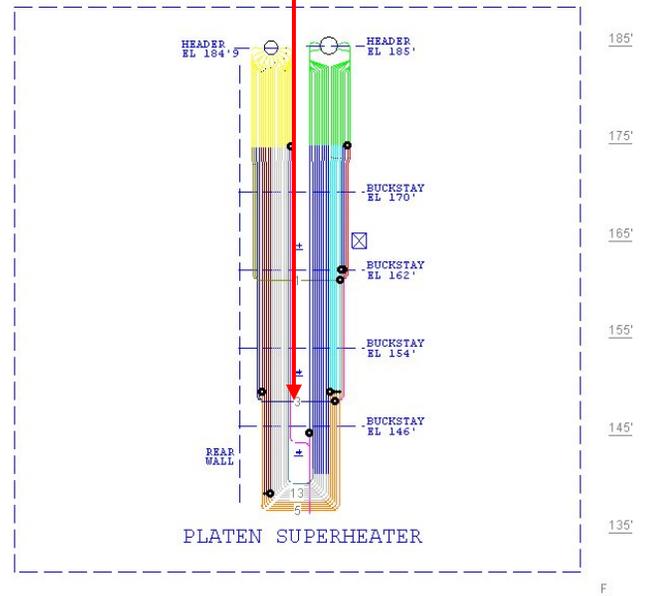
Cause: Erosion (Soot Blower)

Tube 15 of assembly 15 on the front half of platen center, has severe erosion on an existing pad weld. Surface finish makes UT inaccurate but visually tube is dished out and in need of **pad weld restoration in a 3" x 14"** area as marked with white grease marker.

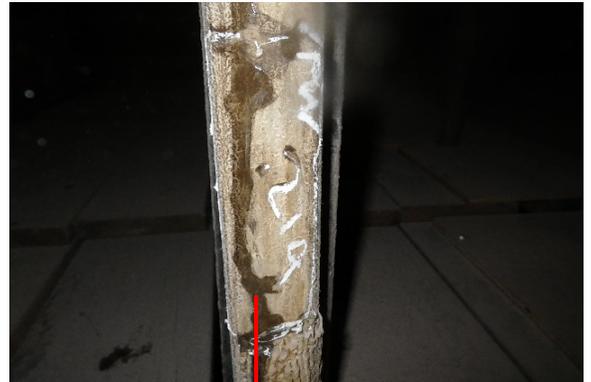
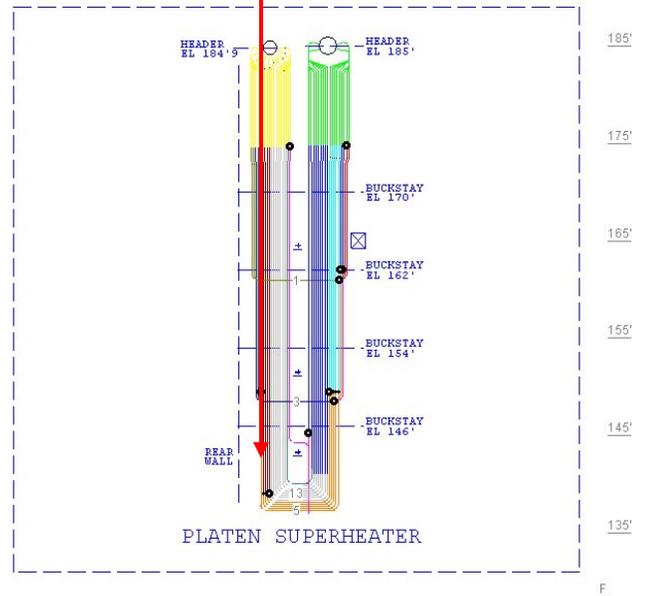
Cause: Erosion (Soot Blower)

A14/R-T5(0.218") 14"

Due to a remaining wall thickness between
66% to 75% of MWT, the following are
recommended for pad weld repair:

The pad weld will encompass the area of
wall loss which has been denoted on
tubing by a white box.

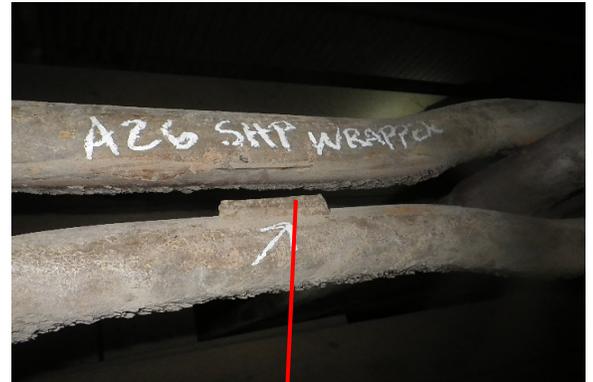
Cause: Fatigue (Thermal/ Vibration)

Appearance: Broken

Weld repair the broken wrapper tube attachment located in the center of Assembly 26.

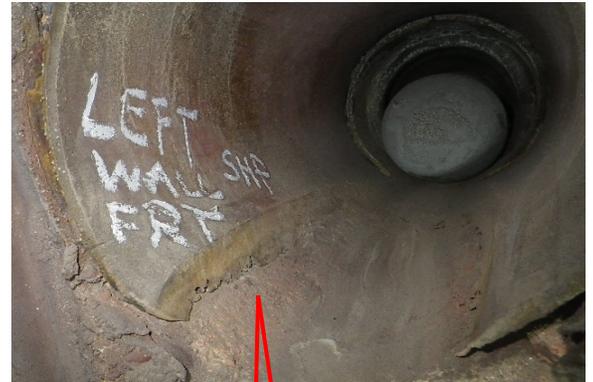
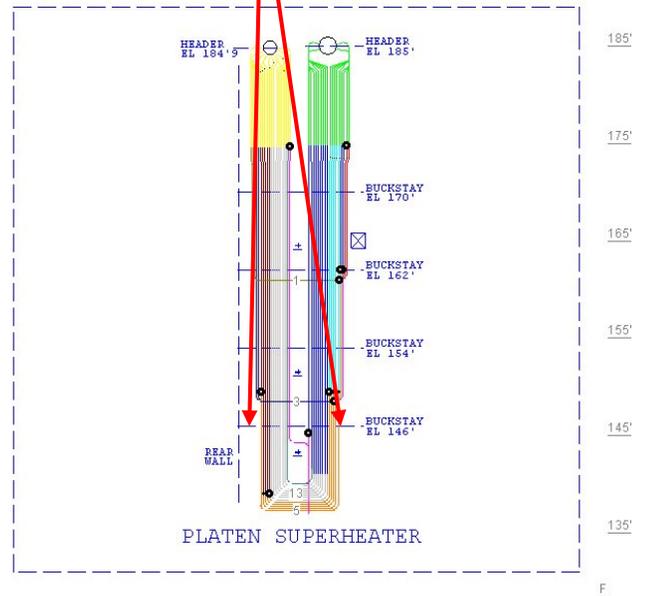
The blower sleeves of IK-1 and 2 at the lower leading side of the Platen appear abraded from the blower lance and/or pre-blowing of the system. Check alignment of the lances and correct as necessary and install new wall sleeves.

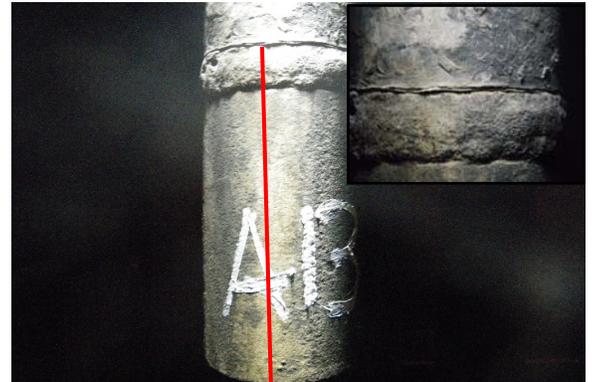
Cause: Fatigue (Thermal/ Vibration)

The DMWs are beginning to show signs of fatigue and possible end of life. It is recommended that further NDE testing (X-Ray, LPA) be completed to determine the severity of the fatigue and remaining life.

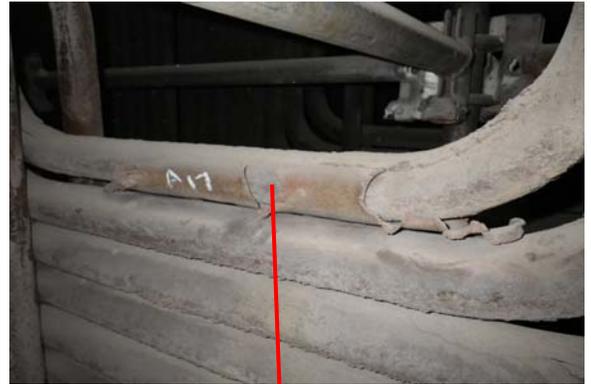
Cause: Overheat (Long Term)

Appearance: Deteriorated

The shields on Assembly 17 T17 on the horizontal and vertical sections of tube are distorted and disengaged due to long-term overheat. It is recommended that these shields be replaced.

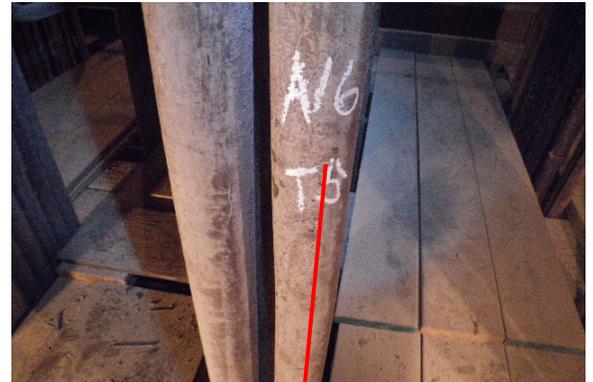
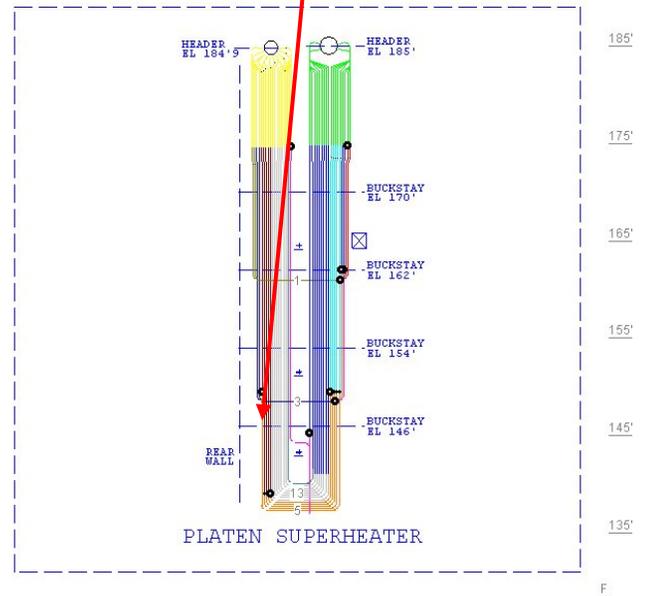
Cause: Fatigue (Thermal)

A16/T5

A26/T5

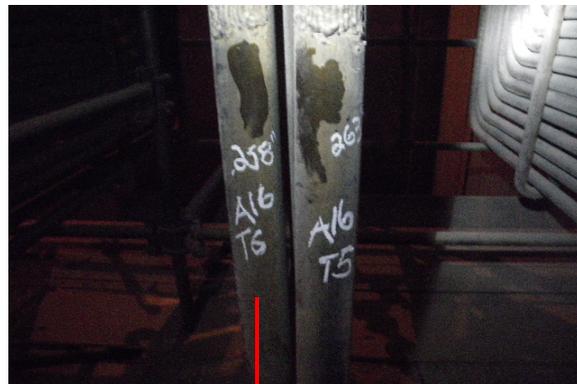
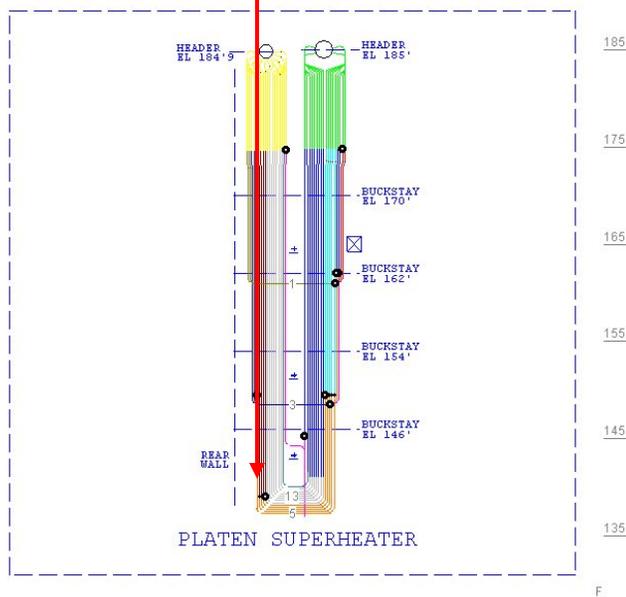
Cause: Erosion (Soot Blower)

Assembly/Front-Rear Tube(RWT):

- A1/R-T5(0.245)
- A3/R-T5(0.260)
- A7/R-T5(.265)
- A8/R-T5(.252)
- A9/R-T5(.252)
- A16/R-T5(0.263")
- A16/R-T6(0.258")
- A19/R-T5(0.270)

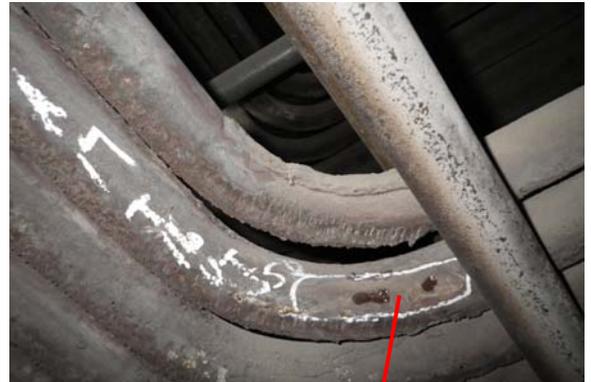
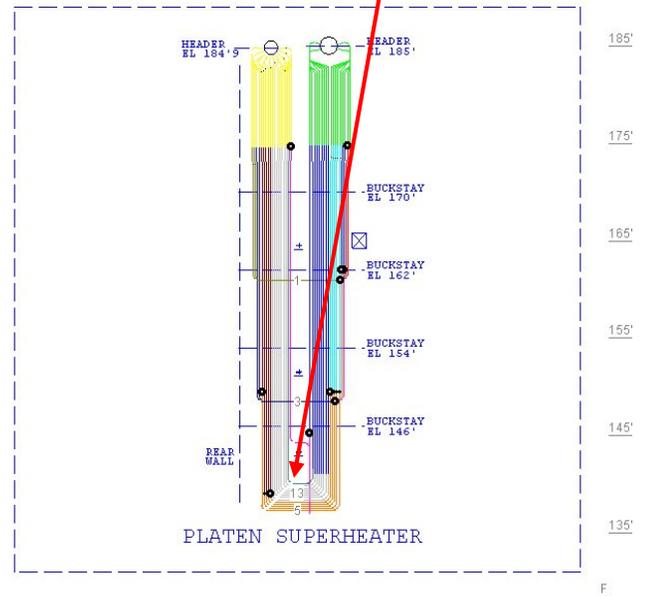
Cause: Erosion (Soot Blower)

Monitor tube 16 of assembly 17 during
future outages. Tube 16 is not in shield
criteria however erosion is apparent.

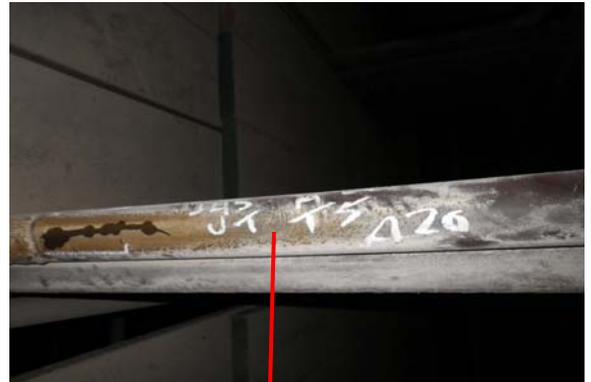
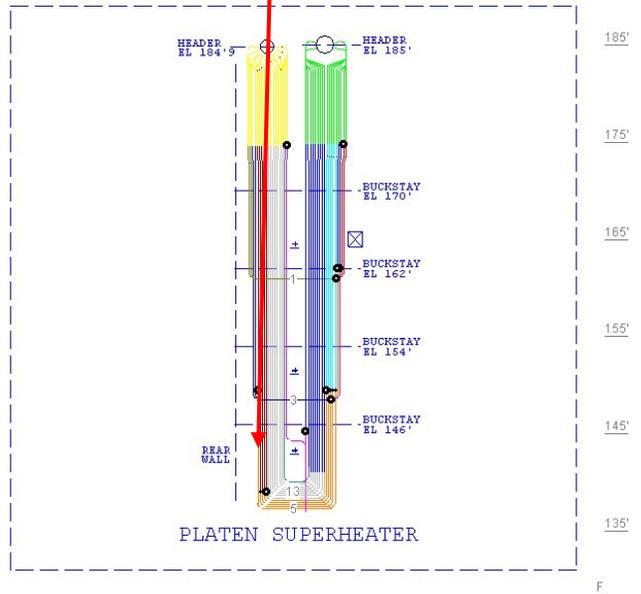
Cause: Erosion (Soot Blower)

Assembly/Front -Rear Tube(RWT):

- A4/R-T5(0.245")
- A5/R-T5(0.251")
- A6/R-T5(0.248")
- A7/R-T3(0.264")
- A9/R-T3(0.264")
- A20/R-T5(0.245")
- A21/R-T5(0.250")
- A22/R-T5(0.242")
