Inspection Report

Station: Mitchell Unit: 2 Report Name: 1-Reheater High Pressure

AREA: Reheater High Pressure

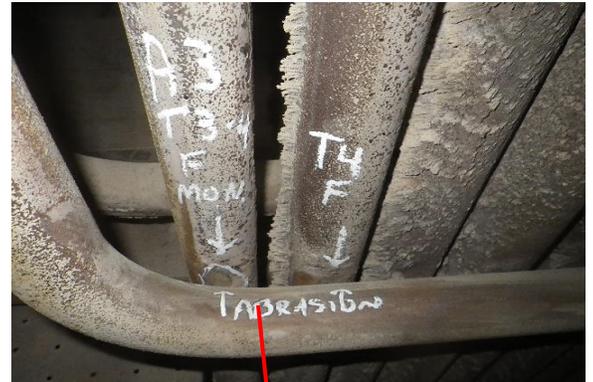
Cause: Fretting or Rubbing (Abrasion)

Light abrasion could be found in several locations throughout the platens where tubes are in contact with the upper wrapper. Assembly 3, Tubes 3&4F are typical of the more severe; however the tubes appear to be above any repair criteria.

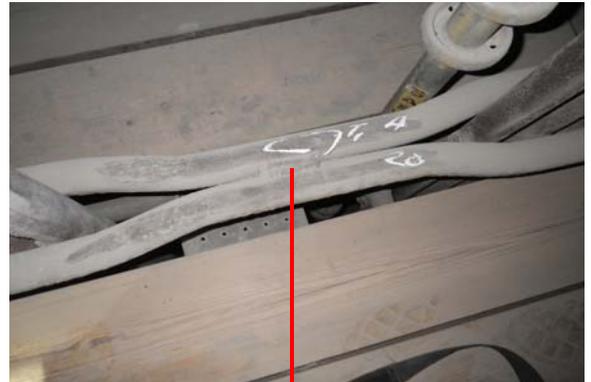
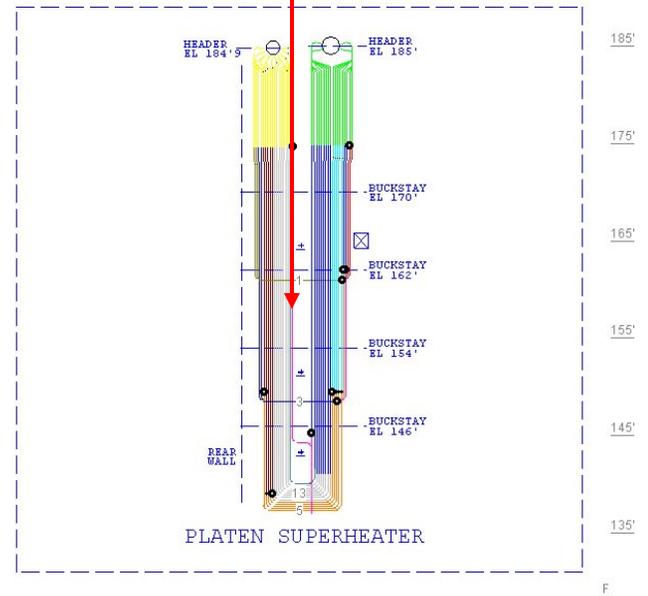
Cause: Erosion (Soot Blower)

Wrapper tube 1 on assemblies A19 and A20 have soot blower erosion flats between the pendants. It is not in pad weld criteria but it is only occurring here at these two locations and needs to be monitored during future outages.

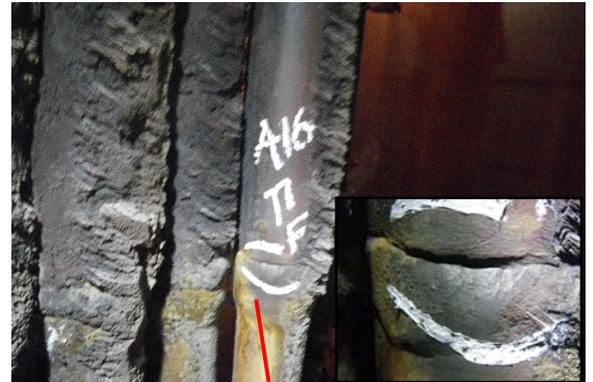
Cause: Work Quality (Welding Flaws)

Upon inspection of the DMWs, Tube 1-Front of Assembly 16 appears to have been undercut during application. It is recommended that further NDE testing (X-Ray, LPA) be completed to determine the integrity of the weld.

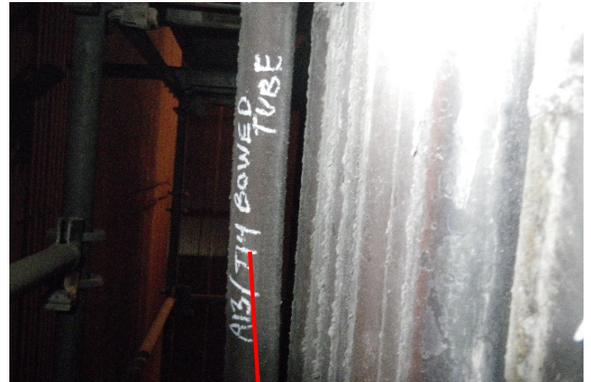
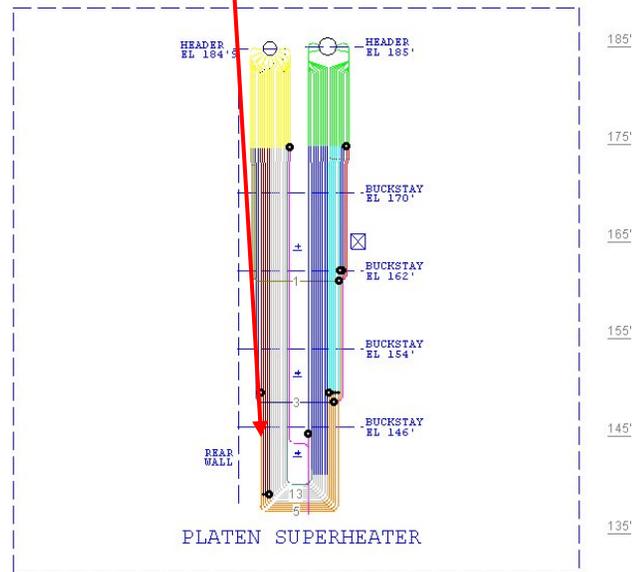
Cause: Fatigue (Thermal/ Vibration)

Plan for future replacement of the following assemblies/tube/length due to excessive bowing equal to or greater than 1 tube diameter -

Assemblies/Tube/Length:

A13/T14/14'

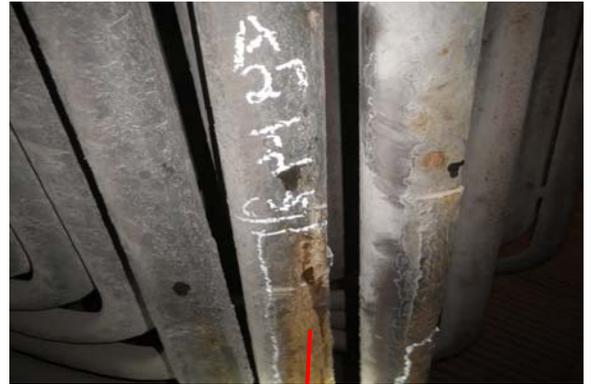
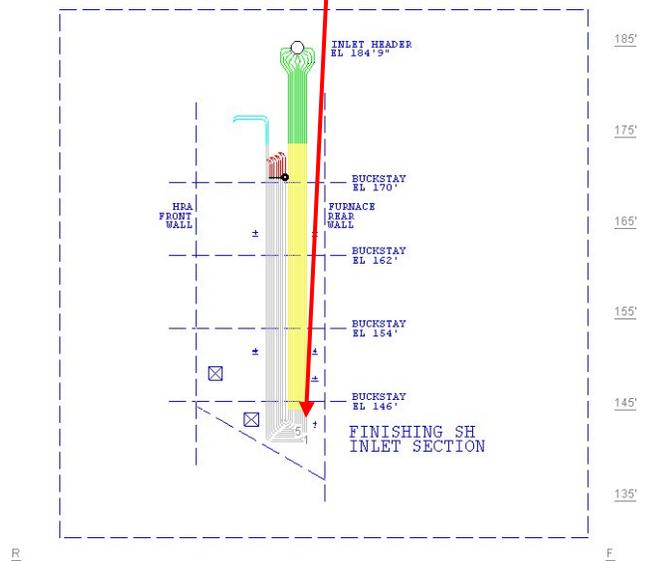
Cause: Erosion (Soot Blower)

Due to a RWT at or less than 65% of MWT, the following are recommended for replacement for a length of 3' on the verticals and 2' on the horizontal legs:
 Assembly/Tube(RWT):

A32/T2(0.334")

A32/T3(0.327")

Cut lines will extend up 3' and horizontal 2' for a total length of 5' encompassing the bend.

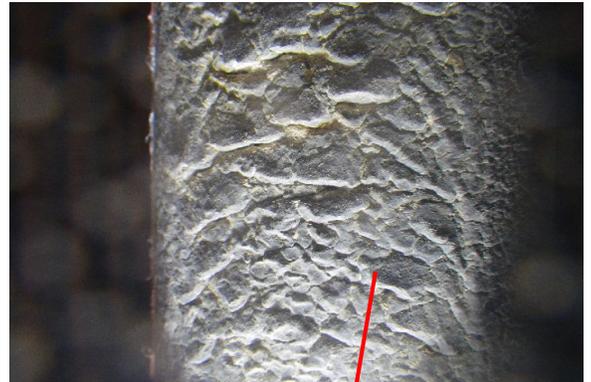
Cause: Soot Blower
Appearance: Quench Cracked Tube

Replace an approximate 5' section of Tube 1, Assembly 56 on the lower leading edge due to apparent quenching from IK-7/8. This tube is also experiencing erosion from the soot blower. Cut-lines are marked on the tube and will involve the lower bend.

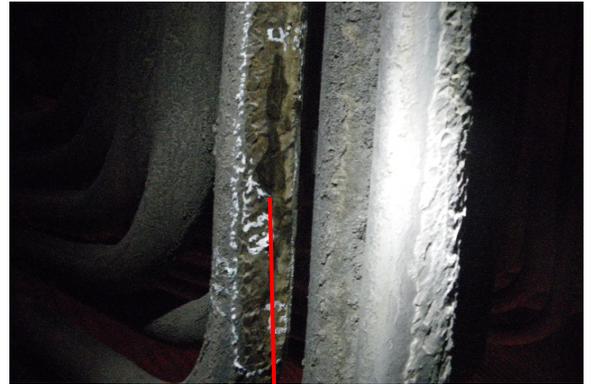
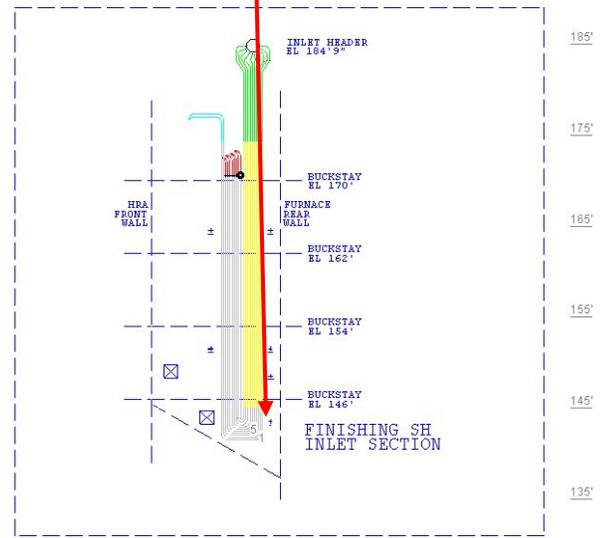
Cause: Erosion (Soot Blower)

Due to a remaining wall thickness between 66% to 75% of MWT, the following are recommended for pad weld repair:

Assembly/Front-Rear Tube(RWT)PW Length:

- A7/F-T3(0.457")18"
- A23/F-T1(0.444")12"
- A24/F-T1(0.422")12"
- A25/F-T1(0.414")14"
- A25/F-T3(0.498")14"
- A26/F-T2(0.461")16"

The pad weld will encompass the area of wall loss which has been denoted on tubing by white box.

Use vertical stringers and feather (taper) by grinding all four of the edges at top, bottom, right and left orientations. Do not horizontal weave pad weld.

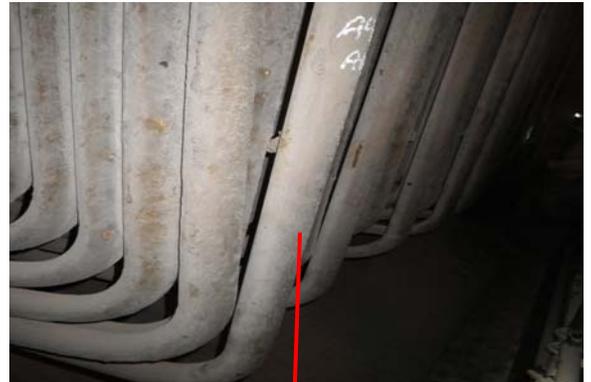
Cause: Fatigue (Thermal/ Vibration)
Appearance: Misaligned

The greater majority of pendants have varying degrees of misalignment by as much as one tube diameter in the lower sections. Broken and deteriorated slip spacers and handcuffs are contributing to this condition.

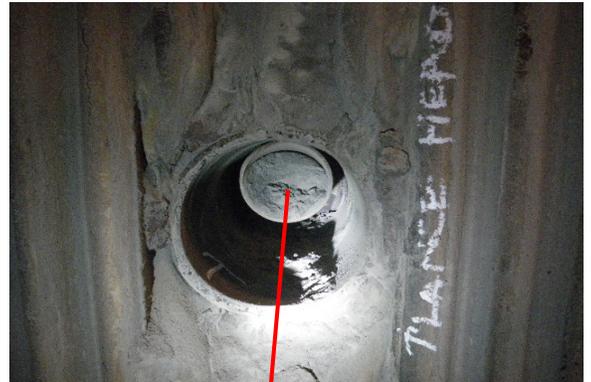
Appearance: Missing

Replace missing blower head on IK-13 between the Finishing Superheater Pendants.

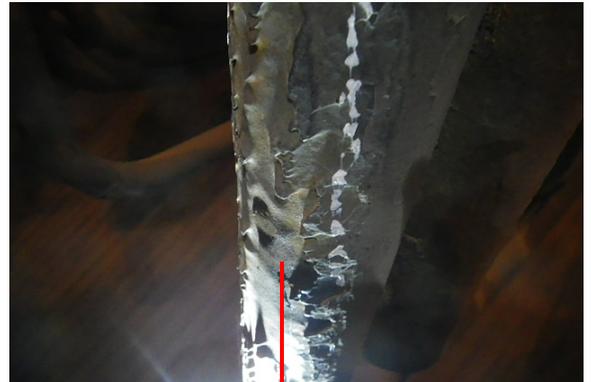
Cause: Erosion (Soot Blower)

Heavy soot blower erosion is occurring throughout the IK-7/8 path impacting mostly Tubes 1-5. Wall loss on the order of 1/8" and greater is present on some tubes. As numerous and multiple weld repairs have been conducted, it is recommended that this area be closely monitored.

It is recommended that the blowers are evaluated for proper maintenance, operation and a plan established to address probable future tube replacements.

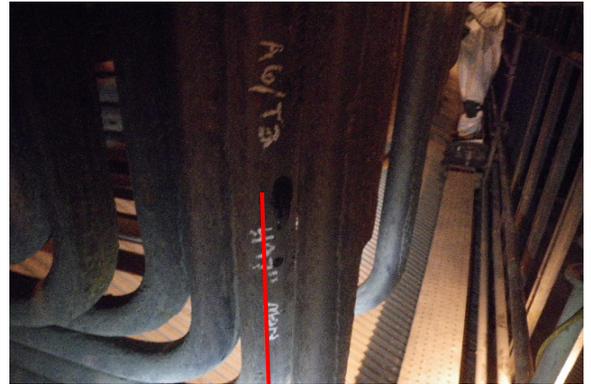
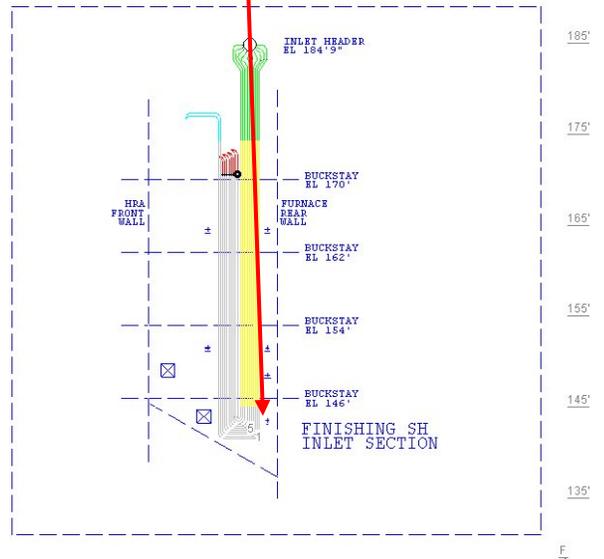
Cause: Erosion (Soot Blower)

Assembly/Front-Rear Tube(RWT):

- A6/F-T2(0.497")
- A15/F-T2(0.468")
- A15/F-T3(0.502")
- A22/F-T1(0.512")

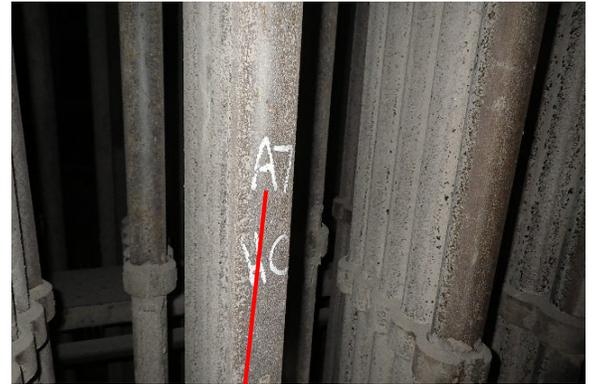
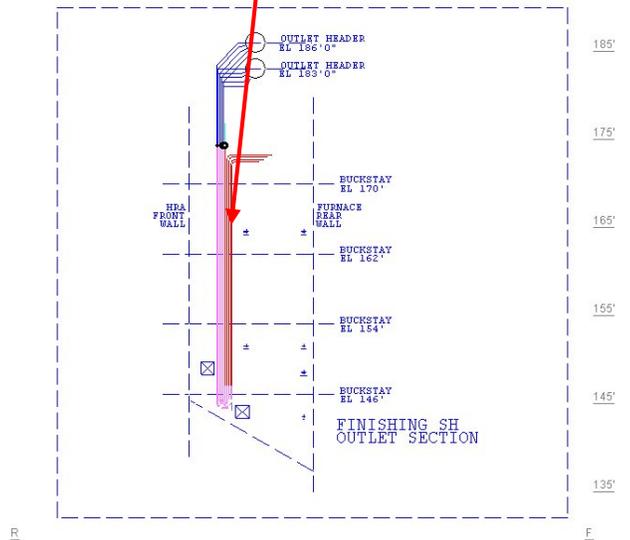
Cause: Fatigue (Thermal/ Vibration)

Appearance: Missing

Handcuff split ring alignment brackets are missing or broken off at the following assemblies: Assembly/Front Rear:

A7F	A21F	A48F	A63F
A10F	A23F	A49R	A66-67F-R
A11F	A25R	A50F	A68R
A11R	A26F	A51F	A74-75R
A12F	A30F-R	A53F	A78-79F
A13R	A34F	A54F	A85F
A14F	A35F	A55F	A90R
A15F	A39R	A57F	A98F
A16F	A41F	A60F	A101F
A18F	A43F	A61F-R	A102FR
A19F	A44R	A62F-R	A104-106F

Install new handcuff split ring castings at these locations.

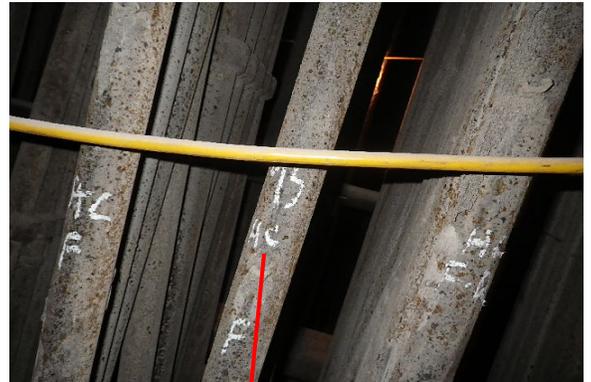
Cause: Fatigue (Thermal/ Vibration)

Appearance: Missing

Several handcuff split ring castings are missing or broken off at over half of all assembly locations. Install new handcuff split ring castings at these locations.

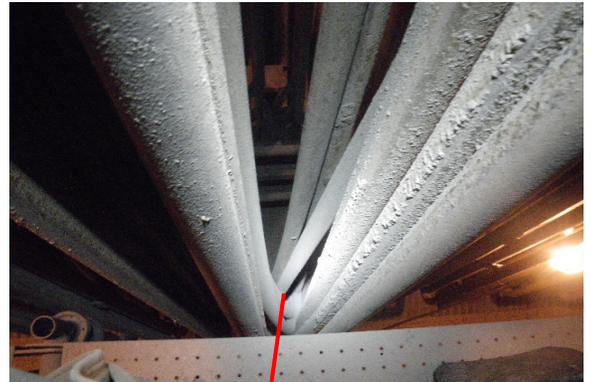
Cause: Fatigue (Thermal)

The assemblies of the Finishing Superheat Outlet pendant are severely out of alignment to where the assemblies are intertwined. It is recommended that these assemblies be realigned to where they are in plane with the leading tube.

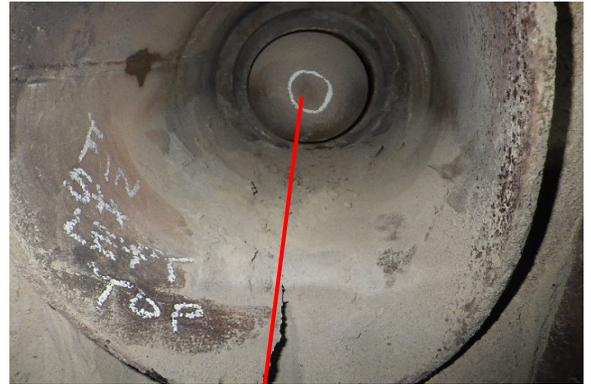
Cause: Fatigue (Thermal)

Appearance: Possible Crack

One small star-like crack was observed in the upper left side (IK-15) soot blower lance head, however it still appears to be in serviceable condition. Re-inspect at next outage.

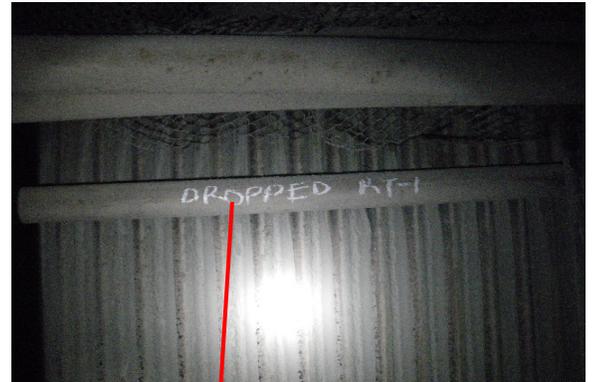
Cause: Fatigue (Thermal/ Vibration)

The roof tubes adjacent to the left and right walls have dropped and are out of alignment.

It is recommended that they be pulled back into plane beginning to the front of the Finishing Superheater Inlet Pendant and extending approximately 25' to the rear of the Rear Water Wall Screen Tubes.

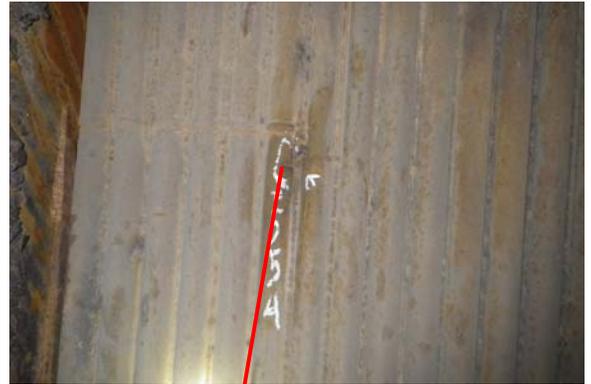
Cause: Work Quality (Maintenance Damage)
Appearance: Gouged Tube

Install a 1' dutchman Tube #554 on the front wall slope 2' below the transition due to a grinder cut approximately 0.062" wide. RWT is unobtainable, however the grinder cut is into the membrane and mineral deposits around this area are indicative of a leak.

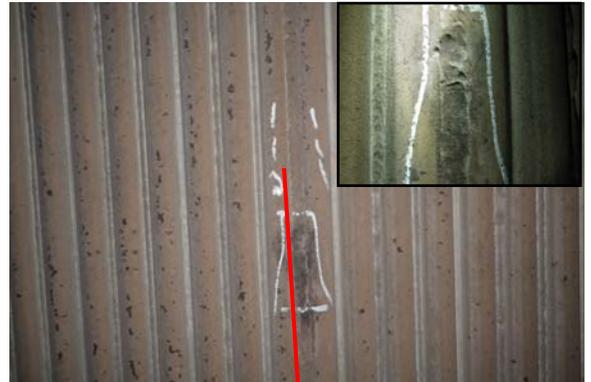
Appearance: Crack Indication

Between tubes 111 and 112 the membrane is built up higher than the rest of the area and there are **two (2) indications of a possible leak**. Recommend grinding membrane at this spot and investigating for possible holes or cracks in tube/tubes. There were mineral deposits around this area indicative of a leak.

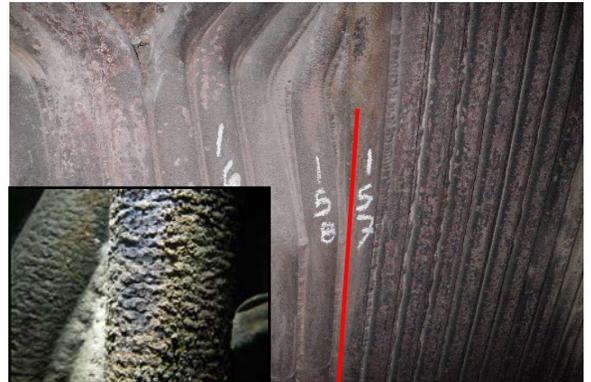
Appearance: Quench Cracked Tube

Tubes 157-159 are showing signs of quench cracking just below the left water cannon on the front wall. It is recommended that tubes be ground down to contour to determine RWT and repair as needed.

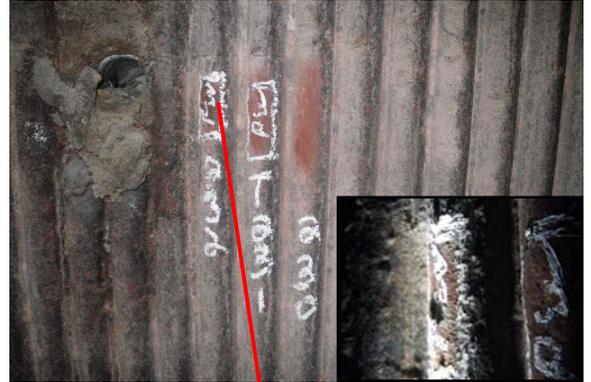
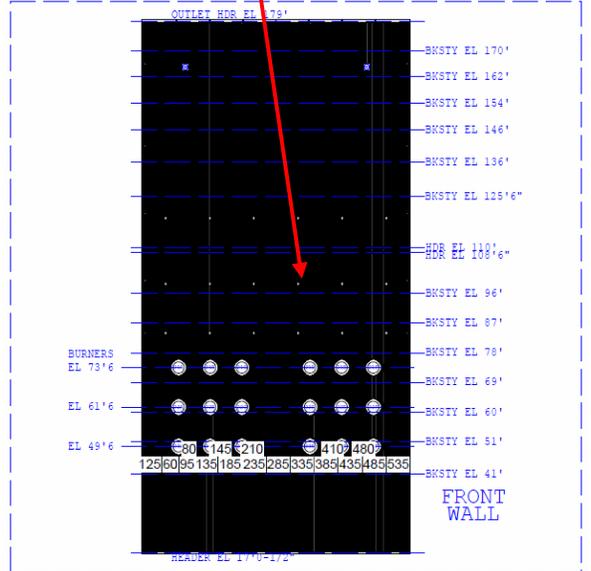
Cause: Erosion (Soot Blower)
 Appearance: Erosion Flat

Restore tubes 231-232 to RWT by applying a 1" x 3" pad weld as denoted by white box. The IR blowers are no longer in service however pad weld repair is recommended based on visual inspection.

Note: RWT was unobtainable due to condition of the tube surface.

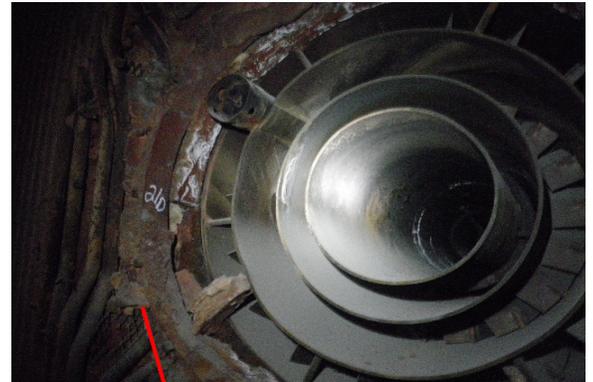
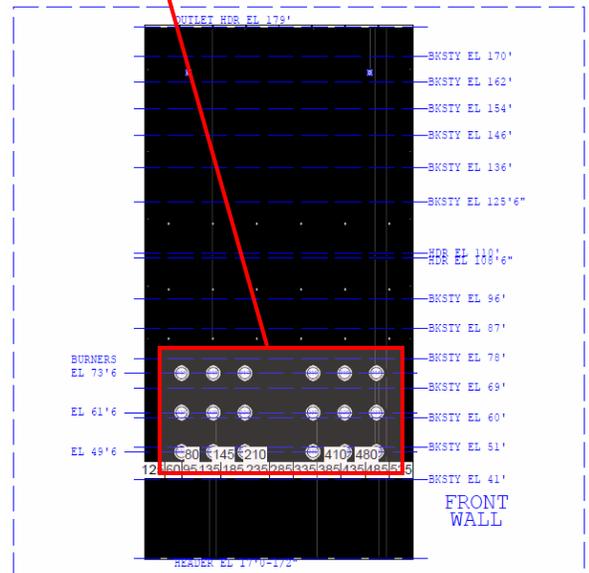
General location is Furnace Front Wall, At Burners.

Replace missing refractory around all of the front water wall burner ports. Although all of the burners are in need of refractory repair, the following are the most severe exposing tube material and expanded metal:

- 21A
- 21D
- 21E
- 21F
- 22B
- 22C
- 22D
- 22E

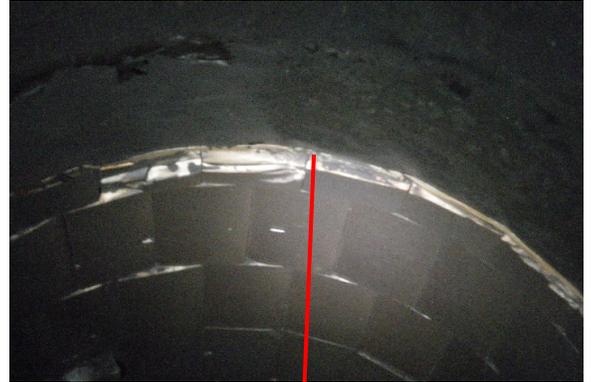
Replace the ceramic tile at the following front wall burners:

The remaining burner tiles are in good condition and no conical diffusers need repair.

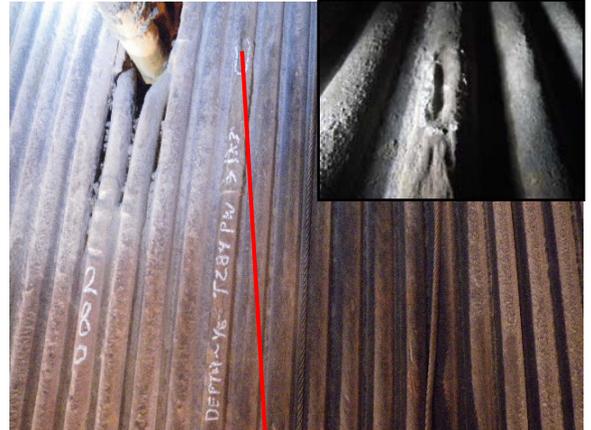
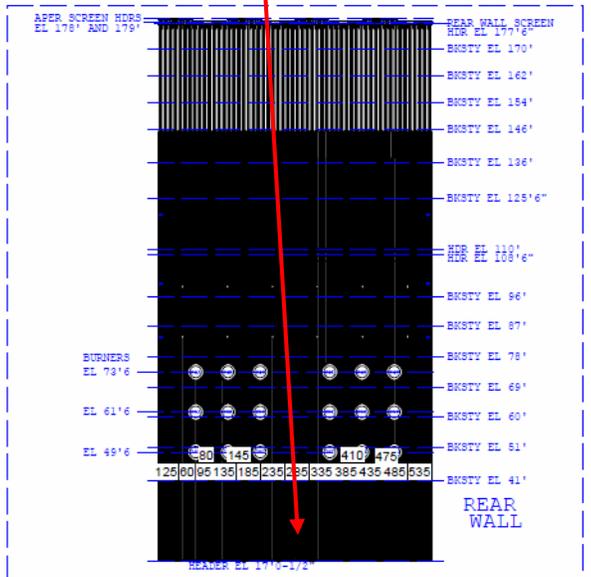
Restore **tube 284 of the lower slope to MWT by applying a 1" x 3" pad weld**. Existing pad weld has a tube gouge approximately 1/8" of an inch depth.

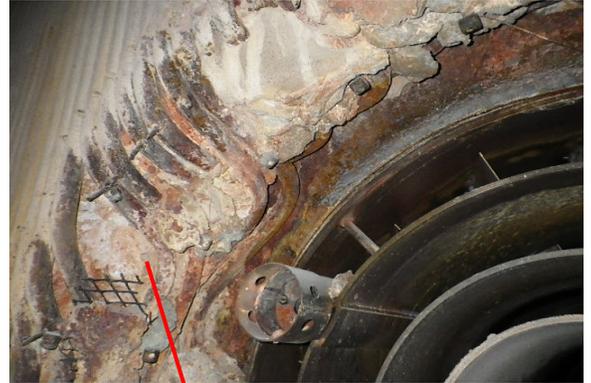
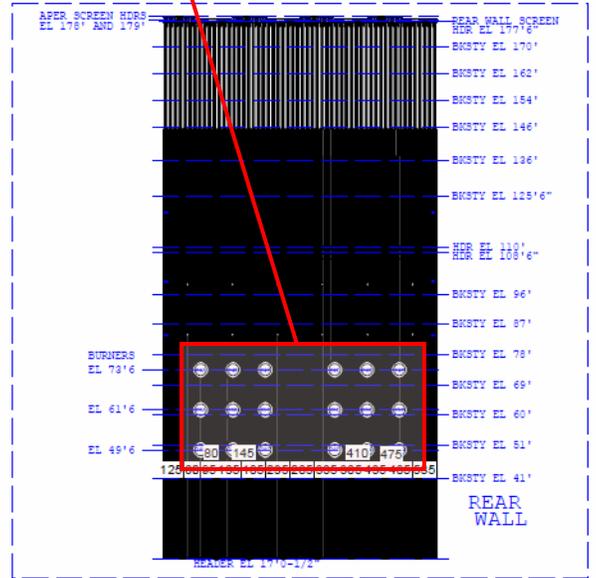
General location is Furnace Rear Wall, Above Burners.

Replace missing refractory around all of the front water wall burner ports. Although all of the burners are in need of refractory repair, the following are the most severe exposing tube material and expanded metal:

- 24A
- 24F
- 25A
- 26A-B

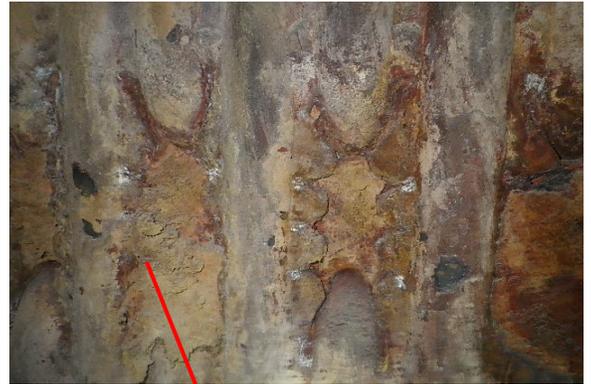
Repack the missing refractory at both header elevations on the rear wall. Missing refractory has exposed the peg fins which are becoming burnt and thermal fatigued.

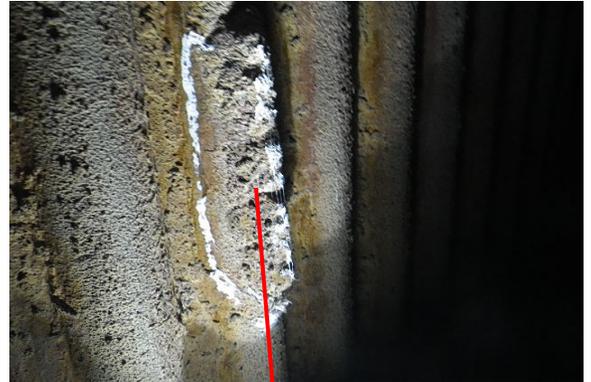
Numerous excessive attachments (>1/8") were observed throughout the rear wall and examples could be found at elevations 47', 83'.

Due to expansion differentials between the tube and attachment, cracking can sometimes initiate. Best practices would indicate their complete removal after completion of their intended use.

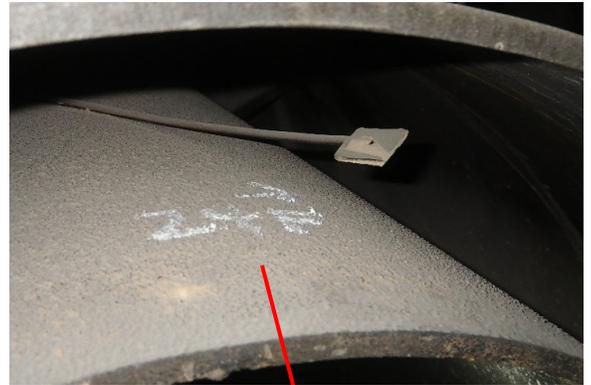
General location is Furnace Rear Wall,
 Burner, 24F.

One thermocouple was observed detached at
 the top side of burner 24F coal nozzle.

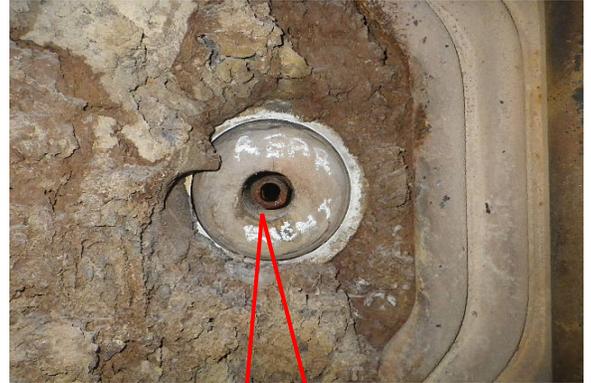
Both rear wall water cannons were inspected and found to be in acceptable condition in regard exposed wall boxes and the minimal cracking on the nozzle tips, however the left side did exhibit more cracking in the tip.

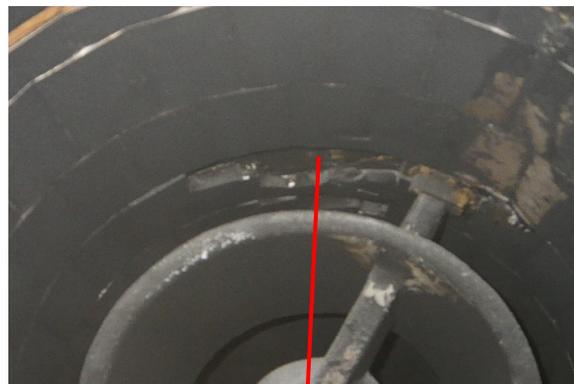
Replace the ceramic tile at the following rear wall burners/clock position:

- 24C/3
- 24D/4-12
- 25B/5-12
- 25C/11
- 26D/12
- 26E/11

The remaining burner tiles are in good condition and no conical diffusers need repair.

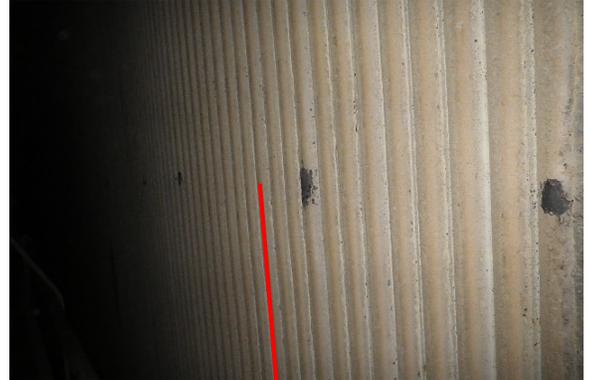
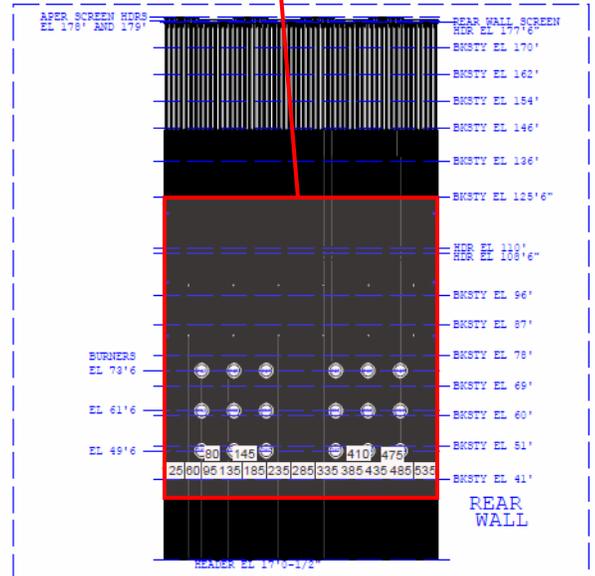
Approximately 40 rear wall tubes were examined at two elevations for the presence of quenching from the water cannons. No indications were visually present in any location.

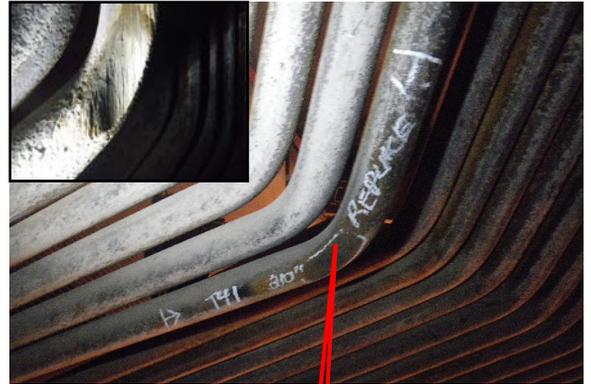
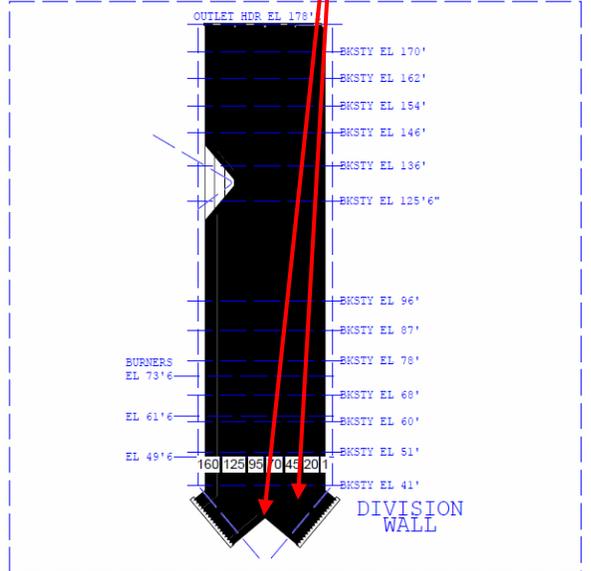
Cause: Fretting or Rubbing (Abrasion)

Due to a RWT at or less than 65% of MWT, the
following are recommended for replacement
for a length of 3' - Tube(RWT):

Cut lines are marked with white grease stick
18" above and below the transition from the
45 degree run and the vertical run.

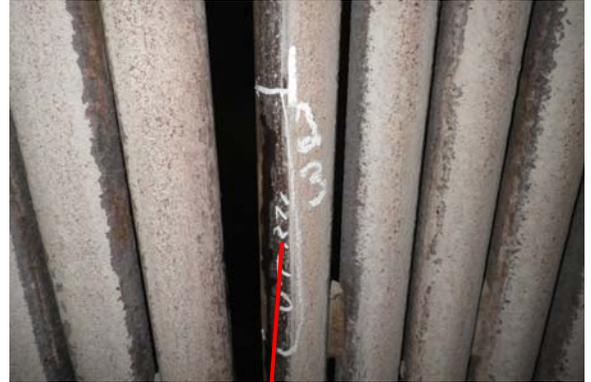
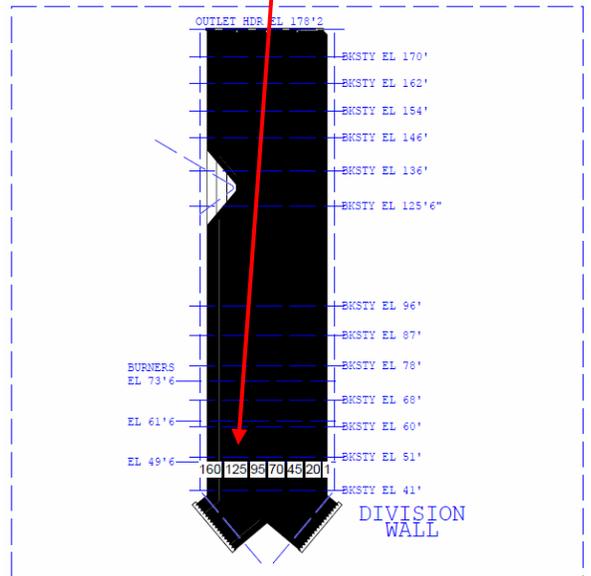
Tube 123 on the division wall is contacting
 tube 124 and abrasion is occurring. **Restore
 tube 123 to MWT by applying a 10" x 2" pad
 weld due to a UT of 0.271"**. The pad weld
 will encompass the area of wall loss which
 has been denoted on tubing by white box.

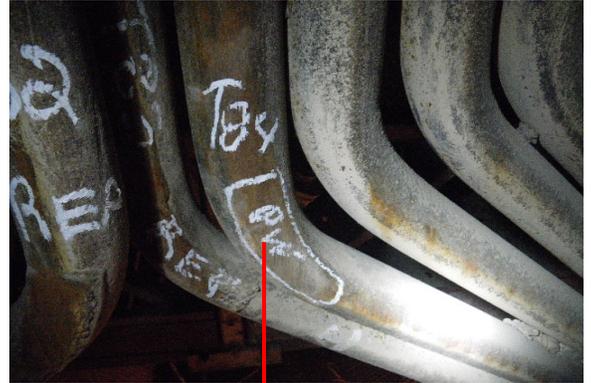
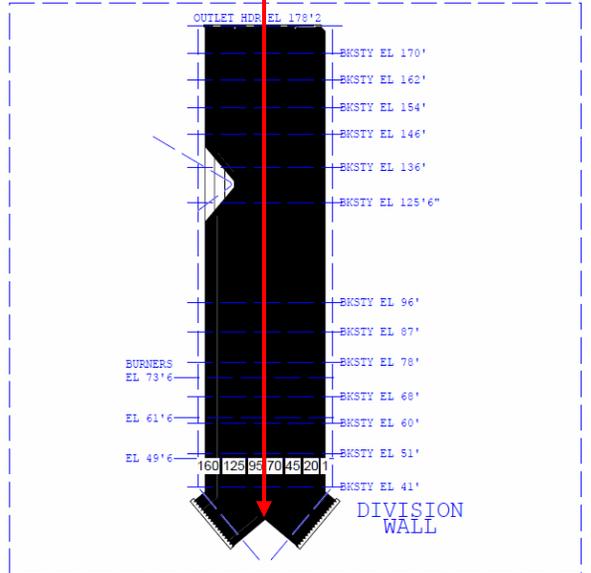
Due to a remaining wall thickness between 66% to 75% of MWT, the following are recommended for pad weld repair: Tube(RWT)PW Length:

- T84(0.N/A") 5"
- T124(0.260") 3"

The pad weld will encompass the area of wall loss which has been denoted on tubing by white box.

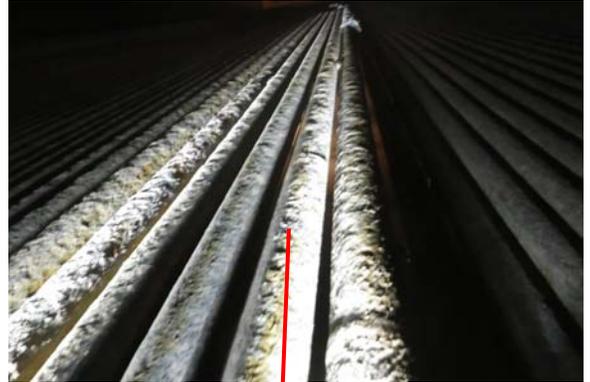
Tubes 70-82 on division wall at first burner level, right side, has fireside corrosion indications. Lowest obtainable RWT was 0.310" and does not warrant repair at this time. It is recommended these tubes be monitored during future outages.

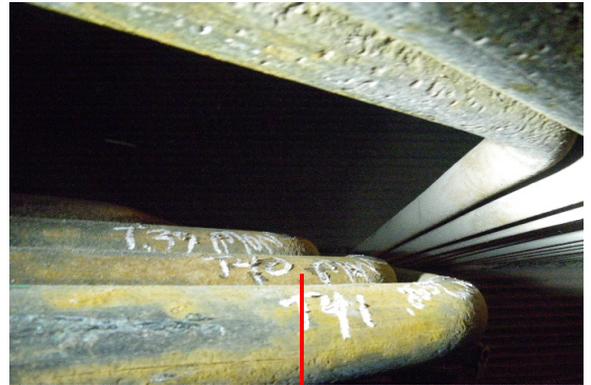
Monitor the left side of tubes 39-40 of the furnace division wall at the transition to the vertical run. Tubes are abraded but warrant no repair at this time.

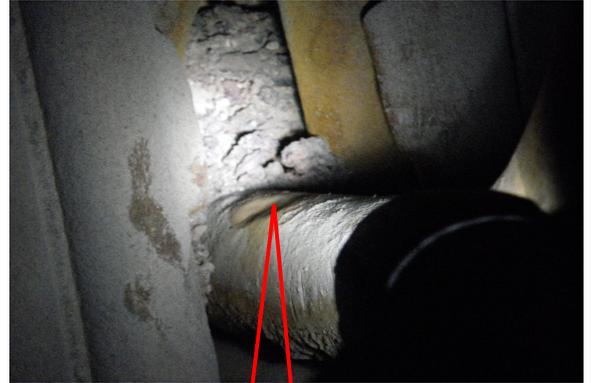
Monitor tubes 1 and 164 of the furnace
division wall where they penetrate the lower
slope. Tubes are showing signs of erosion
but warrant no repair at this time.

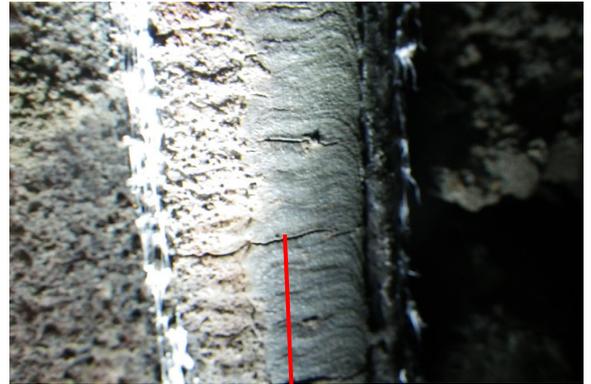
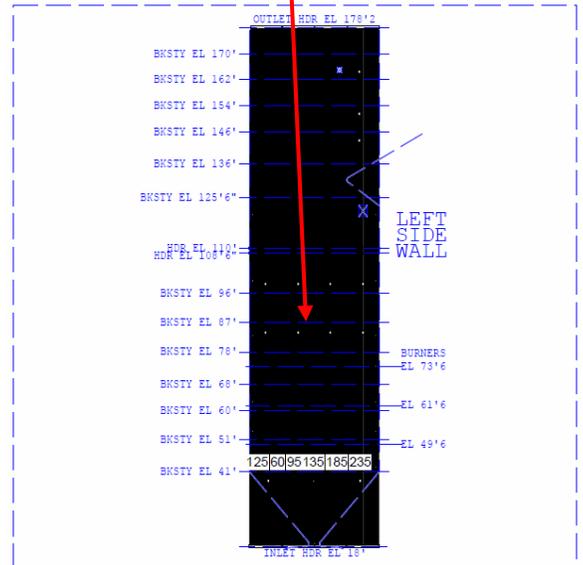
Circumferential crack indications in the weld overlay were observed at Tube 170 adjacent to IR-3 over an approximate 6" area.

NOTE: Tube may be marked 172 in the field.

It is recommended that the indications be ground to termination to determine if the cracks may have propagated into the tube boundary and are in need of pad weld or replacement repairs. RWT values between .188" to .164" would indicate pad weld restoration and below .163" is replacement, per UDC criteria.

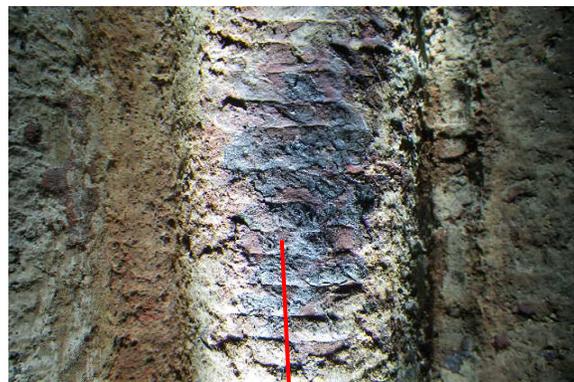
Located in the upper most IR band below the deflection arch, quenching indications were observed on approximately a total 38 tubes around the 1st and 3rd IR ports. At the 1st port there are 7 to the left of center and 17 to the right. At the 3rd, 6 to the left of center and 8 to the right.

NOTE: The involved areas are marked off in 3' to 4' squares.

It is recommended that the indications be ground to termination to determine the need for weld or replacement repairs. RWT values between .188" to .164" would indicate restoration and below .163" is replacement, per UDC criteria.

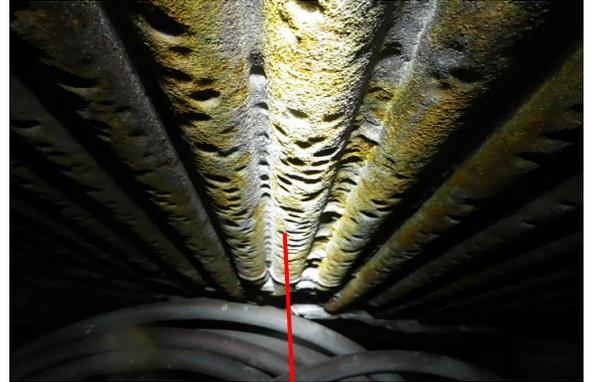
As time and/or resources allow, plan or consider a 15'-20' tube panel replacement at the lower center of the left wall above the throat due to impacts from extensive shotgun deslagging. Long term tube integrity may have been sacrificed by the numerous impacts.

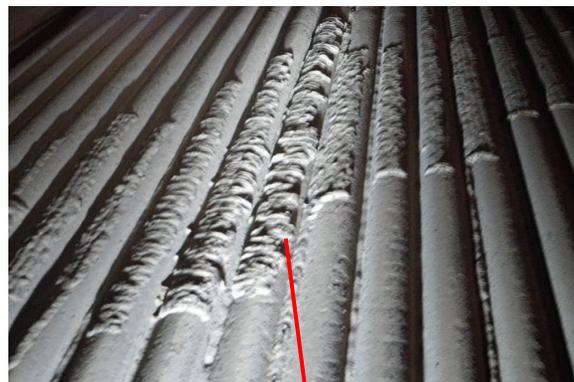
As time and/or resources allow consider a plan to replace an approximate 20 tube panel x 6' to 8' in length located at the front wall IR approximately 1' above the wall to slope transition. Should a panel not be considered, Tubes 35-36 display the heaviest amount of excessive pad welds.

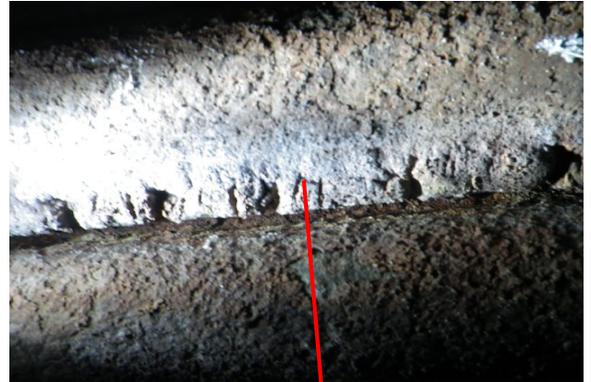
The membrane on the following Tubes located between the mix headers has become thermal fatigued and cracked. Consider replacement to ensure that cracking does not propagate into the tube wall. Tubes: 44, 65, 87, 107, 129, 150, 170.

NOTE: Due to the pick arrangement, tubes near the front and rear corners could not be examined. The tube count in the field may be off by 2. All tubes are marked with an X and tube number.

Remove existing peg fin remnants and replace with new like material. Install fins with non-continuous side against tube and apply >80% penetration welds not extending past each fin break. Start and stop welds on fin. Do not weld around ends of fins.

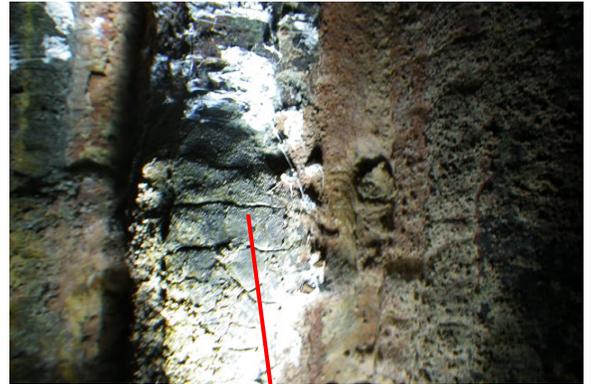
Circumferential crack indications in the weld overlay was observed at Tubes 106 and 107 at elevation 61 over an approximate 4" area.

It is recommended that the indications be ground to termination to determine if the cracks may have propagated into the tube boundary and the need for weld or replacement repairs. RWT values between .188" to .164" would indicate restoration and below .163" is replacement, per UDC criteria.

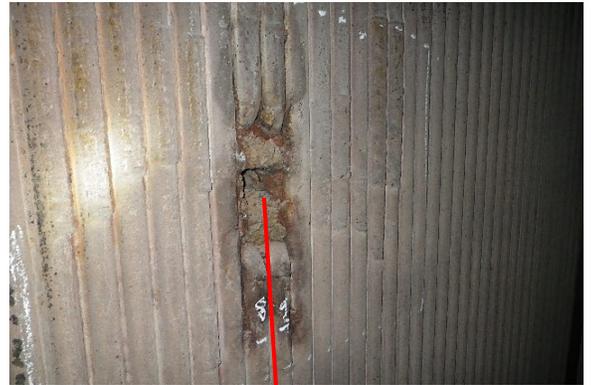
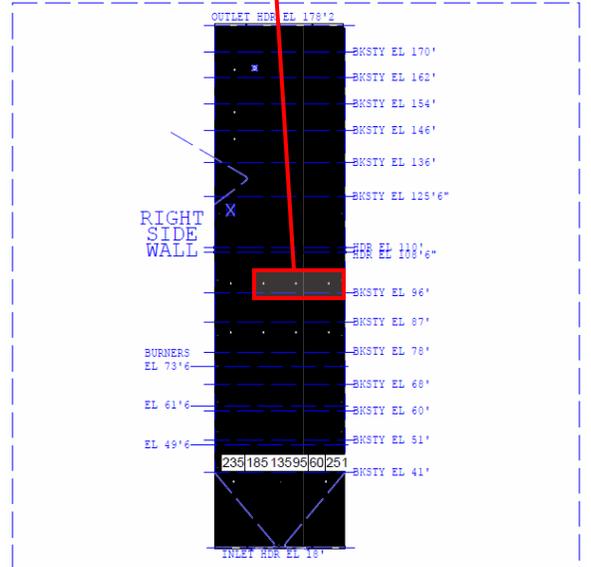
Located in the upper most IR band below the deflection arch, quenching indications were observed on approximately a total 50 tubes around the 1st, 2nd and 3rd IR ports.

At the 1st port there are 9 to the front of center and 8 to the rear. At the 2nd, 9 to the front of center and 8 to the rear, and at the 3rd, 8 tubes either side. It is recommended that the indications be ground to termination to determine the need for weld or replacement repairs. RWT values between .188" to .164" would indicate restoration and below .163" is replacement, per UDC criteria.

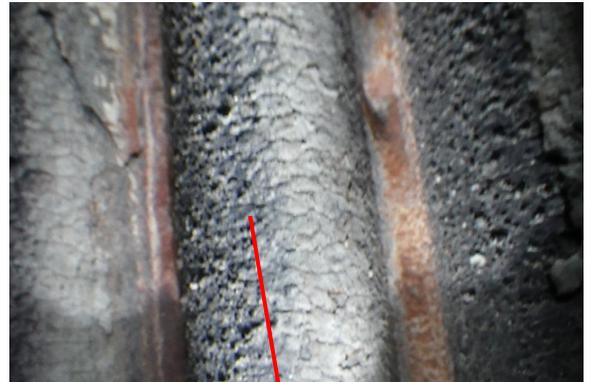
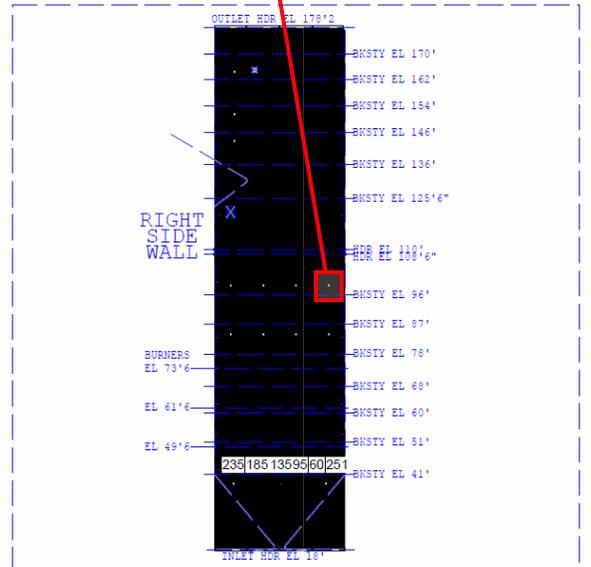
Located on tubes 25-41 adjacent to IR-1, quenching indications were observed on an approximate total of 25 tubes. It is recommended that the indications be ground to termination to determine the need for weld or replacement repairs. RWT values between .188" to .164" would indicate restoration and below .163" is replacement, per UDC criteria.

NOTE: The involved areas are marked off in 3' to 4' squares.

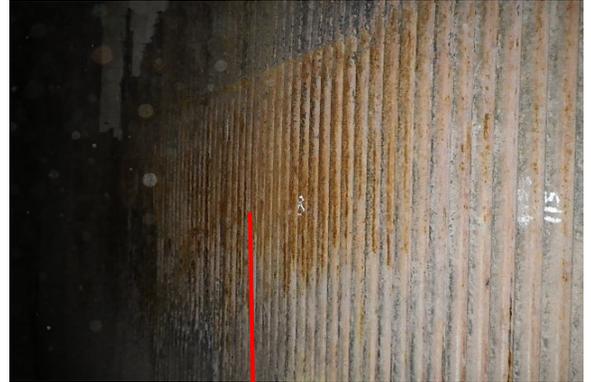
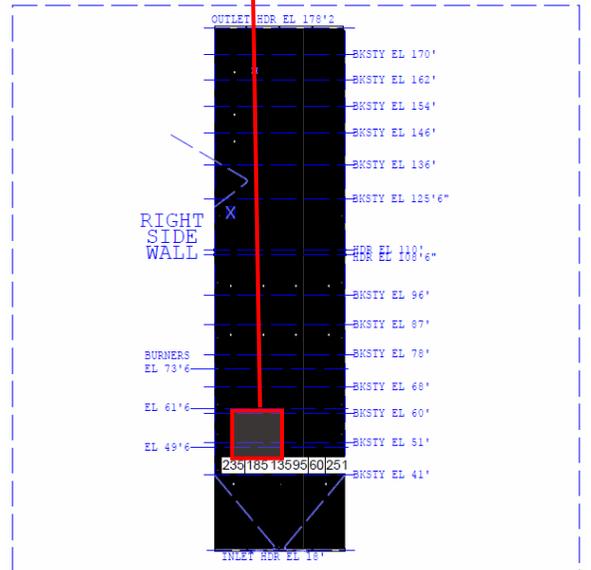
Evidence of what appears like fireside corrosion was observed from about tube 115 to tube 200 located in an area approximately 4' down from the lowest existing weld overlay. At present, the wastage seems to be light with no action needed at this time. Monitor at future outages.
