# Mitchell Unit #2 spring 2012 Turbine/Generator Outage

Turbine Serial Number	170X394
Generator Serial Number	180X394
Unit Out of Service	2/17/2012
Unit Release for Service	4/13/2012

## 1. Summary

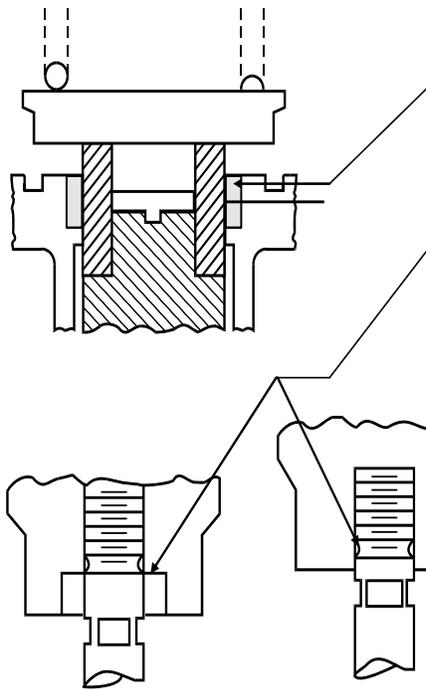
**#3 stem has a crack in the seat/pin area near the spline ( needs replaced ).**

**#3 Stem has a cracked area in the seat /pin area needs replaced**

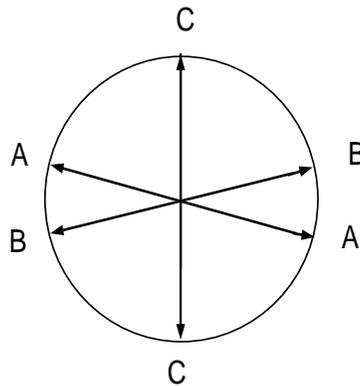
Location and Row	Packing Casing			Out of Round (V-H)	Horizontal Reading	
	A-Dia	B-Dia	C-Dia		Tightwire Adjustment	Unbolted
						U/H    L/H
N-8 GRV-1	27.472	27.477	27.520	0.046	set low by 0.023	
N-8 GRV-3	27.474	27.472	27.529	0.056	set low by 0.028	
N-9 GRV-1	27.441	27.444	27.562	0.120	set low by 0.060	
N-9 GRV-3	27.452	27.448	27.559	0.109	set low by 0.054

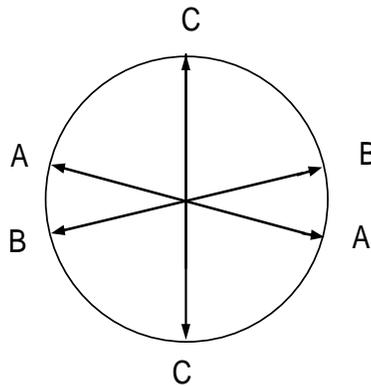
Location and Row	Packing Casing			Out of Round (V-H)	Horizontal Reading		
	A-Dia	B-Dia	C-Dia		Tightwire Adjustment	Unbolted	
						U/H	L/H
<b>N-6 GRV-1</b>	27.483	27.487	27.518	0.033	set low by 0.017		
<b>N-6 GRV-3</b>	27.481	27.473	27.528	0.051	set low by 0.025		
<b>N-7 GRV-1</b>	27.487	27.489	27.520	0.032	set low by 0.016		
<b>N-7 GRV-3</b>	27.499	27.493	27.506	0.010	set low by 0.005		
<b>N-8 GRV-1</b>	27.416	27.468	27.567	0.125	set low by 0.063		
<b>N-8 GRV-3</b>	27.396	27.430	27.584	0.171	set low by 0.085		
<b>N-9 GRV-1</b>	27.438	27.462	27.554	0.104	set low by 0.052		
<b>N-9 GRV-3</b>	27.456	27.479	27.532	0.064	set low by 0.032
