# RussMar Logistics, LLC.

Case No. 2012-00361<sup>362</sup>

The following documentation is being submitted by RussMar Logistics, LLC. on behalf of the Tompkinsville Natural Gas System.

1. Leak Survey(City): (24 pages)
2. Visual Inspection of Main: (1 page)
3. Leak Repairs: (26 pages)
4. Office Chart Clock: (18 pages)
5. Public Awareness Meeting(s): (Oct 1 & Oct 24)

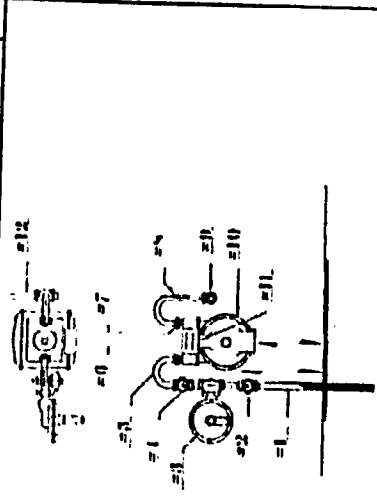
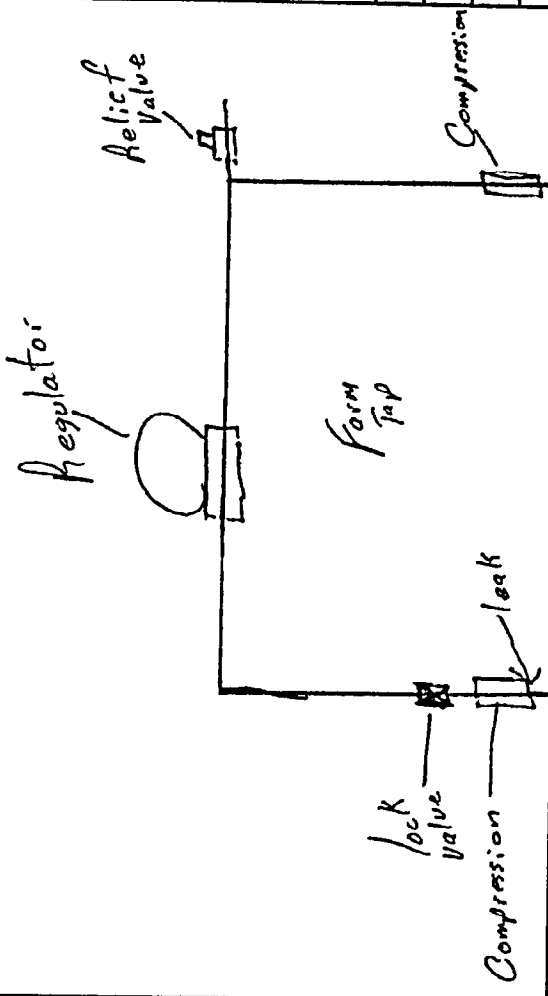
Leak called in by customer.  
 Repaired 9-13-13

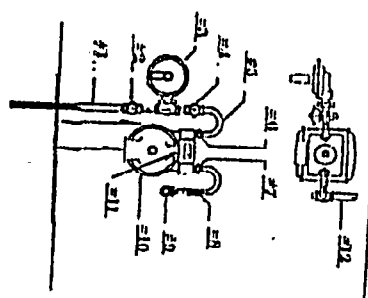
Lock valve was leaking through on an old service with no meter. We broke down the service & replaced the faulty lock valve. We then locked off the service & tested for leaks.

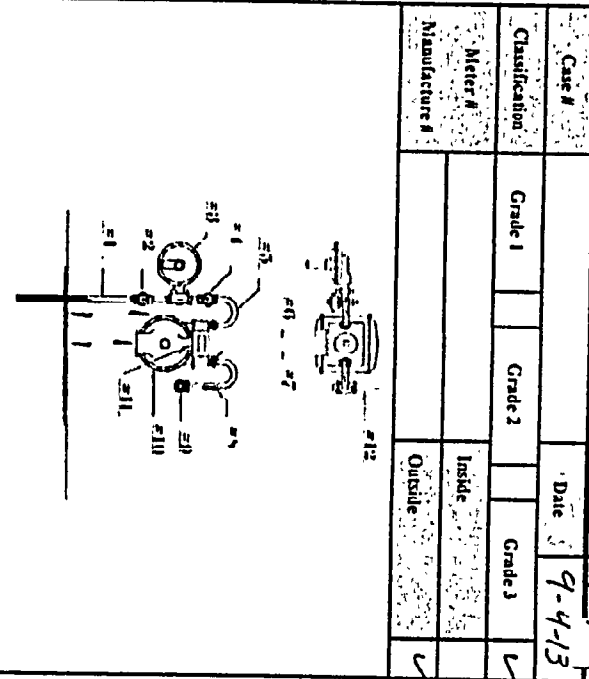
Address: 408 6th Street City: Tompkinsville / Monroe State: KY Date: 9-4-13

Leak found on compression tee. We cut it out + fused a PE tee back in place.

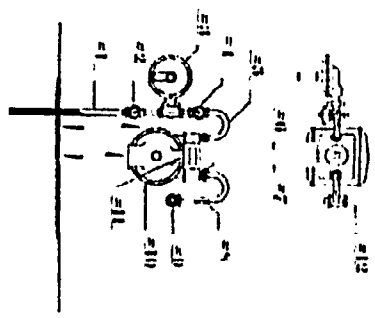
Leak was on the bottom of the regulator we broke down the service + redoped the leaking fittings. We then rebuilt it + tested for leaks.

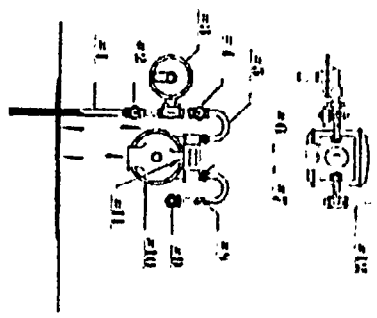
The leak was on the bottom of the regulator. We broke down the service, redepiped the fitting + rebuilt the loop. We then tested for leaks.

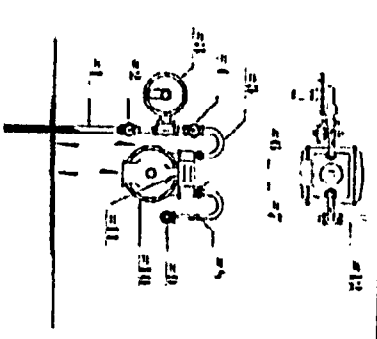
Leak on the bottom of the regulator.  
 We broke the loop down, redoped the fittings, + rebuilt the loop. We then tested for leaks.

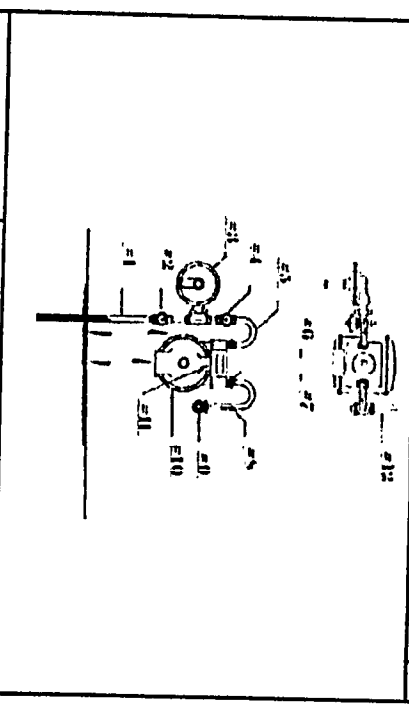
Christ the King Church, Celina Rd, Clay City, Mo, Tomkinsville / Monroe, State KY

Broke down meter loop & redoped the fittings. We then rebuilt it & tested for leaks

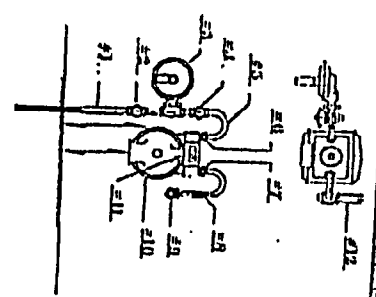
We broke down the meter set + rebuilt it. We redoped every fitting when putting it back together. We then tested for leaks.

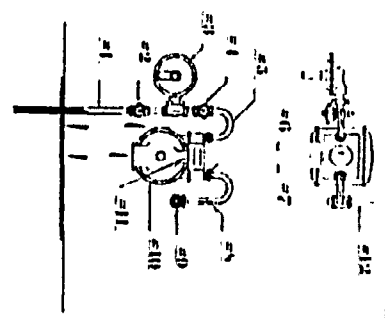
Castle Heights Rd

Regulator was believed to be venting off at this location. We rechecked the area & found nothing. Area clear.

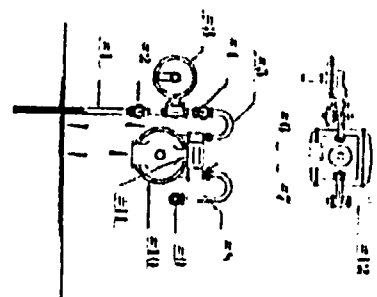
Leak repaired from leak survey  
 Repaired by Carey

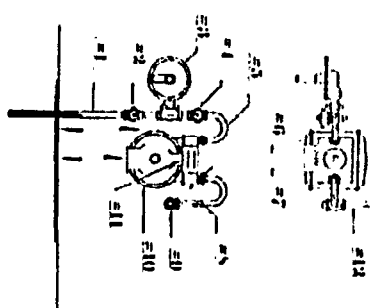
Leak repaired from leak survey  
Repaired by Carry

We broke down the meter set & redoped the leaking fittings. We had to replace a 3" nipple also due to corrosion. We then rebuilt the set, checked for leaks, & relit the customer.

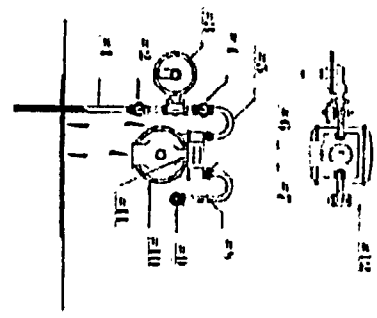
Leak repaired from leak survey. Repaired by Casey

Replaced the leak valve, a 4" 3/4 nipple, & replaced the regulator. We also repaired four small leaks on the meters set.

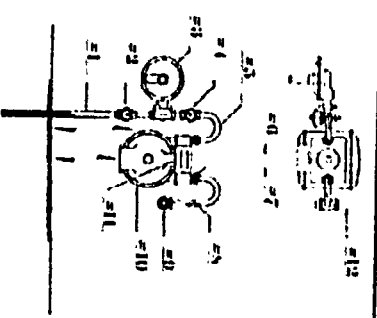
*Leak was on the lock valve. Broke down meter set & redeveloped all fittings to repair the leak.*

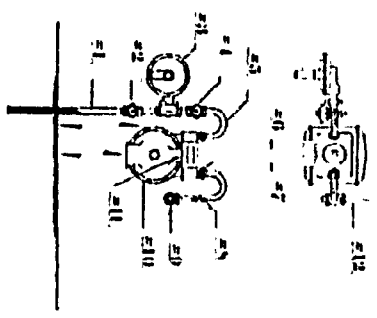
Had a small leak on the spud. Tightened down to fix the leak.

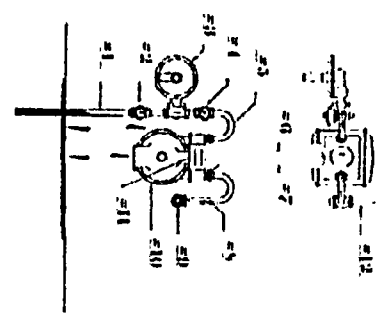
We found a leak on the top of the lock valve. We broke down the meter set & discovered that lightning had ion in on the service & chipped the meter & spud. We replaced the faulty parts & exchanged the meter.

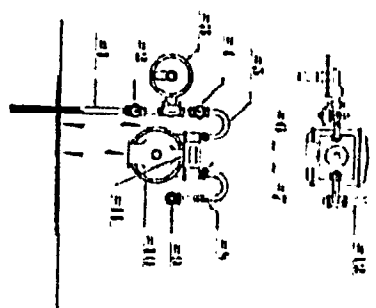
Leak found on a nipple in the meter set. We broke down the meter & re-labeled the leaking nipple to repair the leak.

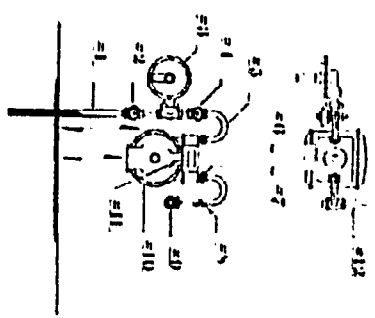
The regulator was old + venting off excessively. We took the down the meter set + replaced the regulator to make the repair.
