Case No. 2012-00362

The following documentation is being submitted by RussMar Utility Management, LLC. on behalf of the Tompkinsville Natural Gas System.

1. Leak Survey (Business District)- June/July, 2014
2. Odorometer Readings- June & September, 2014
3. Patrolling- a. Business District- March, 2014
b. Outside Business District- June, 2014
4. Third Party Excavation Inspection- June 23, July 1 & 11
5. Natural Gas Main & Service Installation Records- May 21, June 16, July 21
6. Visual Inspections of Mains & Service Pipelines-May 29, June 11 & 18-24, August 8 & 20, September 17.
7. Main * Service Abandonment Report- June 4, 11, 24, September 18
8. Leak Repair- August 13
9. Office Chart Clock

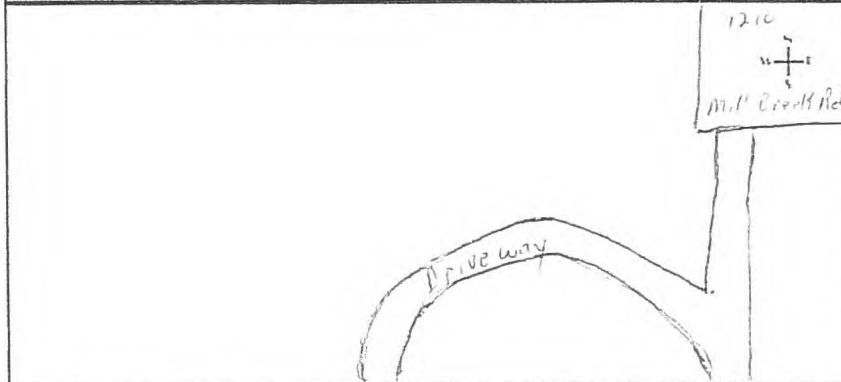
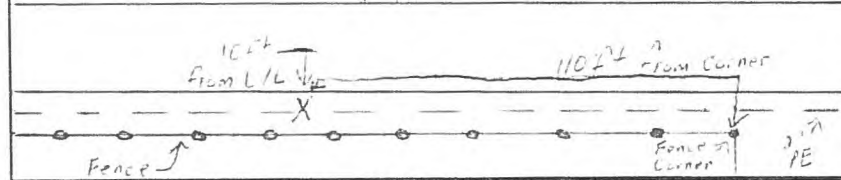
Case# _____ Date 7-11-14
 Contractor/Third Party DB & K Underground Cable
 Name _____
 Address _____
 City/State _____
 Excavation Description DB & K was trenching in phone cables hit a 2" PE main line Locates were called in, but they were incorrectly located.

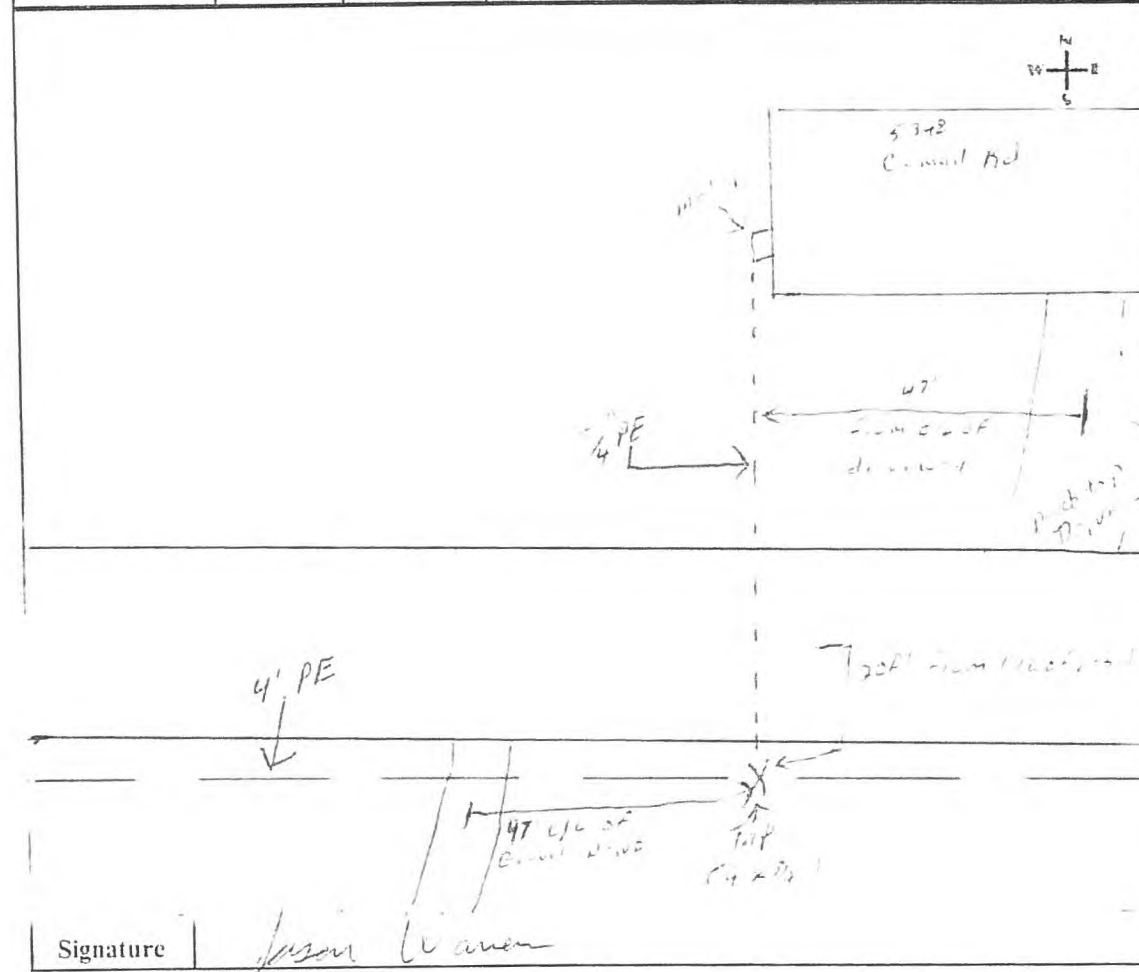
Meter Locked	Yes	<input checked="" type="checkbox"/>	No	<input type="checkbox"/>	Card Left	Yes	<input type="checkbox"/>	No	<input type="checkbox"/>
LOCATION									
Gas Main Location	Gamont Rd - across road from home								
Mainline Valve Installed	Yes	<input type="checkbox"/>	No	<input checked="" type="checkbox"/>					
Service Location	5348 Gamont Rd.								
Service Valve	Tapping Tee			<input checked="" type="checkbox"/>					
REMARKS									
Installed 95 ft of 3/4" PE gas service line, a 4x3/4" electrofusion tap tee, an excess flow valve, 150' + meter.

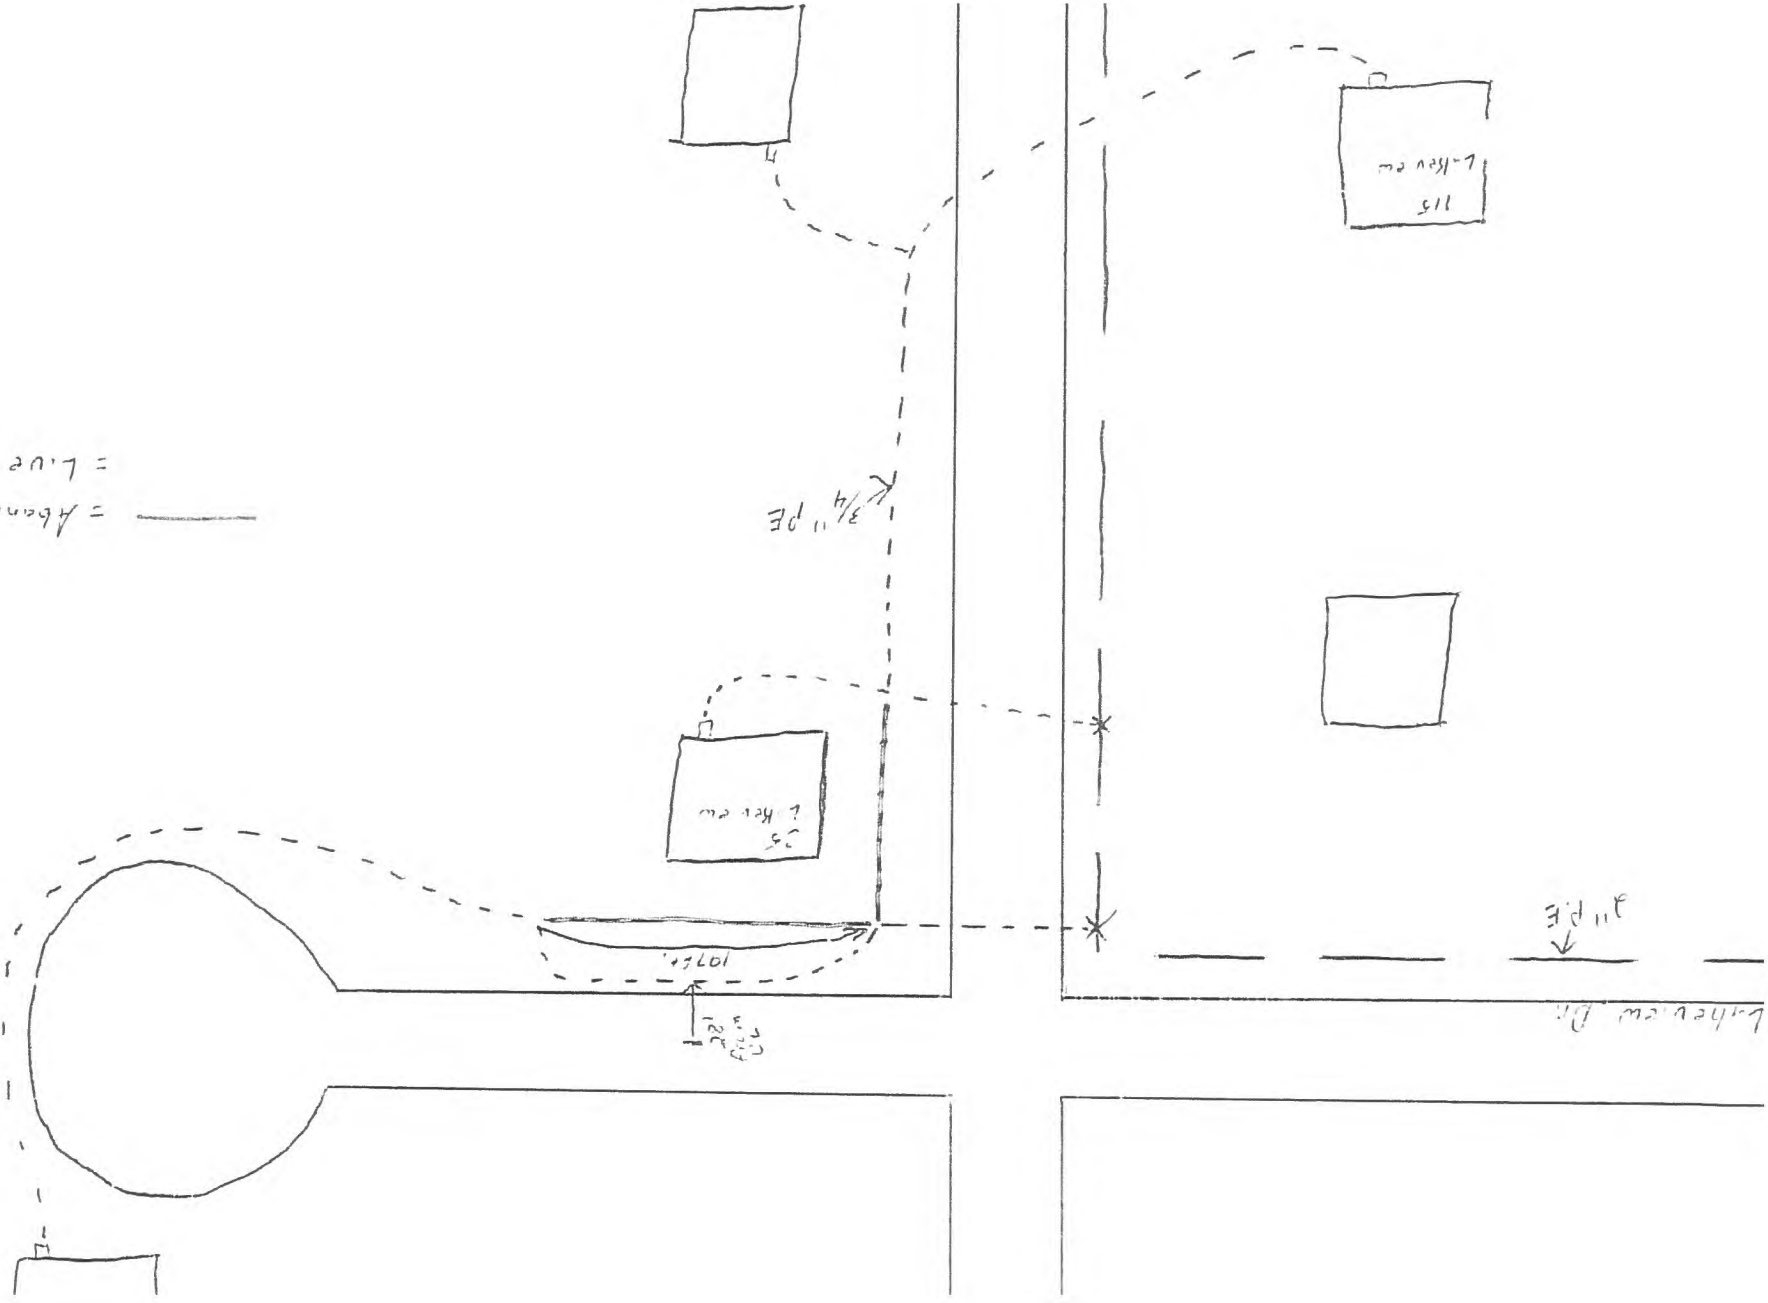
35 Lakeview Dr.

Meter Locked	Yes	No	Card Left	Yes	No
LOCATION					
Gas Main Location					
Mainline Valve Installed	Yes	No			
Service Location					
Service Valve		Tapping Tee			
REMARKS					
The 3/4" PE circled in red was believed to be capped off & not in use. The homeowner at 35 Lakeview was going to do ground work in the location. We cut & capped the line back out of the way for him to work. We later found that the service continued down the street & crossed the road to feed another home. We had to put it back together & restore service. We had no way to trace the line.
