KY PSC & PHMSA Pipeline Safety Seminar 2010

Lessons Learned and Other Safety Related Topics

Ronald Six
Senior Utility Consultant
Loss Control Division
AEGIS Insurance Services, Inc.
201/417-2487
RonaldSix@aegislimited.com

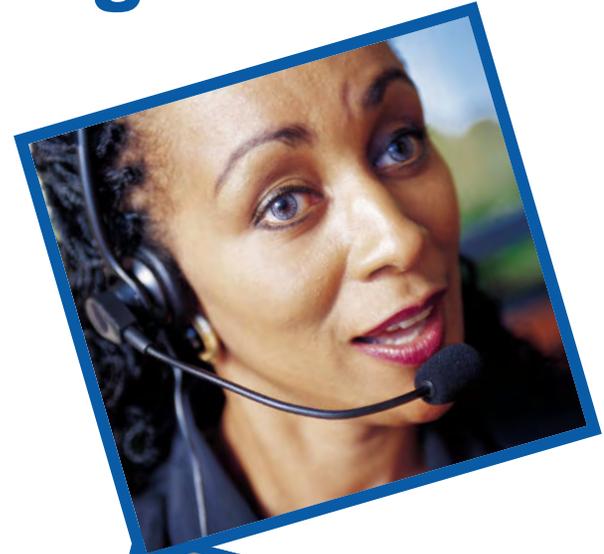
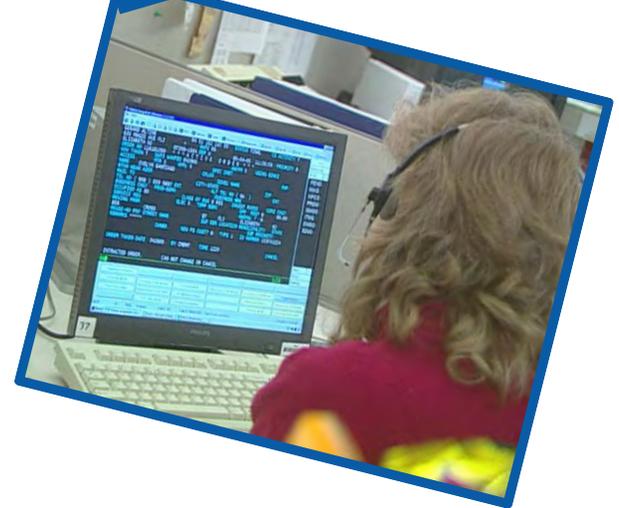
20% Gas In Sewer Manhole

Resident calls
@ 3:34 pm Gas
odor
46

First Responder smells a very strong odor of gas in the area as he arrives (4:05 pm). Checks sewer manholes in the street and finds 20% gas in each manhole. Calls for a crew.

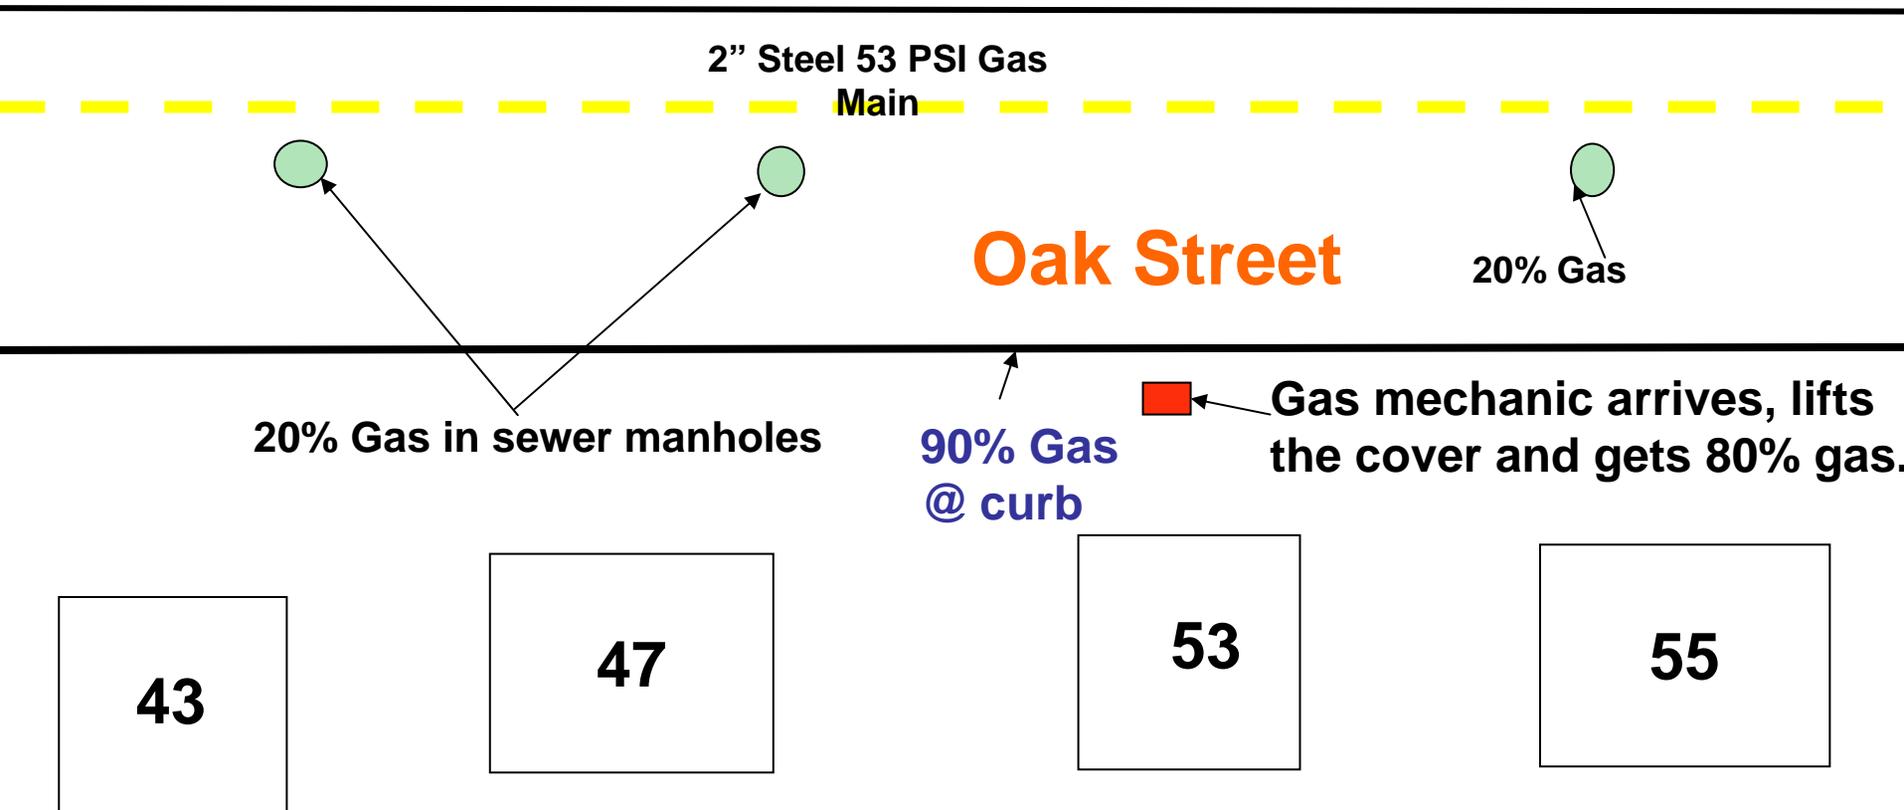
Gas mechanics arrive and they lift the cover on the electric service box and They get a 80% gas in air reading.

90% Gas
@ curb

Cause of the leak attributed to a short in electric service cables caused current to flow onto the steel gas main where they crossed. Arcing created holes in both the electric conduit and the gas main.

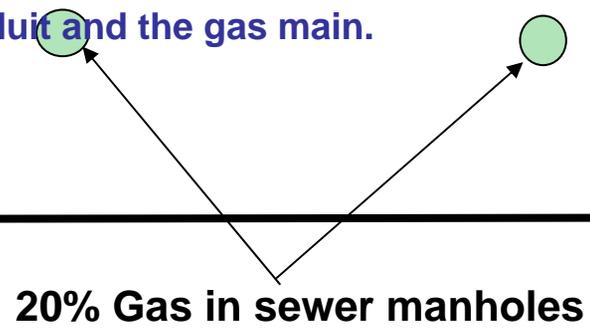
90% Gas @ curb
