COMMONWEALTH OF KENTUCKY
BEFORE THE PUBLIC SERVICE COMMISSION

KENTUCKY UTILITIES COMPANY)
_____))
ALLEGED FAILURE TO COMPLY WITH) CASE NO. 98-275
ADMINISTRATIVE REGULATION)
807 KAR 5:041, SECTION 3)

**UTILITY ACCIDENT
 INVESTIGATION REPORT**

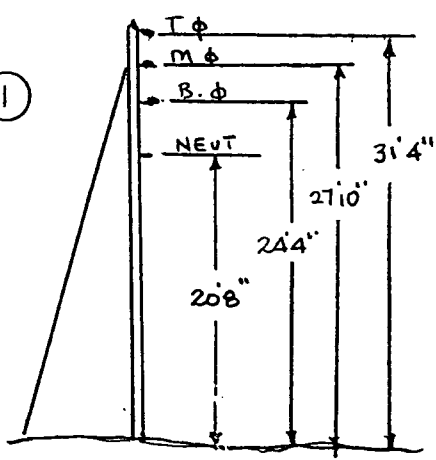
KENTUCKY UTILITIES CO		
DANNY LUCK ACCIDENT		
DATE 6-19-97	SCALE NONE	BY L.K.L.
SHEET NO	FILE NO.

4. After installing the utility pole, the KU crew began removing and storing its equipment. While Roberson removed the derrick truck's boom from the 3-phase circuit, the pole grabber assembly at the end of the boom penetrated the line slot on the underneath side of the line hose. As a result, the truck became energized. At the time, Luck was storing the hydraulic tamper on the derrick truck. He received an electric shock and suffered burns to his right hand.

5. At the time of the incident, the derrick truck was not grounded and Luck was wearing only work gloves.
