CLOSURE OF INVESTIGATION OF	)	
MARCH 8, 2018 INCIDENT – INTER-COUNTY	)	CASE NO.
ENERGY COOPERATIVE CORPORATION	)	2018-00268

## **ACCIDENT INVESTIGATION STAFF REPORT**

**Serving Utility:** Inter-County Energy Cooperative Corporation

**Accident Location:** 1940 Spencer Hamilton Road in Marion County,  
Kentucky

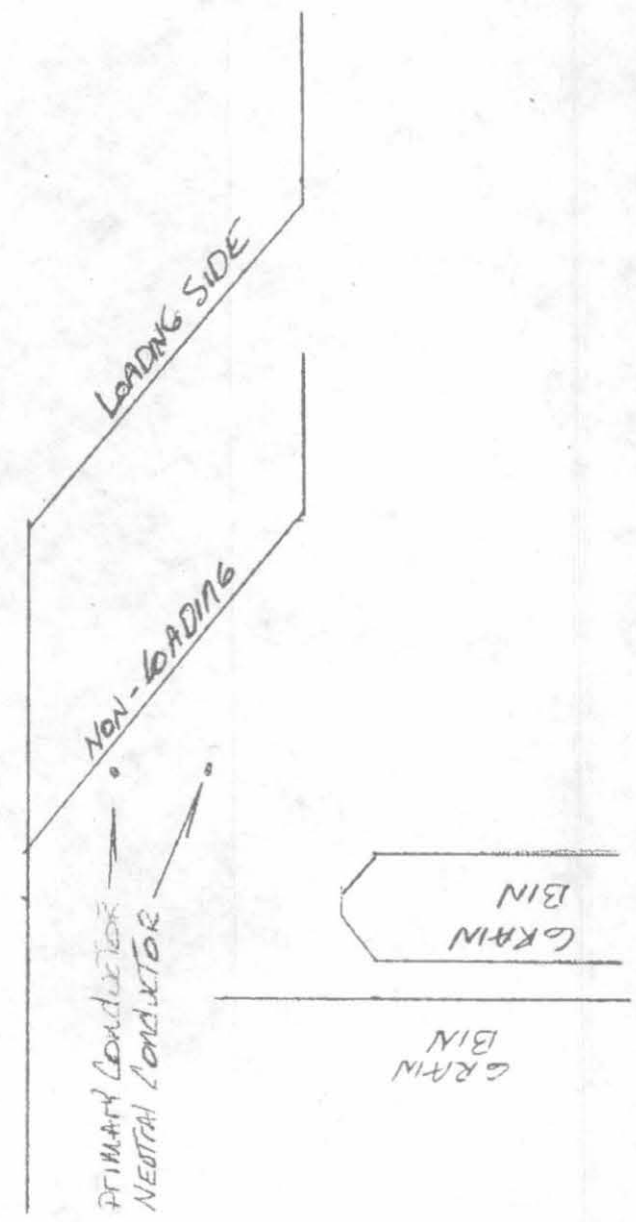
Figure 234-4(b)—Clearance envelope for grain bins filled by portable augers, conveyors, or elevators

BOTH CONDUCTORS ARE IN THE CLEARANCE ENVELOPE.  
 THIS DOES NOT MEET THE REQUIREMENTS OF THE NESL  
 FOR LOADING SIDE AND NON-LOADING SIDES OF GRAIN BIN.  
 THIS WAS A LOADING SIDE ACCIDENT.
