Event

Root Cause Failure Analysis

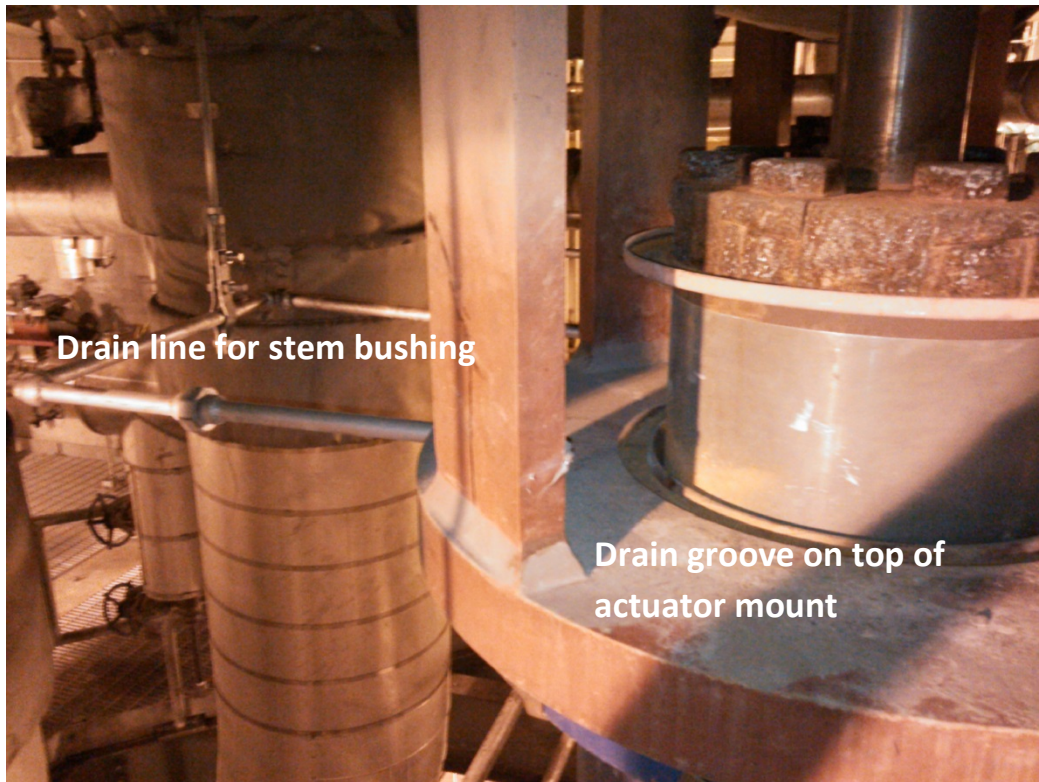
A source of water into the EHC system could be during start up when the Main Stop and Re-Heat Stop Valve stems are not back seated. These drain line from the stem bushings below the valves should be ensured free of obstructions to prevent water from backing up on top of the actuators. Observe this and ensure lines are clear and no stand water is on top of these actuators during the next start up.
