Assessment of Dam Safety Coal Combustion Surface Impoundments (Task 3) Final Report

American Electric Power
Big Sandy
Generating Station
Louisa, Kentucky

February 17, 2010

CHA Project No. 20085.7000.1510

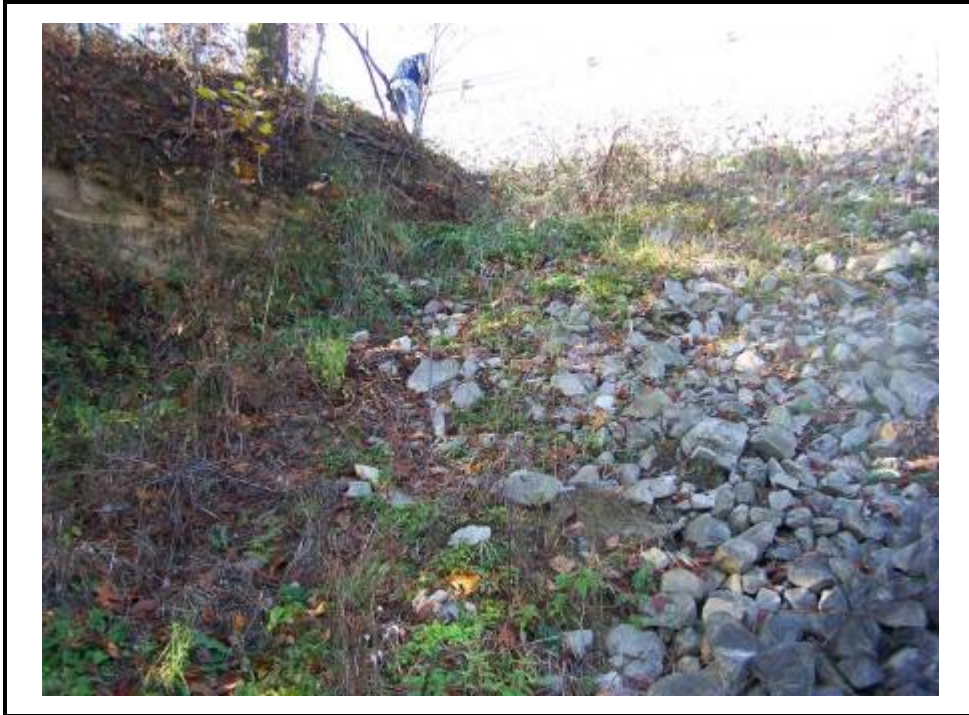
3

South groin of downstream slope and abutment at Saddle Dam.

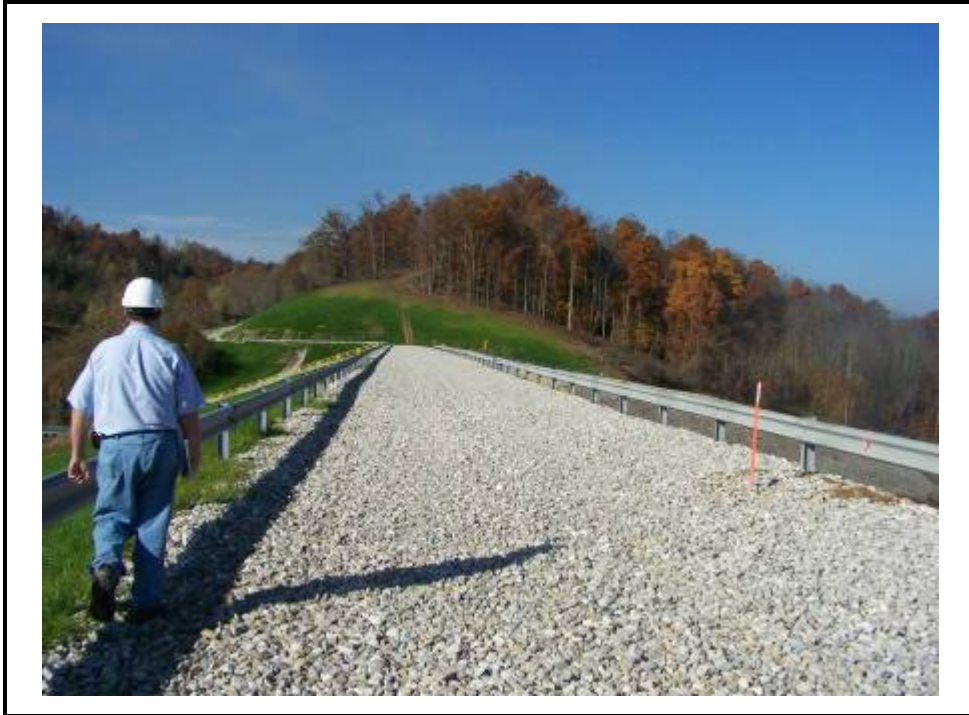
21

Crest of Horseford Creek Dam, looking east.

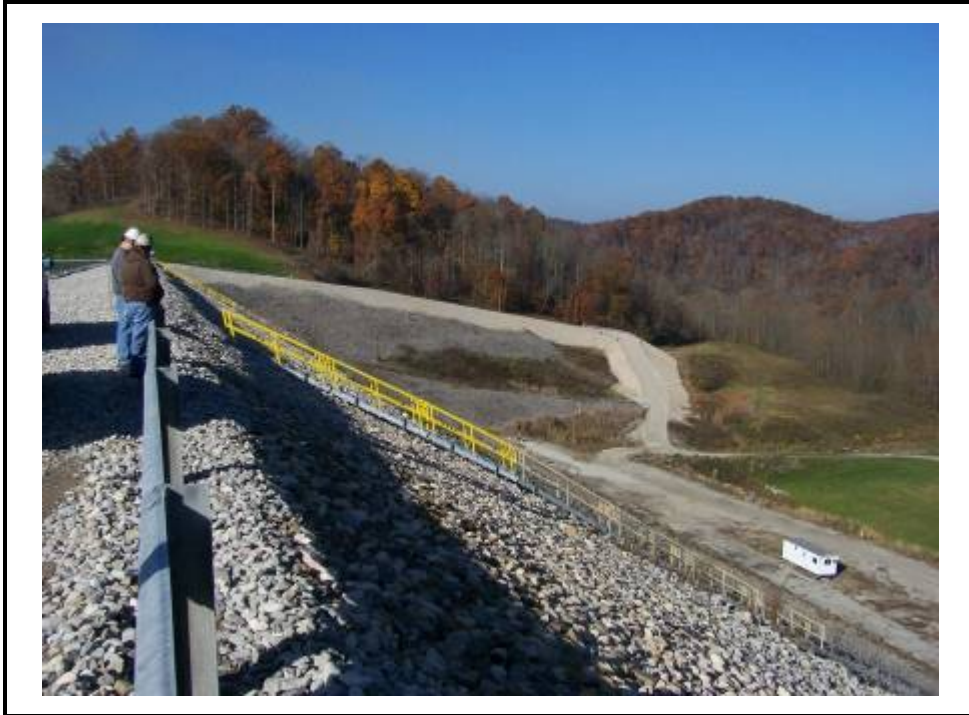
23

Downstream slope Horseford Creek Dam, looking west.

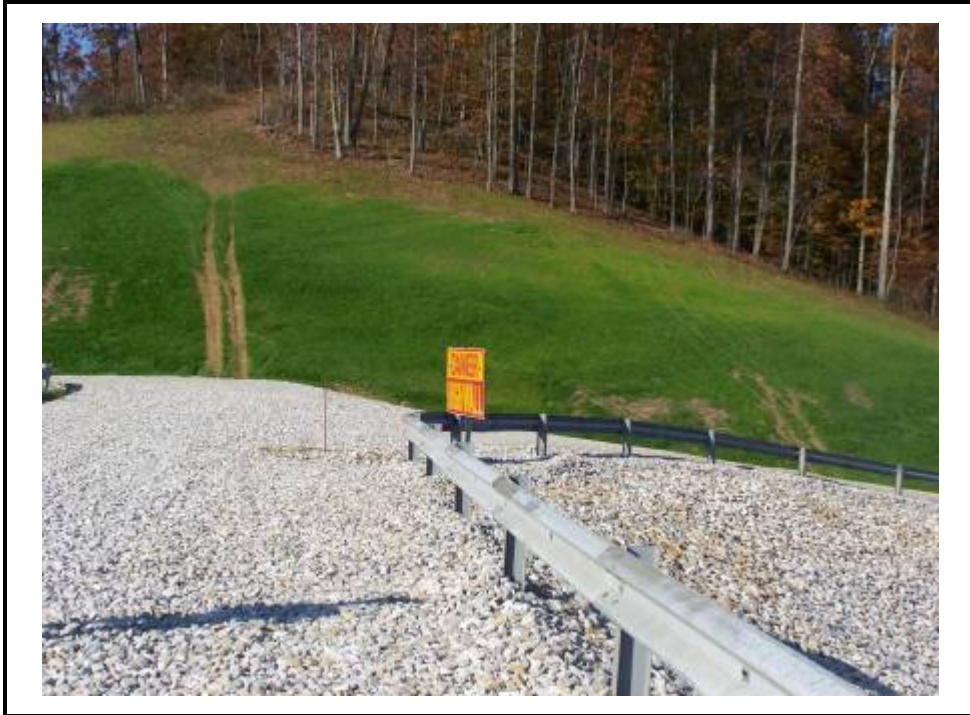
25

West abutment of Horseford Creek Dam, looking west.

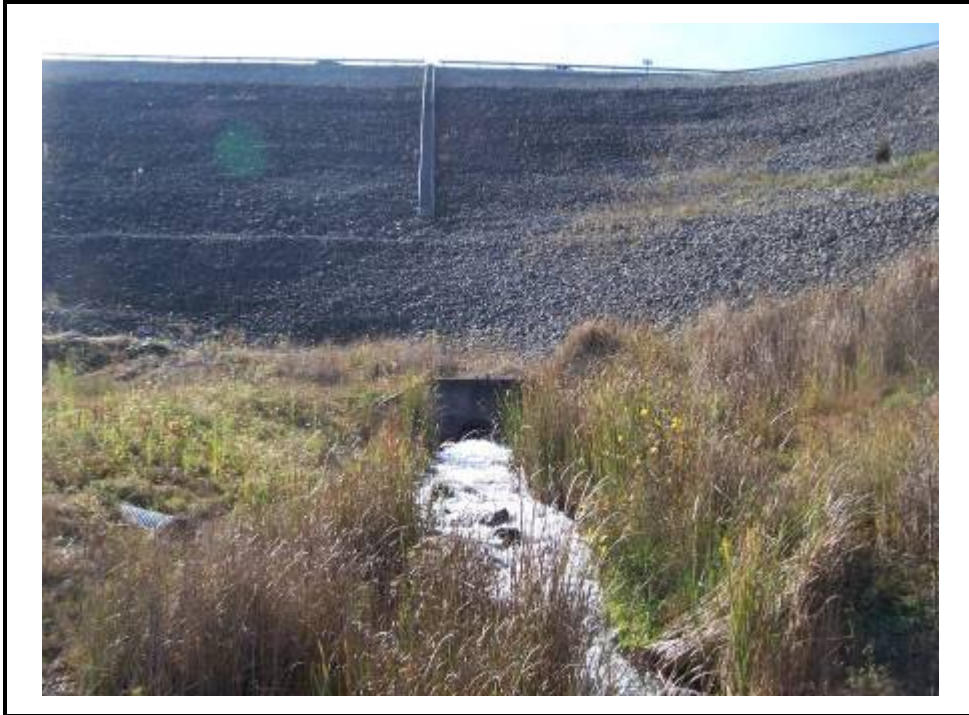
35

Discharge pipe at toe of Horseford Creek Dam.
Stairs on slope provide access to instrumentation.

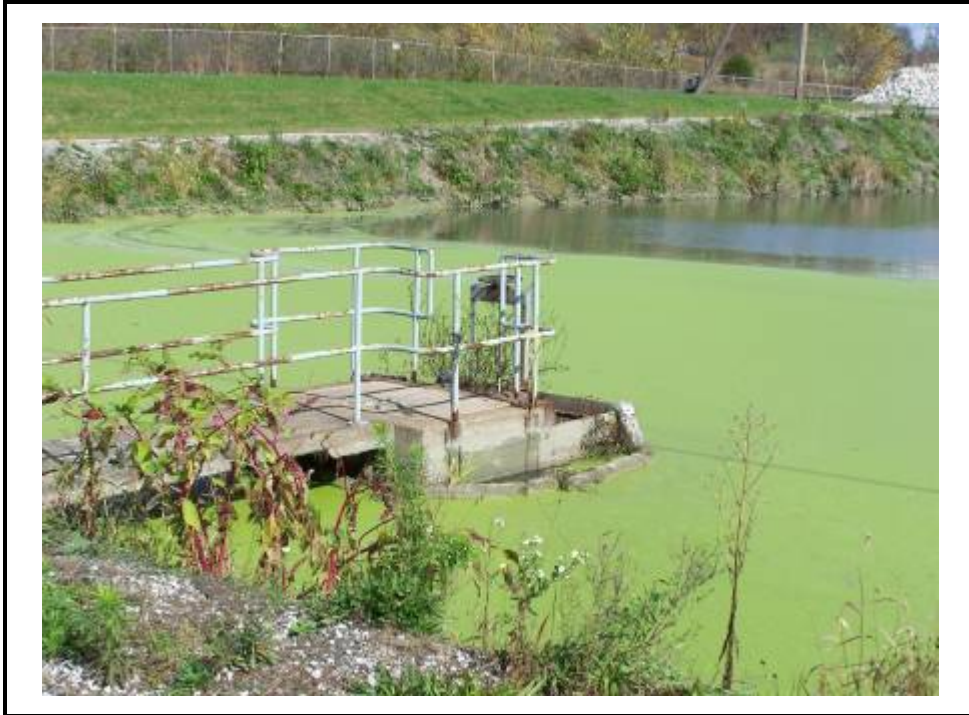
59

Discharge structure from north Clearwater Pond to Reclaim Pond
and upstream slope of North Dike of Bottom Ash Complex.
Note crest of North Dike slopes down to the west.

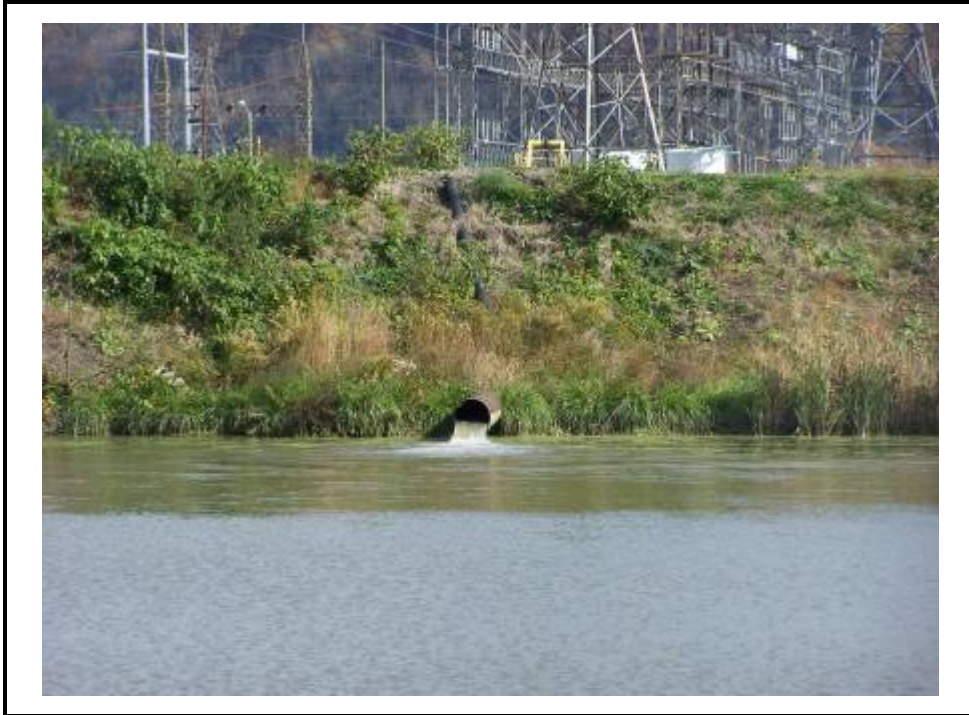
61

West slope of Splitter Dike between North Bottom Ash and Clearwater Ponds showing discharge pipe from North Bottom Ash Pond.

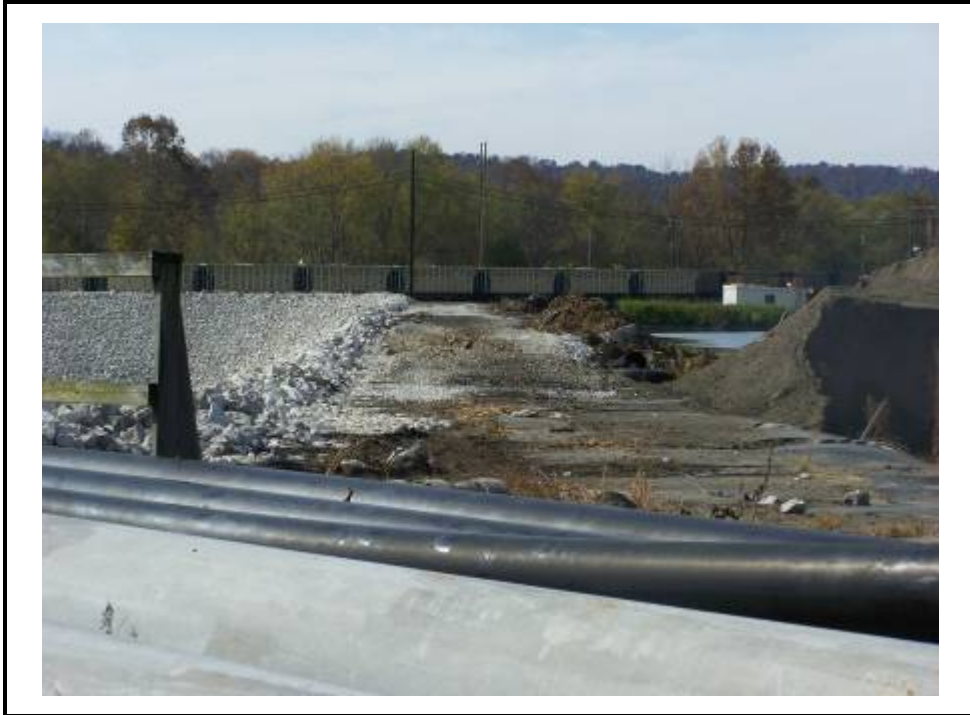
63

Crest of Splitter Dike between south Bottom Ash and south Clearwater Ponds.

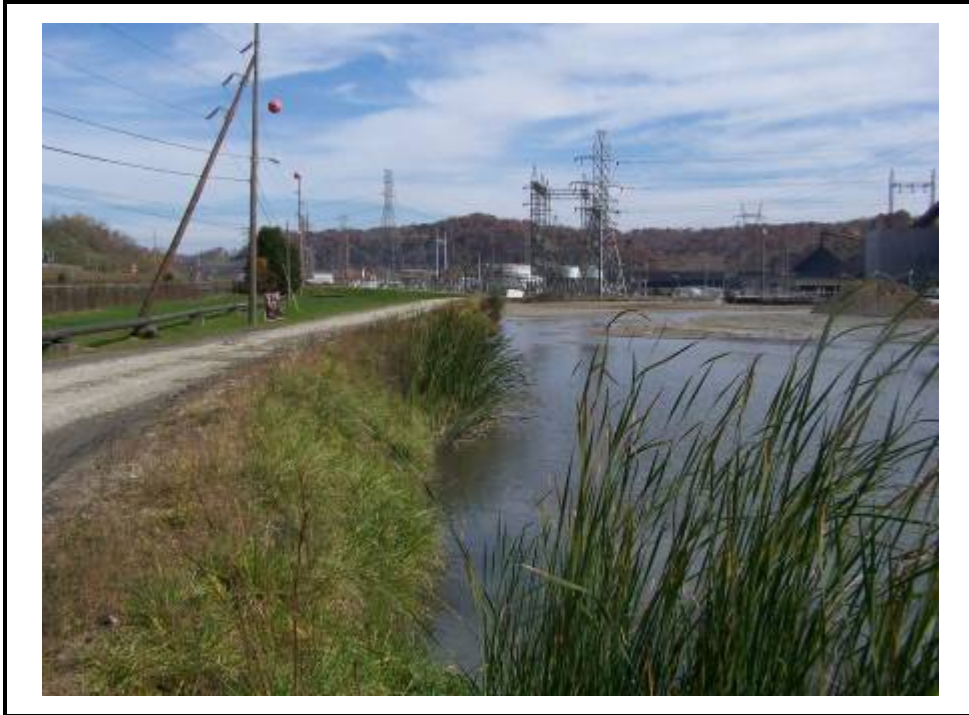
65

Upstream slope of North Dike at the Bottom Ash Complex adjacent to north Bottom Ash Pond, looking east.

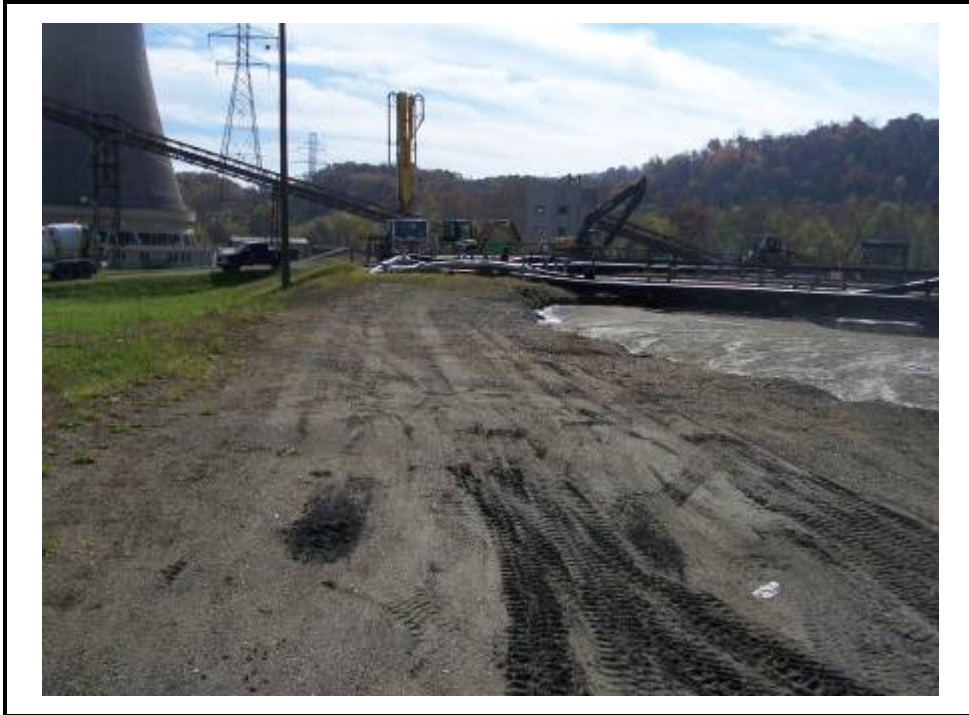
67

Crest of East Dike of the Bottom Ash Pond, looking south.

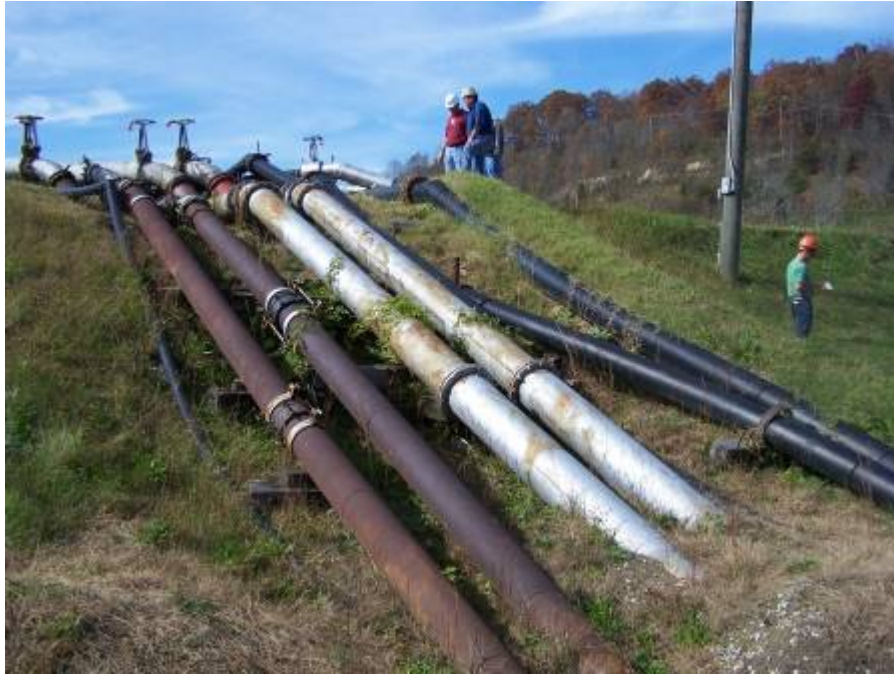
69

Sluice lines on downstream slope of East Dike.
