Louisville Gas and Electric Company
2021 Annual Report
Case No. 2017-00119

Exhibit A
Report No. 202102056

Metallurgical Evaluation of a 16" Coupling and Associated Hardware

Location: 7th St. and Bernheim Ln.
Designation: 2021-20

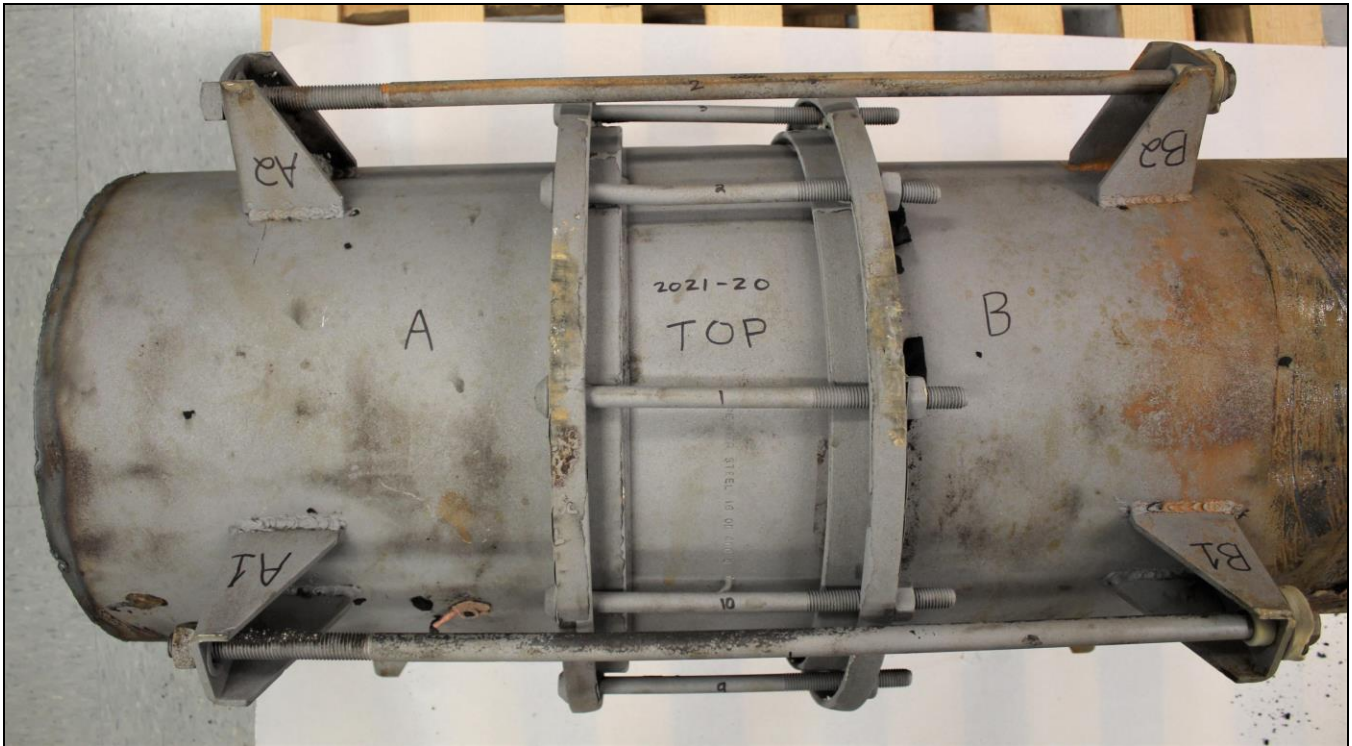
Figure 1. Photograph of the top of the submitted coupling sample.

The submitted pipe section with the coupling is shown in Figures 1 through 4. Four lugs of the joint harnesses had been fillet welded to both pipe segments. Four rods and associated nuts had been affixed through the welded lugs to apply compression to the coupled joint. The coupling consisted of a steel coupling with an interior nonmetallic gasket / sleeve. Prior to receipt, the ends of the pipe segment were labelled as Ends A and B, as shown in Figures 1 and 2. The top and bottom of the coupling section were also marked. Lugs A1, A2, A3, and A4 were welded to Pipe A, and Lugs B1, B2, B3, and B4 were welded to Pipe B. The rod between Lugs A1 and B1 was identified as Rod 1. The remaining lugs were identified in a corresponding fashion.

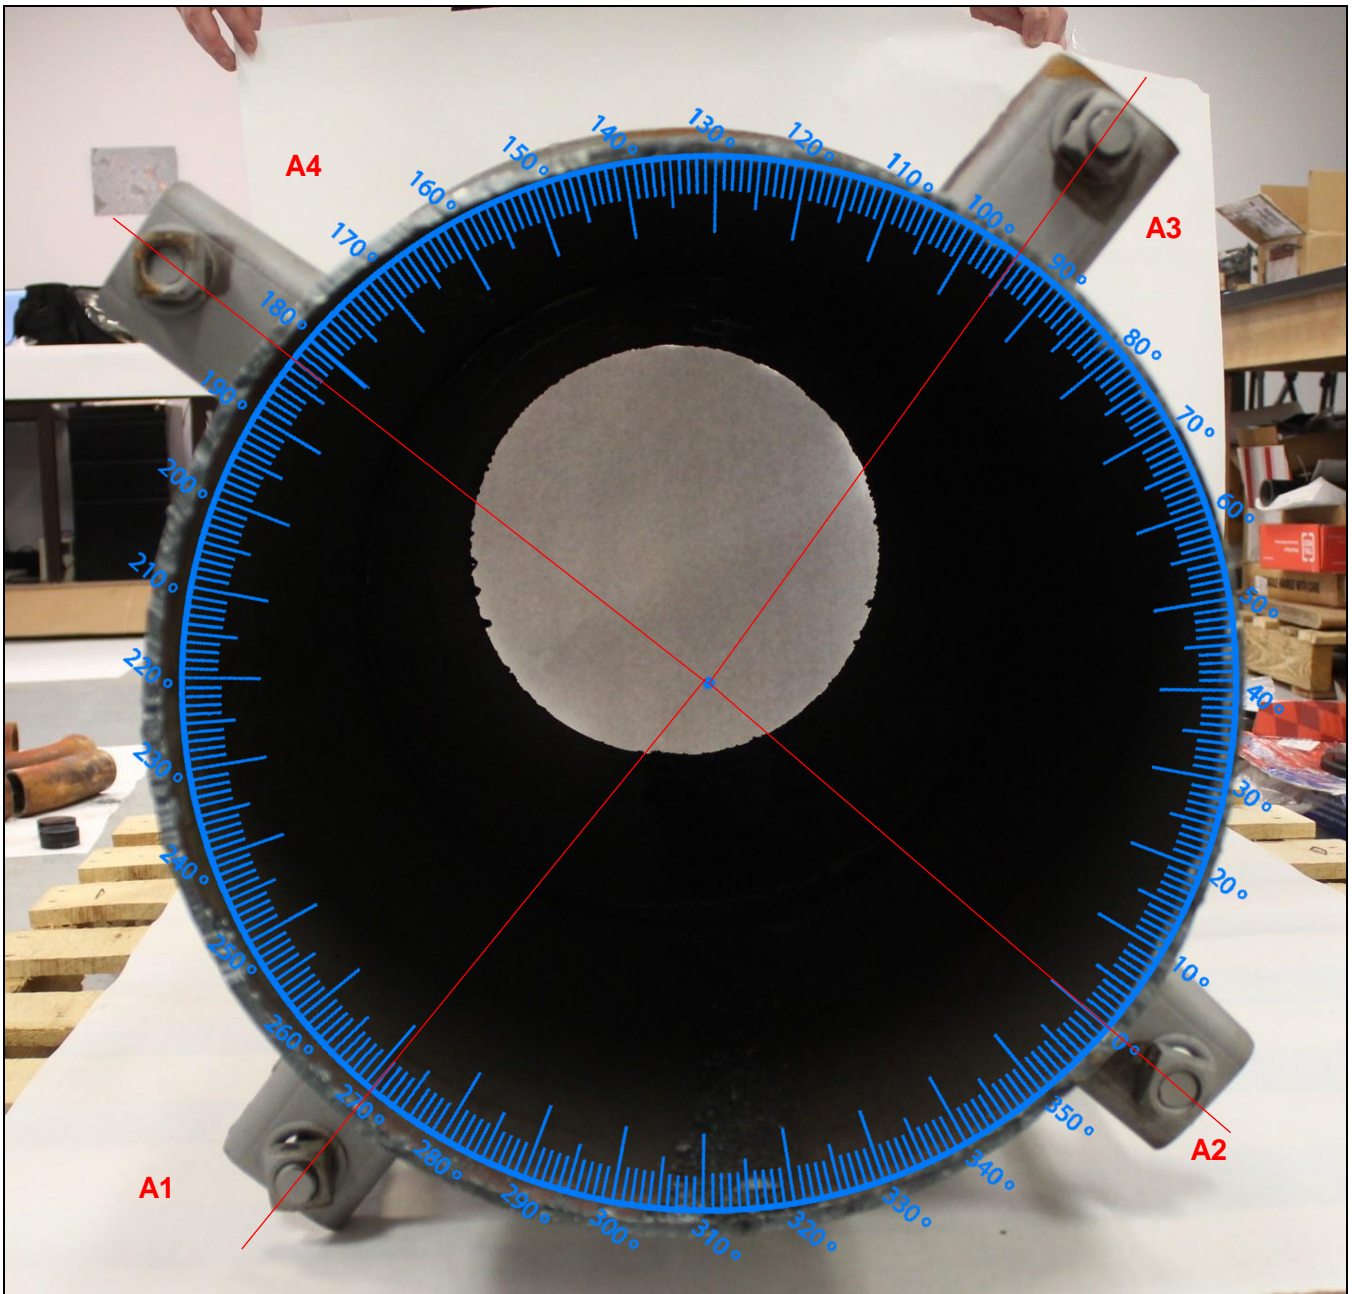
Figure 3. End facing image of the sample at End A with a superimposed protractor.

The four sets of harness lugs were positioned around the pipe. The relative orientations of the harness lugs were measured by photographing the assembly from the ends and applying a protractor overlay for angle measurement. The obtained measurements are shown in Figures 3 and 4 with the data summarized in Table 1. The depth of insertion of the pipe segments into the coupling was also measured and the dimensions are provided in Table 2. No requirements were provided for these characteristics.

Compound	Angle	Deviation from 90°	Image
Rod A1 / Rod A2	89	1	Figure 3
Rod A2 / Rod A3	95	5	Figure 3
Rod A3 / Rod A4	88	2	Figure 3
Rod A4 / Rod A1	88	2	Figure 3
Rod B1 / Rod B2	92	2	Figure 4
Rod B2 / Rod B3	85	5	Figure 4
Rod B3 / Rod B4	92	2	Figure 4
Rod B4 / Rod B1	91	1	Figure 4

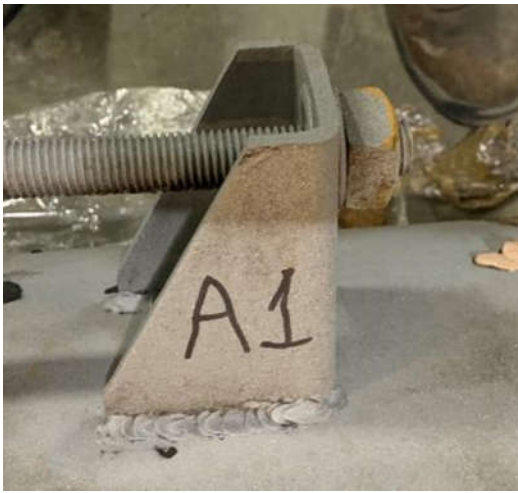
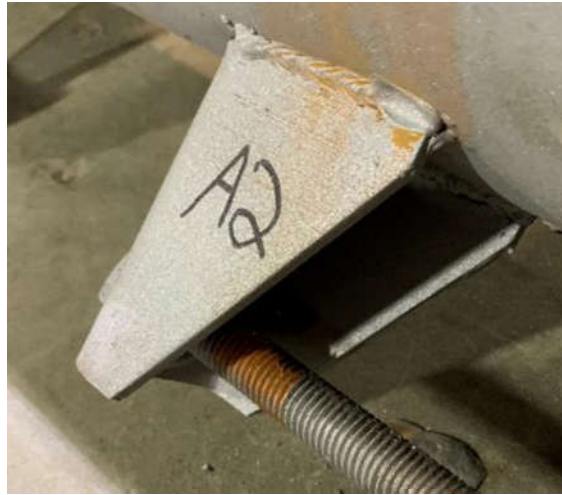
Figure 5 Lugs A1 and A2

Lug	Lug	Assembly sets aligned?	Deformed?	Deflected? (angle of)
A1	B1	No	Yes, slightly bowed	n/a
A2	B2	Yes	No	n/a
A3	B3	No	No	n/a
A4	B4	Yes	No	n/a

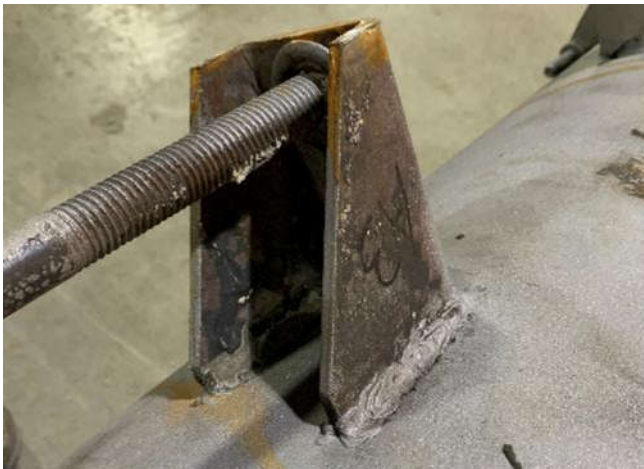
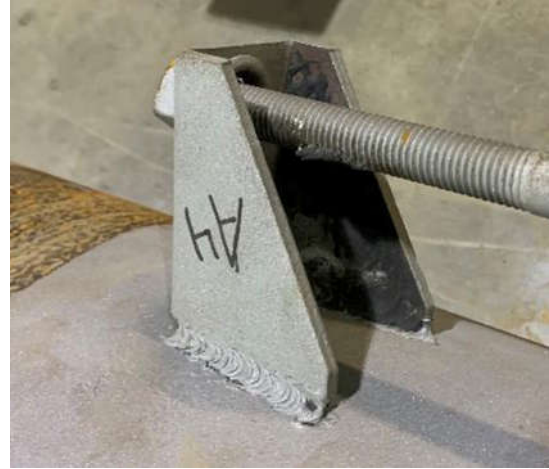
Figure 6 Lugs A3 and A4

Pipe Side	Lug Number	Welded on all sides of interior? If no, describe	Are welds on interior continuous? If no, describe
A	1	Yes	Yes
A	2	Yes	No
A	3	No	No, one only goes halfway
A	4	Yes	Yes
B	1	Yes	Yes
B	2	Yes	Yes
B	3	Yes	Yes
B	4	Yes	Yes

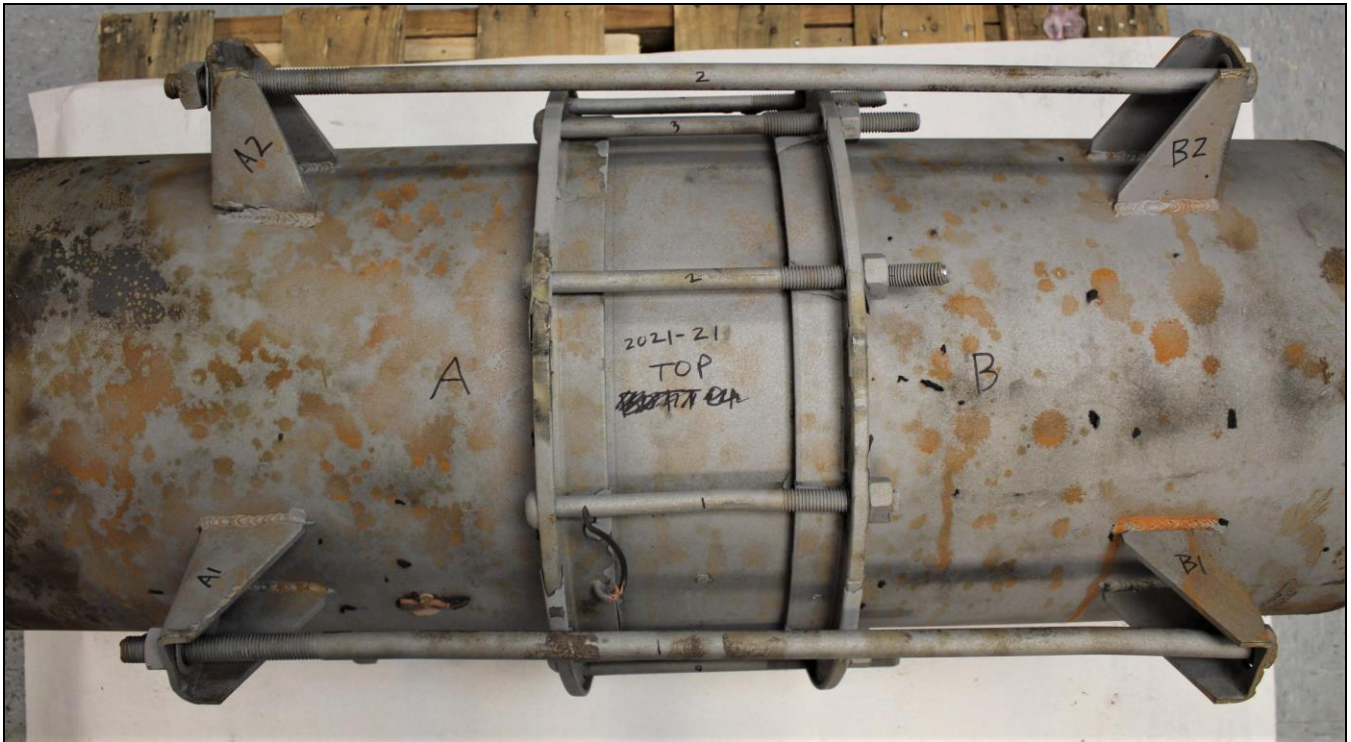
Figure 1. Photograph of the top of the submitted coupling sample.

The submitted pipe section with the coupling is shown in Figures 1 through 4. Four lugs of the joint harnesses had been fillet welded to both pipe segments. Four rods and associated nuts had been affixed through the welded lugs to apply compression to the coupled joint. The coupling consisted of a steel coupling with an interior nonmetallic gasket / sleeve. Prior to receipt, the ends of the pipe segment were labelled as Ends A and B, as shown in Figures 1 and 2. The top and bottom of the coupling section were also marked. Lugs A1, A2, A3, and A4 were welded to Pipe A, and Lugs B1, B2, B3, and B4 were welded to Pipe B. The rod between Lugs A1 and B1 was identified as Rod 1. The remaining lugs were identified in a corresponding fashion.

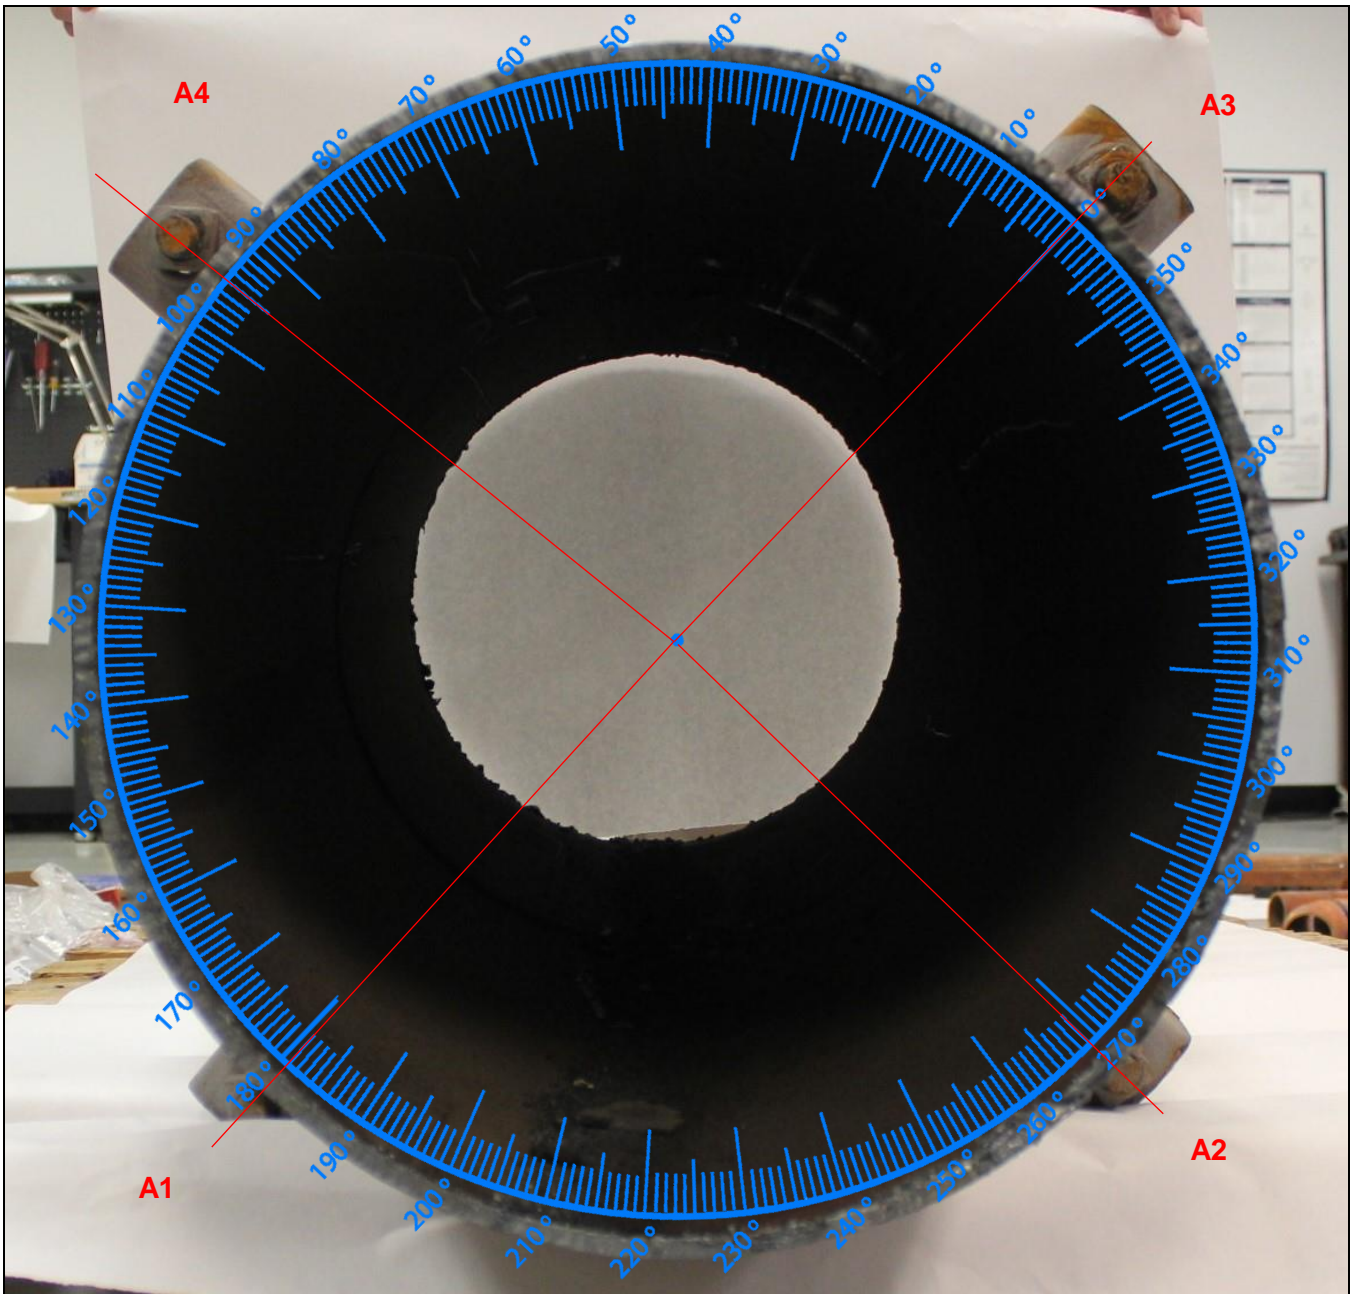
Figure 3. End facing image of the sample at End A with a superimposed protractor.

The four sets of harness lugs were positioned around the pipe. The relative orientations of the harness lugs were measured by photographing the assembly from the ends and applying a protractor overlay for angle measurement. The obtained measurements are shown in Figures 3 and 4 with the data summarized in Table 1. The depth of insertion of the pipe segments into the coupling was also measured and the dimensions are provided in Table 2. No requirements were provided for these characteristics.

Compound	Angle	Deviation from 90°	Image
Rod A1 / Rod A2	88	2	Figure 3
Rod A2 / Rod A3	91	1	Figure 3
Rod A3 / Rod A4	95	5	Figure 3
Rod A4 / Rod A1	86	4	Figure 3
Rod B1 / Rod B2	88	2	Figure 4
Rod B2 / Rod B3	97	7	Figure 4
Rod B3 / Rod B4	82	8	Figure 4
Rod B4 / Rod B1	93	3	Figure 4

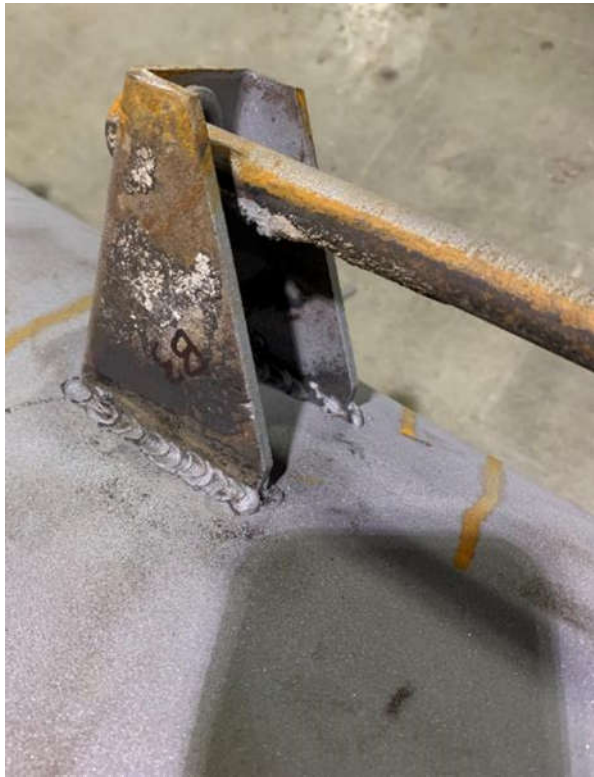
Figure 13: Lug B2

Pipe Side	Lug Number	Welded on all sides of interior? If no, describe	Are welds on interior continuous? If no, describe
A	1	Yes	Yes
A	2	Yes	Yes, but one is broken
A	3	Yes	No, one only goes halfway
B	4	Yes	No, stops short
B	1	Yes	Yes
B	2	n/a; one side covered with rock	n/a
B	3	Yes	Yes, but one side looks poorly done
B	4	Yes	No, stops a little short
