Louisville Gas and Electric Company
2022 Annual Report
Case No. 2017-00119

In accordance with the Kentucky Public Service Commission's Order of March 16, 2018 in Case No. 2017-00119, Louisville Gas and Electric Company ("LG&E") is submitting the fifth and final annual report for the years 2018– 2022. The annual report provides the completion of the implementation of LG&E's Action Plan and the number of bolted-style coupling systems removed in 2022 from distribution lines having an operating pressure in excess of 60 psig along with observations of the removed couplings. LG&E has completed all requirements of the order.

Distribution Couplings removed from the ground:

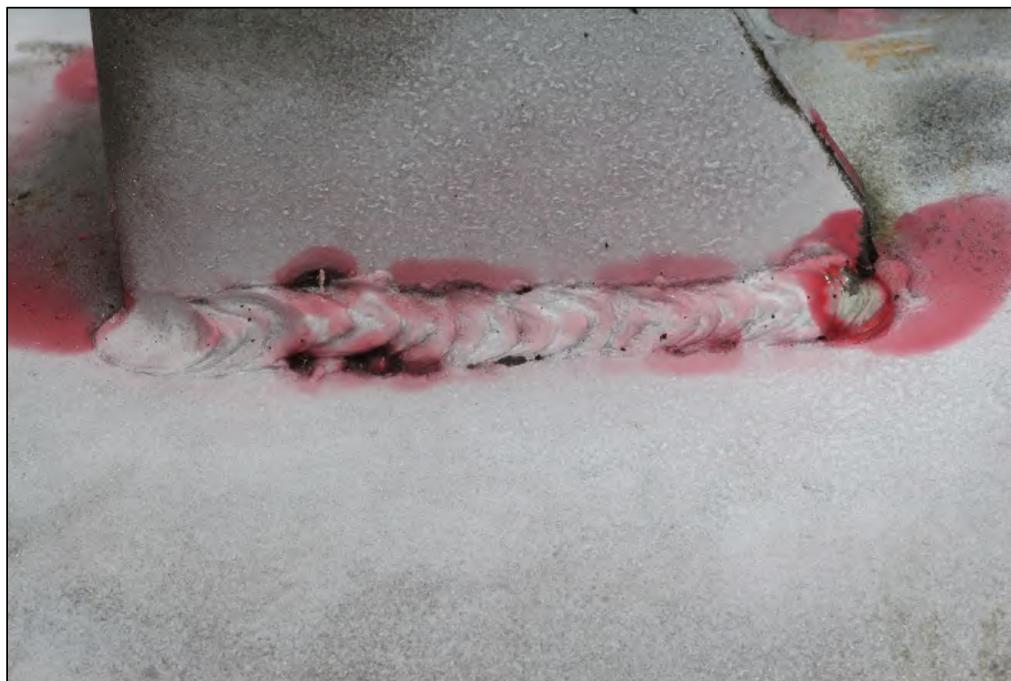
The two separated ends of the disassembled coupling were sent to a third party NDE laboratory for inspection. Visual and liquid dye penetrant inspections were performed on the lug attachment welds. Inspection was performed in accordance with the acceptance criteria of API 1104 "Welding of Pipelines and Related Facilities". The inspection results are provided as Appendices A and B. Two representative welds are shown in Figures 10 and 11 with the dye penetrant test media remaining.

Figure 10. Image of the Lug A4 exterior top weld after dye penetrant media had been used during inspection.

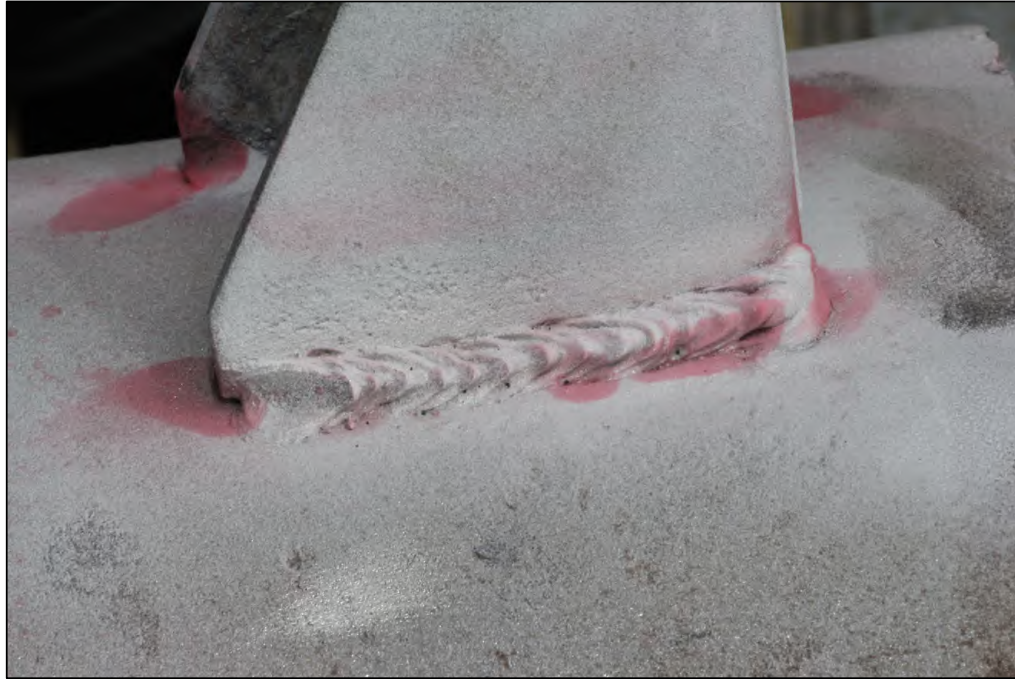
Figure 11. Image of the Lug B2 exterior top weld after dye penetrant media had been used during inspection.

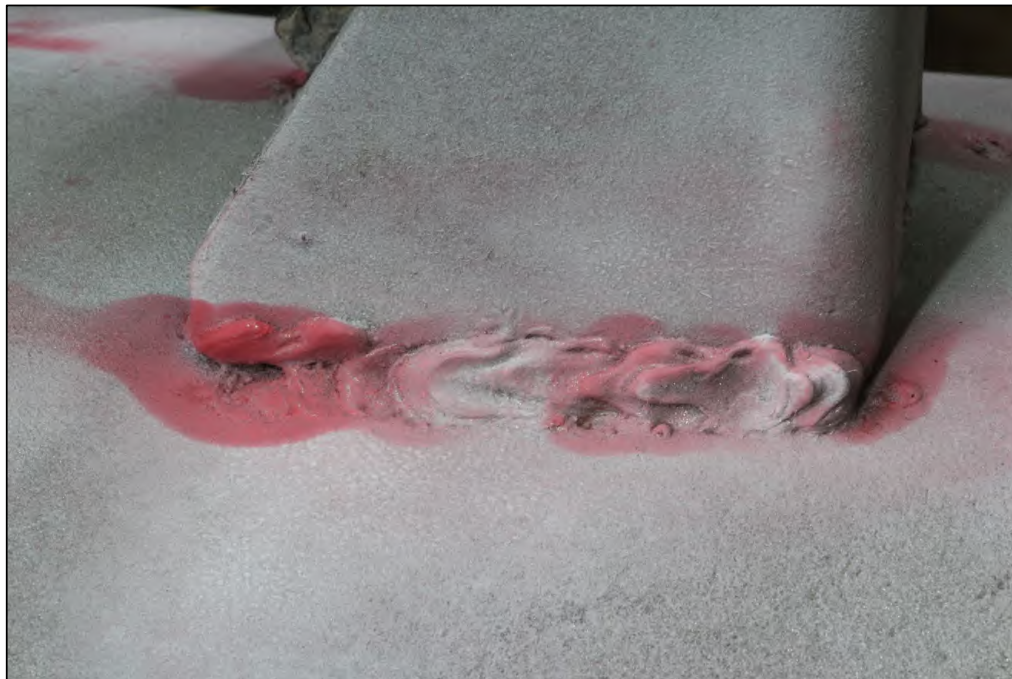
The two separated ends of the disassembled coupling were sent to a third party NDE laboratory for inspection. Visual and liquid dye penetrant inspections were performed on the lug attachment welds. Inspection was performed in accordance with the acceptance criteria of API 1104 “Welding of Pipelines and Related Facilities”. The inspection results are provided as Appendices A and B. Two representative welds are shown in Figures 10 and 11 with the dye penetrant test media remaining.

Figure 10. Image of the Lug A1 exterior weld after dye penetrant media had been used during inspection.

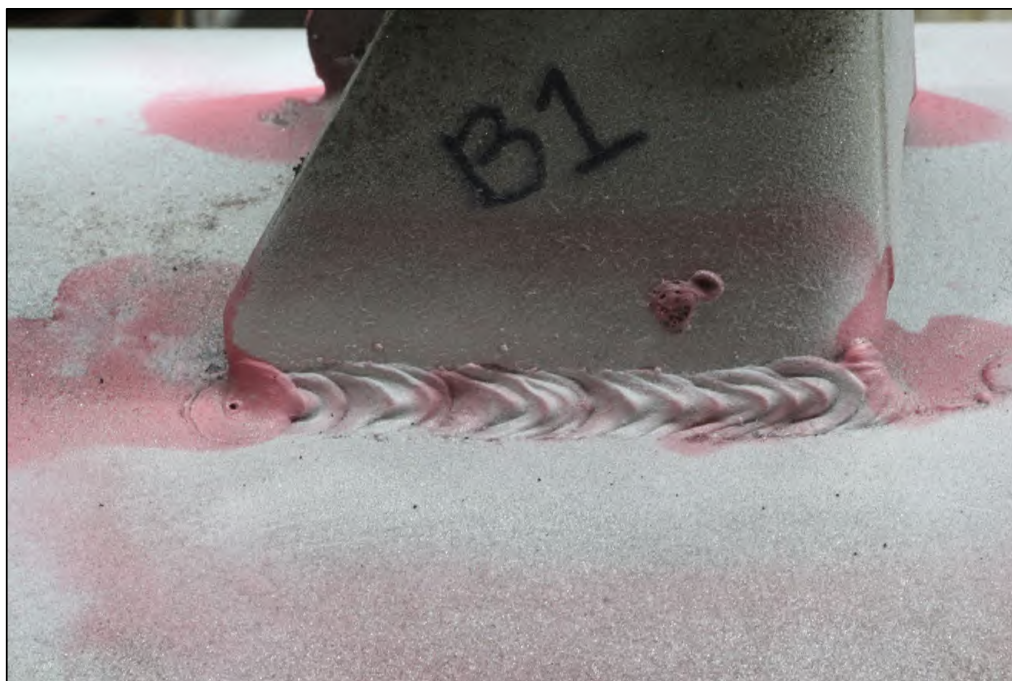
Figure 11. Image of the Lug B1 exterior top weld after dye penetrant media had been used during inspection.

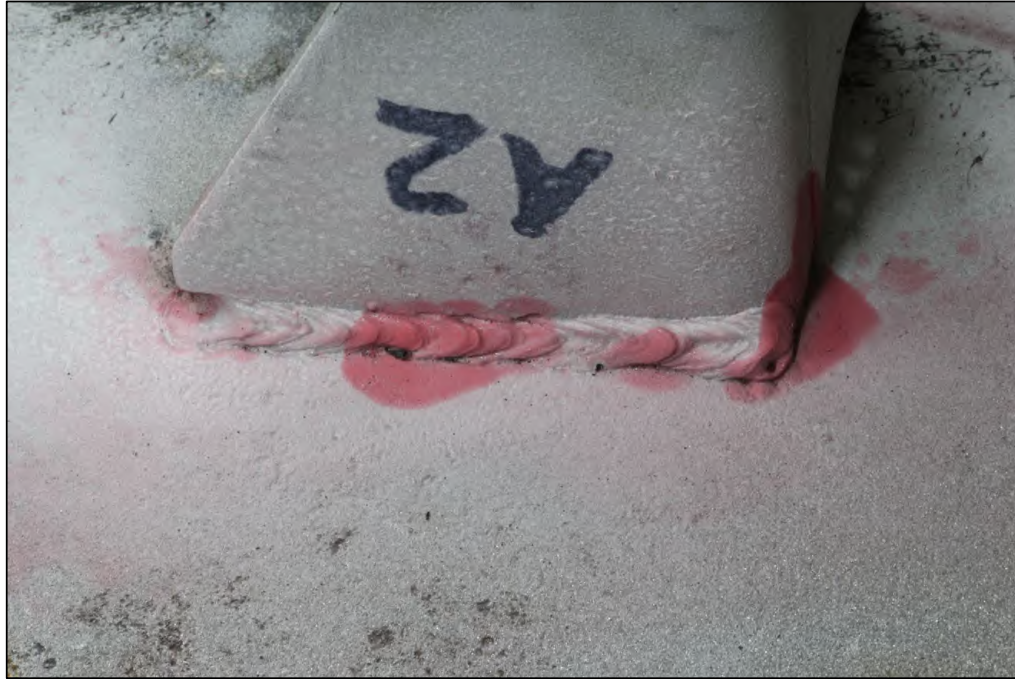
The two separated ends of the disassembled coupling were sent to a third party NDE laboratory for inspection. Visual and liquid dye penetrant inspections were performed on the lug attachment welds. Inspection was performed in accordance with the acceptance criteria of API 1104 “Welding of Pipelines and Related Facilities”. The inspection results are provided as Appendix A. Two representative welds are shown in Figures 11 and 12 with the dye penetrant test media remaining.

Figure 11. Image of the Lug A2 exterior top weld after dye penetrant media had been used during inspection.

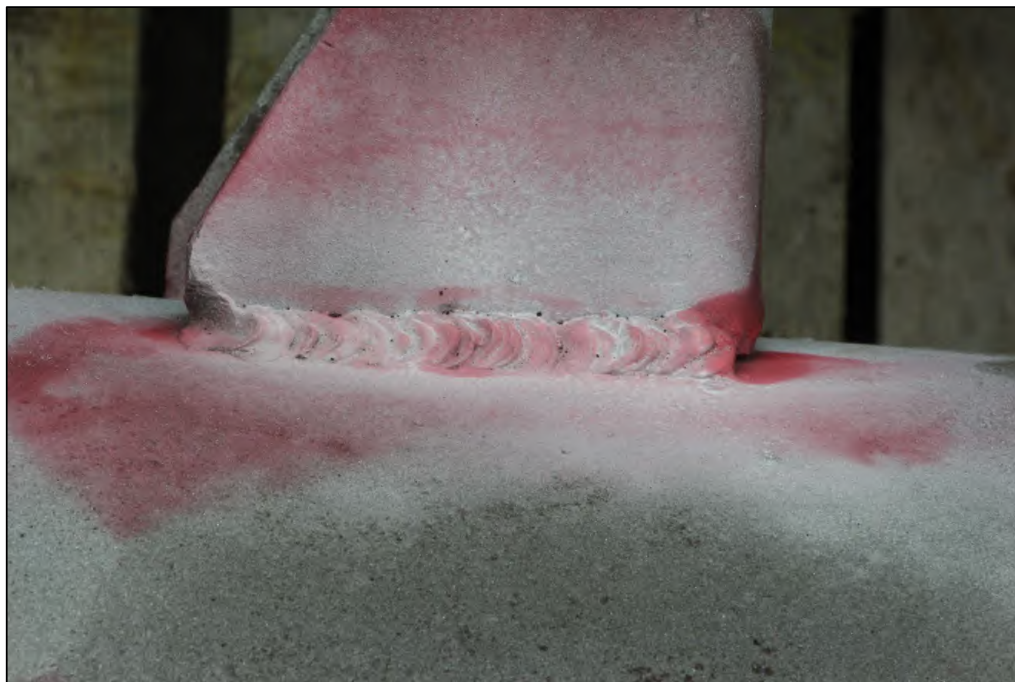
Figure 12. Image of the Lug B1 exterior top weld after dye penetrant media had been used during inspection.

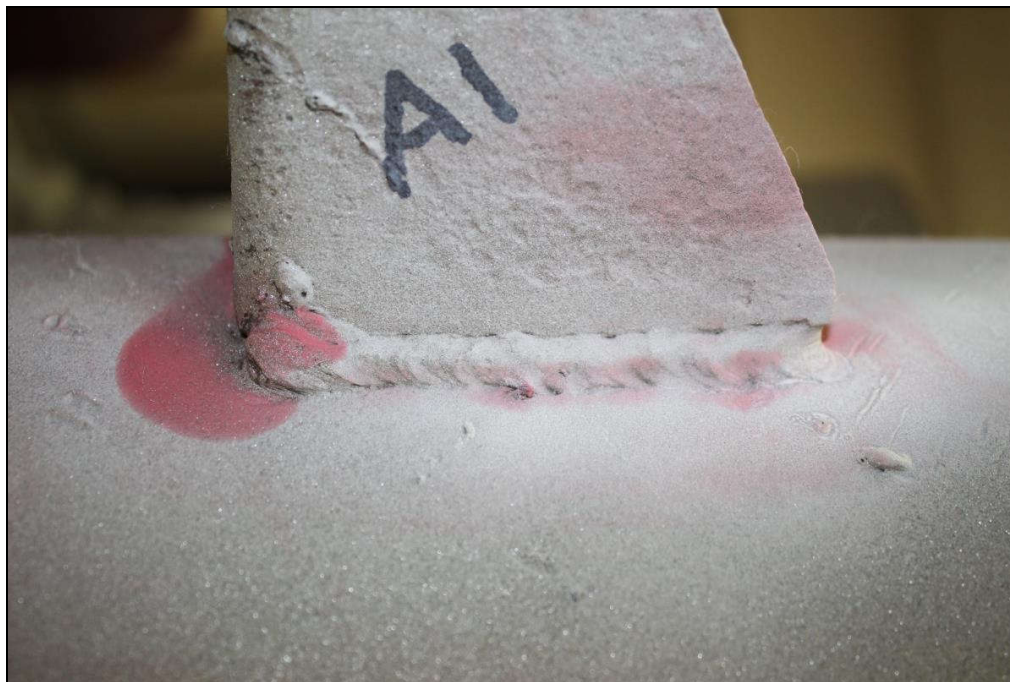
The two separated ends of the disassembled coupling were sent to a third party NDE laboratory for inspection. Visual and liquid dye penetrant inspections were performed on the lug attachment welds. Inspection was performed in accordance with the acceptance criteria of API 1104 "Welding of Pipelines and Related Facilities". The inspection results are provided as Appendices A and B. Two representative welds are shown in Figures 9 and 10 with the dye penetrant test media remaining.

Figure 9. Image of the Lug A4 exterior top weld after dye penetrant media had been used during inspection.

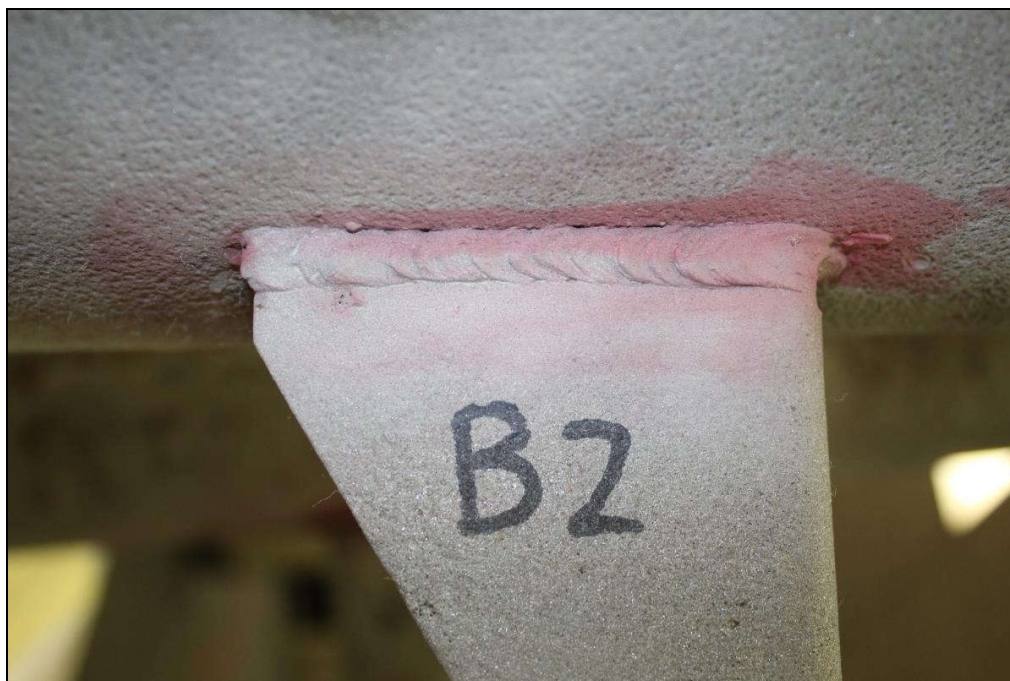
Figure 10. Image of the Lug B2 exterior top weld after dye penetrant media had been used during inspection.
