ELECTRONIC INVESTIGATION INTO)
EXCESSIVE WATER LOSS BY KENTUCKY'S) Case No. 2019-00041
JURISDICTIONAL WATER UTILITIES)

**West Carroll Water District
Case No. 2019-00041
Commission Staff's Second Request for Information issued May 3, 2019**

100,000 GALLON ELEVATED WATER TANK

50,000 GALLON ELEVATED WATER TANK

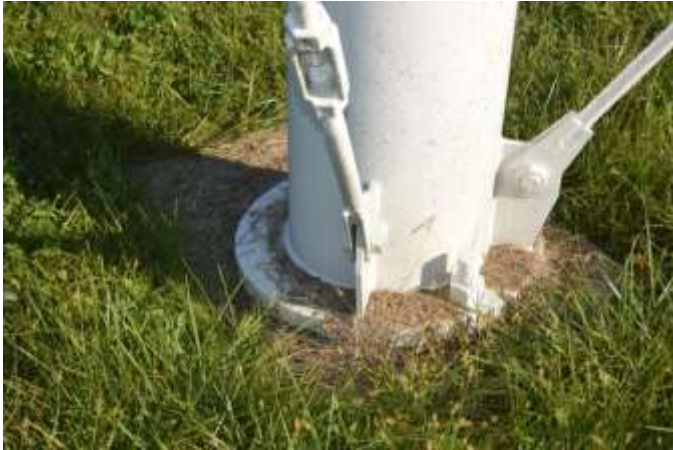
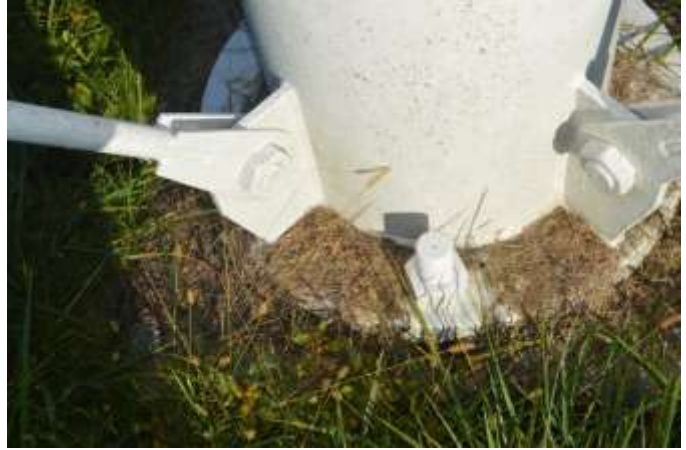
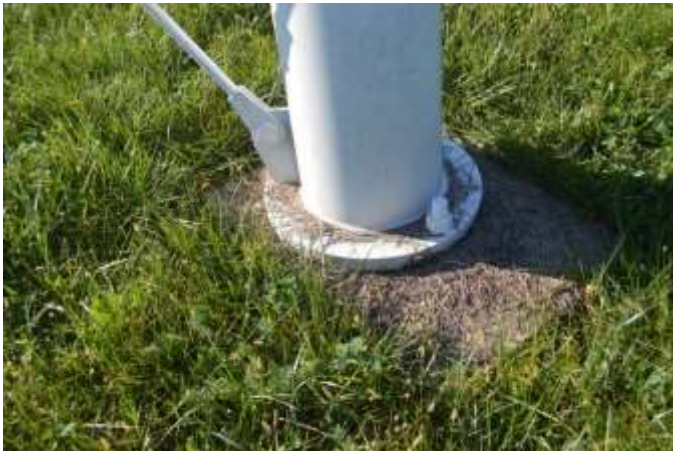
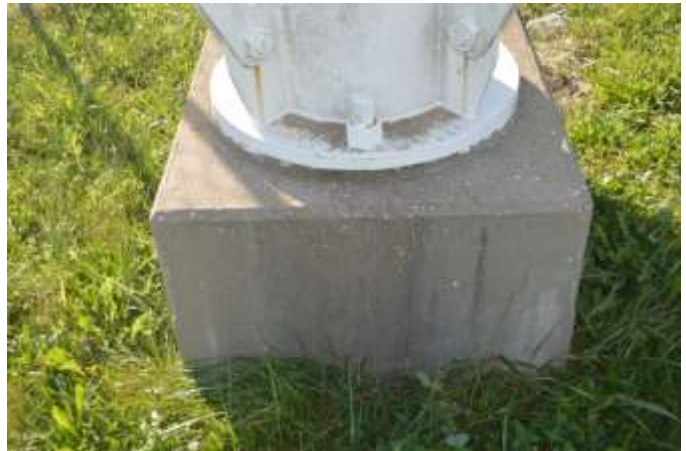
PHOTO SHOWS FOUNDATION

THE FOUNDATION IS SHOWING SIGNS OF CRACKING/SPALLING AND IS NOT PROPERLY SEALED TO SAFEGUARD FROM WATER PENETRATION AND THE EFFECTS OF THE FREEZE-THAW CYCLE DURING COLD WEATHER. WE RECOMMEND TO HAND TOOL CLEAN FOUNDATION, REPAIR SPALLING/CRACKING AREAS AND APPLY ONE COAT OF SEALER TO EXPOSED AREAS.

THE GRADE LEVEL SURROUNDING THE TANK IS NOT AT THE PROPER HEIGHT TO ALLOW FOR THE AWWA AND NFPA RECOMMENDED FOUNDATION EXPOSURE. WE RECOMMEND CONTRACTING A LOCAL EXCAVATOR TO GRADE CIRCUMFERENCE OF TANK TO EXPOSE A MINIMUM OF SIX INCHES OF FOUNDATION TO CREATE POSITIVE RUN OFF IN ACCORDANCE WITH NFPA 2013 12.3.1 AND AWWA D-100-11 12.6 REQUIREMENTS.

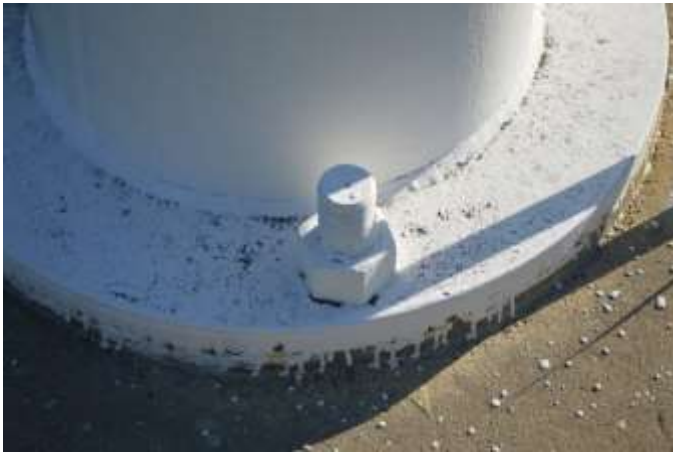
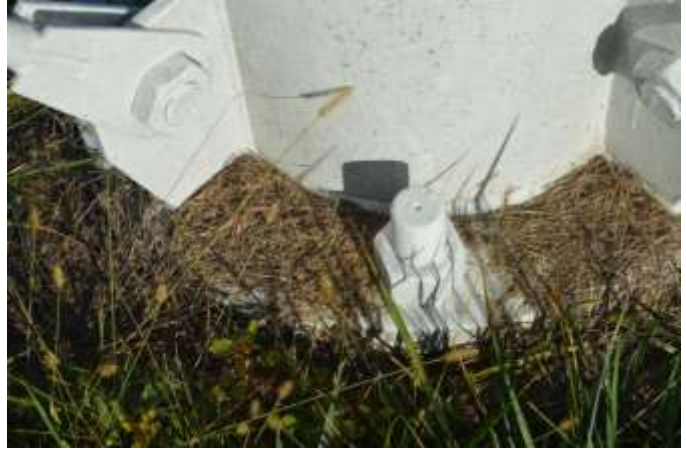
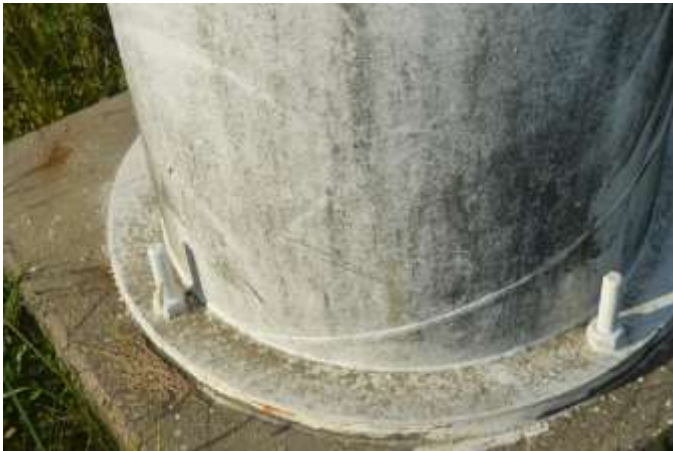
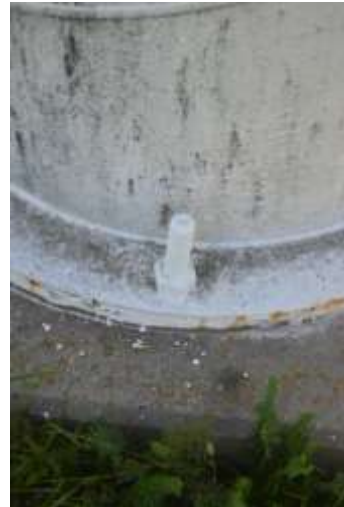
PHOTO SHOWS ANCHOR BOLTS

THE STRUCTURAL INTEGRITY OF THE ANCHOR BOLTS SHOULD BE MAINTAINED TO WITHSTAND 100 MPH WINDS BLOWING FROM ANY DIRECTION AS REQUIRED BY THE AWWA. WE RECOMMEND TO CLEAN AROUND THE ANCHOR BOLTS AND WELD AROUND THE CIRCUMFERENCE OF THE BOLT-TO-NUT AND NUT-TO-BASE CONNECTION TO REINFORCE.

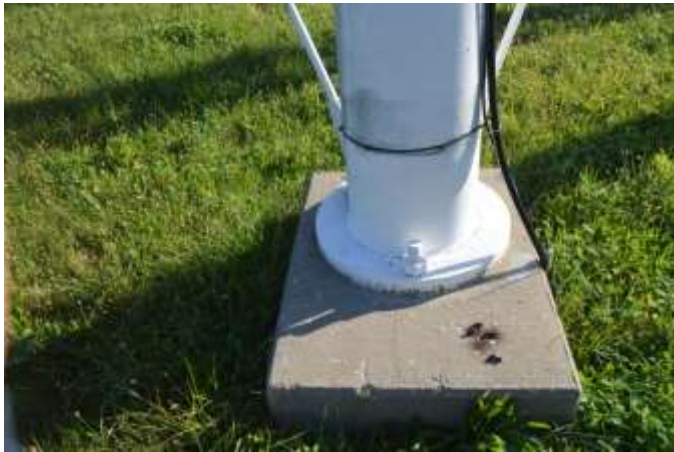
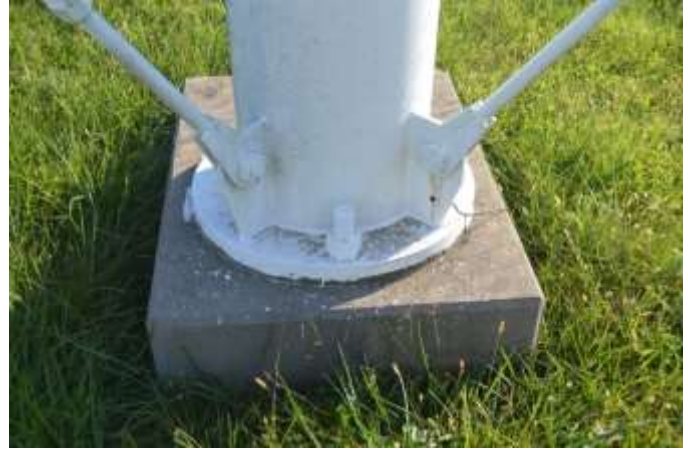
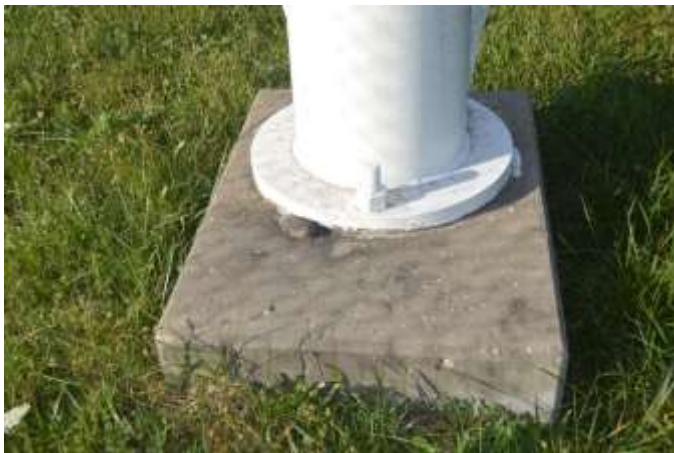
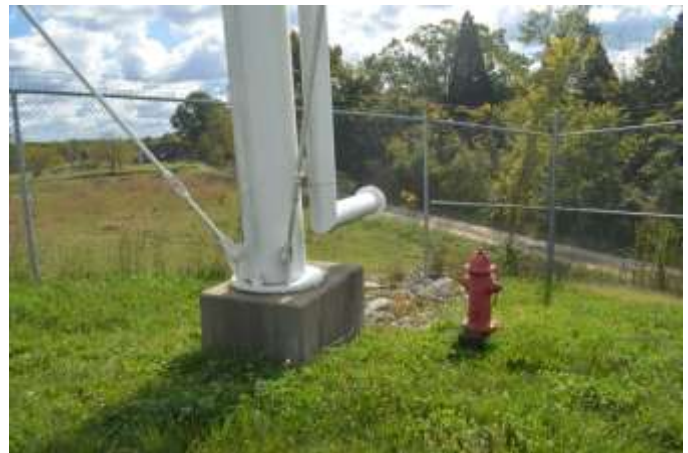
PHOTO SHOWS FOUNDATION

TANK IS NOT PROPERLY GROUNDED ACCORDING TO NFPA 780 4.9.10 AND 4.9.10.1 REQUIREMENTS. WE RECOMMEND TO FURNISH AND INSTALL TWO GROUND CONDUCTORS, STRUCTURES EXCEEDING 250 FEET IN PERIMETER, ARE REQUIRED TO HAVE AN ADDITIONAL CONDUCTOR FOR EVERY 100 FEET OF PERIMETER IN ACCORDANCE WITH NFPA 780 4.9.10 AND 4.9.10.1 REQUIREMENTS.

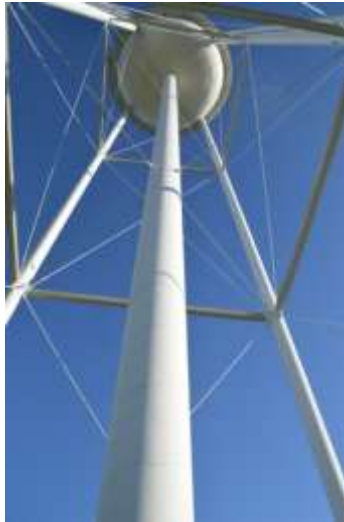
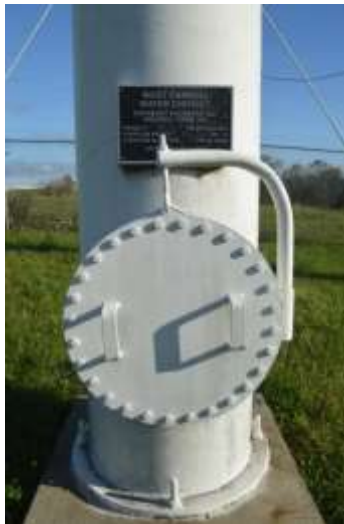
PHOTO SHOWS RISER/RISER MANWAY

THIS TANK DOES NOT HAVE THE REQUIRED SIGNAGE BY OSHA. WE RECOMMEND TO FURNISH AND INSTALL CONFINED SPACE, FALL PROTECTION EQUIPMENT REQUIRED, AND HOMELAND SECURITY SIGNS ON THE TANK IN ACCORDANCE WITH OSHA US CODE TITLE 42 300i-1, AND THE DEPARTMENT OF HOMELAND SECURITY CODES.

WE RECOMMEND TO FURNISH AND INSTALL A 2" DIAMETER FROST PROOF AND LOCKABLE DRAIN VALVE TO AS CLOSE TO THE BOTTOM OF THE RISER AS POSSIBLE. WE ARE MAKING THIS RECOMMENDATION AS MOST TANK OWNER'S DO NOT HAVE THE MEANS IN PLACE TO EFFECTIVELY DRAIN THEIR TANKS. MOST FACILITIES MUST FOLLOW WATER DRAINAGE REQUIREMENTS THAT COMPLY WITH THEIR FACILITIES STORM WATER PLAN WHICH REQUIRES THE WATER TO BE DIRECTED INTO A STORM DRAIN. THE DRAIN VALVE ALLOWS THE HOOKUP OF A DRAIN LINE SO THE WATER MAY BE DIRECTIONALIZED.

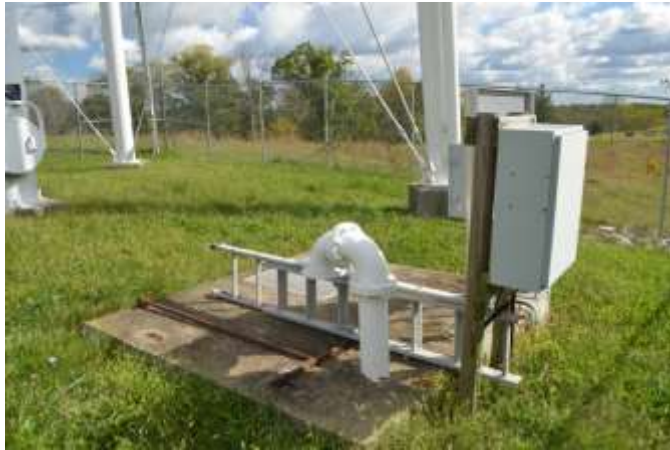
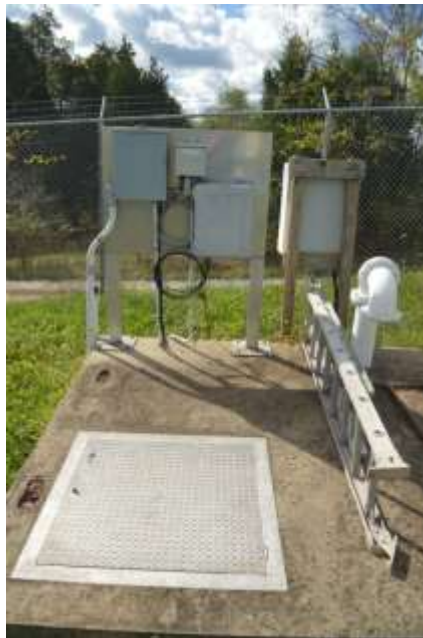
PHOTO SHOWS TANK CONTROLS AND VALVE PIT IN GOOD CONDITION

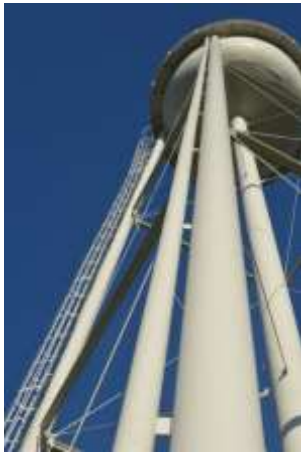
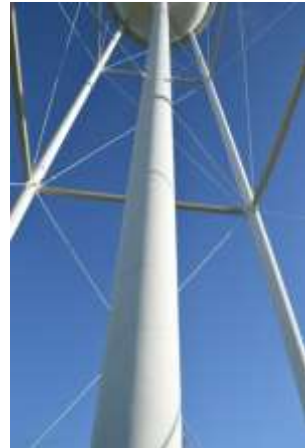
PHOTO SHOWS EXTERIOR OF TANK

OVERALL, THE EXTERIOR COATING APPEARS TO BE IN GOOD CONDITION. IN ORDER PROMOTE THE LONGEVITY OF THE EXISTING COATING, WE RECOMMEND TO POWER WASH ALL EXTERIOR SURFACES AND TOUCH UP COATING AS NECESSARY.

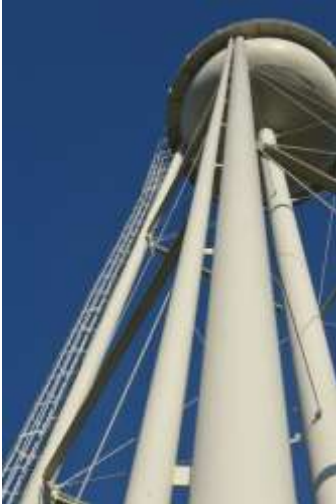
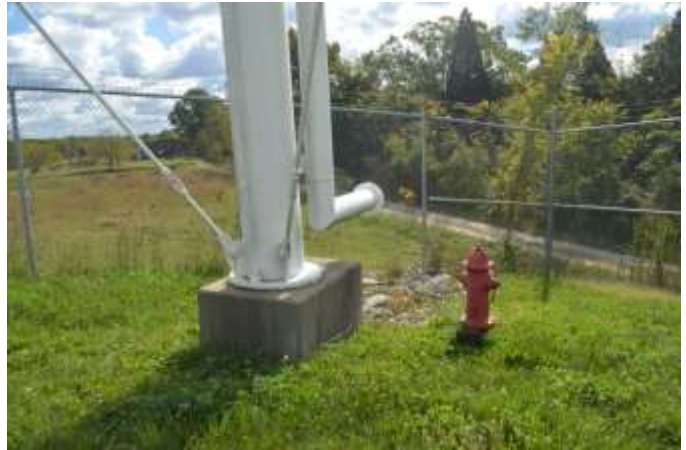
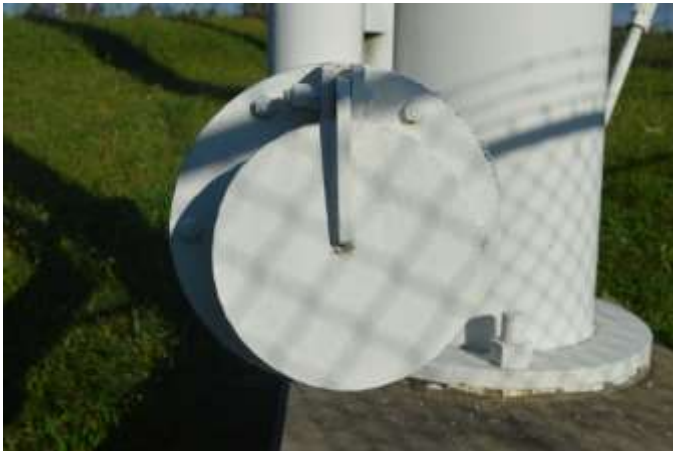
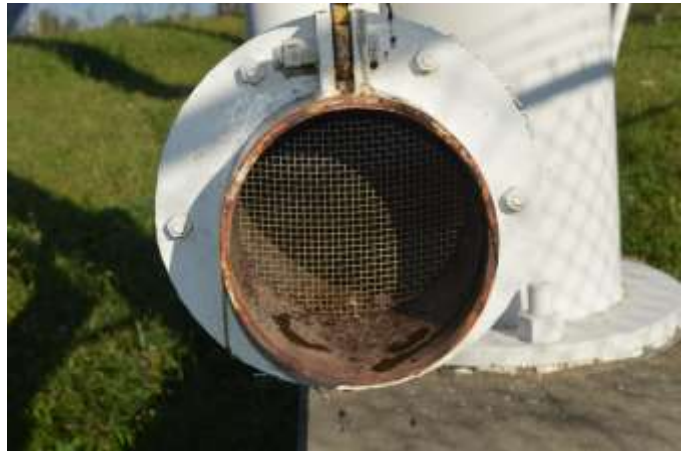
PHOTO SHOWS OVERFLOW

WE RECOMMEND TO REPLACE SCREEN ON THE EXISTING FLAPPER VALVE TO PREVENT THE INGRESS OF CONTAMINANTS IN ACCORDANCE WITH AWWA D100-11 7.3 AND NFPA 22 2013 14.6 REQUIREMENTS.

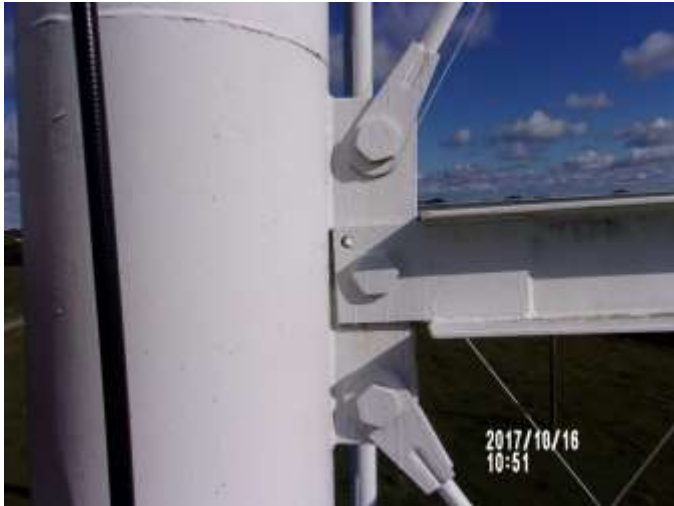
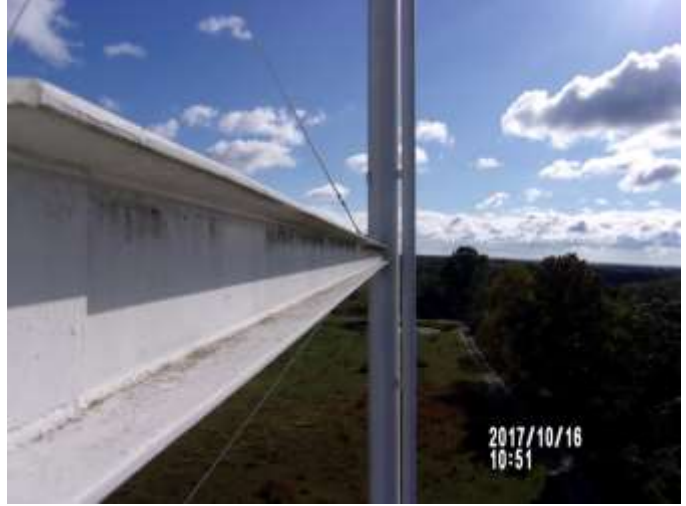
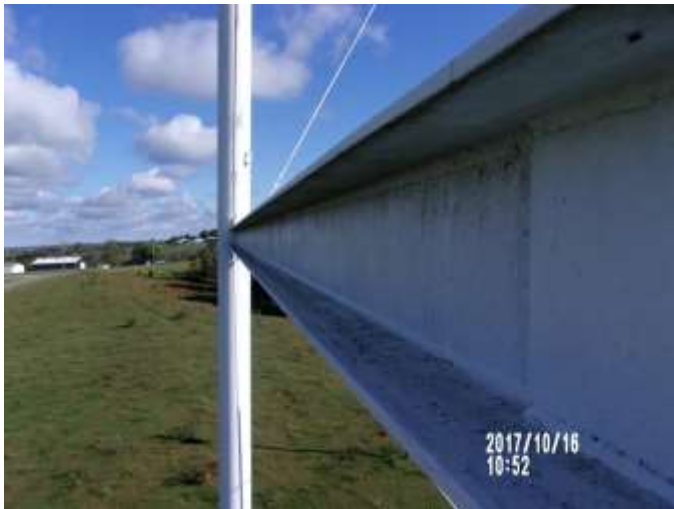
PHOTO SHOWS STRUTS

WE RECOMMEND RE-ENFORCING THE STRUT ENDS BY WELDING AFTER ADJUSTING WINDAGE AND STAY RODS.

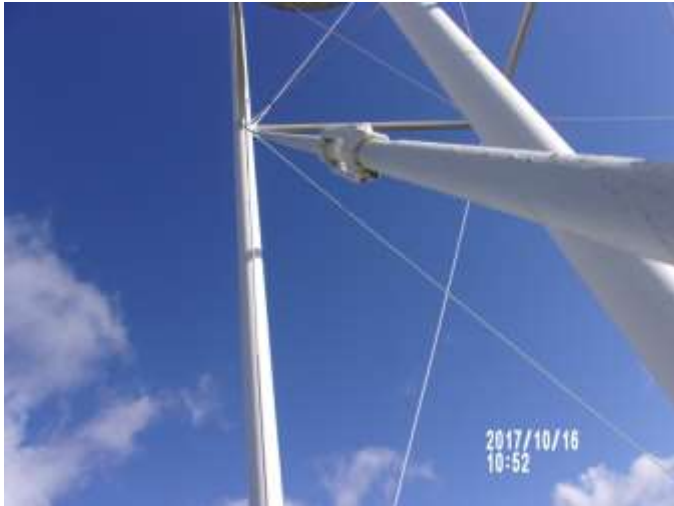
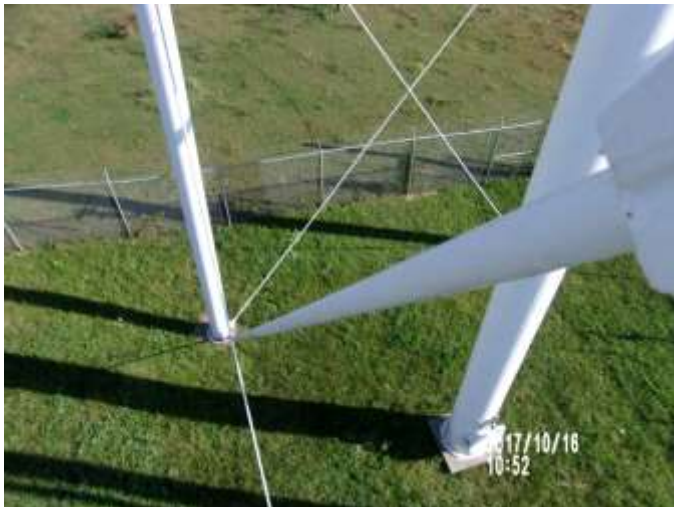
PHOTO SHOWS WINDAGE RODS

THE WINDAGE RODS ARE DESIGNED TO RESIST AND STABILIZE THE TANK STRUCTURE AGAINST WIND AND SEISMIC LOADS COMBINED WITH DEAD AND LIVE LOADS. THE RODS SHOULD WITHSTAND 100 MPH WINDS BLOWING FROM ANY DIRECTION. IF THE BRACING REMAINS LOOSE, A SUDDEN COLLAPSE COULD OCCUR. WE RECOMMEND TO ADJUST THE WINDAGE RODS AND RISER STAY RODS TO WITHSTAND 100 MPH WINDS BLOWING FROM ANY DIRECTION, AS REQUIRED BY AWWA D100-11 3.1.4, REQUIREMENTS. THIS SHOULD BE DONE ON AN EMERGENCY BASIS.

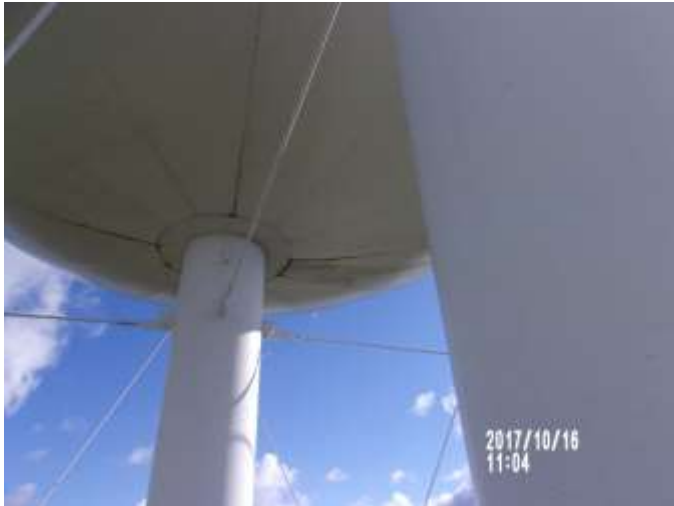
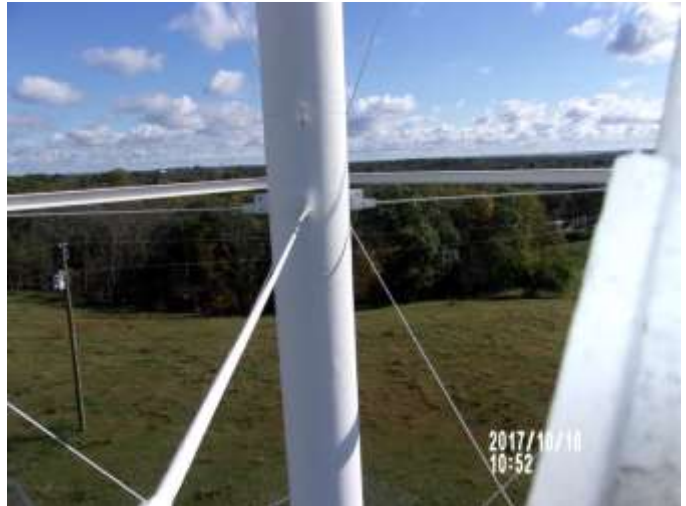
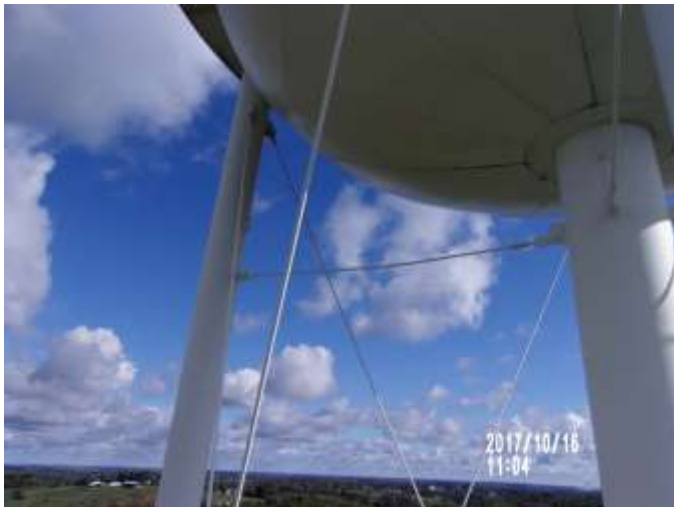
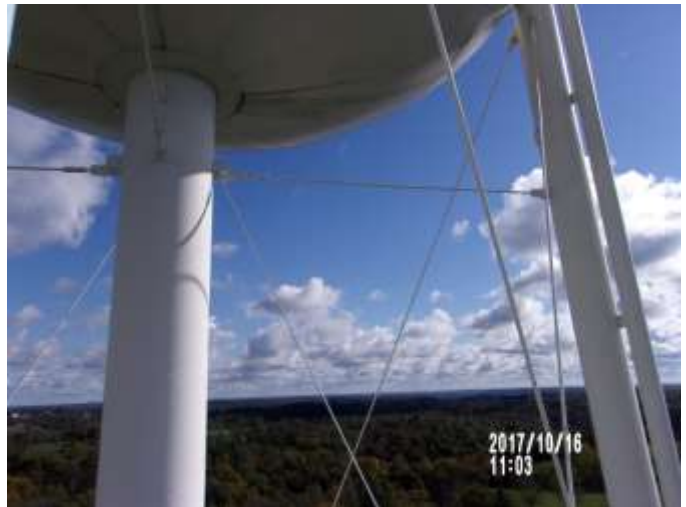
PHOTO SHOWS RISER TO BOWL CONNECTION & STAY RODS

WE RECOMMEND TO ADJUST THE RISER RODS TO WITHSTAND 100 MPH WINDS BLOWING FROM ANY DIRECTION, AS REQUIRED BY AWWA.

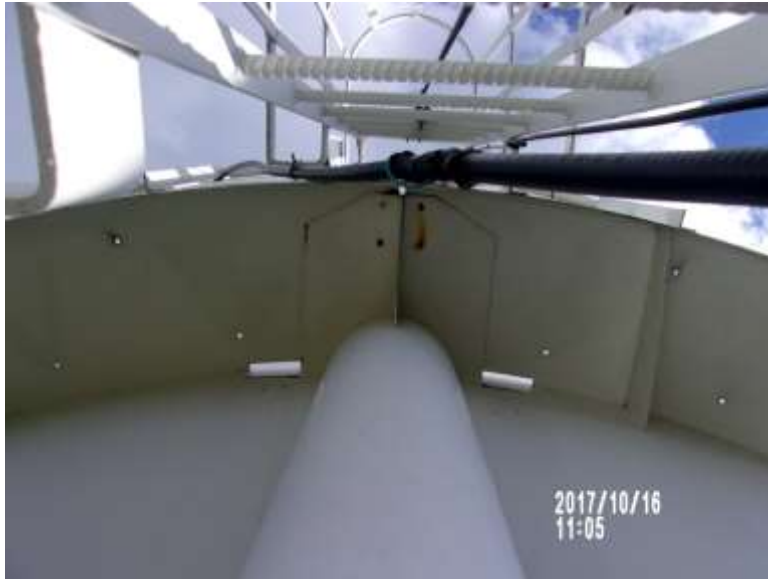
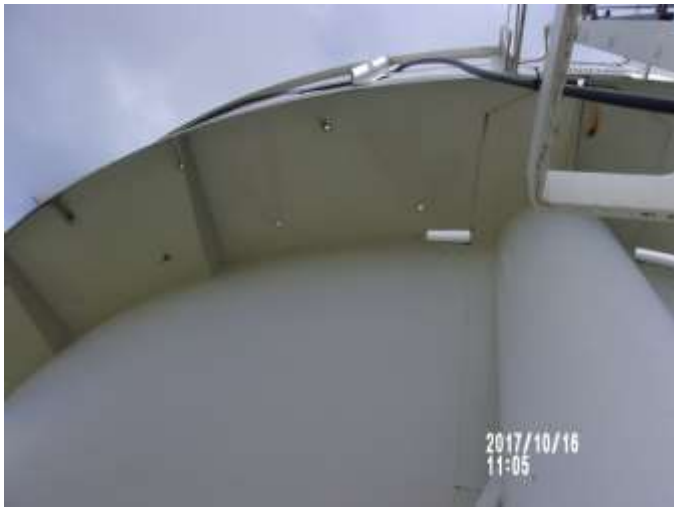
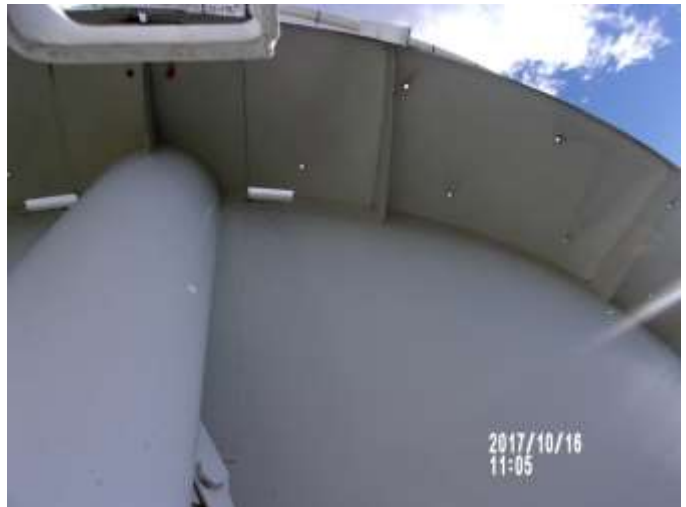
PHOTO SHOWS UNDERSIDE OF CATWALK IN GOOD CONDITION

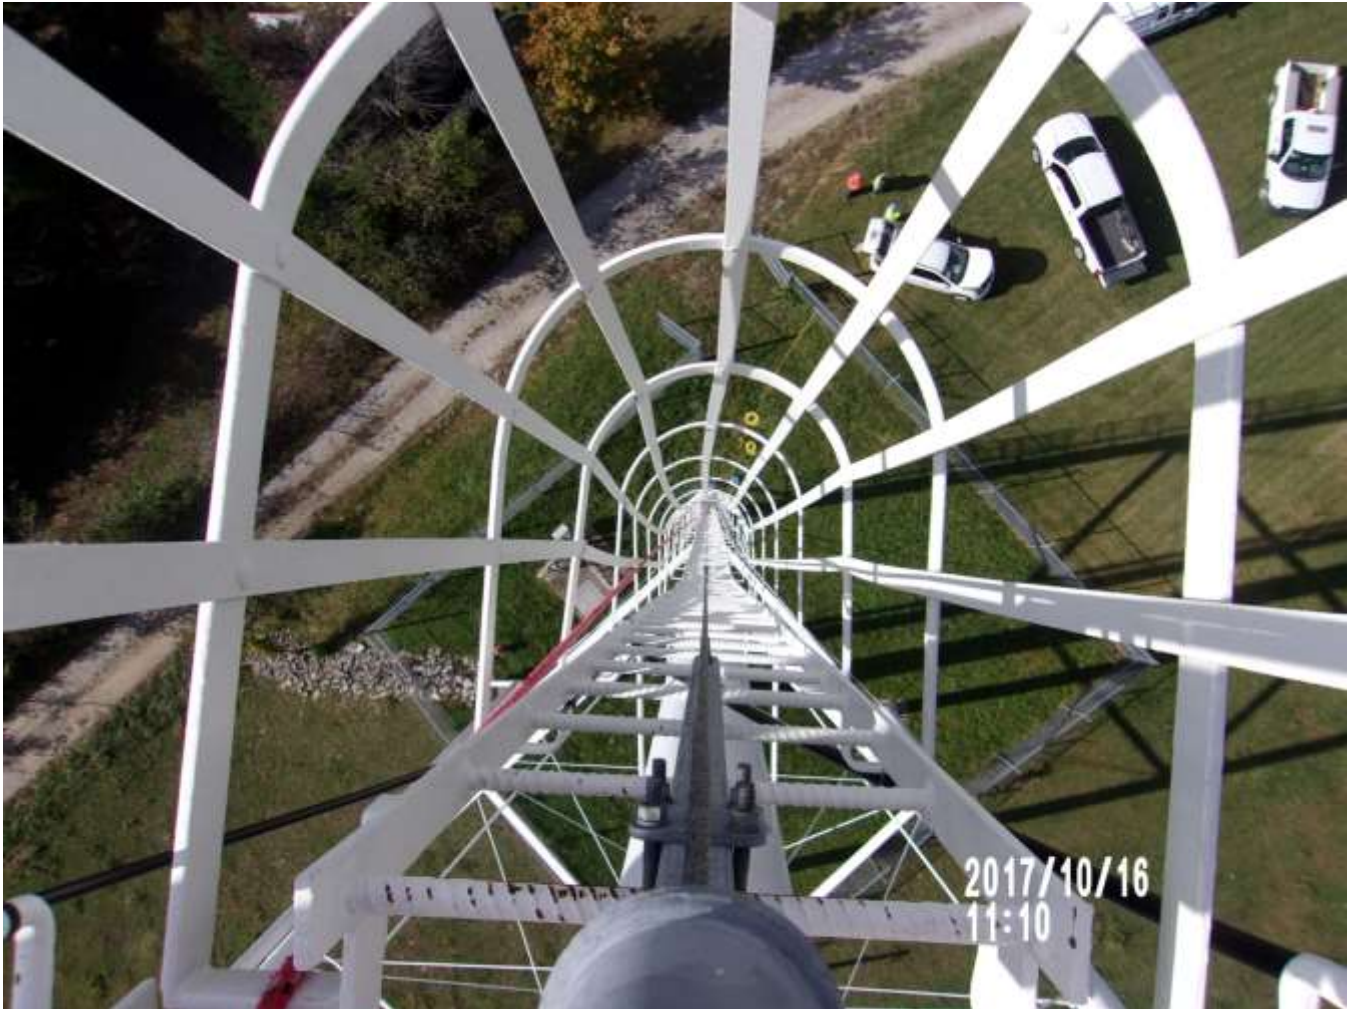
PHOTO SHOWS DOWNWARD VIEW OF LADDER IN GOOD CONDITION

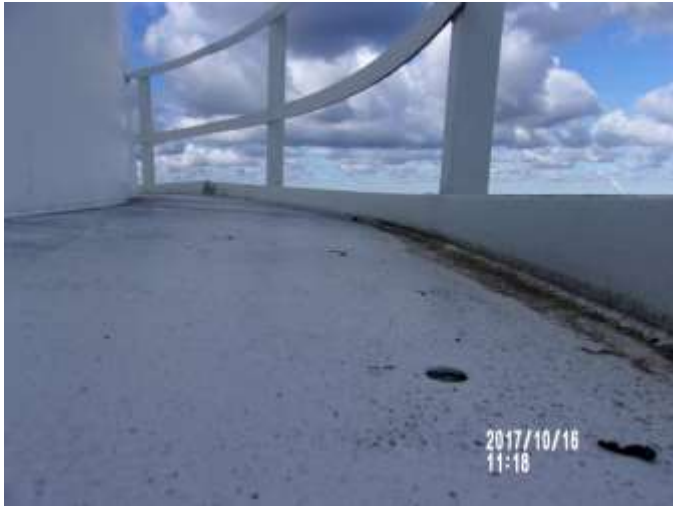
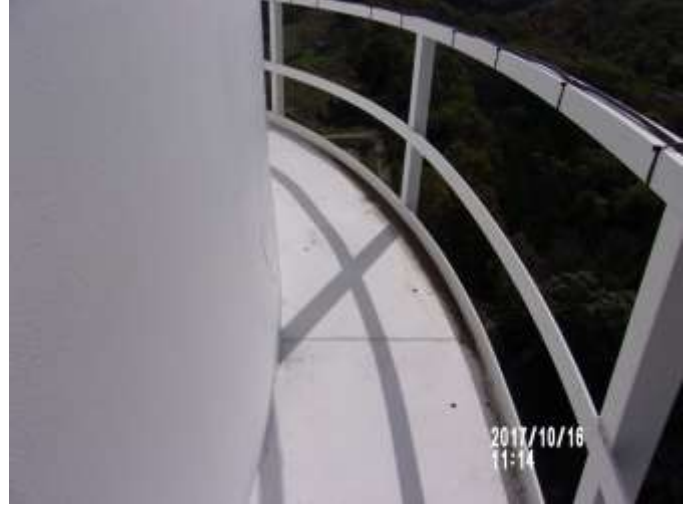
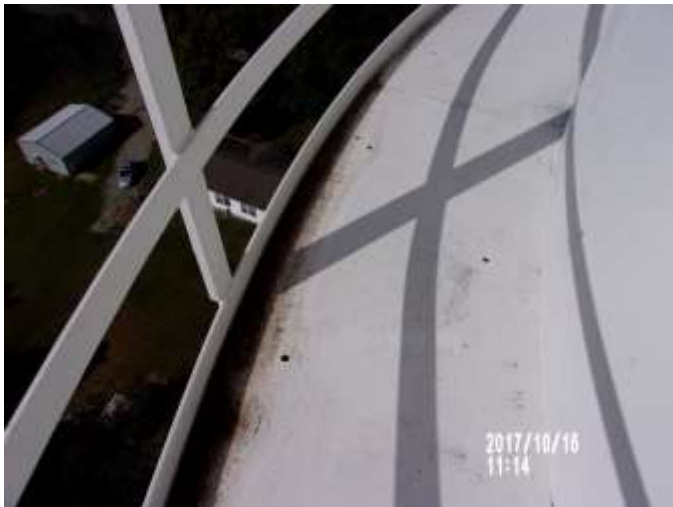
PHOTO SHOWS CATWALK HANDRAILS

WE RECOMMEND DRILLING ADDITIONAL WEEP HOLES IN THE STRUTS AS NECESSARY TO PREVENT THE PONDING OF WATER.

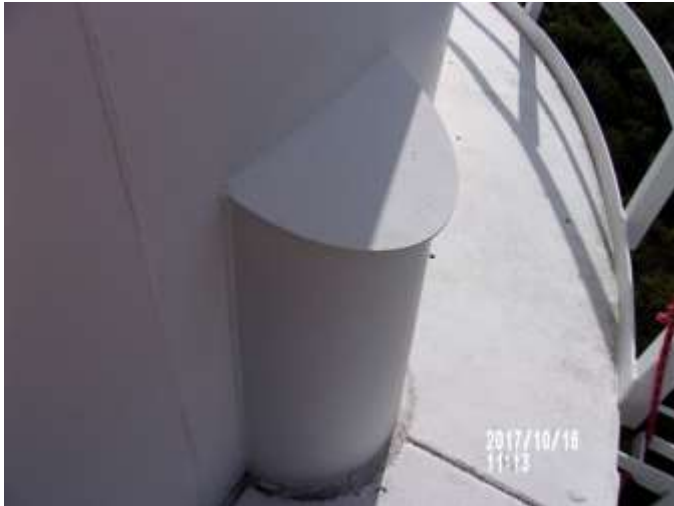
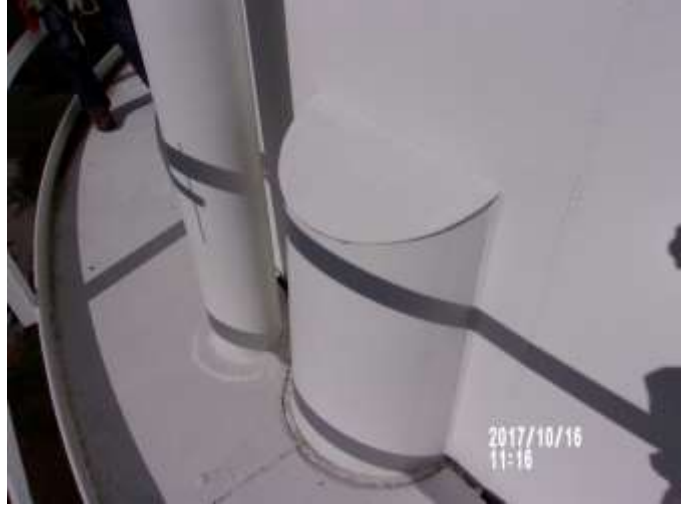
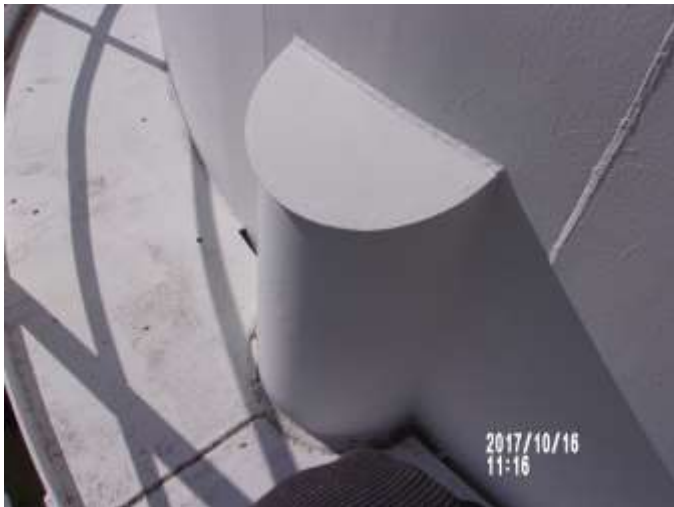
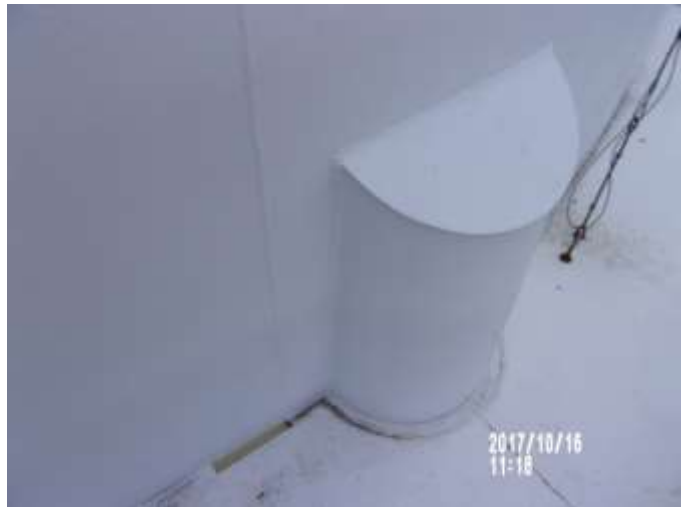
PHOTO SHOWS CATWALK AND POSTHEAD CONNECTIONS

**TO ENSURE THE STRUCTURAL INTEGRITY OF THE TANK, WE RECOMMEND TO RE-WELD
POST HEAD CONNECTIONS ABOVE THE CATWALK.**

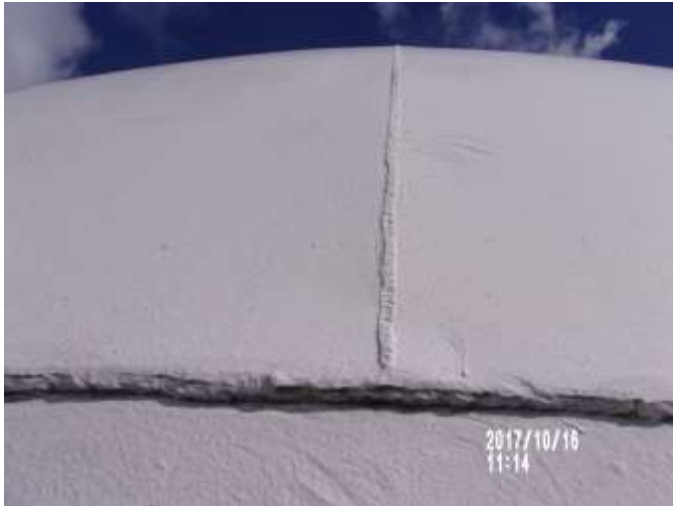
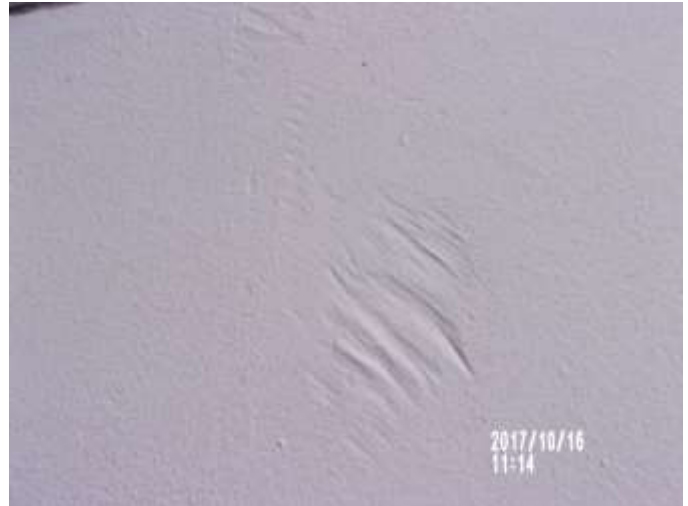
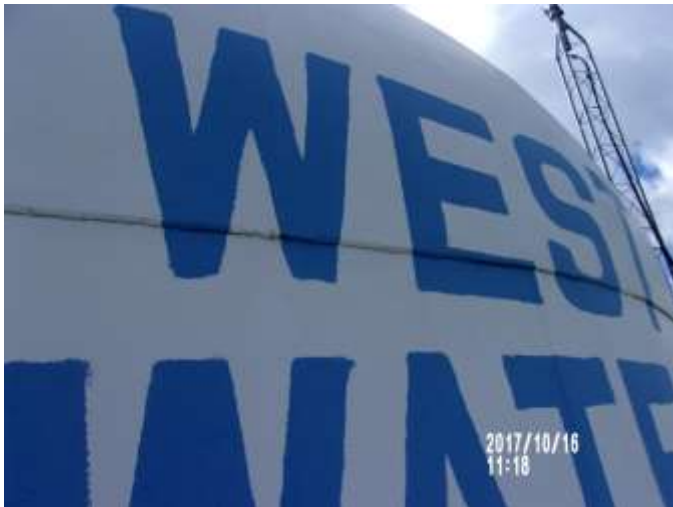
PHOTO SHOWS EXTERIOR OF TANK

AT MINIMUM, WE RECOMMEND TO POWER WASH ALL EXTERIOR SURFACES, PROPERLY PREPARE SURFACE, PRIME, AND APPLY ONE COMPLETE COAT OF ENAMEL. FURTHERMORE, FOR SUPERIOR COLOR, GLOSS RETENTION, AND LONGEVITY OF COATING PERFORMANCE, WE RECOMMEND A FULL COAT OF PRIMER FOLLOWED BY A FINISH COAT OF ACRYLIC OR URETHANE.

TANK IS NOT EQUIPPED WITH SHELL MANWAYS. WE RECOMMEND TO INSTALL TWO 24" SHELL MANWAYS COMPLETE WITH A DAVIT ARM AND GALVANIZED BOLTS AT THE CATWALK LEVEL SPACED AT 180 DEGREES APART IN CONJUNCTION WITH TWO INTERIOR BOWL LADDERS INCLUDING SAFETY CLIMB DEVICES IN ACCORDANCE WITH OSHA, AWWA D100-11 7.4.4, AND NFPA 22 2013 14.7.2 REQUIREMENTS.

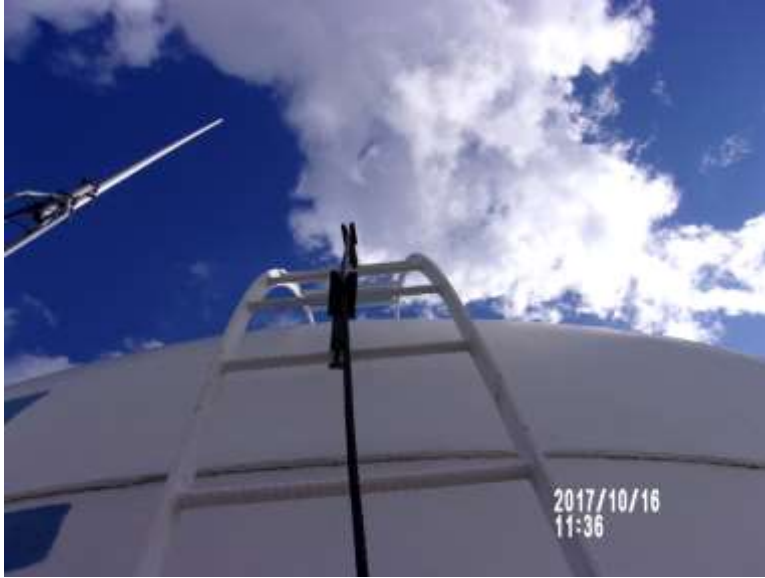
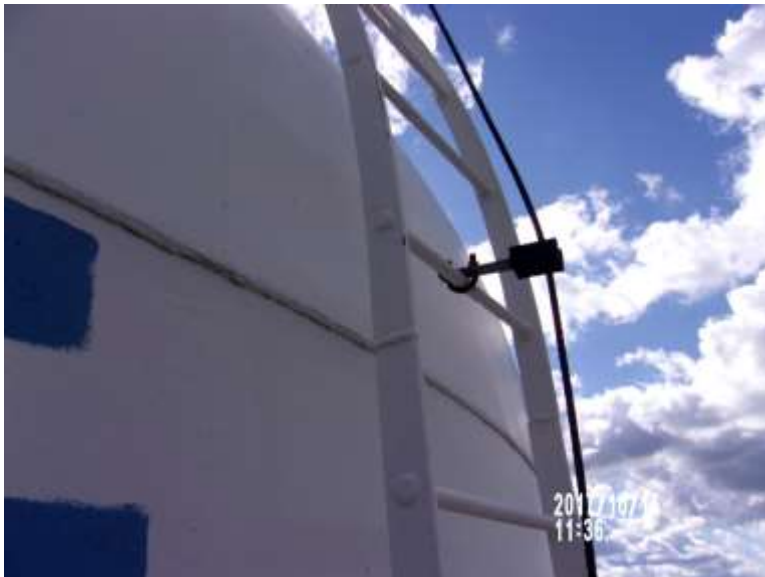
PHOTO SHOWS SHELL LADDER IN GOOD CONDITION

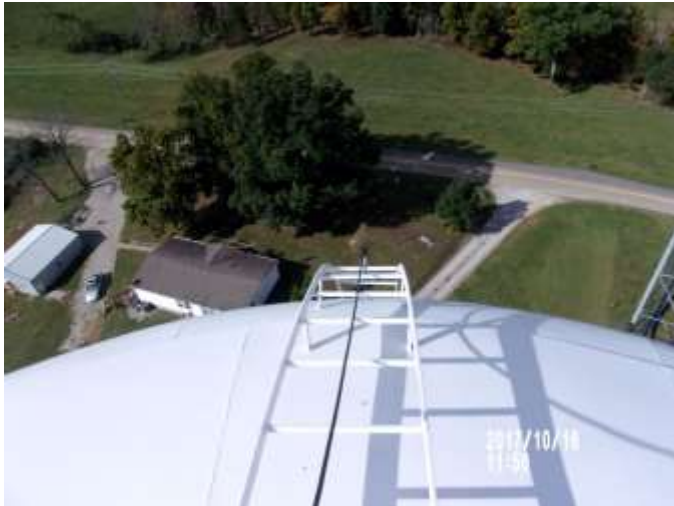
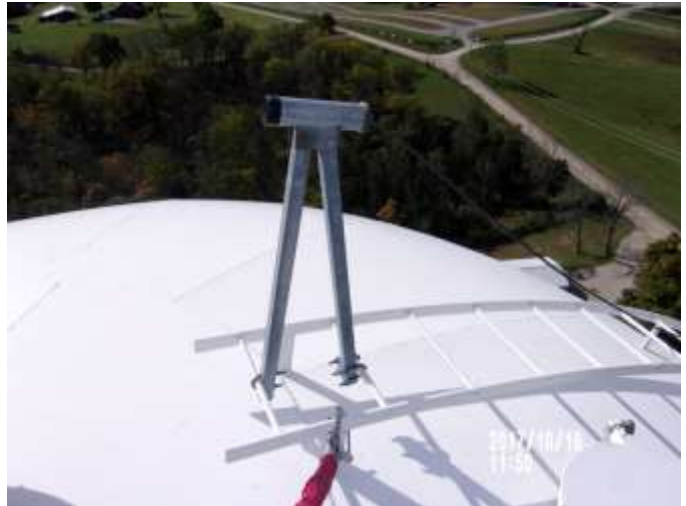
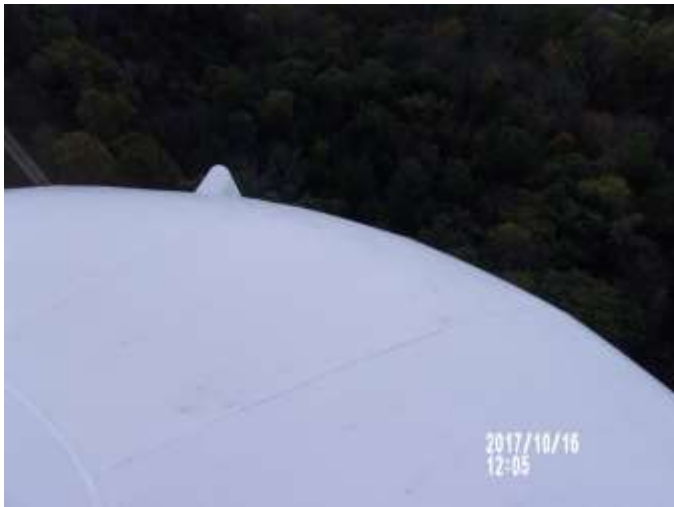
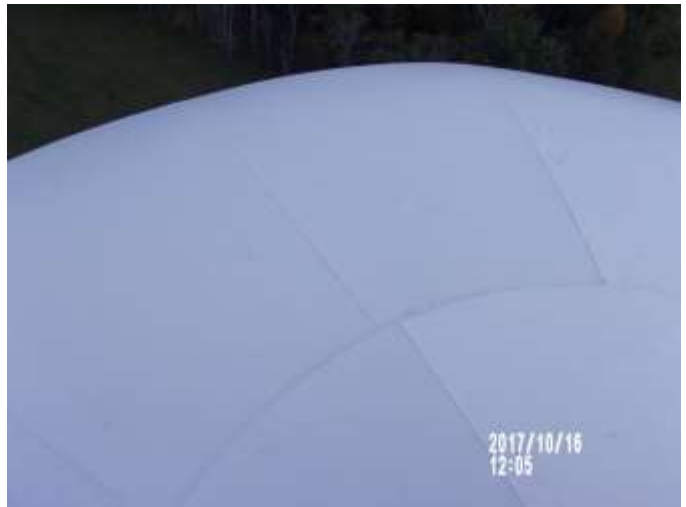
PHOTO SHOWS EXTERIOR OVERVIEW OF ROOF

TANK IS NOT EQUIPPED WITH AN OSHA APPROVED HANDRAIL SYSTEM. WE RECOMMEND TO FURNISH AND INSTALL 42" HANDRAILS AROUND THE CIRCUMFERENCE OF THE TANK ROOF IN ACCORDANCE WITH OSHA, AWWA D100-11 3.1.7 AND NFPA 22 2013 8.7.9 REQUIREMENTS.

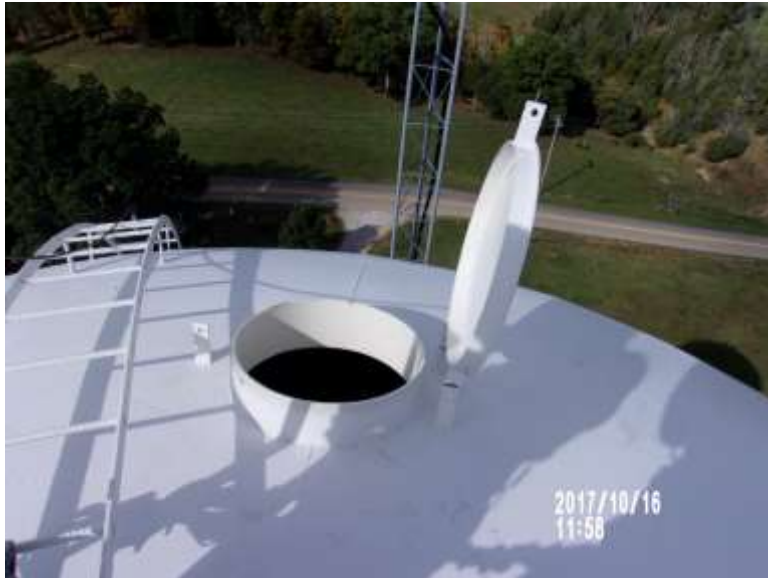
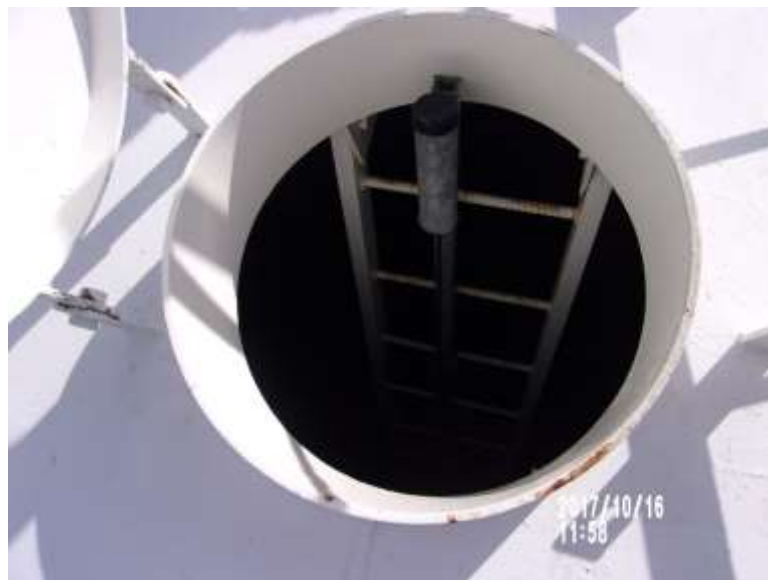
PHOTO SHOWS OPEN VIEW OF ROOF HATCH

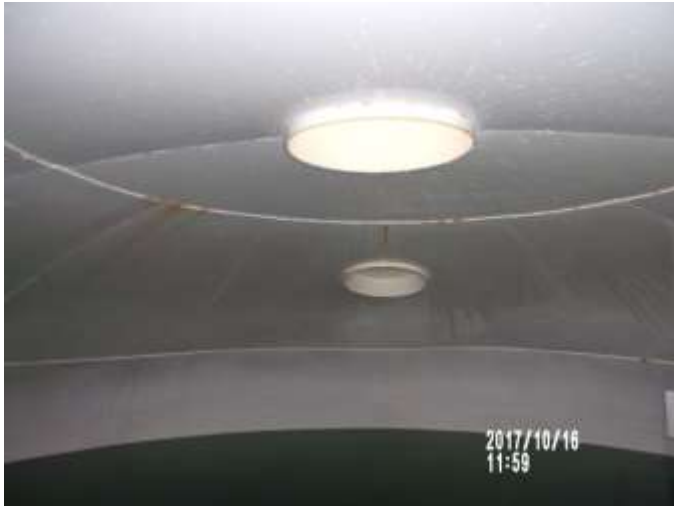
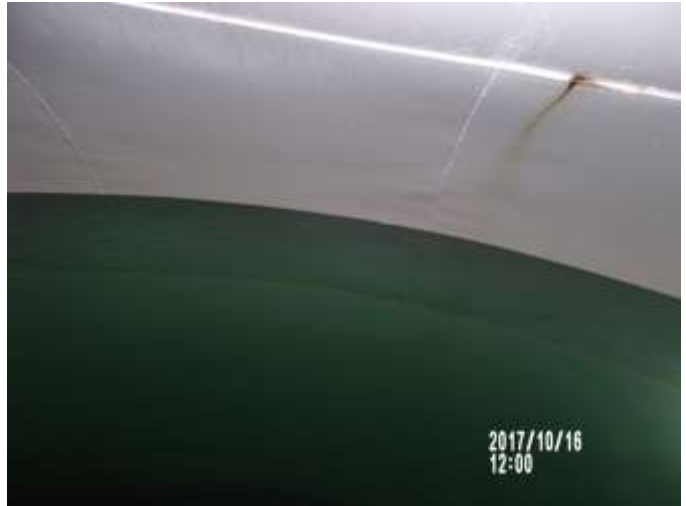
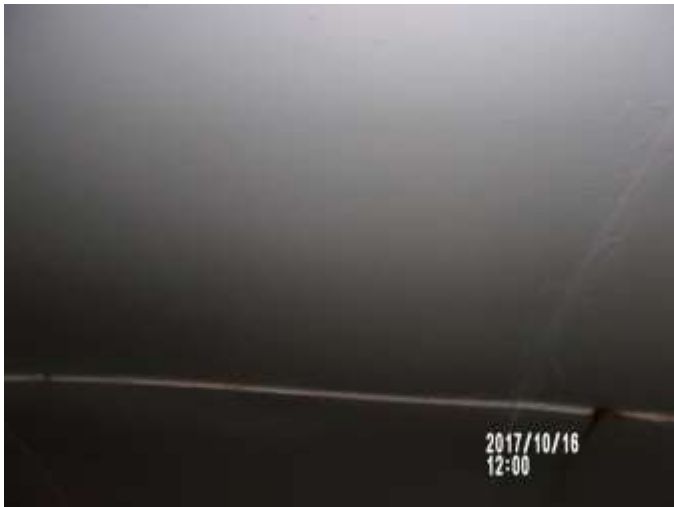
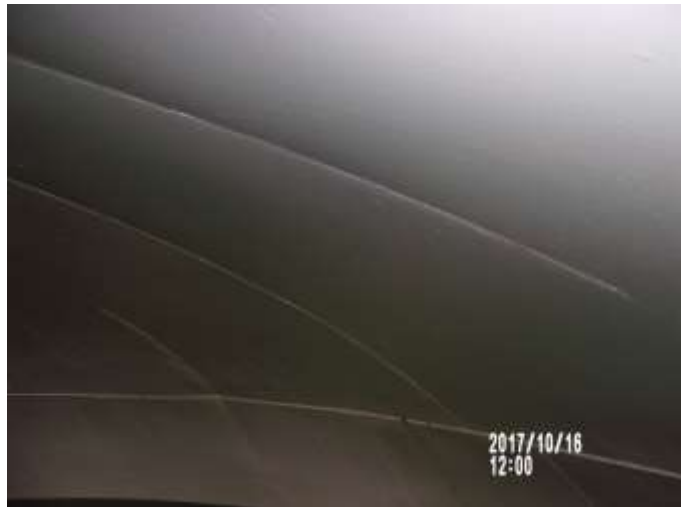
PHOTO SHOWS INTERIOR OVERVIEW OF ROOF

**WE RECOMMEND TO CAULK INTERIOR LAPPED ROOF JOINTS AFTER PAINTING TO PREVENT
PREMATURE FAILURE OF COATING.**

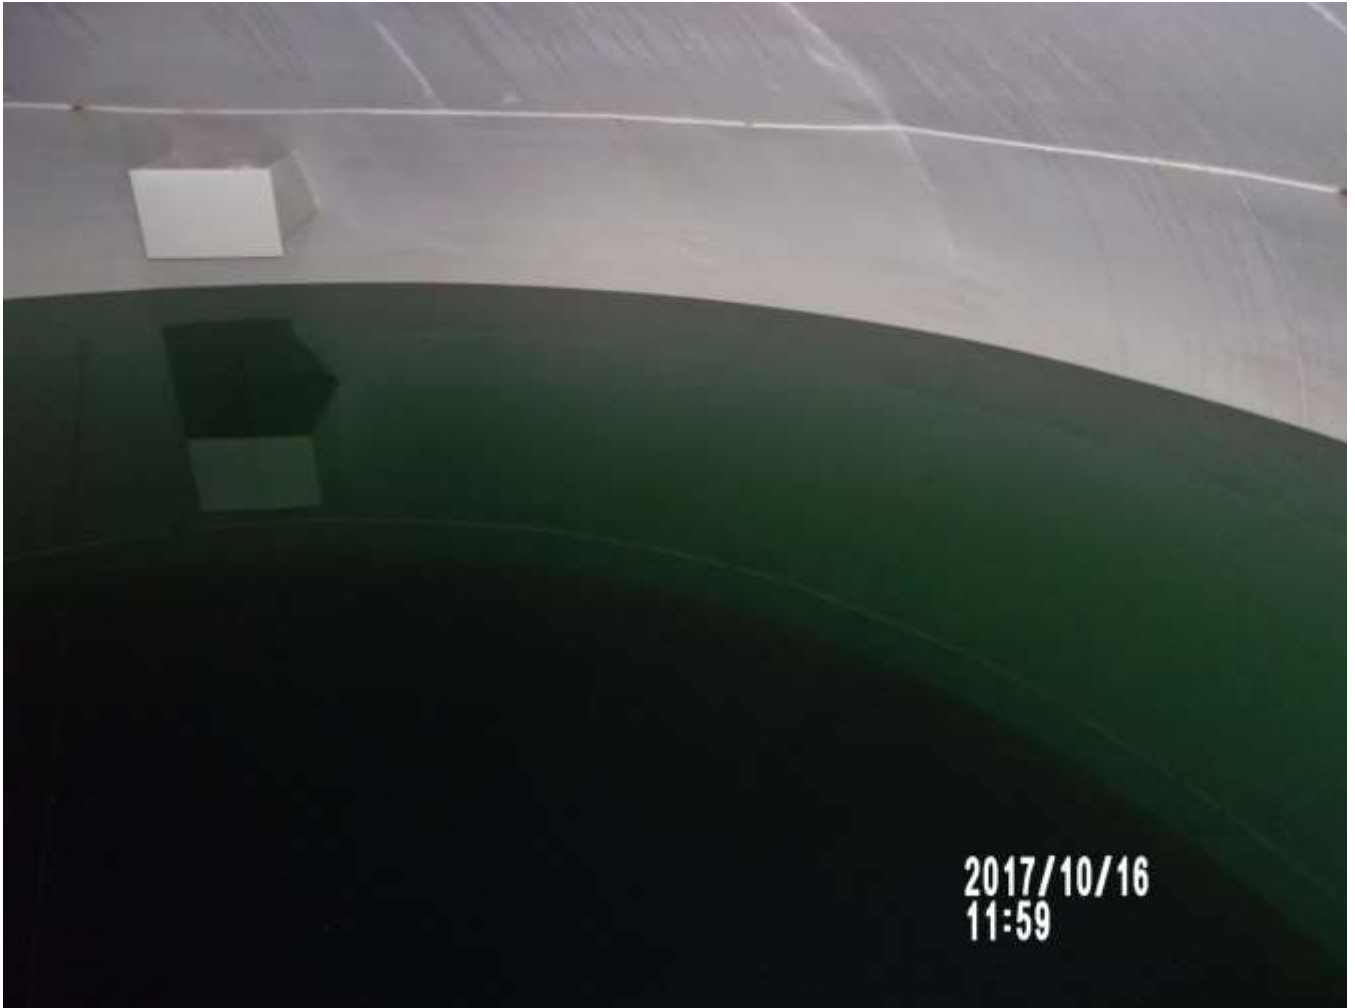
PHOTO SHOWS INTERIOR VIEW OF WEIR BOX IN GOOD CONDITION
