ELECTRONIC INVESTIGATION INTO)
EXCESSIVE WATER LOSS BY KENTUCKY'S) Case No. 2019-00041
JURISDICTIONAL WATER UTILITIES)

**West Carroll Water District
Case No. 2019-00041
Commission Staff's Second Request for Information issued May 3, 2019**

100,000 GALLON ELEVATED WATER TANK

50,000 GALLON ELEVATED WATER TANK

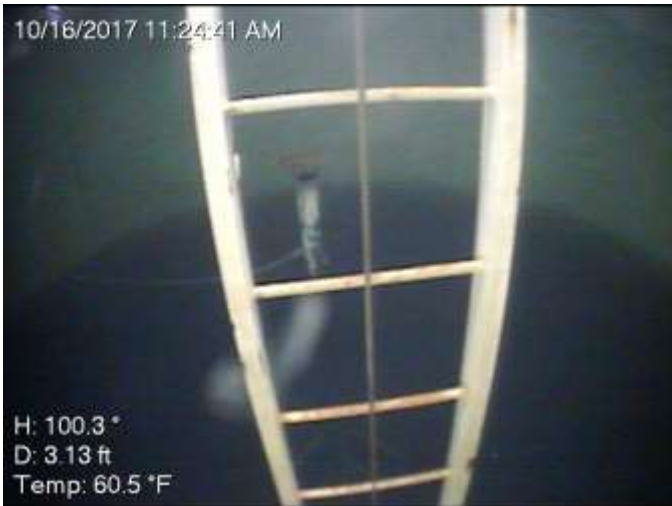
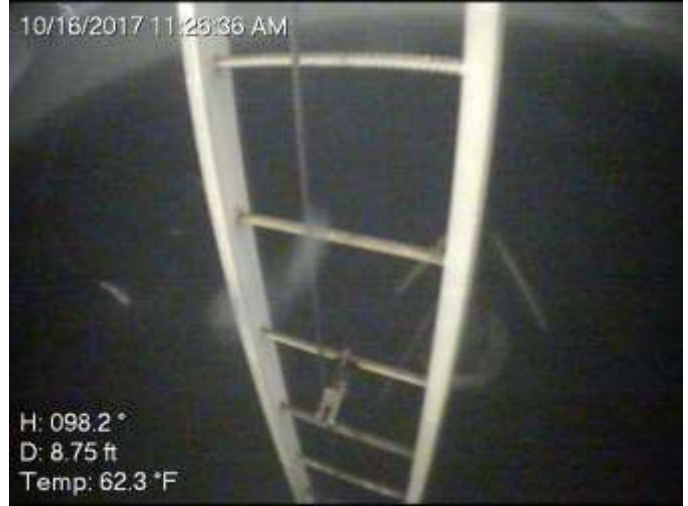
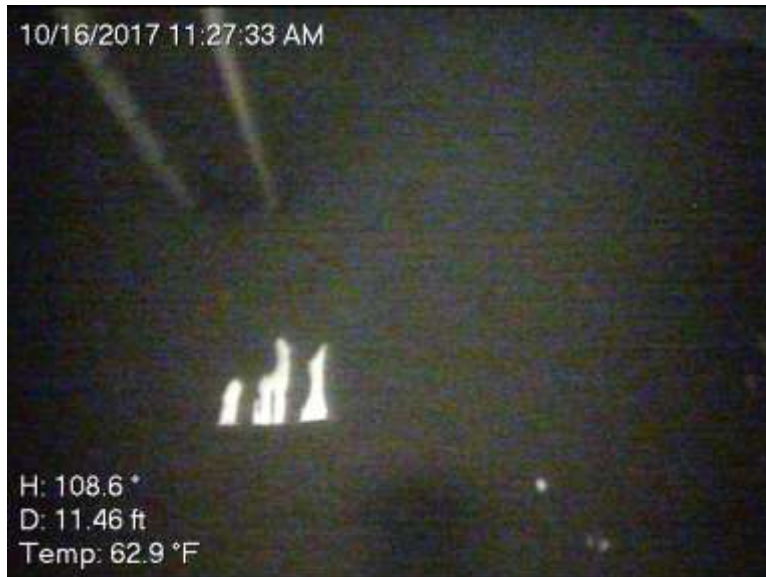
PHOTO SHOWS INTERIOR LADDER IN GOOD CONDITION

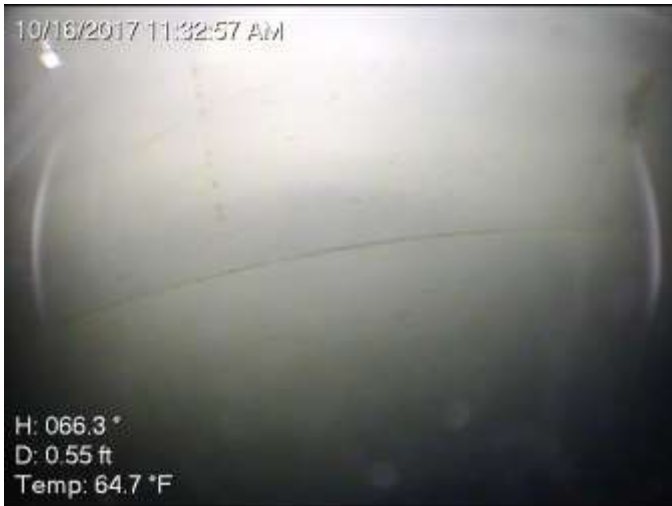
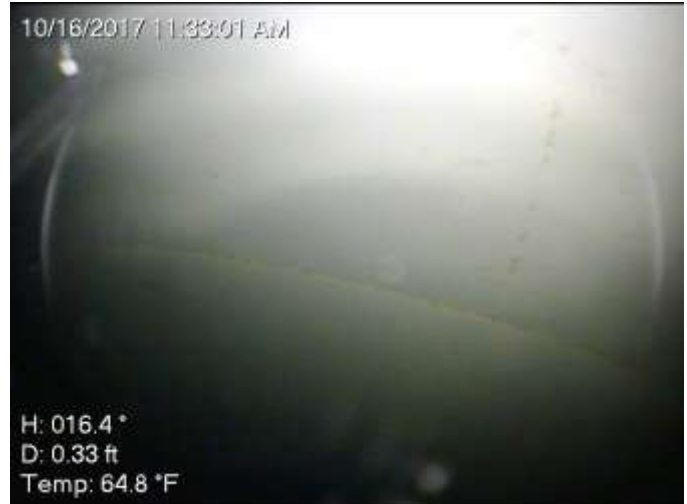
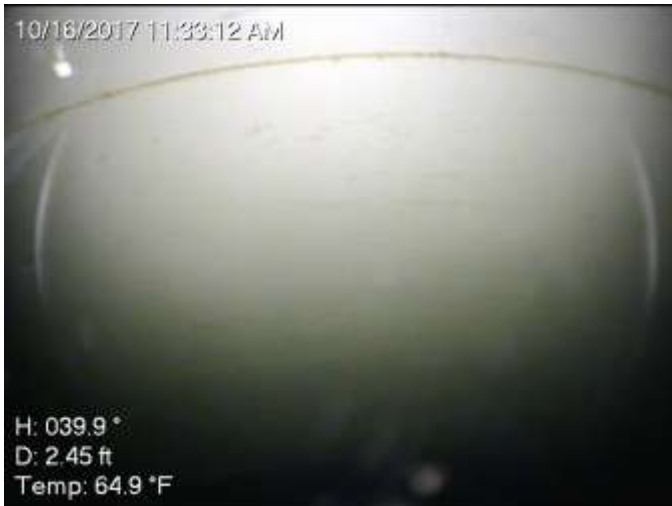
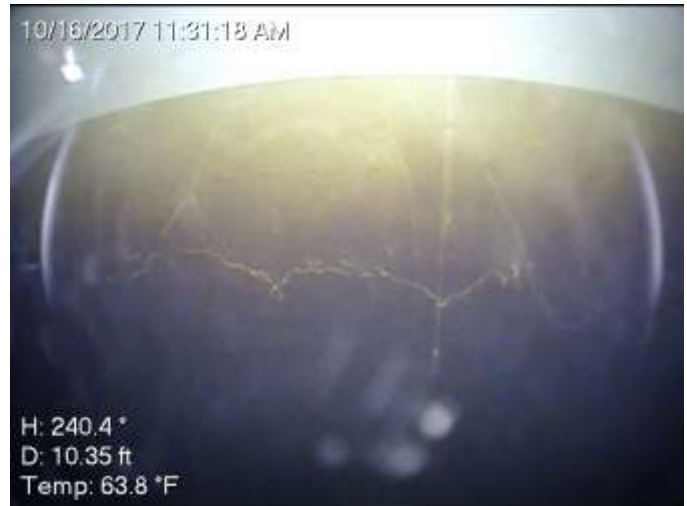
PHOTO SHOWS PAINTERS RING/INTERIOR OF TANK

OVERALL, THE INTERIOR COATING APPEARS TO BE IN GOOD CONDITION. IN ORDER PROMOTE THE LONGEVITY OF THE EXISTING COATING, WE RECOMMEND TO POWER WASH ALL INTERIOR SURFACES AND TOUCH UP COATING AS NECESSARY.

CATHODIC PROTECTION IS AN EFFECTIVE WAY TO HELP PROTECT YOUR TANK FROM THE EFFECTS OF CORROSION. WE RECOMMEND TO FURNISH AND INSTALL A PASSIVE CATHODIC PROTECTION SYSTEM AS A COST EFFECTIVE AND LOW MAINTENANCE MEANS OF FURTHER PROTECTING AND EXTENDING THE SERVICE LIFE OF YOUR TANK.

AS PREVIOUSLY MENTIONED, TANK IS NOT EQUIPPED WITH SHELL MANWAYS. WE RECOMMEND TO INSTALL TWO 24" SHELL MANWAYS COMPLETE WITH A DAVIT ARM AND GALVANIZED BOLTS AT THE CATWALK LEVEL SPACED AT 180 DEGREES APART IN CONJUNCTION WITH TWO INTERIOR BOWL LADDERS INCLUDING SAFETY CLIMB DEVICES IN ACCORDANCE WITH OSHA, AWWA D100-11 7.4.4, AND NFPA 22 2013 14.7.2 REQUIREMENTS.

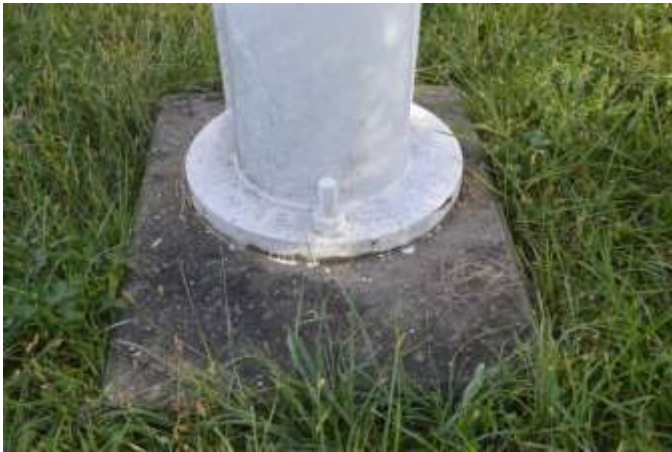
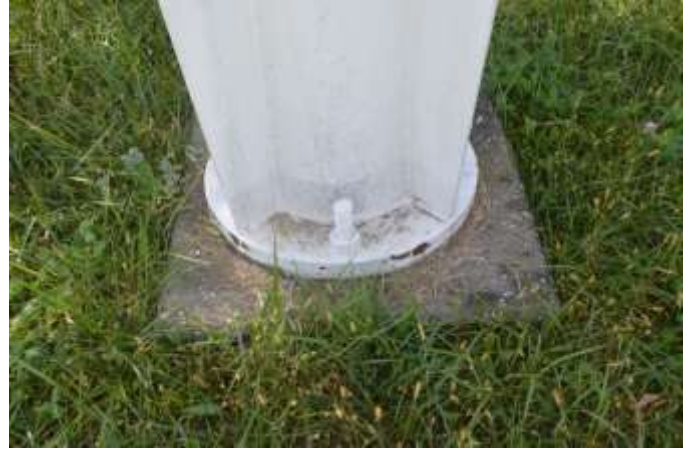
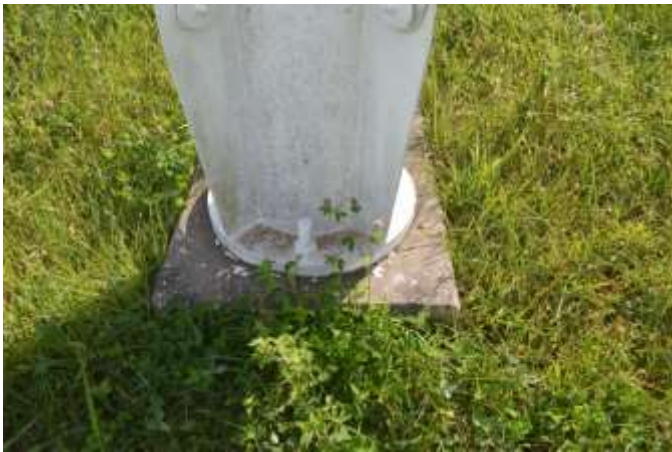
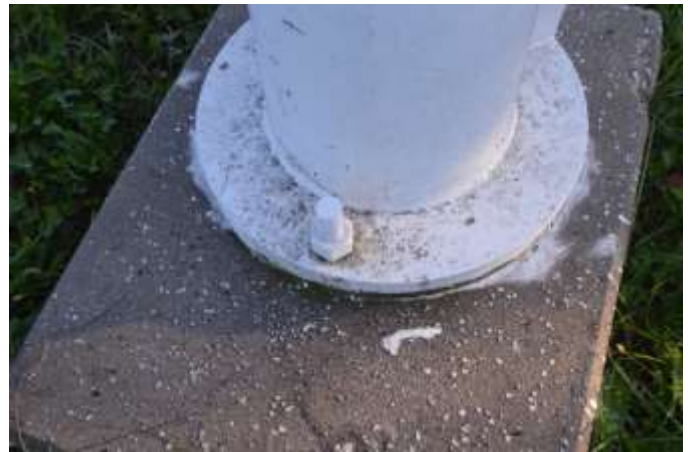
PHOTO SHOWS FOUNDATION

THE FOUNDATION IS SHOWING SIGNS OF CRACKING/SPALLING AND IS NOT PROPERLY SEALED TO SAFEGUARD FROM WATER PENETRATION AND THE EFFECTS OF THE FREEZE-THAW CYCLE DURING COLD WEATHER. WE RECOMMEND TO HAND TOOL CLEAN FOUNDATION, REPAIR SPALLING/CRACKING AREAS AND APPLY ONE COAT OF SEALER TO EXPOSED AREAS.

THE GRADE LEVEL SURROUNDING THE TANK IS NOT AT THE PROPER HEIGHT TO ALLOW FOR THE AWWA AND NFPA RECOMMENDED FOUNDATION EXPOSURE. WE RECOMMEND CONTRACTING A LOCAL EXCAVATOR TO GRADE CIRCUMFERENCE OF TANK TO EXPOSE A MINIMUM OF SIX INCHES OF FOUNDATION TO CREATE POSITIVE RUN OFF IN ACCORDANCE WITH NFPA 2013 12.3.1 AND AWWA D-100-11 12.6 REQUIREMENTS.

TANK IS NOT PROPERLY GROUNDED ACCORDING TO NFPA 780 4.9.10 AND 4.9.10.1 REQUIREMENTS. WE RECOMMEND TO FURNISH AND INSTALL TWO GROUND CONDUCTORS, STRUCTURES EXCEEDING 250 FEET IN PERIMETER, ARE REQUIRED TO HAVE AN ADDITIONAL CONDUCTOR FOR EVERY 100 FEET OF PERIMETER IN ACCORDANCE WITH NFPA 780 4.9.10 AND 4.9.10.1 REQUIREMENTS.

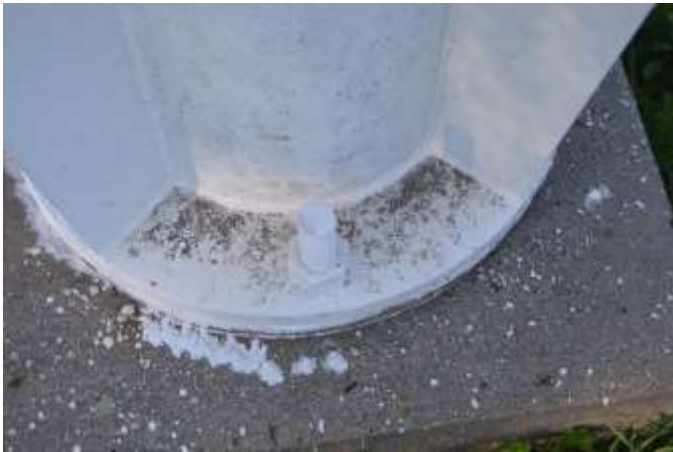
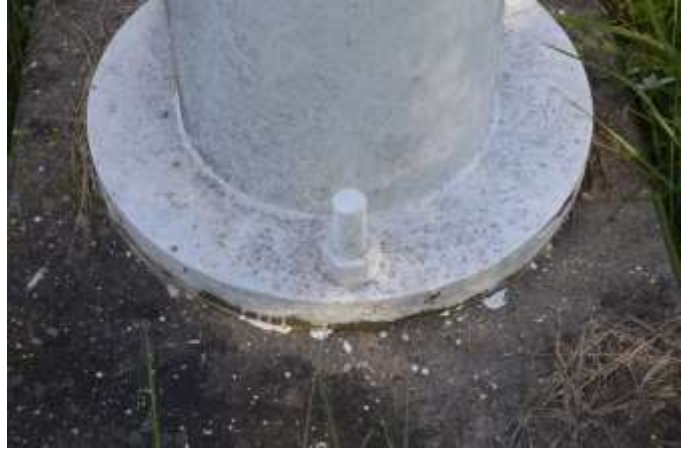
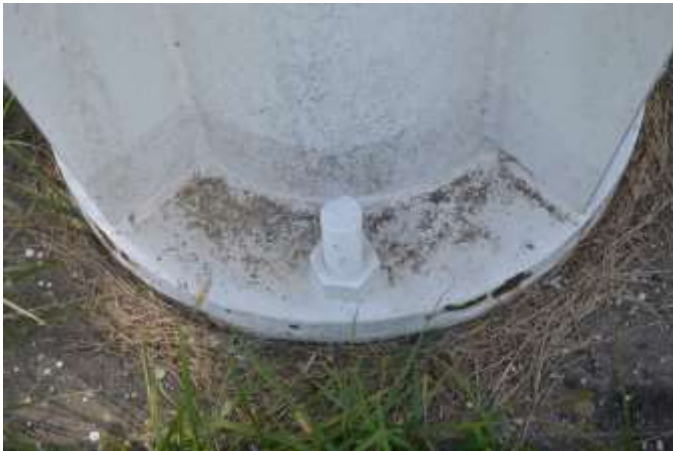
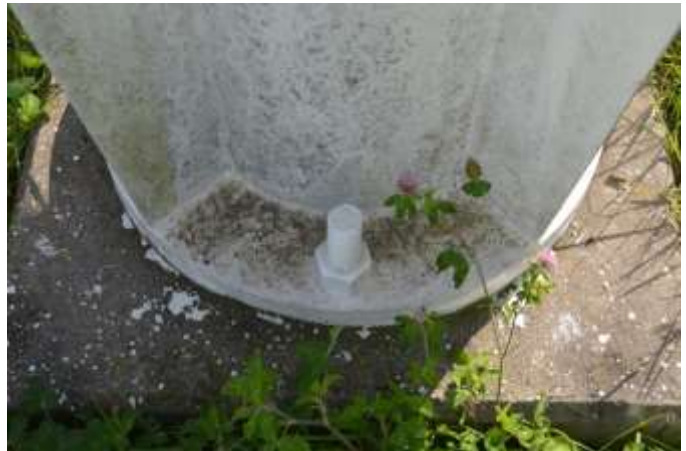
PHOTO SHOWS ANCHOR BOLTS

THE STRUCTURAL INTEGRITY OF THE ANCHOR BOLTS SHOULD BE MAINTAINED TO WITHSTAND 100 MPH WINDS BLOWING FROM ANY DIRECTION AS REQUIRED BY THE AWWA. WE RECOMMEND TO CLEAN AROUND THE ANCHOR BOLTS AND WELD AROUND THE CIRCUMFERENCE OF THE BOLT-TO-NUT AND NUT-TO-BASE CONNECTION TO REINFORCE.

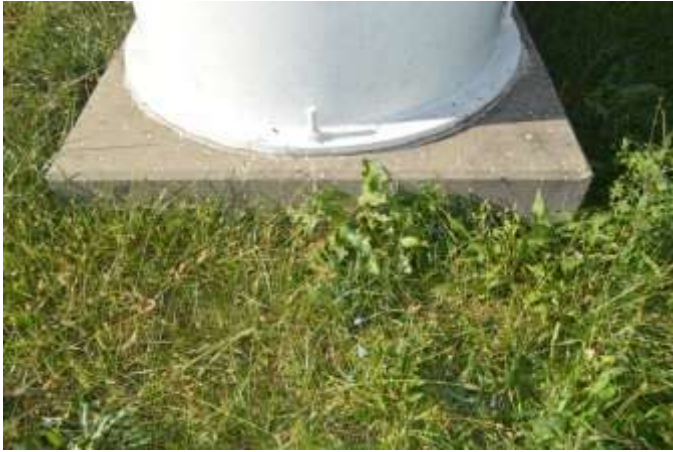
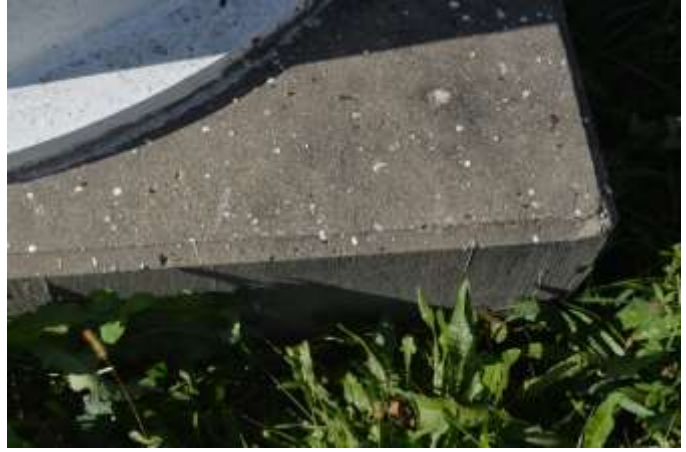
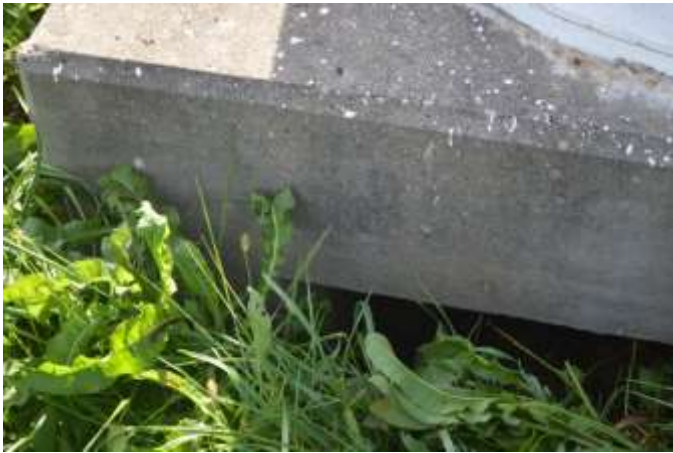
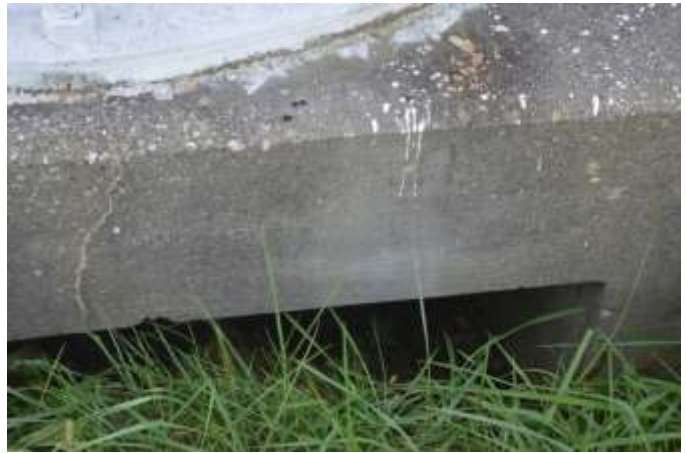
PHOTO SHOWS RISER FOUNDATION

THE RISER FOUNDATION HAS AREAS WHERE THE BOTTOM OF THE FOUNDATION IS EXPOSED AND IS ALLOWING THE INGRESS OF WATER. WE RECOMMEND TO BACK FILL THESE AREAS AS NEEDED.

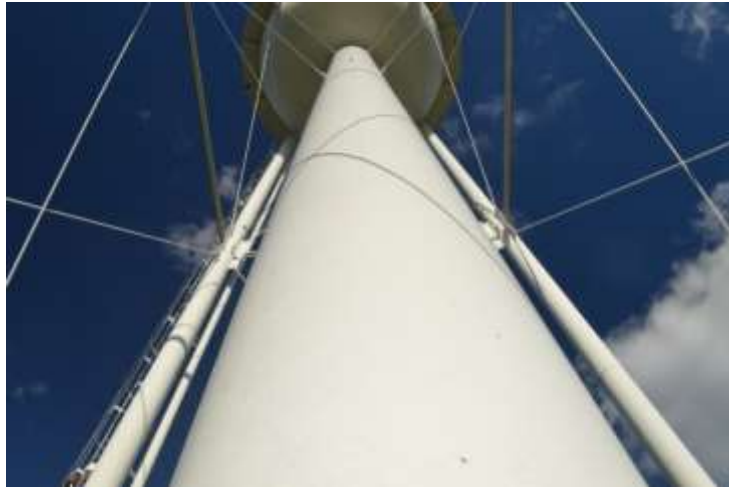
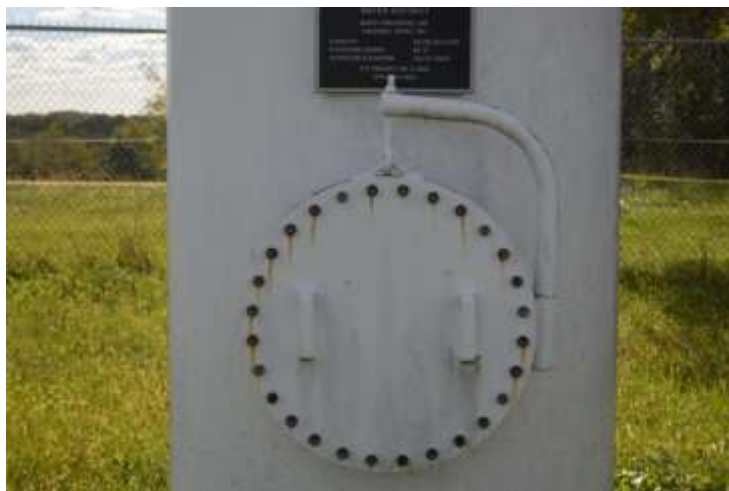
PHOTO SHOWS RISER/RISER MANWAY

THIS TANK DOES NOT HAVE THE REQUIRED SIGNAGE BY OSHA. WE RECOMMEND TO FURNISH AND INSTALL CONFINED SPACE, FALL PROTECTION EQUIPMENT REQUIRED, AND HOMELAND SECURITY SIGNS ON THE TANK IN ACCORDANCE WITH OSHA US CODE TITLE 42 300i-1, AND THE DEPARTMENT OF HOMELAND SECURITY CODES.

THE EXISTING MANWAY BOLTS ARE SHOWING SIGNS OF CORROSION, WHICH CAN LEAD TO BOLT FAILURE AND STAINING OF FINISHED SURFACES. WE RECOMMEND TO REPLACE EXISTING BOLTS WITH GALVANIZED BOLTS AS A PREVENTATIVE MEASURE TO ENSURE PROPER FASTENER OPERATION AND TO SAFE GUARD EXTERIOR COATING.

WE RECOMMEND TO FURNISH AND INSTALL A 2" DIAMETER FROST PROOF AND LOCKABLE DRAIN VALVE TO AS CLOSE TO THE BOTTOM OF THE RISER AS POSSIBLE. WE ARE MAKING THIS RECOMMENDATION AS MOST TANK OWNER'S DO NOT HAVE THE MEANS IN PLACE TO EFFECTIVELY DRAIN THEIR TANKS. MOST FACILITIES MUST FOLLOW WATER DRAINAGE REQUIREMENTS THAT COMPLY WITH THEIR FACILITIES STORM WATER PLAN WHICH REQUIRES THE WATER TO BE DIRECTED INTO A STORM DRAIN. THE DRAIN VALVE ALLOWS THE HOOKUP OF A DRAIN LINE SO THE WATER MAY BE DIRECTIONALIZED.

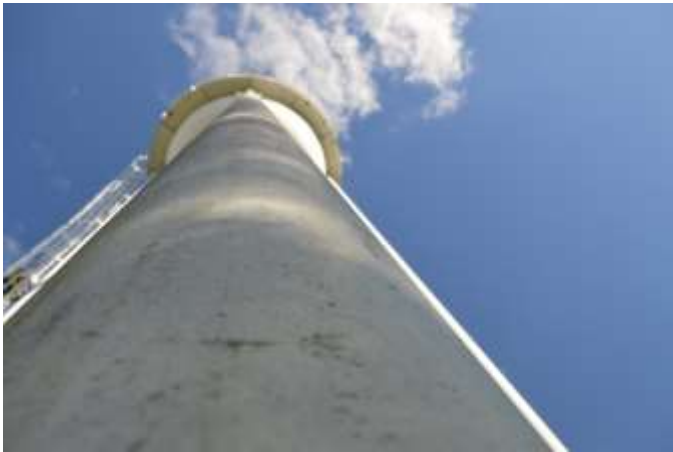
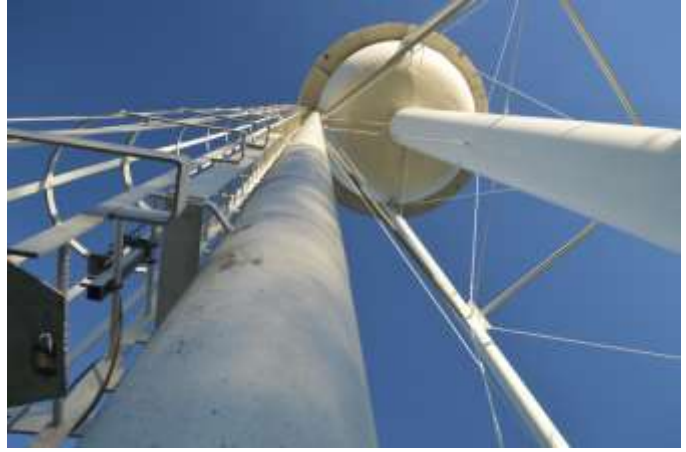
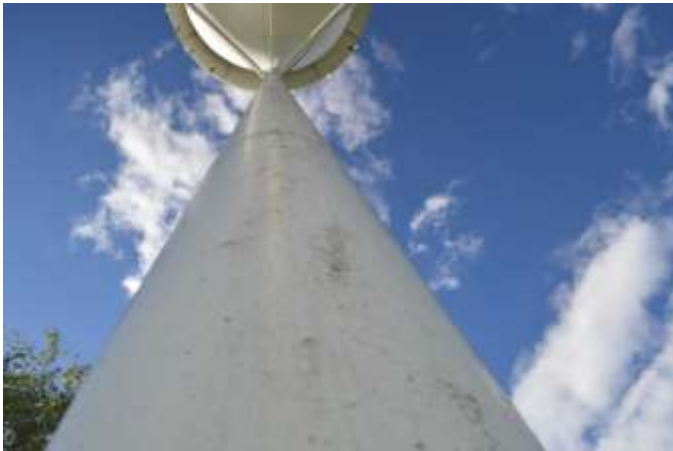
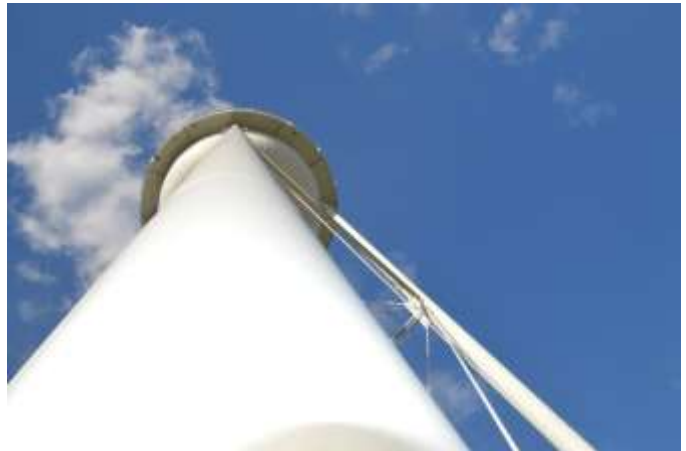
PHOTO SHOWS EXTERIOR OF TANK

AT MINIMUM, WE RECOMMEND TO POWER WASH ALL EXTERIOR SURFACES, PROPERLY PREPARE SURFACE, PRIME, AND APPLY ONE COMPLETE COAT OF ENAMEL. FURTHERMORE, FOR SUPERIOR COLOR, GLOSS RETENTION, AND LONGEVITY OF COATING PERFORMANCE, WE RECOMMEND A FULL COAT OF PRIMER FOLLOWED BY A FINISH COAT OF ACRYLIC OR URETHANE.

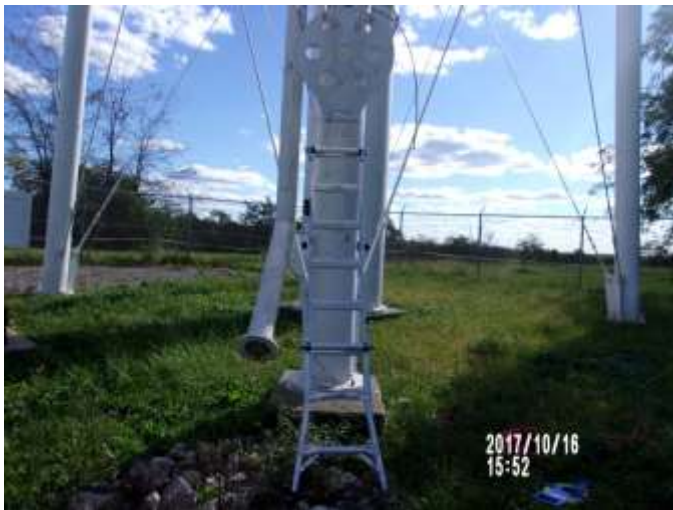
PHOTO SHOWS OVERFLOW

WE RECOMMEND TO FURNISH AND INSTALL A FLAPPER VALVE ON EXISTING OVERFLOW IN ACCORDANCE WITH AWWA D103-09 7.3 AND NFPA 22 2013 14.6 CODE REQUIREMENTS.

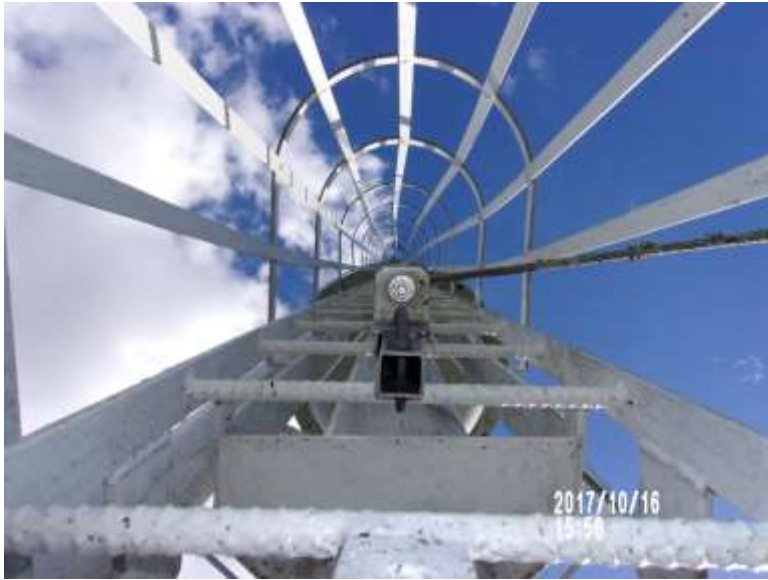
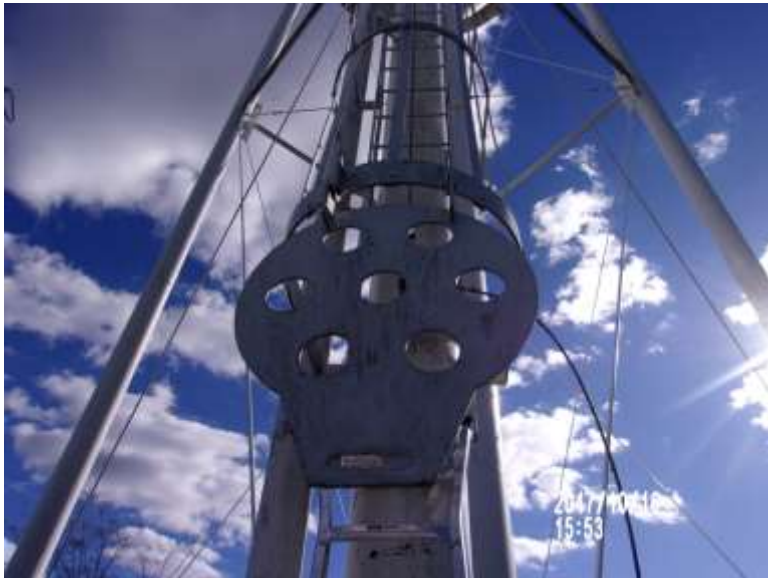
PHOTO SHOWS UPWARD VIEW OF LADDER IN GOOD CONDITION

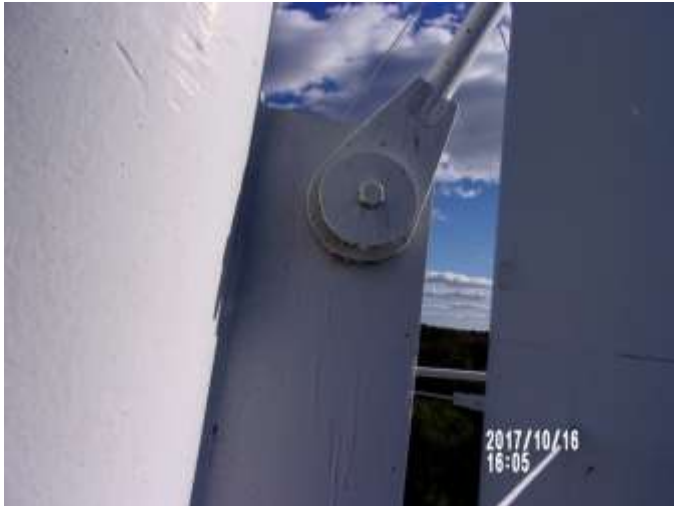
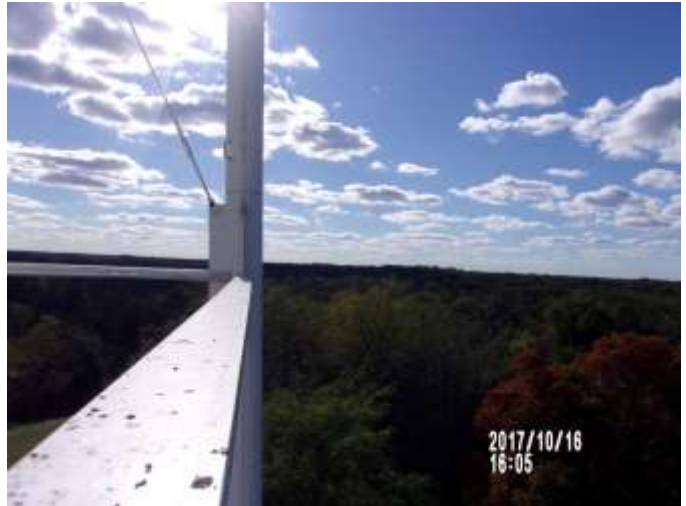
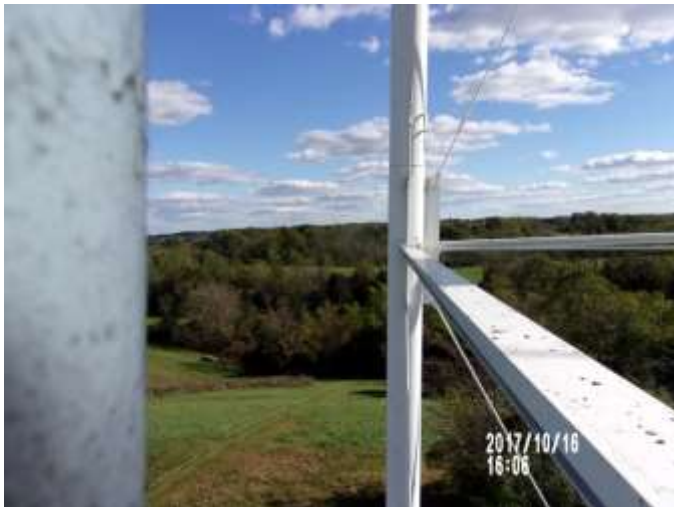
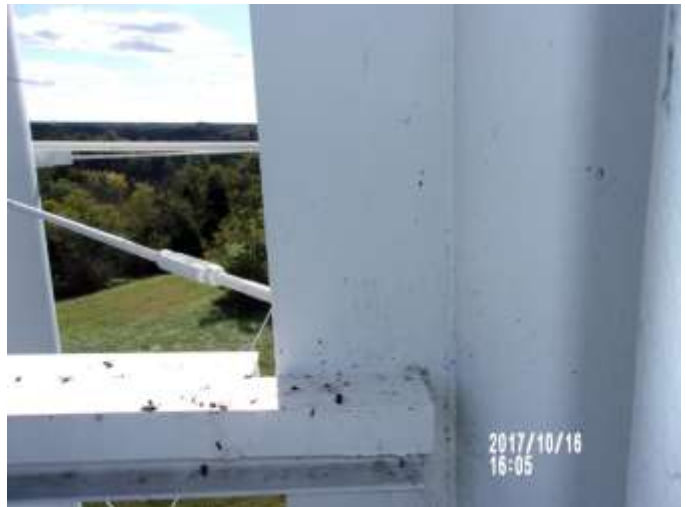
PHOTO SHOWS STRUTS IN GOOD CONDITION

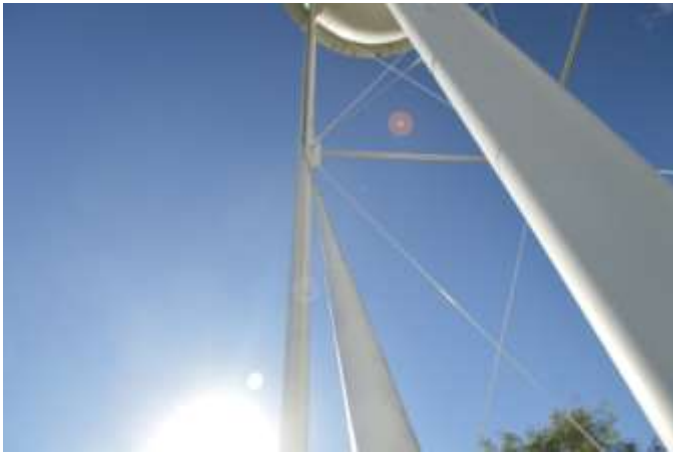
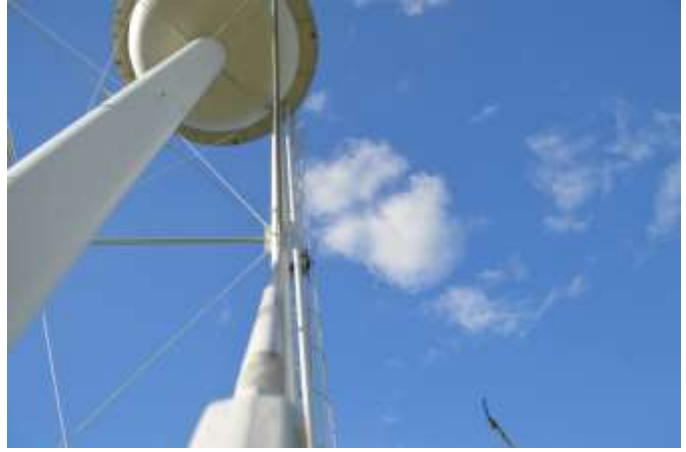
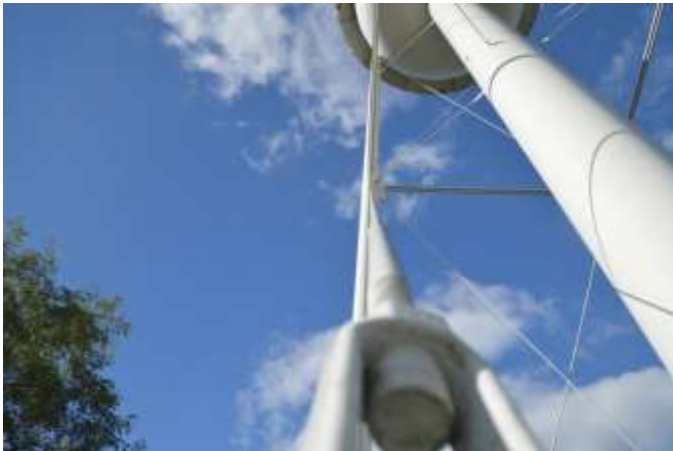
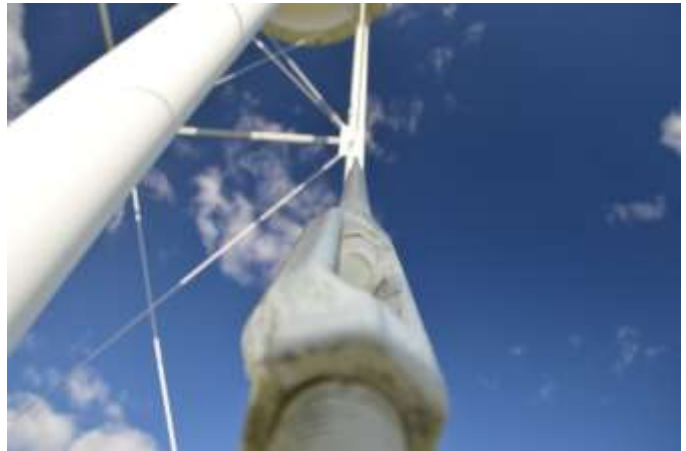
PHOTO SHOWS WINDAGE RODS

THE WINDAGE RODS ARE DESIGNED TO RESIST AND STABILIZE THE TANK STRUCTURE AGAINST WIND AND SEISMIC LOADS COMBINED WITH DEAD AND LIVE LOADS. THE RODS SHOULD WITHSTAND 100 MPH WINDS BLOWING FROM ANY DIRECTION. IF THE BRACING REMAINS LOOSE, A SUDDEN COLLAPSE COULD OCCUR. WE RECOMMEND TO ADJUST THE WINDAGE RODS AND RISER STAY RODS TO WITHSTAND 100 MPH WINDS BLOWING FROM ANY DIRECTION, AS REQUIRED BY AWWA D100-11 3.1.4, REQUIREMENTS. THIS SHOULD BE DONE ON AN EMERGENCY BASIS.

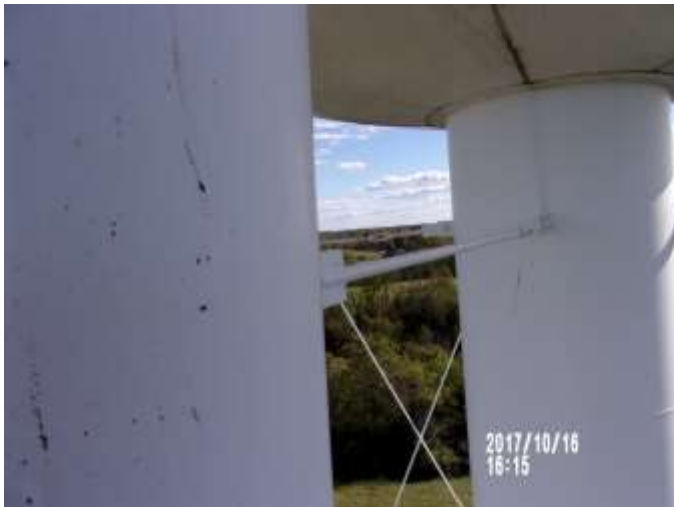
PHOTO SHOWS RISER TO BOWL CONNECTION/STAY RODS

WE RECOMMEND TO ADJUST THE RISER RODS TO WITHSTAND 100 MPH WINDS BLOWING FROM ANY DIRECTION, AS REQUIRED BY AWWA.

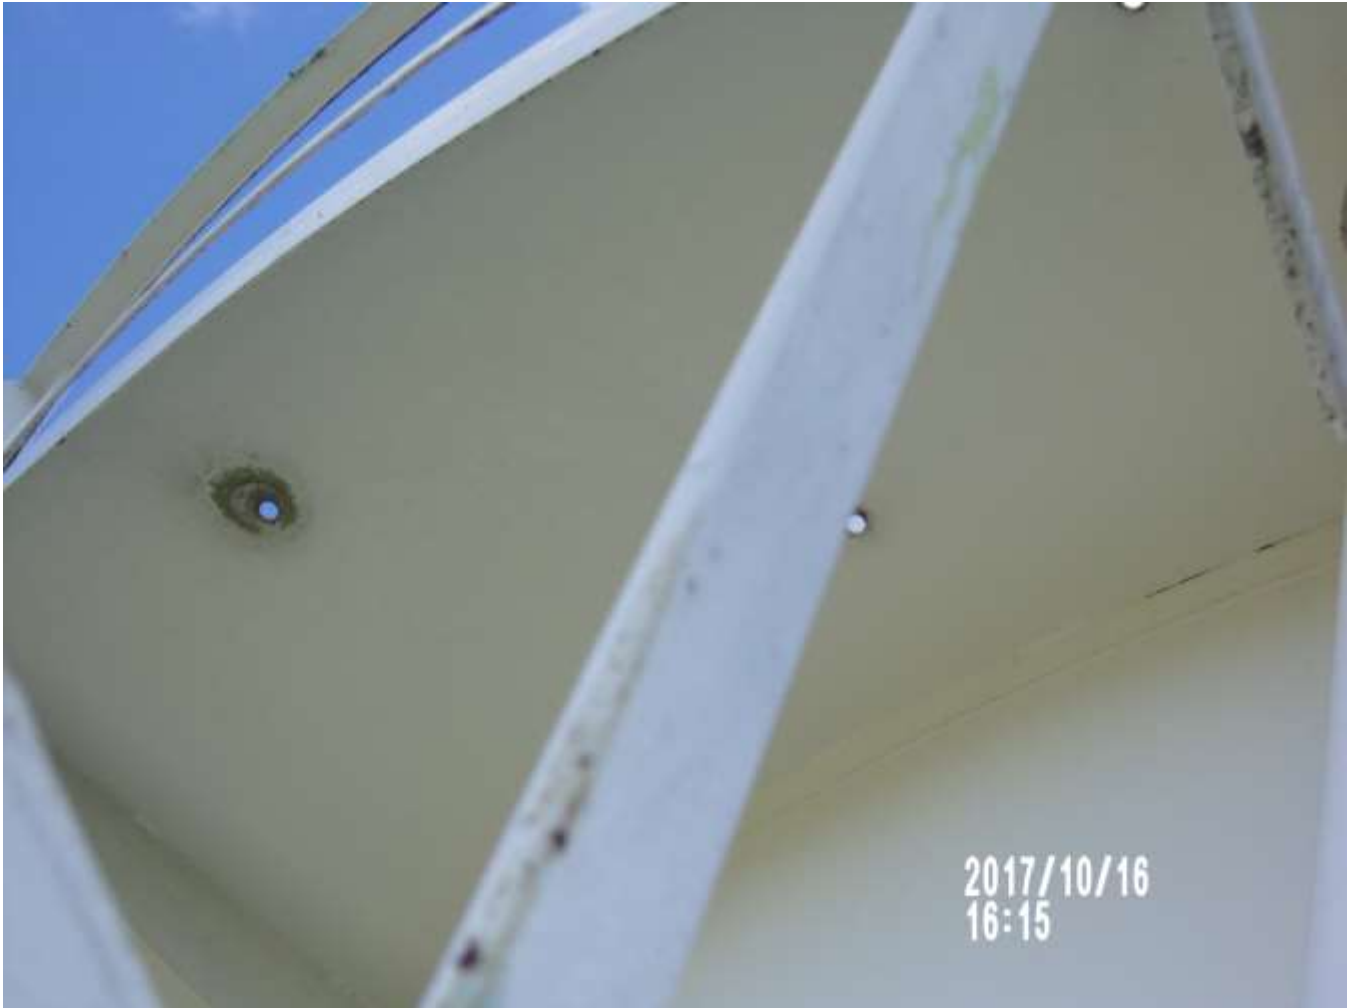
PHOTO SHOWS UNDERSIDE OF CATWALK IN GOOD CONDITION

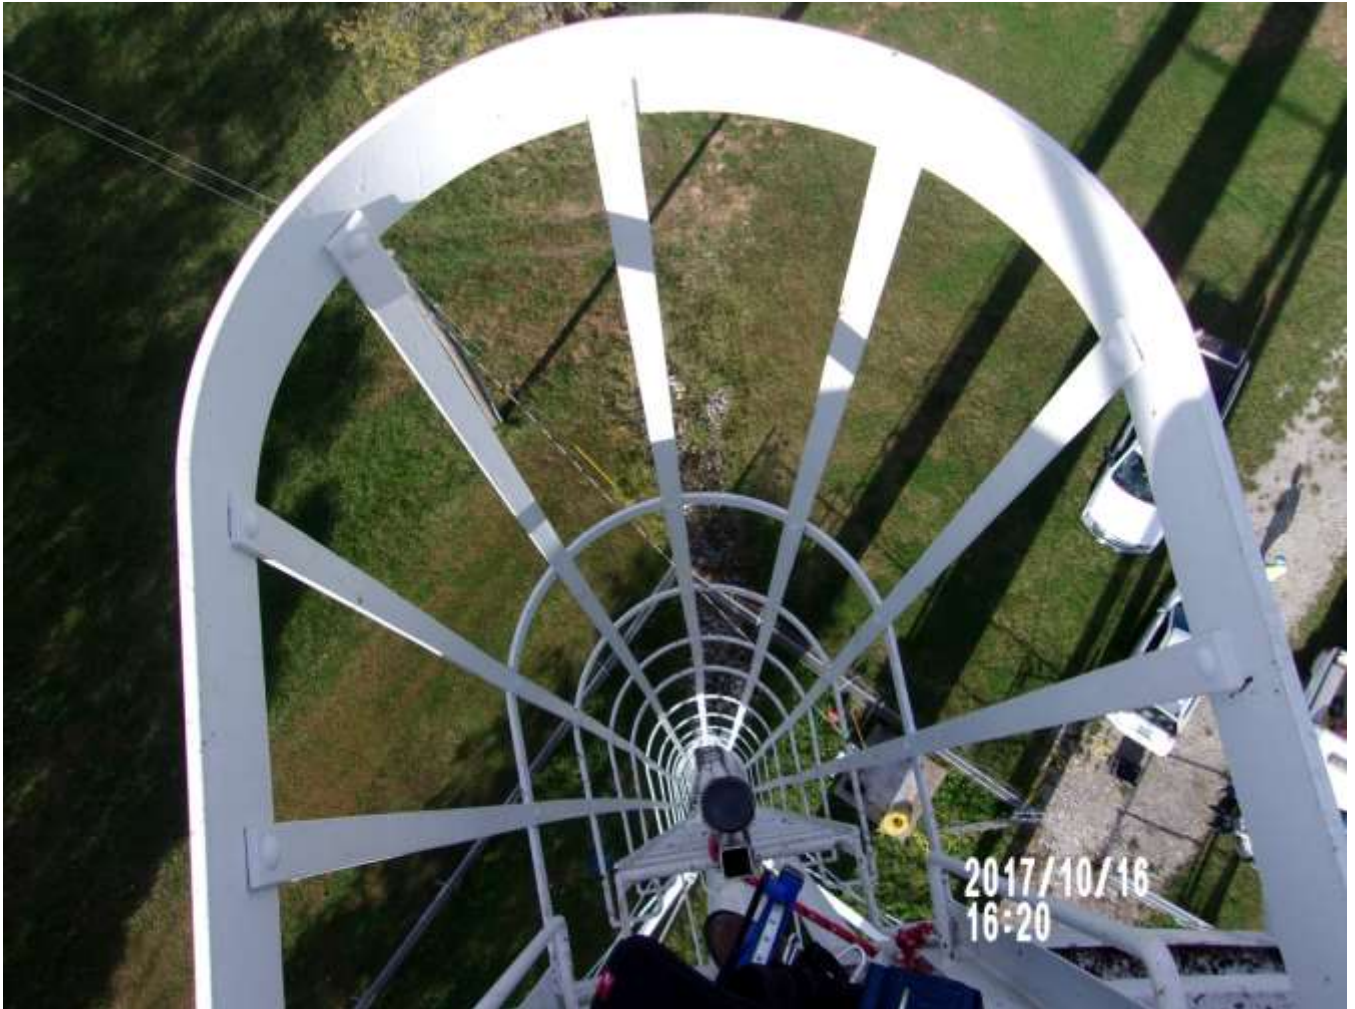
PHOTO SHOWS DOWNWARD VIEW OF LADDER

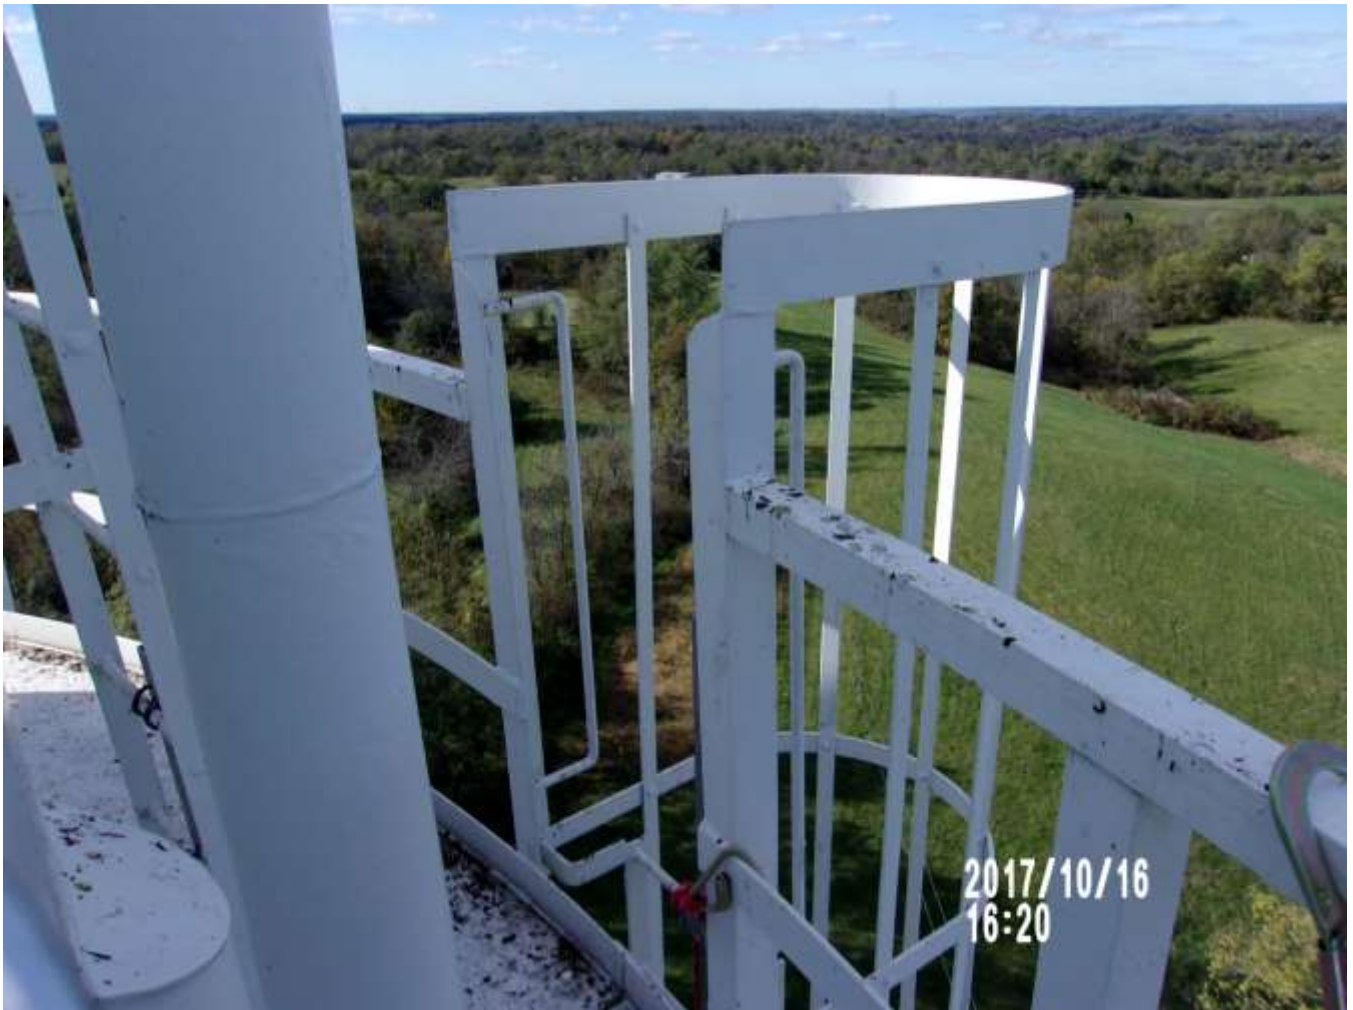
PHOTO SHOWS CATWALK OPENING OF LADDER

THE HANDRAIL OPENING IS NOT PROTECTED BY A SWING GATE. WE RECOMMEND TO FURNISH AND INSTALL A SWING GATE IN THE HANDRAIL OPENING IN ACCORDANCE WITH OSHA, AWWA D100-11 3.1.7, AND NFPA 22 2013 8.7.9 REQUIREMENTS.

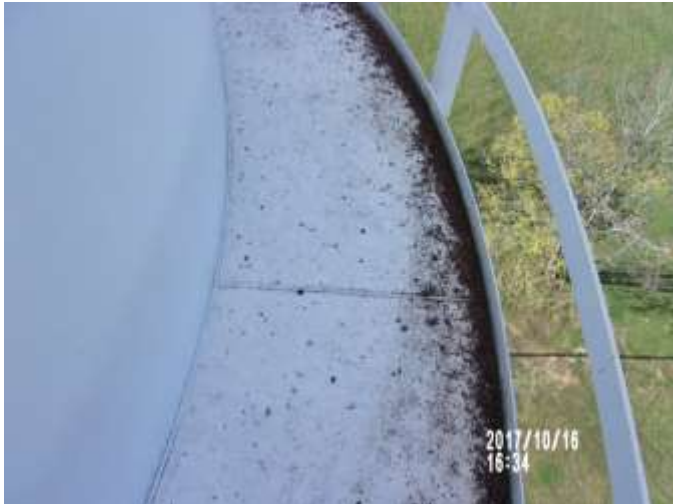
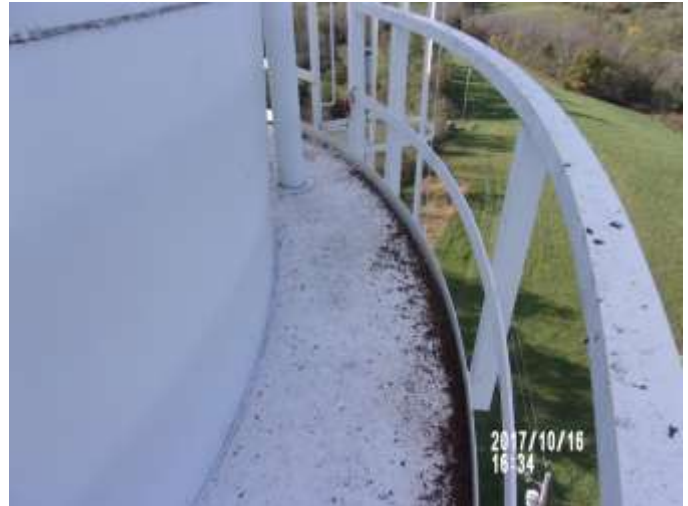
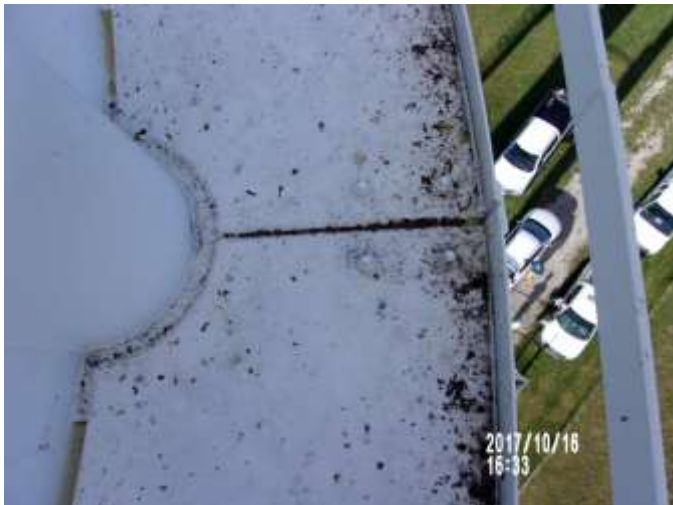
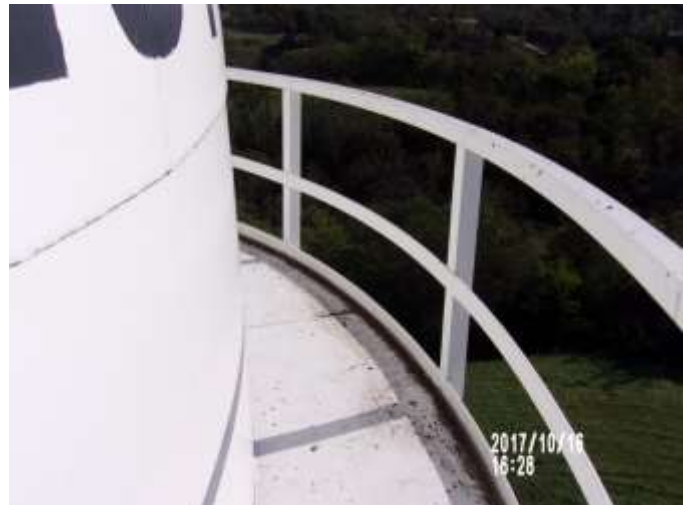
PHOTO SHOWS CATWALK HANDRAILS

THERE IS EVIDENCE THAT WATER IS PONDING ON THE CATWALK. WE RECOMMEND DRILLING ADDITIONAL WEEP HOLES IN THE CATWALK AS NECESSARY TO PREVENT THE PONDING OF WATER.

WE RECOMMEND TO WELD SPLICE PLATES IN BETWEEN CATWALK SECTIONS TO IMPROVE STRUCTURAL INTEGRITY OF CATWALK.

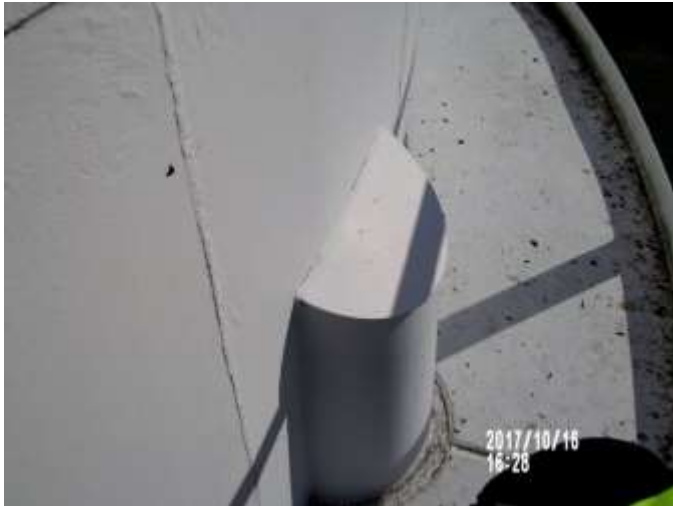
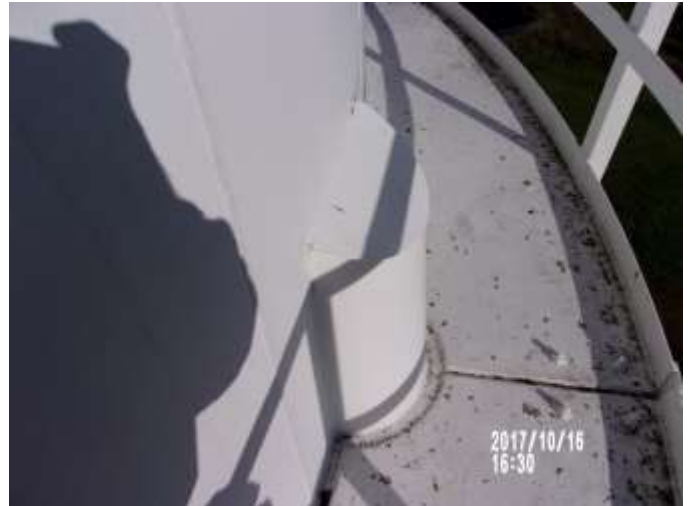
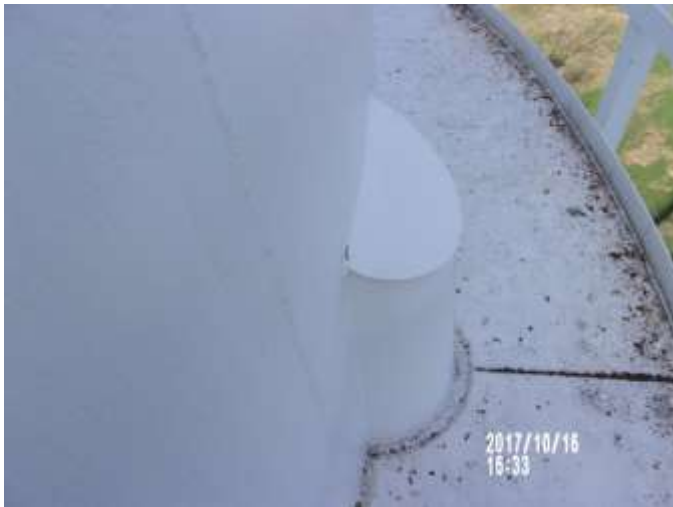
PHOTO SHOWS CATWALK AND POSTHEAD CONNECTIONS

**TO ENSURE THE STRUCTURAL INTEGRITY OF THE TANK, WE RECOMMEND TO RE-WELD
POST HEAD CONNECTIONS ABOVE THE CATWALK.**

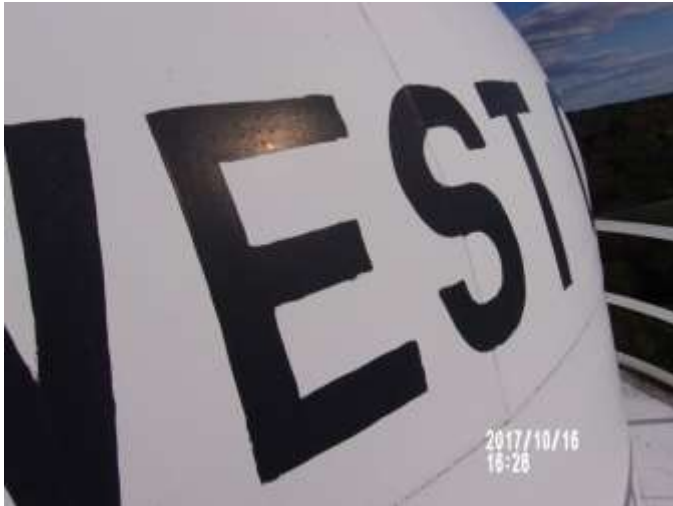
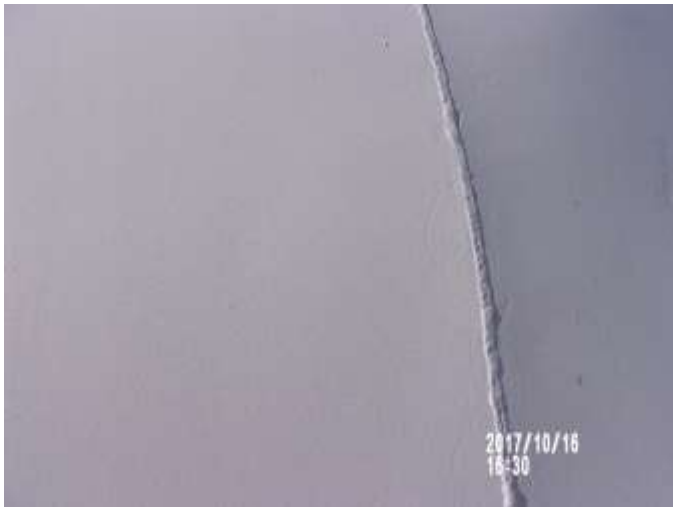
PHOTO SHOWS EXTERIOR OF TANK

AT MINIMUM, WE RECOMMEND TO POWER WASH ALL EXTERIOR SURFACES, PROPERLY PREPARE SURFACE, PRIME, AND APPLY ONE COMPLETE COAT OF ENAMEL. FURTHERMORE, FOR SUPERIOR COLOR, GLOSS RETENTION, AND LONGEVITY OF COATING PERFORMANCE, WE RECOMMEND A FULL COAT OF PRIMER FOLLOWED BY A FINISH COAT OF ACRYLIC OR URETHANE.

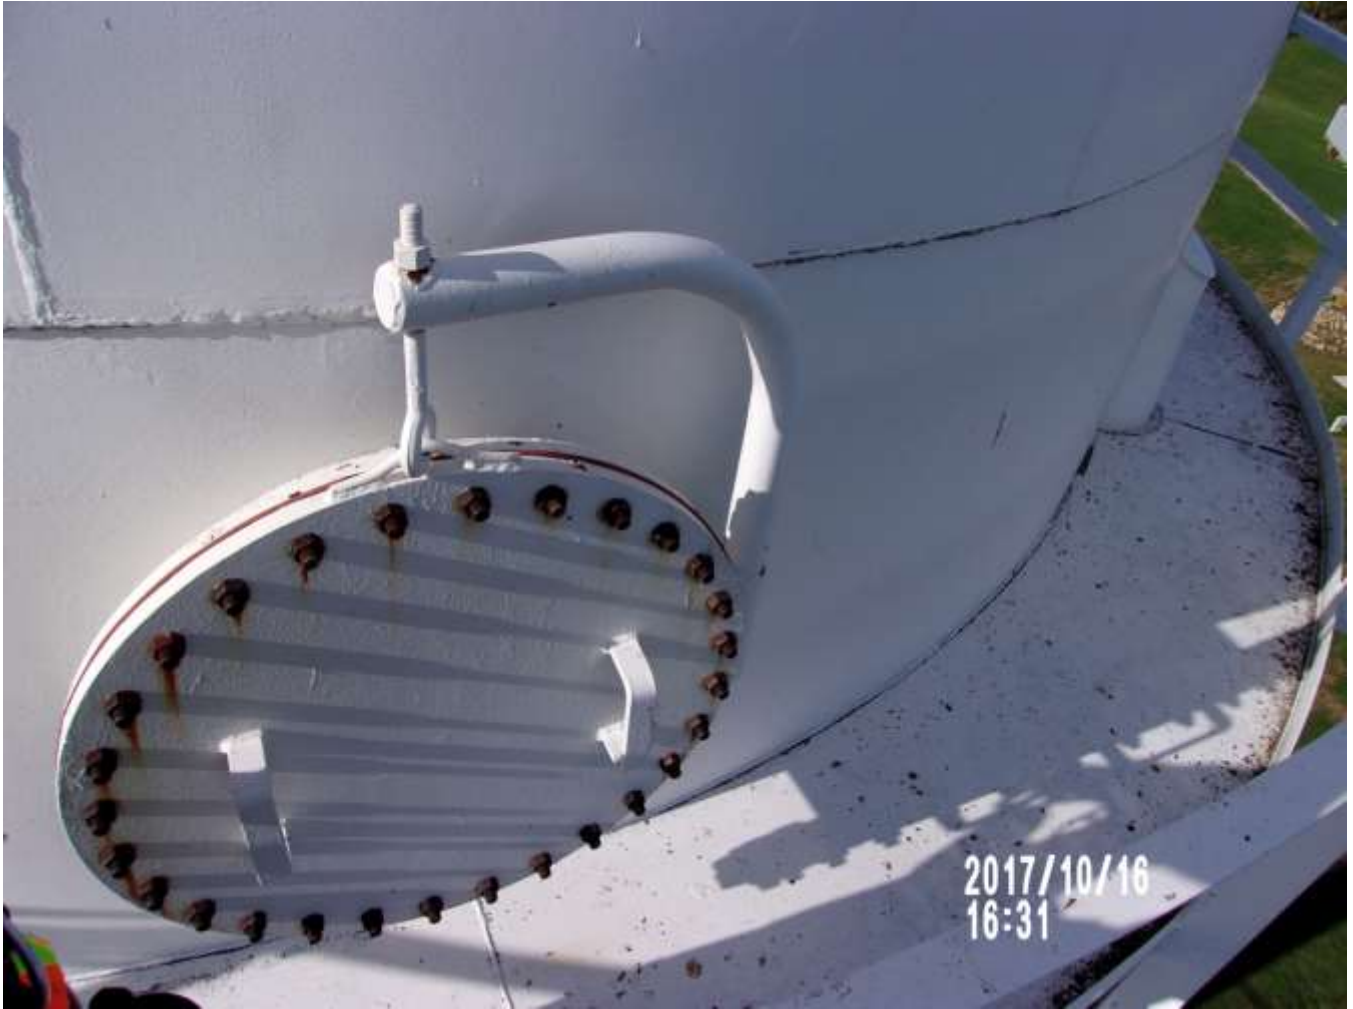
PHOTO SHOWS SHELL MANWAY

THIS TANK DOES NOT HAVE THE REQUIRED SIGNAGE BY OSHA. WE RECOMMEND TO FURNISH AND INSTALL CONFINED SPACE, FALL PROTECTION EQUIPMENT REQUIRED, AND HOMELAND SECURITY SIGNS ON THE TANK IN ACCORDANCE WITH OSHA US CODE TITLE 42 300i-1, AND THE DEPARTMENT OF HOMELAND SECURITY CODES.

THE EXISTING MANWAY BOLTS ARE SHOWING SIGNS OF CORROSION, WHICH CAN LEAD TO BOLT FAILURE AND STAINING OF FINISHED SURFACES. WE RECOMMEND TO REPLACE EXISTING BOLTS WITH GALVANIZED BOLTS AS A PREVENTATIVE MEASURE TO ENSURE PROPER FASTENER OPERATION AND TO SAFE GUARD EXTERIOR COATING.

WE RECOMMEND TO FURNISH AND INSTALL A SECONDARY 24" MANWAY COMPLETE WITH A DAVIT ARM AND GALVANIZED BOLTS AT THE CATWALK LEVEL IN ACCORDANCE WITH OSHA, AWWA D100-11, AND NFPA 22 2013 14.7.2 REQUIREMENTS.

WE RECOMMEND TO FURNISH AND INSTALL AN INTERIOR BOWL LADDER IN CONJUNCTION WITH THE INSTALLATION OF THE SECONDARY CATWALK MANWAY WITH A SAFETY CLIMB DEVICE IN ACCORDANCE WITH OSHA, AWWA D100-11 7.4.2.4 AND NFPA 22 2013 5.7.4 REQUIREMENTS.
