ELECTRONIC INVESTIGATION INTO)
EXCESSIVE WATER LOSS BY KENTUCKY'S) Case No. 2019-00041
JURISDICTIONAL WATER UTILITIES)

**West Carroll Water District
Case No. 2019-00041
Commission Staff's Second Request for Information issued May 3, 2019**

100,000 GALLON ELEVATED WATER TANK

50,000 GALLON ELEVATED WATER TANK

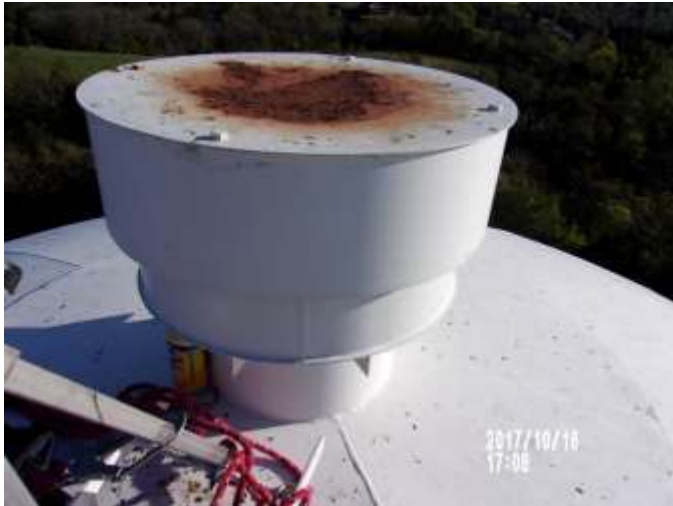
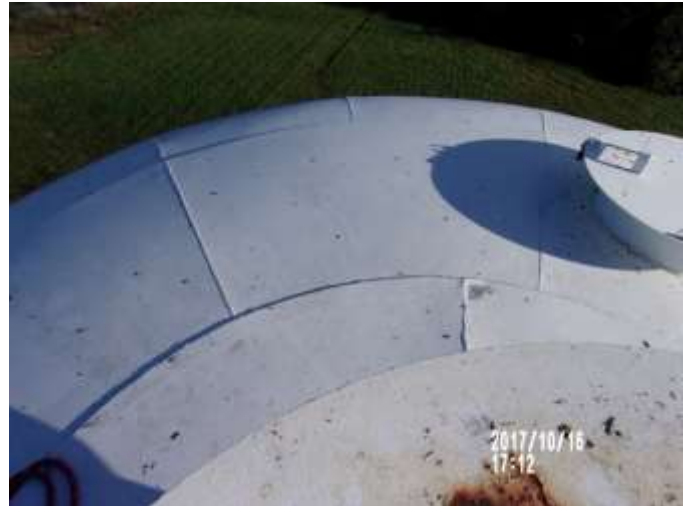
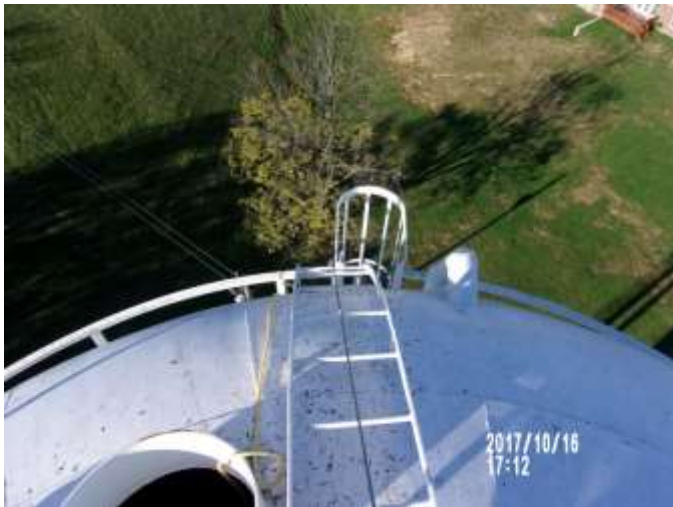
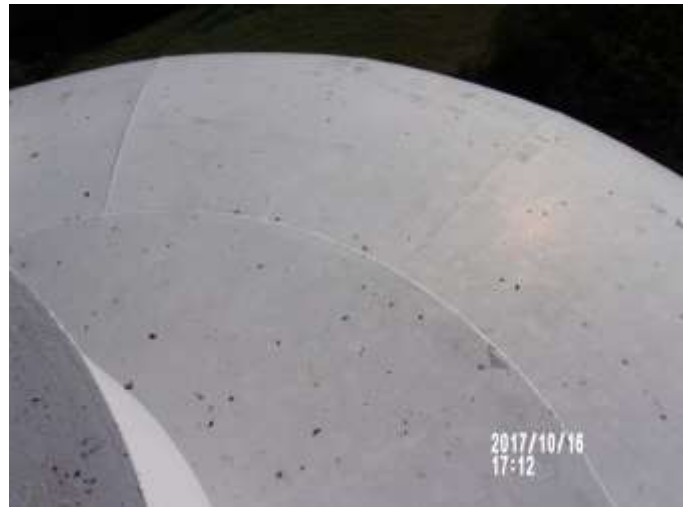
PHOTO SHOWS EXTERIOR OVERVIEW OF ROOF

TANK IS NOT EQUIPPED WITH AN OSHA APPROVED HANDRAIL SYSTEM. WE RECOMMEND TO FURNISH AND INSTALL 42" HANDRAILS AROUND THE CIRCUMFERENCE OF THE TANK ROOF IN ACCORDANCE WITH OSHA, AWWA D100-11 3.1.7, AND NFPA 22 2013 8.7.9 REQUIREMENTS.

THERE IS EVIDENCE OF BIRD ROOSTING AND THERE FECAL MATTER WILL DAMAGE EXTERIOR COATINGS AND CAN CONTAMINATE THE CONTENTS OF A WATER TANK. WE RECOMMEND TO FURNISH AND APPLY BIRD X TO THE ROOF TO REPEL BIRDS FROM THE TANK.

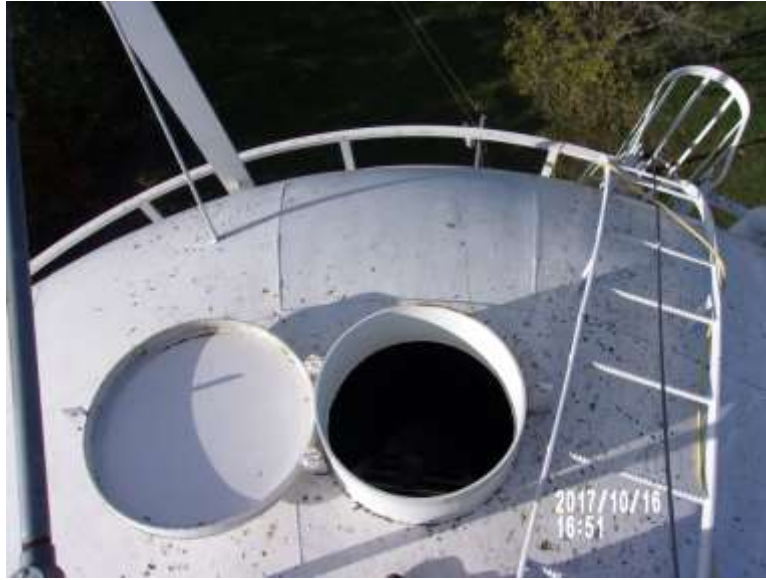
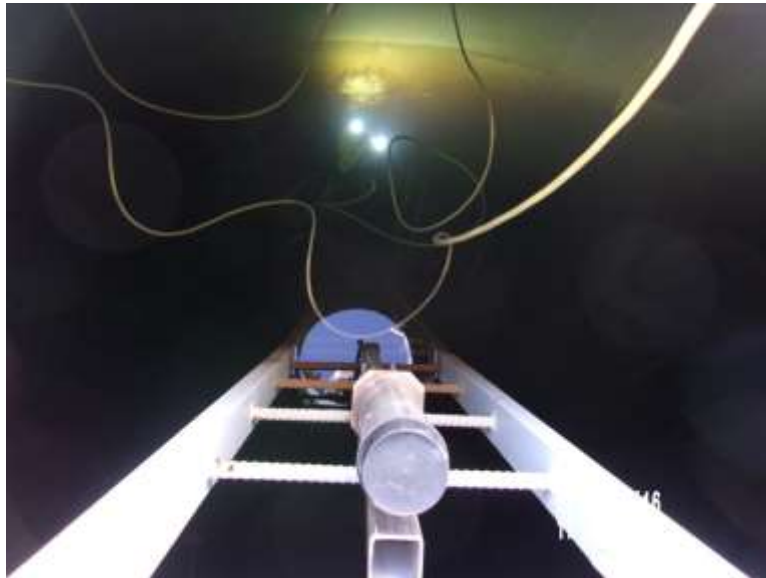
PHOTO SHOWS OPEN VIEW OF ROOF HATCH

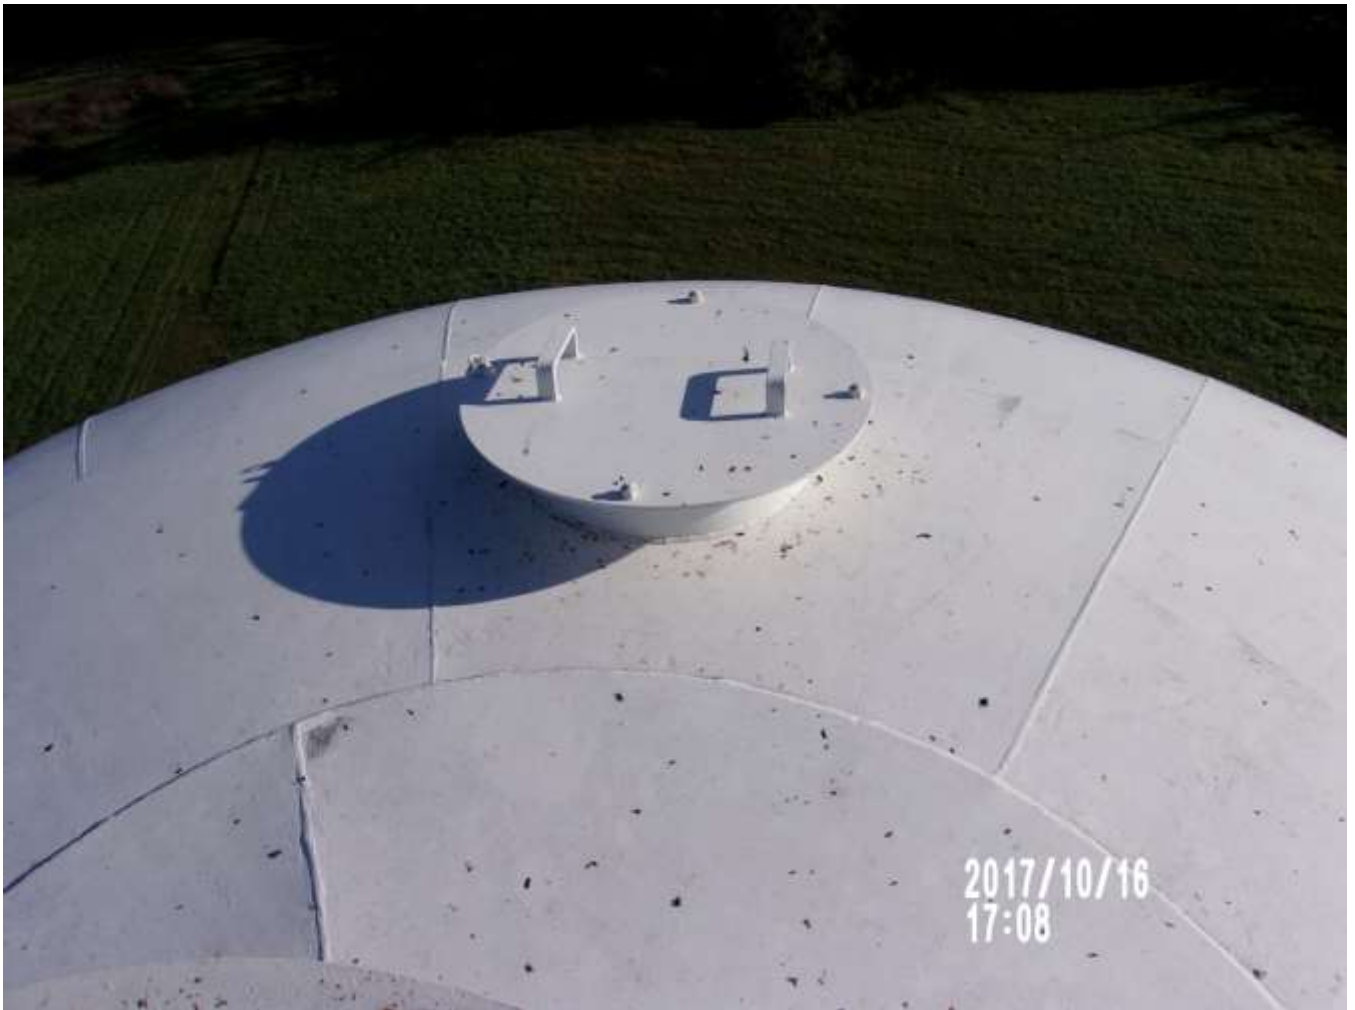
PHOTO SHOWS SECONDARY ROOF HATCH CLOSED

WE RECOMMEND TO REPLACE THE EXISTING SECONDARY ROOF HATCH WITH A 24" X 24" SQUARE ROOF HATCH IN ACCORDANCE WITH AWWA D100-11 5.4.3.1, AND NFPA 22 2013 5.7.3.1 REQUIREMENTS.

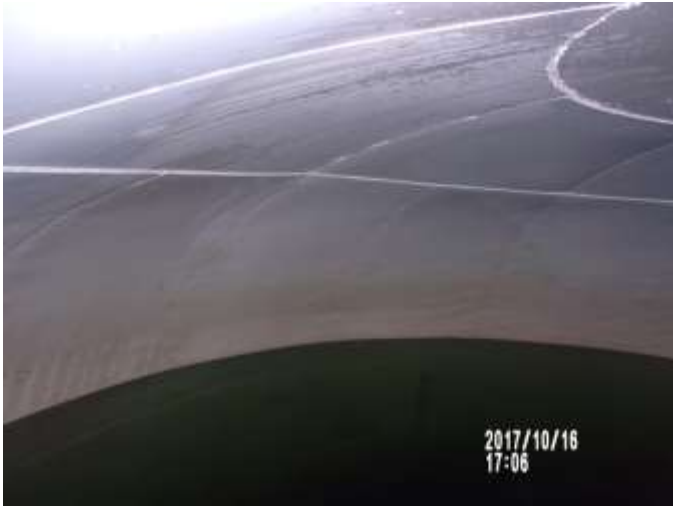
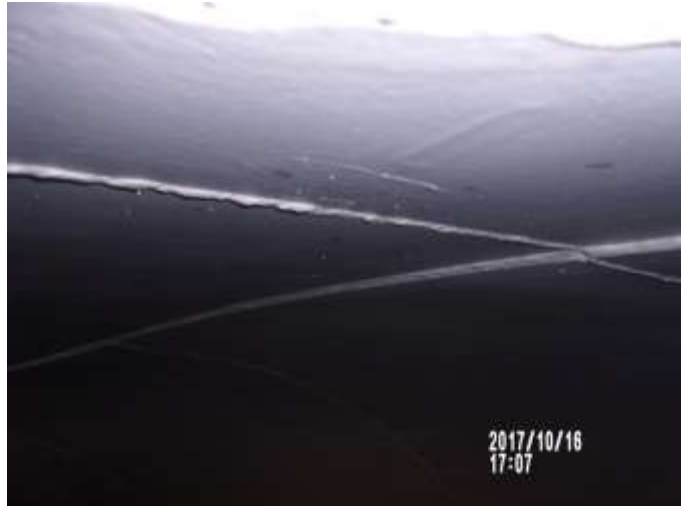
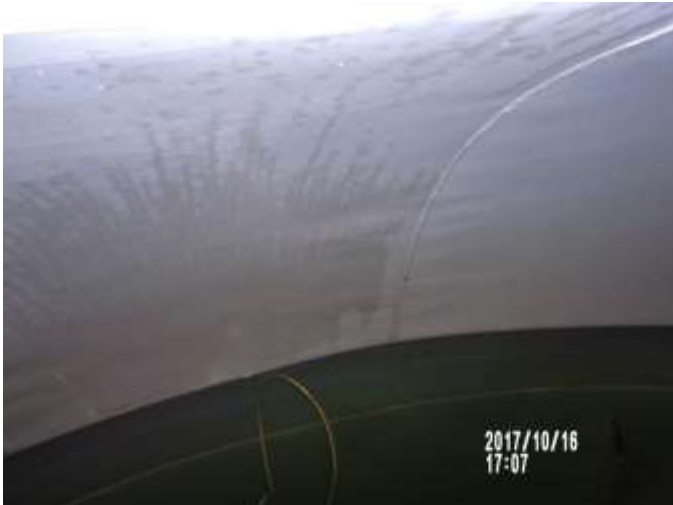
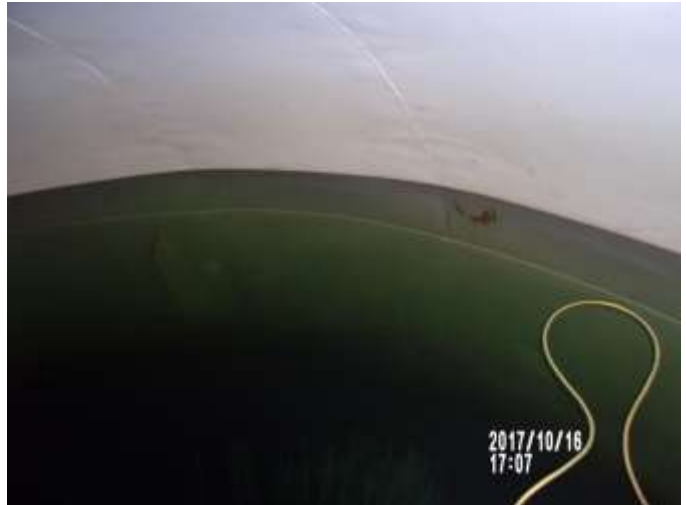
PHOTO SHOWS INTERIOR OVERVIEW OF ROOF

WE RECOMMEND TO CAULK INTERIOR LAPPED ROOF JOINTS AFTER PAINTING TO PREVENT PREMATURE FAILURE OF COATING.

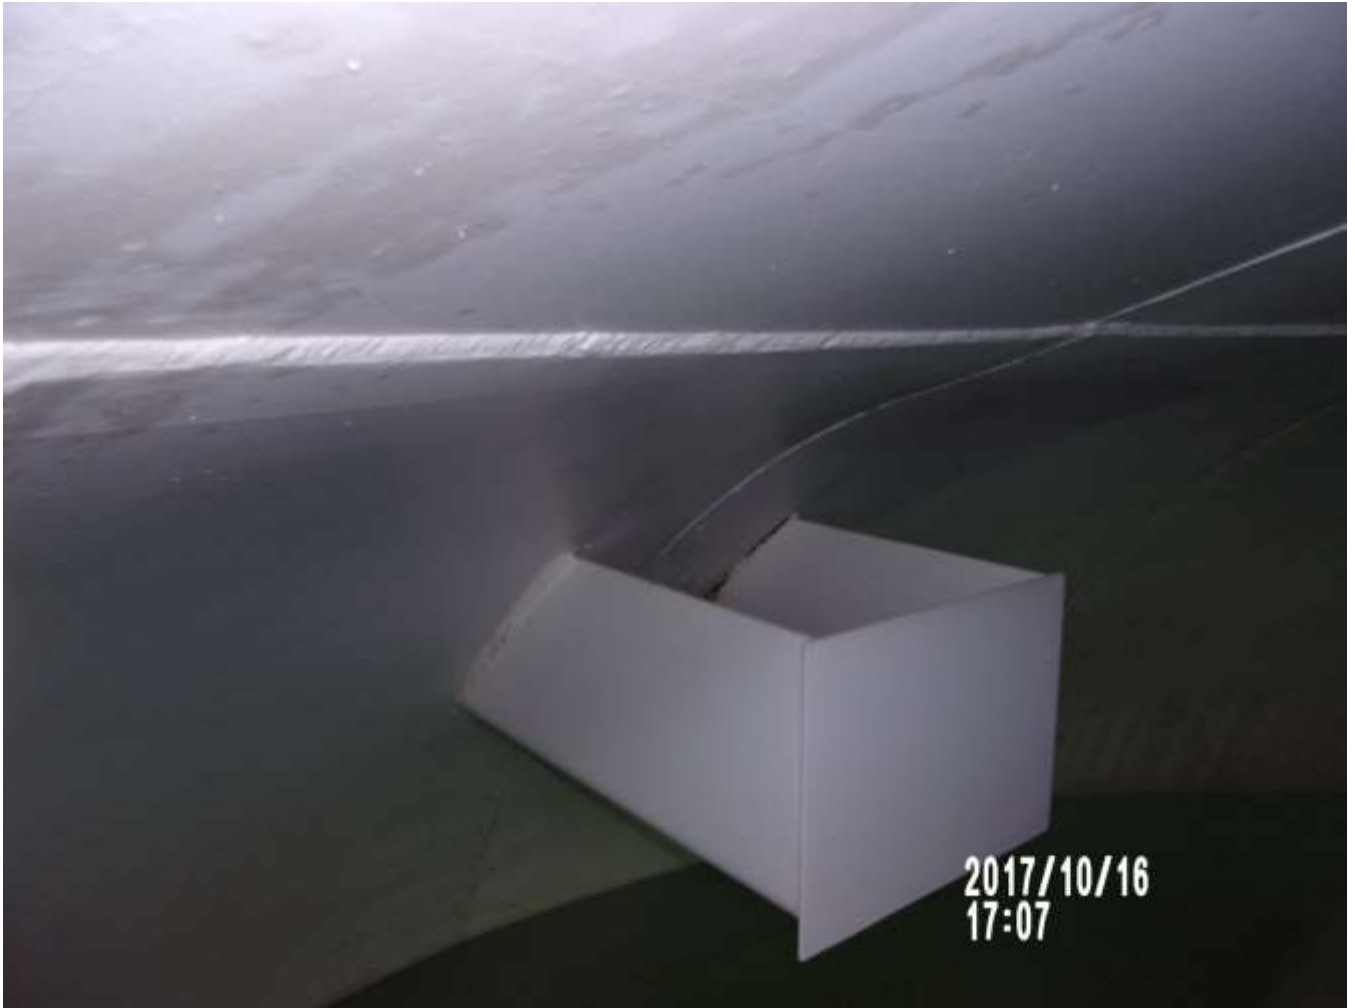
PHOTO SHOWS INTERIOR VIEW OF WEIR BOX IN GOOD CONDITION

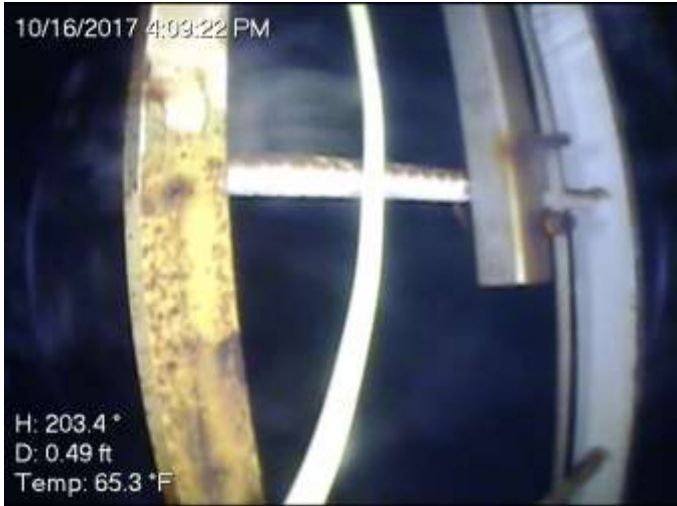
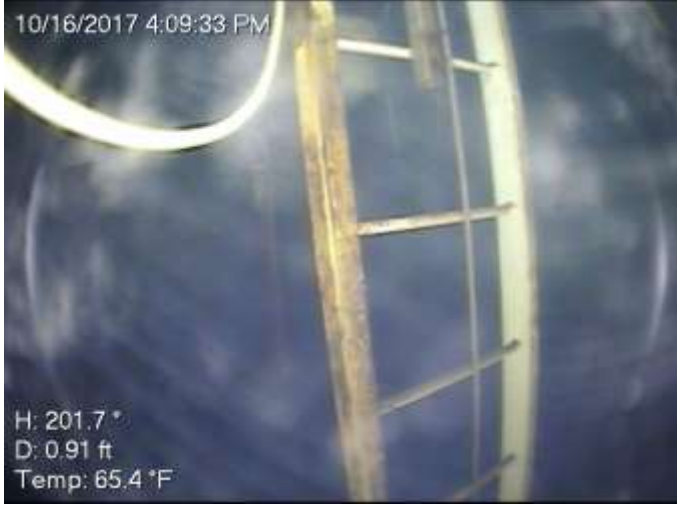
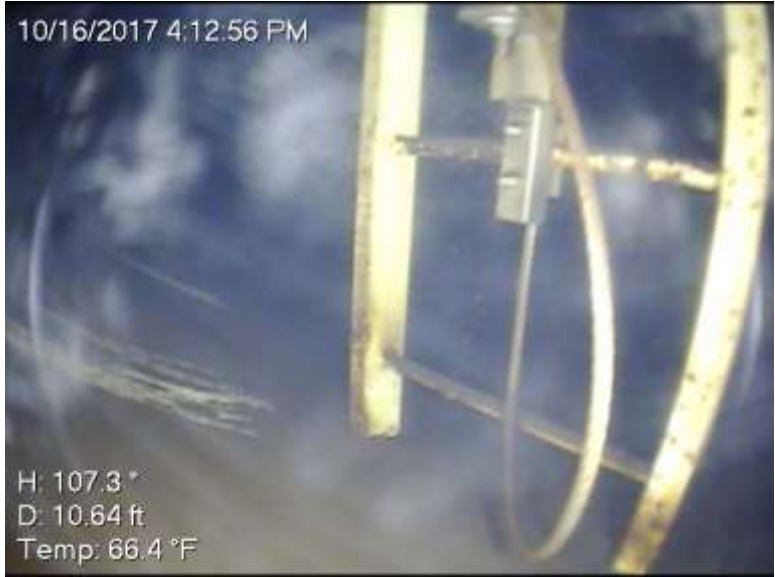
PHOTO SHOWS INTERIOR LADDER IN GOOD CONDITION

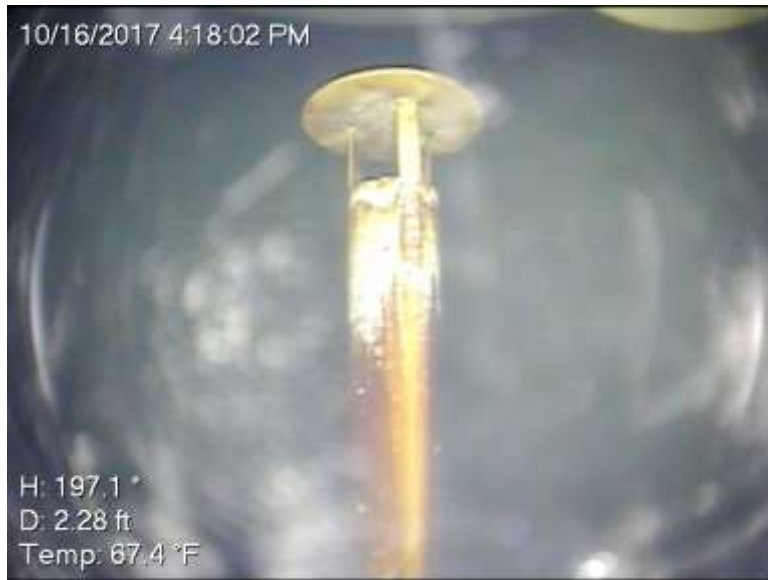
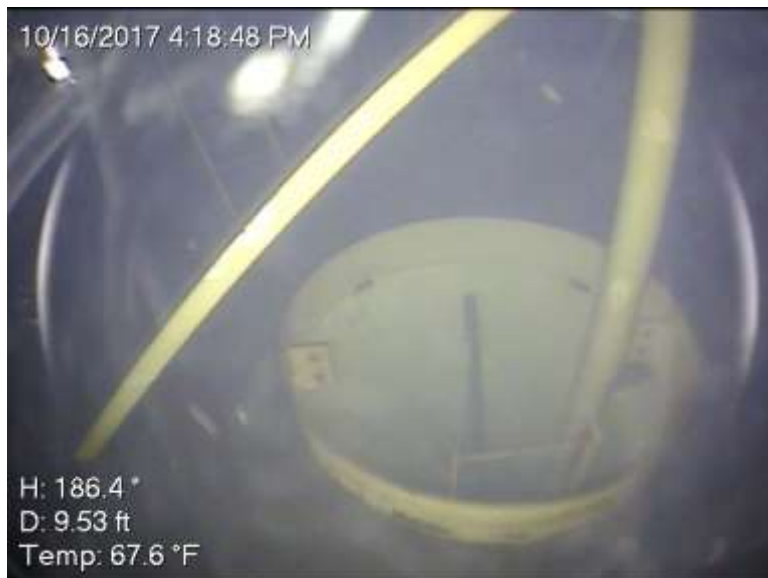
PHOTO SHOWS RISER LADDER/RISER OPENING

THERE ISN'T A SAFETY GRATE PROTECTING THE RISER OPENING. WE RECOMMEND TO FURNISH AND INSTALL SAFETY GRATE AT RISER OPENING IN ACCORDANCE WITH OSHA REQUIREMENTS.

WE RECOMMEND TO FURNISH AND INSTALL AN OSHA APPROVED HANDRAIL SYSTEM AROUND RISER OPENING.

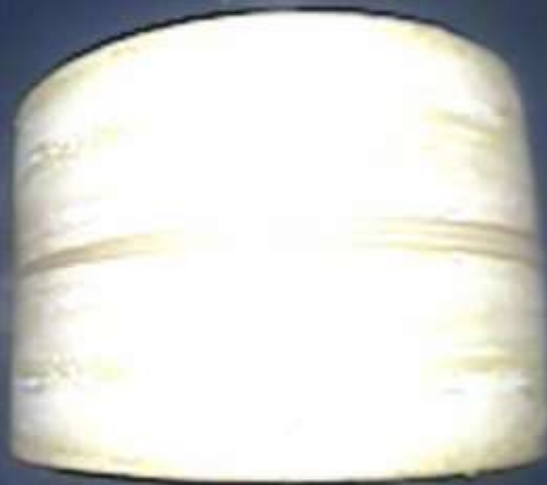
PHOTO SHOWS LIQUID LEVEL FLOAT

LIQUID LEVEL INDICATOR IS IN NEED OF PREVENTIVE MAINTENANCE. WE RECOMMEND TO CLEAN AND LUBRICATE ALL MOVING PARTS OF THE EXISTING LIQUID LEVEL INDICATOR IN ACCORDANCE WITH NFPA 22 2013 14.1.8 REQUIREMENTS.

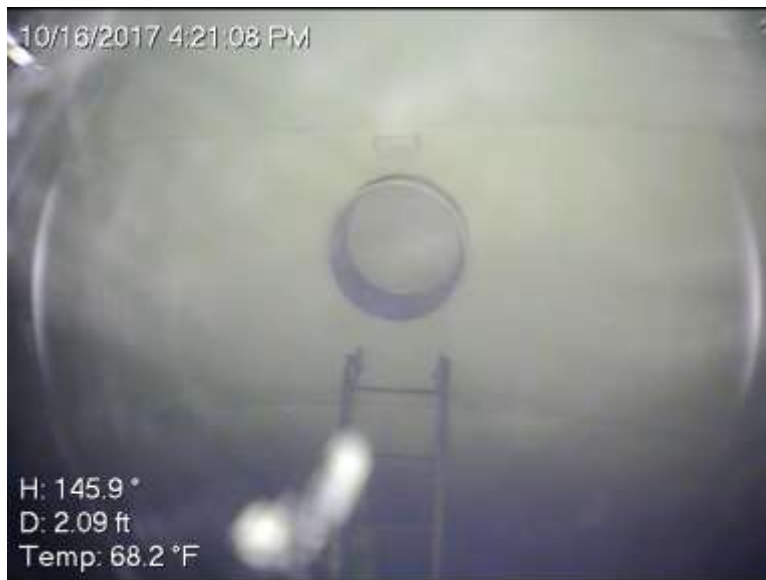
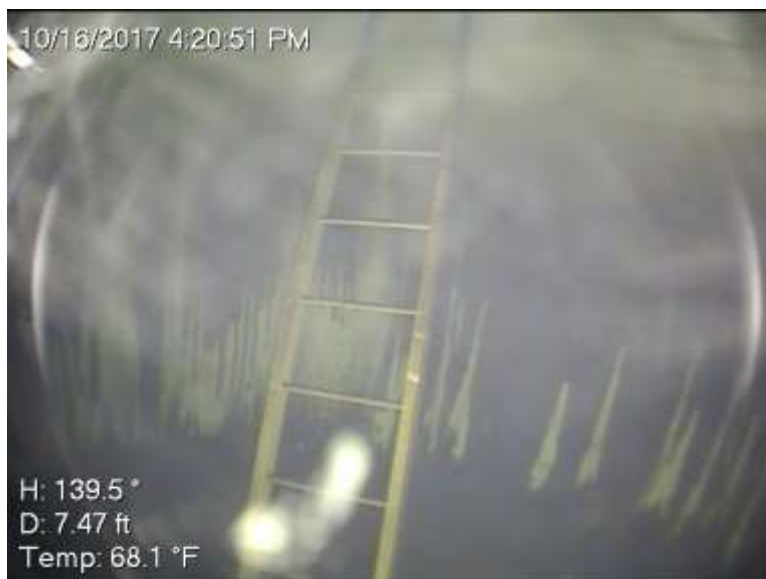
PHOTO SHOWS MANWAY

THE BOWL LADDER IS NOT EQUIPPED WITH A SAFETY CLIMB DEVICE. THIS IS AN OSHA VIOLATION. WE RECOMMEND TO FURNISH AND INSTALL A SAFETY CLIMB DEVICE ON BOWL LADDER IN ACCORDANCE WITH OSHA REQUIREMENTS.

CATHODIC PROTECTION IS AN EFFECTIVE WAY TO HELP PROTECT YOUR TANK FROM THE EFFECTS OF CORROSION. WE RECOMMEND TO FURNISH AND INSTALL A PASSIVE CATHODIC PROTECTION SYSTEM AS A COST EFFECTIVE AND LOW MAINTENANCE MEANS OF FURTHER PROTECTING AND EXTENDING THE SERVICE LIFE OF YOUR TANK.

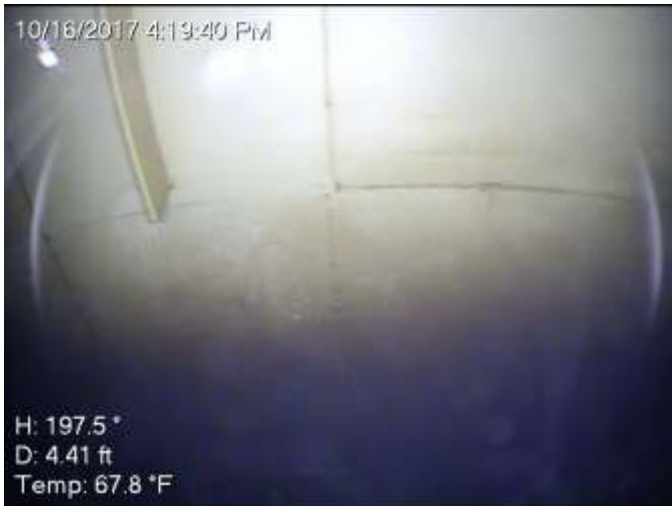
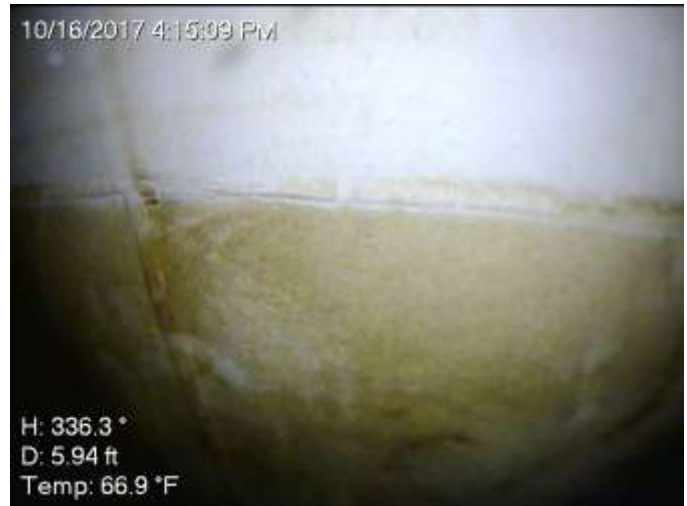
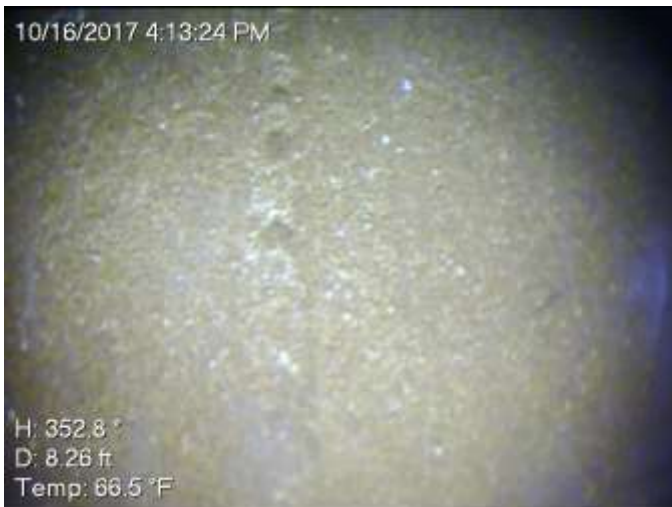
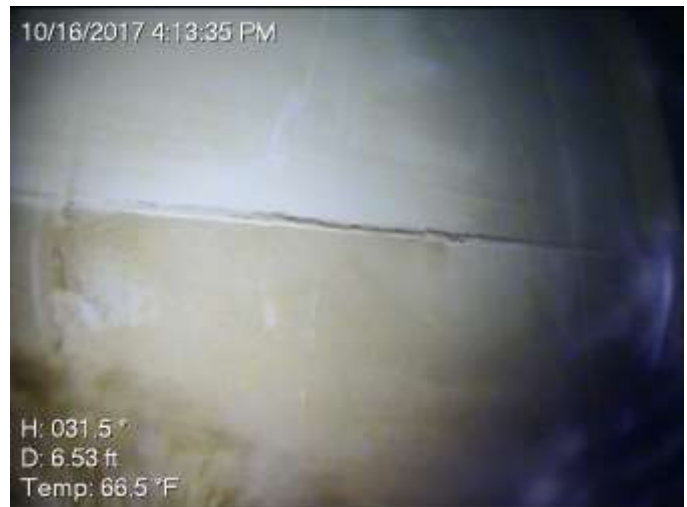
PHOTO SHOWS PAINTERS RING/INTERIOR OF TANK

OVERALL, THE INTERIOR COATING APPEARS TO BE IN GOOD CONDITION. IN ORDER PROMOTE THE LONGEVITY OF THE EXISTING COATING, WE RECOMMEND TO POWER WASH ALL INTERIOR SURFACES AND TOUCH UP COATING AS NECESSARY.

PITTING IS THE RESULT OF THE CORROSION OF THE TANK SHELL THAT DIMINISHES THE THICKNESS AND STRENGTH OF THE TANK SHELL. WE RECOMMEND TO INSTALL 12" X 12" X 3/16" PATCH PLATES OVER AREAS WHERE MULTIPLE PITS ARE IN AN AREA, WELD ISOLATED PITS THAT ARE 1/8" DEEP OR DEEPER, SEAM SEAL THE SHALLOW PITS WITH SEAM SEALER, AND TO REPAIR WELD SEAMS BY WELDING.

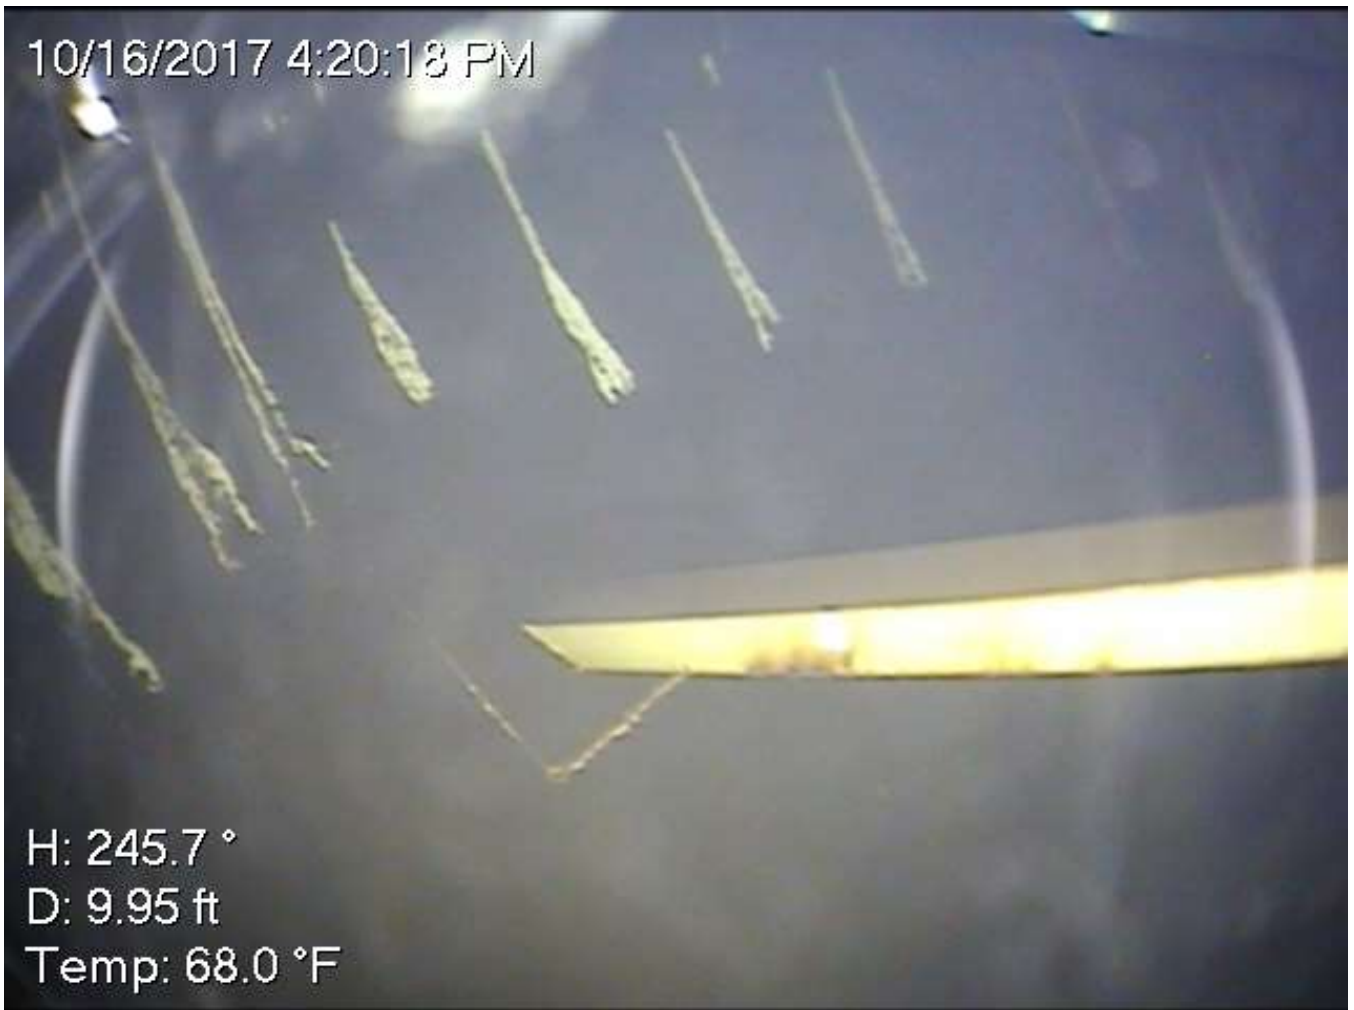
PHOTO SHOWS SEDIMENT ON TANK FLOOR

DUE TO SEDIMENT ACCUMULATION ON TANK BOTTOM WE RECOMMEND A CLEAN OUT OF THIS TANK, THIS ALLOWS US TO FURTHER INSPECT THE BOTTOM OF THE TANK.

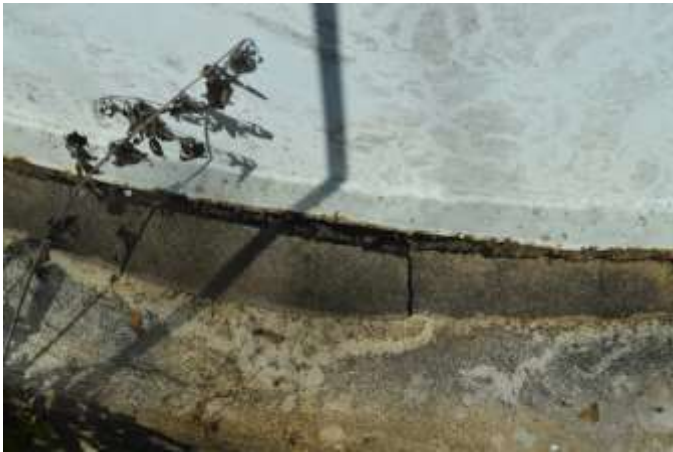
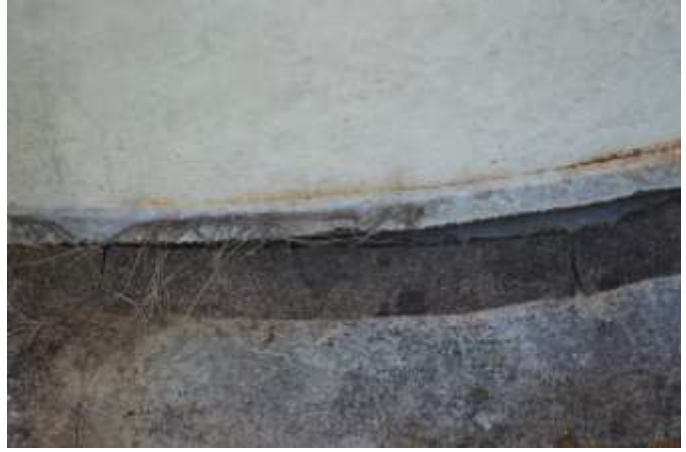
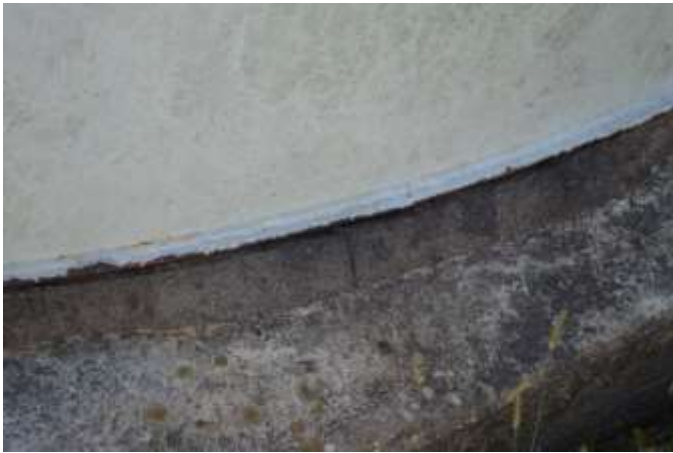
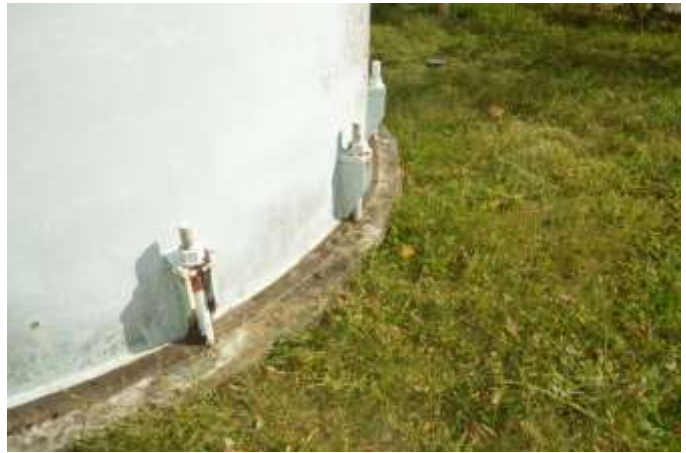
PHOTO SHOWS FOUNDATION

THE FOUNDATION IS SHOWING SIGNS OF CRACKING/SPALLING AND IS NOT PROPERLY SEALED TO SAFEGUARD FROM WATER PENETRATION AND THE EFFECTS OF THE FREEZE-THAW CYCLE DURING COLD WEATHER. WE RECOMMEND TO HAND TOOL CLEAN FOUNDATION, REPAIR SPALLING/CRACKING AREAS AND APPLY ONE COAT OF SEALER TO EXPOSED AREAS.

THE AREA BETWEEN THE FOUNDATION AND THE CHIME IS NOT PROPERLY SEALED. WE RECOMMEND TO CAULK BETWEEN FOUNDATION AND CHIME TO PREVENT INGRESS OF WATER UNDER TANK BOTTOM IN ACCORDANCE WITH NFPA 22 2013.12.2.1.2 REQUIREMENTS.

THE GRADE LEVEL SURROUNDING THE TANK IS NOT AT THE PROPER HEIGHT TO ALLOW FOR THE AWWA AND NFPA RECOMMENDED FOUNDATION EXPOSURE. WE RECOMMEND CONTRACTING A LOCAL EXCAVATOR TO GRADE CIRCUMFERENCE OF TANK TO EXPOSE A MINIMUM OF SIX INCHES OF FOUNDATION TO CREATE POSITIVE RUN OFF IN ACCORDANCE WITH NFPA 22 2013 12.3.1. AND AWWA D100-11 12.6 REQUIREMENTS.

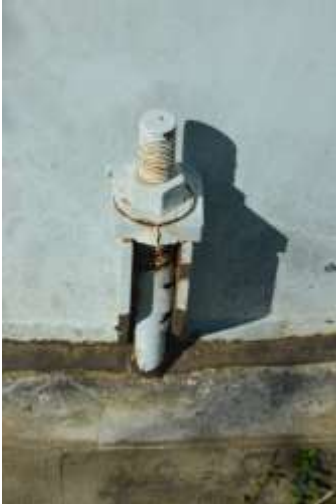
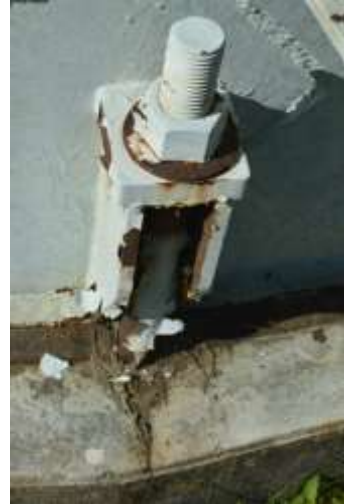
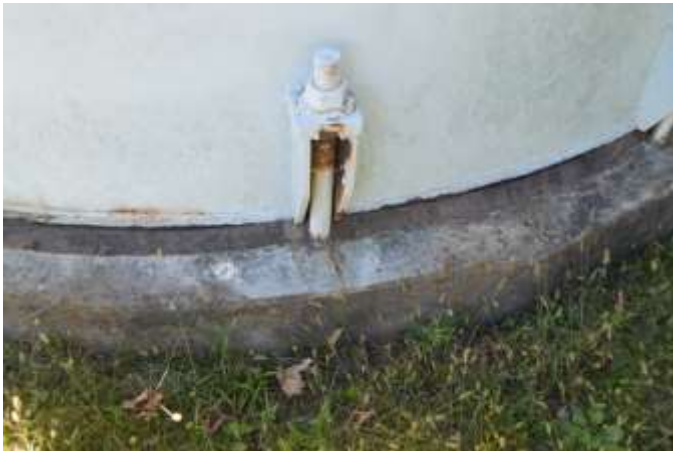
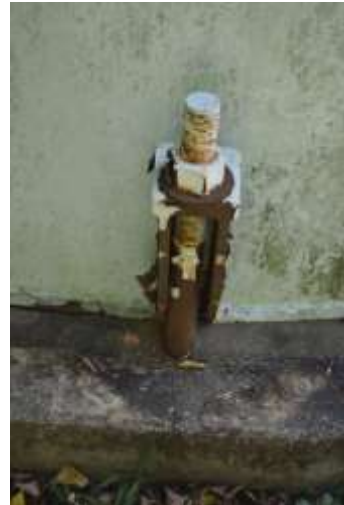
PHOTO SHOWS FOUNDATION

THE STRUCTURAL INTEGRITY OF THE ANCHOR BOLTS SHOULD BE MAINTAINED TO WITHSTAND 100 MPH WINDS BLOWING FROM ANY DIRECTION AS REQUIRED BY THE AWWA. WE RECOMMEND TO CLEAN AROUND THE ANCHOR BOLTS AND WELD AROUND THE CIRCUMFERENCE OF THE BOLT-TO-NUT AND NUT-TO-BASE CONNECTION TO REINFORCE.

TANK IS NOT PROPERLY GROUNDED ACCORDING TO NFPA 780 4.9.10 and 4.9.10.1 REQUIREMENTS. WE RECOMMEND TO FURNISH AND INSTALL TWO GROUND CONDUCTORS, STRUCTURES EXCEEDING 250 FEET IN PERIMETER, ARE REQUIRED TO HAVE AN ADDITIONAL CONDUCTOR FOR EVERY 100 FEET OF PERIMETER IN ACCORDANCE WITH NFPA 780 4.9.10 and 4.9.10.1 REQUIREMENTS.

CORROSION CONTROL IS AN ESSENTIAL PART OF THE MAINTENANCE AND LONGEVITY OF WATER TANKS. WE RECOMMEND TO FURNISH AND INSTALL A RADIAL CATHODIC PROTECTION SYSTEM TO ACT AS A PREVENTATIVE MEASURE CORROSION AGAINST THE UNDERSIDE OF TANK FLOOR.

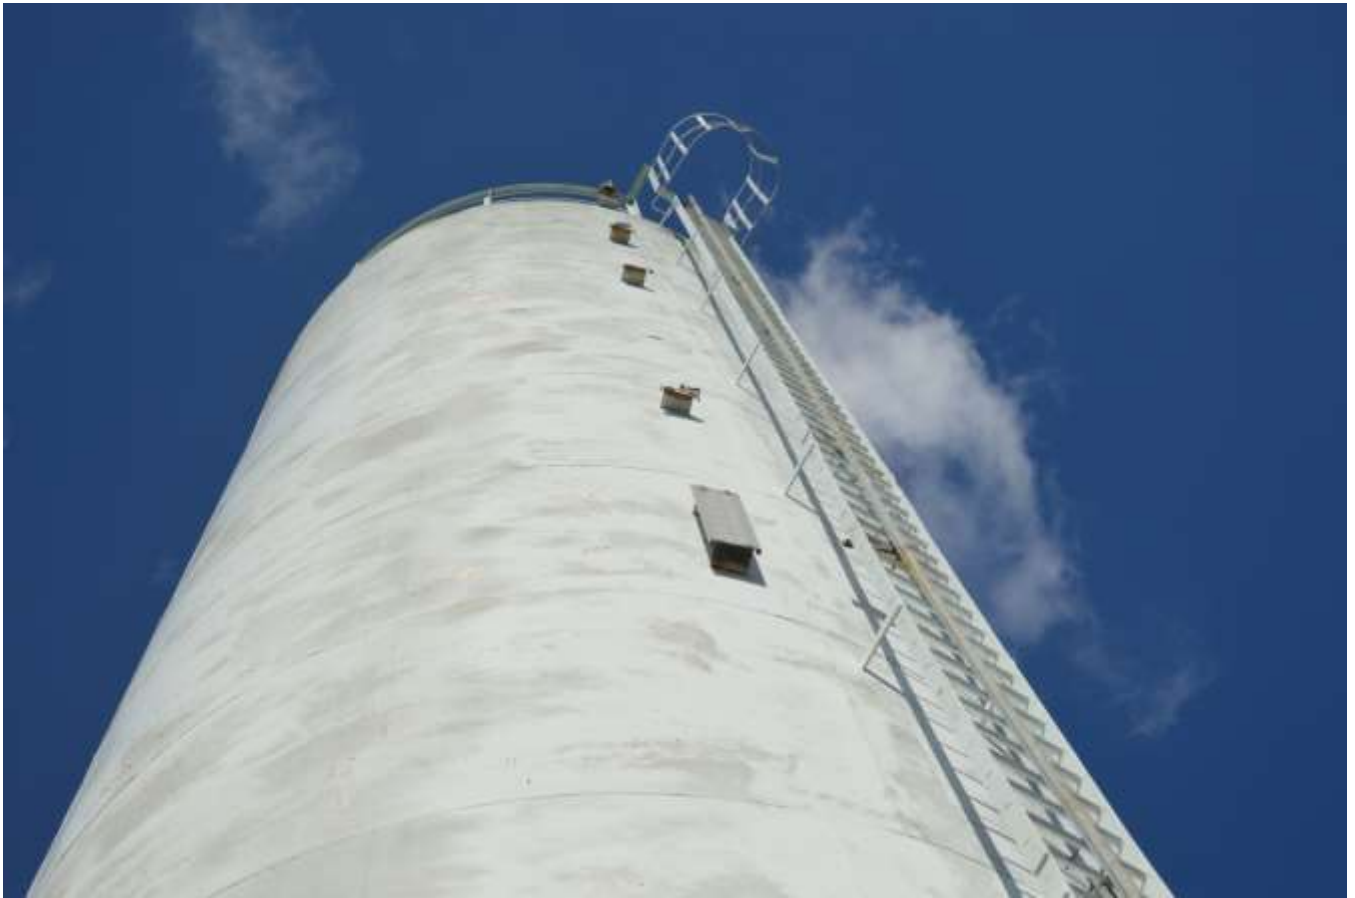
PHOTO SHOWS LIQUID LEVEL INDICATOR

THE LIQUID LEVEL INDICATOR IS BROKEN. WE RECOMMEND TO REPAIR, CLEAN, AND LUBRICATE THE EXISTING LIQUID LEVEL INDICATOR AS NECESSARY IN ACCORDANCE WITH NFPA 22 2013 14.1.8 REQUIREMENTS.

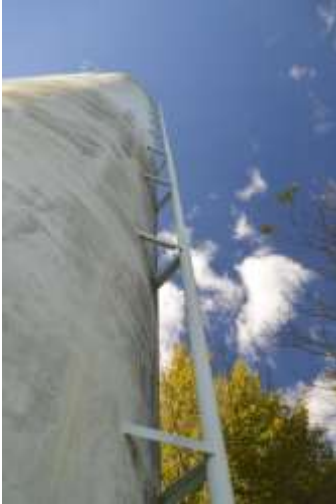
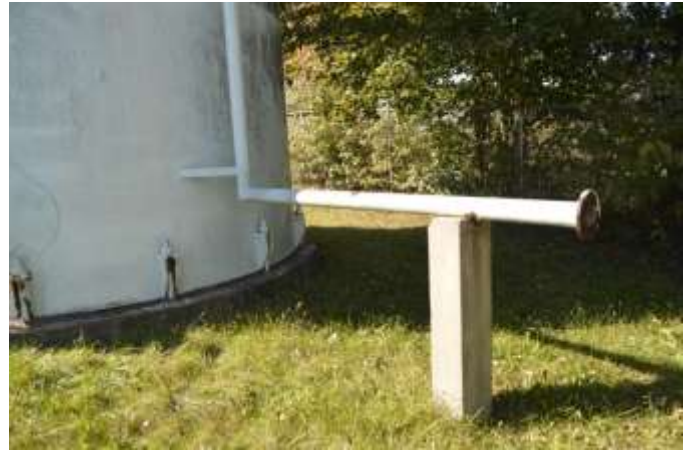
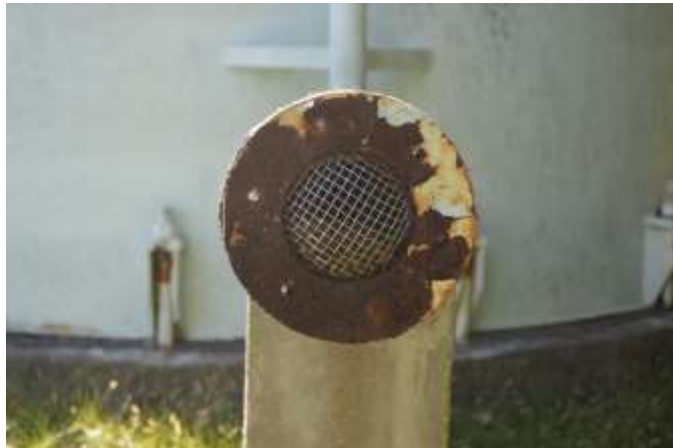
PHOTO SHOWS OVERFLOW

WE RECOMMEND TO FURNISH AND INSTALL A FLAPPER VALVE ON EXISTING OVERFLOW IN ACCORDANCE WITH AWWA D103-09 7.3 AND NFPA 22 2013 14.6 CODE REQUIREMENTS.

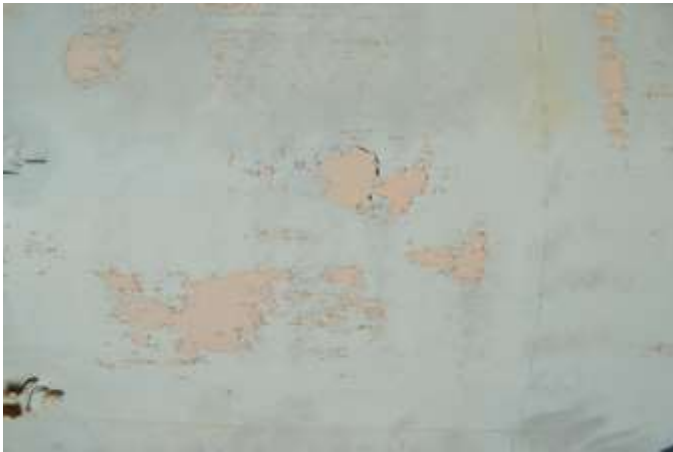
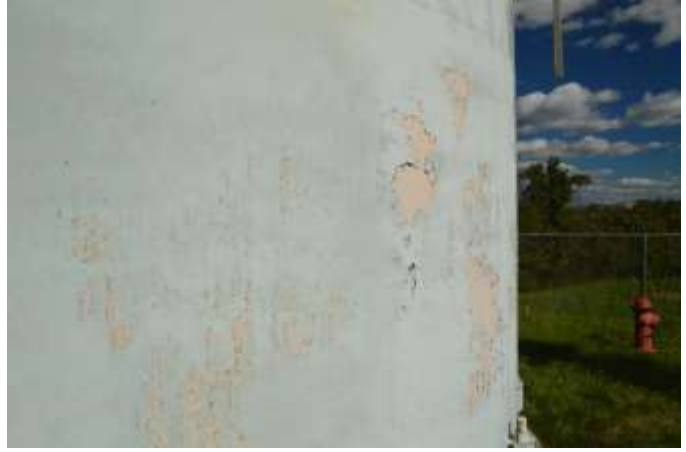
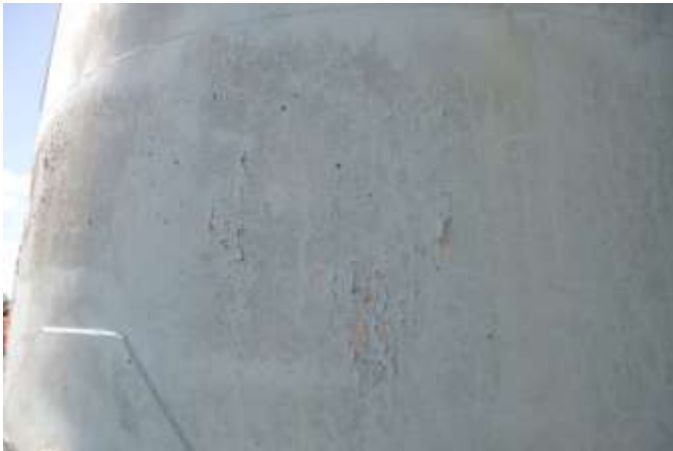
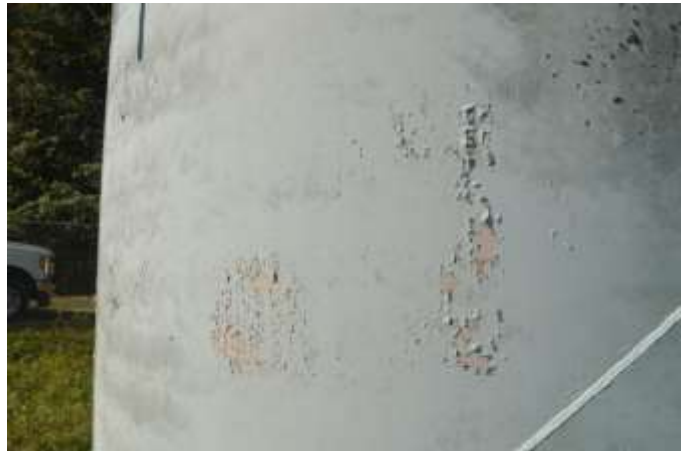
PHOTO SHOWS EXTERIOR SHELL CONDITION

AT MINIMUM, WE RECOMMEND TO POWER WASH ALL EXTERIOR SURFACES, PROPERLY PREPARE SURFACE, PRIME, AND APPLY ONE COMPLETE COAT OF ENAMEL. FURTHERMORE, FOR SUPERIOR COLOR, GLOSS RETENTION, AND LONGEVITY OF COATING PERFORMANCE, WE RECOMMEND A FULL COAT OF PRIMER FOLLOWED BY A FINISH COAT OF ACRYLIC OR URETHANE.

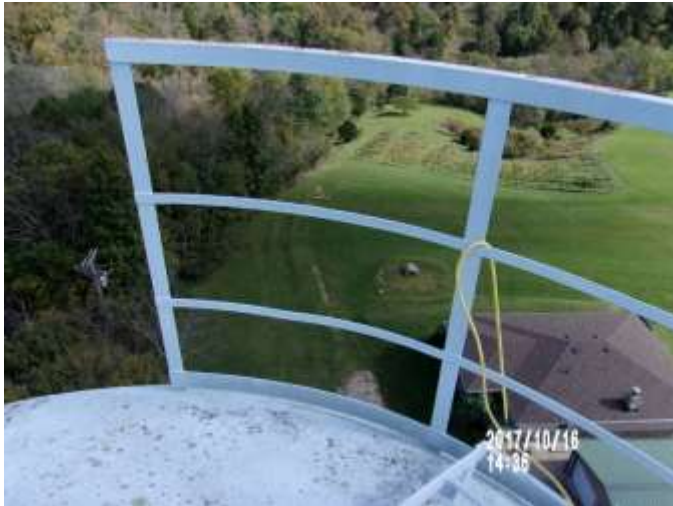
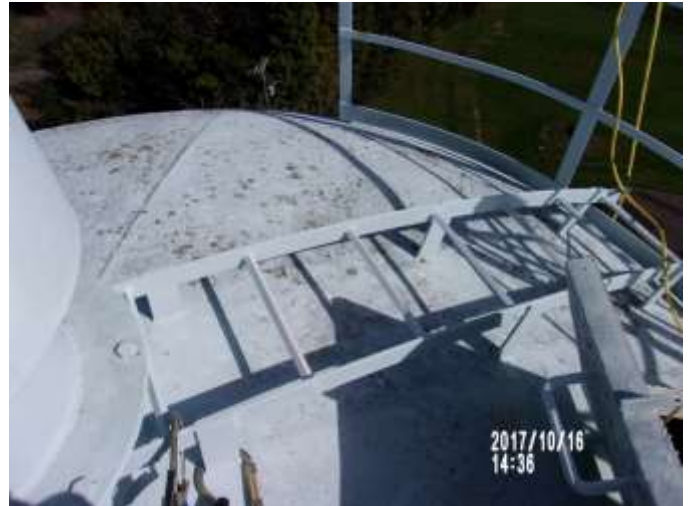
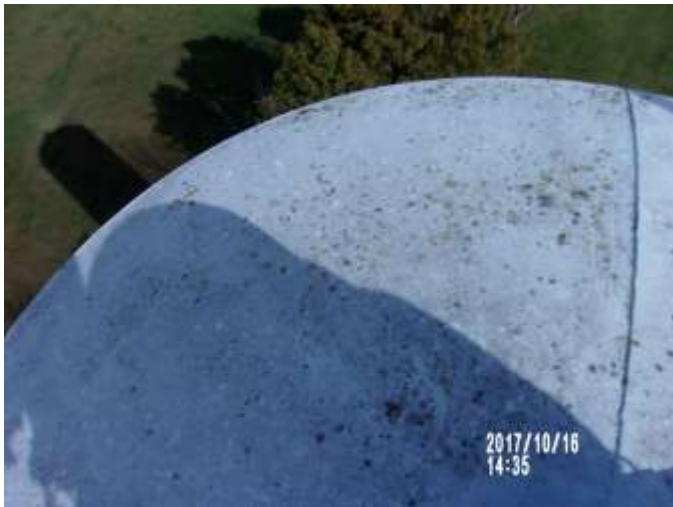
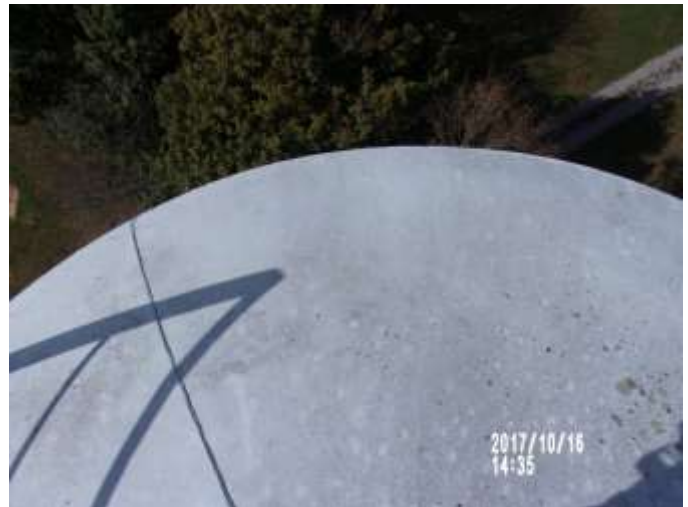
PHOTO SHOWS ROOF OVERVIEW

TANK IS NOT EQUIPPED WITH AN OSHA APPROVED HANDRAIL SYSTEM. WE RECOMMEND TO FURNISH AND INSTALL 42" HANDRAILS AROUND THE CIRCUMFERENCE OF THE TANK ROOF IN ACCORDANCE WITH OSHA, AWWA D100-11 3.1.7 AND NFPA 22 2013 8.7.9 REQUIREMENTS.

THE ROOF LADDER IS NOT EQUIPPED WITH A SAFETY CLIMB DEVICE. WE RECOMMEND TO FURNISH AND INSTALL A SAFETY CLIMB DEVICE ON EXTERIOR ROOF LADDER IN ACCORDANCE WITH OSHA REQUIREMENTS.

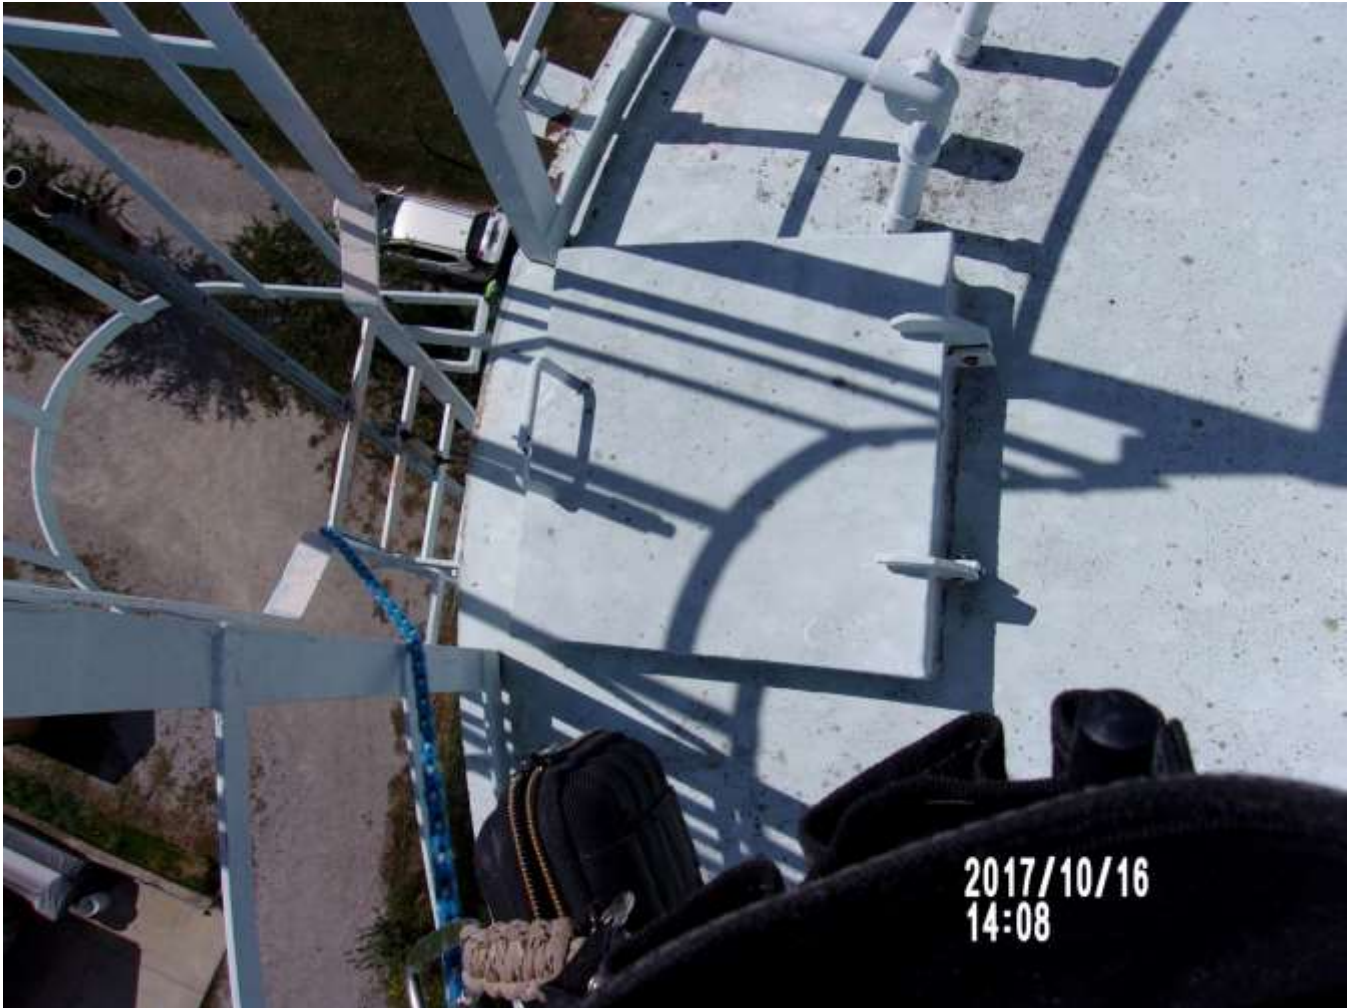
PHOTO SHOWS PRIMARY ROOF HATCH

TANK ROOF IS NOT EQUIPPED WITH A SECONDARY OSHA APPROVED ROOF HATCH. WE RECOMMEND TO FURNISH AND INSTALL A SECONDARY 24" SQUARE ROOF HATCH 180 DEGREES FROM THE PRIMARY ROOF HATCH IN ACCORDANCE WITH AWWA D100-11 5.4.3.1 AND NFPA 22 2013 5.7.3 REQUIREMENTS.

WE RECOMMEND TO FURNISH AND INSTALL A SECONDARY INTERIOR AND AN EXTERIOR LADDER INCLUDING SAFETY CLIMB DEVICES AND AN ANTI CLIMB DEVICE IN CONJUNCTION WITH THE INSTALLATION OF A SECONDARY 24" SQUARE ROOF HATCH 180 DEGREES FROM THE PRIMARY ROOF HATCH IN ACCORDANCE WITH OSHA, AWWA D100-11 5.4.2.5 AND NFPA 22 5.7.4 REQUIREMENTS.

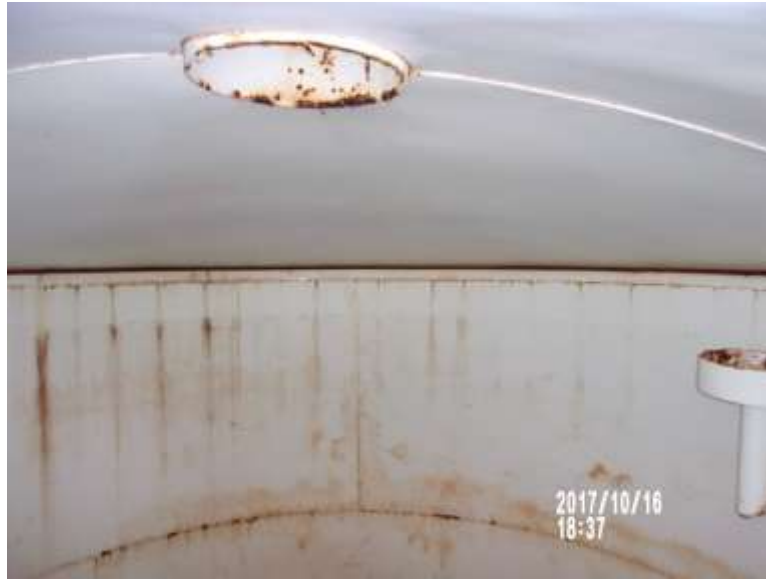
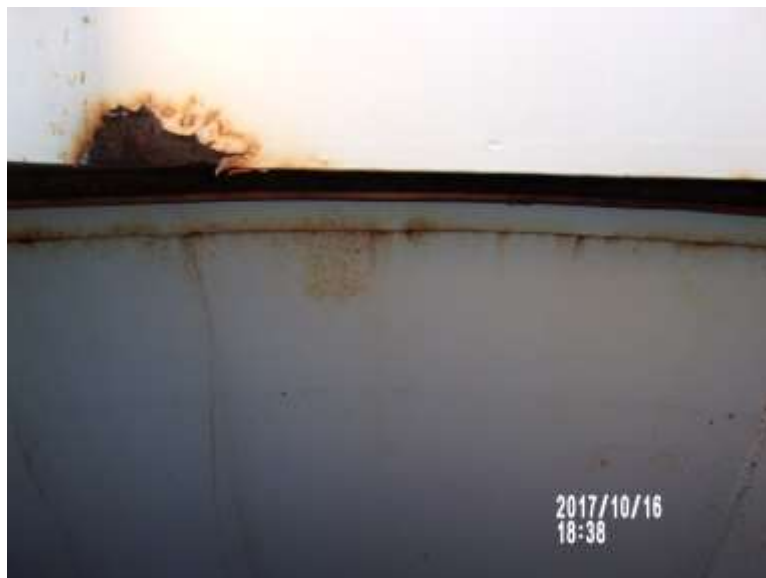
PHOTO SHOWS OVERVIEW OF ROOF INTERIOR

**WE RECOMMEND TO CAULK INTERIOR LAPPED ROOF JOINTS AFTER PAINTING TO PREVENT
PREMATURE FAILURE OF COATING.**
