ELECTRONIC INVESTIGATION INTO)
EXCESSIVE WATER LOSS BY KENTUCKY'S) Case No. 2019-00041
JURISDICTIONAL WATER UTILITIES)

**West Carroll Water District
Case No. 2019-00041
Commission Staff's Second Request for Information issued May 3, 2019**

100,000 GALLON ELEVATED WATER TANK

50,000 GALLON ELEVATED WATER TANK

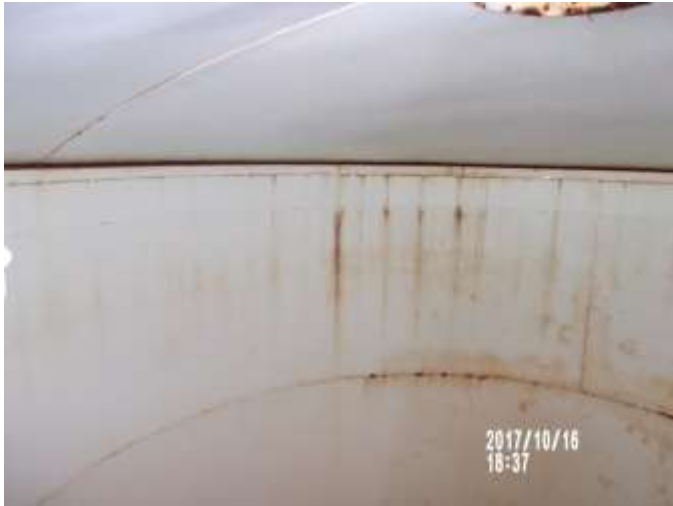
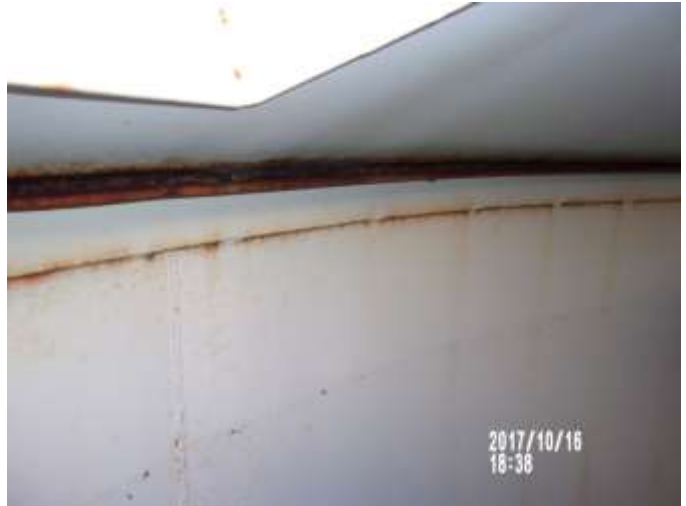
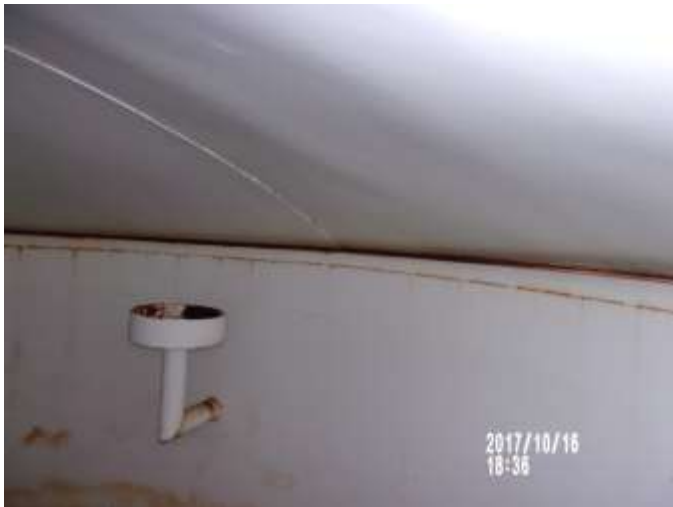
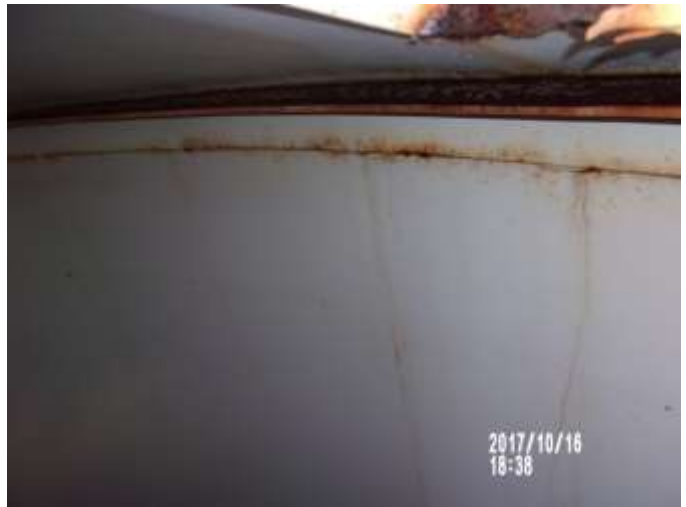
PHOTO SHOWS INTERIOR TANK SHELL ABOVE WATER LINE

**WE RECOMMEND TO CAULK THE ROOF TO RIM ANGLE CONNECTION TO PREVENT
PREMATURE FAILURE OF COATING.**

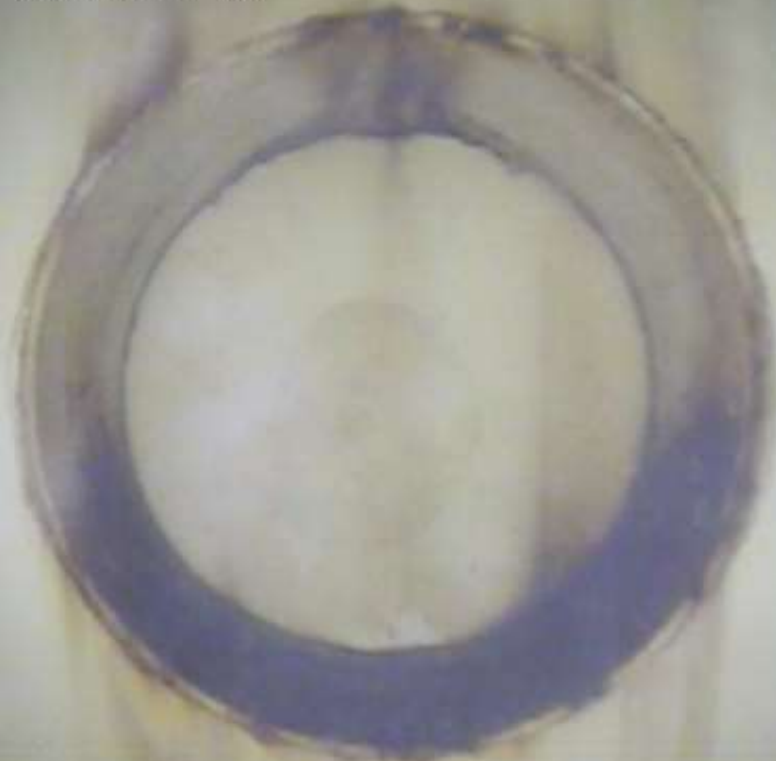
PHOTO SHOWS MANWAY

CATHODIC PROTECTION IS AN EFFECTIVE WAY TO HELP PROTECT YOUR TANK FROM THE EFFECTS OF CORROSION. WE RECOMMEND TO FURNISH AND INSTALL A PASSIVE CATHODIC PROTECTION SYSTEM AS A COST EFFECTIVE AND LOW MAINTENANCE MEANS OF FURTHER PROTECTING AND EXTENDING THE SERVICE LIFE OF YOUR TANK.

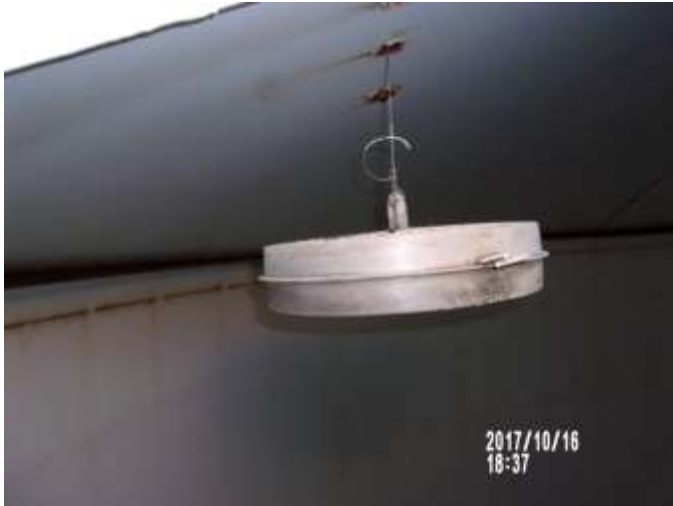
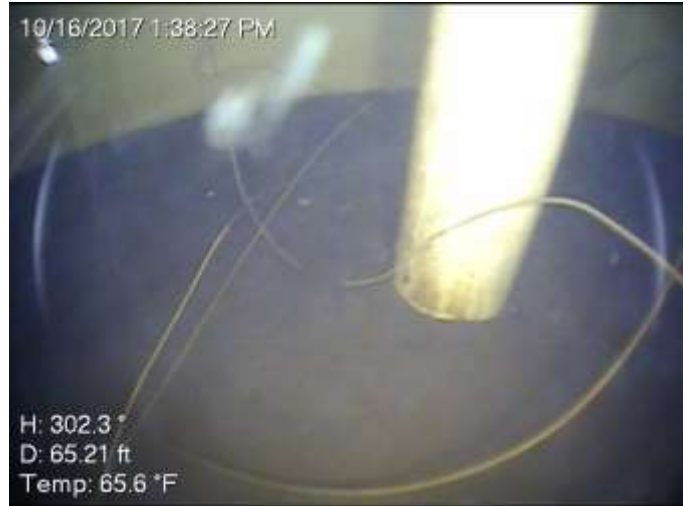
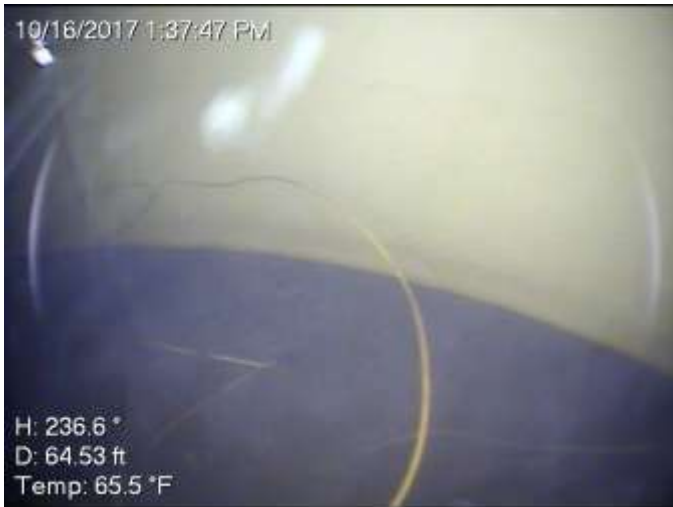
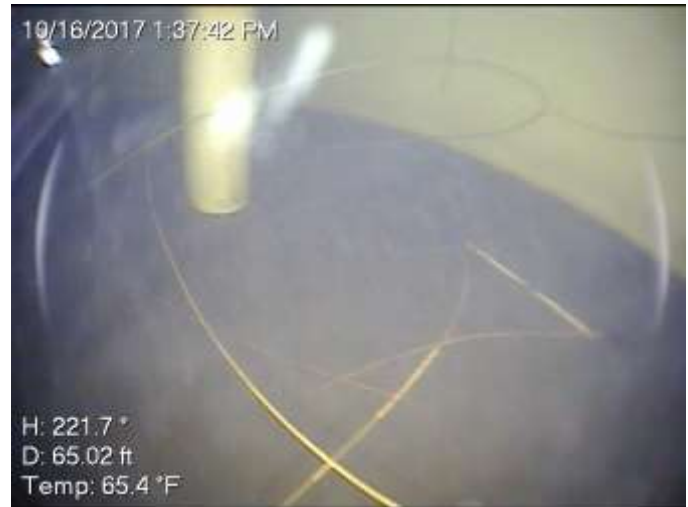
PHOTO SHOWS LIQUID LEVEL INDICATOR STABLIZERS

AS PREVIOUSLY MENTIONED, THE LIQUID LEVEL INDICATOR IS BROKEN. WE RECOMMEND TO REPAIR, CLEAN, AND LUBRICATE THE EXISTING LIQUID LEVEL INDICATOR AS NECESSARY IN ACCORDANCE WITH NFPA 22 2013 14.1.8 REQUIREMENTS.

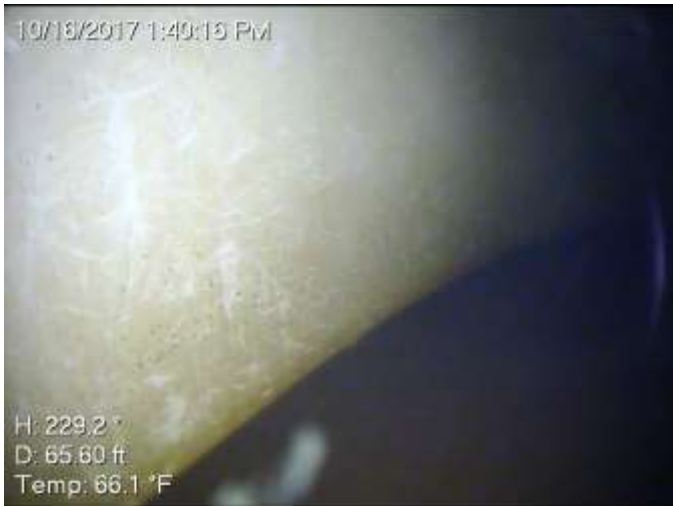
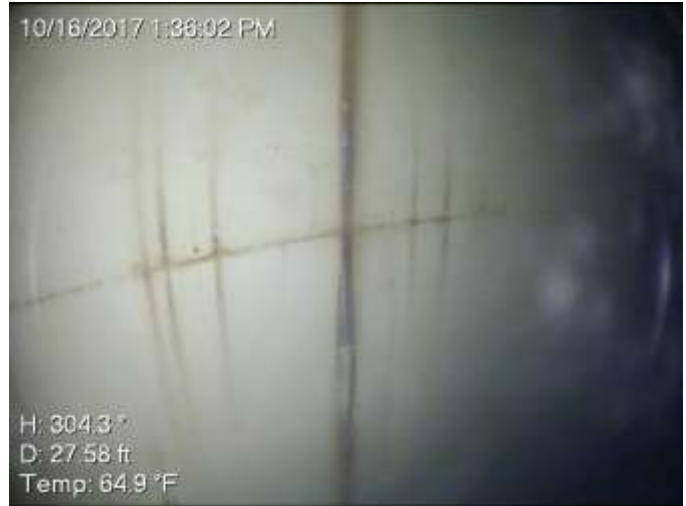
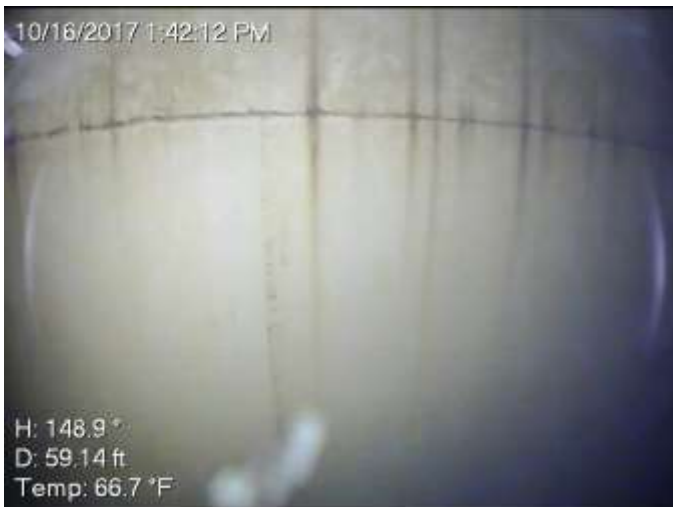
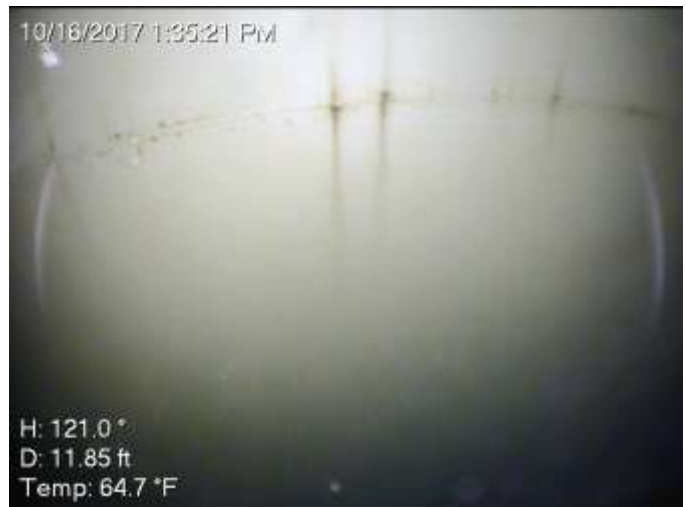
PHOTO SHOWS INTERIOR SHELL CONDITION

THE INTERIOR OF THIS TANK IS EXHIBITING SIGNS OF CORROSION/STAINING/COATING FAILURE. WE RECOMMEND TO PROPERLY PREPARE THE AREAS OF DEFECT AND/OR ENTIRE INTERIOR SURFACE AND APPLY AN AWWA/NFPA APPROVED INTERIOR COATING SYSTEM AS NEEDED.

PITTING IS THE RESULT OF THE CORROSION OF THE TANK SHELL THAT DIMINISHES THE THICKNESS AND STRENGTH OF THE TANK SHELL. WE RECOMMEND TO INSTALL 12" X 12" X 3/16" PATCH PLATES OVER AREAS WHERE MULTIPLE PITS ARE IN AN AREA, WELD ISOLATED PITS THAT ARE 1/8" DEEP OR DEEPER, SEAM SEAL THE SHALLOW PITS WITH SEAM SEALER, AND TO REPAIR WELD SEAMS BY WELDING.
