Notice of Filing per 9/16/2022 Order

Phase I Environmental Site Assessment

Golden Solar Site • Fredonia,
Kentucky

Karst Survey and Assessment

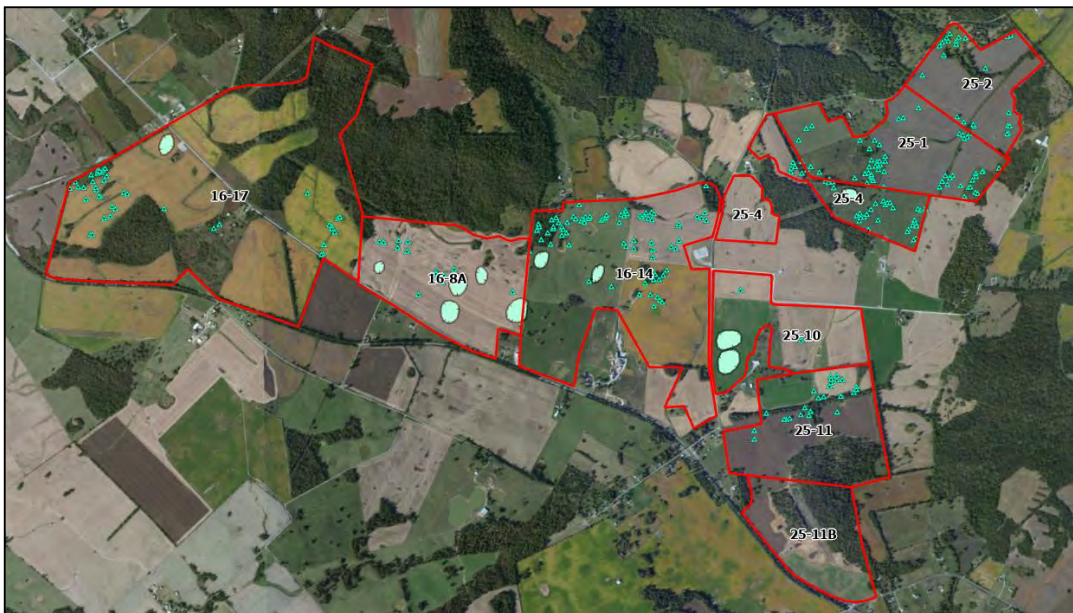
Based on the methods and procedures for the data review as detailed previously in Section 2.1, the majority of identified suspect karst features (SKFs) were identified throughout the proposed site. Review of the existing high-resolution LiDAR datasets resulted in two hundred and ninety-six (296) suspect karst features. These SKF areas are highlighted in Figure 1 and indicate areas of karst development that were verified during the field survey.

Figure 1. Map of the Golden Solar site showing the SKf zones identified during the data review prior to field reconnaissance. Proposed site boundary (outlined in red), SKf (blue points and blue areas).
