Airview-Kentucky (Wastewater)

Engineering Memorandum

Date: December 22, 2018

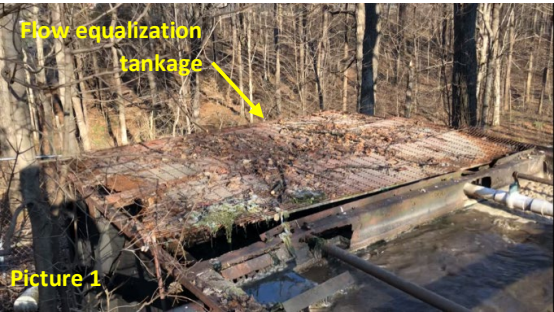
Various items of concern exist as this facility. The flow equalization tank is in poor shape and is covered with failing grates that are allowing leaves to enter the plant. (Appendix Picture 1)

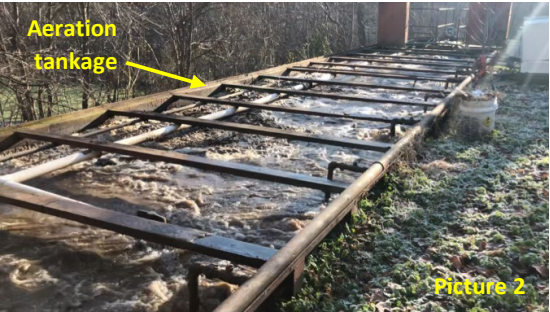
While the aeration appeared to be reasonable operating, standard testing parameters were not performed when we were present to determine the quality of the mixed liquor. Due to the upkeep of the remaining portions of the facility, I do not believe the diffusers have been checked and/or cleaned in some time. (Appendix Picture 2)

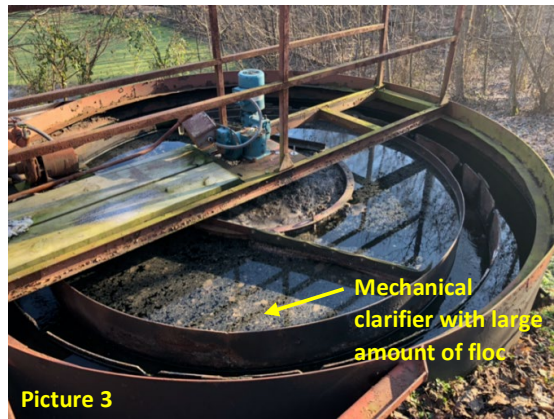
The mechanical clarifier appears to be working properly. However, the supernatant water of the clarifier had a large amount of floc and/or sludge coming to the surface. While this might be a operational issue in regards to control of the mixed liquor and return sludge flow, the clarifier is not operating at an optimal level. The clarifier discharges to the outside of the circular wall of the clarifier. This area is the discharge water that is pumped to the creek. Sludge was observed in this area and therefore was being pumped to the creek. (Appendix Picture 3)

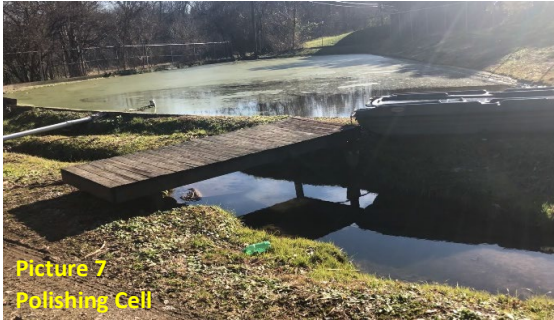
Picture 7
Polishing Cell

to the polishing cell. While this cell can protect sludge from discharging into the stream, the cell must be periodically cleaned to avoid sludge build up and recontamination of the effluent. I can't confirm sludge levels from this visit. Sludge judging of this cell should be completed. Additionally, I'm not aware of the depth of this cell. A shallow cell may have algae growth that will cause effluent problems. Since no aeration exists in the cell to improve mixing, I anticipate the cell turning over similar to a pond and may have contamination of the effluent from solid deposits on the cell bottom. (See polishing cell photo in Appendix Picture 7)

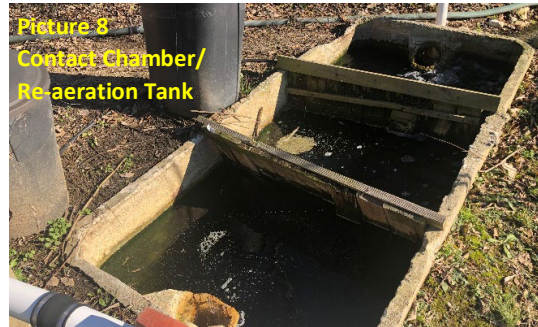
Picture 8
Contact Chamber/
Re-aeration Tank

The contact chamber does not have typical baffling and may experience short circuiting. While it doesn't appear there are any violations for E. Coli, the contact chamber should be replaced or disinfection should be converted to Ultraviolet disinfection. (Appendix Picture 8)

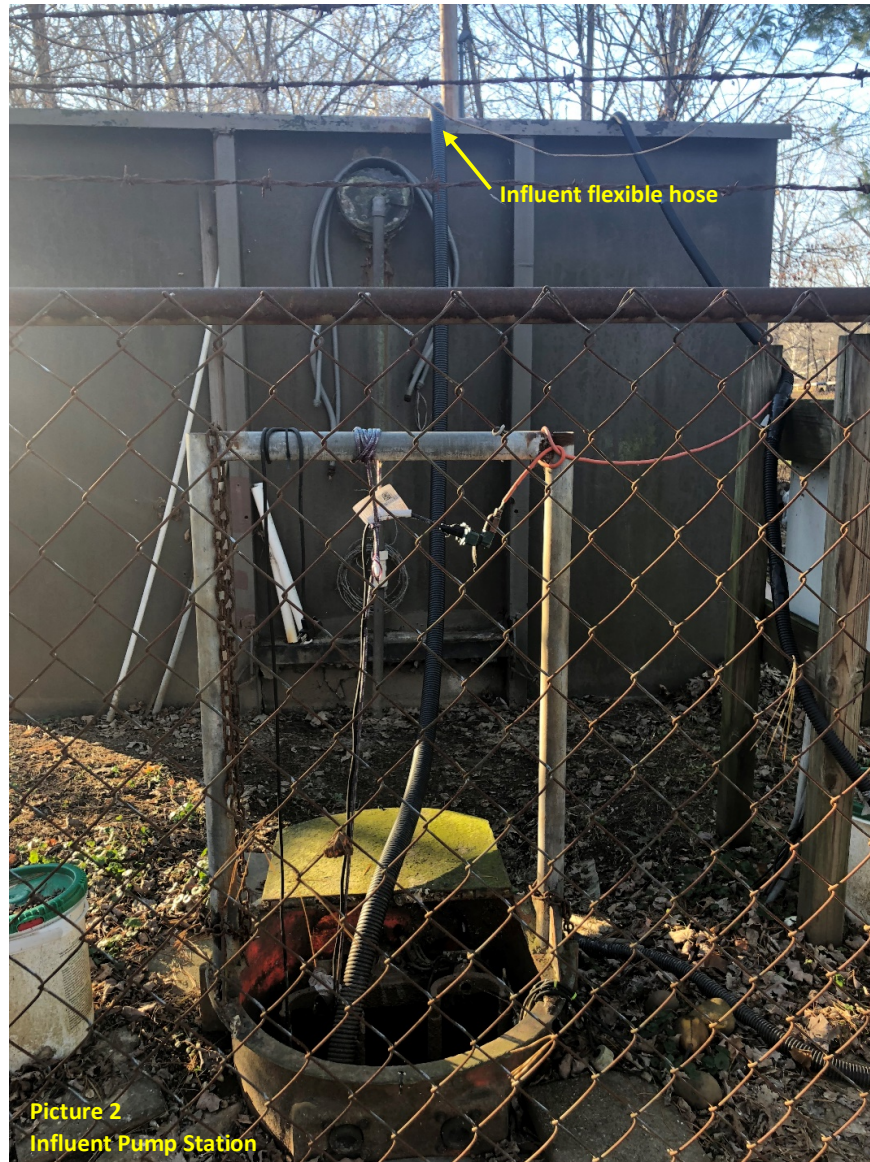
Picture 2
Influent Pump Station

The influent pump station will need to be overhauled in order to ensure reliability. The size of the influent pumps are unknown. The pumps will need to be pulled, inspected, and evaluated for capacity. The facility is using a flexible black hose instead of a metal and/or buried pipe that will help avoid freezing and break down from sun exposure. This pipe should be replaced. Additionally, the operator believes there are inflow and infiltration issues in the system. Additional capacity should be added to the influent pump station to provide more consistent flow to the plant if additional analysis confirms this need. (Appendix Picture 2)

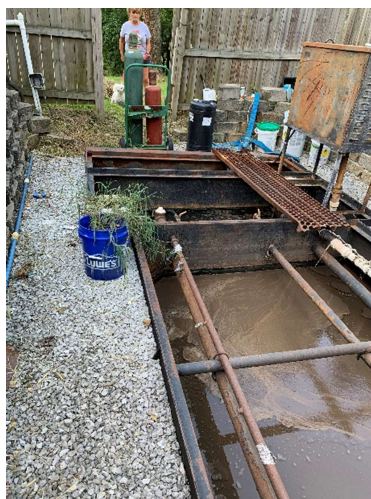
The packaged plant has aged and shows significant signs of wear and corrosion. The blowers and diffusers are in need of replacement, and one of the two RAS lines has broken off into the aeration basin. The access platform became dangerous to use and has since been removed. The basin does not include handrail needed to protect operators or visitors from falling into the package plant.

Aeration Tank, Clarifier, Contact Tank

- The condition of the tank calls for taking the facility off line for structural repair, at a minimum to include the addition of either supplemental or replacement stiffeners, safety handrail, welding repairs, and the addition of a new RAS line from one of the hopper bottomed clarifiers to the front end of the plant.

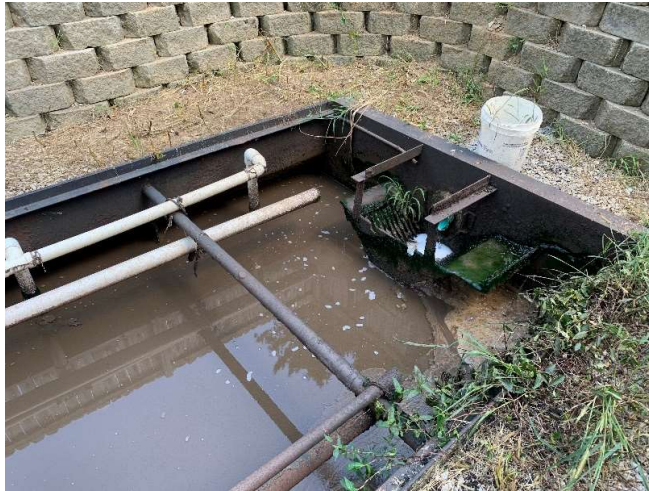
Manually Cleaned Bar Screen

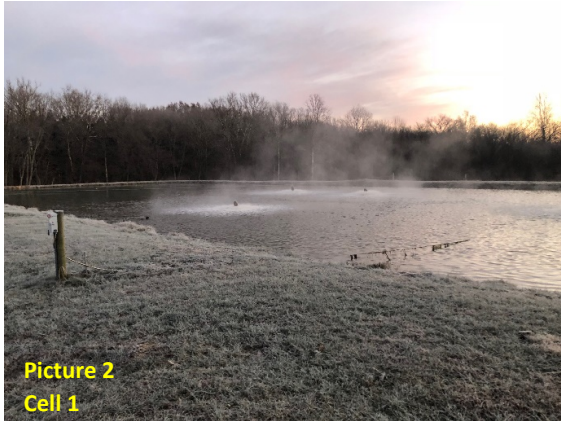
Picture 2
Cell 1

The first lagoon cell had four aerators functioning upon the site visit. One additional aerator was removed from the lagoon cell and sitting on the lagoon bank. Lagoon systems are typically designed to have all equipment functioning. This aerator needs to be repaired and placed back into service. Additionally, I reached out to the operator and they do have issues with the first aerator which gets pulled every other month due to being fouled up with rags. Operational changes should be made to reduce the fouling up of the aerator. (Appendix Picture 2, 3, & 4)

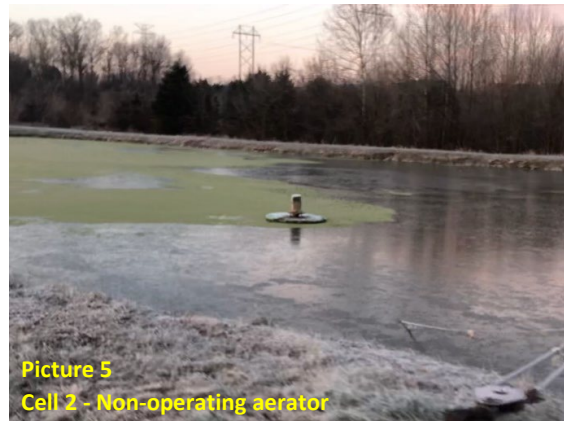
Picture 5
Cell 2 - Non-operating aerator

The second lagoon cell has 3 aerators in the cell. However, none of them were running during the site visit. Lagoon systems are typically designed to have all equipment functioning. Additionally, the lagoon cell is mostly covered with duckweed. Duckweed does have pros and cons for existing within a lagoon. It can help remove nutrients and keep algae blooms. Alternatively, duckweed will reduce dissolved oxygen levels and will die off returning some of the nutrients to the lagoon as sludge at the bottom of the cell. As duckweed breaks down on the bottom of the cell, it could release ammonia to cause problems with sampling. Duckweed prefers stagnant water and does not like surface aeration. Therefore, if the aerators were all functioning, the amount of duckweed would be less. If the aerators were all functioning, the duckweed would be reduced and make it easier to control. Additionally, aeration can also reduce algae blooms as well. The owner should evaluate the existence of the duckweed and decide if it is beneficial at this facility. In review of the aerator layout, one of the aerators in the final cell is downstream of the baffle. The owner should evaluate the design and effluent quality to determine if this aerator should be up stream of the baffle. (Appendix Picture 5)

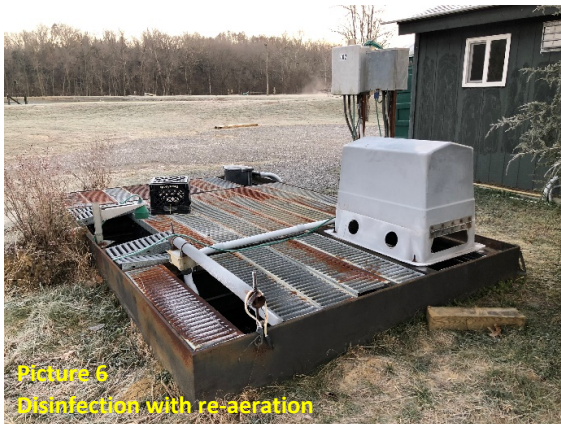
Picture 6
Disinfection with re-aeration

Next to the contact chamber, the liquid chlorine is housed in a small equipment shed. The contact chamber should be evaluated for capacity to provide contact time. In conversations with the operator after the site visit, they stated she is constantly adjusting the chlorine feed pump flow rate based on lagoon effluent flow. Chemical usage is either wasted or under chlorinated. The system should be modified to either utilize ultraviolet disinfection or setup to automatically adjust chlorine pump. The operator stated that they have struggled to meet disinfection requirements in the past and feel it was due to the chlorine dosage levels not being sufficient for disinfection. Additionally, the blower was operating providing some re-aeration in the contact chamber prior to discharging. (Appendix Picture 6)

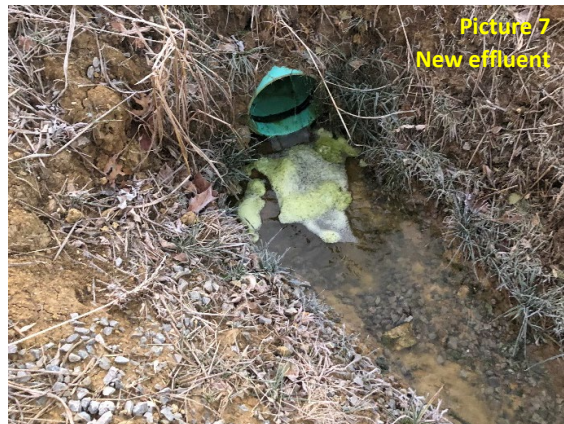
Picture 7
New effluent

The discharge pipe was recently installed that removed the irrigation lake from being a part of the treatment process. This is consistent with the proposed permit that has yet to be issued by the state. In conversations with the operator, the owner/operator had concerns that the lagoon wildlife and overland flow coming into the irrigation lake may have been causing contamination issues on their DMRs. Therefore, they felt direct discharge would help bring the effluent quality closer to consistently meeting limits. At the time of the visit, the effluent discharge was almost directly on soil and should have some type of erosion protection. Additionally, the effluent appeared to have an algae problem. The owner should look to have the aeration operating in the final cell to reduce the potential for algae blooms in the wastewater prior to discharging. (Appendix Picture 7)

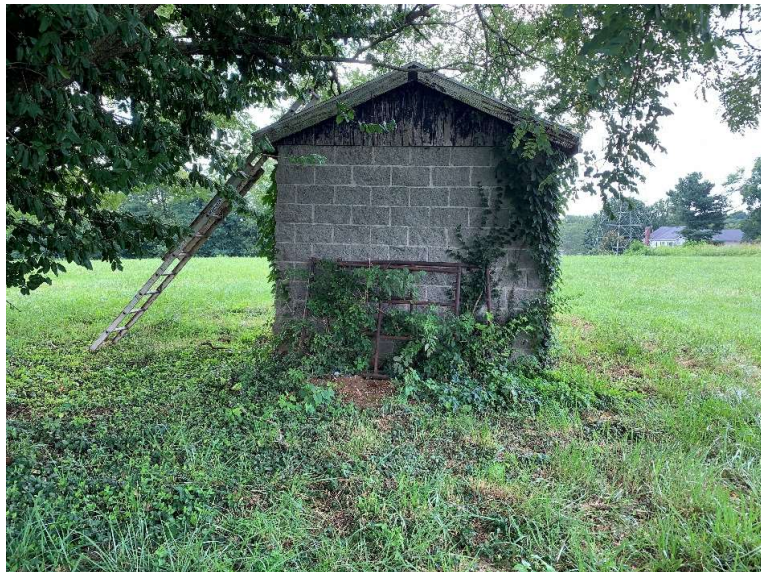
There is a single control panel for all four irrigation pumping systems located in a masonry building between the pump stations and the irrigation area. The pump stations, controls, electrical gear and masonry building internals all appear to be in good working order.

Electrical / Control Building and Irrigation Area in Background
