Kentucky Power Company  
KPSC Case No. 2021-00370  
AG/KIUC's First Set of Show Cause Issue Data Requests  
Dated October 16, 2023  
Page 1 of 3

TRK Engineering Services, Inc. was retained by AEP Mitchell Plant to inspect the Unit 2 electrostatic precipitators (Box 3 and Box 4), develop a punch list of mandatory repairs, document needed repairs and make recommendations after evaluating the findings. Work priority was established with the plant during a “kick-off” meeting prior to entering the unit.

The AEP Unit 2 electrostatic precipitator (ESP) system consists of two (2) side-by-side precipitators (ESP 3 & ESP 4) operating in parallel. The precipitators serve an 850 MW boiler. The dual chamber precipitators were designed and manufactured by Wheelabrator (installation circa late 1970s).

**2022 Big Sandy Unit 1 Generator Inspection Report 10/11/2022 to 10/14/2022**

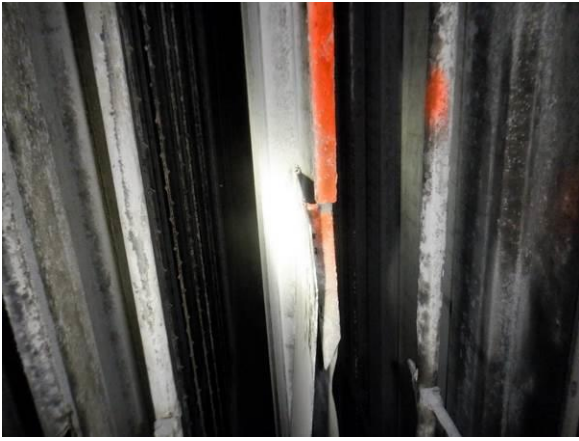
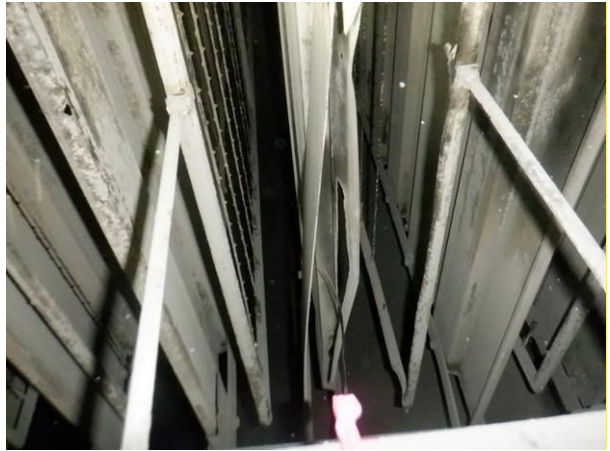
**Above/Below:** More photographs of fields with damaged collecting plate panels along the bottom of the fields.

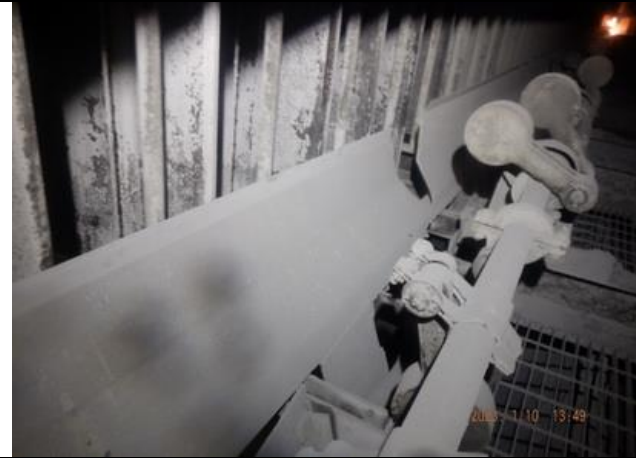
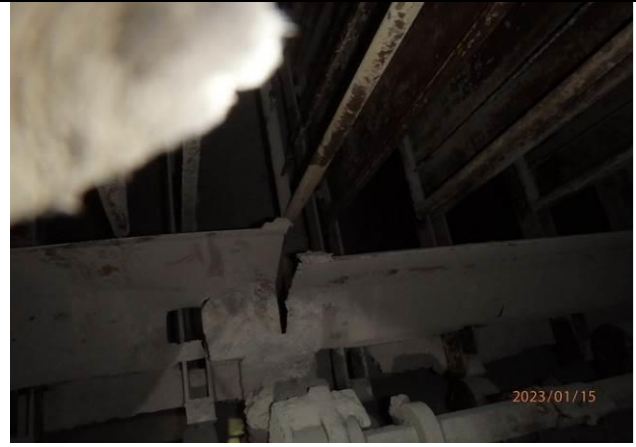
**Above:** More broken collecting plate hammer baffles causing a close electrical clearance.  
**Below Left:** The tabs, which hold the baffles together on the collecting plate hammers, stick out toward the high voltage. This is causing a spark point. When repairs are made in the future, the tabs should be put on the back of the baffle so a sharp point is not sticking out to the high voltage.  
**Below Right:** An example of damage on a collecting plate causing a close electrical clearance; these panels were removed.

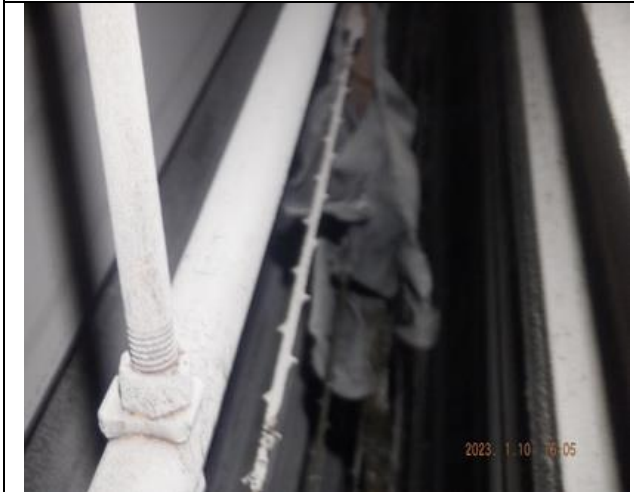
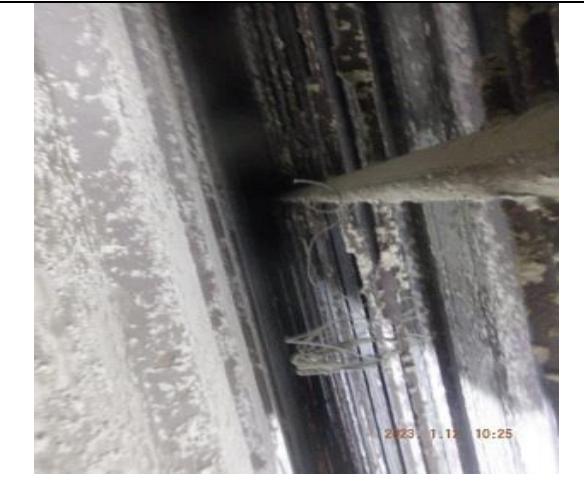
**Above Left:** A piece of a collecting plate panel was found laying on a field. The piece of plate was sitting on the high voltage and touching the collecting plates, grounding out the field.

**Above Right:** More tie wire found in a field causing a close electrical clearance. **Below Left:** A piece of scaffold was found tied between two electrical fields.

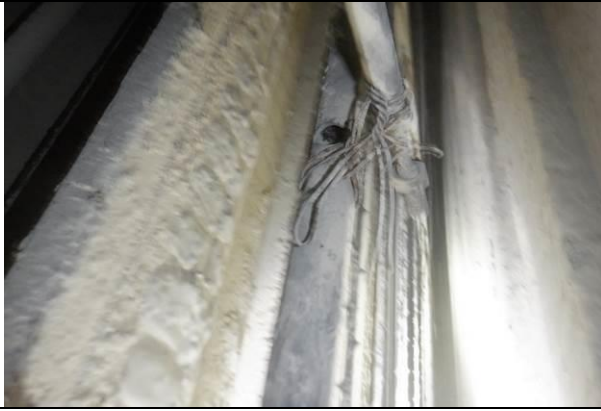
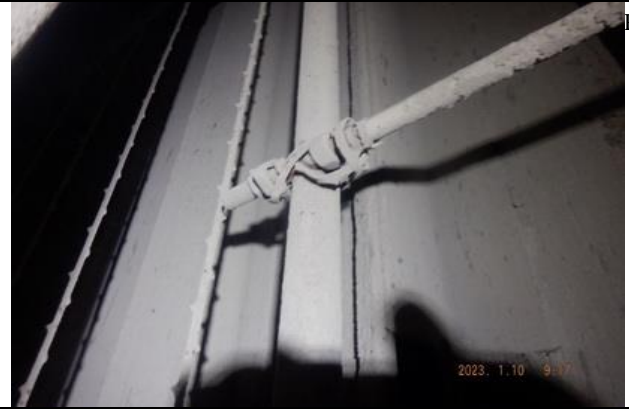
**Above / Below left:** More areas where tie wire was used to hold rigid mast pieces together. The photograph on the left is either causing a close electrical clearance or a ground.  
**Below Right:** Quick repairs on a broken piece of rigid mast. In the future these areas should be replaced with split pieces of pipe and rewelded over the bad areas. The alignment bar can then be properly repaired.

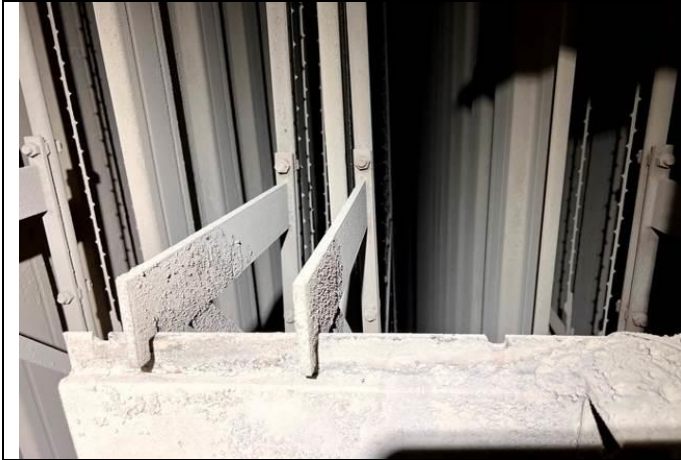
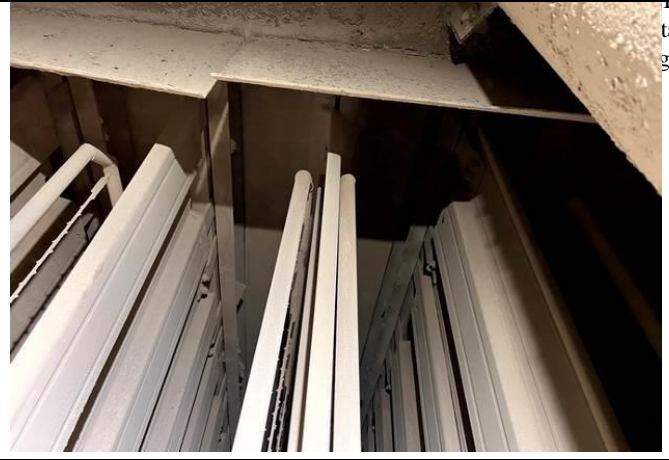
**Above Left:** Another field where the high voltage angles for the rigid masts are out of position. Again, it is suspected that this is occurring from over filled hoppers.

**Above Right:** A high voltage rigid mast touching a collecting plate causing a short. This is a result of one of the high voltage support pieces being broken and out of position.

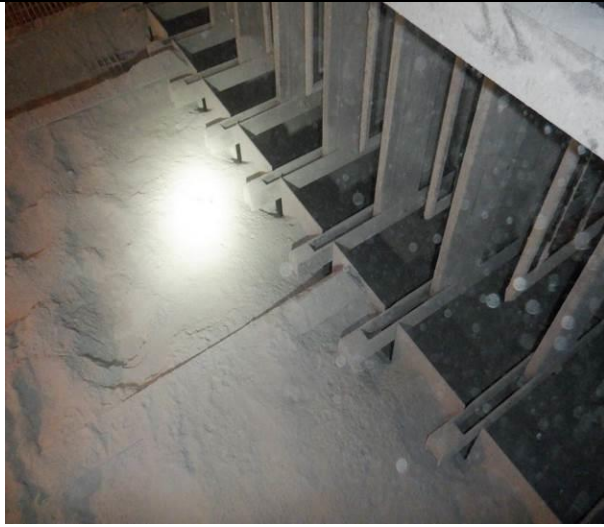
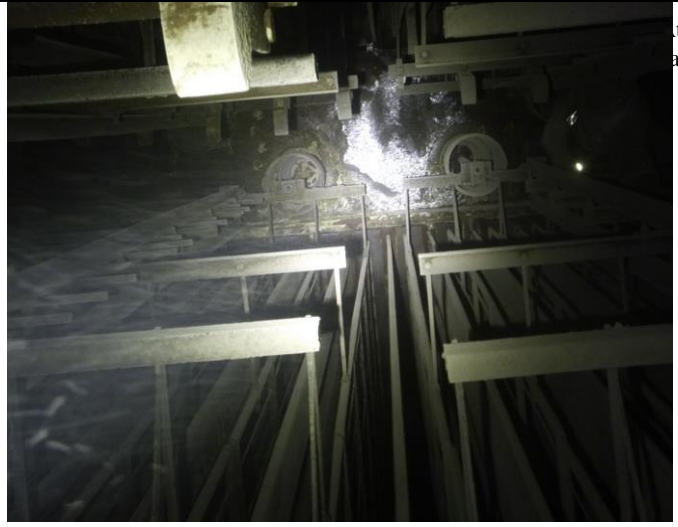
**Above Left:** Another area with a full hopper causing a grounded field.

**Above Right:** Dampness on the roof above.

**Below Left:** A view of hammers and shock bars on the non-rapped side.

**Below Right:** Example of damaged shock bars.

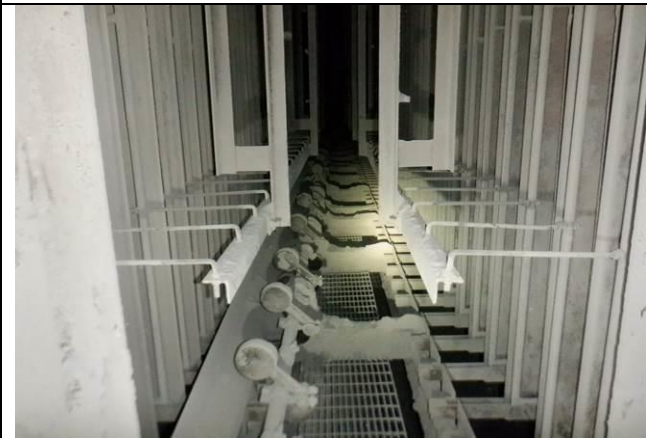
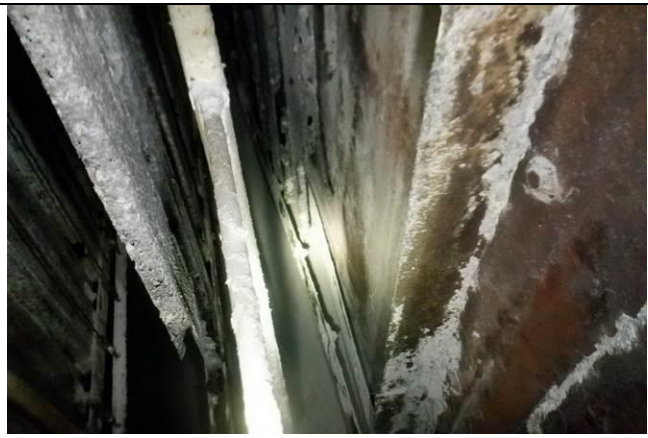
**Above/Below Left:** There were many damaged shock bars identified during this outage. The only repairs the plant typically performs is to change the anvil piece and weld the side piece of the flat bar back to that piece. There were not enough repair anvil pieces to change all of the broken shock bars that were identified. Instead, only the worst areas were replaced with new anvil pieces and repairs were made in all other areas by pulling the broken pieces of the shock bars in and welding them in place. Both of these repairs are temporary. Plans should be made to replace all shock bars starting with the inlet fields and then moving out to the second field. Hoppers will need to be scaffolded in order to do this. This repair effort should be done systematically.

**Bottom Right:** Many problems were identified with the collecting plate hammers. There are a significant amount of hammers missing and worn bearings. There are also two different styles of hammers installed.

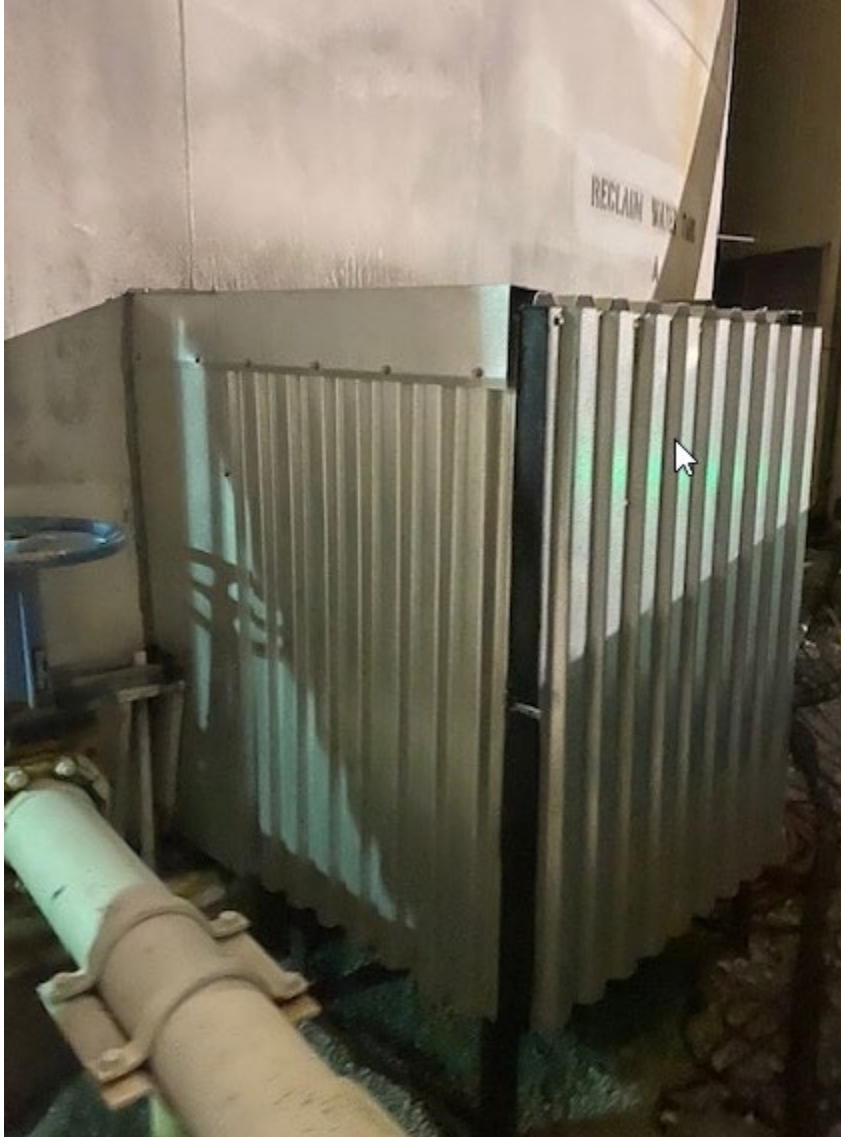
The reclaim tank level transmitter has been heat traced & enclosed as shown in the photo below.

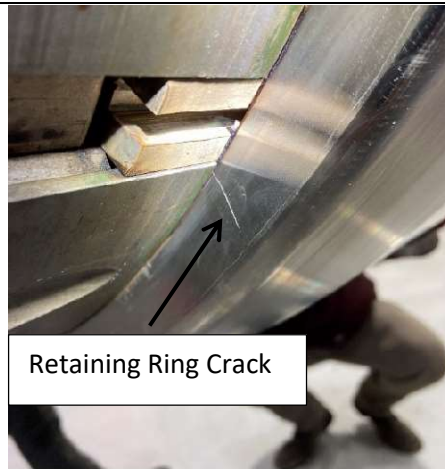
AS FOUND EXCITER END RETAINING RING CRACK

Before rotor final installation into the main generator, an approximately 1-inch crack was found on the inboard side of the exciter end retaining ring. The turbine end retaining ring had non-destructive (NDE) testing (ultrasonic testing) completed and no indications or visible cracks were found; this retaining ring was not replaced. Please see the structural integrity report for further details on the turbine end retaining ring NDE testing.

The exciter end retaining ring was removed and replaced with a new retaining ring from MD&A and was installed by CMS; new retaining ring winding insulation was used and was supplied by GUND company. Due to the outage timeline, the exciter end cracked retaining ring failure analysis was not able to be completed (see ATC failure analysis report) therefore, the AEP team decided to remove any possible stress concentrations on the rotor forging in the retaining ring shrink fit location to prevent a future crack re-occurrence. It should be noted that the shrink fit of the retaining ring was reviewed and is of the industry standard of 2-3 mills per inch of diameter. Finally, the retaining ring inboard side radius was also increased as it appeared that the existing radius was somewhat small. The rotor was not balanced before being returned to service.

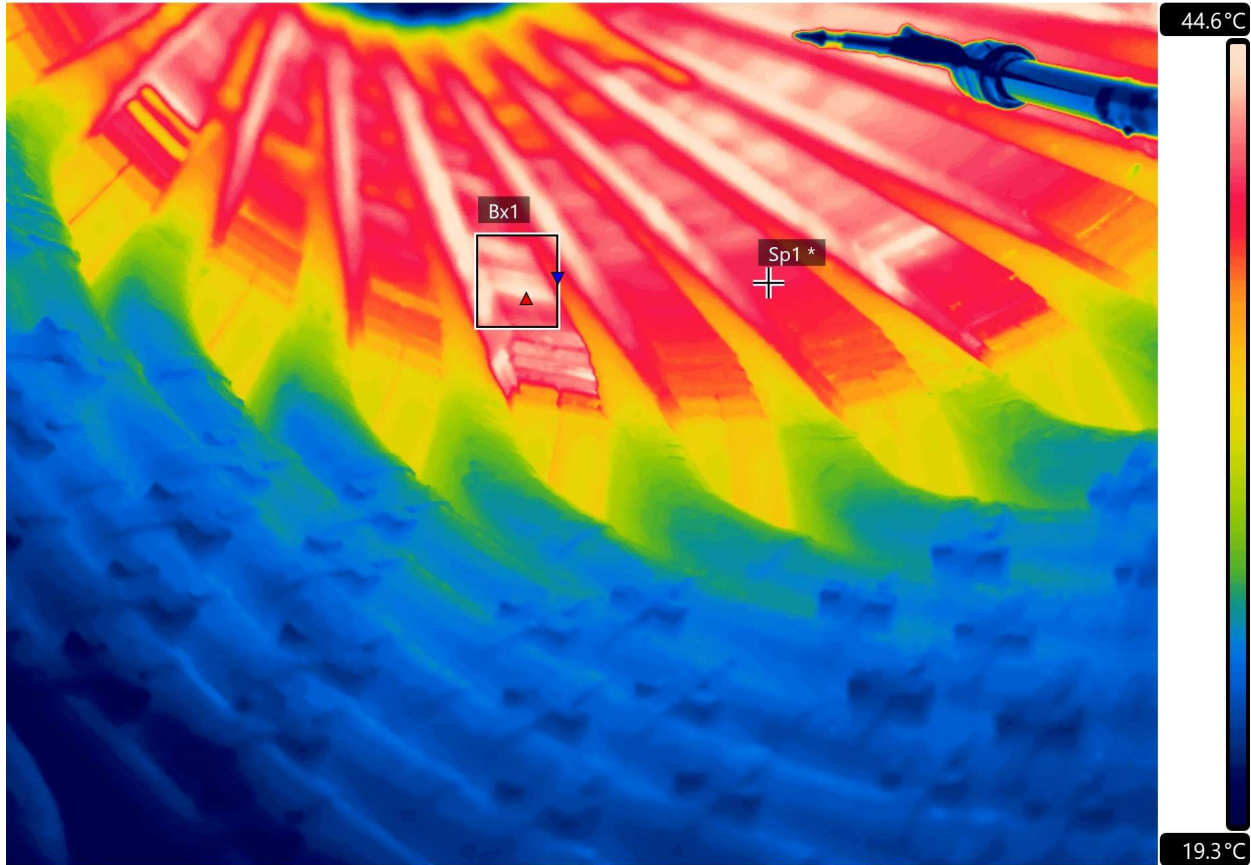
FLIR0542.jpg | 246° SW

5 C  
 Quadrant 2, exciter end, in the core iron.

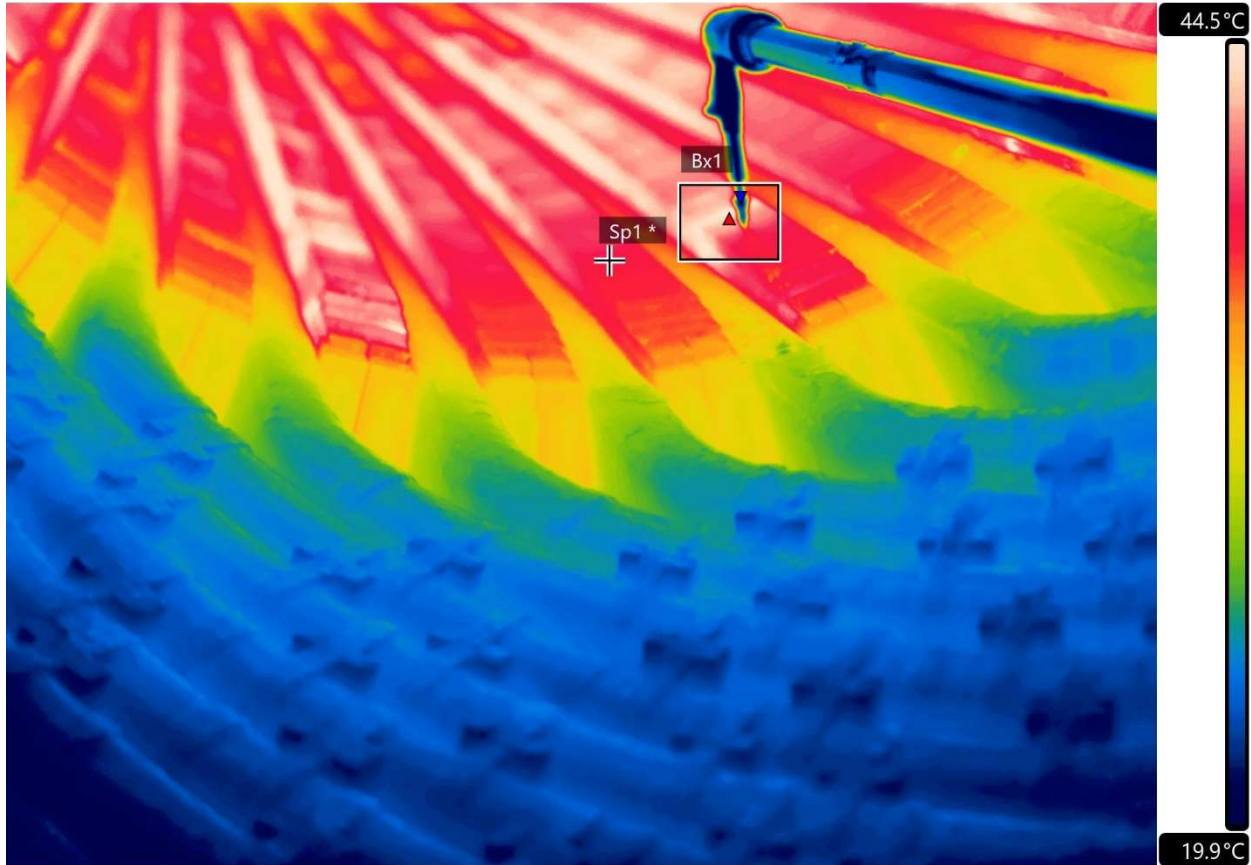
FLIR0544.jpg | 309° NW

8 C  
 Quadrant 2, exciter end, in the core iron, just past the end iron.

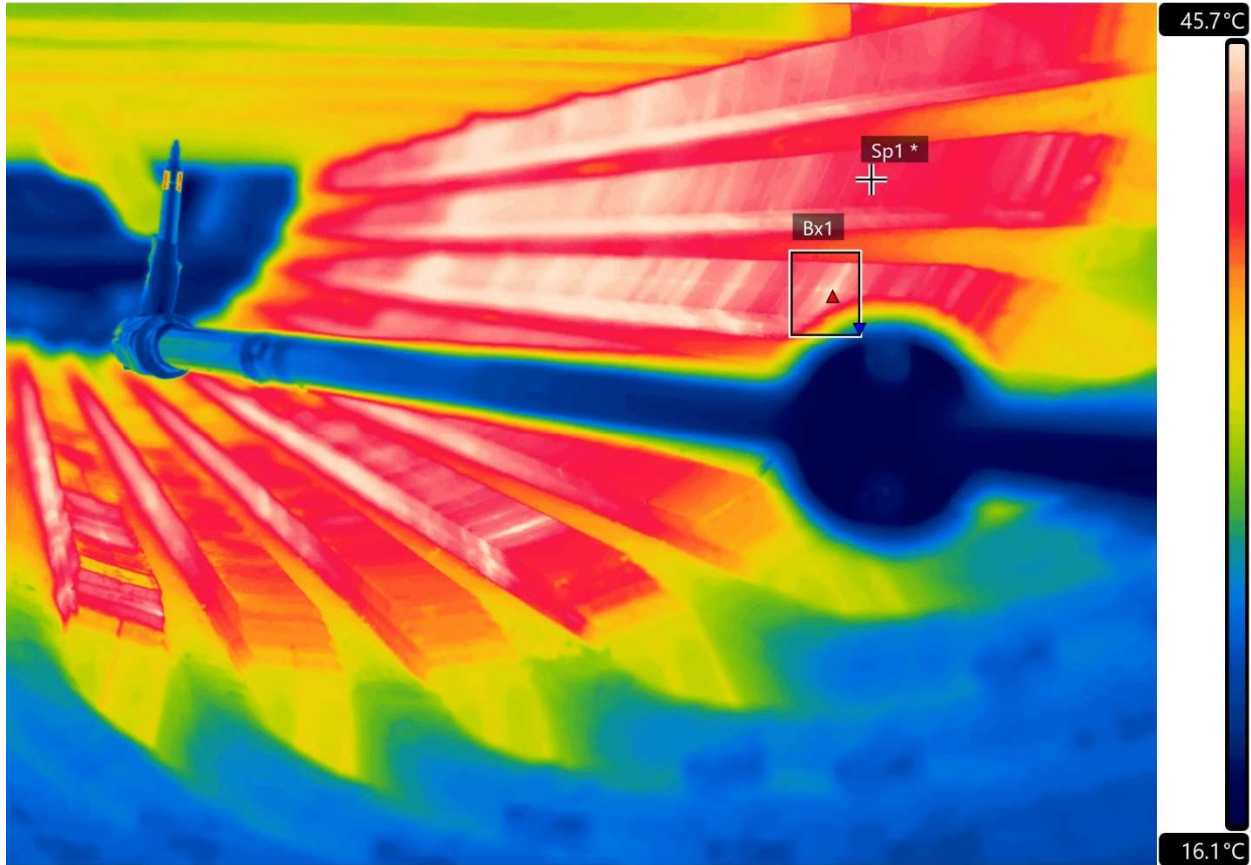
FLIR0546.jpg | 328° NW

5 C  
 Quadrant 2, exciter end, in the core iron.

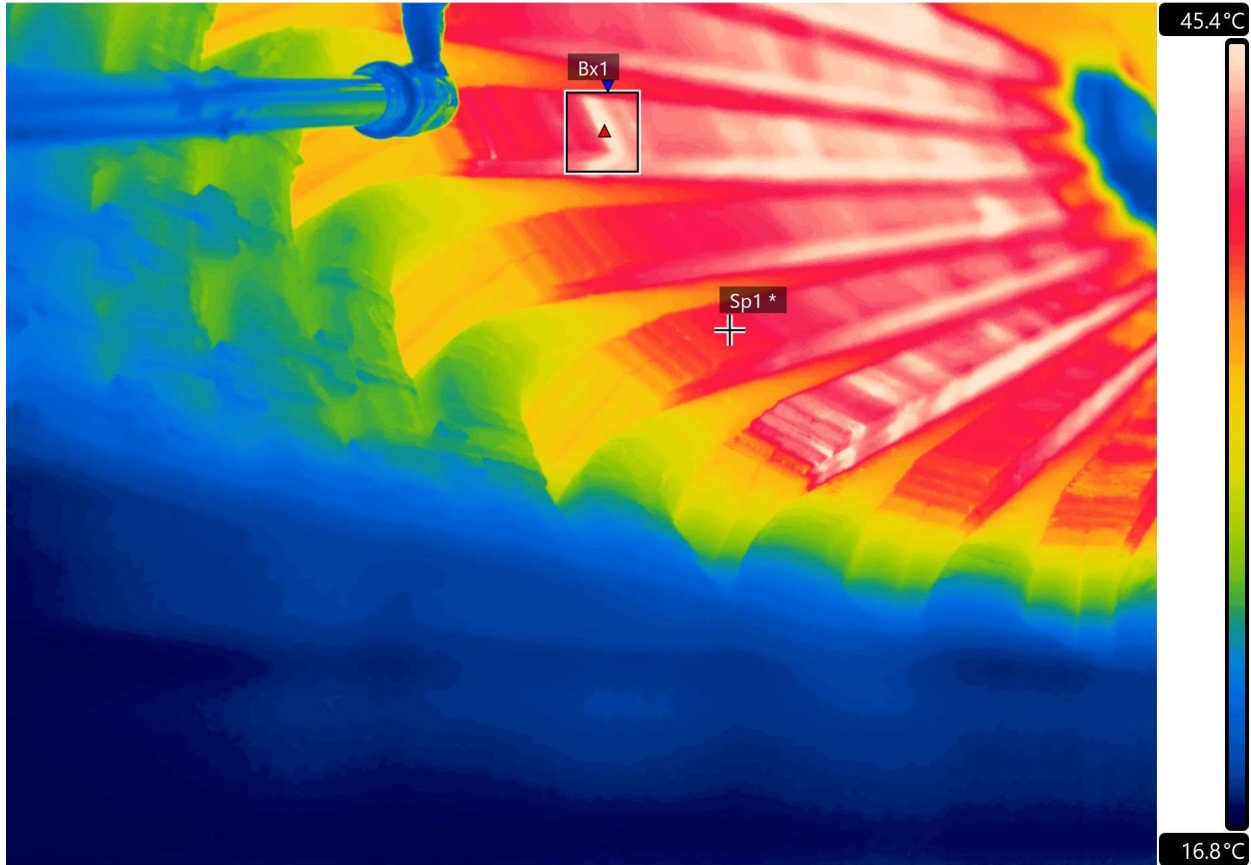
FLIR0548.jpg |

9 C  
 Quadrant 3, exciter end, in the core iron, just past the end iron.

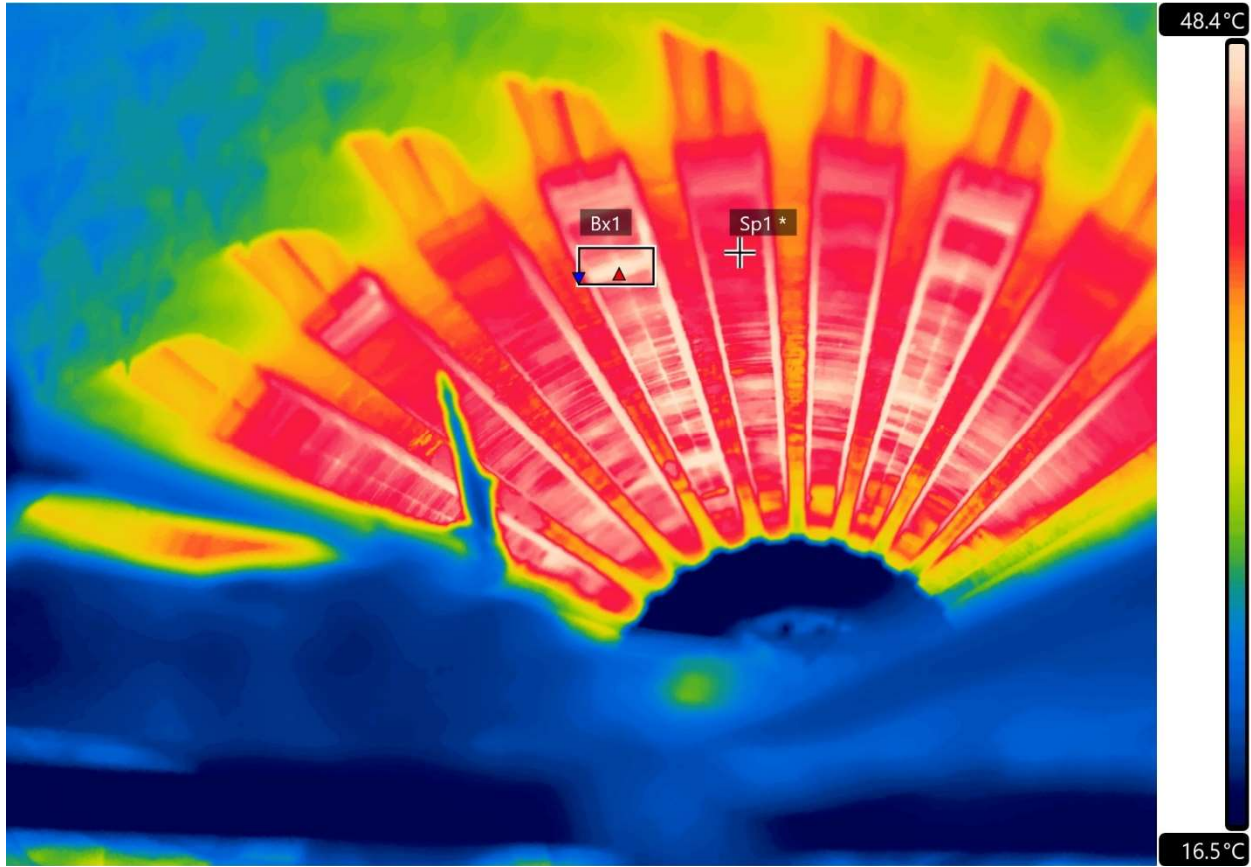
FLIR0550.jpg |

Quadrant 4, exciter end, This is in the core iron, just past the end iron.

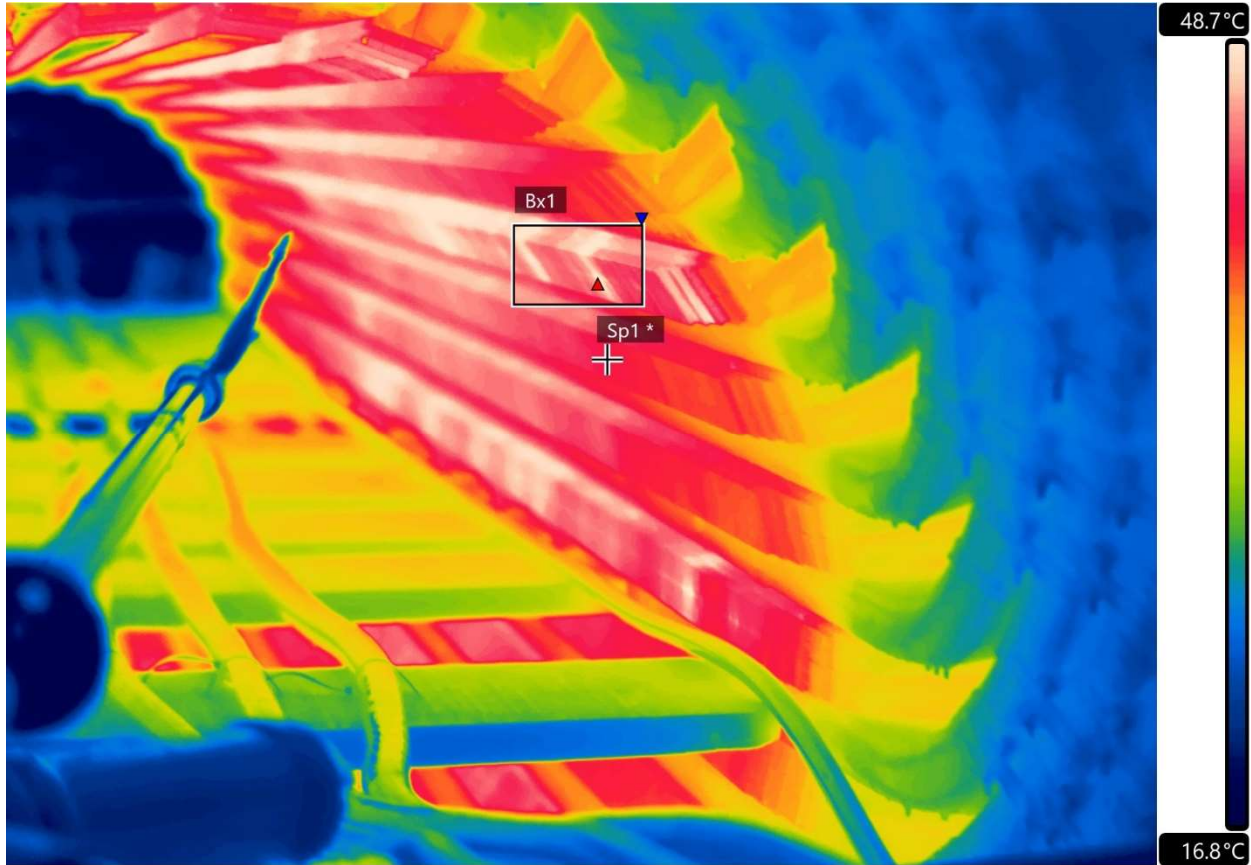
FLIR0552.jpg |

Quadrant 1, exciter end, this is in the core iron, about a foot into the iron.

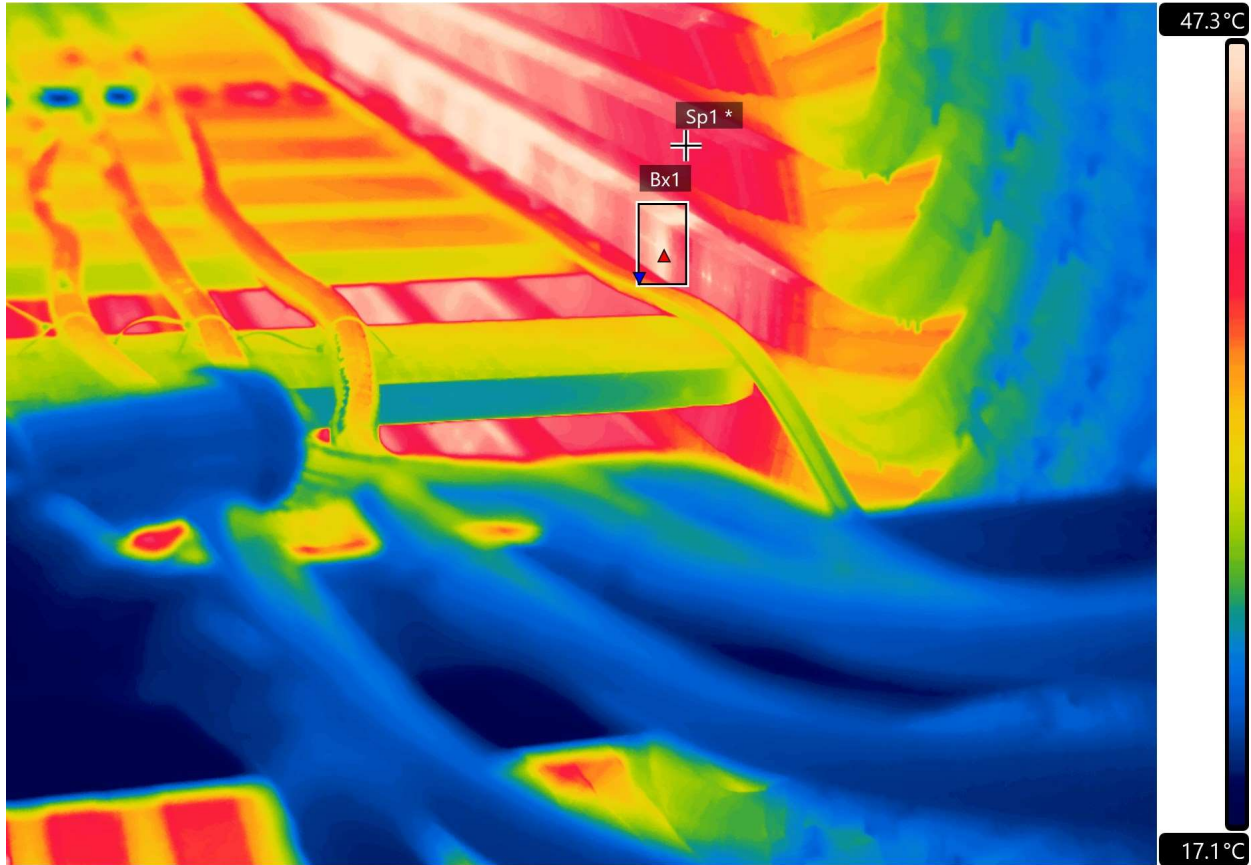
FLIR0554.jpg | 315° NW

12 C  
 Quadrant 1, exciter end, in the core iron about 6 inches past  
 the end ironl

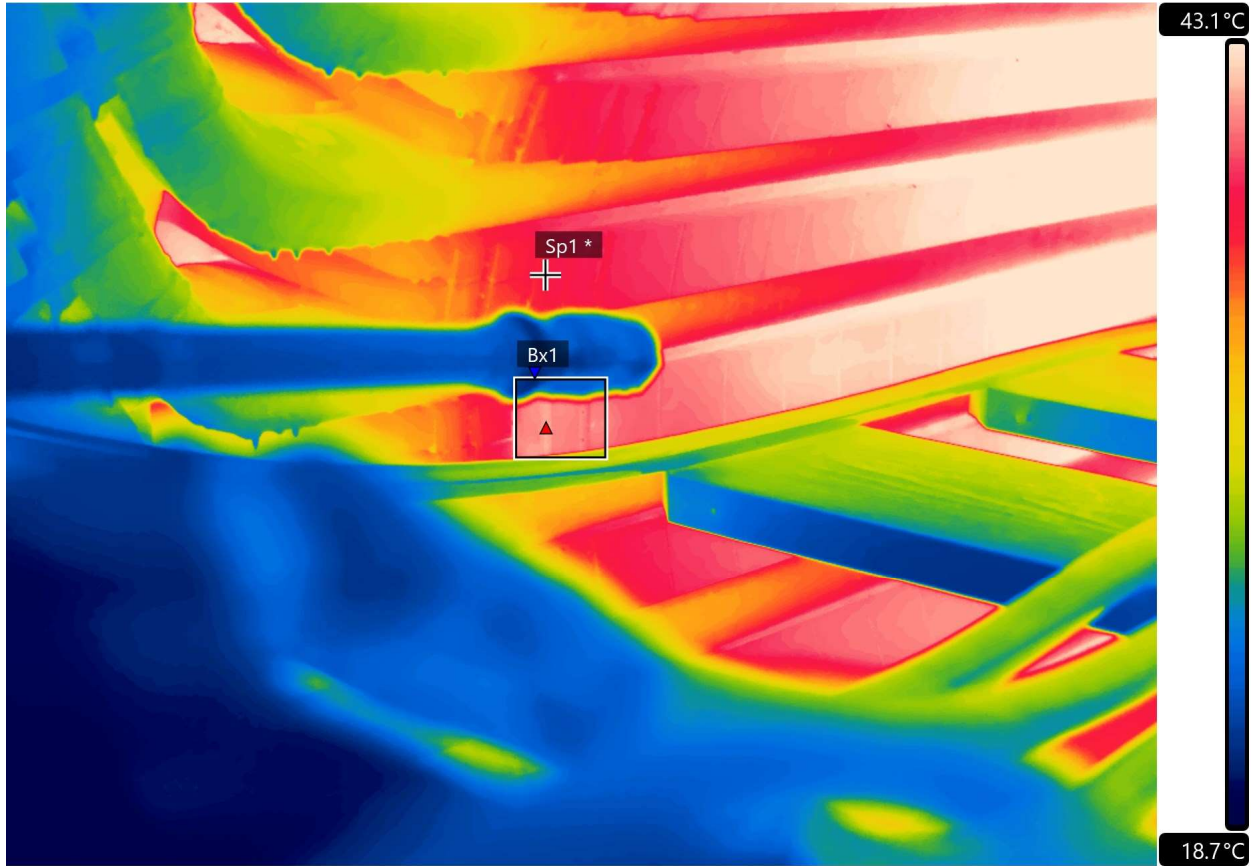
FLIR0556.jpg |

3 C  
 Quadrant 1, turbine end, in the end iron.

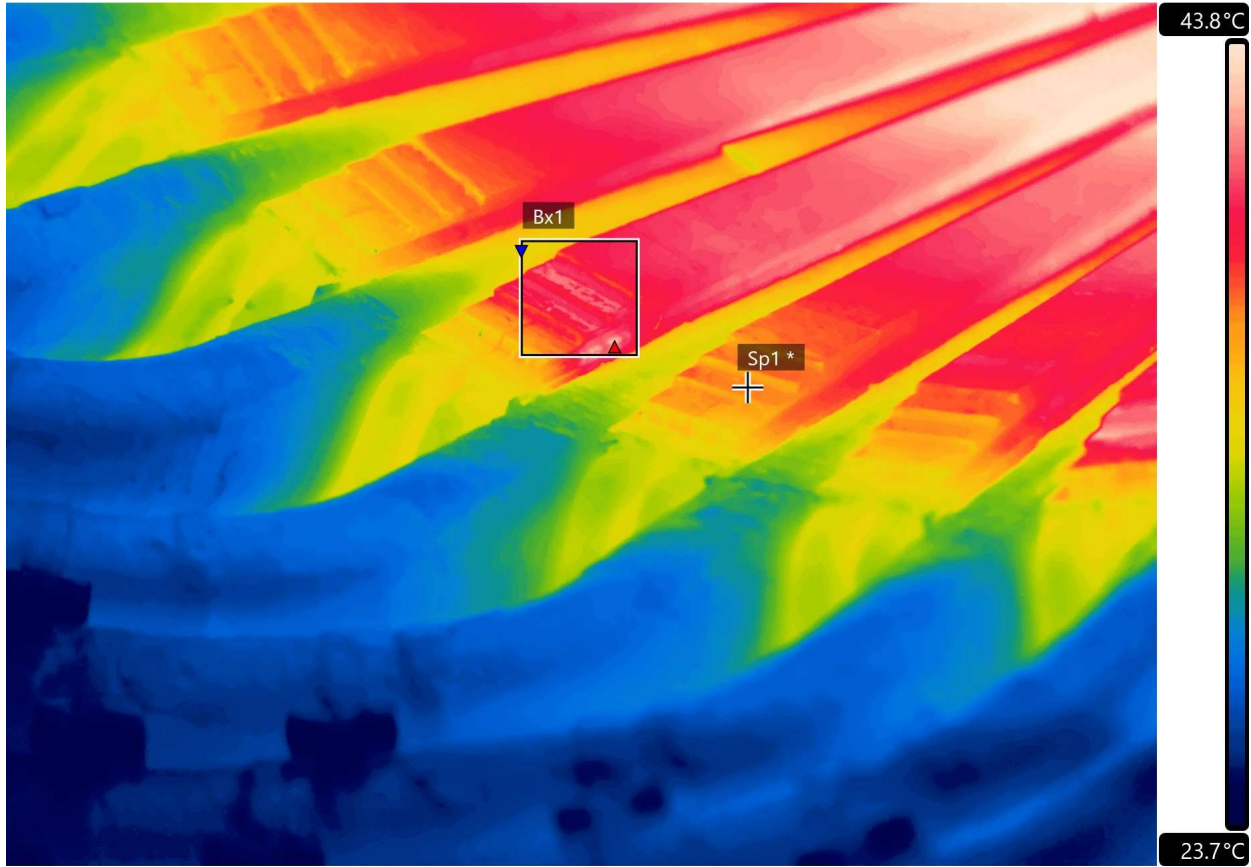
FLIR0558.jpg | 42° NE

6 C  
 Quadrant 2, turbine end, in the end iron. This one was 18 C  
 the day before.

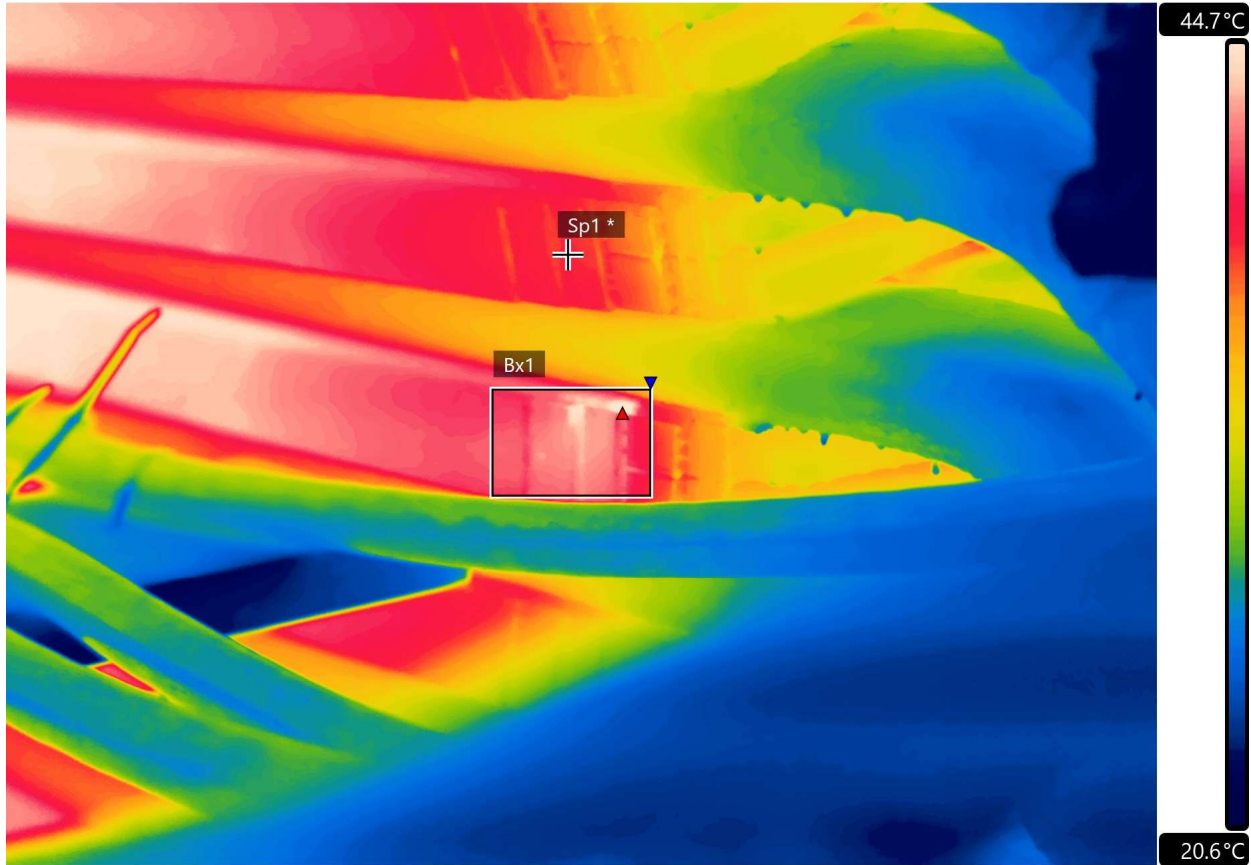
FLIR0560.jpg |

9 C  
 Quadrant 4, turbine end, in the end iron.

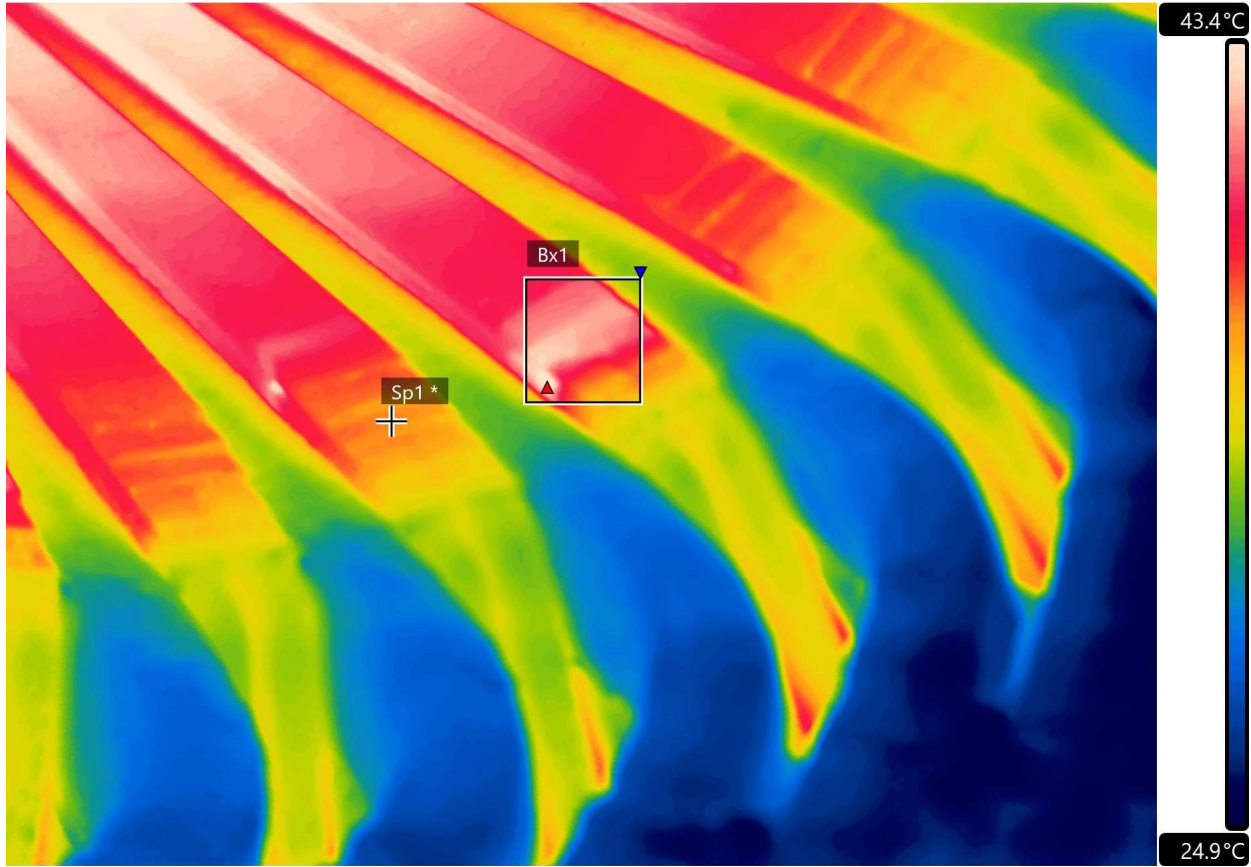
FLIR0562.jpg | 126° SE

7 C  
 Quadrant 3, turbine end, in the end iron.

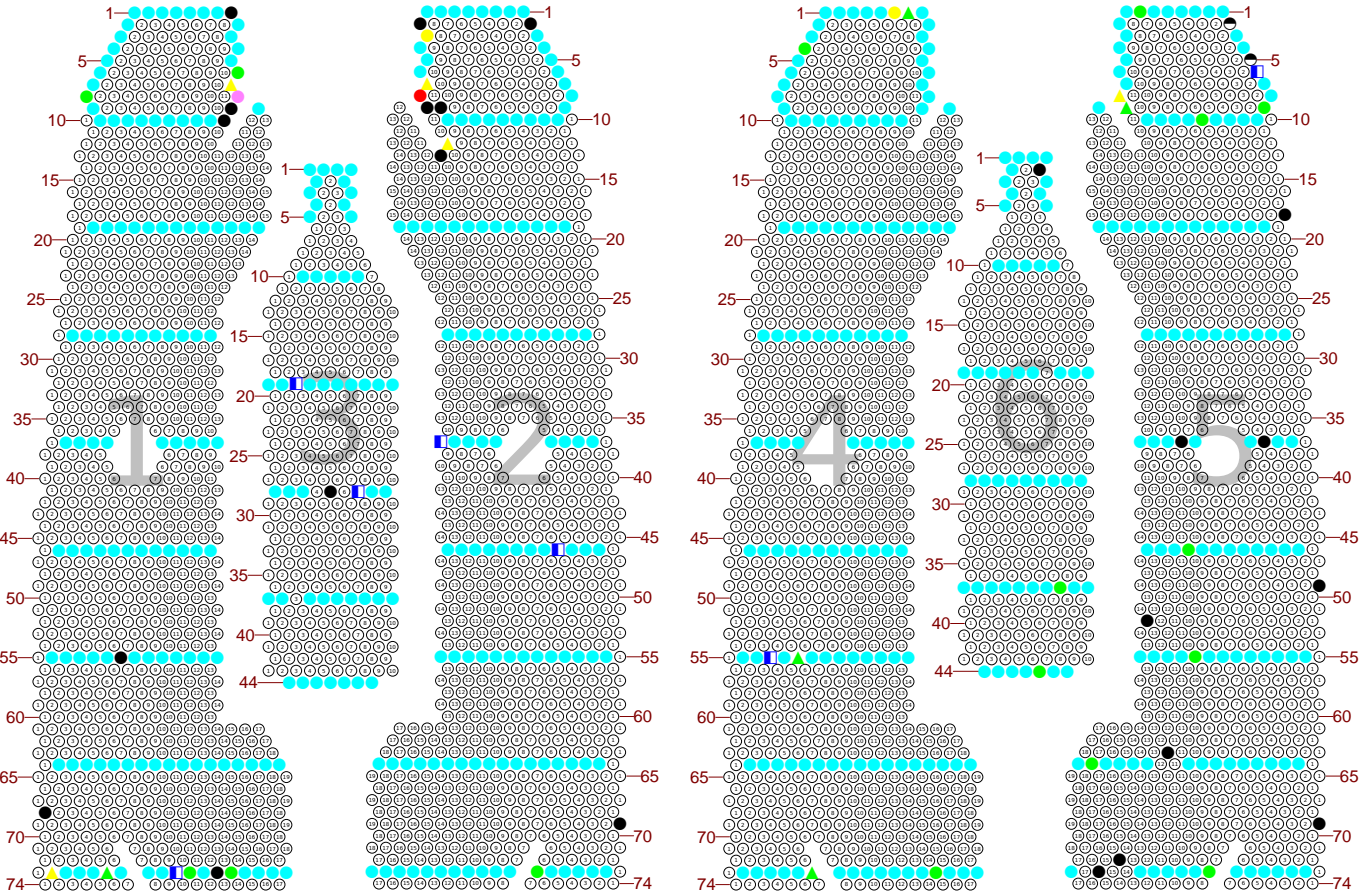
**RESULTS MAP**  
 KENTUCKY POWER  
 BIG SANDY  
 UNIT 1  
 MAIN CONDENSER  
 WEST UPPER  
 09-2022

Of the 589 tubes tested, a total of 30 tubes were found with pit-like indications measuring between 20% and 84% through-wall. Most of these pits were found on the tube OD. Nearly all were small, solitary indications. A total of 14 tubes had recordable dents. A total of 8 tubes were only partially tested due to restrictions (mainly dents) in the tube.

Overall, the tubes appeared to be in very good condition. One (1) tube is recommended to be plugged, based on the plugging criterion stated below.

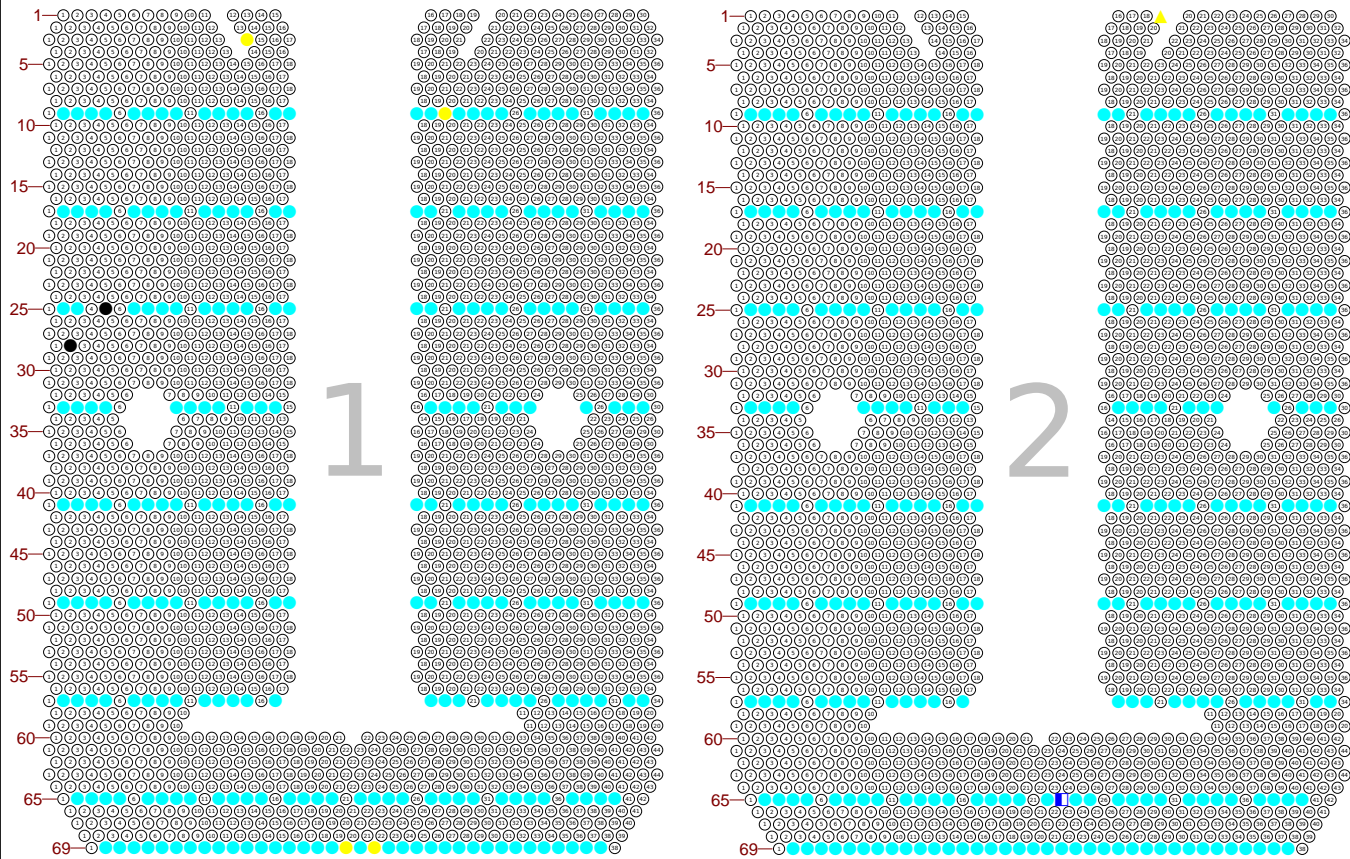
**RESULTS MAP**  
**KENTUCKY POWER**  
**BIG SANDY**  
**UNIT 1**  
**MAIN CONDENSER**  
**WEST LOWER**  
 09-2022

Of the 488 tubes tested, a total of 20 tubes were found with pit-like indications measuring between 20% and 60% through-wall. Most of these pits were found on the tube OD and nearly all were small, solitary indications. A total of 9 tubes had recordable dents. A total of 12 tubes were only partially tested due to restrictions (mainly dents) in the tube.

Overall, the tubes appeared to be in very good condition. There were no tubes recommended to be plugged.

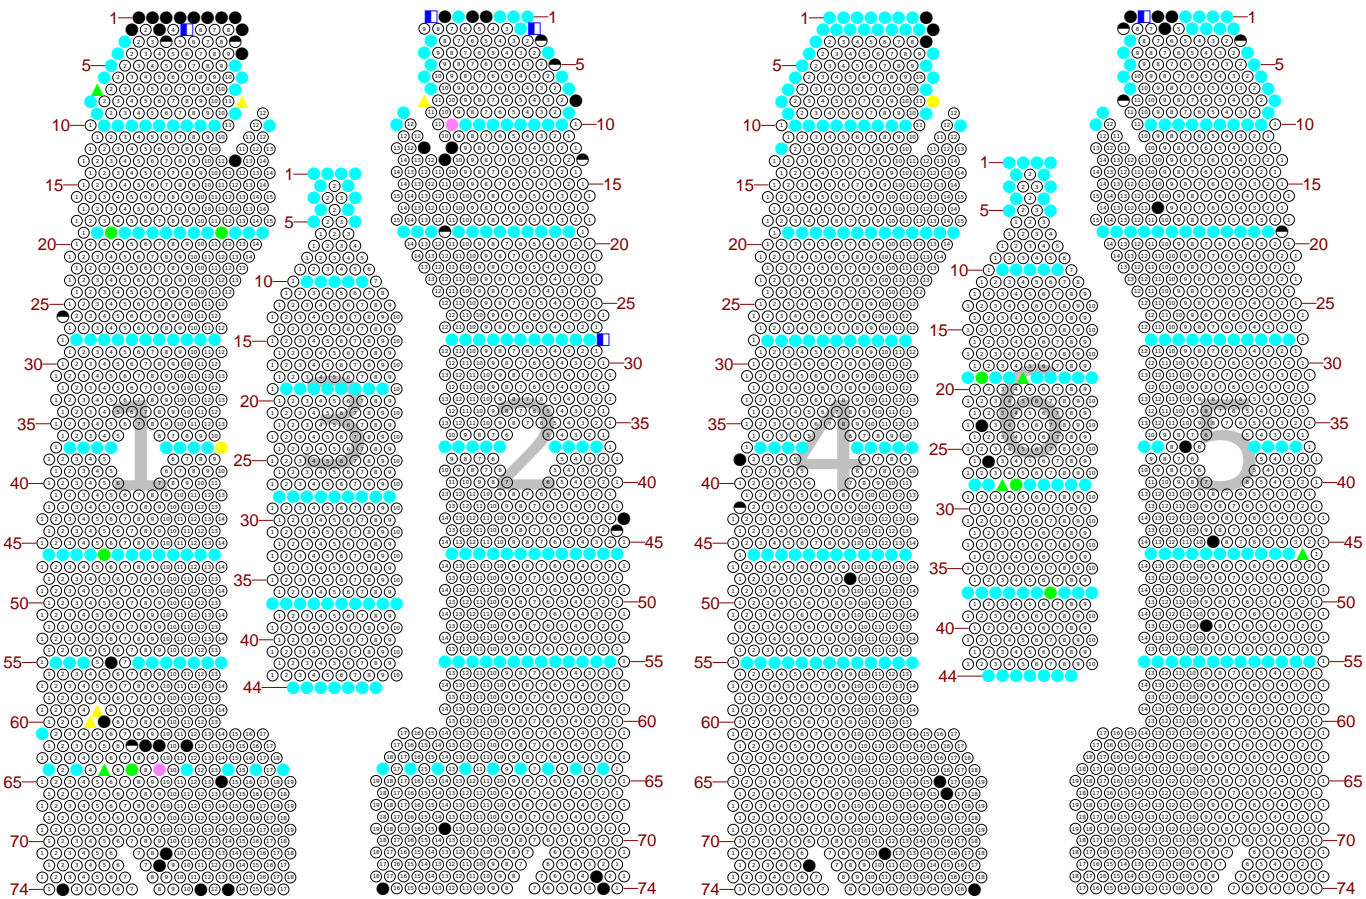
**RESULTS MAP**  
 KENTUCKY POWER  
 BIG SANDY  
 UNIT 1  
 MAIN CONDENSER  
 EAST UPPER  
 09-2022

Of the 518 tubes tested, a total of 5 tubes were found with pit-like indications measuring between 30% and 72% through-wall. All of these pits were found on the tube OD, and all were small, solitary indications. A total of 1 tube was only partially tested due to a restriction in the tube. Overall, the tubes appeared to be in very good condition. There were 31 tubes found to have been previously plugged. There were no additional tubes recommended to be plugged.
