Kentucky Power Company  
KPSC Case No. 2021-00370  
AG/KIUC's First Set of Show Cause Issue Data Requests  
Dated October 16, 2023  
Page 1 of 3

TRK Engineering Services, Inc. was retained by AEP Mitchell Plant to inspect the Unit 2 electrostatic precipitators (Box 3 and Box 4), develop a punch list of mandatory repairs, document needed repairs and make recommendations after evaluating the findings. Work priority was established with the plant during a “kick-off” meeting prior to entering the unit.

The AEP Unit 2 electrostatic precipitator (ESP) system consists of two (2) side-by-side precipitators (ESP 3 & ESP 4) operating in parallel. The precipitators serve an 850 MW boiler. The dual chamber precipitators were designed and manufactured by Wheelabrator (installation circa late 1970s).

**2022 Big Sandy Unit 1 Generator Inspection Report 10/11/2022 to 10/14/2022**

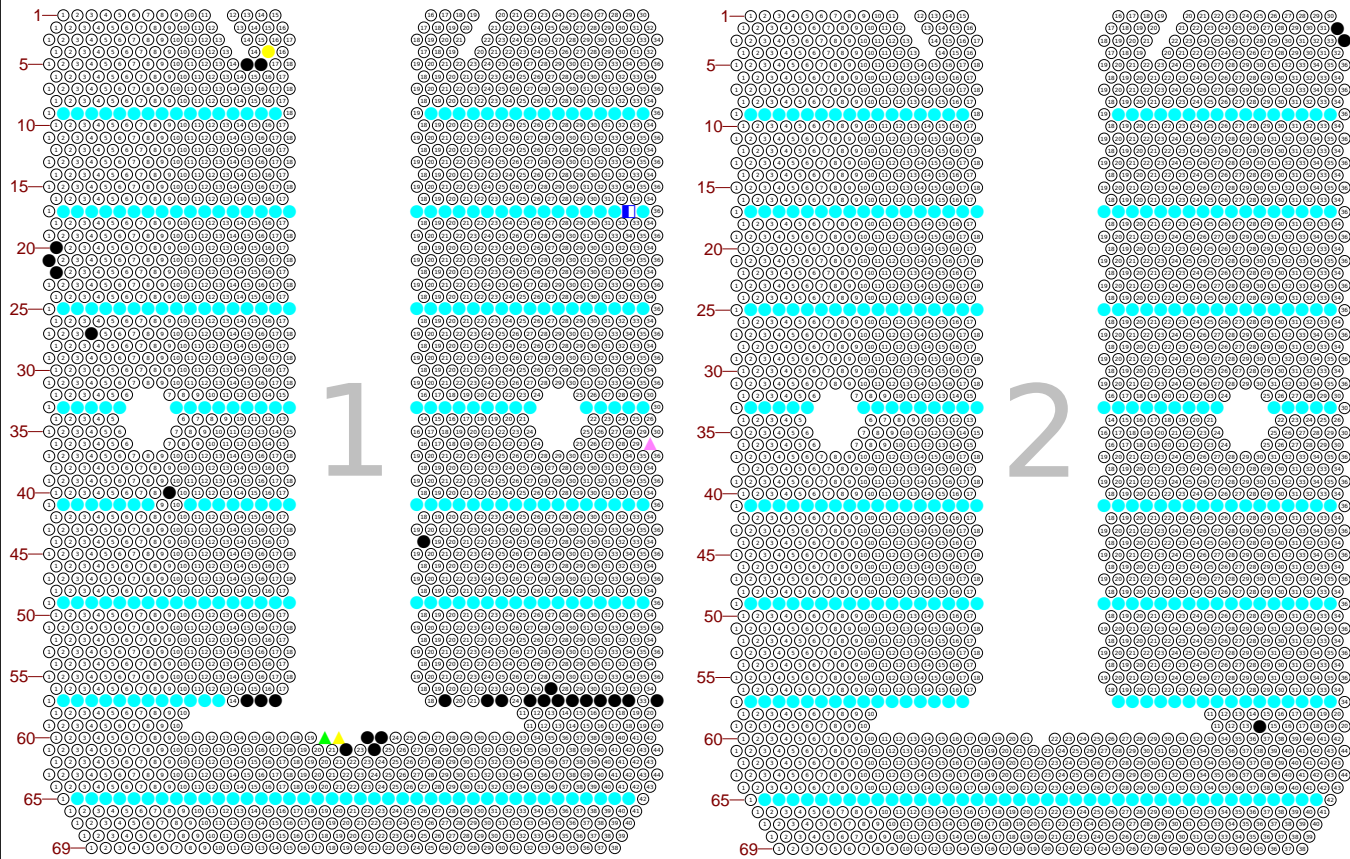
**RESULTS MAP**  
**KENTUCKY POWER**  
**BIG SANDY**  
**UNIT 1**  
**MAIN CONDENSER**  
**EAST LOWER**  
**09-2022**

Of the 513 tubes tested, a total of 5 tubes were found with pit-like indications measuring between 40% and 54% through-wall. All of these pits were found on the tube OD, and all were small, solitary indications. A total of 1 tube was only partially tested due to a restriction in the tube. Overall, the tubes appeared to be in very good condition. There were no tubes recommended to be plugged.

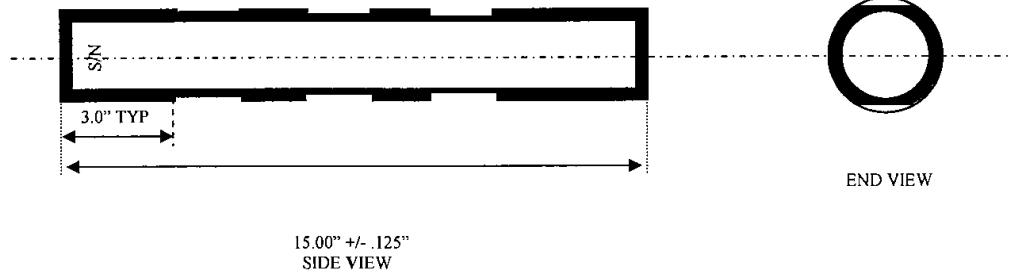
LOCATION	A	B	C	D	E	F	G	H	I	J
ACTUAL DEPTH	.013"	.026"	.039"							
% OF WALL LOSS	25%	50%	75%							
FLAW WIDTH/DIA. +/- .005"	1.0"	1.0"	1.0"

ALL LOCATIONS SHOW O D FLATS 1.00" IN LENGTH AXIALLY MILLED @ 0 DEG. & 180 DEG.

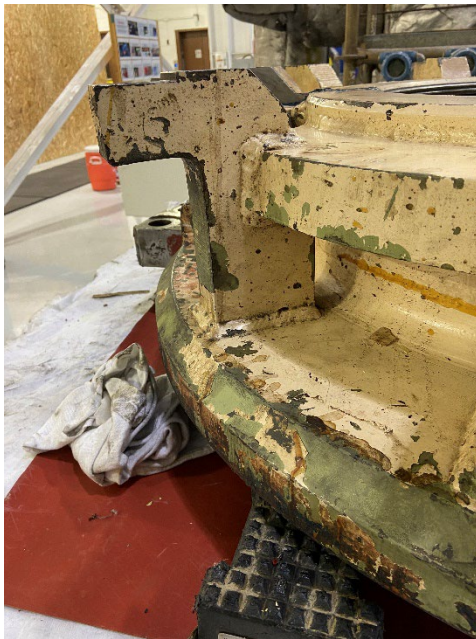
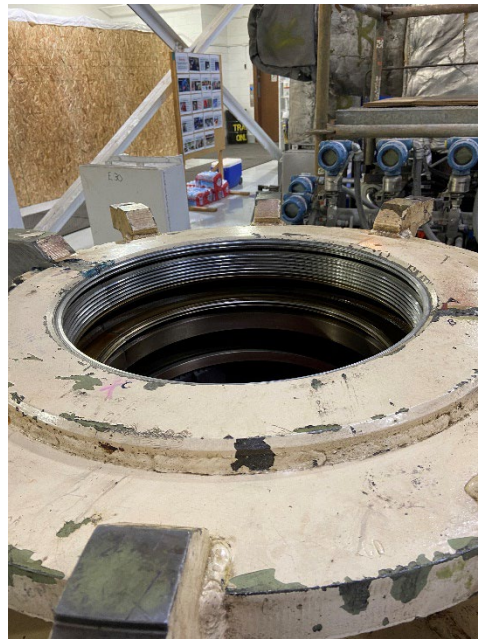
Visual inspections of the housings after removal revealed loose and flaking paint. Lead containing dust, believed to be paint chips, were found inside the generator stator. Due to the above, the existing lead paint was removed from the hydrogen seal housing by laser ablation. Both hydrogen seal housings were repainted with Red Glyptal prior to reassembly.

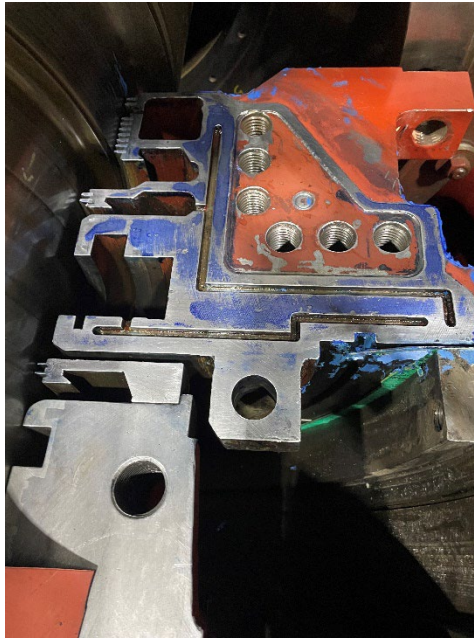
During an air test the collector end hydrogen seal housing was found leaking on the left side horizontal joint. The gland seal housing and seal rings were shipped to CMS for inspections and repairs. The following picture shows the lower left

side horizontal joint bluing prior to repairs. As can be seen the contact on the outboard side (middle of photo) was found insufficient. Blue checks after repairs showed good contact. RTV60 was applied to the horizontal joint during reassembly. Subsequent stator air tests revealed no further leaks at the hydrogen seal.

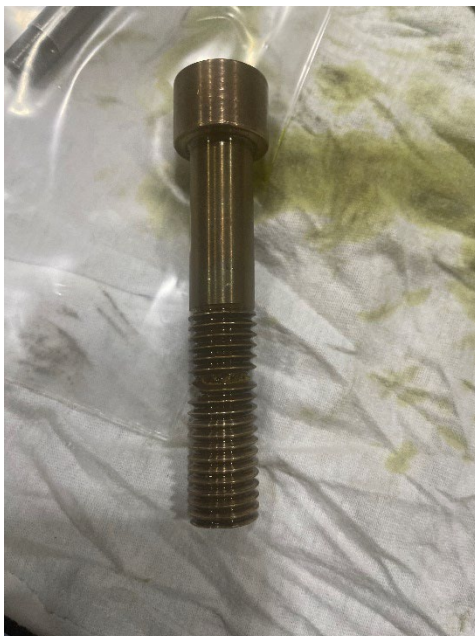
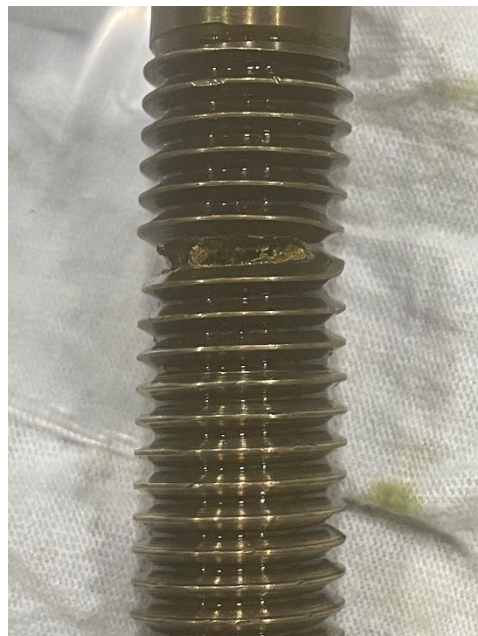
A brass bolt used to secure the top and bottom seal rings was found cracked/broken. A new bolt was fabricated Dillon Machine and installed during reassembly.

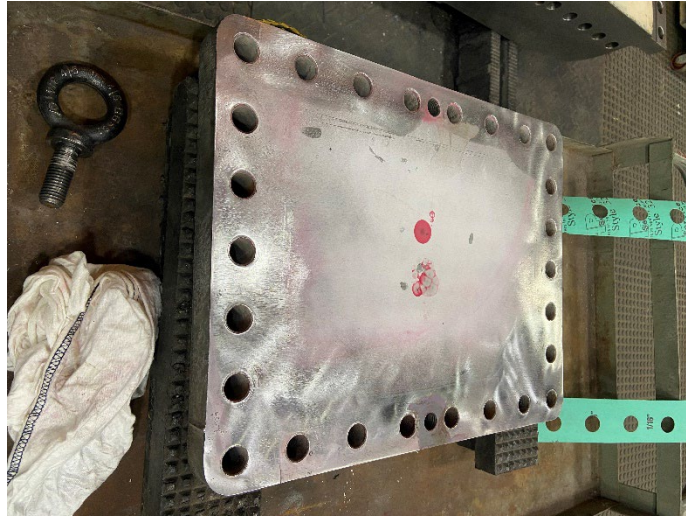
A manway door bolted to the belly of the stator was found to be leaking. The leaks appeared to be from a previous weld repair. Attached is the NDE report and pictures of the leaking area. A new door was fabricated at the AEP Fab Shop and installed with a new gasket. No further leaks were noted.
