Engineering Memorandum

Randview (Wastewater) – No discharge/No permit Engineering Memorandum Date: February 8, 2020

River Bluff (Wastewater) – KY0043150

Springcrest Sewer – Springcrest Wastewater Disposal System Kentucky Engineering Memorandum Date: September 11, 2020

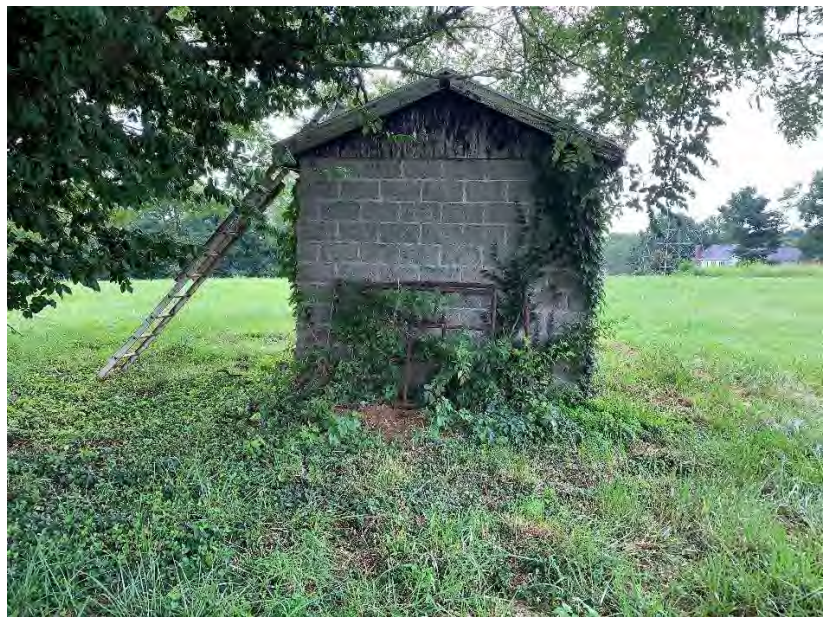
There is a single control panel for all four irrigation pumping systems located in a masonry building between the pump stations and the irrigation area. The pump stations, controls, electrical gear and masonry building internals all appear to be in good working order.

Electrical / Control Building and Irrigation Area in Background

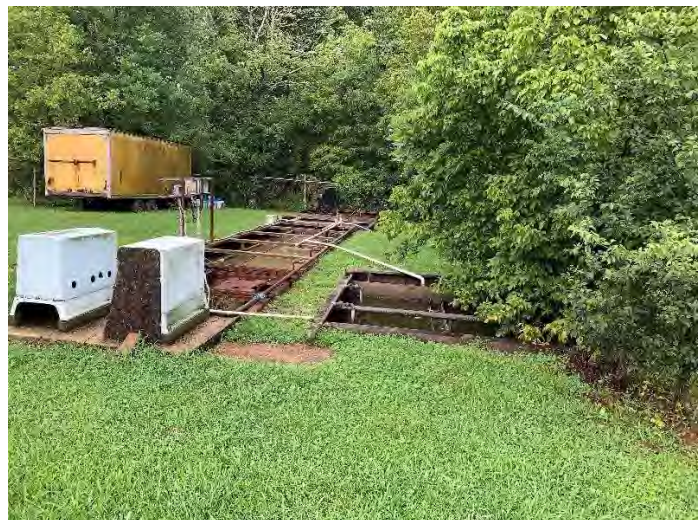
The existing facility includes an extended aeration package plant including a mechanically cleaned bar rack screen, a single aeration basin, equalization basin with two influent pumps (one portable), aerobic digestion, rapid sand filter, and a chlorine contact tank. Dechlorination is utilized downstream of disinfection.

The packaged plant has aged and shows significant signs of wear and corrosion. The blowers and diffusers are in need of replacement, and one of the two RAS lines has broken off into the aeration basin. The basin appears to have been modified over time with changes to original structural components. The basin does not include handrail needed to protect operators or visitors from falling into the package plant.

- The condition of the tank calls for taking the facility off line for structural repair, at a minimum to include the addition of access bridge improvements, safety handrail, welding repairs, and the addition of a new RAS line from one of the hopper bottomed clarifiers to the front end of the plant. Because of this, it makes sense to take advantage of the down time to upgrade the

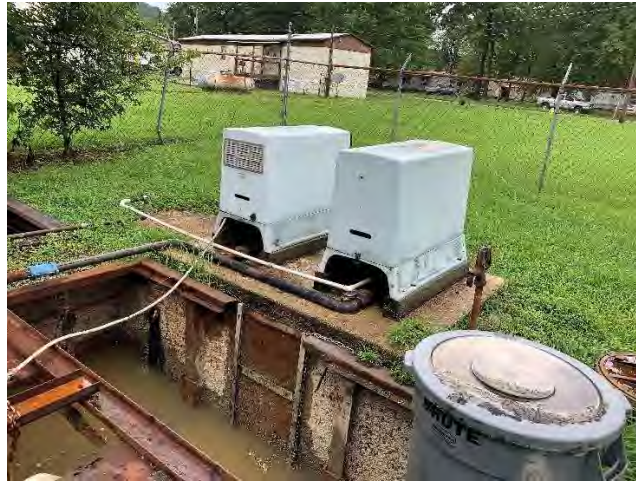
Blowers, EQ Basin, and Electrical Cables

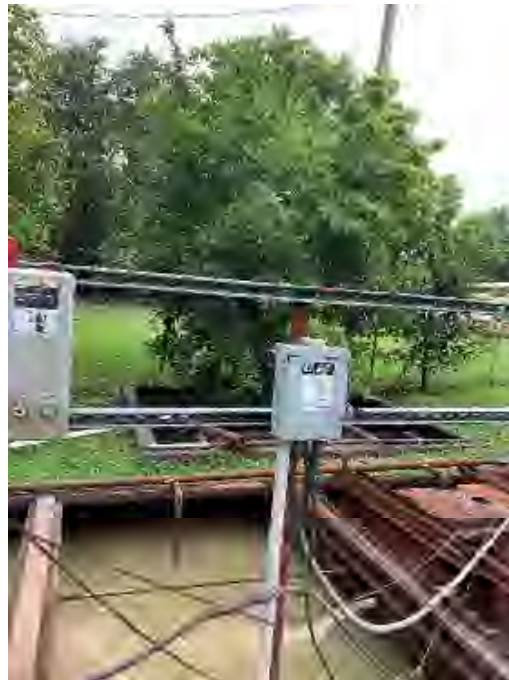
**Electrical Boxes and
Electrical Cabling**

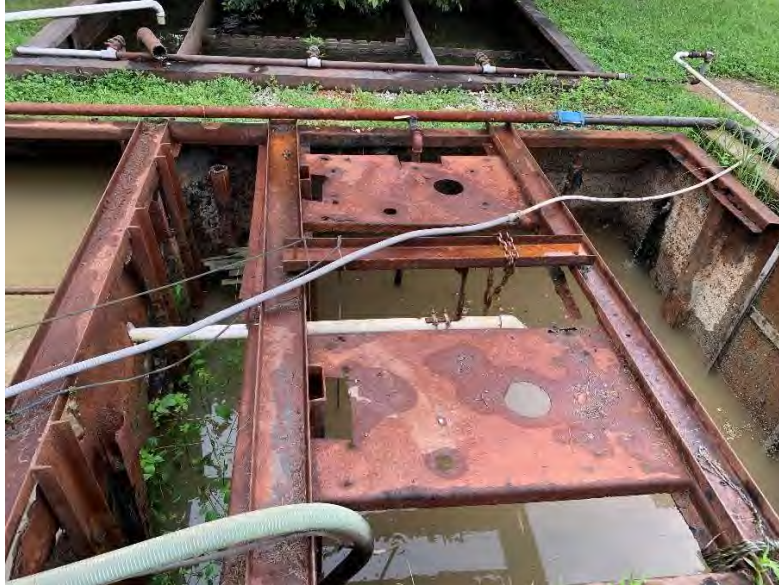
**EQ Basin, Portable Pump Discharge,
Digester, Miscellaneous Electrical Cables**

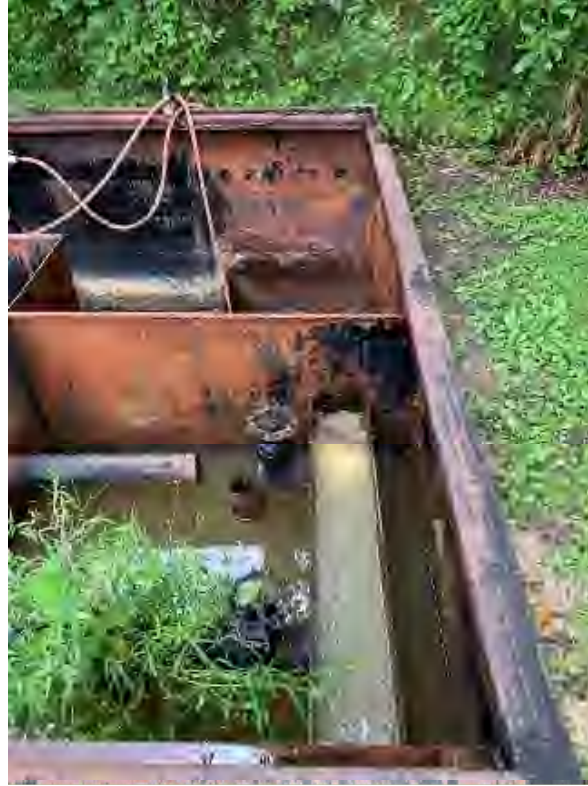
Chlor/Dechlor Structure

- The operator believes it is necessary to turn off aeration during wet weather events to minimize the loss of solids and to retain a healthy biomass.
- The tertiary treatment basin (rapid sand filter, contact tank and dechlorination tank) is highly corroded.
