**COMMONWEALTH OF KENTUCKY
BEFORE THE PUBLIC SERVICE COMMISSION**

**ELECTRONIC APPLICATION OF)
BLUEGRASS WATER UTILITY)
OPERATING COMPANY, LLC FOR AN) Case No. 2022-00432
ADJUSTMENT OF SEWAGE RATES)**

DIRECT TESTIMONY

JACOB FREEMAN

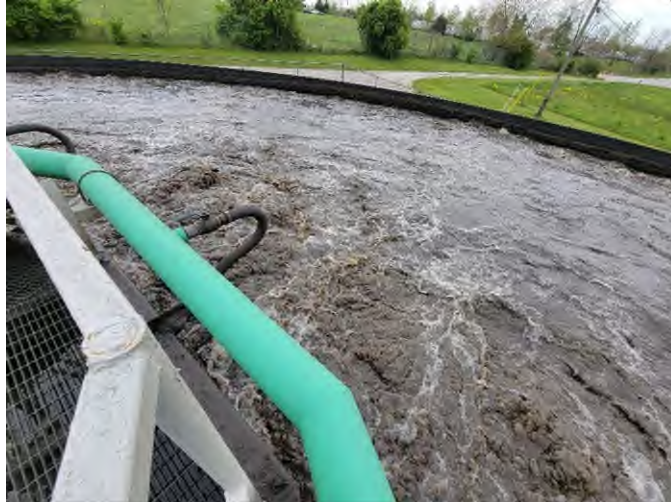
Coarse air diffusion pattern in aeration basins.

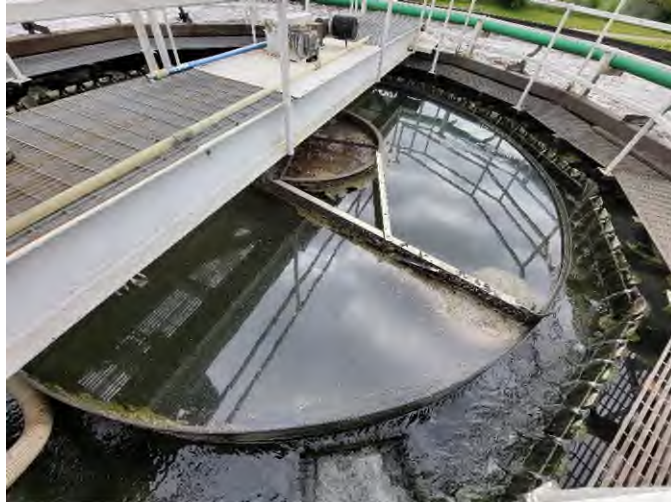
Notable solids passing through clarifier.

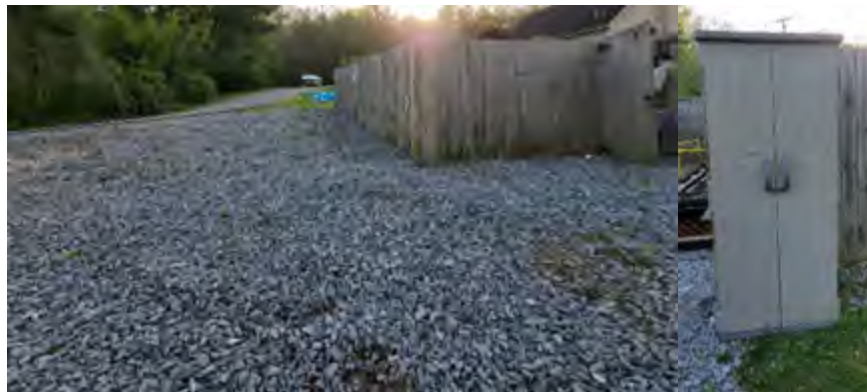
11
12 *New rock applied to site and storage cabinet installed.*

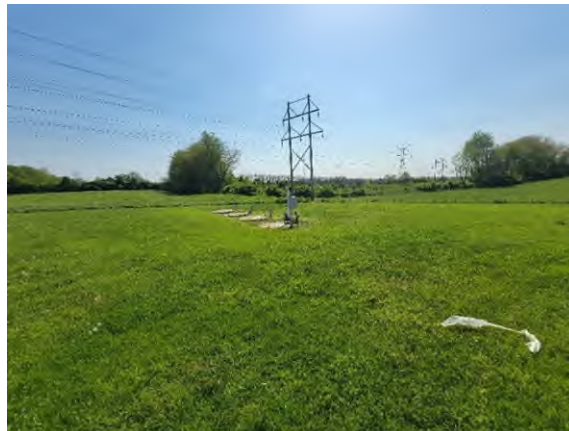
14
15 *Drain field and wet well area mowed and being maintained.*

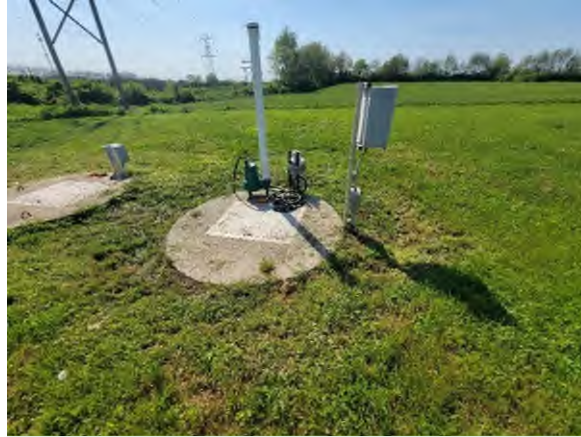
Small blower and control panel installed at wet well basins.

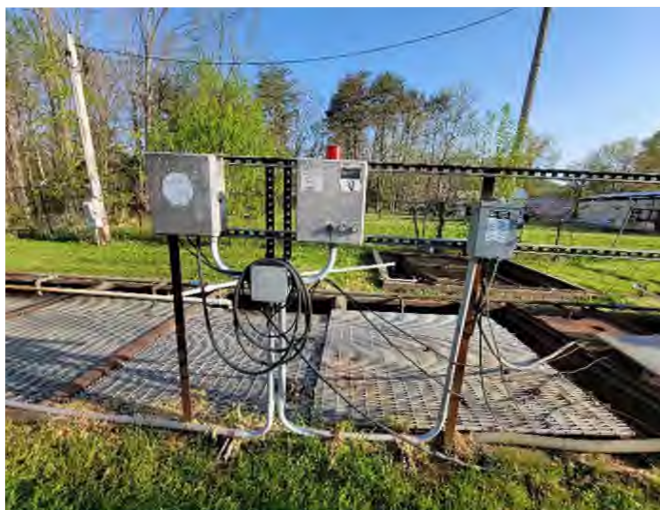
15 *New handrails and basin covers installed for operator safety.*
