Great Oaks-Kentucky (Wastewater, KY0080845)

Engineering Memorandum

Date: February 19, 2019

Herrington Haven Subdivision – Herrington Haven WWTP KY0053431
Kentucky
Engineering Memorandum
Date: September 11, 2020

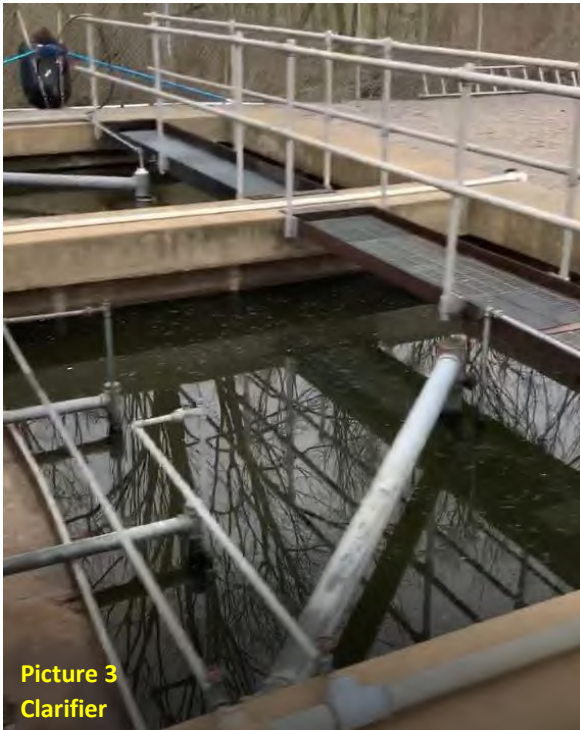
Picture 3
Clarifier

floc in the clarifier is vital in maintaining a healthy facility. Additionally, the effluent trough appears to have some green algae attached to the bottom, which if not cleaned, may build up and cause issues with effluent samples periodically. The clarifier should be cleaned as well as evaluated for size after actual dimensions and/or as-built drawings are provided. (Appendix Picture 3)
