Phase I Environmental Site Assessment

Frontier Solar Site

Marion and Washington Counties, Kentucky

19 January 2024

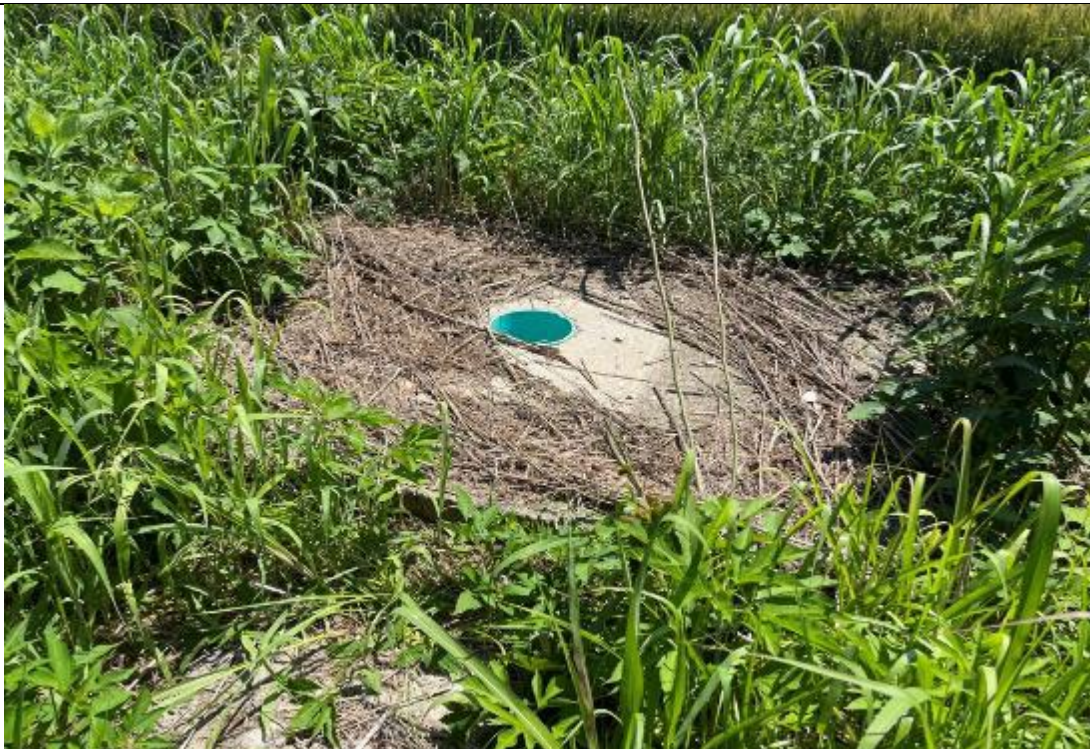
Photograph: 4 | View of groundwater well.

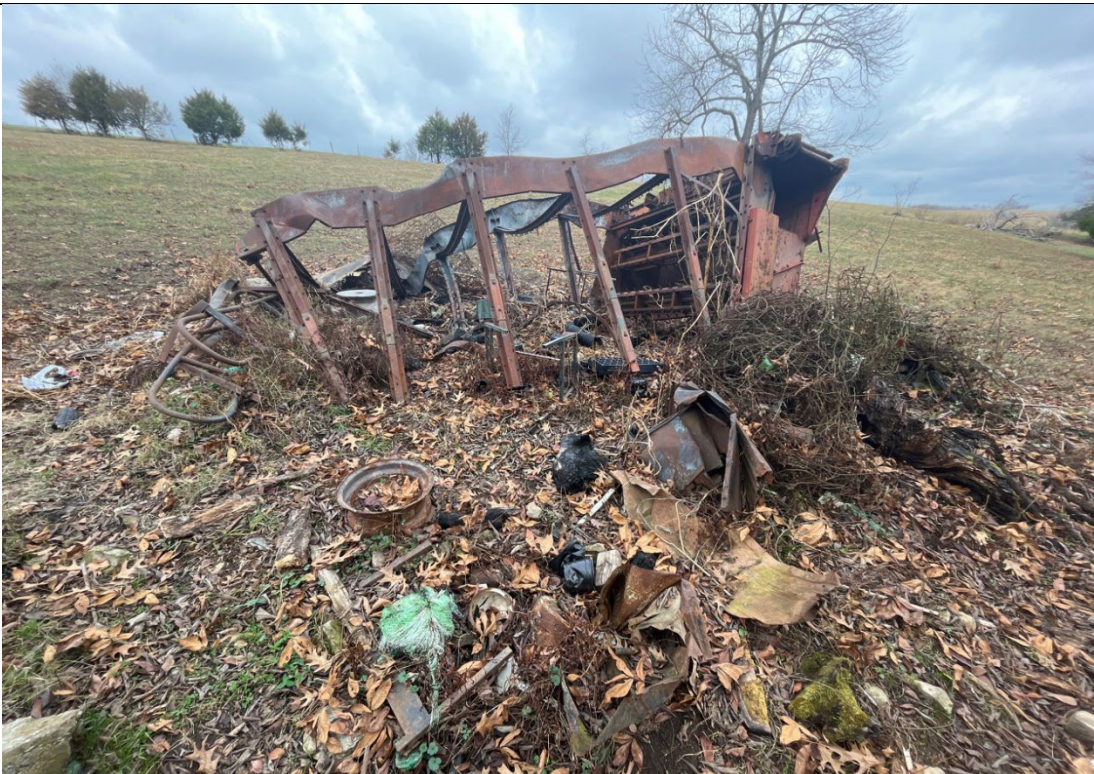
Photograph: 8 | View of a scrap metal debris pile.

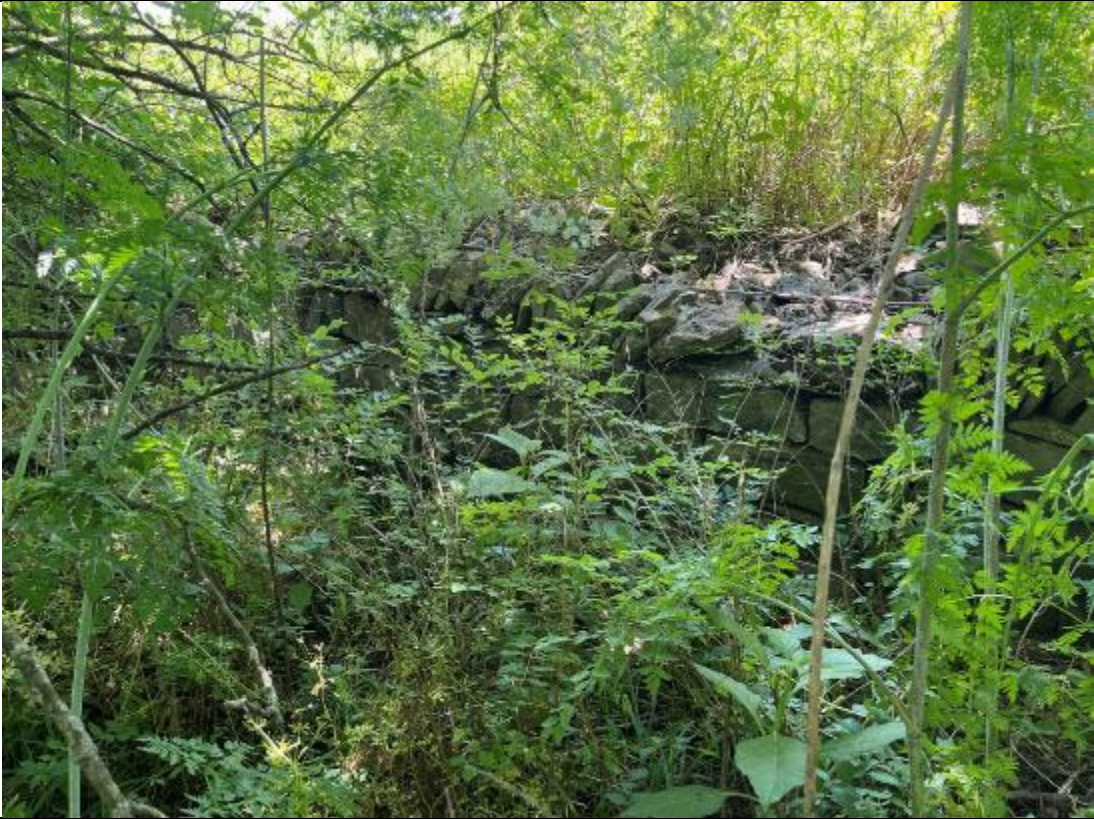
Photograph: 11 | View of the former building foundation.

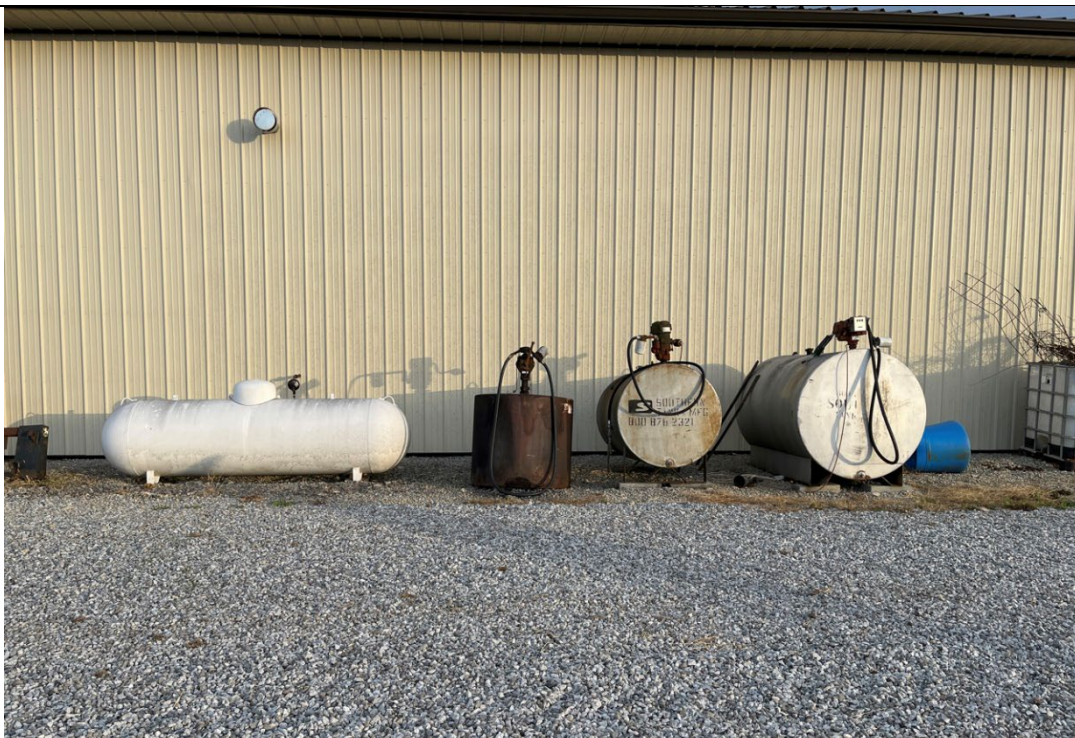
Photograph: 14 View of ASTs land tote located within the eastern-central portion of the Site.

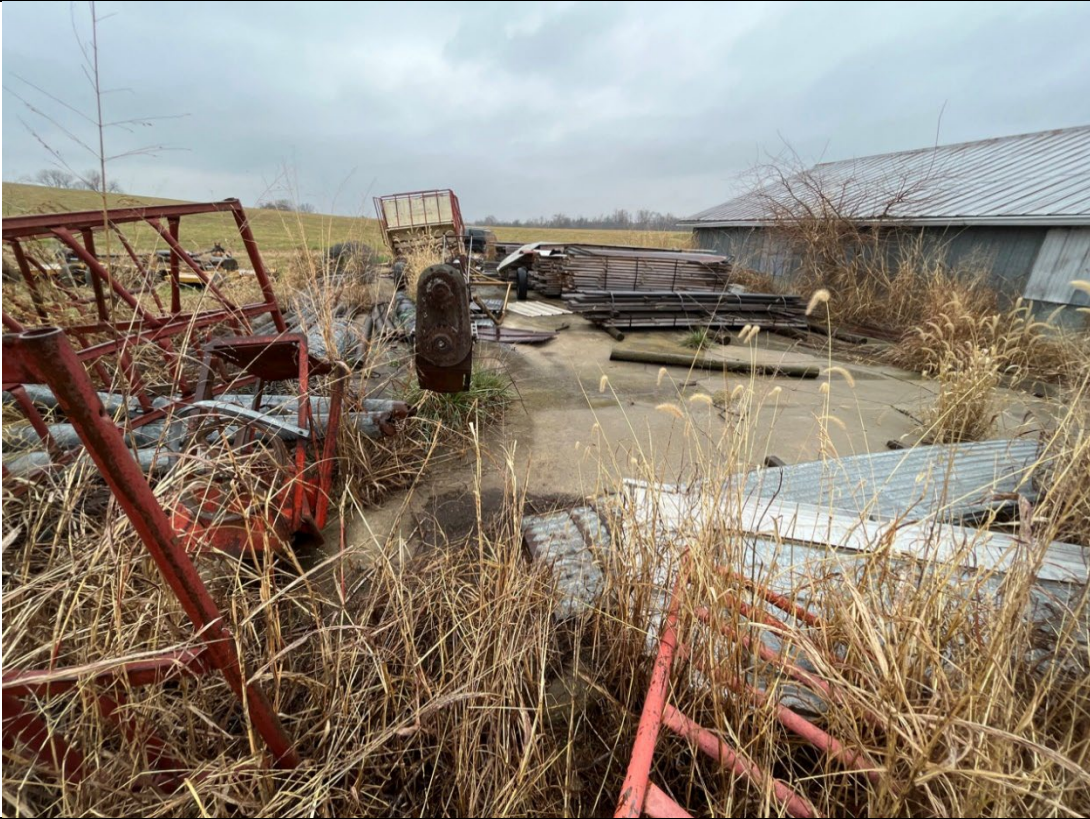
Photograph: 21 | View of a concrete foundation with equipment and building materials.

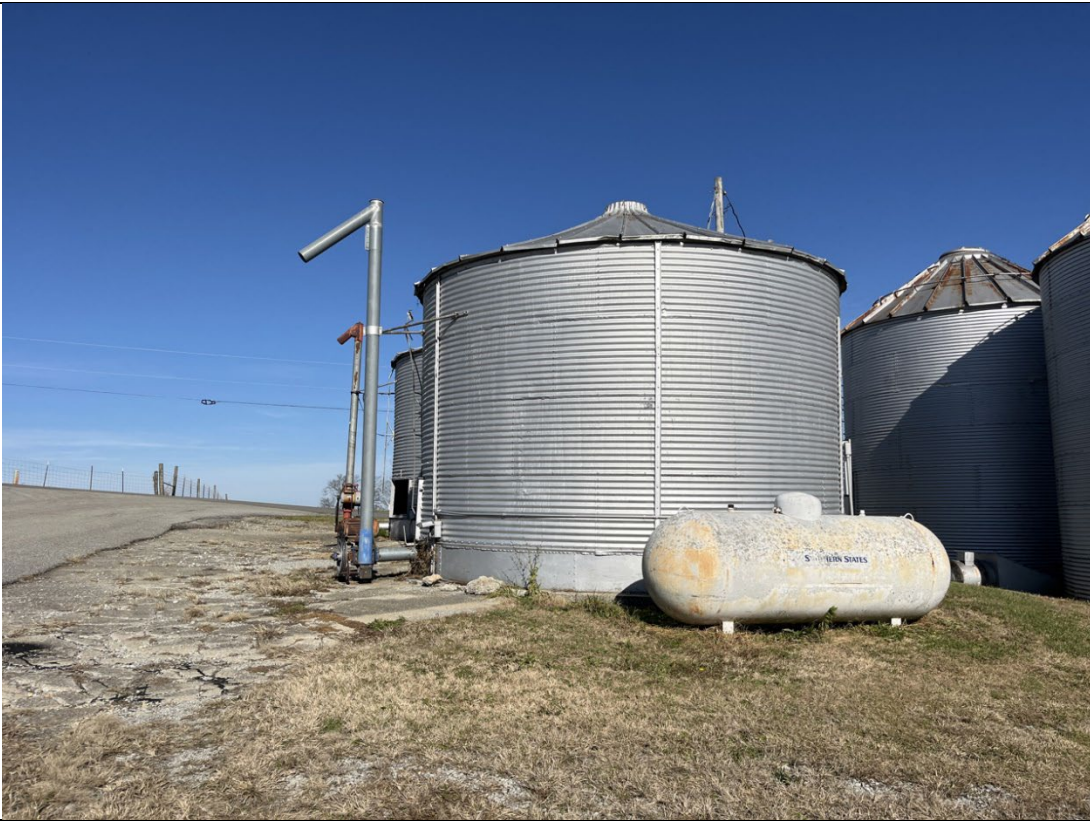
Photograph: 27 | View of silos with AST along McLain Rd.

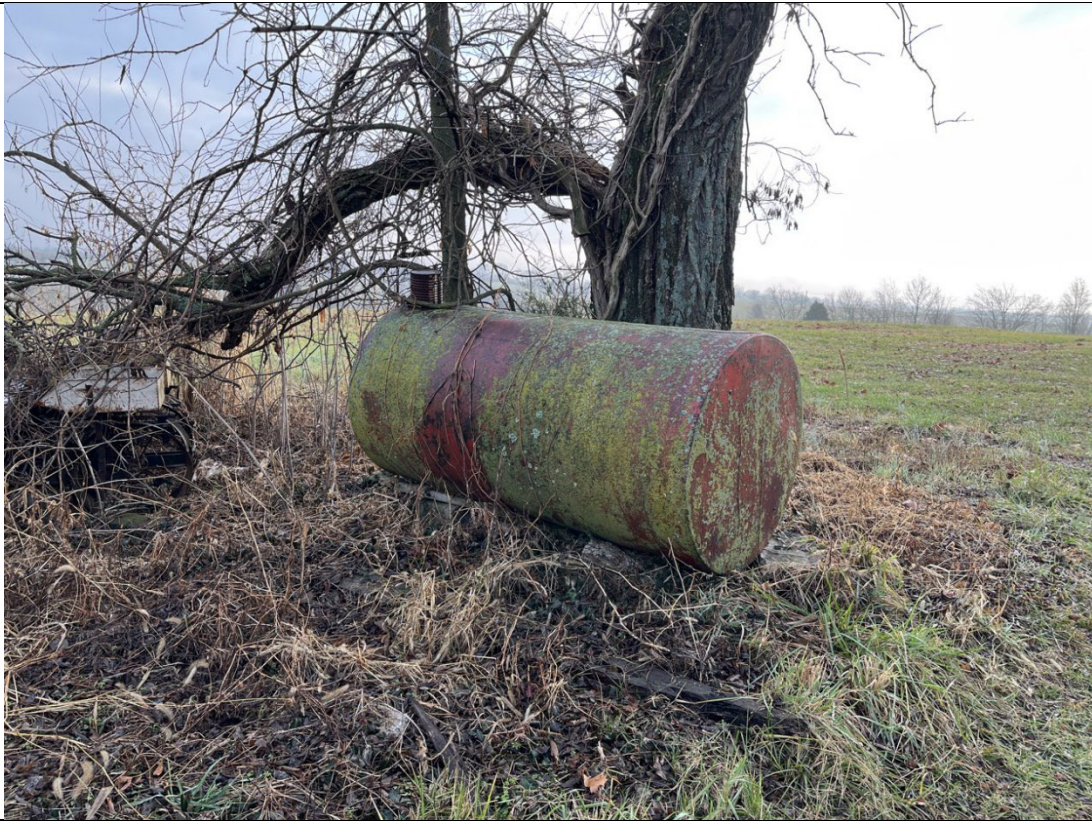
Photograph: 39 | View of AST along Lebanon Rd
