# Subsidence Review

## Weirs Creek Solar Project Hopkins and Webster Counties, Kentucky

July 2023

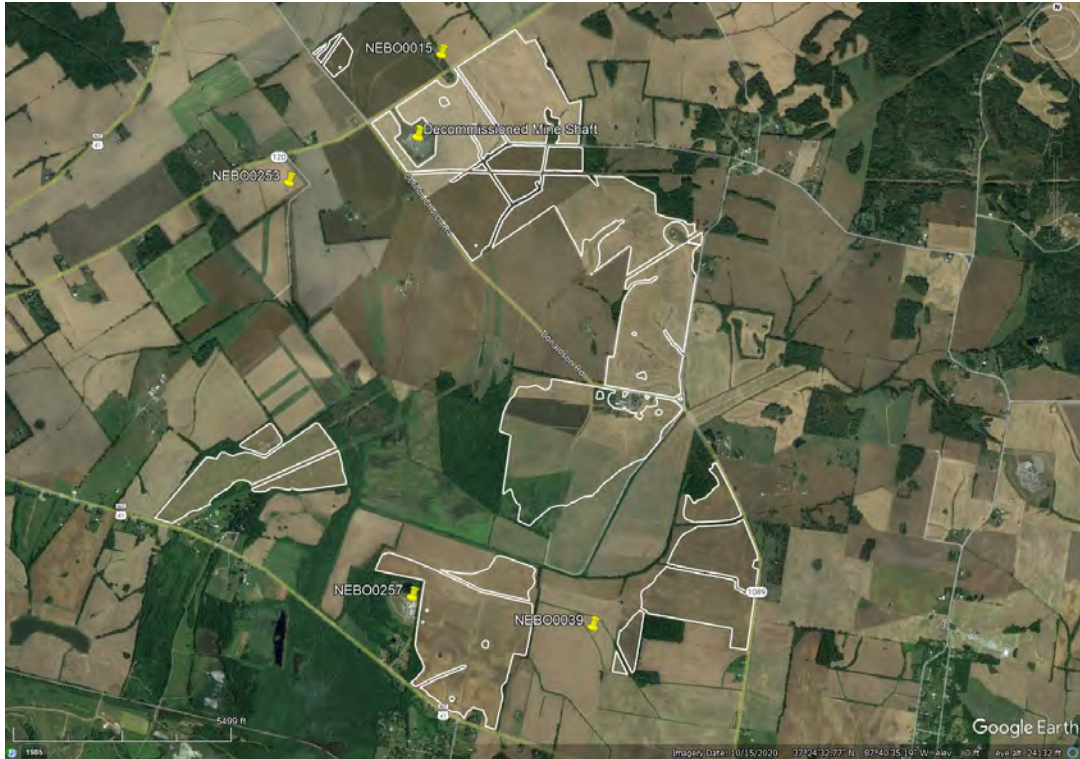
Tetra Tech used the information available from the University of Kentucky database to review lithological data from boreholes drilled in proximity to the Project Area. The lithological information from the boreholes shows a small vertical section of the formations, including coal seams and other rock formations, below the surface. Tetra Tech selected four boreholes to evaluate depth to coal seam from the surface. The four boreholes were labeled the NEBO0257, NEBO0039, NEBO0253, and the NEBO0015. These boreholes are highlighted in yellow in **Figure 6**.

**Figure 6: Borehole Locations (Google Earth)**

The NEBO0257 borehole lithology denotes the WKy No 13 seam located 245.5 ft to 253.3 ft below the surface. The next recoverable seam was the WKy No 9 seam located 359.5 ft to 363.4 ft below the surface. In this instance, the borehole tagged an existing mine workings where the coal had been mined out previously. (location: 37.392792, -87.686851, drilled in 1984 by Consol with Island Creek Coal Co.)

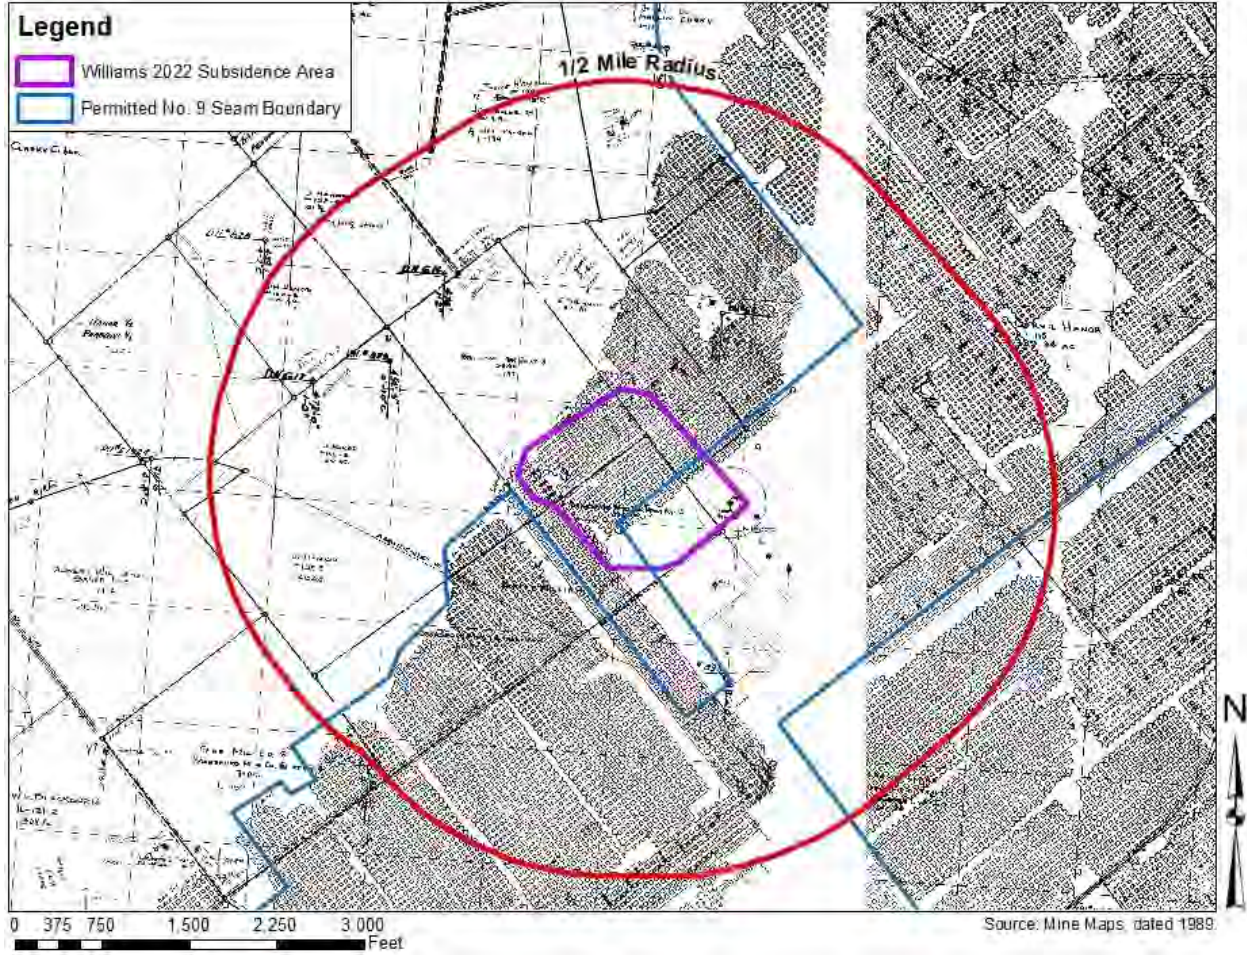
There are two coal seams within the area of concern, both containing documented mining. The No. 9 coal seam (also known locally as the WKY #9 seam) is located approximately 412 feet below the elevation of the Williams property. This seam contains underground mining permitted by Webster County Coal LLC, Permit No. 917-5013, and was conducted directly beneath the Williams property (Figure 3). The mining in this area took place from 1973 to 1974. See Table 2 for the transfer history of this permit. Note that the No. 9 seam mining in this area was conducted pre-law<sup>6</sup>. It was then added to Webster County Coal Corporation Permit No. 717-5000. A small part of the underground works in the No. 9 seam under the Williams subsidence area are still permitted under Webster County Coal LLC Permit No. 917-5013 (Figure 3). This permit is currently in O2 status<sup>7</sup>, and remains under the jurisdiction of DMRE.

Figure 3. 1989 Mine Maps showing documented coal mining in the No. 9 seam within ½ mile radius of the Williams property, by Webster County Coal LLC, Permit No. 917-5013 from 1973-1974.

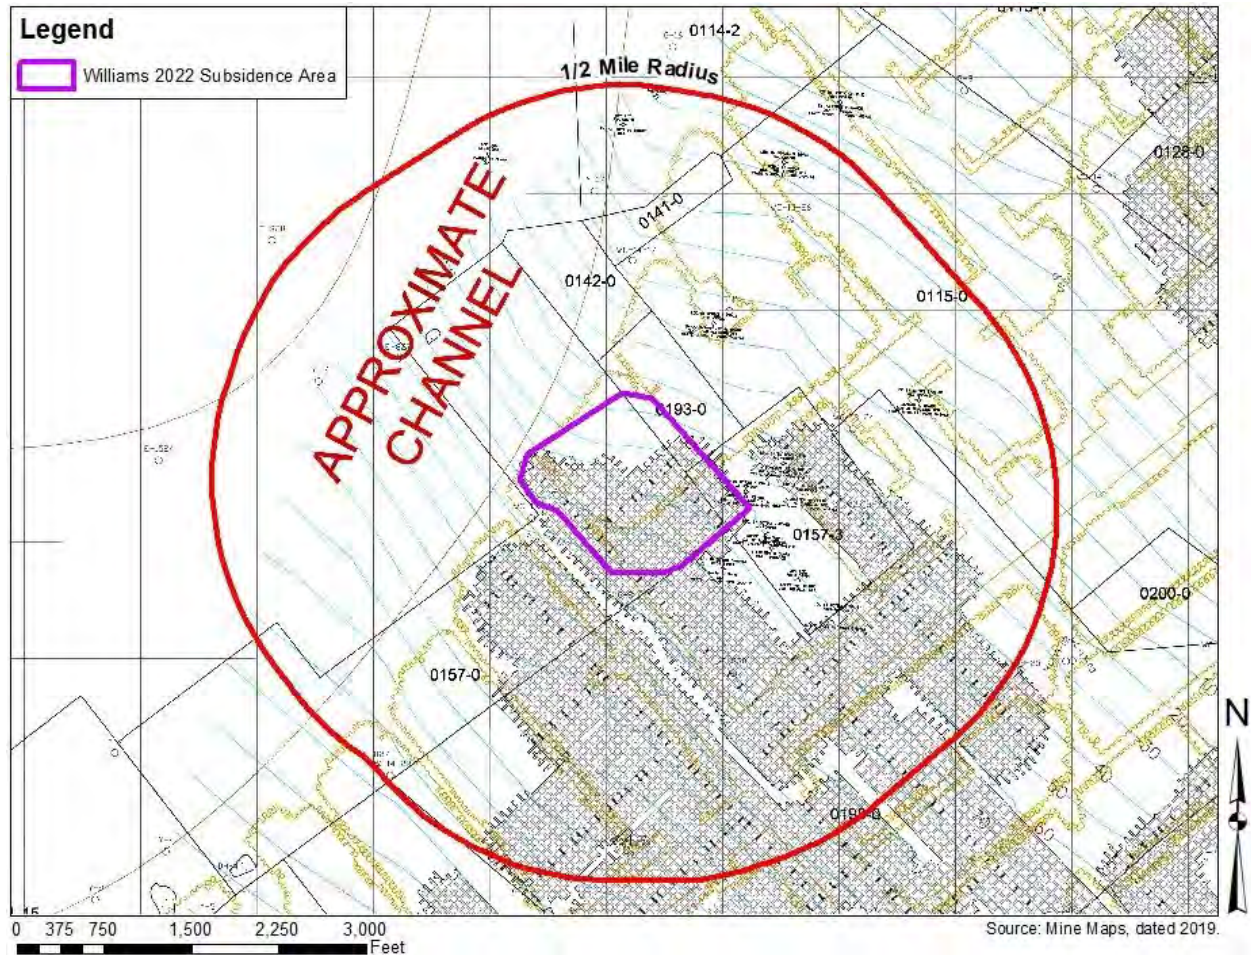
The No. 13 coal seam (also known locally as the WKY #13 seam) is located approximately 312 feet below the elevation of the Williams property. This seam contains underground mining permitted by Webster County Coal LLC, Permit No. 917-5023, and was conducted directly beneath the Williams property (Figure 4). The mining in this area took place in 2014. This permit is currently in A2 status<sup>8</sup>, and remains under the jurisdiction of DMRE. This mining was also over permitted by Webster County Coal LLC, Permit No. 917-5013.

Figure 4. 2019 Mine Maps showing documented coal mining in the No. 13 seam within ½ mile radius of the Williams property, by Webster County Coal LLC, Permit Nos. 917-5023 and 917-5013.

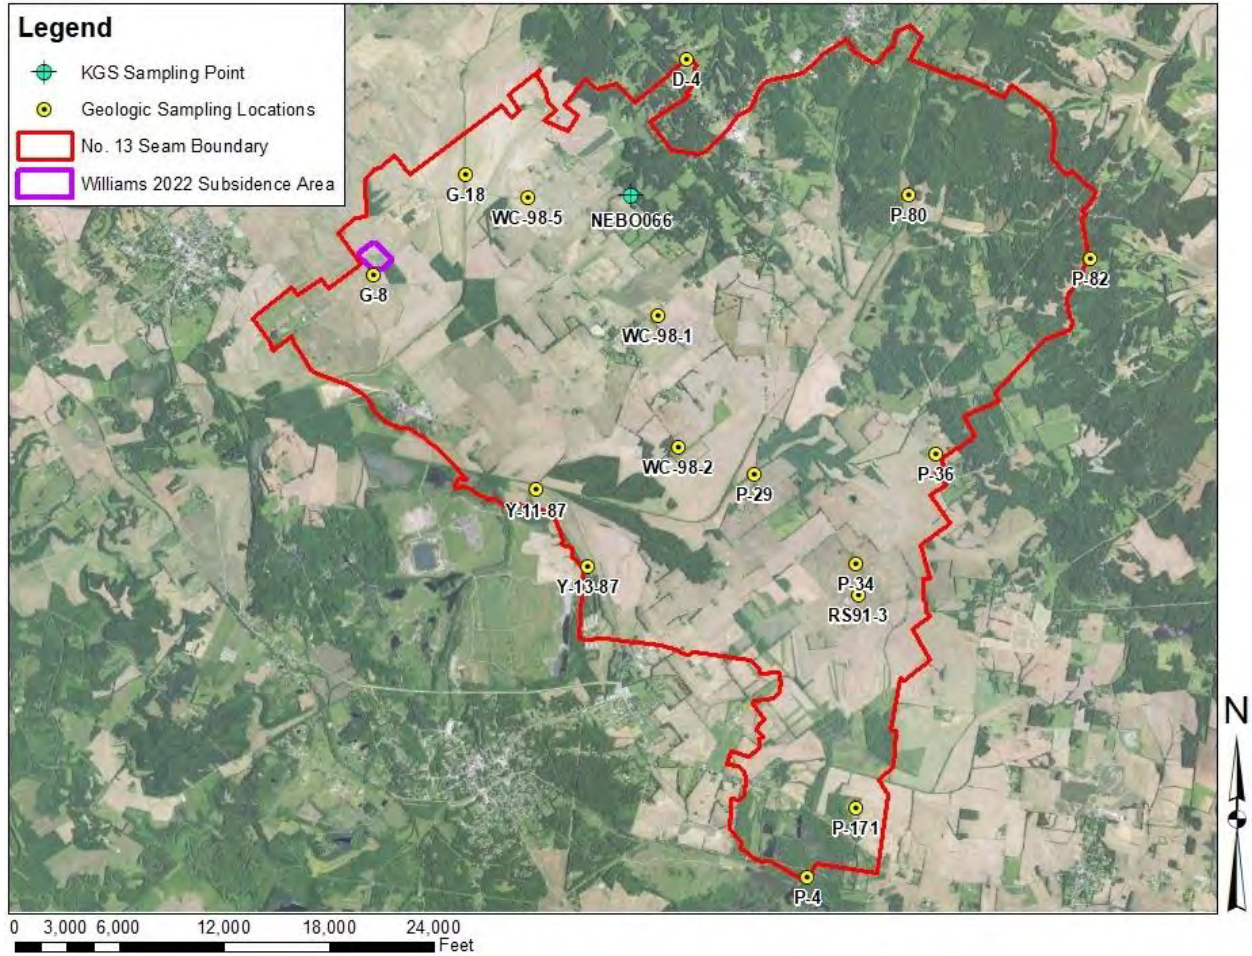
The lithology of Kentucky Geological Survey Borehole NEBO066 (Appendix A) was compared to the geologic sampling points from Webster County Coal LLC, Permit No. 917-5023, and found to be similar. This borehole is located approximately 2.7 miles northeast of the Williams property, closer than most of the sampling points from the permit (Figure 10). This borehole contained nearly 80 feet of slates and shales above the No. 9 coal seam. The No. 9 coal seam was found to be 4.8 feet thick in this location, with 2.7 feet of fireclay beneath it. Over 160 feet of shale is located above the No. 13 seam at this location. The No. 13 seam is 8.2 feet thick here, with a 1.5 foot band of gray shale within it. The floor is comprised of a 9.8 foot thick gray clay.

Figure 10. 2020 Aerial photograph showing geologic sampling locations for Webster County Coal LLC, Permit No. 917-5023 and a nearby Kentucky Geological Survey borehole. Note that geologic information was unavailable for the No. 9 seam at the WC-98-1, WC-98-2, WC-98-5, D-4, P-4 and P-171 locations.
